# Appendix 10

## Hydrology, Geology and Hydrogeological Assessment

## A10.1 WATERCOURSE CROSSING ASSESSMENT

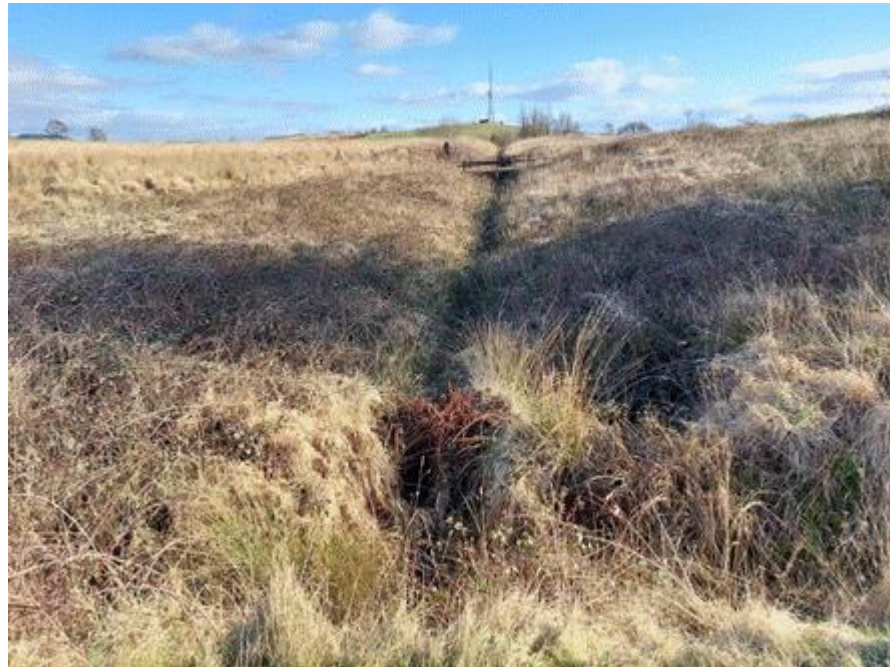
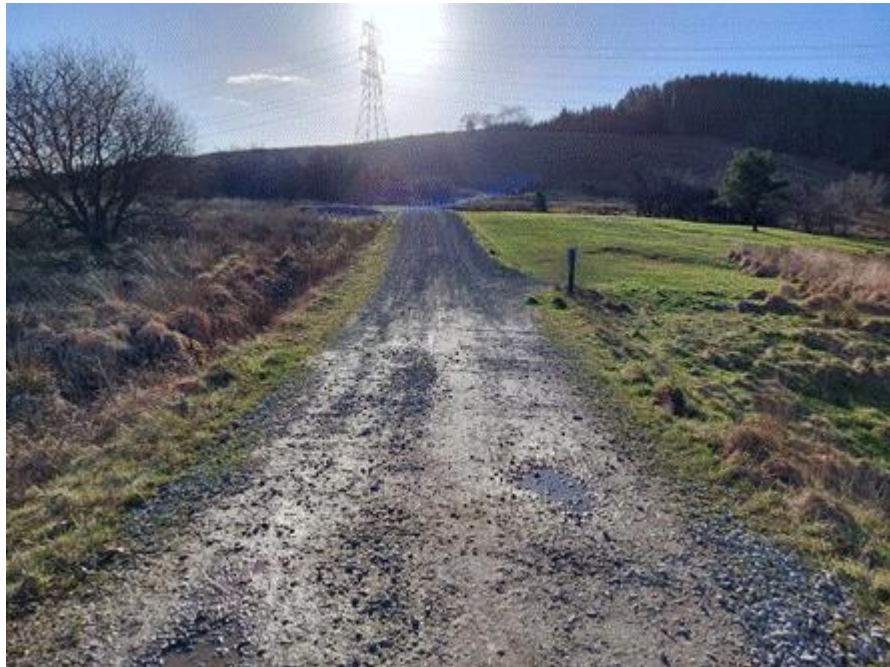
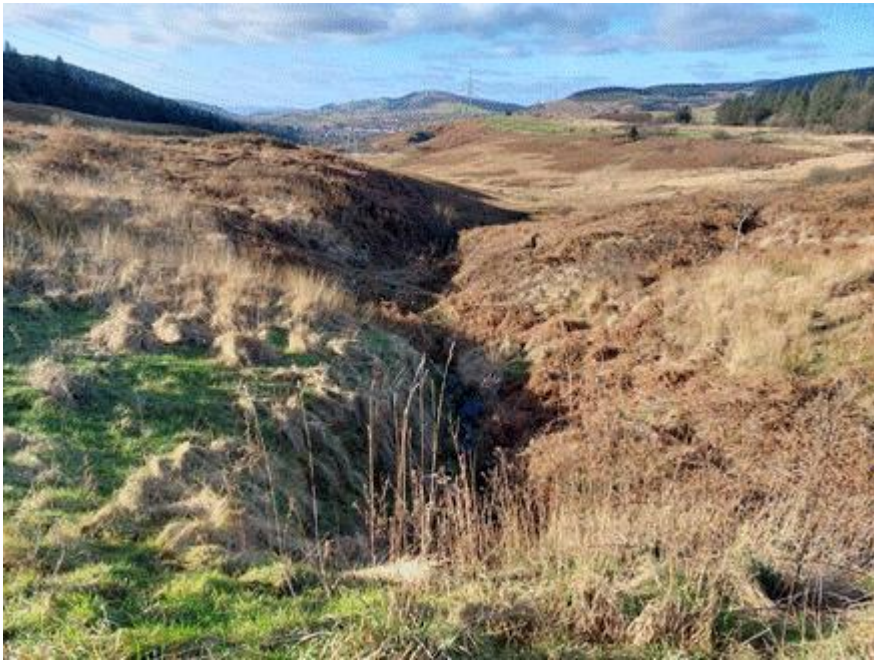
Table A10.13: Crossing WX12

| WX12 (283595, 191540) | | |
|---|---|---|
| <div></div> <p>© Crown Copyright 2023. All rights reserved. Ordnance Survey Licence 0100031673.</p> | <ul style="list-style-type: none"><li>• <b>Existing Crossing:</b> Yes</li><li>• <b>Crossing Type (existing):</b> Circular Culvert</li><li>• <b>Crossing Material (existing):</b> Concrete</li><li>• <b>Crossing Condition (existing):</b> Good</li><li>• <b>Channel Type:</b> Incised</li><li>• <b>Gradient:</b> Moderate</li><li>• <b>Valley form:</b> Deep vee</li><li>• <b>Bank condition:</b> Stable</li><li>• <b>Bed material:</b> Boulders, Coarse gravel, Fine sand/silt</li><li>• <b>Riparian corridor:</b> Moorland, Heavily Vegetated (e.g., gorse, bramble), Other</li><li>• <b>Flow condition:</b> Moderate</li></ul> <ul style="list-style-type: none"><li>• <b>Culvert Dimensions (m):</b> 0.5</li><li>• <b>Water width (m):</b> 0.4</li><li>• <b>Water depth (m):</b> 0.05</li><li>• <b>Bankfull width (m):</b> 1.7</li><li>• <b>Bankfull height (m):</b> 0.7</li><li>• <b>Notes:</b> On golf course. Less incised upstream of culvert</li></ul> | |

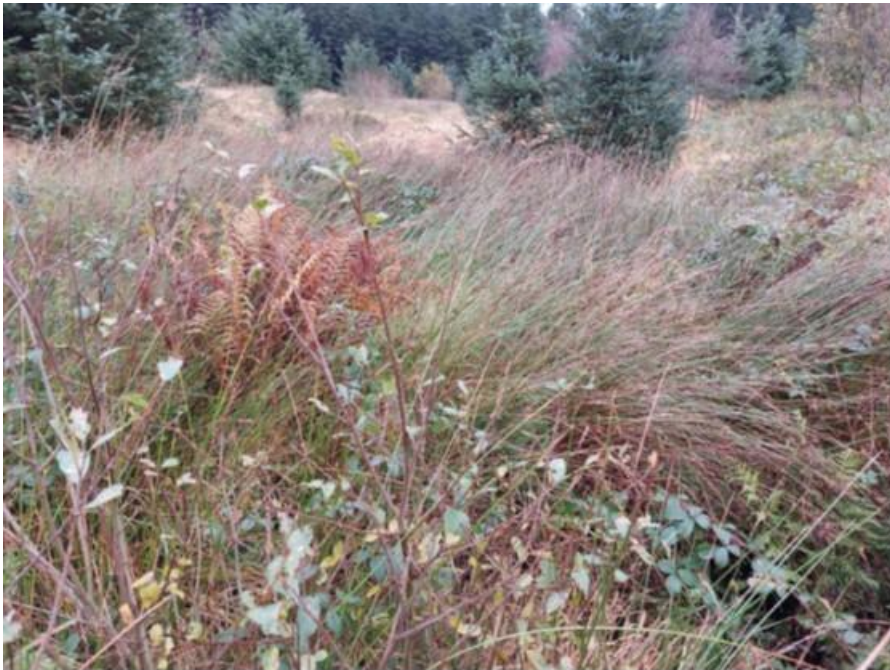
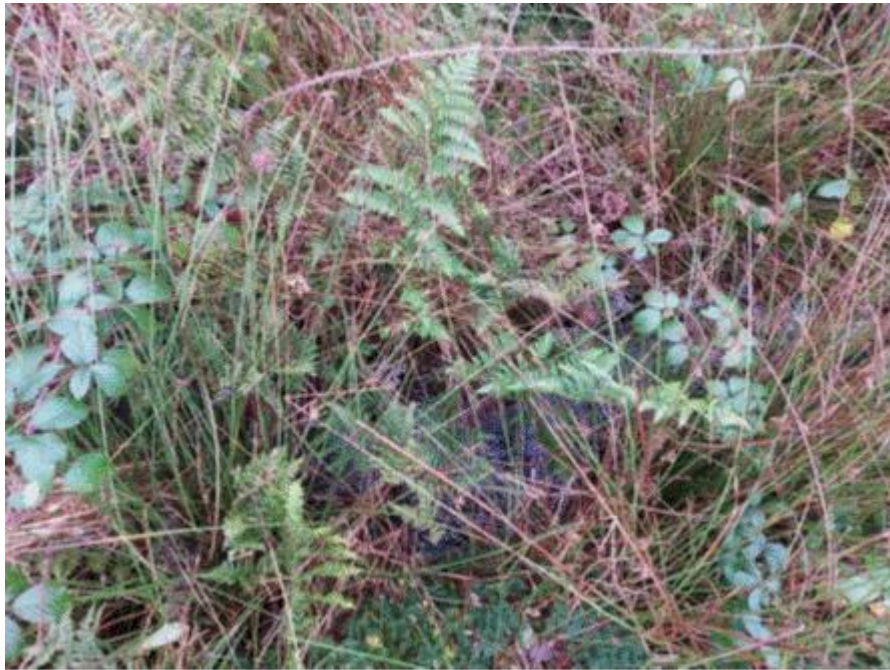
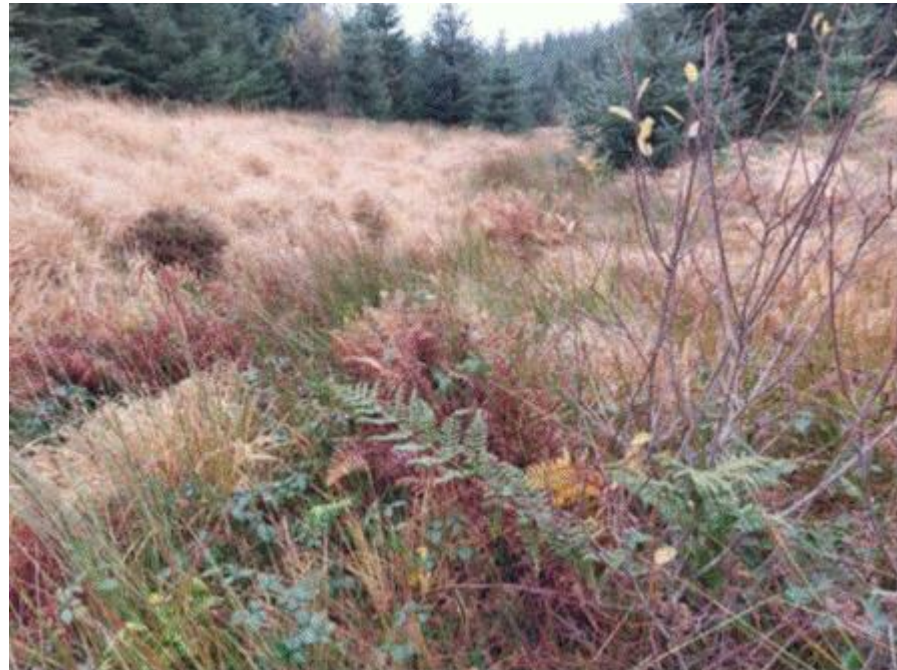
Table A10.14: Crossing WX13

| WX13 (283686, 193024) | | |
|---|---|---|
| | <ul style="list-style-type: none"><li>• <b>Existing Crossing:</b> No</li><li>• <b>Channel Type:</b> Incised</li><li>• <b>Gradient:</b> Moderate</li><li>• <b>Valley form:</b> Shallow vee</li><li>• <b>Bank condition:</b> Stable</li><li>• <b>Bed material:</b> Rounded pebbles, Coarse gravel, Fine sand/silt</li><li>• <b>Riparian corridor:</b> Heavily Vegetated (e.g., gorse, bramble), Productive Forestry</li><li>• <b>Flow condition:</b> Moderate</li><li>• <b>Water width (m):</b> 0.7</li><li>• <b>Water depth (m):</b> 0.15</li><li>• <b>Bankfull width (m):</b> 0.7</li><li>• <b>Bankfull height (m):</b> 0.7</li><li>• <b>Notes:</b> None</li><li>• <b>Proposed Crossing Type:</b> Circular Culvert</li></ul> | |
