# DEAN & THOMAS LTD

Our Ref: MJD/LKL/7085

**RE: 30 Queen Street, Neath, SA11 1DL**

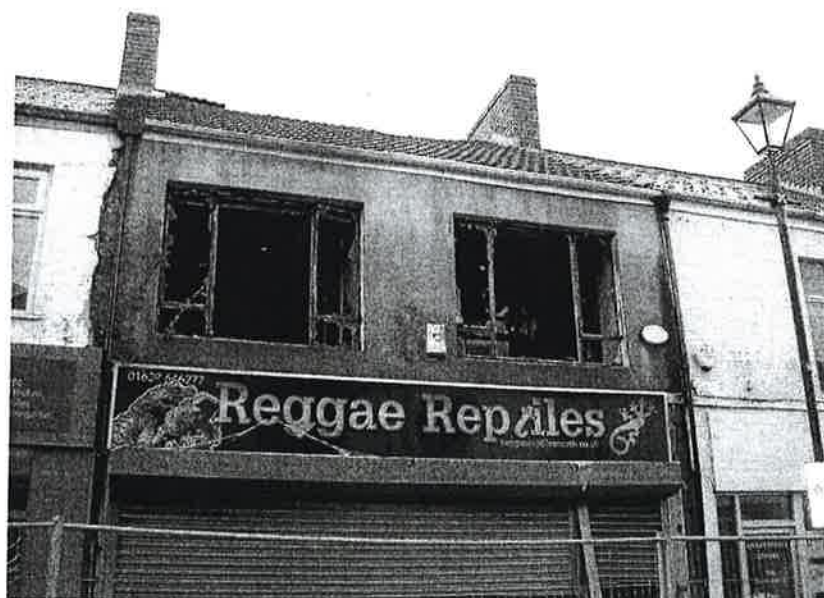
*Photo 1.*

The main roof is concrete-tile finished, and of conventional rafter and purlin construction. A main timber truss provides support to the purlins about midway between party walls. Inspection from Queen Street shows ridge tiles to be missing but front slope roof tiles to be mainly intact. (See Photo 1.)

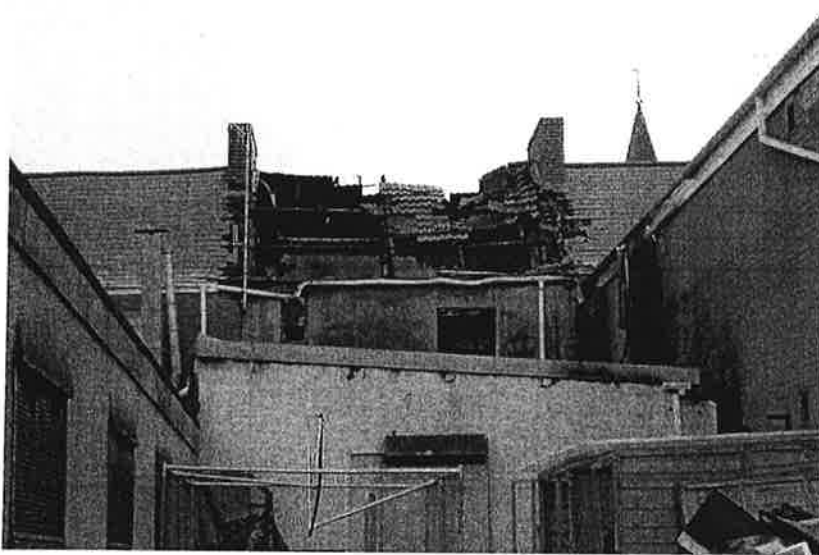
***Photo 2.***

Inspection from the rear of the premises shows the majority of rear slope roof tiles and rafters to no longer be present – purlins and main roof truss visually appear badly fire-damaged and at least one purlin appears to have dropped. Both adjoining properties have a slate roof finish – slates have been lost above both party walls. Both party walls are now exposed to the weather, and water ingress into the walls is almost certainly taking place. (*See Photo 2.*) The condition of the roof is such that a full-collapse of the roof could occur at any time, particularly should the weather become windy. In view of the risk to the public safety I recommend the main roof be taken down as a matter of urgency.

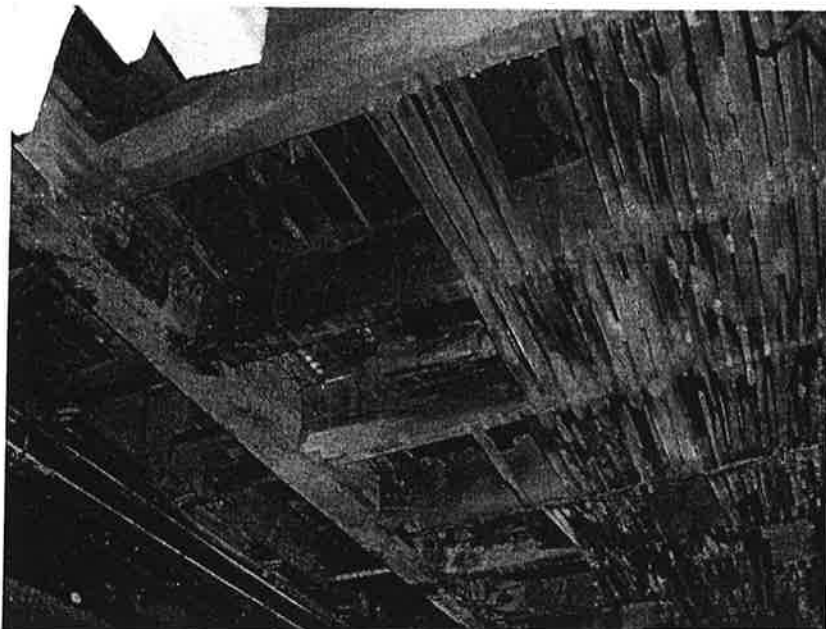
***Photo 3.***

First floor construction comprises timber joists spanning front-to-rear. At the front wall the joists were notched into the web of a steel beam spanning the shop-front window. Movement has occurred between the timber joists and steel beam resulting in the joists no longer bearing onto the beam. (*See Photo 3.*)

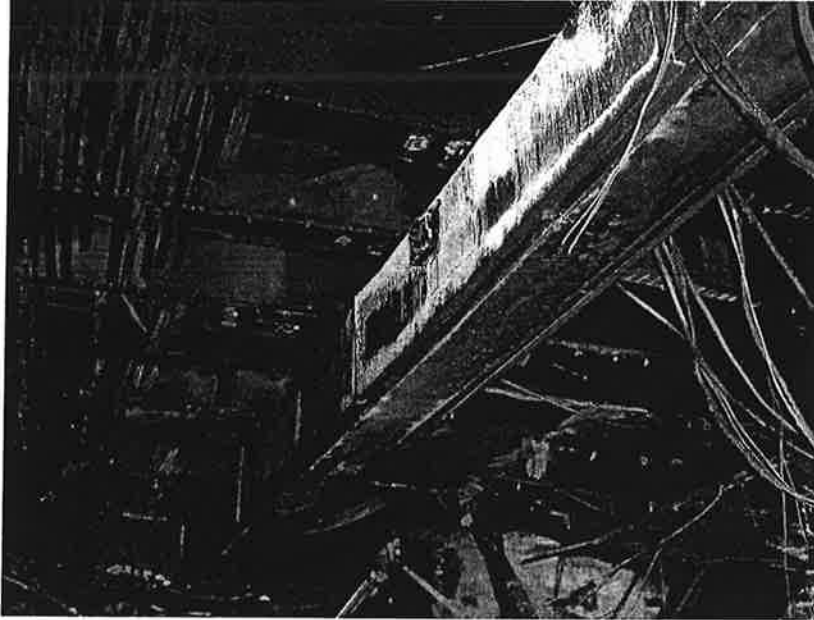
***Photo 4.***

Approximately midway between the front wall and rear wall a steel beam is present below the joists spanning the width of the shop – the steel beam appears to be relatively undamaged. (See Photo 4.)

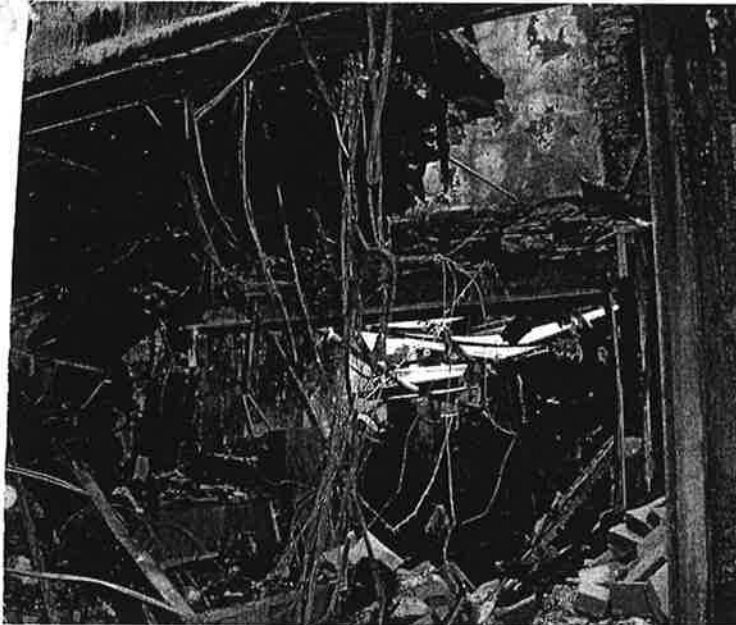
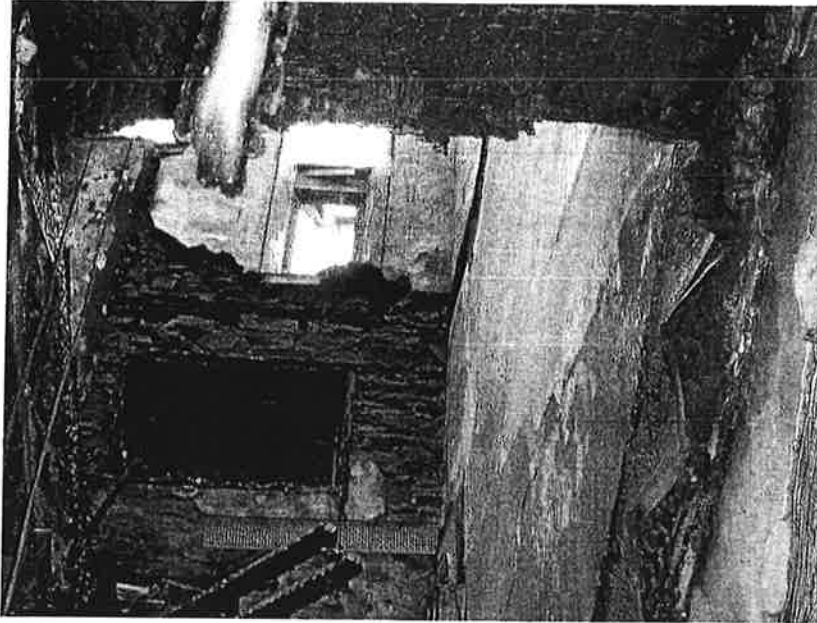
The majority of joists no longer extend to the rear wall due to collapse of the fire-damaged floor construction. (See Photos 5 and 6.) The stairs up to the first floor have been destroyed by the fire. The condition of the first floor construction is such that the floor is unsafe and at risk of further collapse.

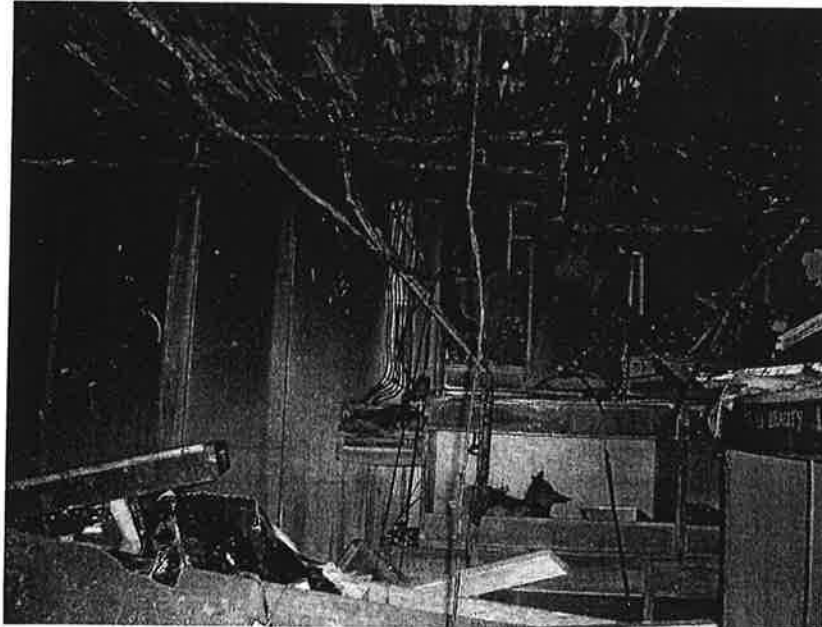
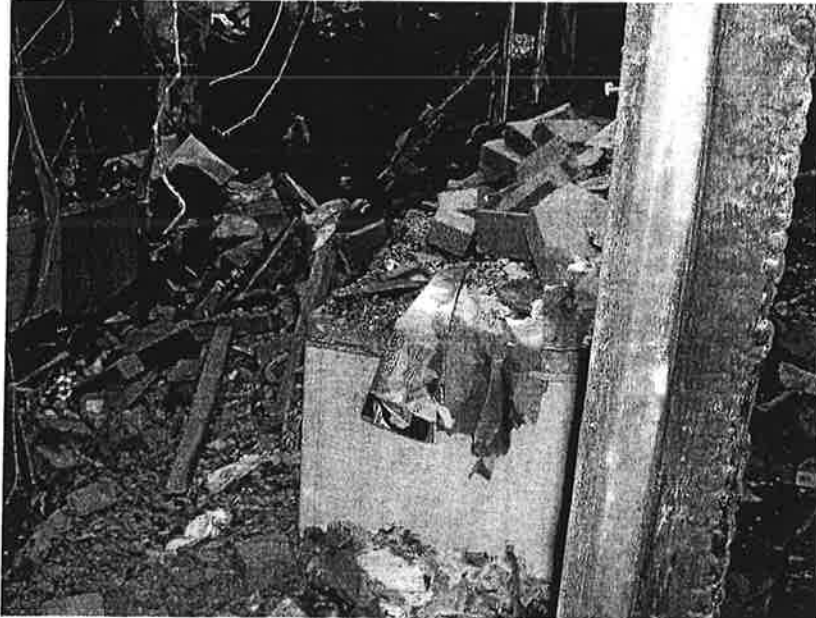
The floor is timber construction. The Fire Department have formed a 'safe' access over the right-hand part of the floor which was necessary to access residual smouldering of the fire within the basement. The remainder of the floor is covered in fire debris and is considered unsafe to access. (See Photos 7 and 8.) Timber trimmer supports to the floor penetrate the party wall and some fire-spread has occurred into the left-hand part of the adjoining right-hand premises.

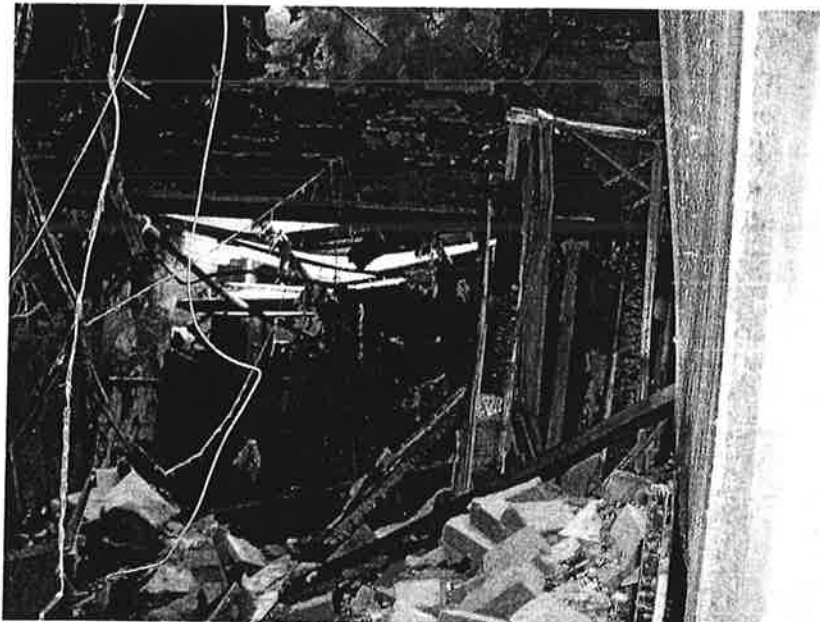
**Photo 9.**

Close inspection not possible. Steel beam support to the wall is present above the opening into the single-storey rear extension. (See Photo 9.)

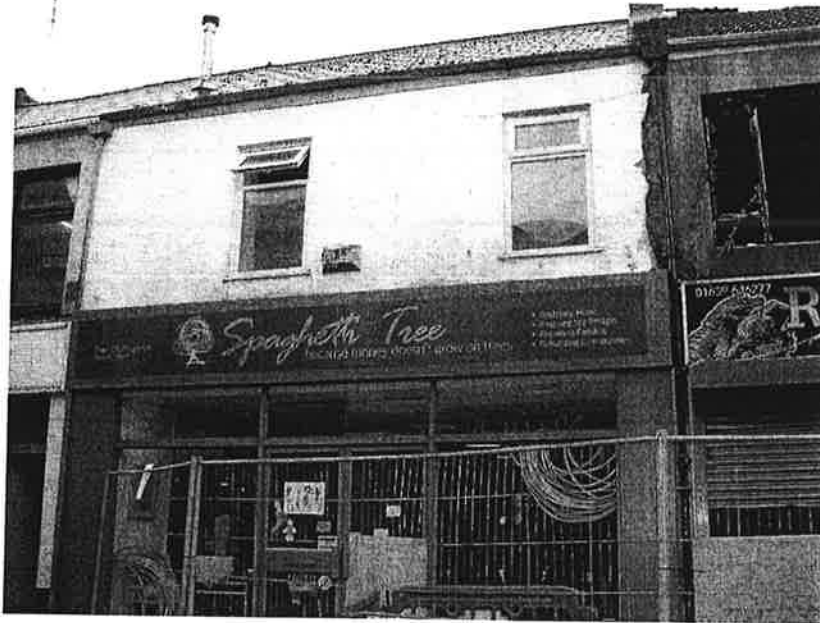
*Photo 10.*

The premises to the left is a Charity Shop trading as 'Spaghetti Tree'. (See Photo 10.) The premises to the right is an adult learning centre trading as NPTC Group Queen Street Campus. (See Photo 3.) Both premises are presently not accessible from Queen Street due to Heras fencing extending across the frontage of both properties. As noted previously the party walls of both premises are now exposed to the weather, and some fire spread has occurred into the NPTC Group building from the basement of No. 30. I anticipate that both adjoining owners have submitted claims to their Buildings Insurers. Party Wall Surveyors will need to be appointed, and the extent of damage to both adjoining premises inspected and assessed.
