# Crymlyn Tip Coed Darcy

## Stability Assessment

St Modwen Developments Ltd  
R1870/23/5287 - Rev 0B

March 2023

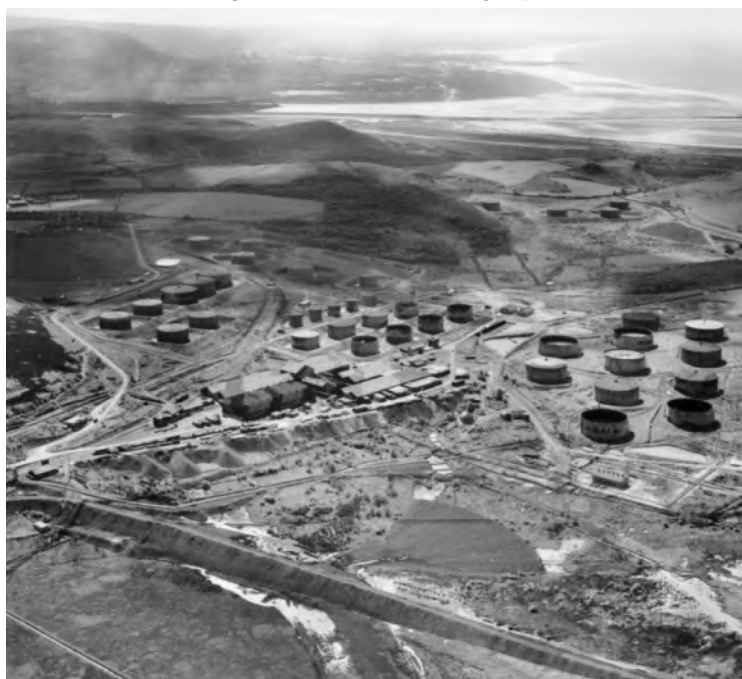
**Figure 1: 1947 Photograph**

It appears that disposal of waste is active in the eastern part of the Tip. Waste is being spread from an access road in the north, and it appears that waste material is potentially being informally deposited from the railhead adjacent to the eastern Tip boundary. Tracks across the centre of the Tip suggest that waste disposal may have taken place in the west by this date. It is understood that at this time, the Tip was used for disposal of a range of refinery wastes including demolition waste, refractory waste and asbestos.

A photograph from 1951 shows the entire area of the Tip looking to the west across the railhead. More extensive waste disposal appears to have taken place in the north eastern corner of the Tip, over the earlier waste deposits and to the same height as the ash bund. The western end of the Tip is flooded, and appears to be natural, marshy ground.

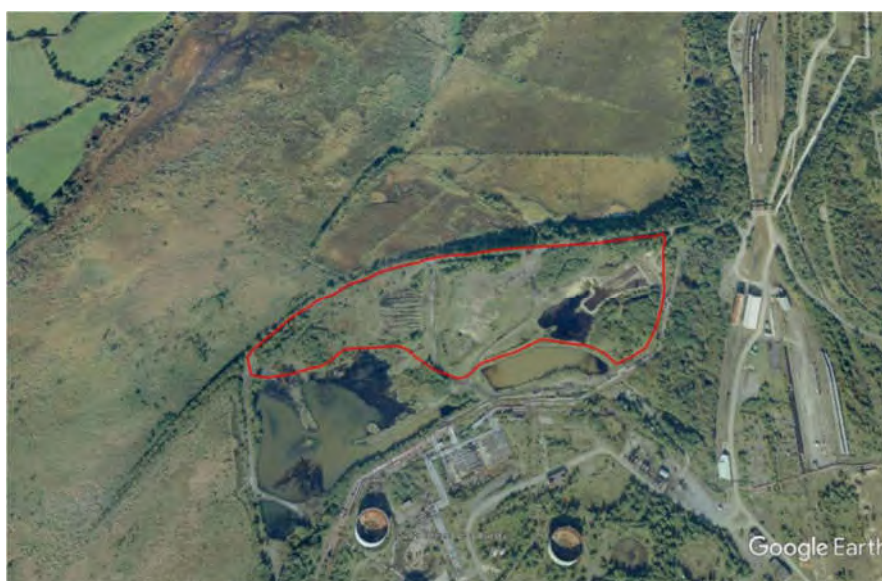
**Figure 2: 1999 Aerial Photograph**

Use of Site 2 for the disposal of substantially oil free general waste was discontinued in November 1999, no waste has been disposed of since 1999, with the site declared non-operational in 2001. The aerial photograph from circa 1999 coincides with the cessation of waste deposition at the Tip. The Tip is well vegetated with grass and scrub vegetation throughout, and dense patches of woodland in the north, east and west. A series of material windrows are located directly to the west of the road which passes through the centre of the permit area aligned north to south. To the east of the road there appears to be a large stockpile of loosely tipped material. Two lagoons are present in the east of the Tip which are understood to correspond with the reported locations of sludge pits.

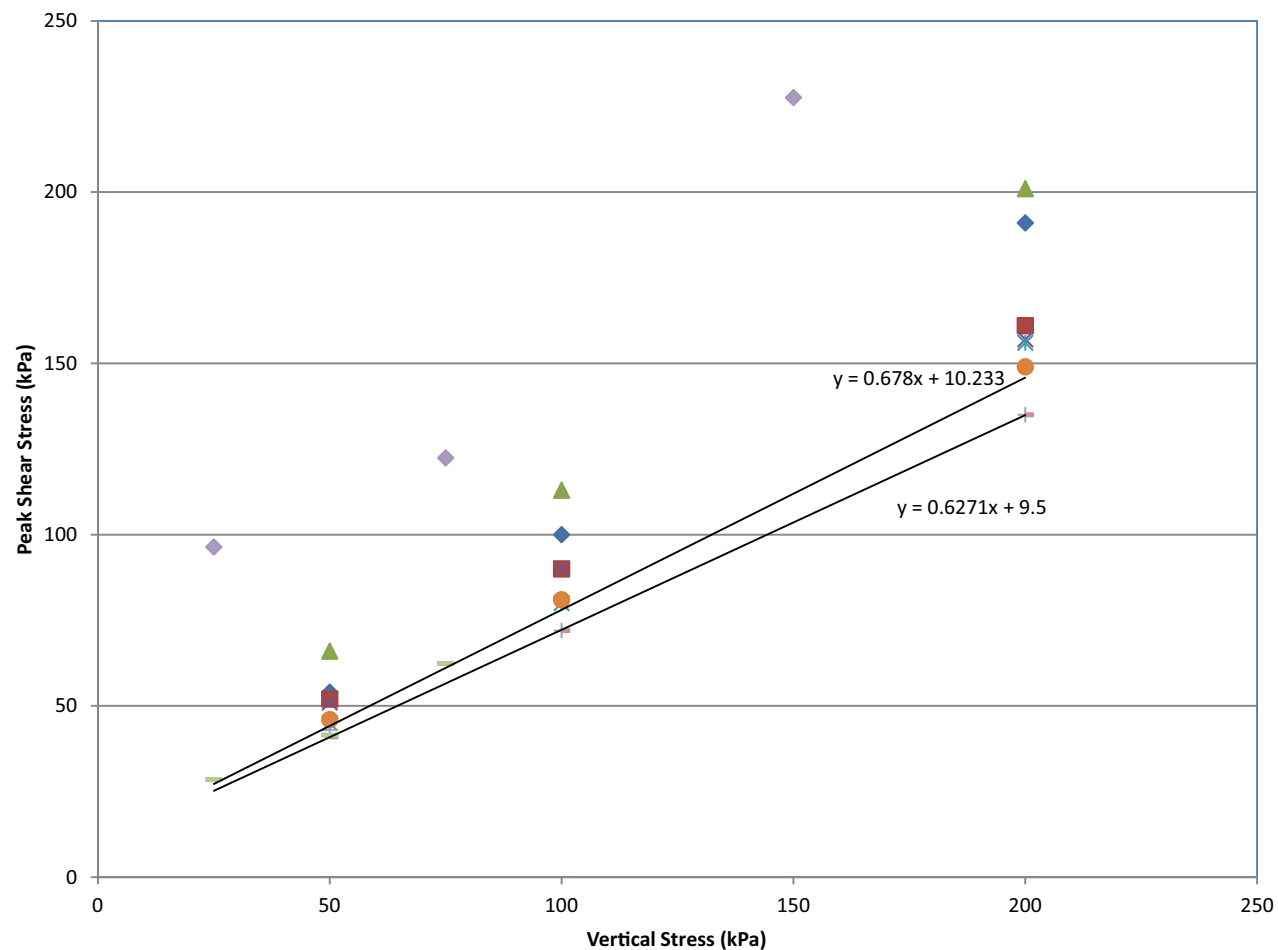
## Summary of Shear Box Testing - Ash Bund and Wastes

Shear box testing was undertaken on two samples, one a combined sample. Figure K6 shows the results of this testing in which Peak Shear Stress is plotted against vertical stress. Use of residual strength parameters is not appropriate for consideration of first-time failures and generally granular materials do not show high brittleness under drained loading conditions. Also shown on this plot are the results of the Atkins testing on waste material ('Batch 1', 'Batch 2' and 'Waste'). The lower bounds from the two datasets are as follows:

The second ash bund sample showed a very high apparent friction angle (47 degrees) and cohesion intercept (59 kPa). In the recent testing the samples were prepared in a loose state. The apparent relatively high cohesion intercept suggests that even in a loose state the material is somewhat dilatant when sheared. This is most likely due to the angular nature of the gravel, which includes ash, clinker and slag.

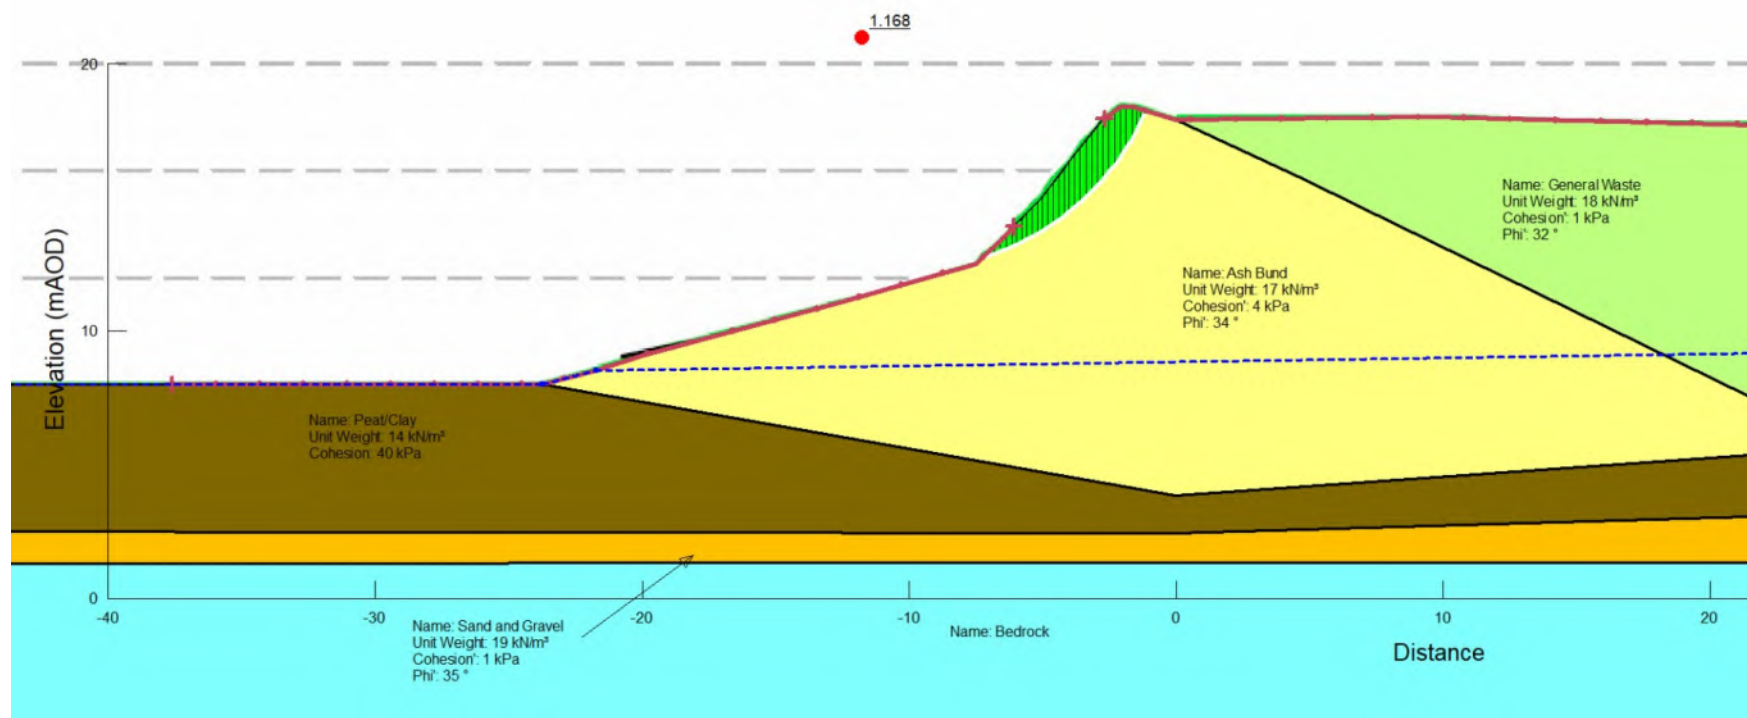
Title  
Typical Critical Failure Surface in Ash Bund

The procedure adopted was to undertake a series of analyses considering each mode for Sections EE and FF, refer to Addendum K1, as these are representative of the highest and steepest sections of the existing embankment where soft clay and peat are present in the foundation soils. Figures K9 and K10 show typical critical failure surfaces for this condition.

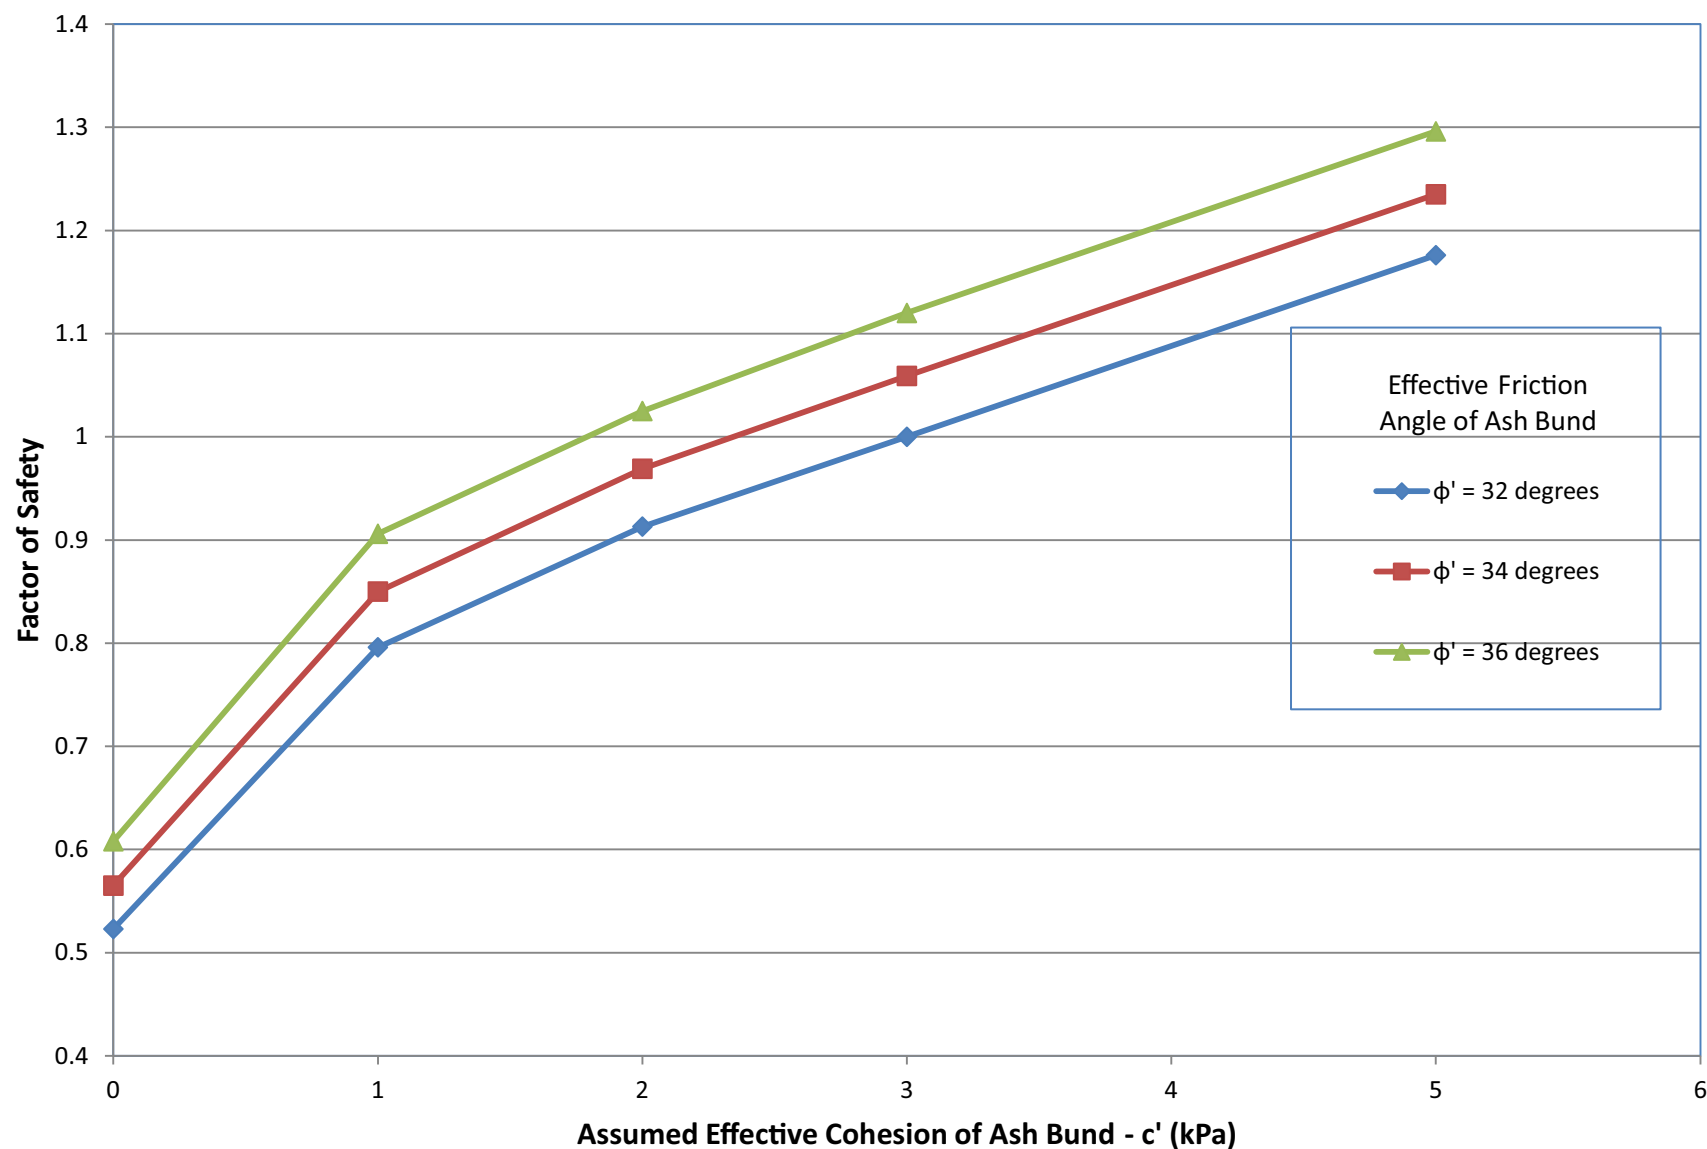
Title  
Section EE - Back Analysis of Existing Slope  
- Failure in Ash Bund

Figure K11 and K12 summarise the results of this analysis for Sections EE and FF, respectively, for shallow failures in the bund, the computed factor of safety is plotted against assumed effective cohesion intercept for various values of effective friction angle.

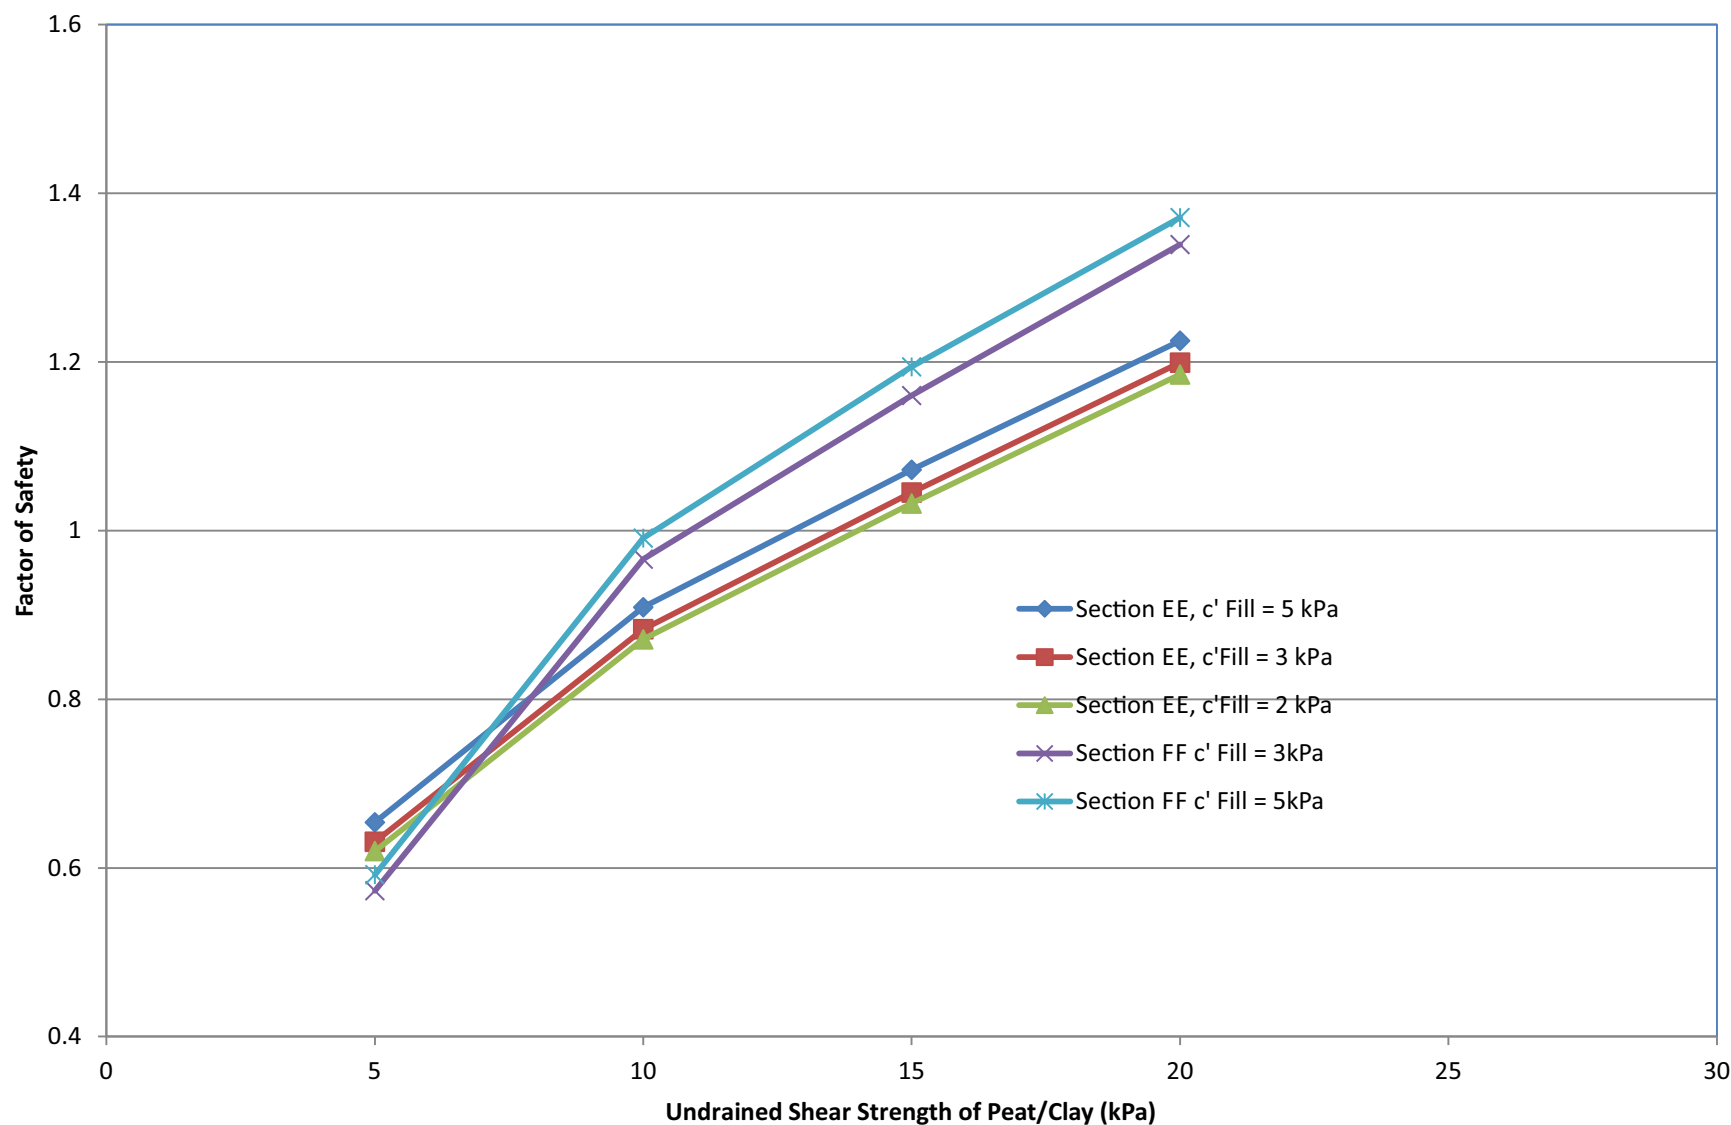
Title  
Back Analysis of Existing Slope  
- Deep Failure in Peat/Clay

Figure K13 summarises the results for deep failures in which factor of safety is plotted against assumed average undrained shear strength of the bog sediments. For this plot it is necessary to assume strength parameters for the ash bund material but for this mode of failure the results are not particularly sensitive to the assumed strength parameters for the ash bund.

In reality the bog sediments are likely stronger below the ash bund than in the main bog area and the above estimate is essentially an inferred minimum average value along potential failure planes.
