## Executive Summary: Desing Statement & Technical Solutions

## Urgent works needed due to settlement and failure of the party wall

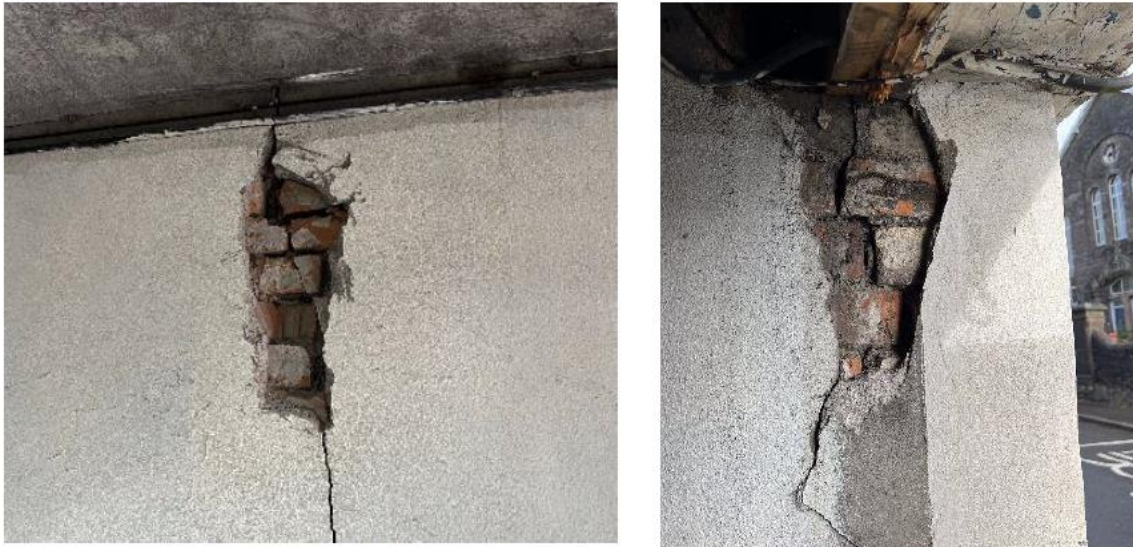
The buildings being of 59-69 redevelopment is critical due to the failure of party wall subjected to differential settlement. The party wall was subject to load transferring from overlaying beam, which was difficult for the soil under the wall with small step footing area of foundation to bear the load. Figure 1 show the failure of the party wall.

Figure 1. Differential settlement of the party wall

The new proposed plane is to remove the load from party wall and transfer it to newly constructed gable end Wall using 6" 10n blocks laid flat to form a 9" wall. The load is being transfer through two 9.5 m long simply supported steel beam having maximum bending moments of 111.86 KN-m. Figure 2 show the proposed plane of gable wall. Figure 3 show the locations of steel beams transferring the load to gable wall.

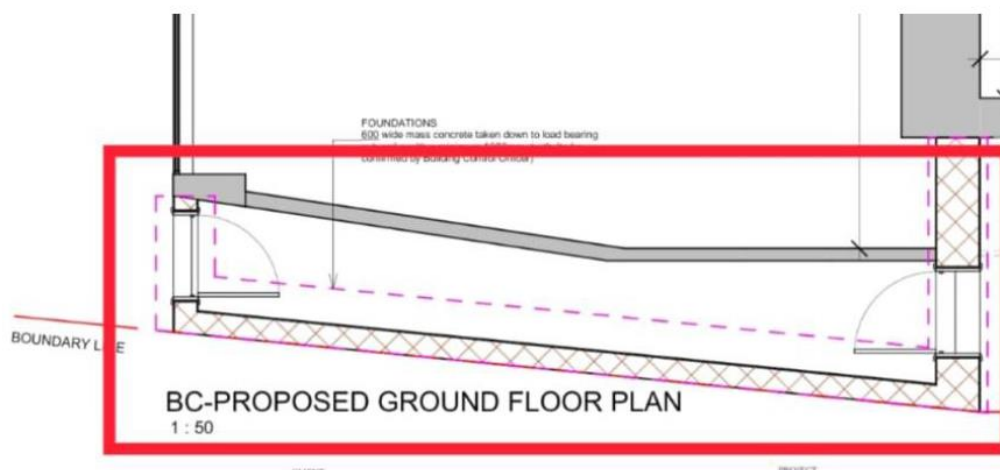
Figure 2. Proposed plane of gable wall and underneath footing

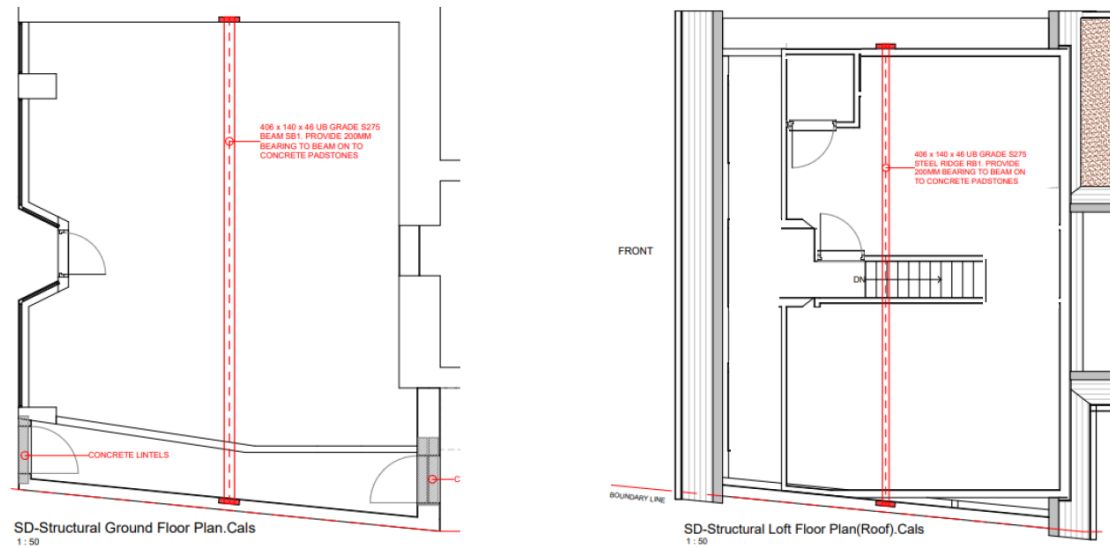
Figure 3. locations of steel beams transferring the load to gable wall

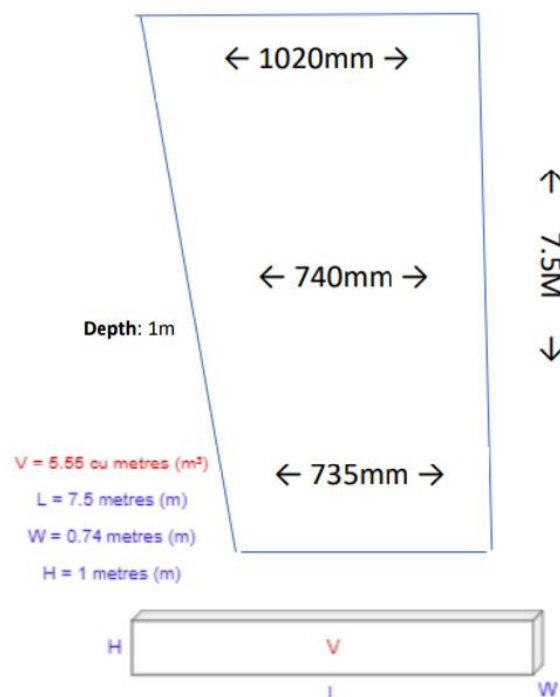
Figure 4. Dimensions of proposed foundation

To prevent the gable wall from producing identical outcomes of differential settlement, the footing is needed to be design with more care. The proposed footing for this project is 7.5m long, 0.735-1.02m wide, and 1 m deep wall footing under gable end with concrete C40 Structural (RC32/40 Material code 39250, cement CIIIA) and Fibrin XT fibers at the dosage of 0.9 kg/m<sup>3</sup>. Figure 5 show the dimensions of proposed footing.

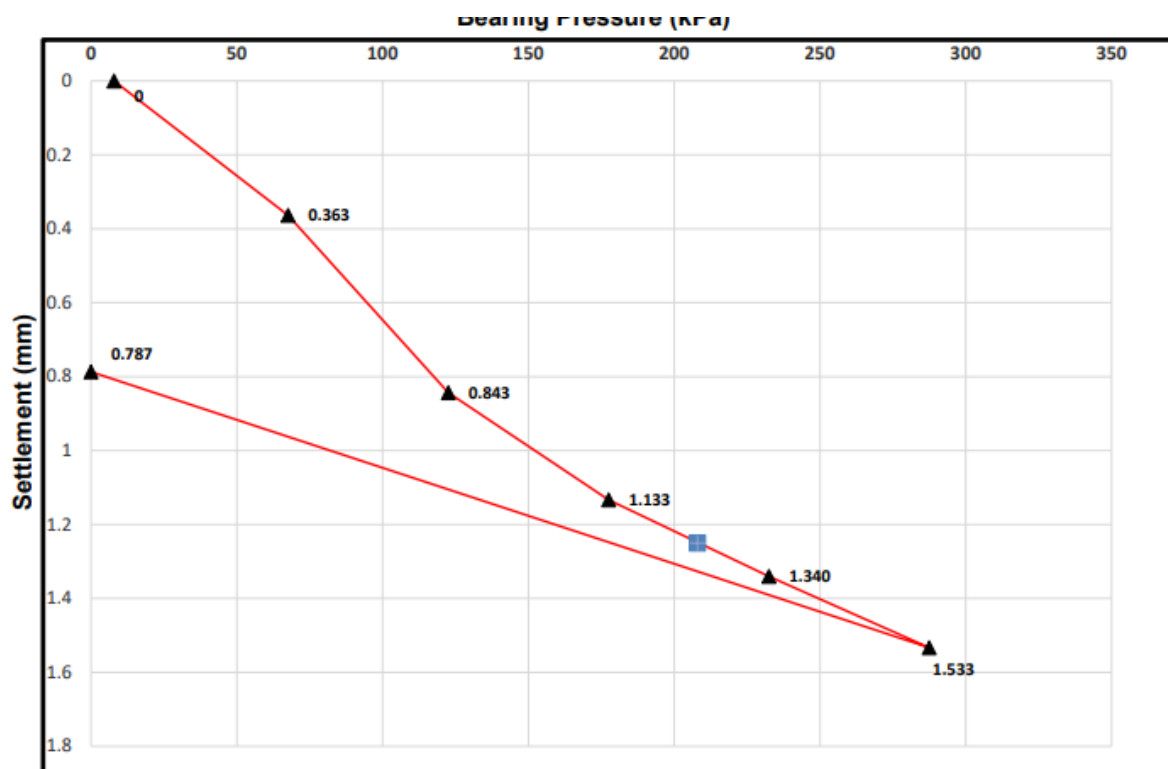
| Site Location | <b>63 Heol Cae Gurwen, Gwaun Cae Gurwen, Ammanford, Neath Port Talbot, SA18 1HG</b> | Test Location | <b>Plate 1</b> |

| Maximum Applied Pressure (kn/m <sup>2</sup> ) | 287.48 |
| Maximum Deformation (mm) | 1.53 |
| Modulus of Subgrade Reaction (k762) | 73.9 (kN/m <sup>2</sup> /mm) |
| CBR Value | 11 (%) |

The soil bearing capacity shows that the footings can hold the gable end without additional measures to distribute the loads, no further action is required as the Abaqus report shows little to no sign of stress and sufficient.

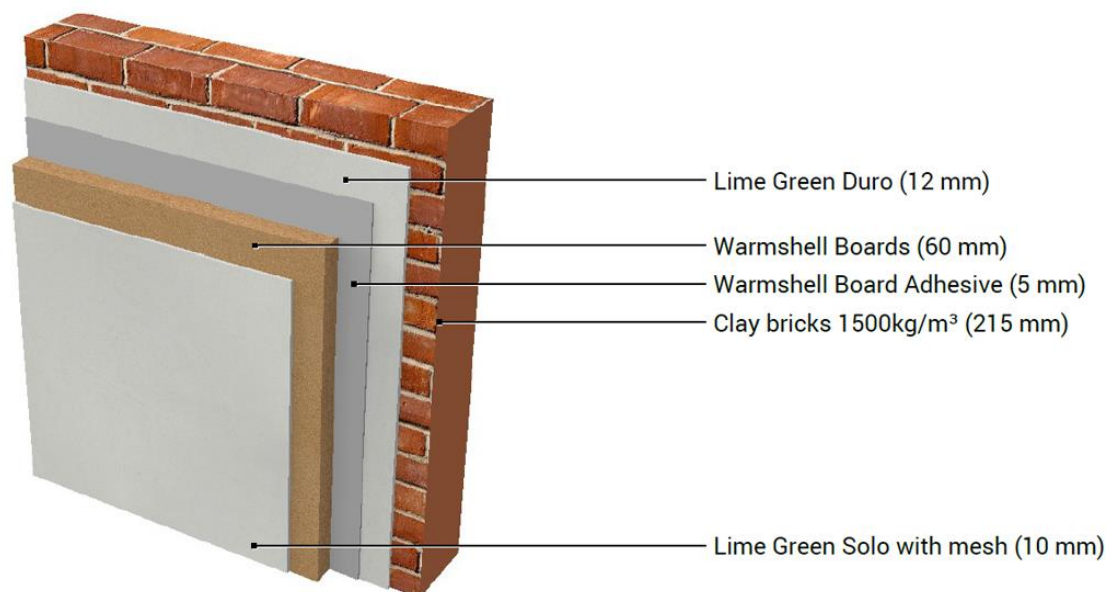
The cracked front concrete render of the building is not the original render and was replaced by a concrete render in the late 80's and thus has not allowed the kiln-dried bricks to breathe and has historically held water. The proposed alternative is to restore it back to brick and repoint the render and lime wash the building back to white. The lime wash will protect the bricks from the elements and help the building breathe and will reduce the likelihood of damp. This hydrophobic material prevents water absorption, ensuring that the walls remain dry and free from water damage.

Internal post lime washing will use a Warmshell insulation, this system of woodfibre board and Solo lime plaster is suitable for solid-wall masonry. The breathable system uses natural materials that will maintain a healthy internal climate. The Woodfibre Internal Wall Insulation System is designed and tested to allow solid walls to stay dry, while offering modern levels of insulation and ease of application. The boards are in thicknesses of 100mm and are applied with Warmshell Adhesive to the flat surface and the Solo plaster is applied in two passes with and embedded fibre mesh. (see the illustration for internal space)
