Project No: J062153

**Dyffryn Lower School**  
**Talcennau Road**  
**Port Talbot**  
**SA13 1EP**

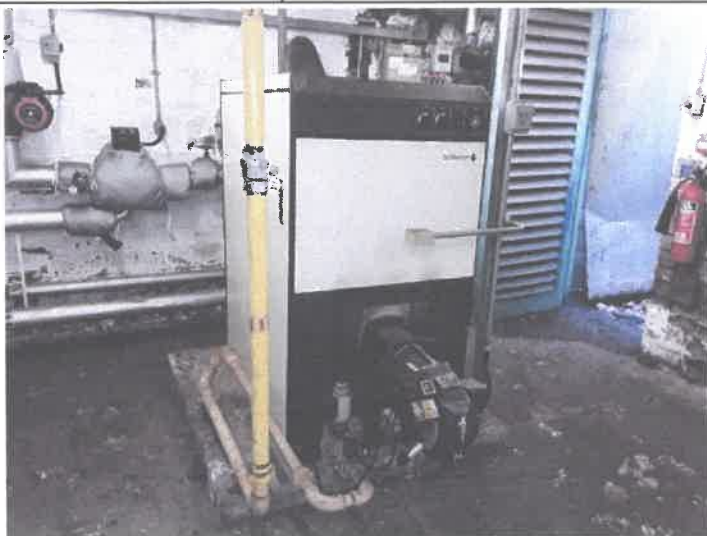
| <b>Item No:</b> 0055 | <b>Sample No:</b> LW005434 |

| <b>Location:</b> Unit 1, Sub Level -1, Boiler room (BF01), Boiler , Seals | |
| <b>Material type:</b> Gasket | <b>Asbestos Type:</b> Chrysotile |

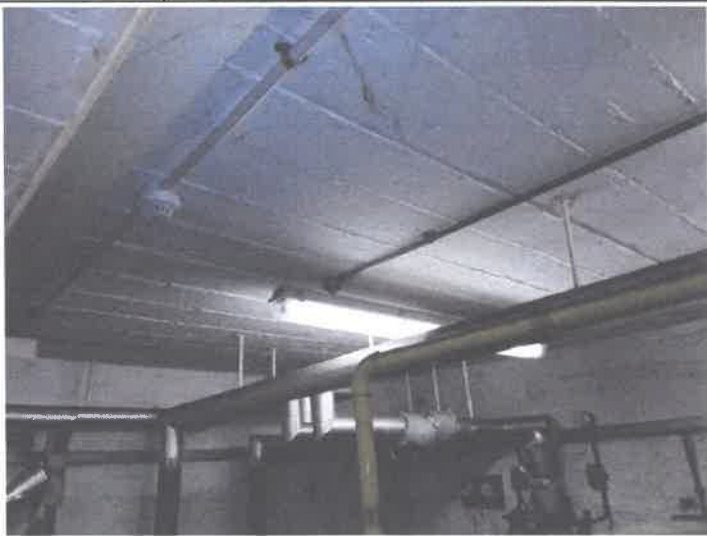
| <b>Item No:</b> 0052 | <b>Sample No:</b> LW005431 |

| <b>Location:</b> Unit 1, Sub Level -1, Boiler room (BF01), Ceiling , Debris | |
| <b>Material type:</b> debris | <b>Asbestos Type:</b> No asbestos detected |

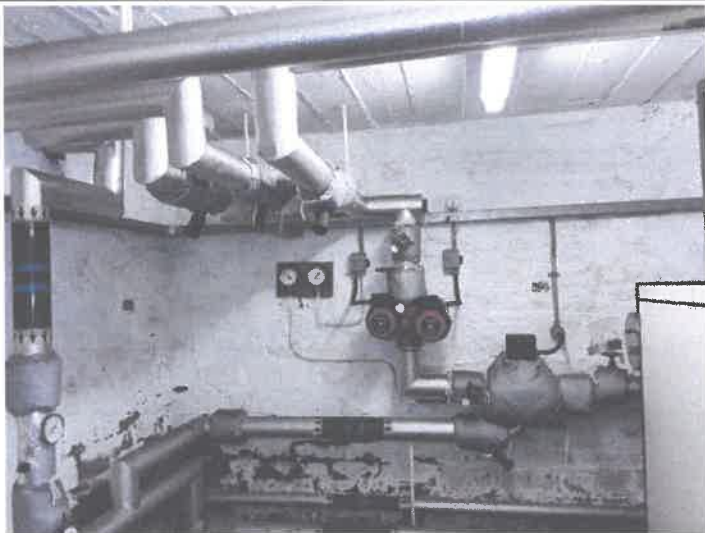
| <b>Item No:</b> 0053 | <b>Sample No:</b> LW005432 |

| <b>Location:</b> Unit 1, Sub Level -1, Boiler room (BF01), Walls, Debris | |
| <b>Material type:</b> debris | <b>Asbestos Type:</b> No asbestos detected |

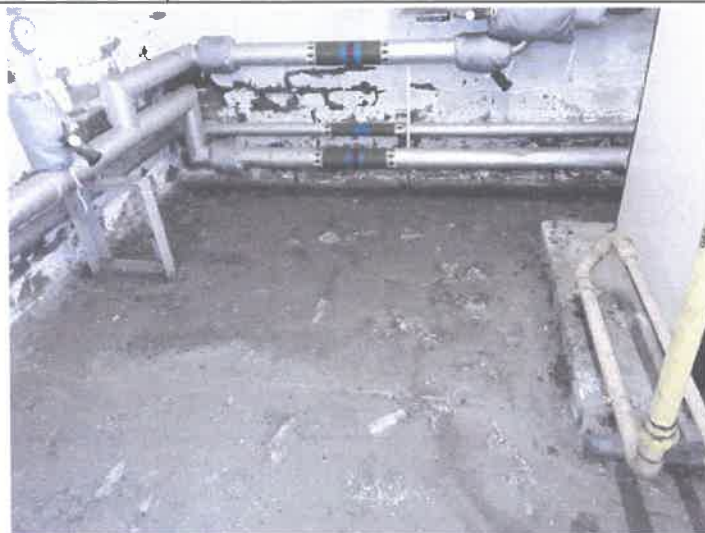
| <b>Item No:</b> 0054 | <b>Sample No:</b> LW005433 |

| <b>Location:</b> Unit 1, Sub Level -1, Boiler room (BF01), Floor, Debris | |
| <b>Material type:</b> debris | <b>Asbestos Type:</b> No asbestos detected |

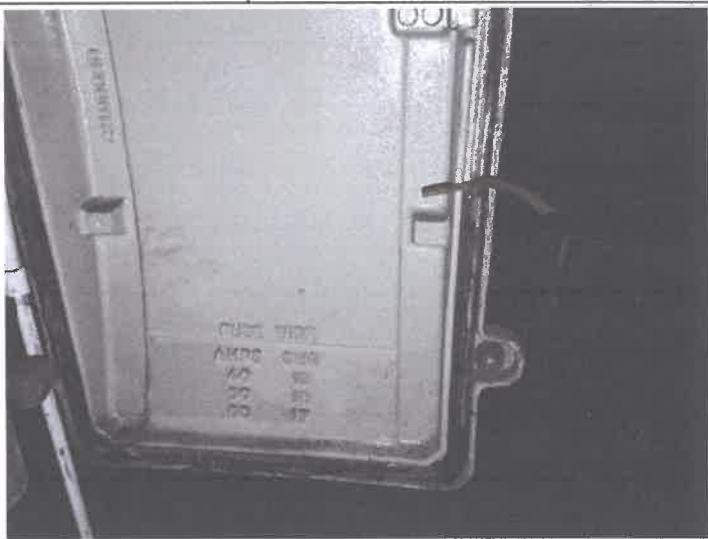
| <b>Item No:</b> 0007 | <b>Sample No:</b> LW005395 |

| <b>Location:</b> Unit 1, Ground Floor, Stage & side corridors (GF05, GF05A & GF05B), Seal to electrical switch box door on wall, Mastic | |
| <b>Material type:</b> Putty | <b>Asbestos Type:</b> Chrysotile |

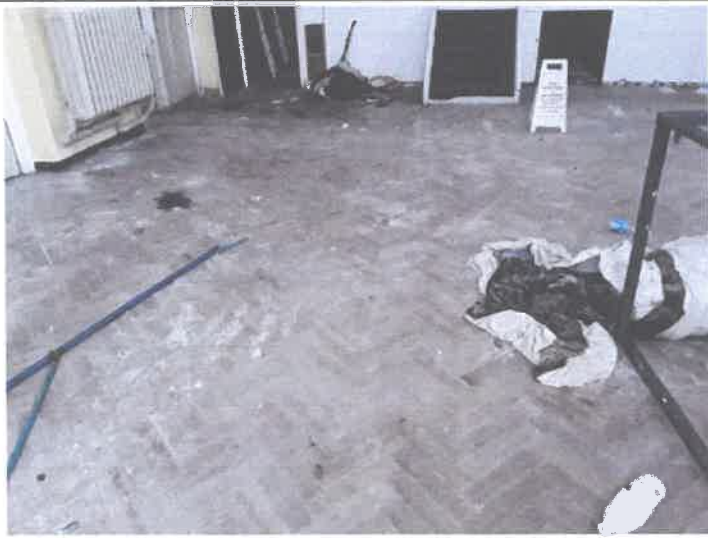
| <b>Item No:</b> 0008 | <b>Sample No:</b> LW005396 |

| <b>Location:</b> Unit 1, Ground Floor, Throughout (000), Floor below Parquet, Adhesive | |
| <b>Material type:</b> Bitumen | <b>Asbestos Type:</b> No asbestos detected |

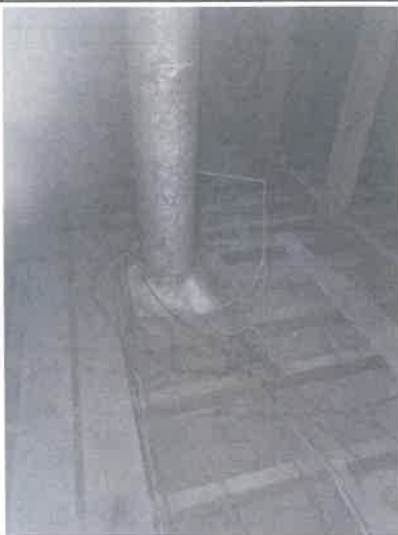
| <b>Item No:</b> 0051 | <b>Sample No:</b> LW005430 |

| <b>Location:</b> Unit 1, Roof Void, Loft (RV), String to ducting, Rope | |
| <b>Material type:</b> Rope | <b>Asbestos Type:</b> No asbestos detected |

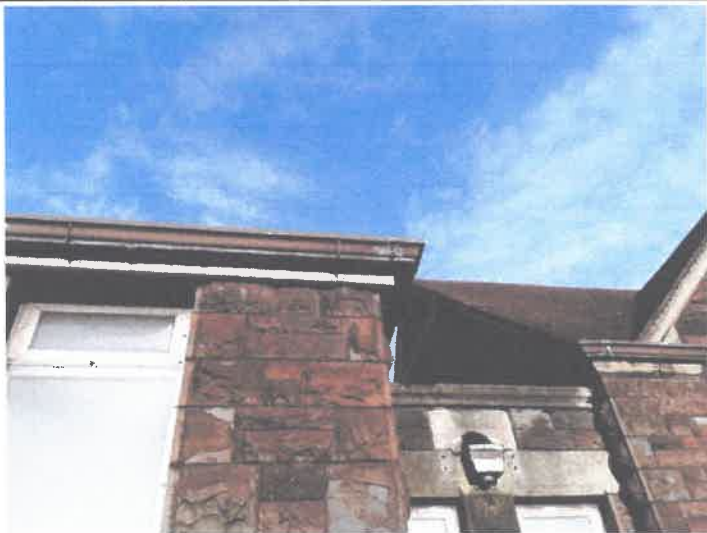
| <b>Item No:</b> 0042 | <b>Sample No:</b> LW005421 |

| <b>Location:</b> Unit 1, External, External (Ex), Joints to rainwater goods, Putty | |
| <b>Material type:</b> Putty | <b>Asbestos Type:</b> No asbestos detected |

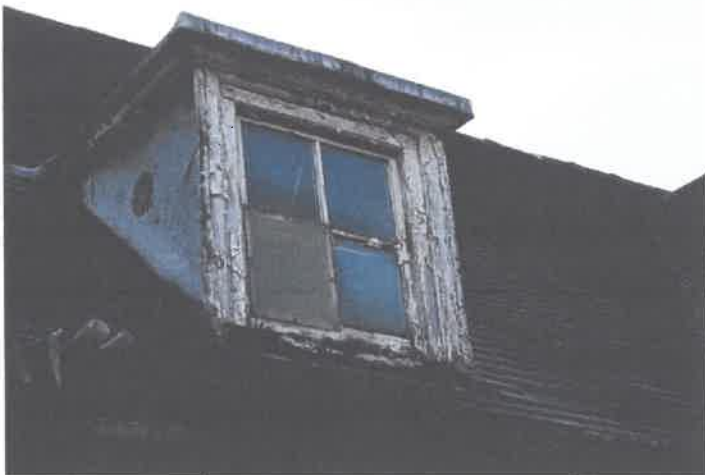
| <b>Item No:</b> 0043 | <b>Sample No:</b> LW005422 |

| <b>Location:</b> Unit 1, External, External (Ex), High level dormer windows, Putty | |
| <b>Material type:</b> Putty | <b>Asbestos Type:</b> No asbestos detected |

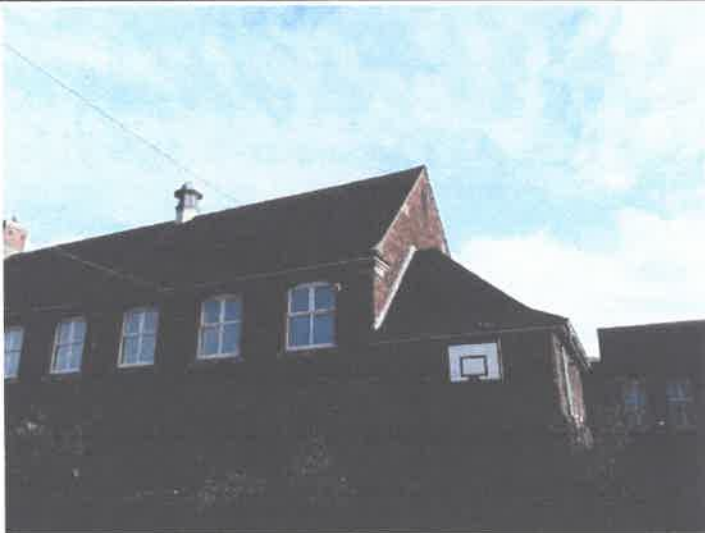
| <b>Item No:</b> 0050 | <b>Sample No:</b> LW005429 |

| <b>Location:</b> Unit 1, External, External (Ex), Downpipes, Seals | |
| <b>Material type:</b> Rope | <b>Asbestos Type:</b> No asbestos detected |

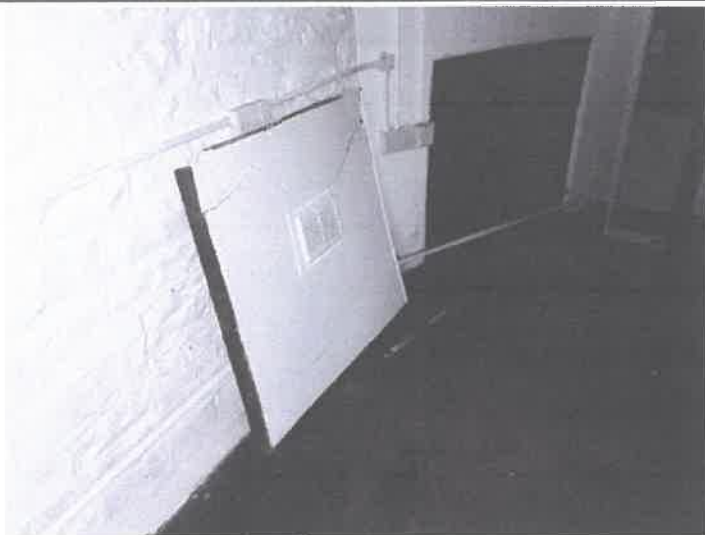
| <b>Item No:</b> 0003 | <b>Sample No:</b> LW005392 |

| <b>Location:</b> Unit 3, Ground Floor, Classroom (GF06), Fireplace , Panel | |
| <b>Material type:</b> Cement | <b>Asbestos Type:</b> Chrysotile |

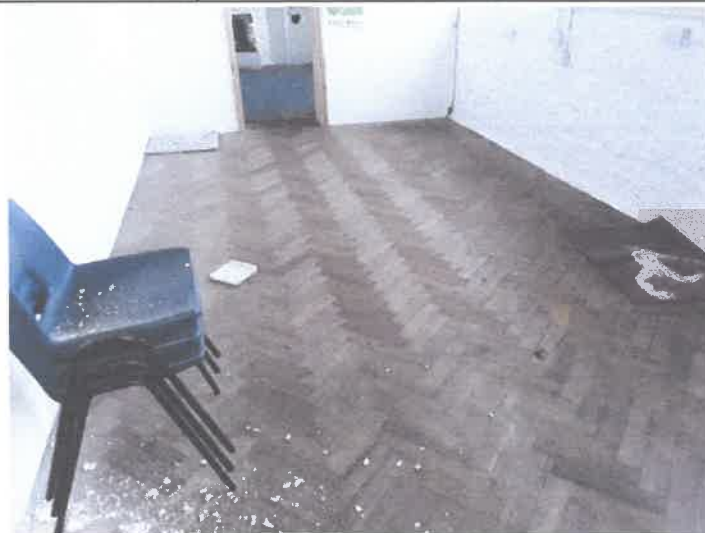
| <b>Item No:</b> 0001 | <b>Sample No:</b> LW005391 |

| <b>Location:</b> Unit 3, Ground Floor, Classroom (GF01), Floor below Parquet, Adhesive | |
| <b>Material type:</b> Bitumen | <b>Asbestos Type:</b> No asbestos detected |

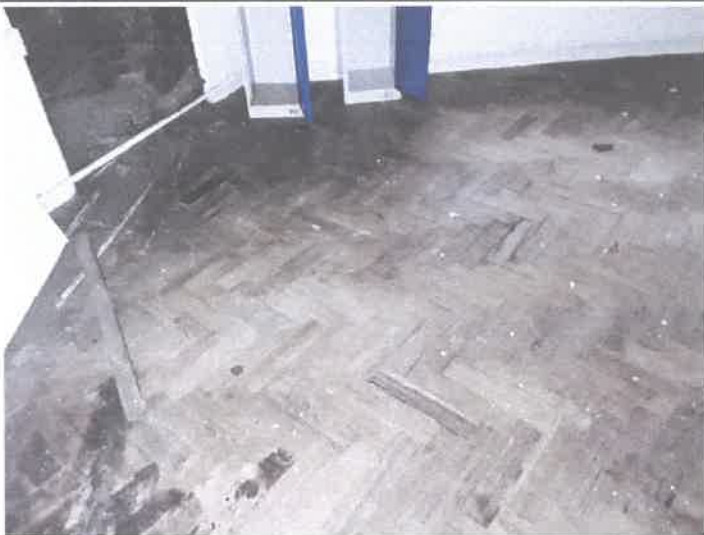
| <b>Item No:</b> 0002 | <b>Sample No:</b> LW005391 Visually Similar As LW005391 |

| <b>Location:</b> Unit 3, Ground Floor, Classroom (GF06), Floor below Parquet, Adhesive | |
| <b>Material type:</b> Bitumen | <b>Asbestos Type:</b> No asbestos detected |

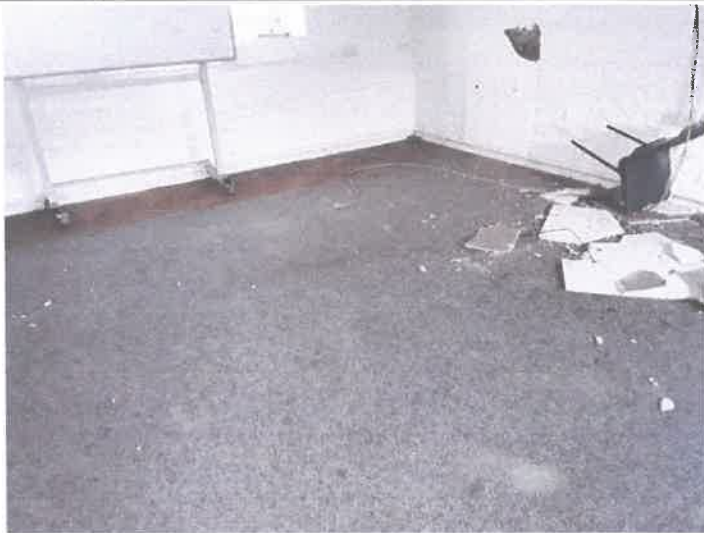
| <b>Item No:</b> 0004 | <b>Sample No:</b> LW005391 Visually Similar As LW005391 |

| <b>Location:</b> Unit 3, Ground Floor, Classroom (GF07), Floor below Parquet, Adhesive | |
| <b>Material type:</b> Bitumen | <b>Asbestos Type:</b> No asbestos detected |

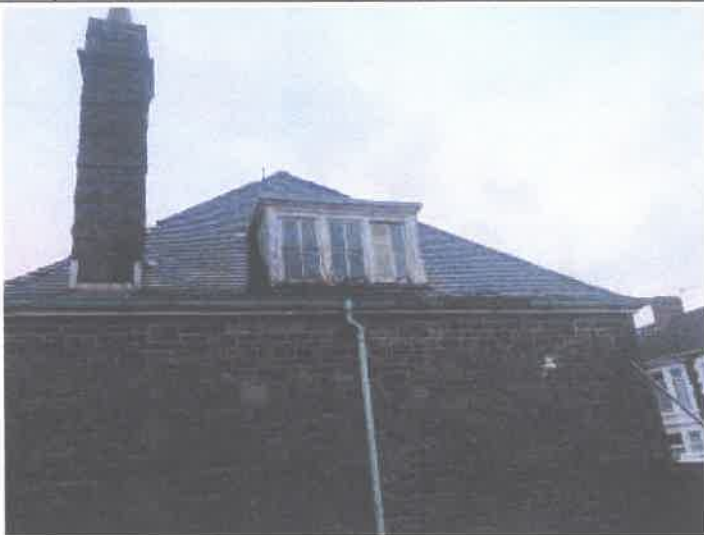
| <b>Item No:</b> 0068 | <b>Sample No:</b> LW005422 Visually Similar As LW005422 |

| <b>Location:</b> Unit 3, External, External (Ex), High level dormer windows, Putty | |
| <b>Material type:</b> Putty | <b>Asbestos Type:</b> No asbestos detected |

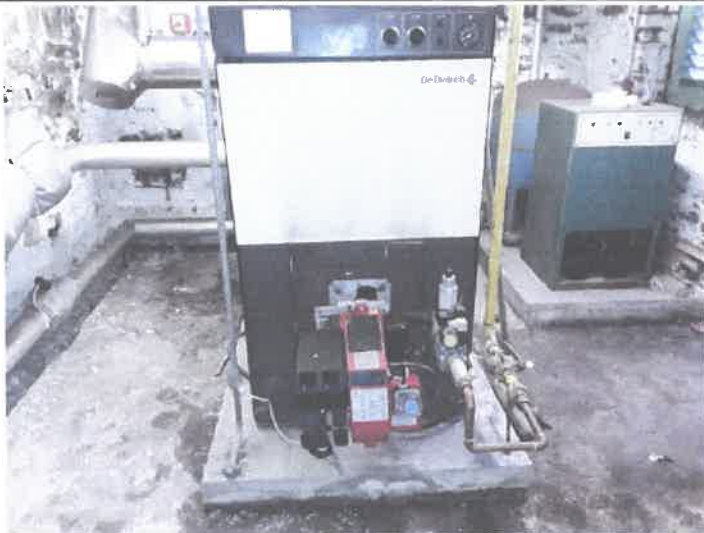
| <b>Item No:</b> 0058 | <b>Sample No:</b> LW005437 |

| <b>Location:</b> Unit 4, Sub Level -1, Boiler room (BF01), Boiler, Seals | |
| <b>Material type:</b> Gasket | <b>Asbestos Type:</b> Chrysotile |

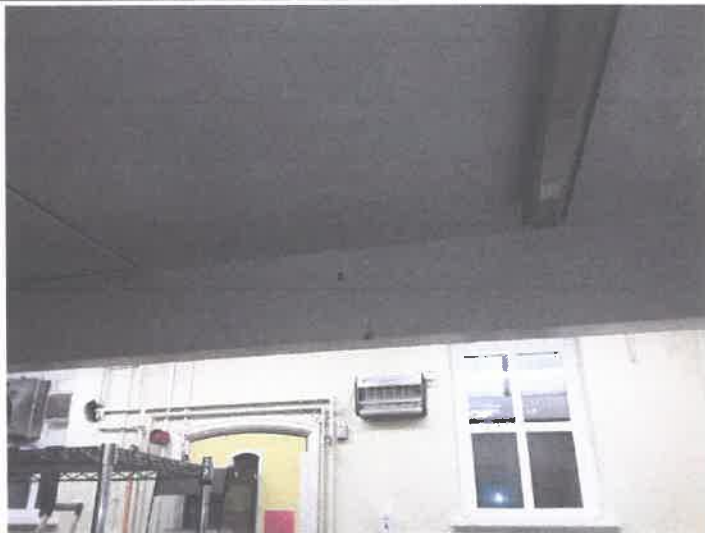
| <b>Item No:</b> 0013 | <b>Sample No:</b> LW005400 |

| <b>Location:</b> Unit 4, Ground Floor, Kitchen (GF07), Beams, Boxing | |
| <b>Material type:</b> Textured coating and Insulating board | <b>Asbestos Type:</b> Chrysotile + Amosite |

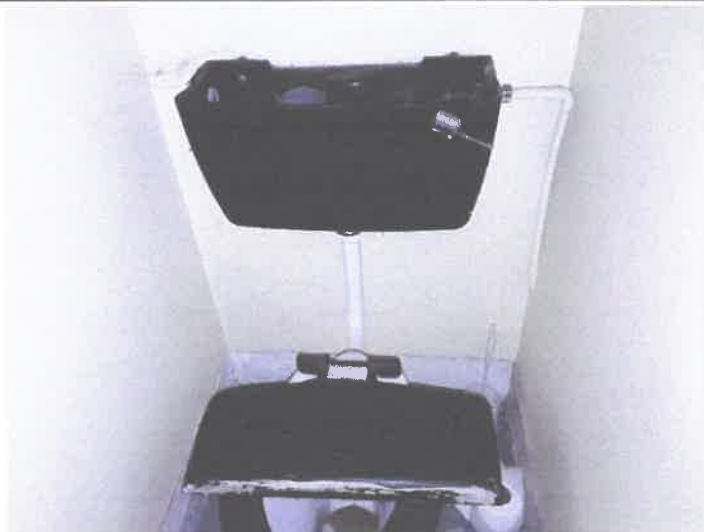
| <b>Item No:</b> 0015 | <b>Sample No:</b> LW005402 |

| <b>Location:</b> Unit 4, Ground Floor, WC (GF16), Wall , Cistern | |
| <b>Material type:</b> Reinforced Plastic | <b>Asbestos Type:</b> Amosite |

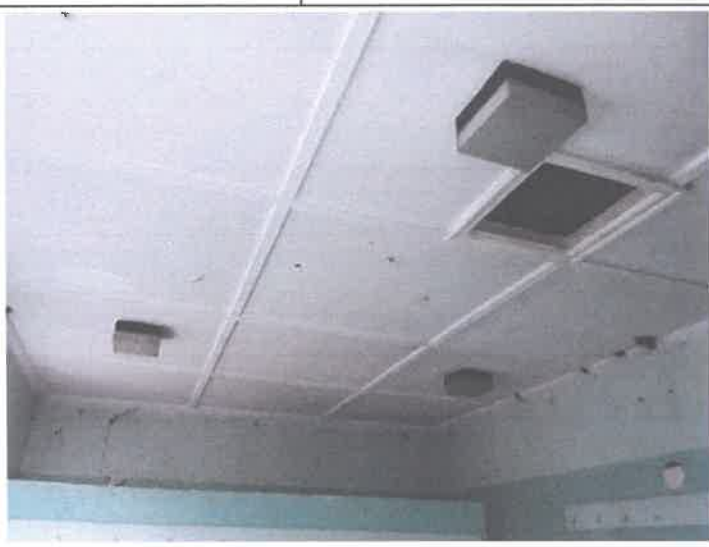
| Item No: 0010 | Sample No: LW005398 |

| Location: Unit 4, Ground Floor, Changing Room (GF19), Ceiling , Panels | |
| Material type: Cement | Asbestos Type: Chrysotile |

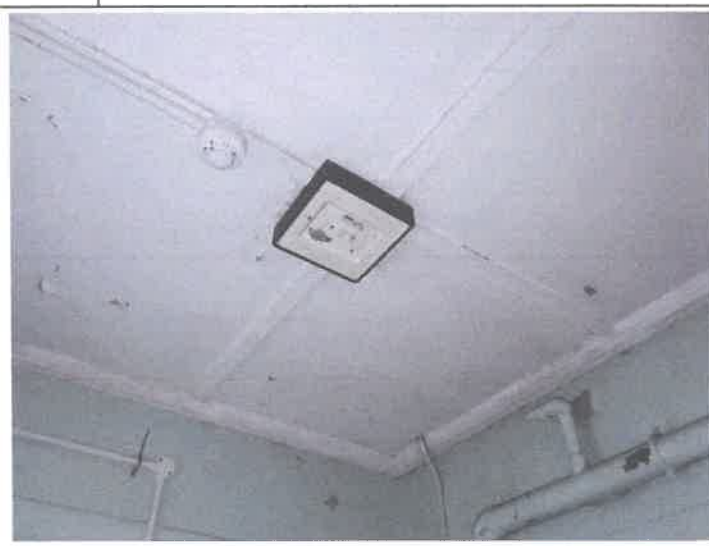
| Item No: 0011 | Sample No: LW005398 Visually Similar As LW005398 |

| Location: Unit 4, Ground Floor, Lobby (GF18), Ceiling , Panels | |
| Material type: Cement | Asbestos Type: Chrysotile |

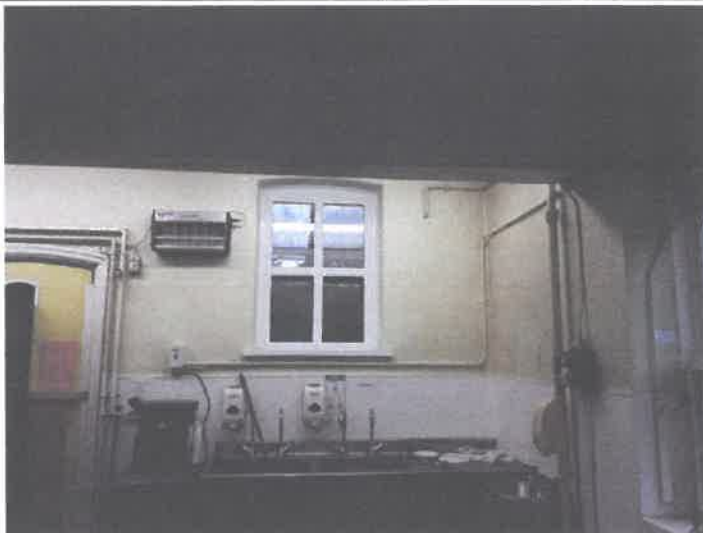
| <b>Item No:</b> 0014 | <b>Sample No:</b> LW005401 |

| <b>Location:</b> Unit 4, Ground Floor, Kitchen (GF07), Walls, Coating to plaster | |
| <b>Material type:</b> Textured Coating | <b>Asbestos Type:</b> Chrysotile |

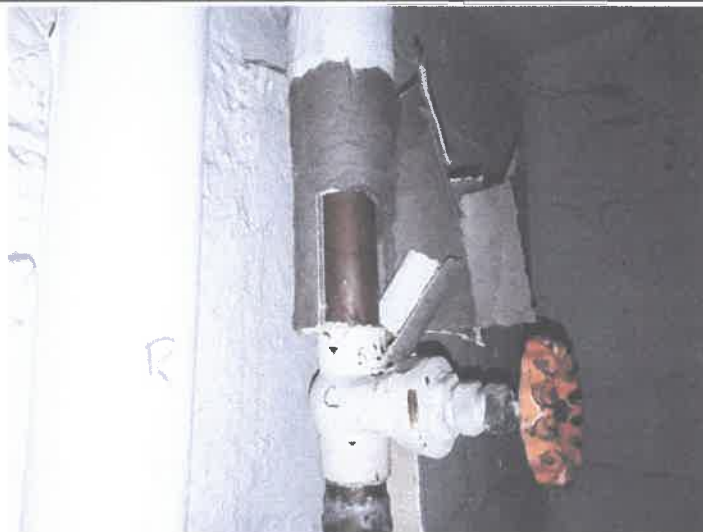
| <b>Item No:</b> 0016 | <b>Sample No:</b> LW005403 |

| <b>Location:</b> Unit 4, Ground Floor, Store Room (GF14), Paper lining layers within insulation to pipework, Insulation | |
| <b>Material type:</b> Paper | <b>Asbestos Type:</b> Chrysotile |

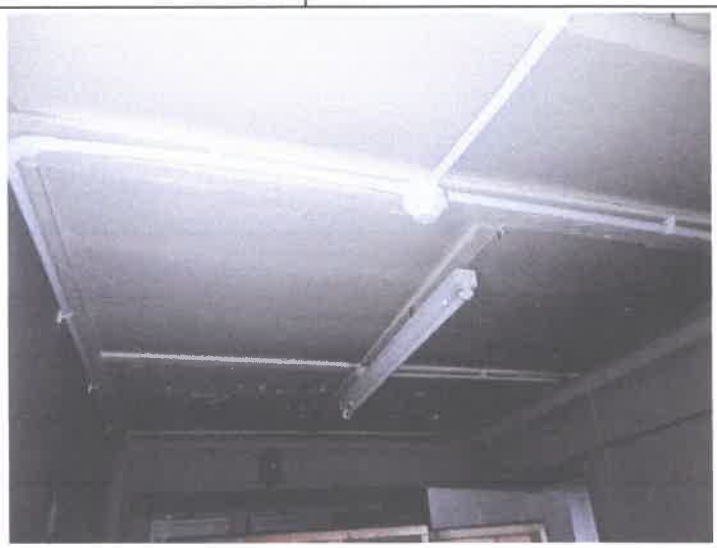
| <b>Item No:</b> 0017 | <b>Sample No:</b> LW005404 |

| <b>Location:</b> Unit 4, Ground Floor, Store (GF11A), Ceiling , Panels | |
| <b>Material type:</b> Cement | <b>Asbestos Type:</b> Chrysotile |

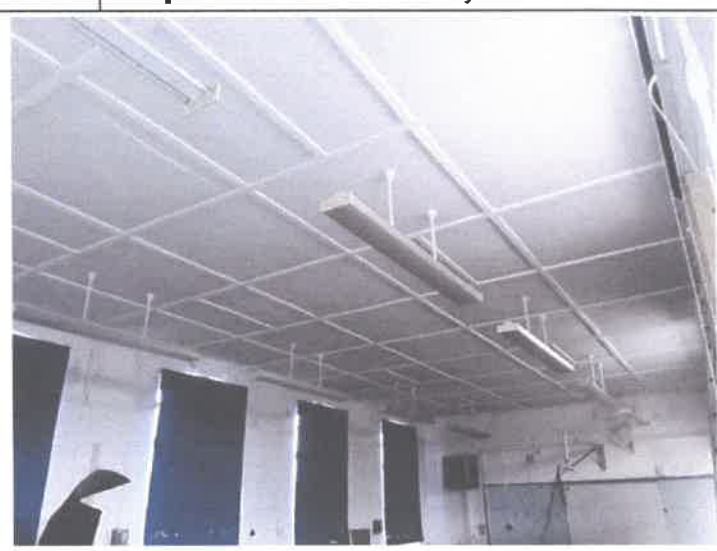
| <b>Item No:</b> 0018 | <b>Sample No:</b> LW005404 Visually Similar As LW005404 |

| <b>Location:</b> Unit 4, Ground Floor, Classroom (GF11), Ceiling , Panels | |
| <b>Material type:</b> Cement | <b>Asbestos Type:</b> Chrysotile |

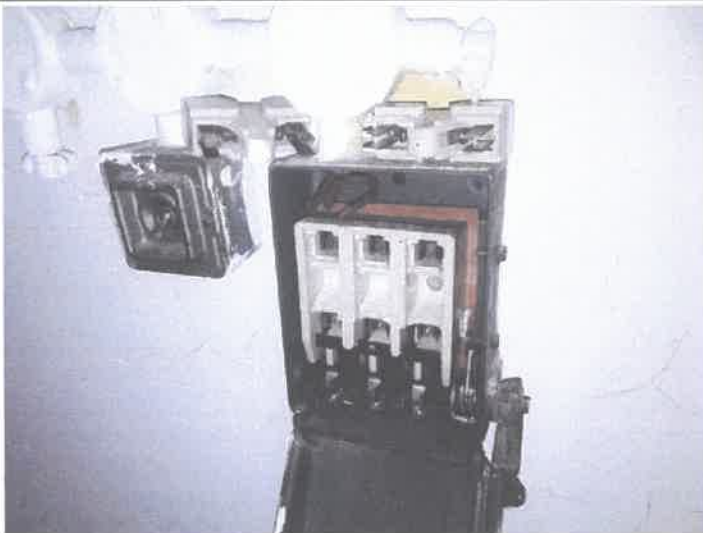
| <b>Item No:</b> 0019 | <b>Sample No:</b> LW005405 |

| <b>Location:</b> Unit 4, Ground Floor, Classroom (GF11), Fuse box to wall, Flash guards | |
| <b>Material type:</b> Textile | <b>Asbestos Type:</b> Chrysotile |

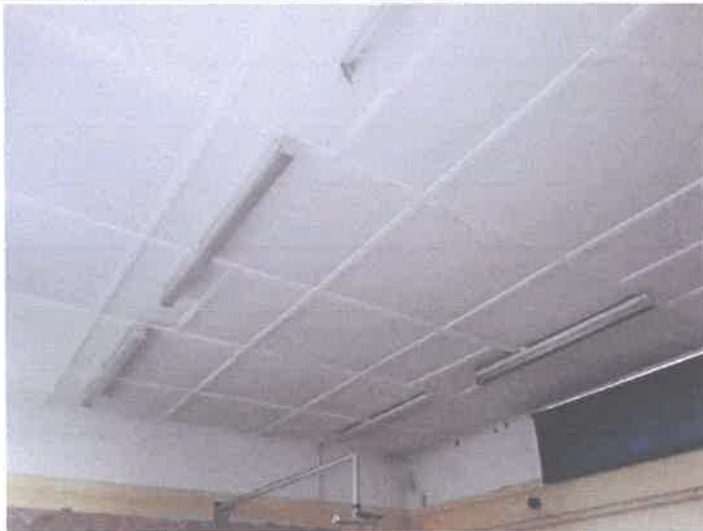
| <b>Item No:</b> 0021 | <b>Sample No:</b> LW005404 Visually Similar As LW005404 |

| <b>Location:</b> Unit 4, Ground Floor, Classroom 3 (GF09), Ceiling , Panels | |
| <b>Material type:</b> Cement | <b>Asbestos Type:</b> Chrysotile |

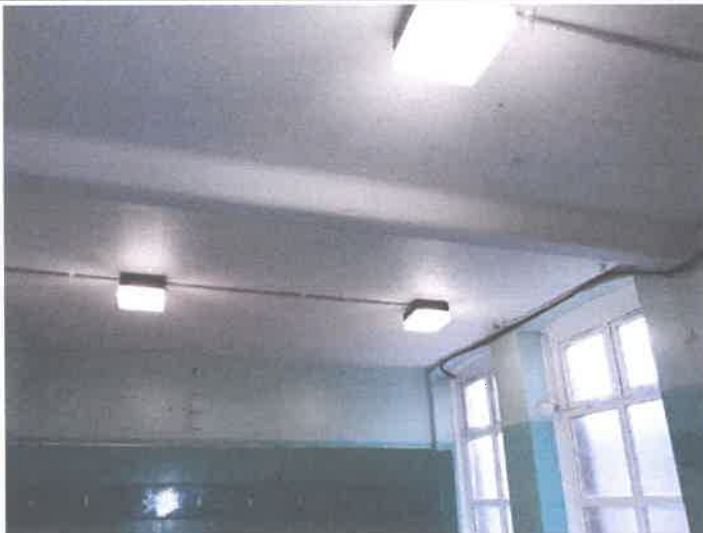
| <b>Item No:</b> 0009 | <b>Sample No:</b> LW005397 |

| <b>Location:</b> Unit 4, Ground Floor, Changing Room (GF03), Ceiling , Coating to plaster | |
| <b>Material type:</b> Textured Coating | <b>Asbestos Type:</b> No asbestos detected |

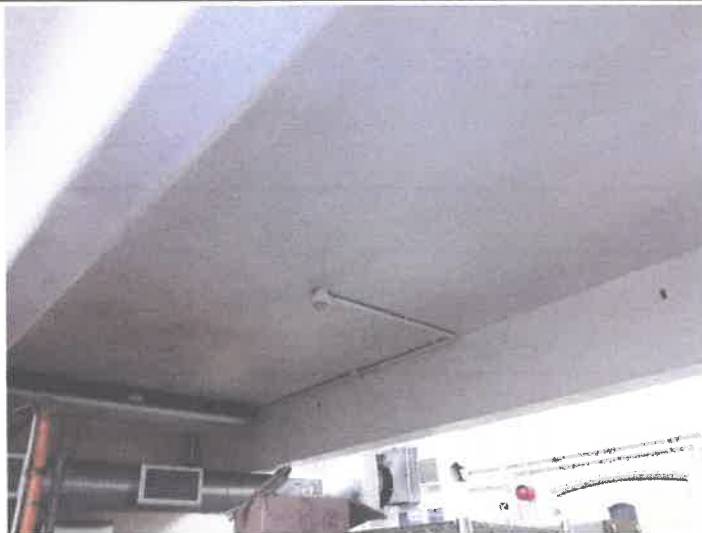
| <b>Item No:</b> 0012 | <b>Sample No:</b> LW005399 |

| <b>Location:</b> Unit 4, Ground Floor, Kitchen (GF07), Ceiling , Coating to plaster | |
| <b>Material type:</b> Textured Coating | <b>Asbestos Type:</b> No asbestos detected |

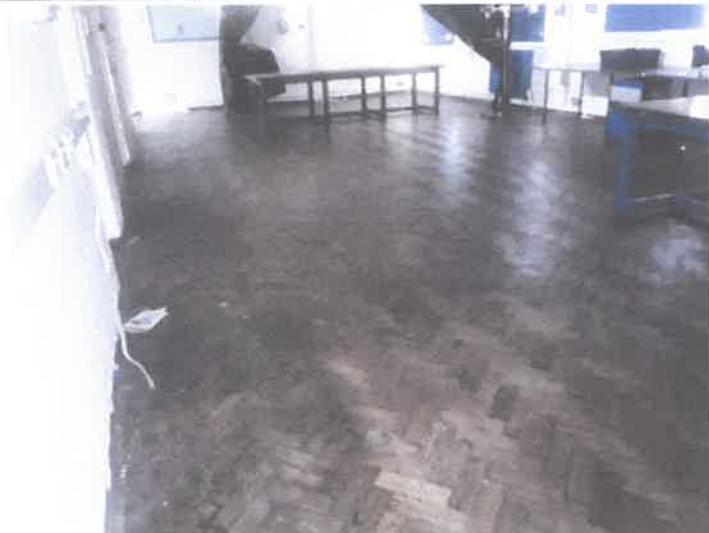
| <b>Item No:</b> 0022 | <b>Sample No:</b> LW005406 |

| <b>Location:</b> Unit 4, Ground Floor, Throughout, Floors bloew Parquet, Adhesive | |
| <b>Material type:</b> Bitumen | <b>Asbestos Type:</b> No asbestos detected |

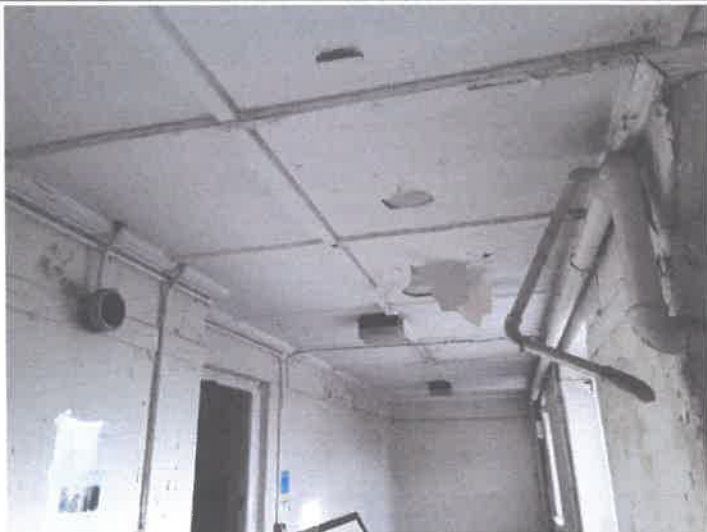
| <b>Item No:</b> 0023 | <b>Sample No:</b> LW005407 |

| <b>Location:</b> Unit 4, 1st Floor, Landing (FF05), Ceiling , Panels | |
| <b>Material type:</b> Cement | <b>Asbestos Type:</b> Chrysotile |

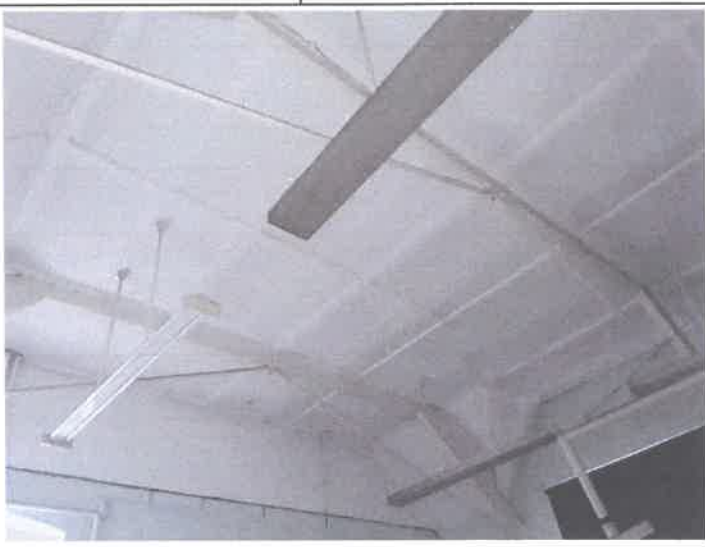
| <b>Item No:</b> 0031 | <b>Sample No:</b> LW005413 |

| <b>Location:</b> Unit 4, 1st Floor, Classroom (FF02), Ceiling , Panels | |
| <b>Material type:</b> Cement | <b>Asbestos Type:</b> Chrysotile |

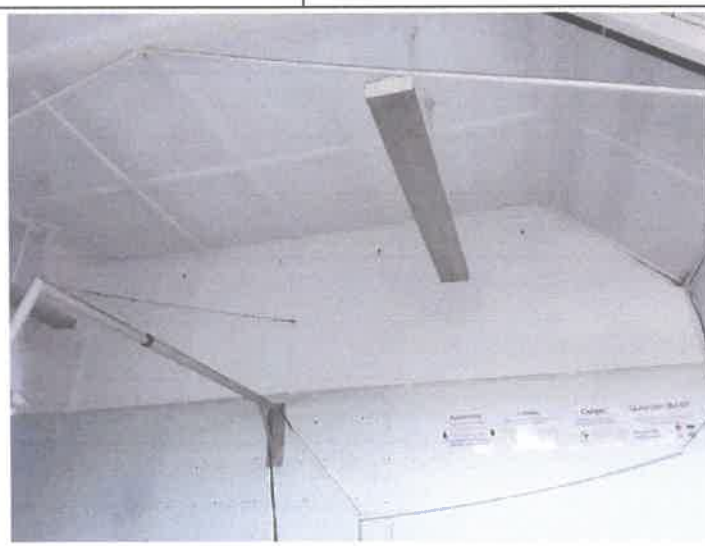
| <b>Item No:</b> 0032 | <b>Sample No:</b> LW005414 |

| <b>Location:</b> Unit 4, 1st Floor, Classroom (FF02), Wall , Panels | |
| <b>Material type:</b> Cement | <b>Asbestos Type:</b> Chrysotile |

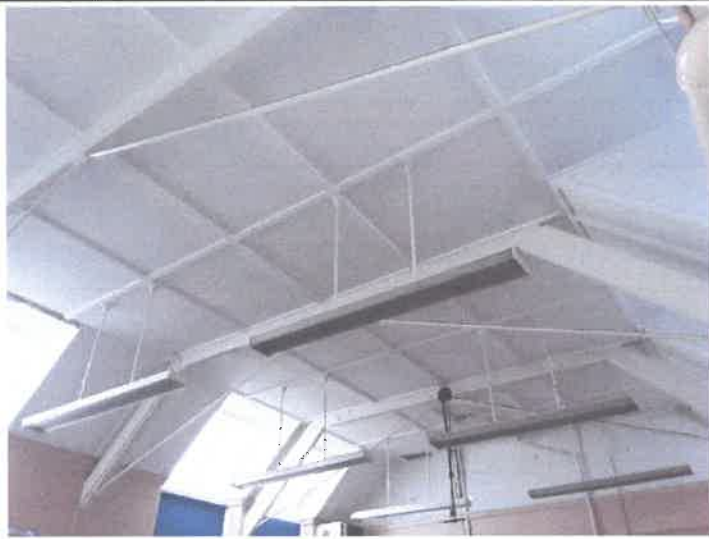
| <b>Item No:</b> 0033 | <b>Sample No:</b> LW005413 Visually Similar As LW005413 |

| <b>Location:</b> Unit 4, 1st Floor, Classroom (FF01), Ceiling , Panels | |
| <b>Material type:</b> Cement | <b>Asbestos Type:</b> Chrysotile |

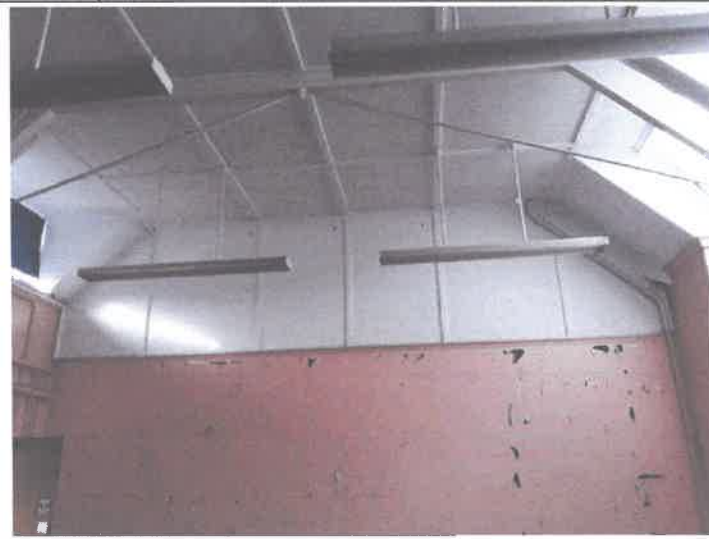
| <b>Item No:</b> 0034 | <b>Sample No:</b> LW005414 Visually Similar As LW005414 |

| <b>Location:</b> Unit 4, 1st Floor, Classroom (FF01), Wall , Panels | |
| <b>Material type:</b> Cement | <b>Asbestos Type:</b> Chrysotile |

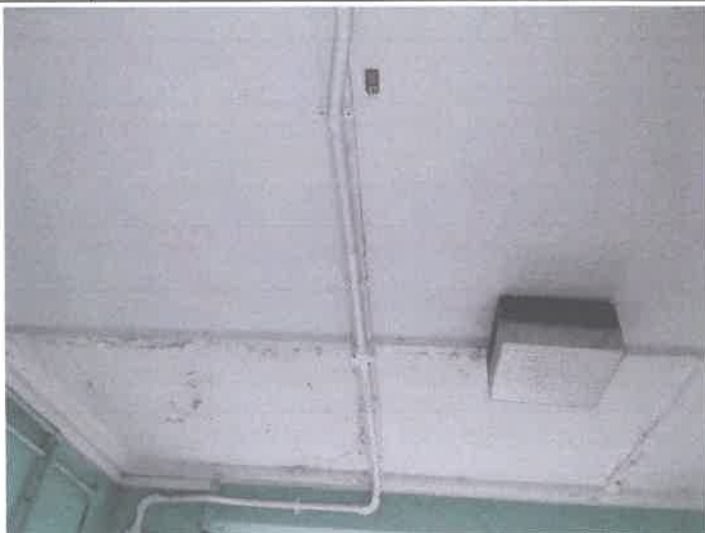
| <b>Item No:</b> 0035 | <b>Sample No:</b> LW005413 Visually Similar As LW005413 |

| <b>Location:</b> Unit 4, 1st Floor, Office (FF07), Ceiling , Panels | |
| <b>Material type:</b> Cement | <b>Asbestos Type:</b> Chrysotile |

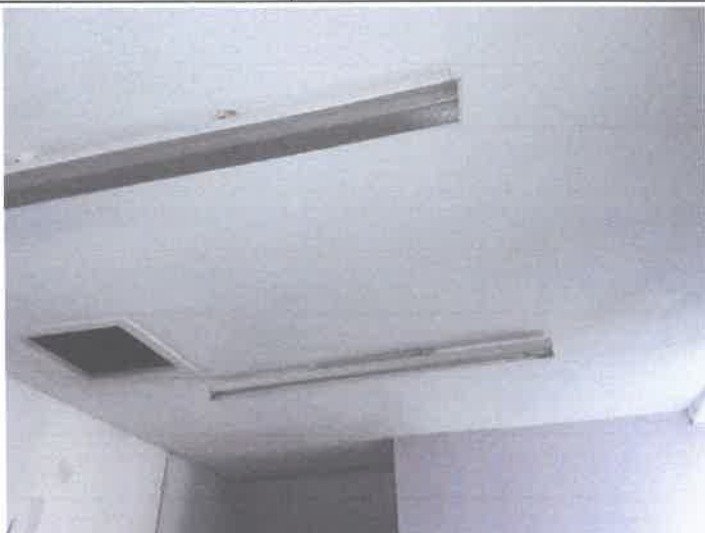
| <b>Item No:</b> 0024 | <b>Sample No:</b> LW005408 |

| <b>Location:</b> Unit 4, 1st Floor, Staff room (FF04), Ceiling , Coating to plasterboard | |
| <b>Material type:</b> Textured Coating | <b>Asbestos Type:</b> No asbestos detected |

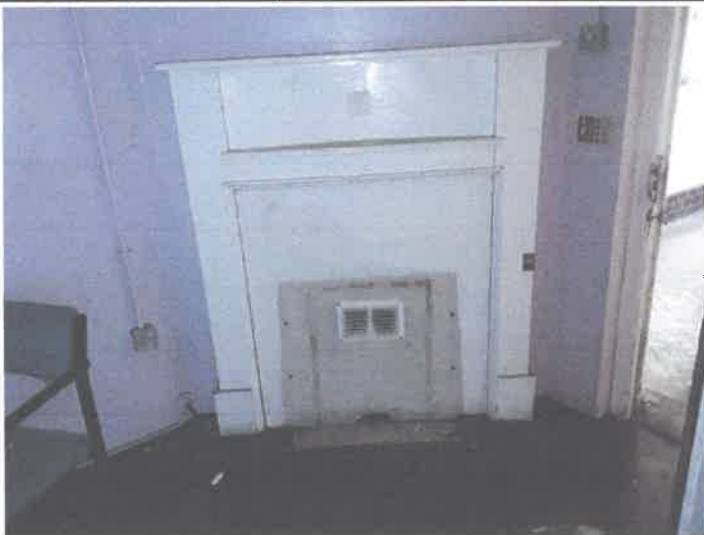
| <b>Item No:</b> 0025 | <b>Sample No:</b> LW005409 |

| <b>Location:</b> Unit 4, 1st Floor, Staff room (FF04), Fireplace , Panel | |
| <b>Material type:</b> Insulating Board | <b>Asbestos Type:</b> No asbestos detected |

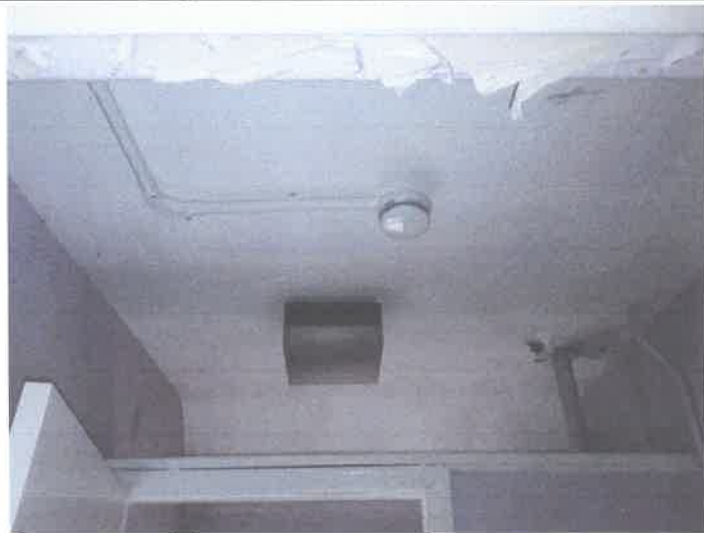
| <b>Item No:</b> 0026 | <b>Sample No:</b> LW005408 Visually Similar As LW005408 |

| <b>Location:</b> Unit 4, 1st Floor, WC (FF08), Ceiling , Coating to plasterboard | |
| <b>Material type:</b> Textured Coating | <b>Asbestos Type:</b> No asbestos detected |

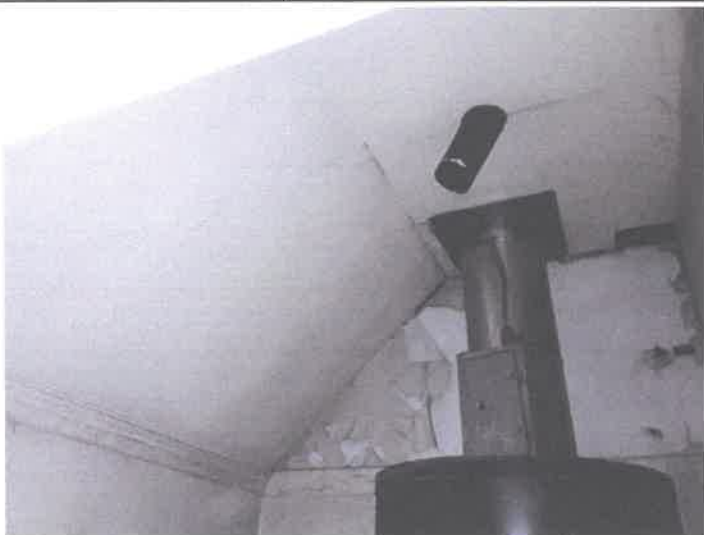
| <b>Item No:</b> 0027 | <b>Sample No:</b> LW005410 |

| <b>Location:</b> Unit 4, 1st Floor, Hot Water Tank Room (FF03), Ceiling , Board | |
| <b>Material type:</b> Insulating Board | <b>Asbestos Type:</b> No asbestos detected |

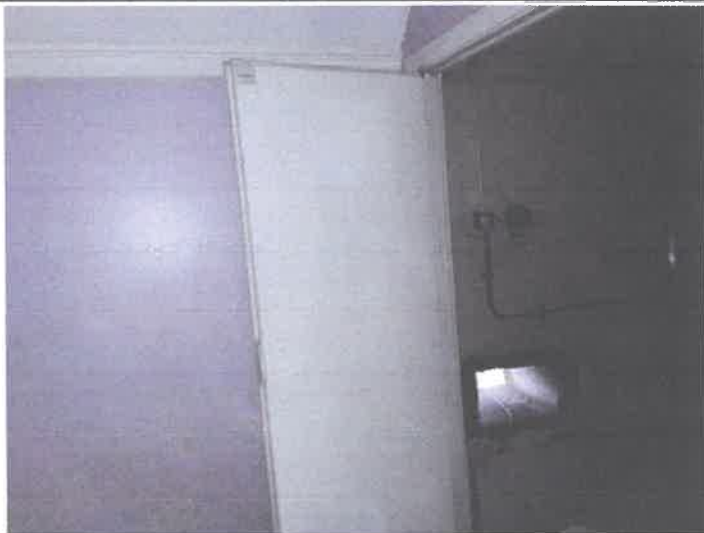
| <b>Item No:</b> 0028 | <b>Sample No:</b> LW005411 |

| <b>Location:</b> Unit 4, 1st Floor, Hot Water Tank Room (FF03), Doors , Panels | |
| <b>Material type:</b> Insulating Board | <b>Asbestos Type:</b> No asbestos detected |

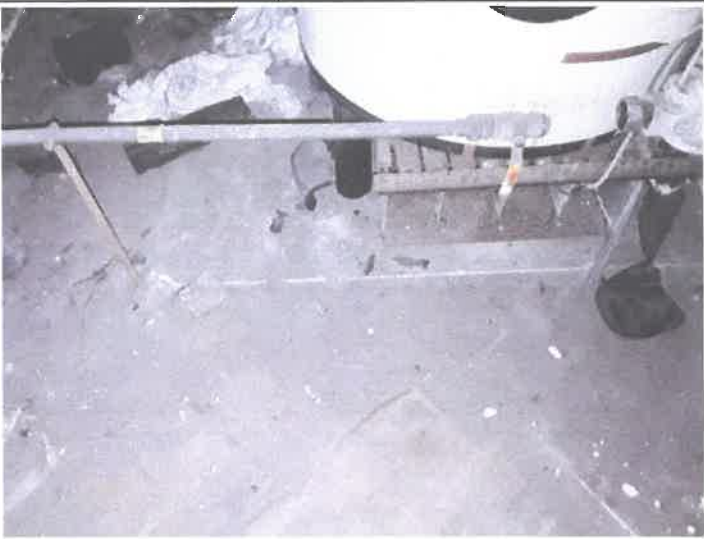
| <b>Item No:</b> 0029 | <b>Sample No:</b> LW005412 |

| <b>Location:</b> Unit 4, 1st Floor, Hot Water Tank Room (FF03), Floor , Panel | |
| <b>Material type:</b> Insulating Board | <b>Asbestos Type:</b> No asbestos detected |

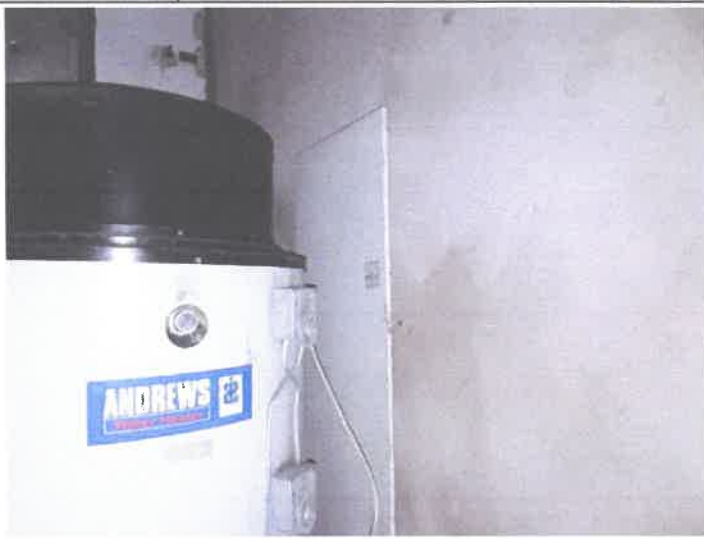
| <b>Item No:</b> 0030 | <b>Sample No:</b> LW005411 Visually Similar As LW005411 |

| <b>Location:</b> Unit 4, 1st Floor, Hot Water Tank Room (FF03), Loose, Panel | |
| <b>Material type:</b> Insulating Board | <b>Asbestos Type:</b> No asbestos detected |

| PROPERTY: | | | | REPORT NOS: | | J062153 | | MSSC/531 Issue 3 Oct 2018 | |
|---|---|---|---|---|---|---|---|---|---|
| 0030 | 1 | FF03, Hot Water Tank Room | Loose | Panel | Insulating Board | Visually Similar As LW005411 | LW005411 Visually Similar As LW005411 | 2m² | J062153 |

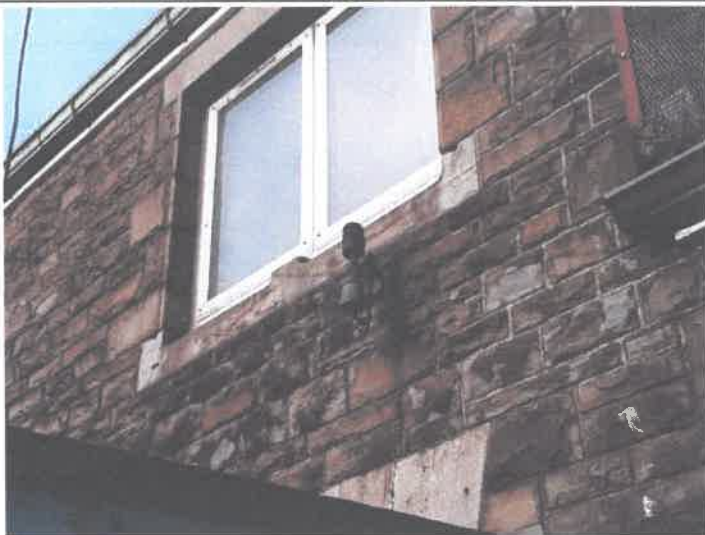
| <b>Item No:</b> 0044 | <b>Sample No:</b> LW005423 |

| <b>Location:</b> Unit 4, External, External (Ex), Walls, Isolator pots | |
| <b>Material type:</b> Reinforced Plastic | <b>Asbestos Type:</b> Chrysotile |

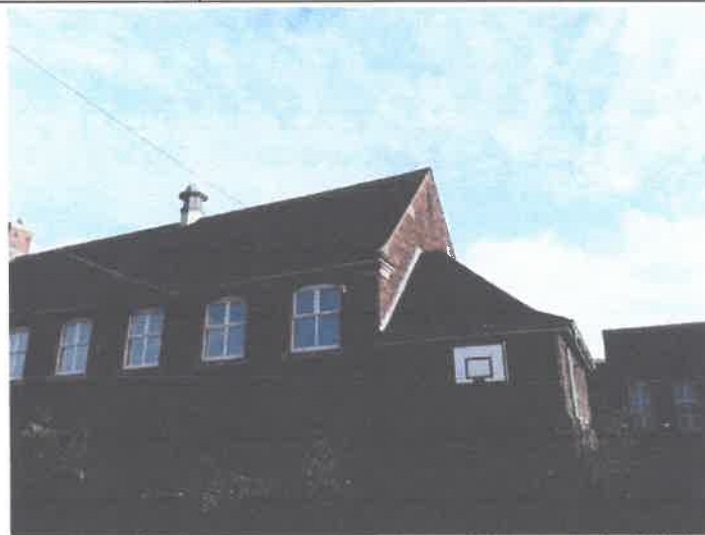
| <b>Item No:</b> 0045 | <b>Sample No:</b> LW005424 |

| <b>Location:</b> Unit 4, External, External (Ex), Main roof, taken above changing rooms, Felt | |
| <b>Material type:</b> Bitumen | <b>Asbestos Type:</b> No asbestos detected |

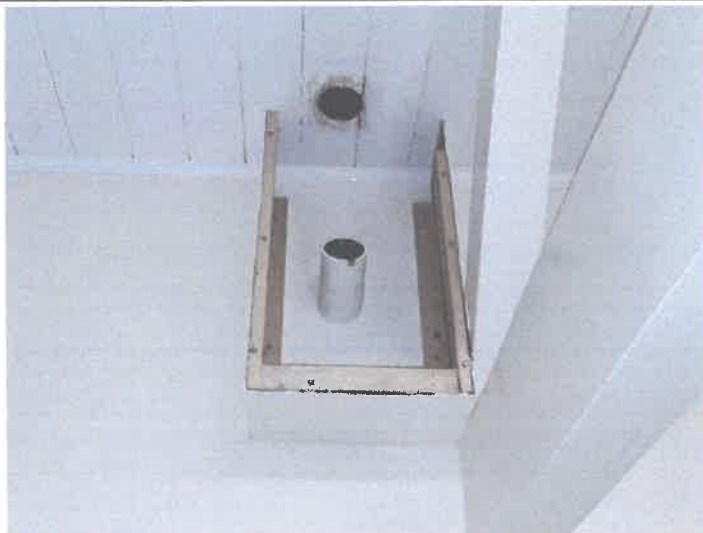
| <b>Item No:</b> 0049 | <b>Sample No:</b> LW005428 |

| <b>Location:</b> Unit 6, Ground Floor, Female WC (GF06), Passing through wall into GF07, Pipe | |
| <b>Material type:</b> Cement | <b>Asbestos Type:</b> Chrysotile + Amosite |

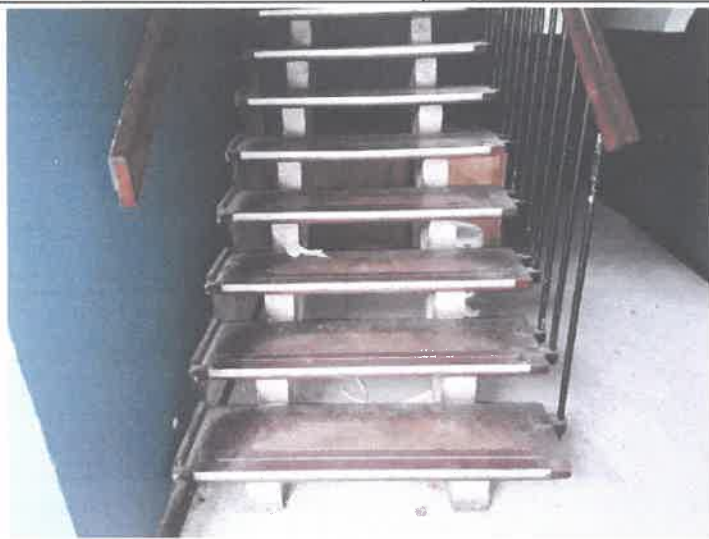
| Item No: 0036 | Sample No: LW005415 |

| Location: Unit 6, Ground Floor, Foyer and stair lobby (GF33), Main stairs, Brown nosing | |
| Material type: Reinforced Plastic | Asbestos Type: Chrysotile |

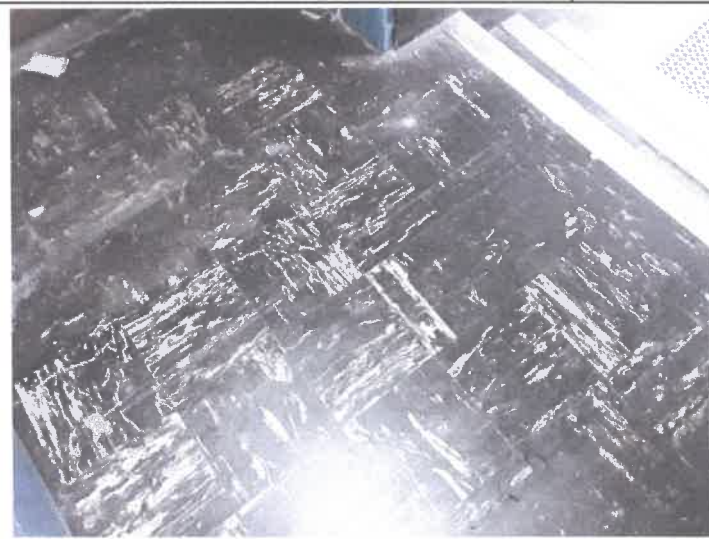
| Item No: 0037 | Sample No: LW005416 |

| Location: Unit 6, Ground Floor, Foyer and stair lobby (GF33), Raised floor and small steps, Black tiles and adhesive | |
| Material type: Thermoplastic floor tiles and adhesive | Asbestos Type: Chrysotile |

| Item No. | Sample No. | Location | Material type | Asbestos Fibre Type | Notes |
|---|---|---|---|---|---|
| 037 | LW005416 | Unit 6, Ground Floor, Foyer and stair lobby (GF33), Raised floor and small steps, Black tiles and adhesive | Thermoplastic floor tiles and adhesive | Chrysotile | Chrysotile found in bitumen adhesive and floor tile |

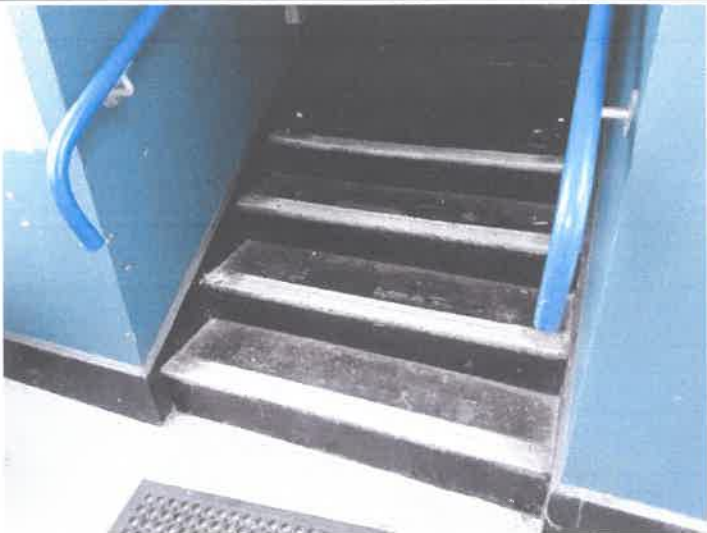
| <b>Item No:</b> 0038 | <b>Sample No:</b> LW005417 |

| <b>Location:</b> Unit 6, Ground Floor, Foyer and stair lobby (GF33), Small steps, White nosing | |
| <b>Material type:</b> Reinforced Plastic | <b>Asbestos Type:</b> Chrysotile |

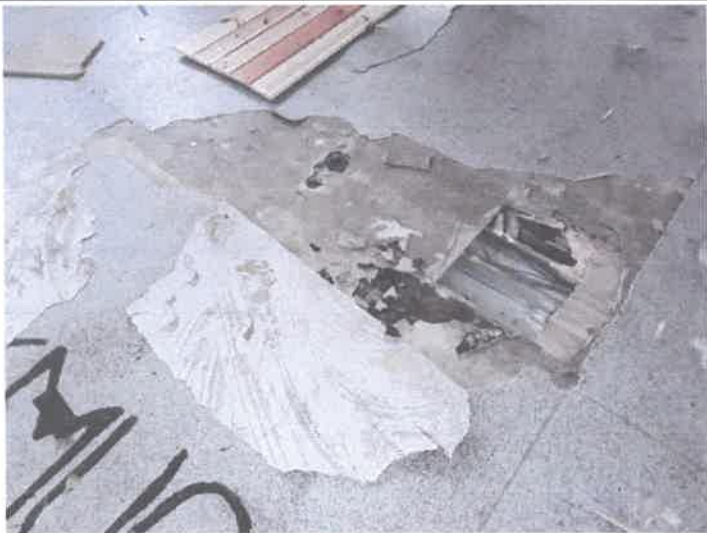
| <b>Item No:</b> 0039 | <b>Sample No:</b> LW005418 |

| <b>Location:</b> Unit 6, Ground Floor, Laboratory (GF34), Floor below modern vinyl and screed, Adhesive | |
| <b>Material type:</b> Bitumen | <b>Asbestos Type:</b> Chrysotile |

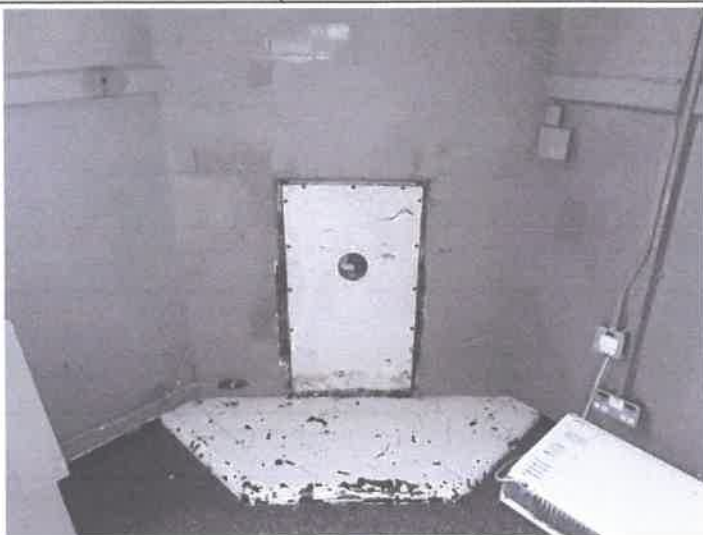
| <b>Item No:</b> 0040 | <b>Sample No:</b> LW005419 |

| <b>Location:</b> Unit 6, Ground Floor, Office (GF24), Blanking to fireplace, Panel | |
| <b>Material type:</b> Insulating Board | <b>Asbestos Type:</b> No asbestos detected |

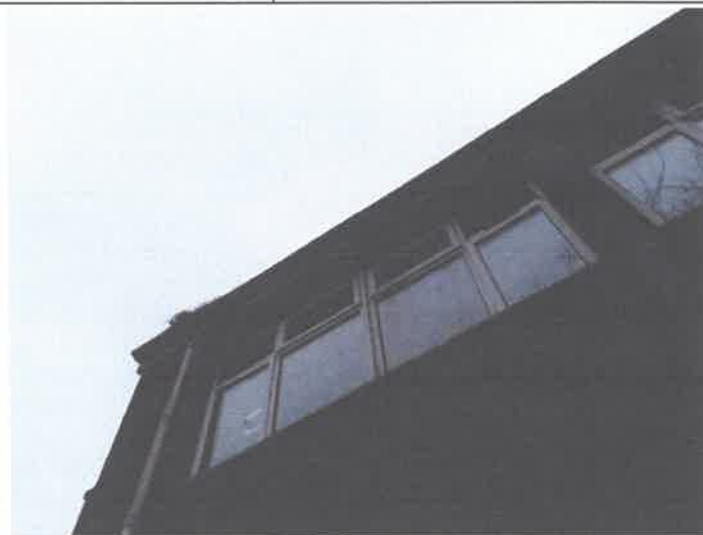
| <b>Item No:</b> 0041 | <b>Sample No:</b> LW005420 |

| <b>Location:</b> Unit 6, External, External (Ex), Soffit around 2 storey science block, Panels | |
| <b>Material type:</b> Insulating Board | <b>Asbestos Type:</b> Chrysotile + Crocidolite |

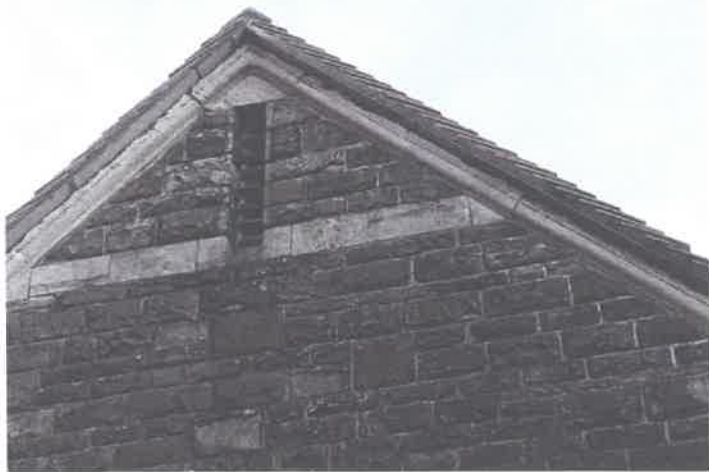
| <b>Item No:</b> 0046 | <b>Sample No:</b> LW005425 |

| <b>Location:</b> Unit 6, External, External (Ex), Gable ends, Undercloak | |
| <b>Material type:</b> Cement | <b>Asbestos Type:</b> Chrysotile |
