Project No: J062153

**Dyffryn Lower School**  
**Talcennau Road**  
**Port Talbot**  
**SA13 1EP**

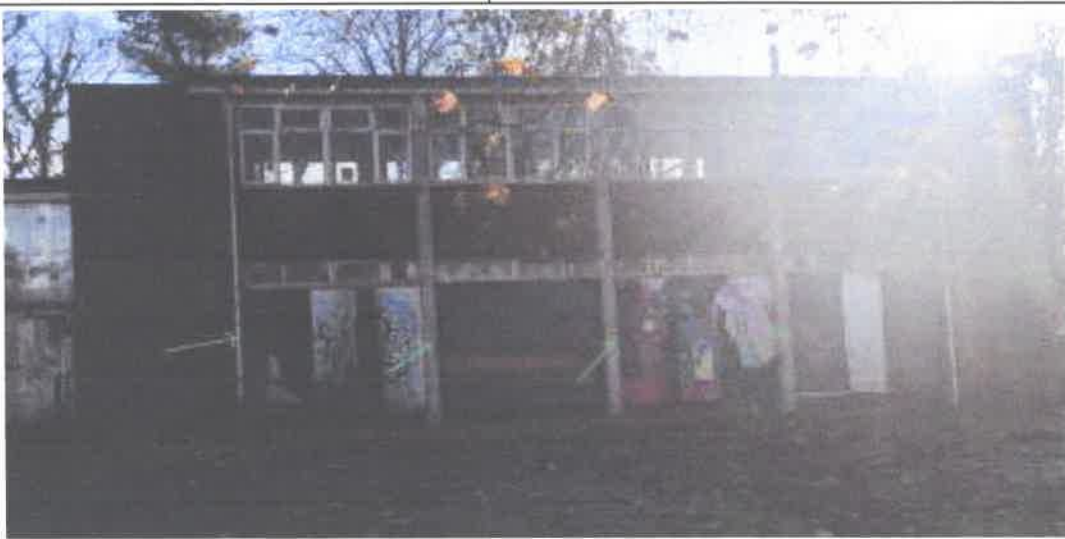
| <b>Item No:</b> 0047 | <b>Sample No:</b> LW005426 |

| <b>Location:</b> Unit 6, External, External (Ex), To concrete columns of science block, Coating to concrete | |
| <b>Material type:</b> Textured Coating | <b>Asbestos Type:</b> No asbestos detected |

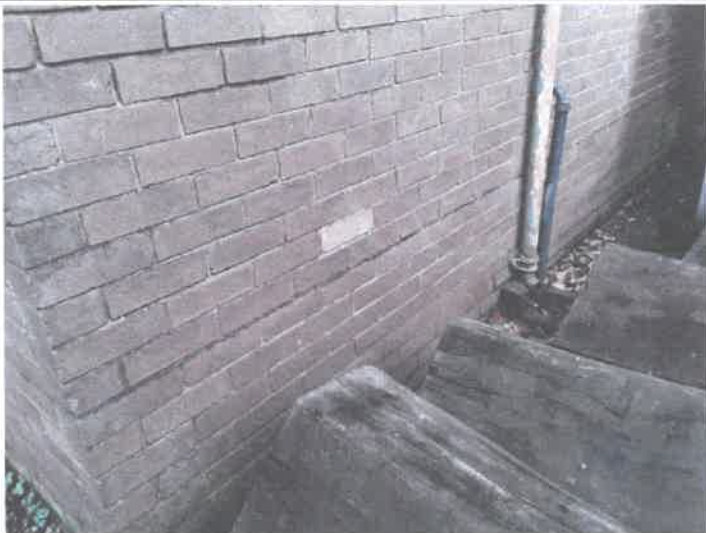
| <b>Item No:</b> 0048 | <b>Sample No:</b> LW005427 |

| <b>Location:</b> Unit 6, External, External (Ex), Walls to science block, Damp Proof Course | |
| <b>Material type:</b> Bitumen | <b>Asbestos Type:</b> No asbestos detected |
