# **BS5837:2012 Tree Survey & Arboricultural Constraints Report**

**Dakota House**

**Client: Mr Robert Bowen**

**March 2024**

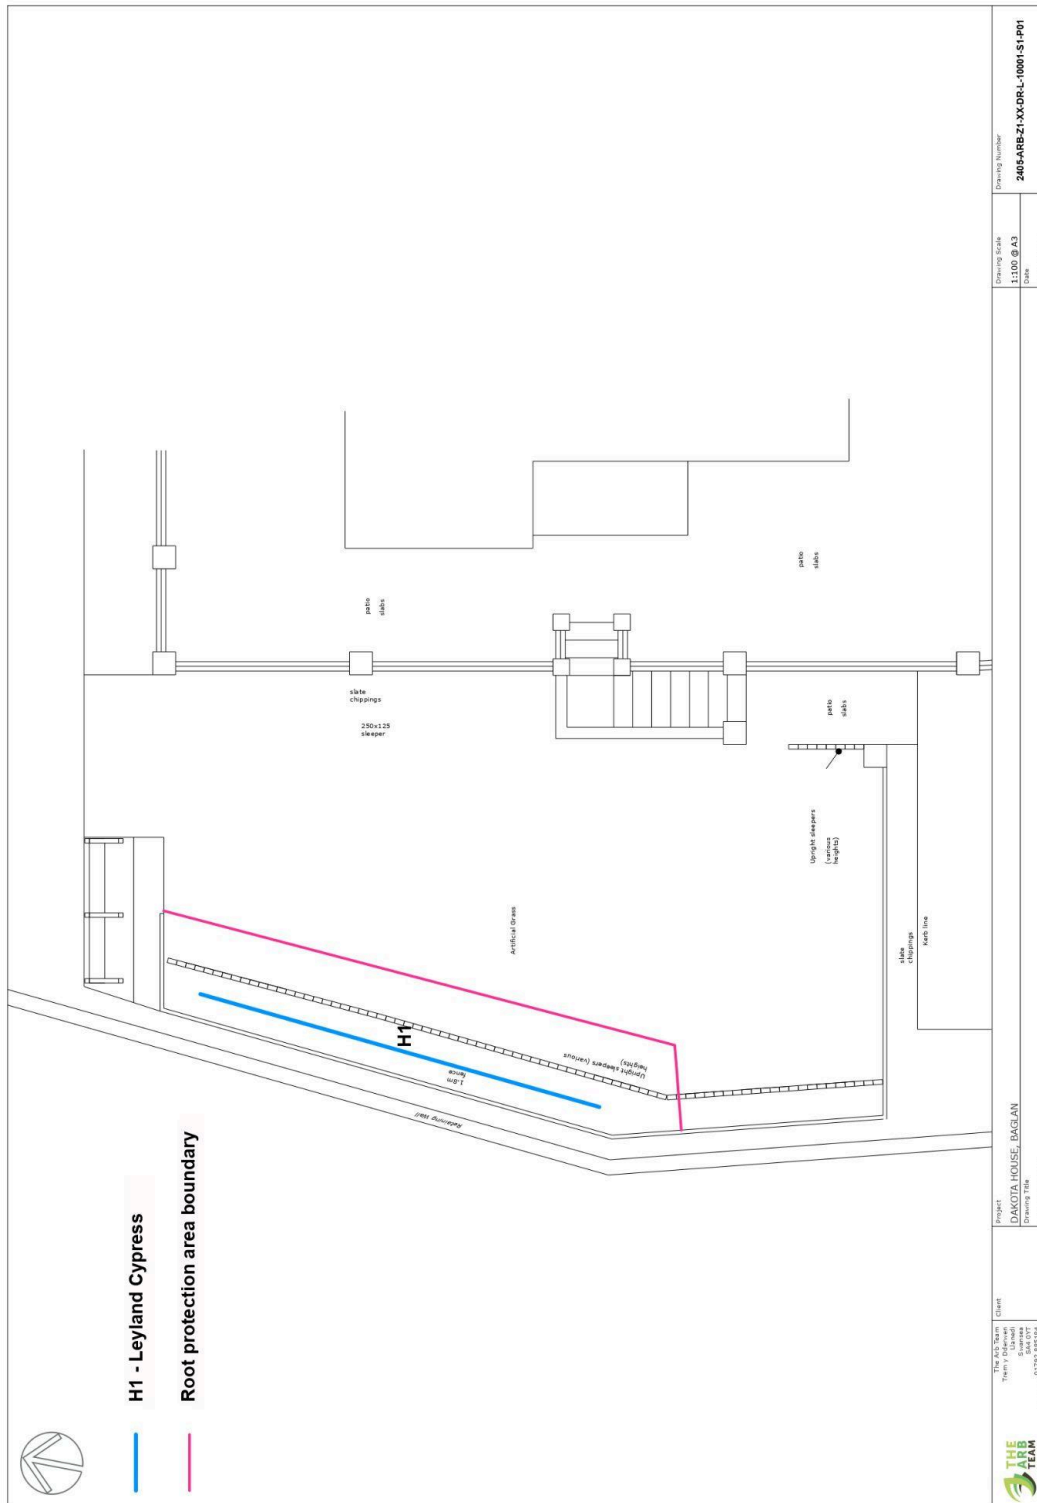
### Site and tree location plan

2.6 All 13 conifers are Leyland Cypress of the variety Castlewellan Gold. At their nearest point the trees are 12 metres from the house. Their position is shown on the site plan.

| <b><u>TABLE D</u></b> | <b>Issues</b> | <b>Observations</b> | <b>Impact</b> |
|---|---|---|---|
| | Structures in RPA | A small section of the north east corner of the new garage extends into the RPA but with ground protection this is within an acceptable tolerance. | |

4.4 The new building does infringe on a small area of the root protection area. To allow a sufficient area for the construction work ground protection is required. After the removal of the artificial grass a membrane should be laid on the soil surface with a 10cms covering of wood chippings and finally the installation of heavy duty bog mats which can then be used for the passage of materials and site staff.

5.1 To protect the trees root protection zones prior to any ground or construction work protective fencing as shown in Appendix 2 must be erected at an adequate distance from the trees. The minimum distances between the base of the main stem and the fencing are shown in Section 3, Table C under the RPA 2 column. After consultation and agreement with the local planning authority if the fence cannot be erected at the recommended distance from the tree it should be erected at the maximum distance possible and ground protection measures as stated in Appendix 3 must be implemented. When the protective fencing and ground protection has been installed weather resistant signs displaying wording such as TREE PROTECTION AREA - NO UNAUTHORISED ACCESS should be attached to the protective fencing at suitable locations. These signs must be adequate in number and prominence.
