**Client Name: Global Centre of  
Rail Excellence**
**Site: GCRE (Onllywyn Washery)**
**Project No.  
5209796**

Client Name: Global Centre of Rail Excellence

Site: GCRE (Main Site)

Project No. 5209796

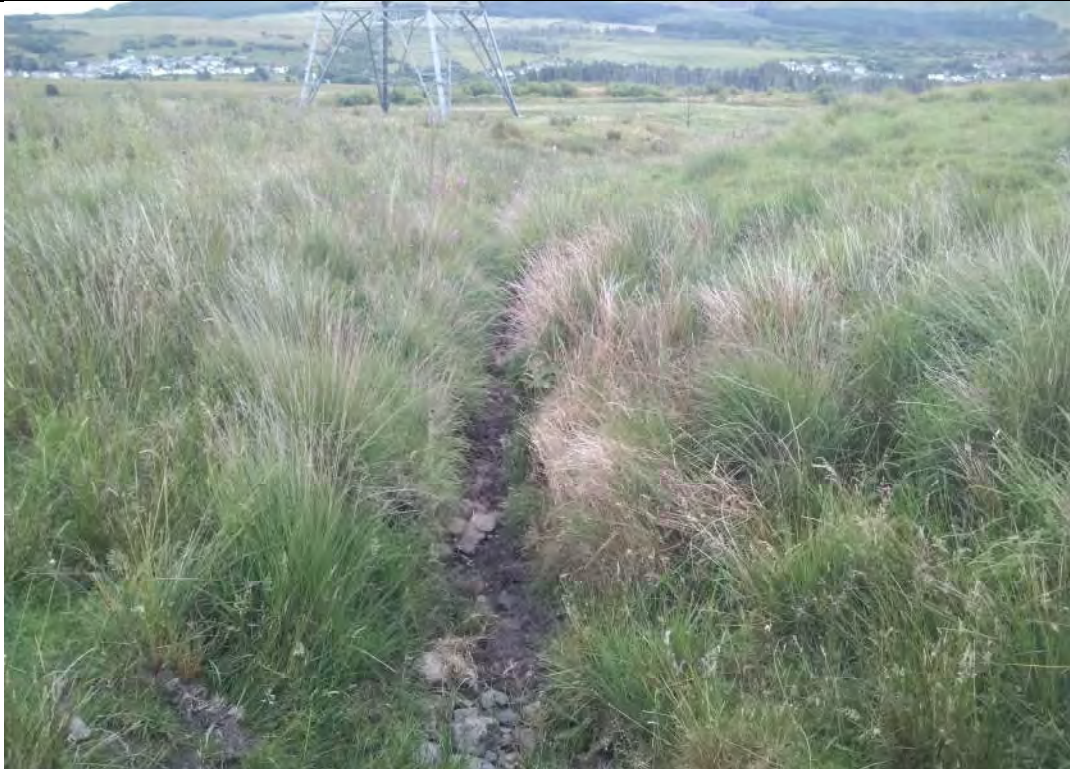
| Photo No. | Date: | |
|---|---|---|
| <b>Surface Water Feature SW-01 CE:</b><br>Surface Water Course (Minor ditch), possibly used as a field drainage/runoff. No water flowing observed at the time. Approximate measurements 1.2m wide, 0.8m depth. | | |

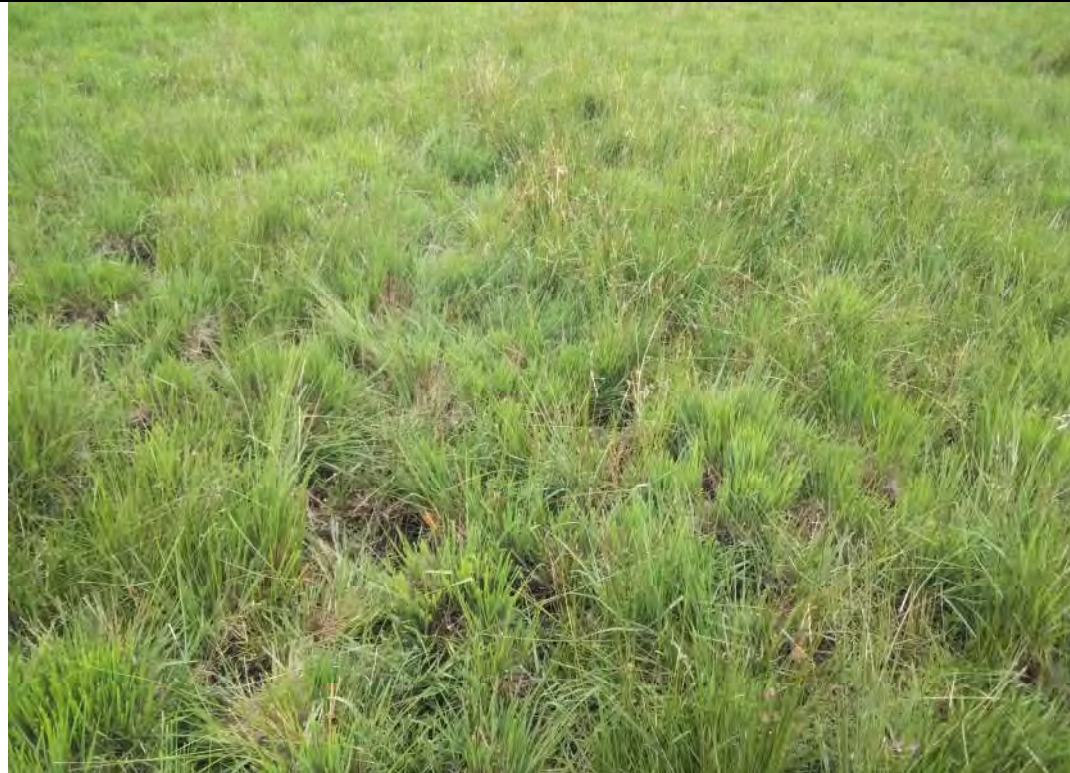
| Photo No. | Date: | |
|---|---|---|
| SW-02 CE | 12 July 2022 | |

| Photo No. | Date: | |
|---|---|---|
| <b>Surface Water Feature SW-02 CE:</b><br>Marshy Land, rainfall/runoff. Mildly wet. No water flowing observed at the time. Approximate measurements 10m wide. | | |

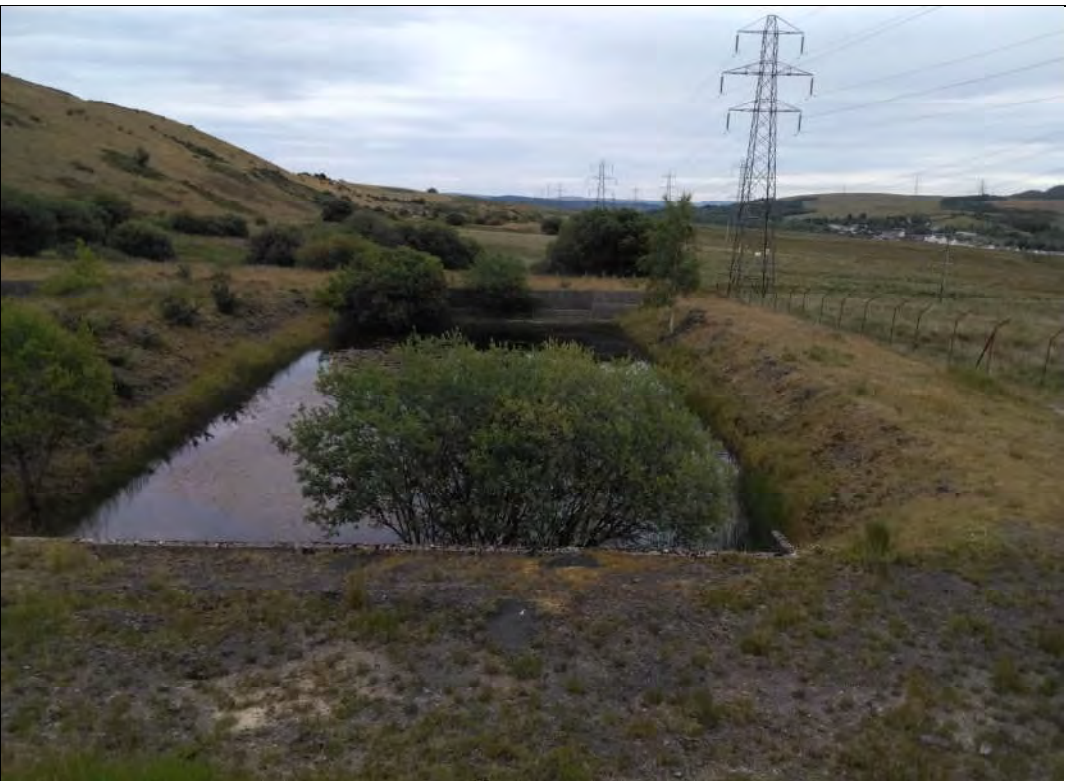
| <b>Photo No.</b><br>SW-03 CE | <b>Date:</b><br>12 July 2022 | |
| <b>Surface Water Feature SW-03 CE:</b><br>Lagoon, water storage area, probably lined with low permeability material, drainage/runoff from restoration area. No water flowing observed at the time. Approximate measurements 5m wide, 10m length. Measurements DO 103.83%, ORP 137.5 mV, Cond 134.34 ms/cm, pH 7.34, T22.8C | | |

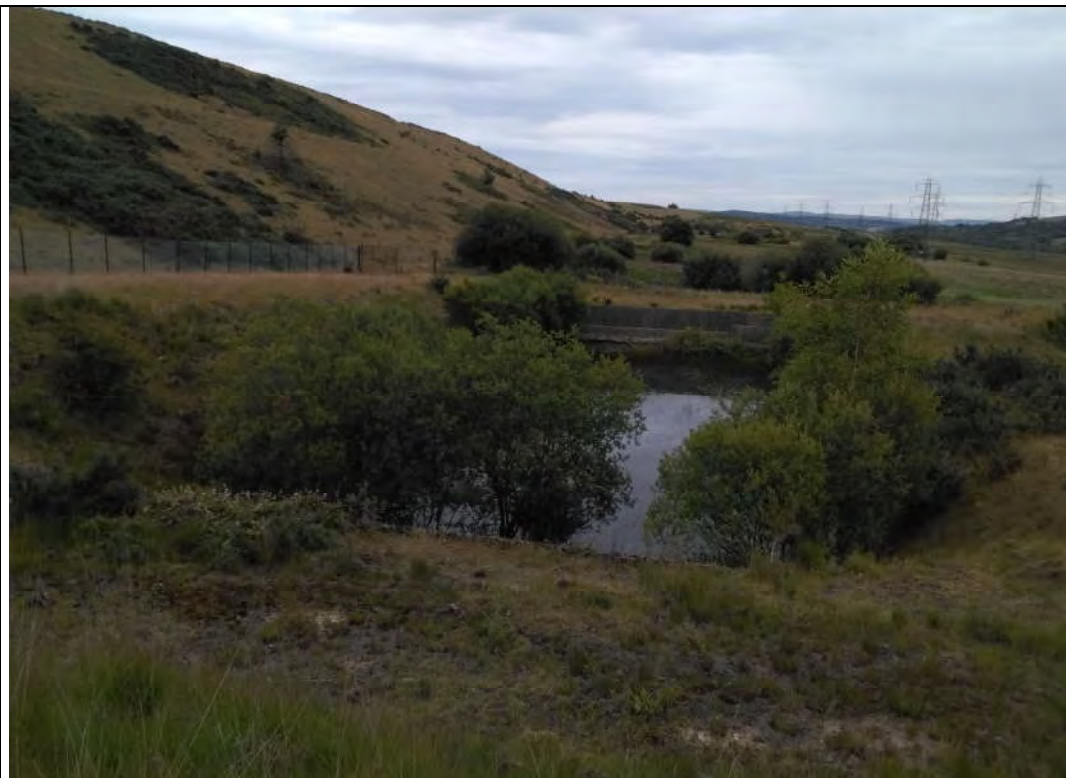
| <b>Photo No.</b><br>SW-04 CE | <b>Date:</b><br>12 July 2022 | |
| <b>Surface Water Feature SW-04 CE:</b><br>Lagoon, water storage area, probably lined, drainage/runoff from restoration area. No water flowing observed at the time. Approximate measurements 5m wide, 10m length. DO 95.89%, ORP 211.0 mV, Cond 144.6ms/cm, pH 7.61, T21.7 | | |

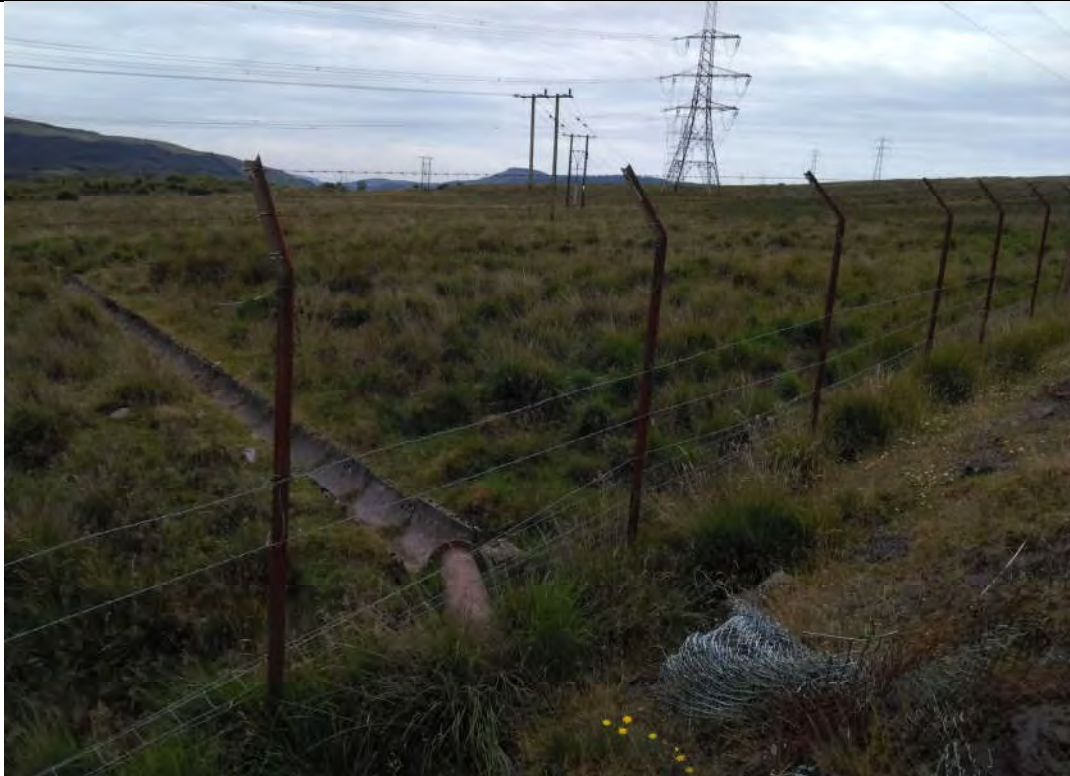
| Photo No. | Date: | |
|---|---|---|
| <b>Surface Water Feature SW-06 CE:</b><br>Discharge ditch from lagoon, lined with concrete cast approximately 70cm wide and 40cm depth, drainage/runoff from lagoon.<br>No water flowing observed at the time.<br>Approximate measurements 5m wide, 10m length. | | |

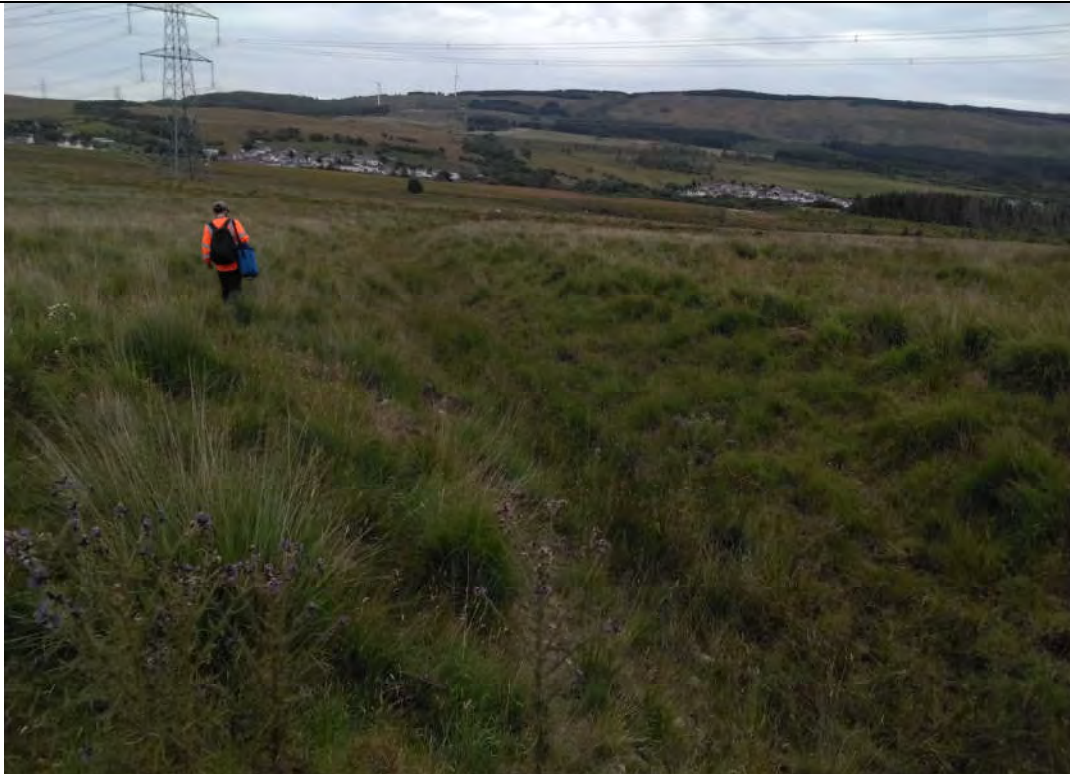
| Photo No. | Date: | |
|---|---|---|
| <b>Surface Water Feature SW-07 CE:</b><br>Surface Water Course (minor ditch), possibly used as a field drainage/runoff.<br>Not lined. No water flowing observed at the time. Approximate measurements 3m wide, 2m depth. | | |

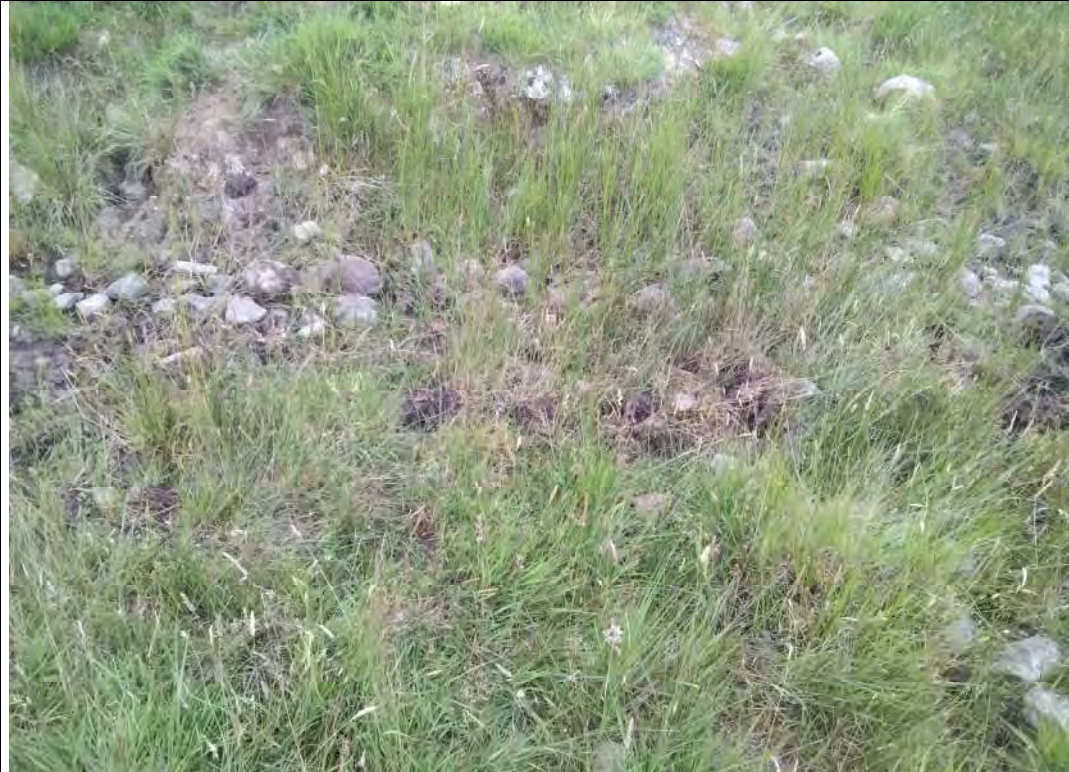
| Photo No. | Date: | |
|---|---|---|
| <b>Surface Water Feature SW-11 CE:</b><br>Surface Water Course (minor ditch), possibly used as a field drainage/runoff. Not lined. Ground slightly wet. No water flowing observed at the time. Approximate measurements 2.5m wide, 0.5m depth. | | |

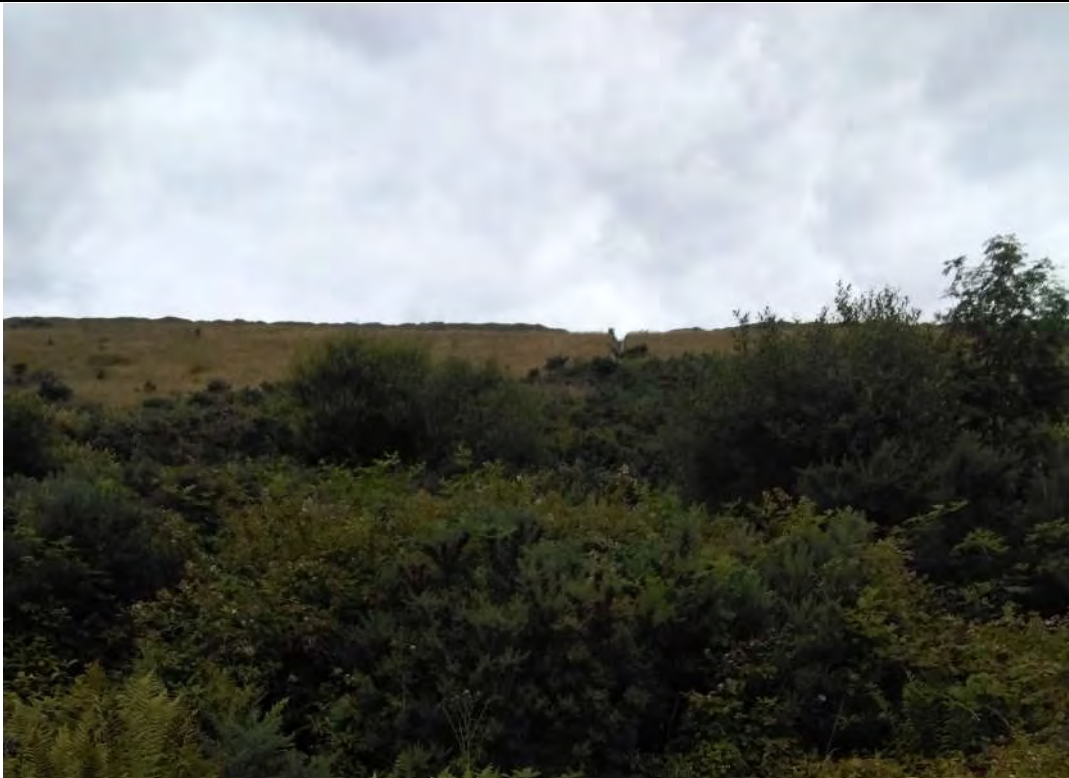
| Photo No. | Date: | |
|---|---|---|
| <b>Surface Water Feature SW-14 CE:</b><br>Surface Water Course (Minor ditch), possibly used as to collect restoration area drainage/runoff. Lined. No water flowing observed at the time. Approximate measurements 5m wide, 1m depth. | | |

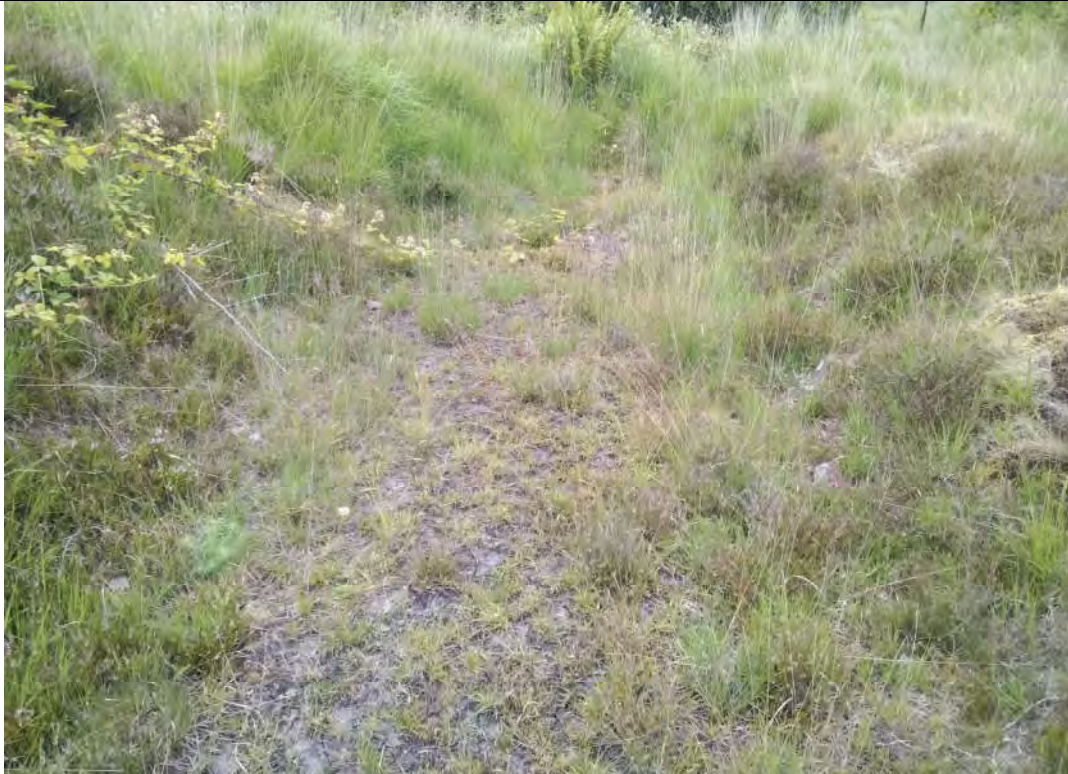
| Photo No. | Date: | |
|---|---|---|
| <b>Surface Water Feature SW-15 CE:</b><br>Surface Water Course (Minor ditch), possibly used as to collect restoration area drainage/runoff. Lined. No water flowing observed at the time. Approximate measurements 5m wide, 1m depth. | | |

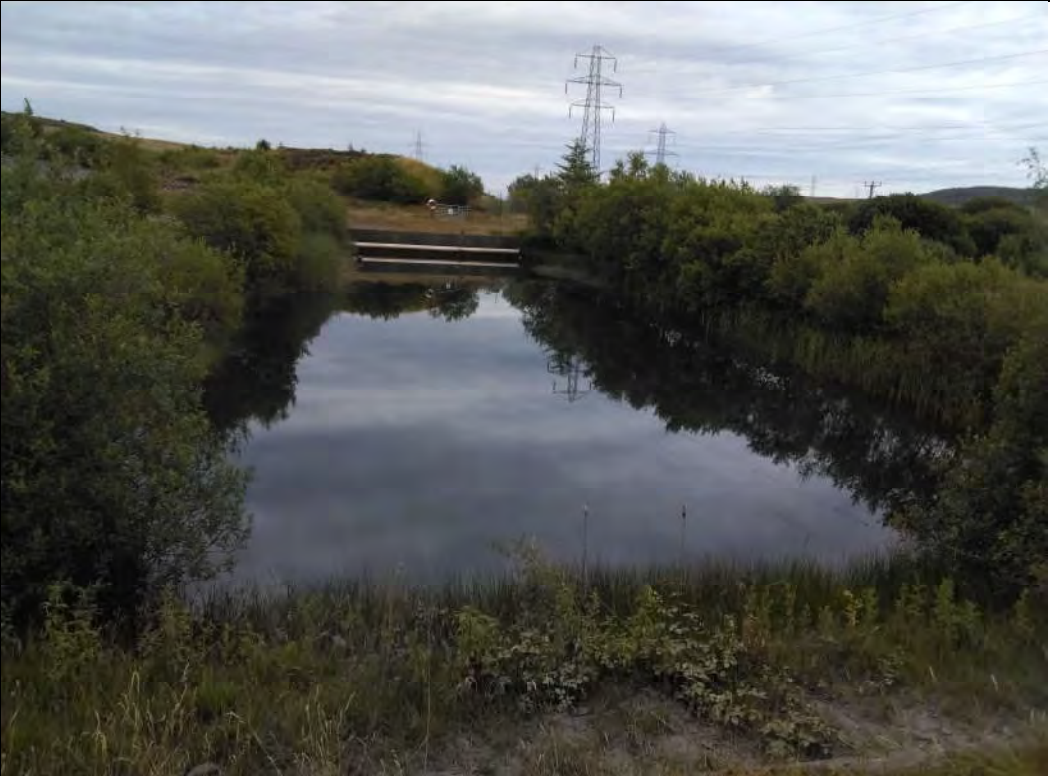
| Photo No. | Date: | |
|---|---|---|
| <b>A Surface Water Feature SW-16 CE:</b><br>Lagoon, water storage area, probably lined, drainage/runoff from restoration area.<br>No water flowing observed at the time in or out. Approximate measurements 10m wide, 20m length.<br>DO 126%, ORP 164.9 mV, Cond 1497ms/cm, pH 7.7, T21.41 | | |

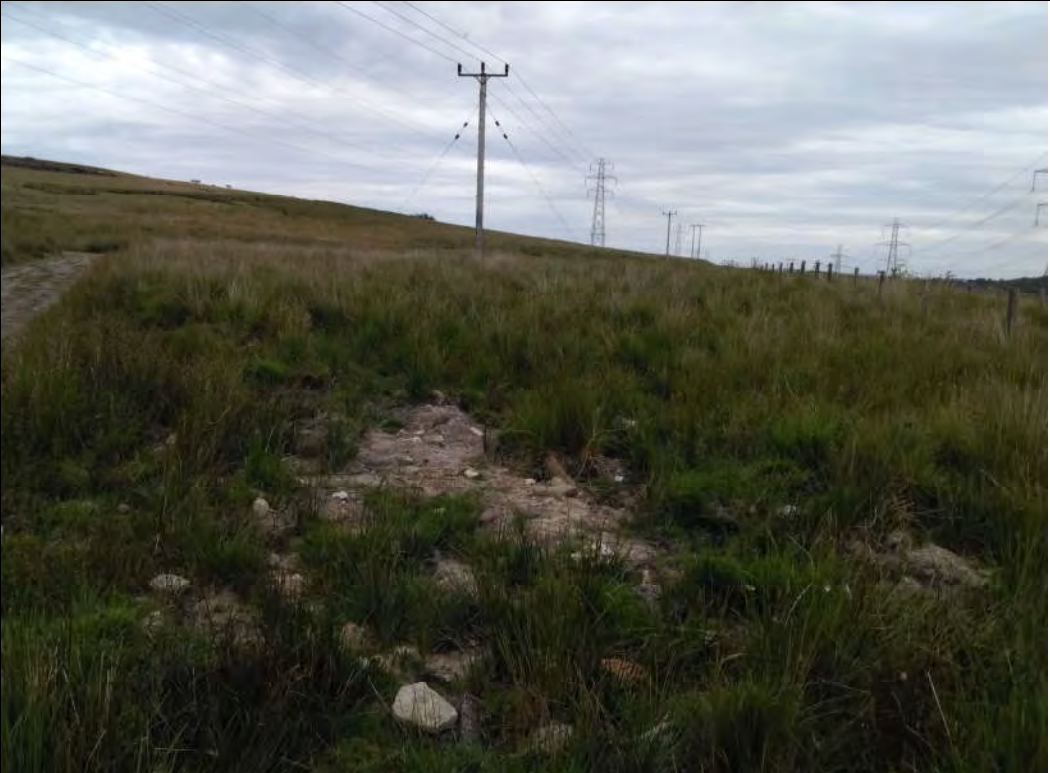
| Photo No. | Date: | |
|---|---|---|
| <b>A Surface Water Feature SW-17 CE:</b><br>Surface Water Course (Minor ditch), possibly used as to collect restoration area drainage/runoff. Lined.<br>No water flowing observed at the time.<br>Approximate measurements 1m wide, 0.5m depth. | | |

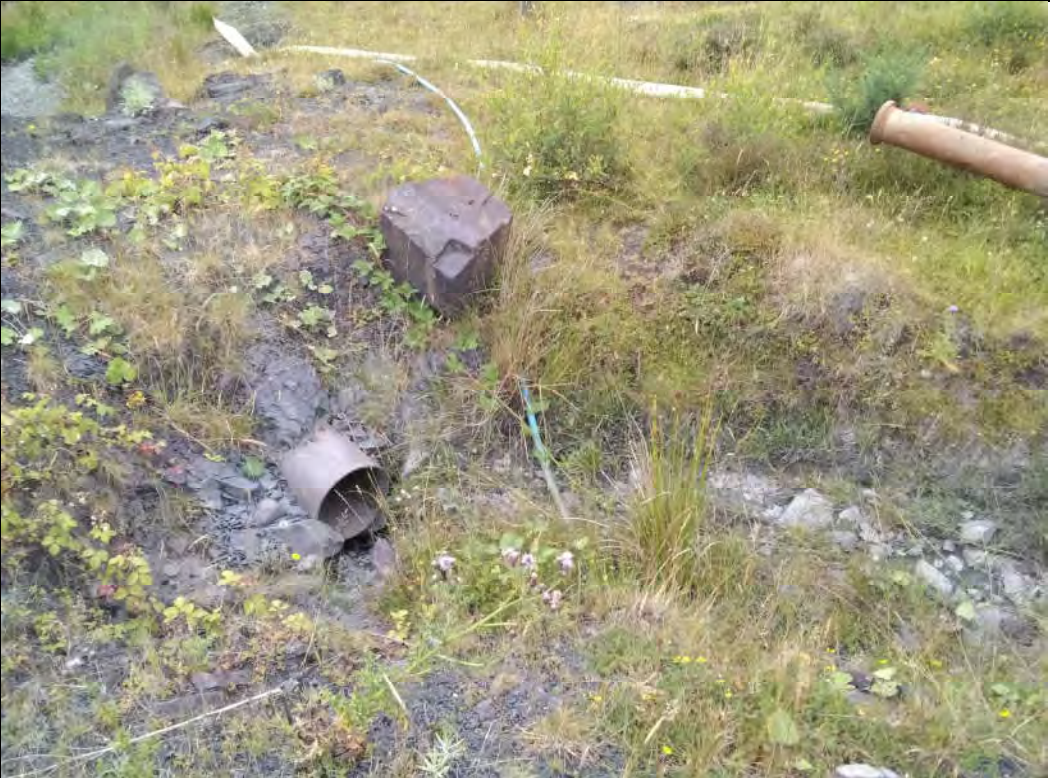
| Photo No. | Date: | |
|---|---|---|
| <b>A Surface Water Feature SW-18 CE:</b><br>Surface Water Course (Minor ditch), connecting two lagoons. Not lined. No water flowing observed at the time. Approximate measurements 1m wide, 0.5m depth. | | |

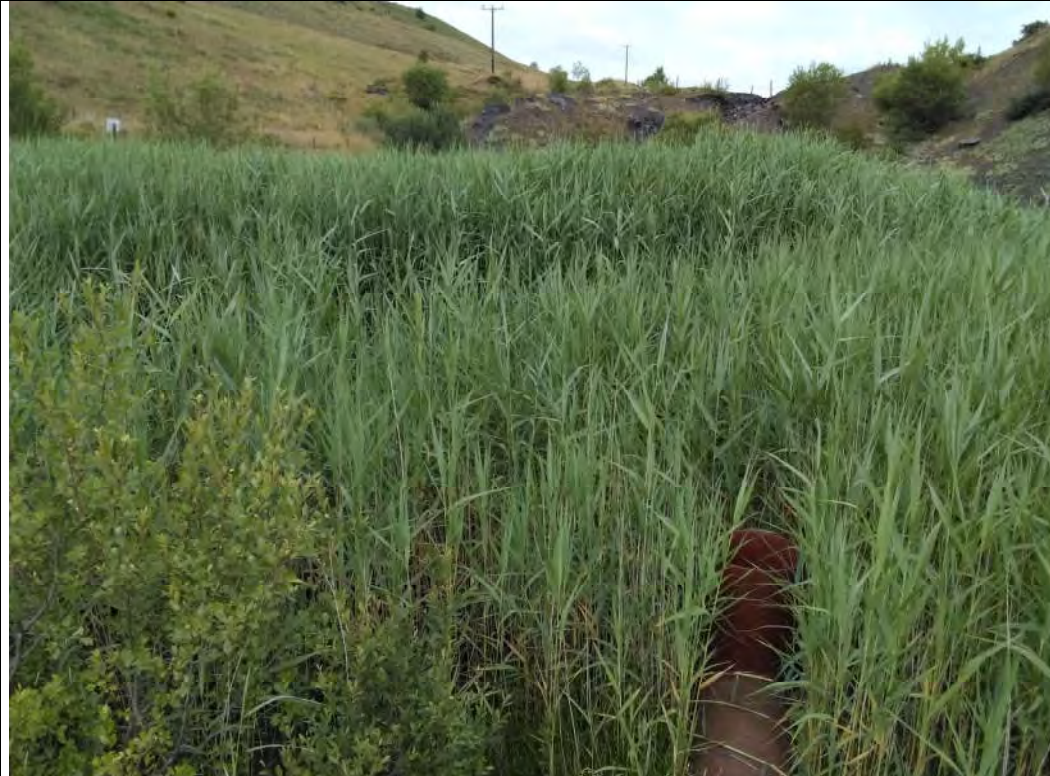
| Photo No. | Date: | |
|---|---|---|
| <b>A Surface Water Feature SW-19 CE:</b><br>Lagoon, quite dry, probably lined but looked silted up, drainage/runoff from restoration area. No water flowing observed at the time in or out. No measurements obtained as mainly dry. | | |

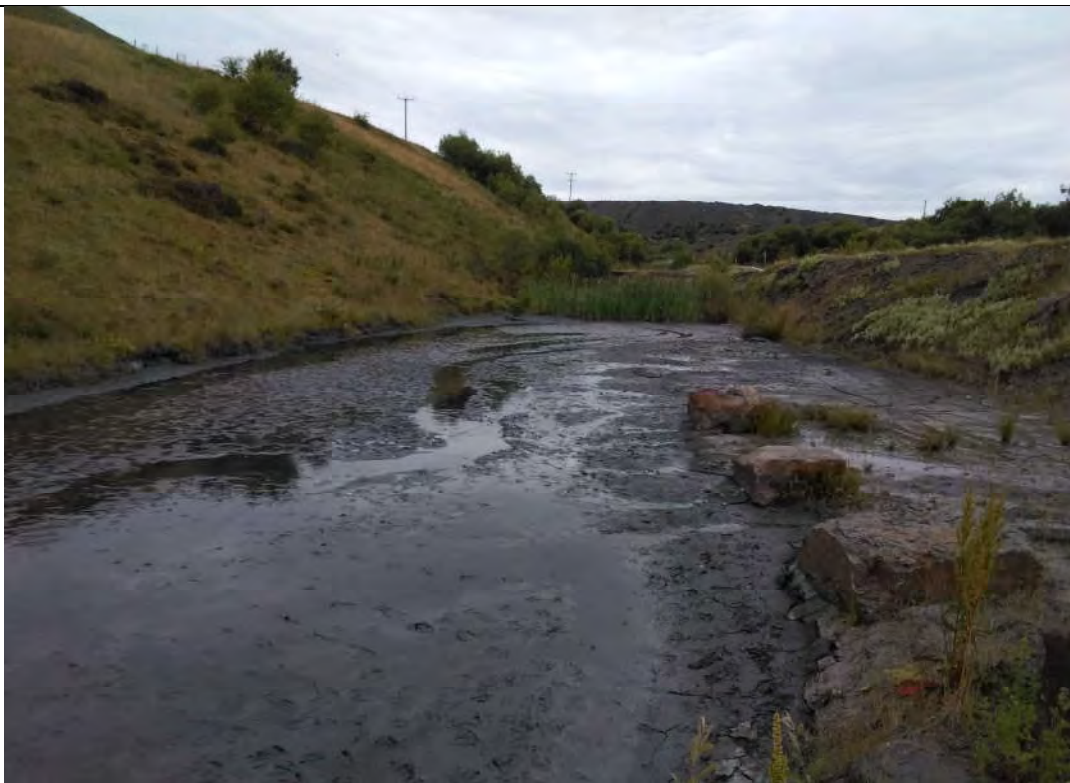
| Photo No. | Date: | |
|---|---|---|
| <b>A Surface Water Feature SW-20 CE:</b><br>Lagoon, quite dry, probably not lined but looked silted up, drainage/runoff from restoration or adjacent areas.<br>Minimal water flowing observed at the time in or out, flow 0.335m/s. 5m wide by 20m long. No measurements obtained low water present. | | |

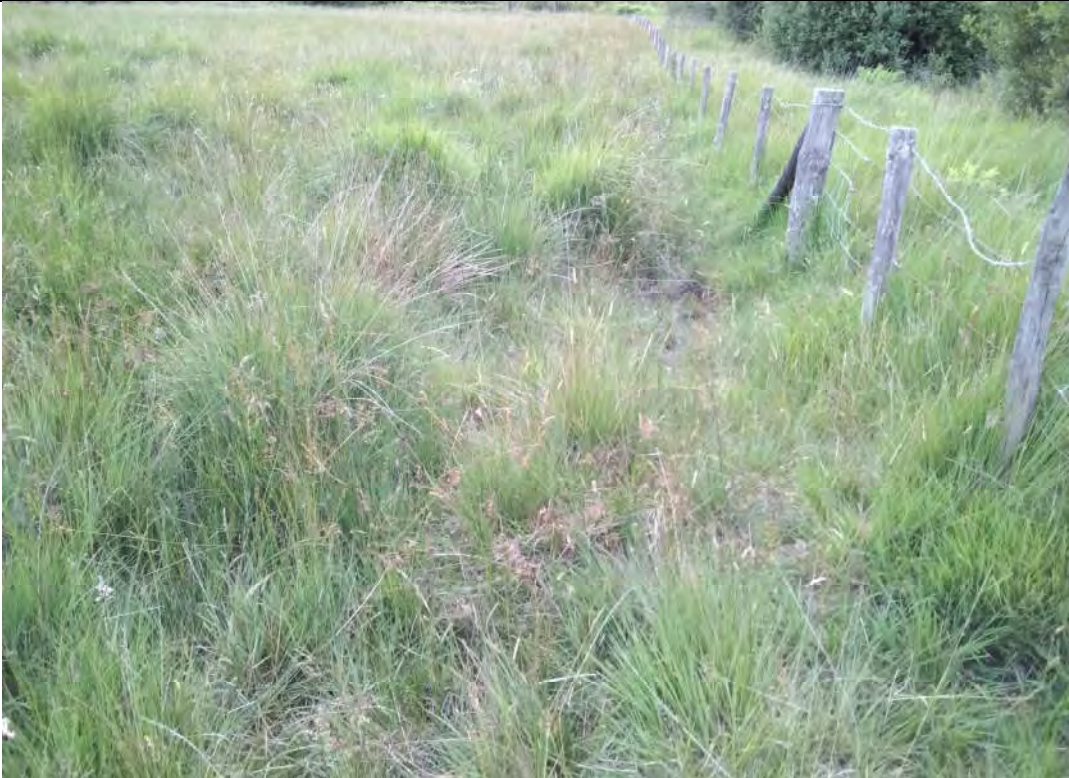
| Photo No.<br>SW-24 CE | Date:<br>12 July<br>2022 | |
|---|---|---|
| <b>A Surface Water Feature SW-24 CE:</b><br>Marshy Land, rainfall/runoff.<br>Soil mostly dry, but occasional signs of moist soil. No water flowing observed at the time.<br>Approximate measurements 2m wide. | | |

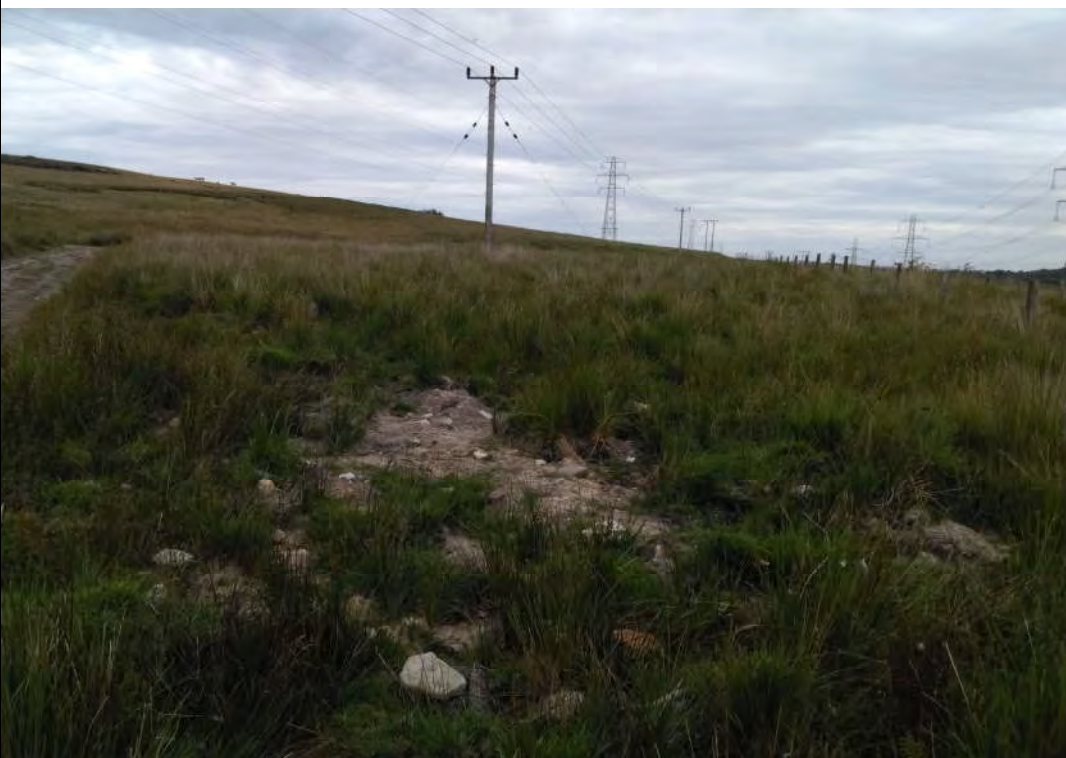
| Photo No.<br>SW-25 CE | Date:<br>12 July<br>2022 | |
|---|---|---|
| <b>A Surface Water Feature SW-25 CE:</b><br>Marshy Land, rainfall/runoff.<br>Soil mostly dry, but occasional signs of moist soil. No water flowing observed at the time.<br>Approximate measurements 2m wide. | | |

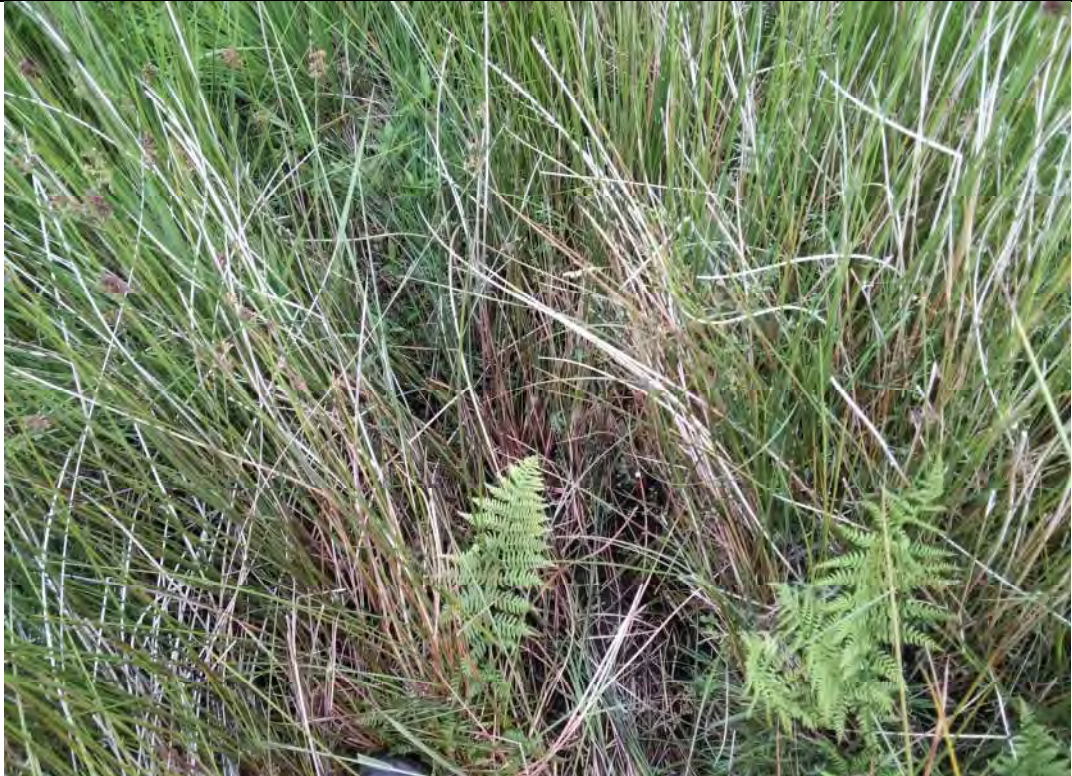
| Photo No. | Date: | |
|---|---|---|
| <b>A Surface Water Feature SW-26 CE:</b><br>Surface Water (minor ditch), land drainage, no flow at the time, area slightly moist. No water flowing observed at the time. Approximate measurements 2m wide by 0.3m depth. | | |

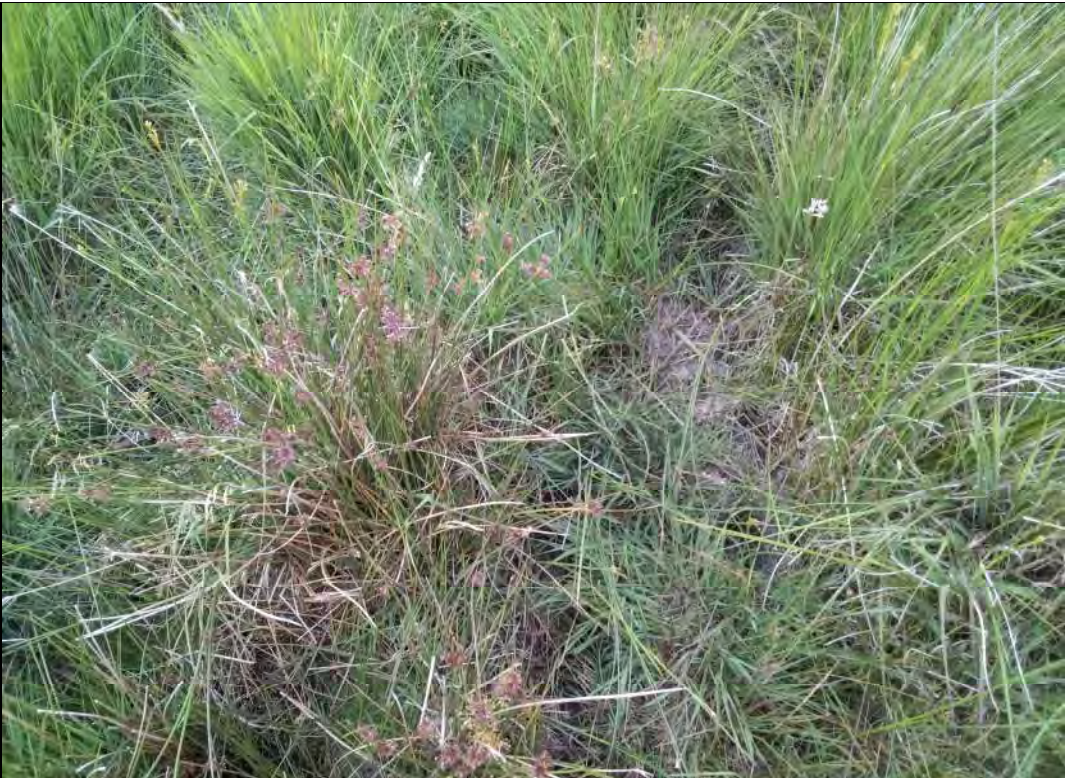
| Photo No. | Date: | |
|---|---|---|
| <b>Surface Water Feature SW-32 CE:</b><br>Marshy Land, rainfall/runoff.<br>Soil mostly dry, but occasional signs of moist soil. No water flowing observed at the time.<br>Approximate measurements 2m wide. | | |

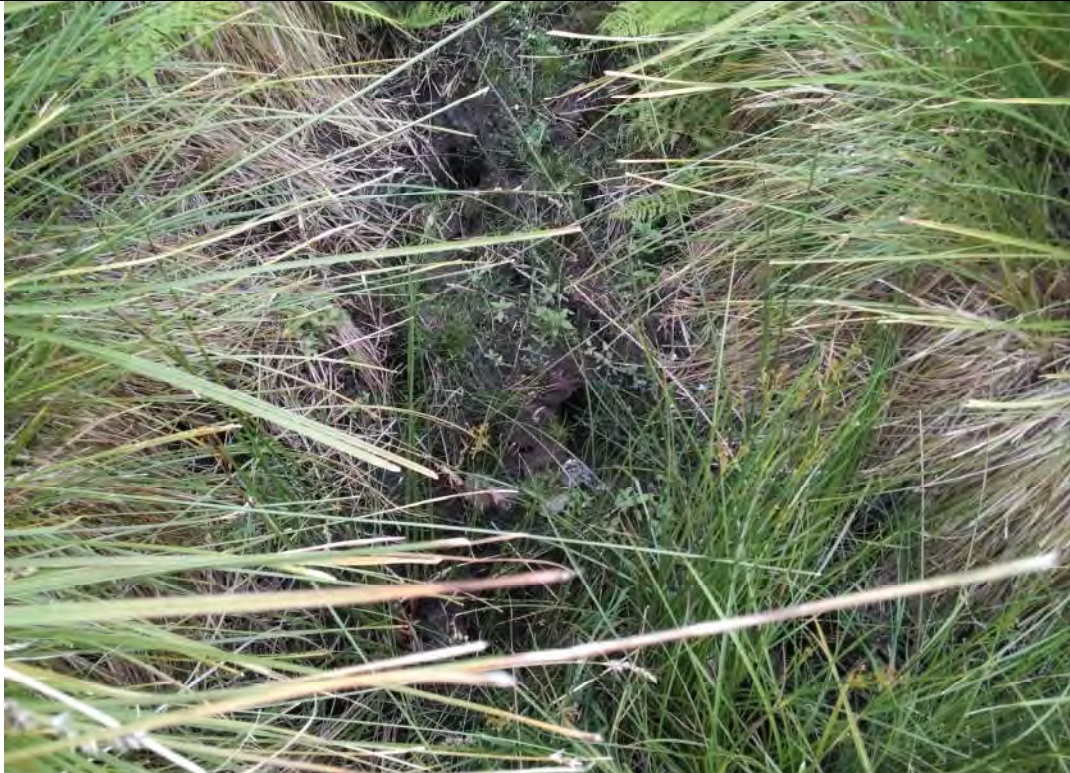
| Photo No. | Date: | |
|---|---|---|
| <b>Surface Water Feature SW-35 CE:</b><br>Surface Water (minor ditch), land drainage from adjacent areas, no flow but ground slightly moist, no likely to be lined. Approximate measurements 1m wide by 0.5 depth. | | |

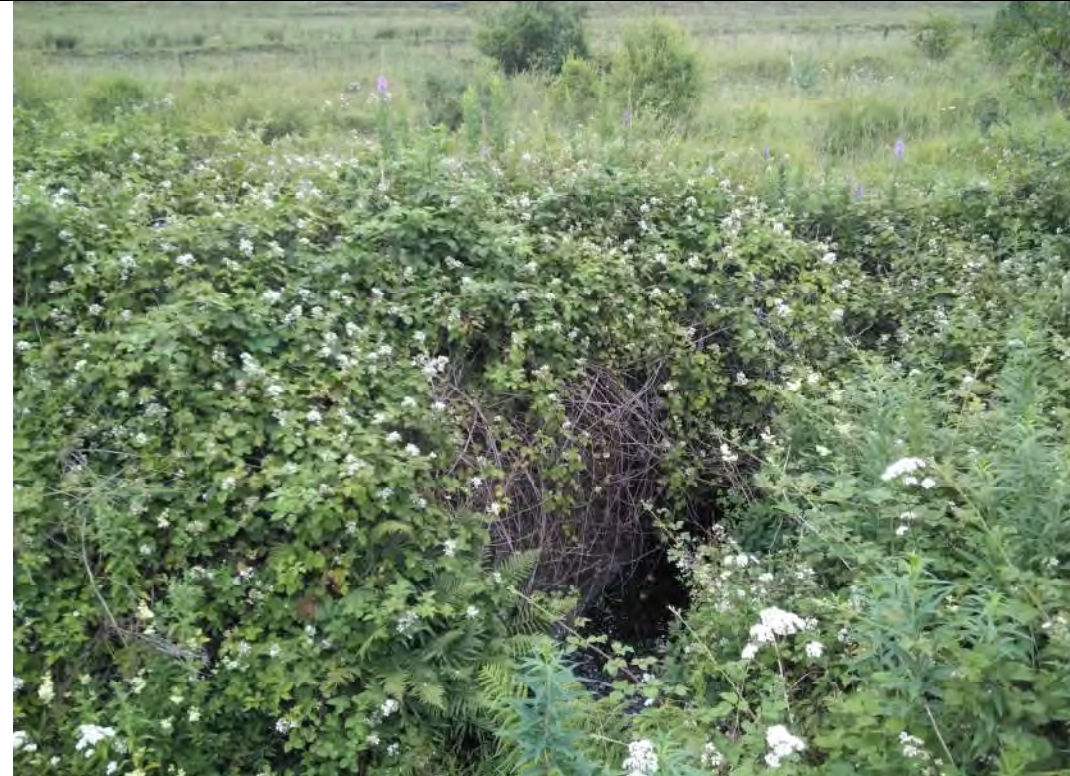
| Photo No. | Date: | |
|---|---|---|
| <b>Surface Water Feature SW-54 CE:</b><br>Surface Water (stream), land drainage/runoff from adjacent restored and pastoral areas and rainfall, flow noted, no likely to be lined. Parameters not taken due to H&S risks. | | |

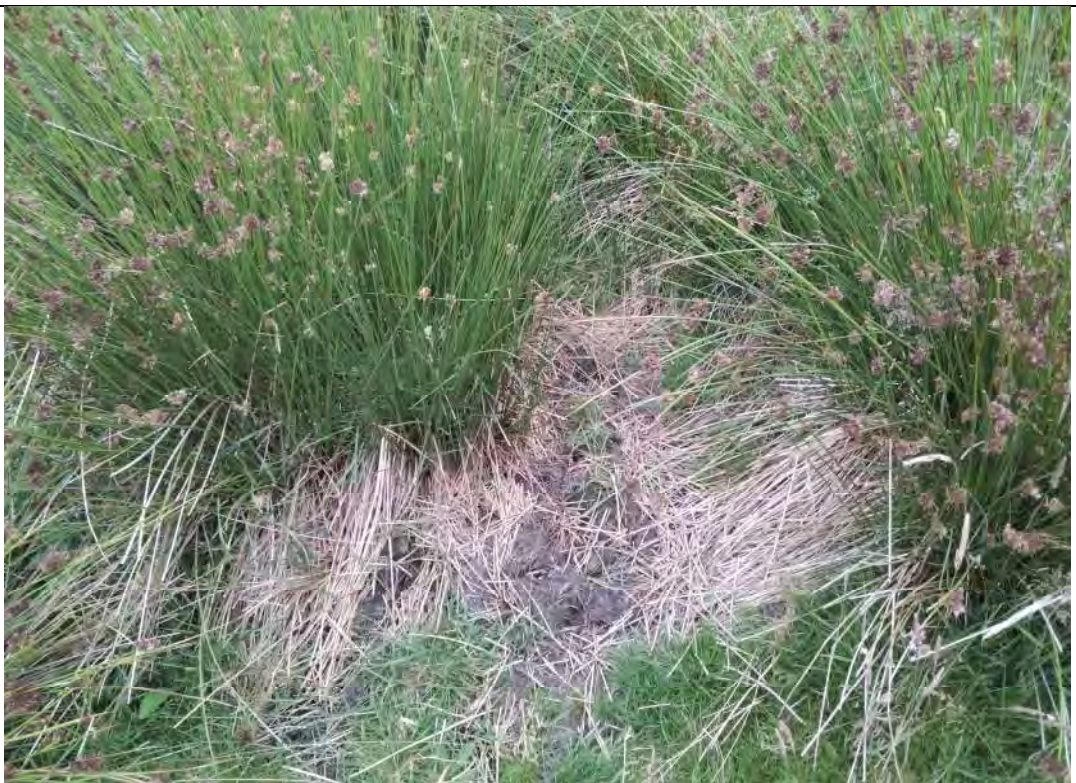
| Photo No. | Date: | |
|---|---|---|
| <b>Surface Water Feature SW-58 CE:</b><br>Marshy Land, rainfall/runoff.<br>Soil mostly dry, but occasional signs of moist soil. No water flowing observed at the time.<br>Approximate measurements 2m wide. | | |

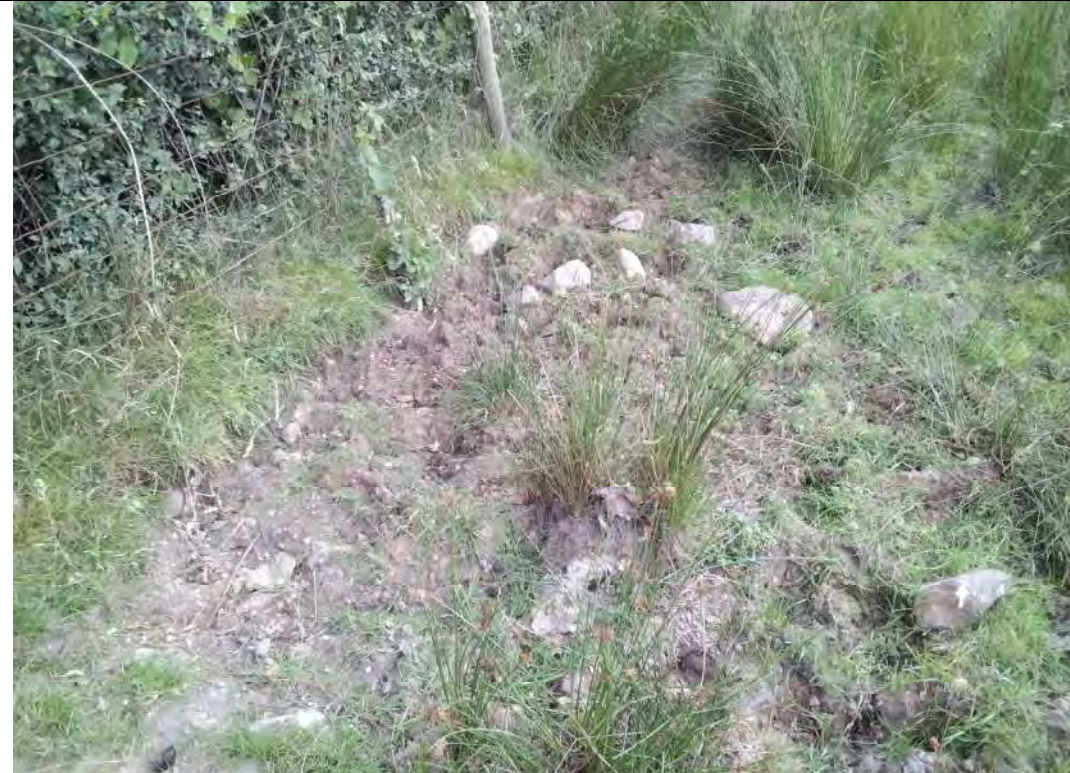
| Photo No. | Date: | |
|---|---|---|
| <b>Surface Water Feature SW-68 CE:</b><br>Marshy Land, rainfall/runoff. Soil mostly dry, but occasional signs of moist soil. No water flowing observed at the time. Approximate measurements 2m wide. | | |

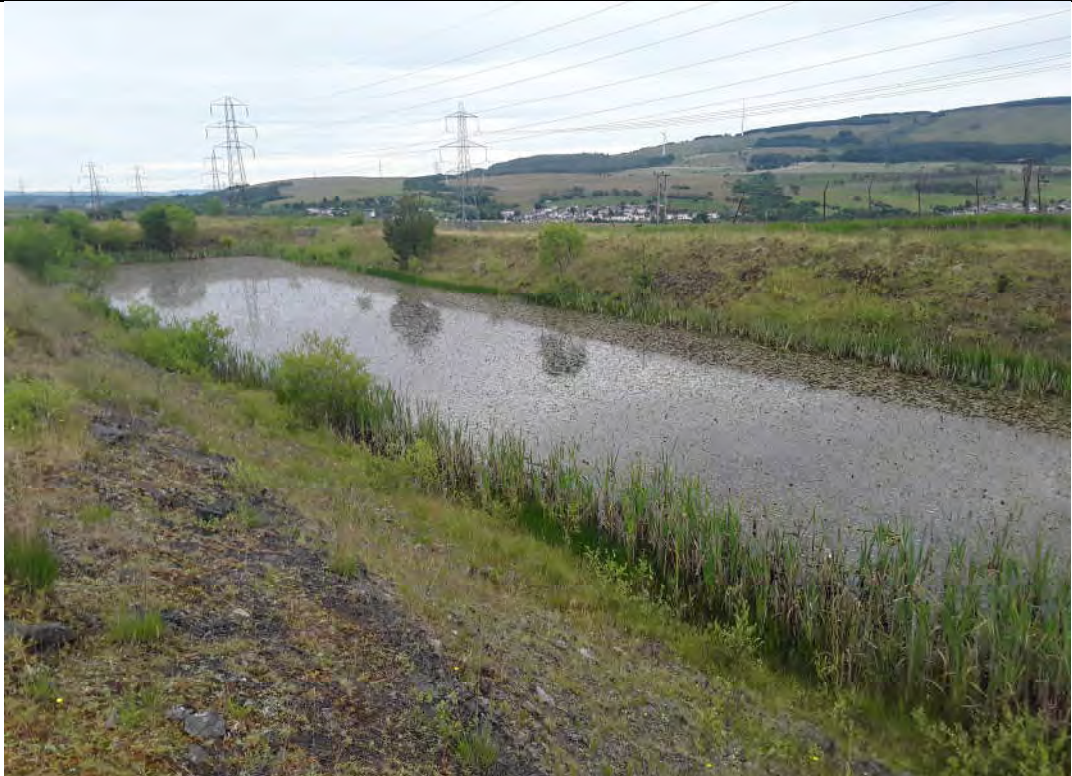
| Photo No. | Date: | |
|---|---|---|
| <b>Surface Water Feature SW-01 DP:</b><br>Lagoon, water storage area, probably lined with low permeability material, drainage/runoff from restoration area. No water flowing observed at the time. Spillway (SW-02 DP) connected to north-eastern corner via culvert. Approximate measurements 10m wide, 70m length. Measurements DO 150.81%, ORP 178.6 mV, Cond 136.84 ms/cm, pH 8.07, T22.17C<br>The photo aspect is east. | | |

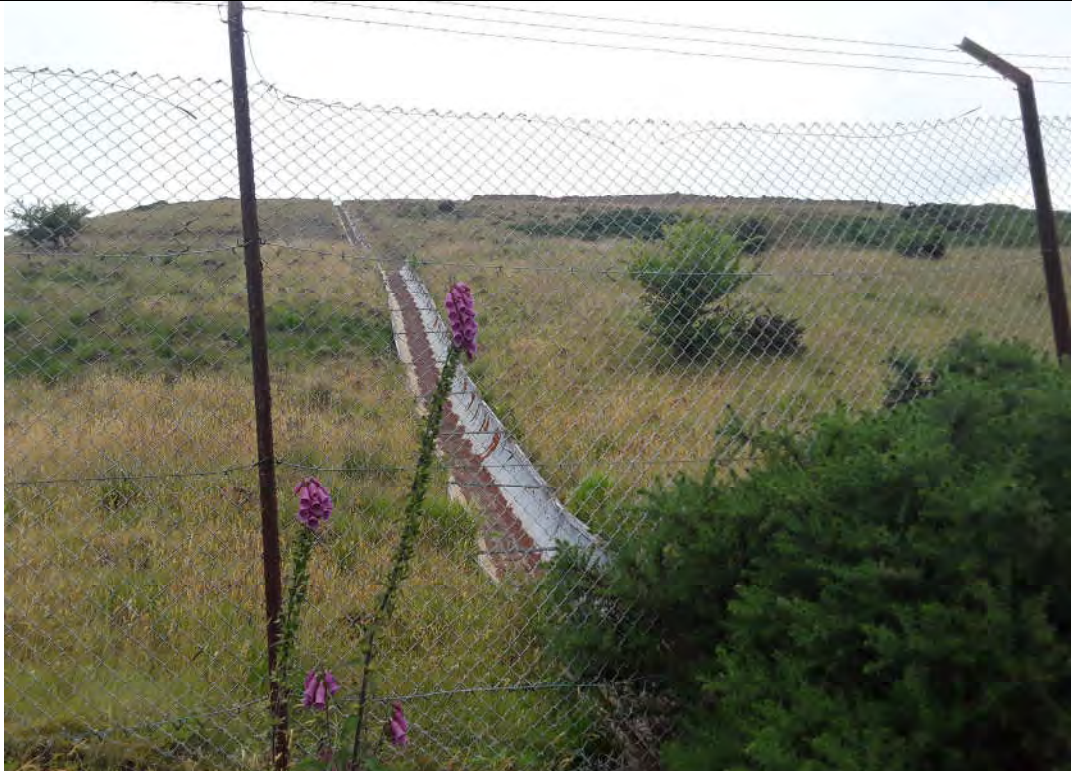
| Photo No. | Date: | |
|---|---|---|
| <b>Surface Water Feature SW-02 DP:</b><br>Spillway chute orientated north to south from the top of the overburden to the lagoon (SW01-DP). No water flowing observed at the time. Constructed of metal. Joins to concrete culvert before reaching lagoon. Rusty base. Approximate measurements 170m length, 0.4m deep, 1.4m wide.<br>The photo aspect is north. | | |

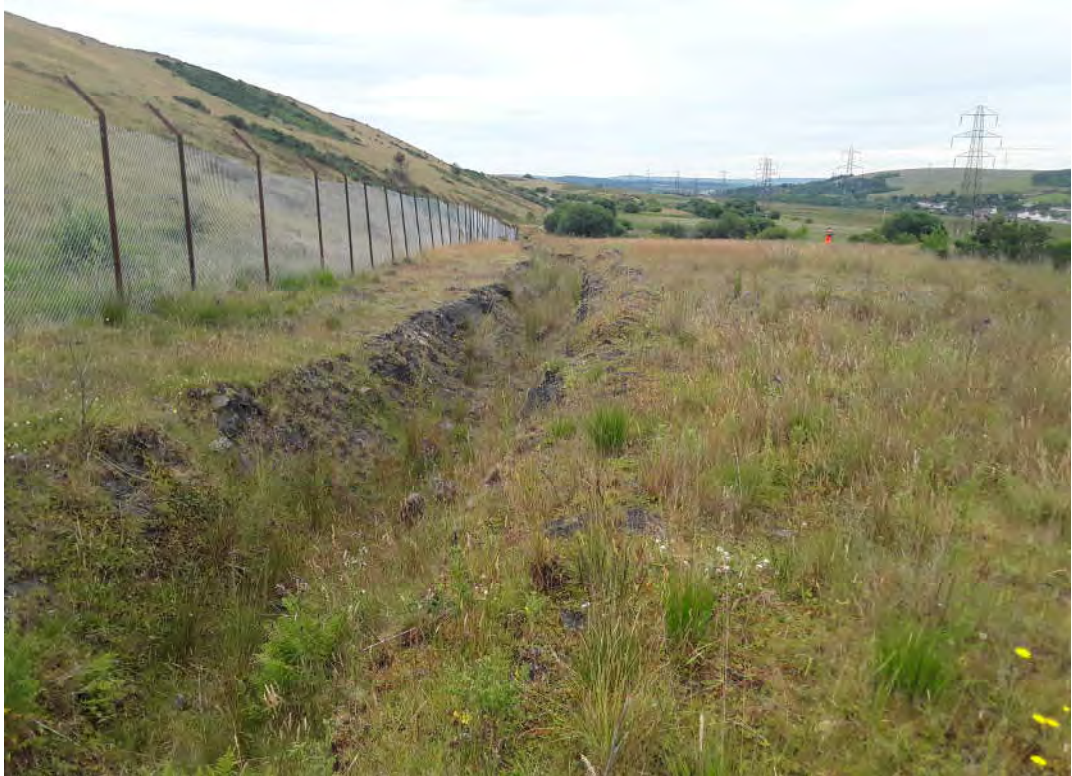
| Photo No. | Date: | |
|---|---|---|
| <b>Surface Water Feature SW-03 DP:</b><br>Overflow ditch connected to spillway chute (SW02-DP) orientated east to west along the entire length of the overburden. No water flowing observed at the time. Vegetated at base along entire length. Approximate measurements 650m length, 1.4m deep, 3.0 m wide. The photo aspect is east | | |
