**Client Name: Global Centre of  
Rail Excellence**
**Site: GCRE (Onllywyn Washery)**
**Project No.  
5209796**

Client Name: Global Centre of Rail Excellence

Site: GCRE (Main Site)

Project No. 5209796

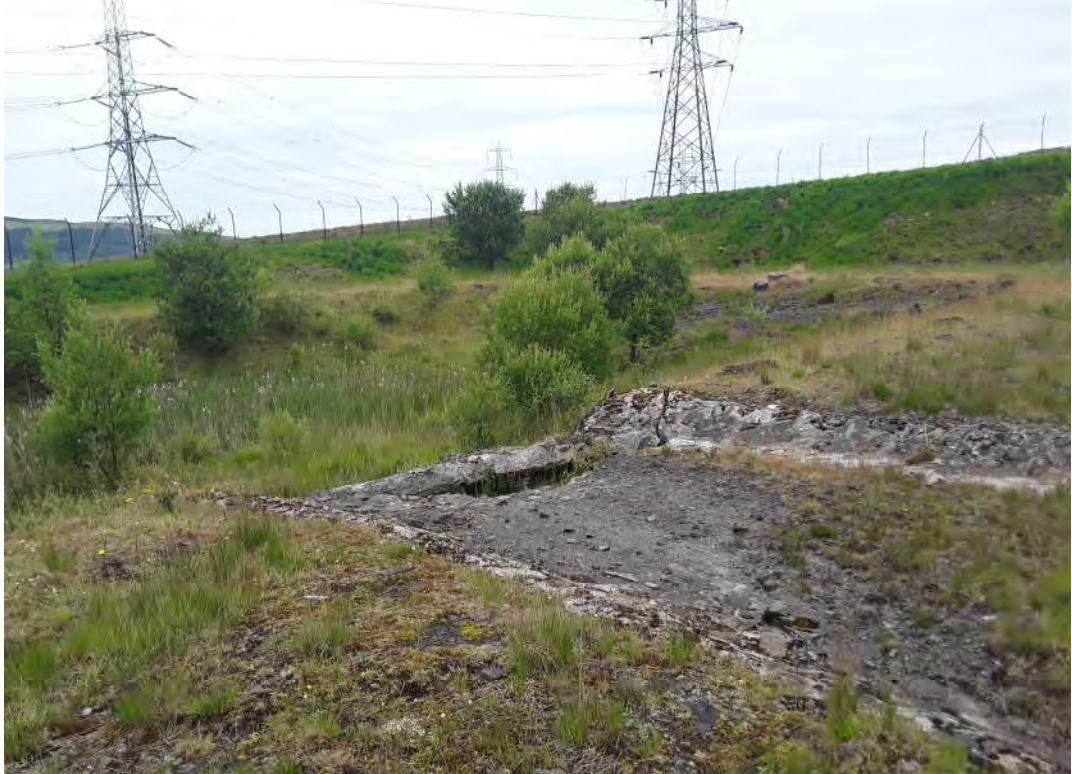
| Photo No. | Date: | |
|---|---|---|
| <b>Surface Water Feature SW-04 DP:</b><br>Concrete culvert at base of spillway chute (SW-02-DP). Poor condition. No water flowing observed at the time. Approximate measurements 0.5m deep, 4.0 m wide. The photo aspect is east | | |

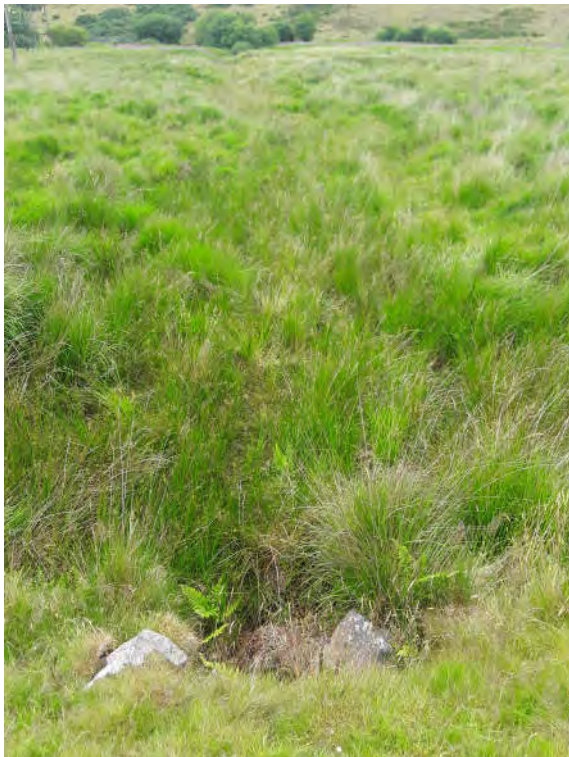
| Photo No.<br>SW-05 DP | Date:<br>12 July<br>2022 | |
|---|---|---|
| <b>Surface Water Feature SW-05 DP:</b><br>Grassy ditch exiting from metal pipe orientated north to south below a grassed bank. Abundant rocks.<br>No water flowing observed at the time.<br>Vegetated at base along entire length.<br>Approximate measurements 650m length, 1.2m deep from the surface, 35.0 m wide.<br>The photo aspect is north | | |

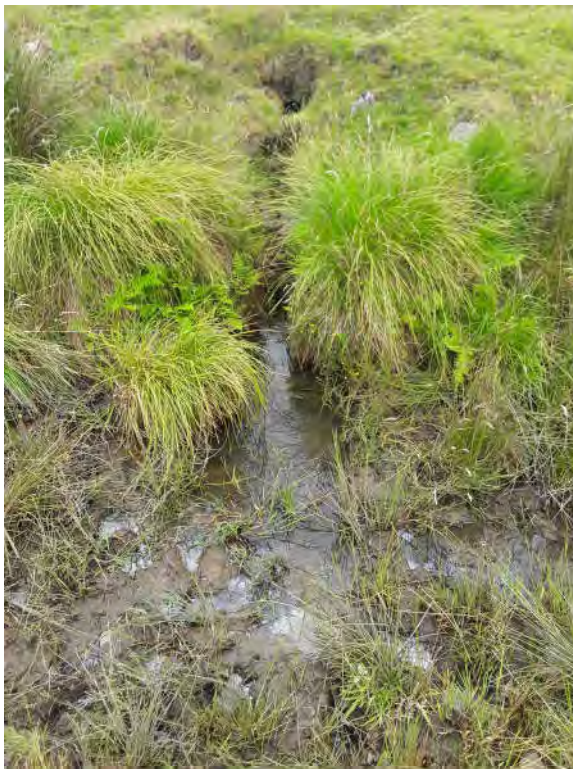
| Photo No.<br>SW-06 DP | Date:<br>12 July<br>2022 | |
|---|---|---|
| <b>Surface Water Feature SW-06 DP:</b><br>Grassy ditch exiting from the south of the grassed bank and ditch (SW05-DP) . This channel extends east to west along the access track along the south of the site. Stagnant water not observed to be flowing. Slight sheen on water from sheep/agriculture. Approximate measurements 0.25 m deep water.<br>The photo aspect is north. Measurements DO 45.51%, ORP 87.60 mV, Cond 666.01 ms/cm, pH 7.26, T20.132C | | |

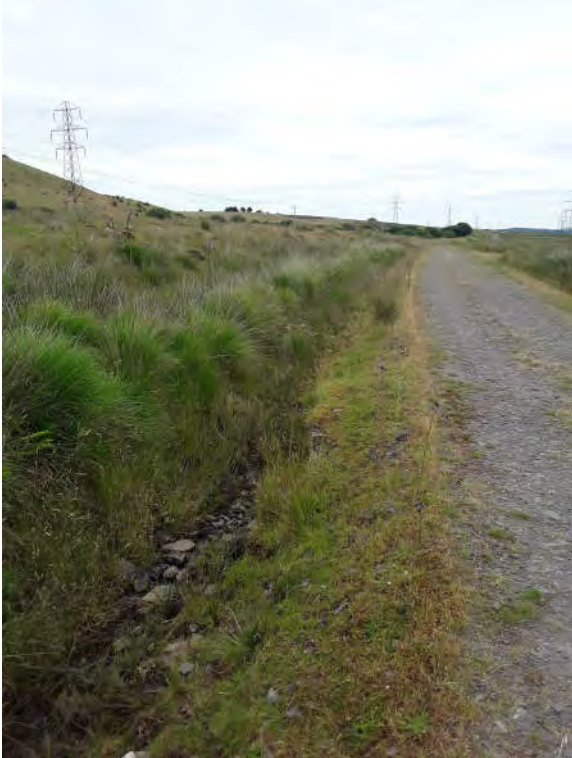
| Photo No.<br>SW-07 DP | Date:<br>12 July<br>2022 | |
|---|---|---|
| <b>Surface Water Feature SW-07 DP:</b><br>Grassed ditch extending east to west along the northern boundary of the access track in the south of the site. Abundant rocks. Multiple ditches to the north feed into this ditch.<br>No water flowing observed at the time.<br>Vegetated at base along entire length. Stagnant standing water in places. Approximate measurements 1.1km length, 1.0m deep from the surface, 2.0 m wide. The photo aspect is east. | | |

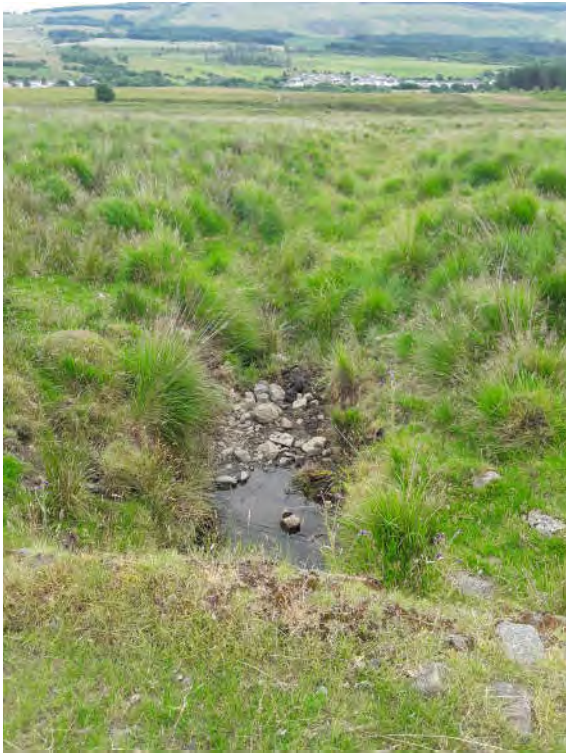
| Photo No.<br>SW-08 DP | Date:<br>12 July<br>2022 | |
|---|---|---|
| <b>Surface Water Feature SW-08 DP:</b><br>Grassed ditch extending south from the access road.<br>No water flowing observed at the time.<br>Stagnant standing water. Becomes vegetated along ditch. Tributary of Nany Ystalwyn, 250m south Approximate measurements 250m length, 1.0m deep 2.0 m wide. The photo aspect is south. | | |

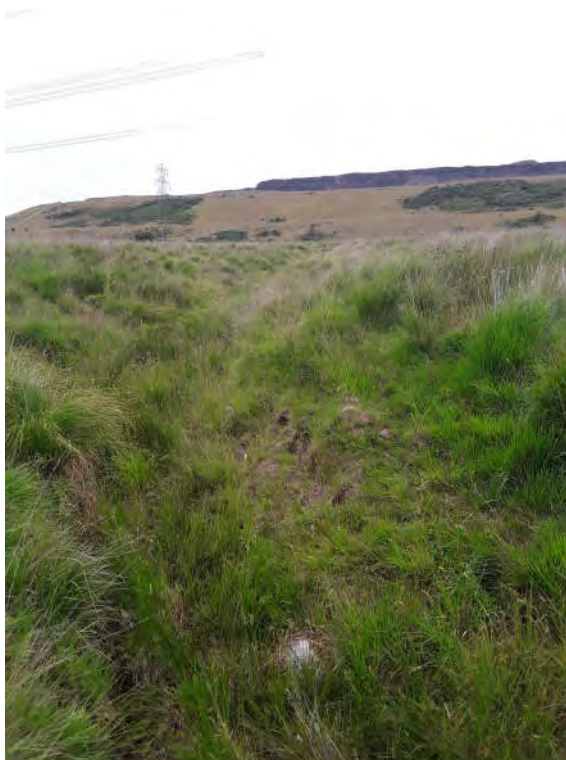
| Photo No.<br>SW-09 DP | Date:<br>12 July<br>2022 | |

| Photo No.<br>SW-09 DP | Date:<br>12 July<br>2022 | |
|---|---|---|
| <b>Surface Water Feature SW-09 DP:</b><br>Continuation of grassed ditch extending south from SW-08 DP.<br>No water flowing observed at the time.<br>The photo aspect is south. | | |

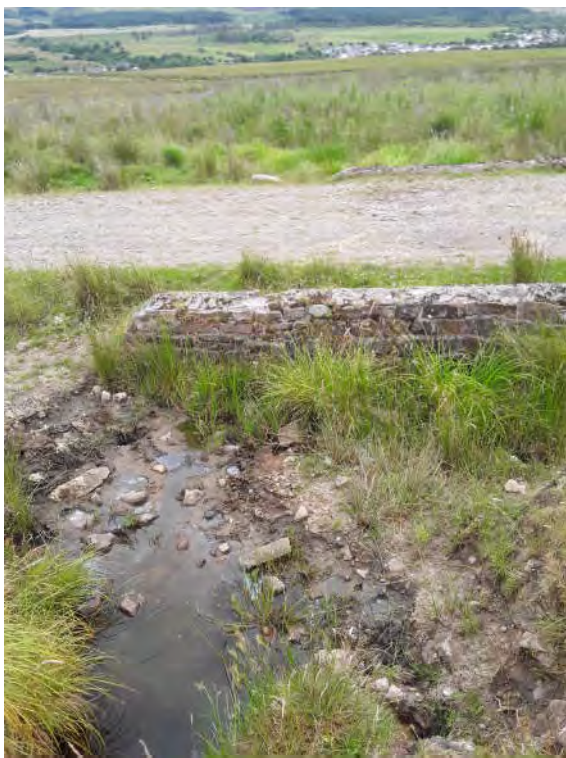
| Photo No.<br>SW-10 DP | Date:<br>12 July<br>2022 | |
|---|---|---|
| <b>Surface Water Feature SW-10 DP:</b><br>Grassed ditch orientated north to south joining the east to west ditch along the northern boundary of the access track.<br>No water flowing observed at the time.<br>Stagnant standing water.<br>Vegetated along ditch to the north.<br>The photo aspect is south. | | |

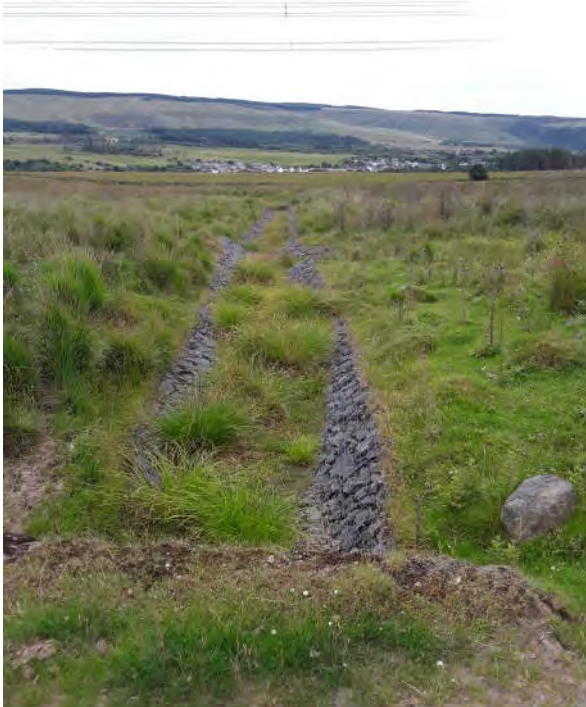
| Photo No.<br>SW-11 DP | Date:<br>12 July<br>2022 | |
|---|---|---|
| <b>Surface Water Feature SW-11 DP:</b><br>Stone lined ditch extending south from access track.<br>No water flowing observed at the time.<br>Vegetated at base along entire length.<br>Approximate measurements 70m length, 1.0m 2.0 m wide.<br>The photo aspect is south. | | |

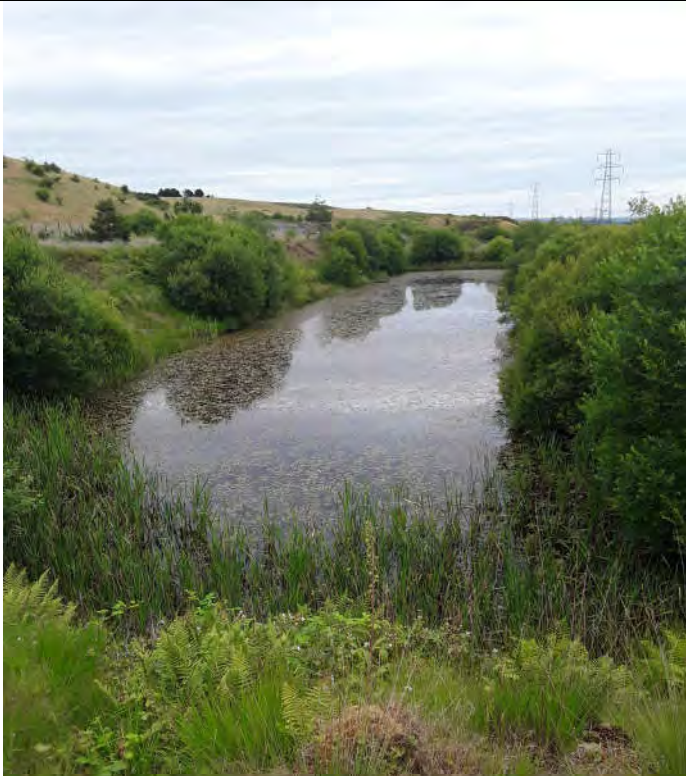
| Photo No.<br>SW-12 DP | Date:<br>12 July<br>2022 | |
|---|---|---|
| <b>Surface Water Feature SW-12 DP:</b><br>Lagoon, water storage area, probably lined with low permeability material, drainage/runoff from restoration area.<br>No water flowing observed at the time.<br>Approximate measurements 10m wide, 100m length.<br>Not accessible for water parameter measurements.<br>The photo aspect is east. | | |

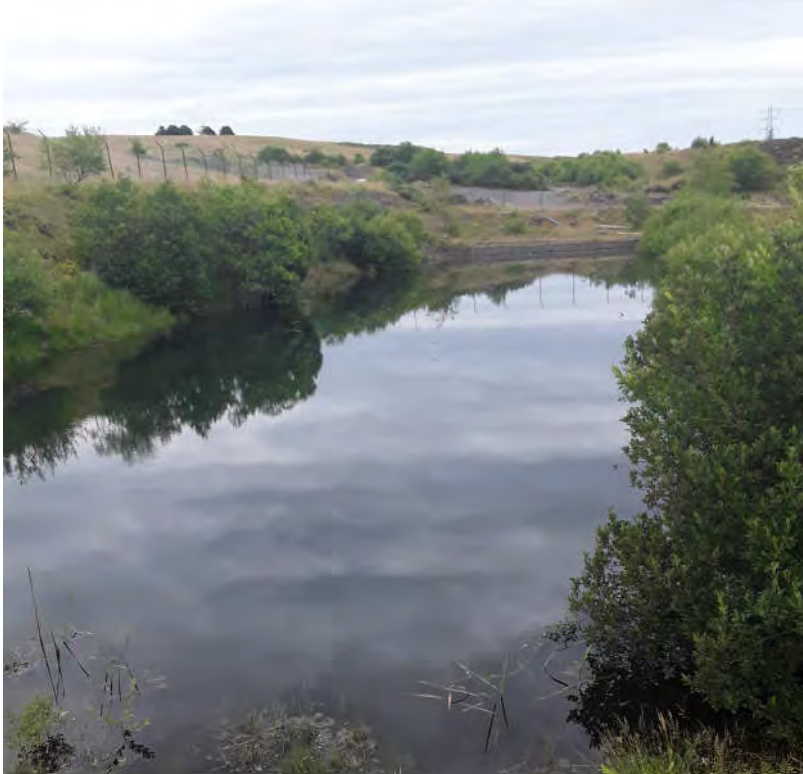
| Photo No.<br>SW-15 DP | Date:<br>12 July<br>2022 | |
|---|---|---|
| <b>Surface Water Feature SW-15 DP:</b><br>Smaller lagoon, water storage area, probably lined with low permeability material, drainage/runoff from restoration area. No water flowing observed at the time. Approximate measurements 10m wide, 50m length. Measurements DO 134.57%, ORP 163.8 mV, Cond 1,602.50 ms/cm, pH 7.62, T19.55C<br><br>The photo aspect is east. | | |

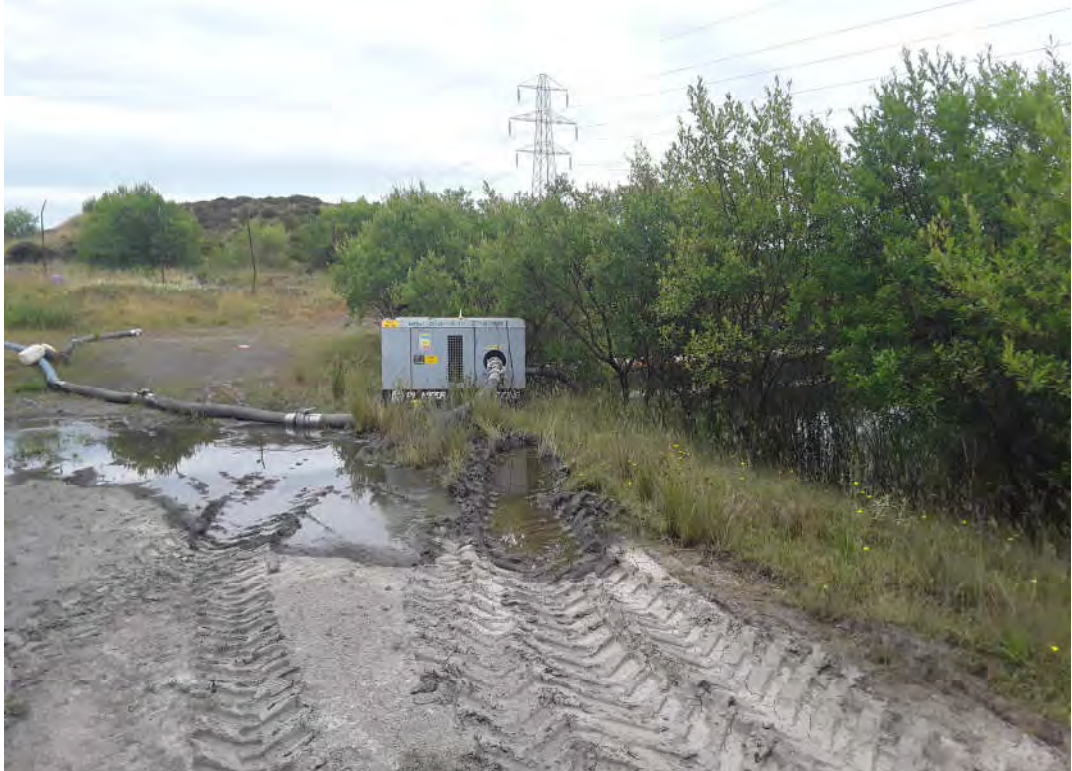
| Photo No.<br>SW-16 DP | Date:<br>12 July<br>2022 | |
|---|---|---|
| <b>Pump SW-16 DP:</b><br>Pump present on northern boundary of SW16 CE holding lagoon. Pump not on at time of walkover. Connected to SW17 DP via pipes and presumed up to pumping uphill to this lagoon.<br><br>The photo aspect is east | | |

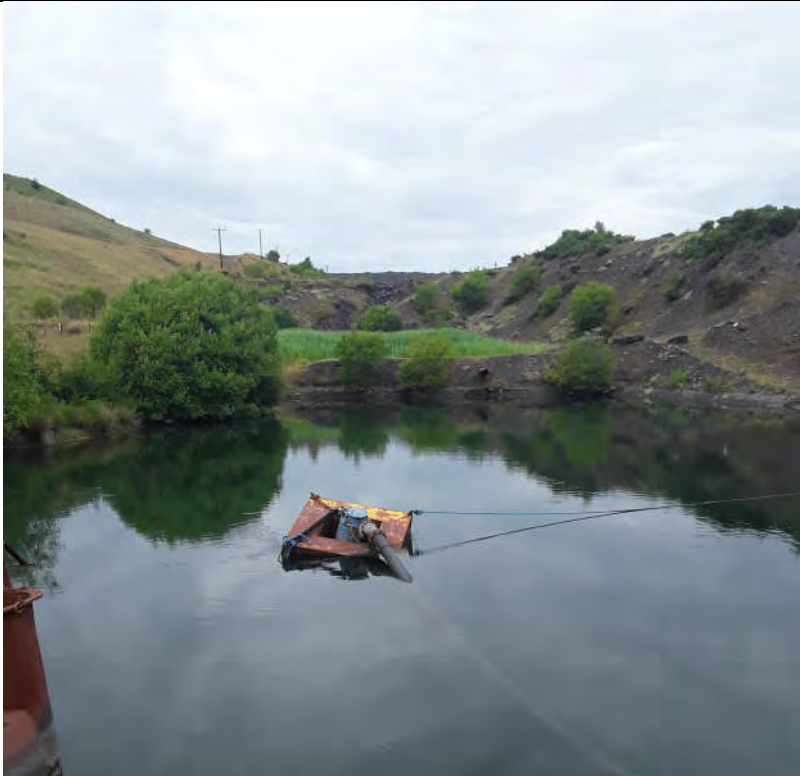
| Photo No.<br>SW-17 DP | Date:<br>12 July<br>2022 | |
|---|---|---|
| <b>Surface Water Feature SW-17 DP:</b><br>Lagoon, water storage area, probably lined with low permeability material, drainage/runoff from restoration area. No water flowing observed at the time. Submersible pump working and pumping water to lagoon to north. Not able to access for water parameter measurements. Approximate measurements 30m wide, 55m length.<br><br>The photo aspect is east. | | |

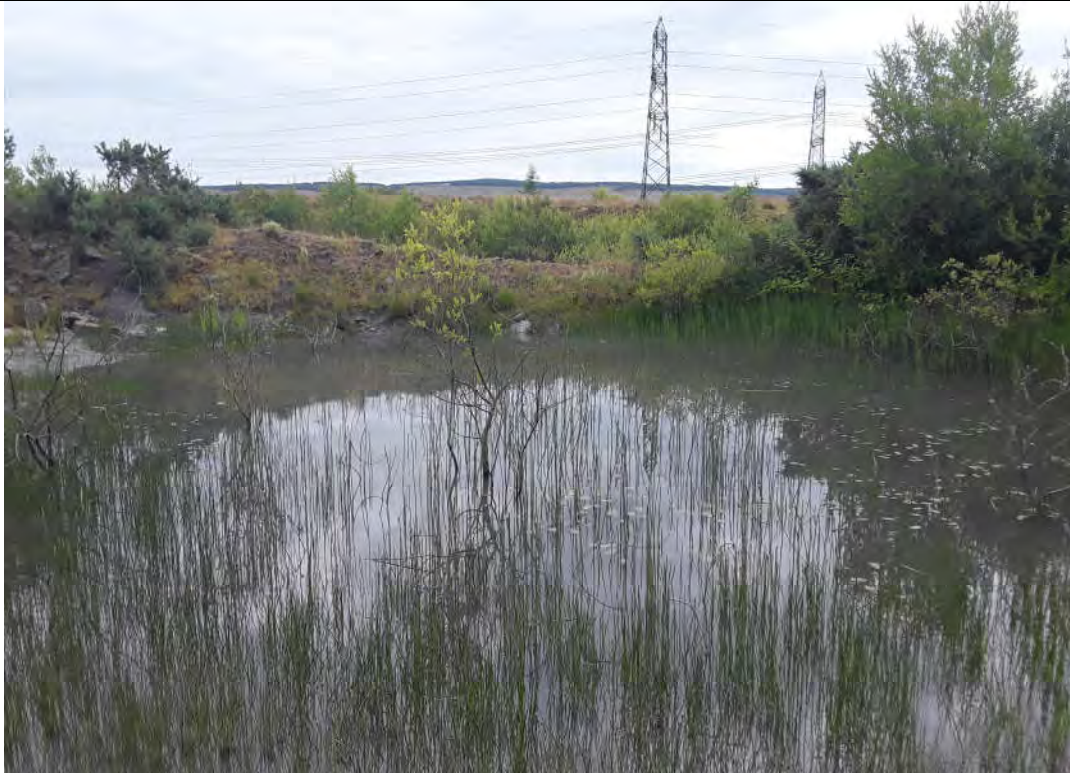
| Photo No.<br>SW-18 DP | Date:<br>12 July<br>2022 | |
|---|---|---|
| <b>Surface Water Feature SW-18 DP:</b><br>Overflow / washout pond. Water observed to be silty. Measurements DO 92.29%, ORP 147.0 mV, Cond 199.29 ms/cm, pH 7.84, T22.79C. Approximate measurements 25m wide, 30m length. The photo aspect is south. | | |

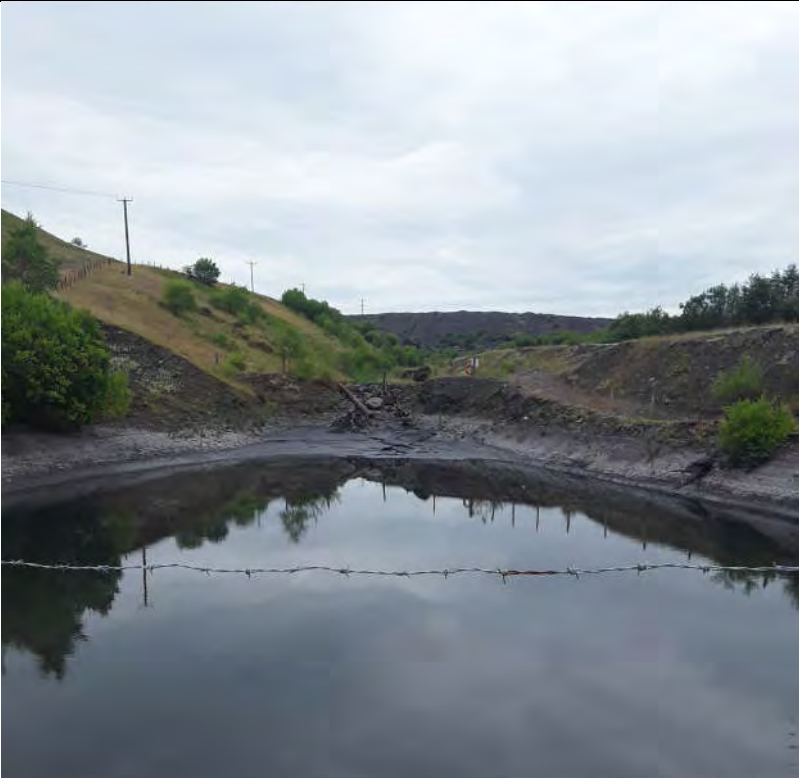
| Photo No.<br>SW-19 DP | Date:<br>12 July<br>2022 | |
|---|---|---|
| <b>Surface Water Feature SW-19 DP:</b><br>Lagoon, water storage area, probably lined with low permeability material, drainage/runoff from restoration area. No water flowing observed at the time. Black and silty. Not able to access for water parameter measurements. Approximate measurements 20m wide, 40m length.<br><br>The photo aspect is north. | | |

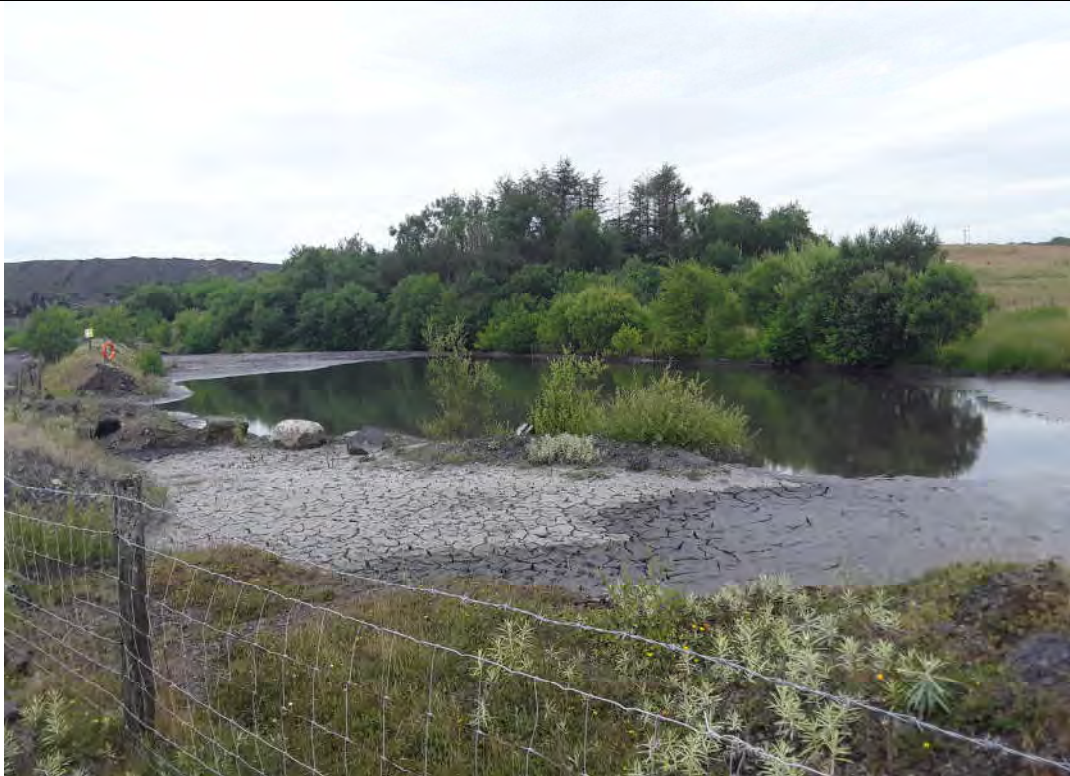
| Photo No.<br>SW-20 DP | Date:<br>12 July<br>2022 | |
|---|---|---|
| <b>Surface Water Feature SW-20 DP:</b><br>Lagoon, water storage area, probably lined with low permeability material, drainage/runoff from restoration area. No water flowing observed at the time. Black and silty. Not able to access for water parameter measurements. Approximate measurements 26m wide, 80m length.<br><br>The photo aspect is north. | | |

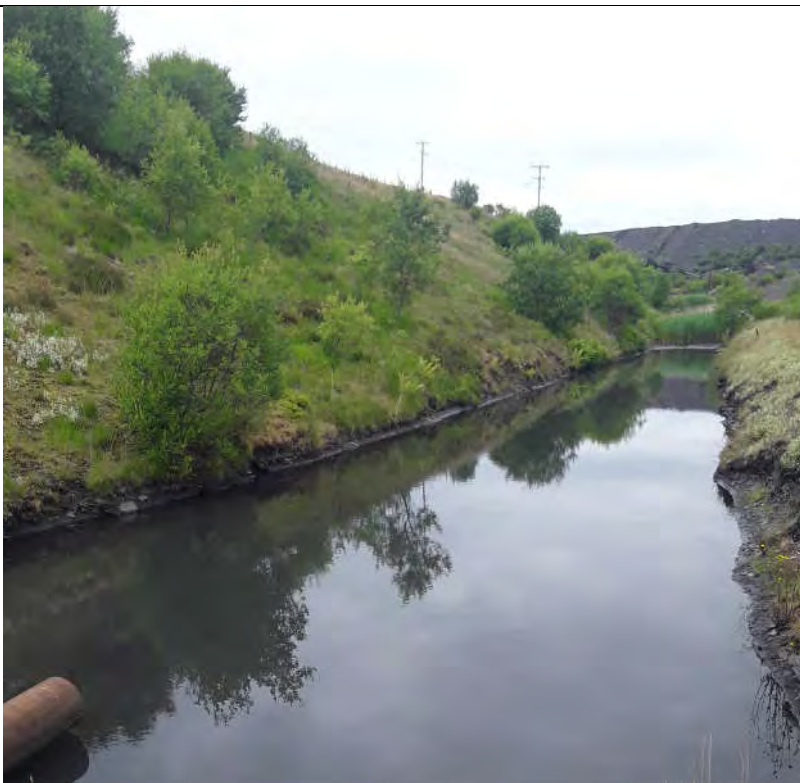
| Photo No.<br>SW-21 DP | Date:<br>12 July<br>2022 | |
|---|---|---|
| <b>Surface Water Feature SW-21 DP:</b><br>Lagoon, water storage area, probably lined with low permeability material, drainage/runoff from restoration area. No water flowing observed at the time. Black and silty. Approximate measurements 26m wide, 80m length. Measurements DO 39.87%, ORP 160.5 mV, Cond 680.60 ms/cm, pH 7.71, T20.00C<br><br>The photo aspect is north. | | |

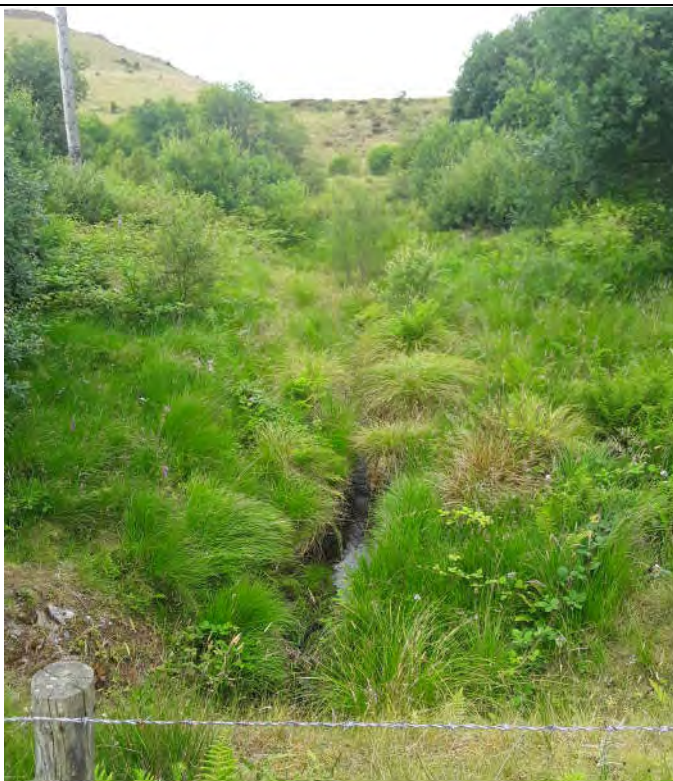
| Photo No.<br>SW-22 DP | Date:<br>12 July<br>2022 | |
|---|---|---|
| <b>Surface Water Feature SW-22 DP:</b><br>Grassed ditch extending south from the holding lagoon area. No water flowing observed at the time. Stagnant standing water 25cm deep. Becomes vegetated along ditch. Tributary of Nany Ystalwyn, Approximate measurements 70m length, 1.20m deep 2.0 m wide. The photo aspect is south. | | |

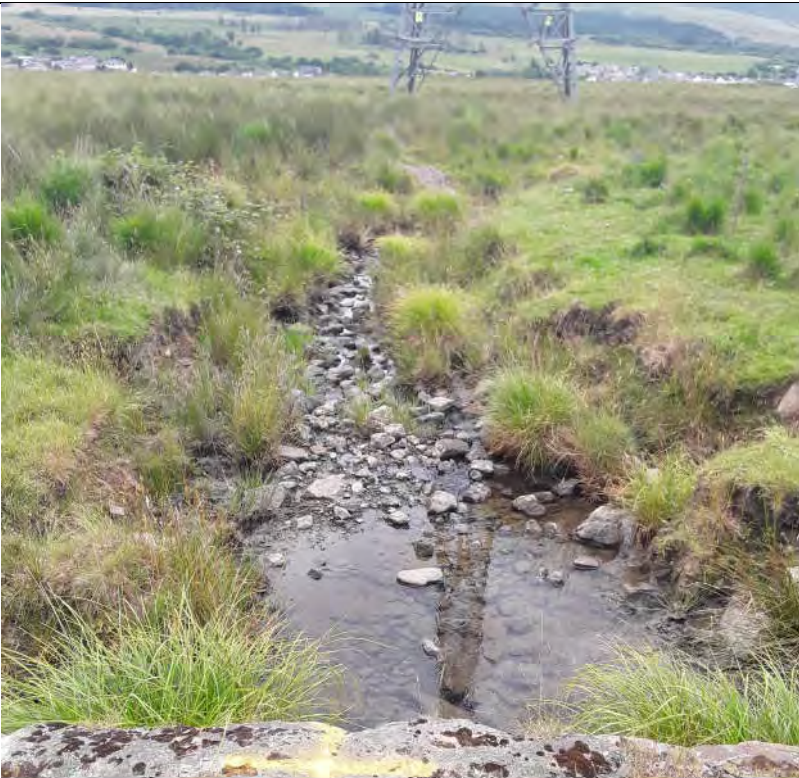
| Photo No.<br>SW-23 DP | Date:<br>12 July<br>2022 | |
|---|---|---|
| <b>Surface Water Feature SW-23 DP:</b><br>Continuation of SW22-DP extending south.<br>Rocky ditch<br>No water flowing observed at the time.<br>Standing water 20cm deep. Becomes vegetated along ditch.<br>Labelled as Nany Ystalwyn, Approximate measurements 1.20m deep 2.0 m wide.<br>Measurements DO 96.95%, ORP 164.8 mV, Cond 1,238.6 ms/cm, pH 8.17, T15.5C<br><br>The photo aspect is south. | | |

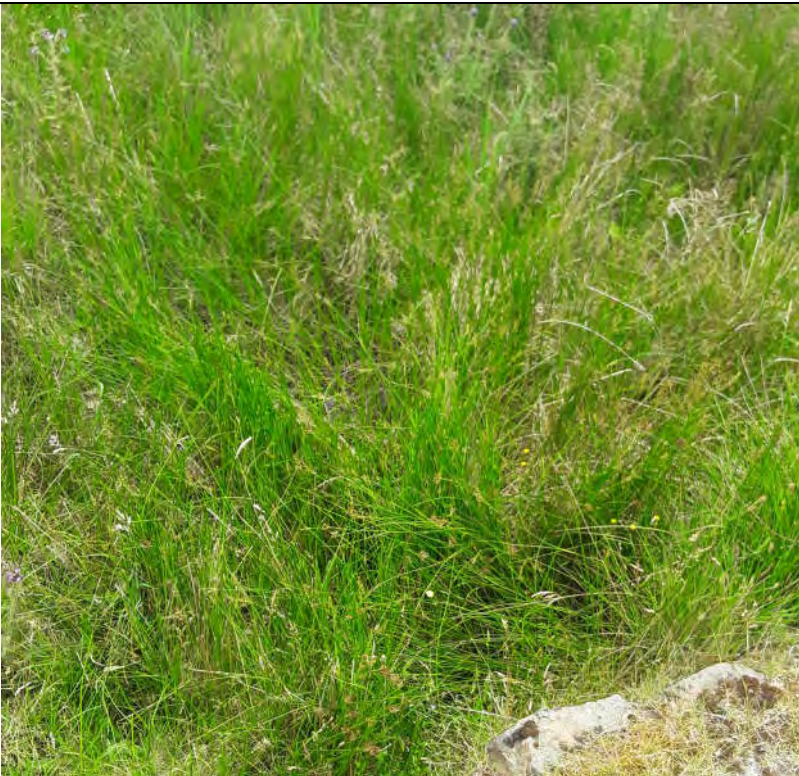
| Photo No.<br>SW-24 DP | Date:<br>12 July<br>2022 | |

| Photo No.<br>SW-24 DP | Date:<br>12 July<br>2022 | |
|---|---|---|
| <b>Surface Water Feature SW-23 DP:</b><br>Dry grassed ditch No water flowing observed at the time. Extending south from the access track<br><br>The photo aspect is south. | | |

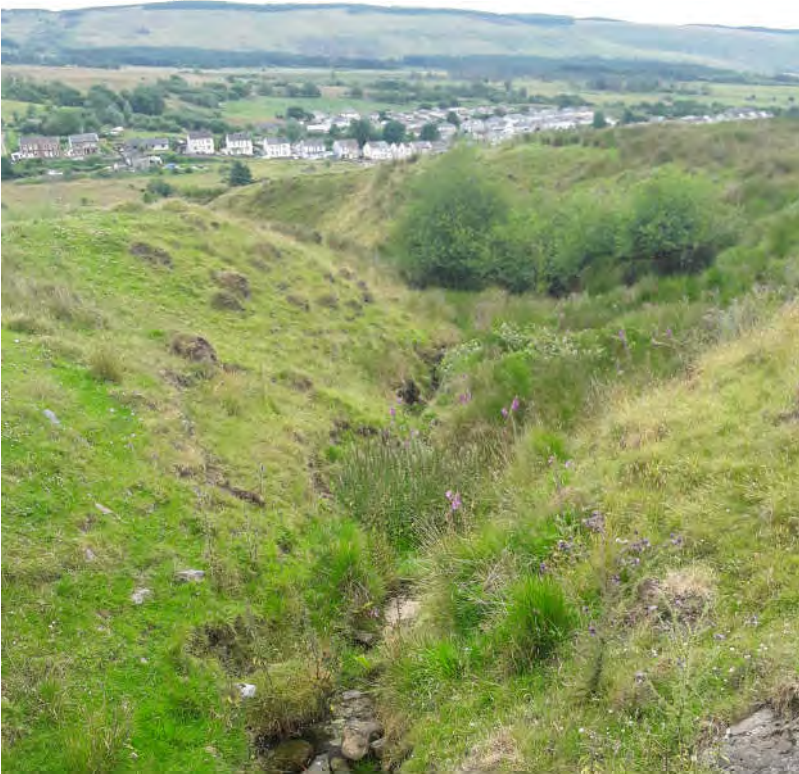
| <b>Surface Water Feature SW-27 DP:</b><br>Rocky gully extending south from the access track.<br>No water flowing observed at the time.<br>Standing water 10cm deep. Becomes vegetated along ditch.<br>Approximate measurements 2.20m deep 1.0 m wide.<br><br>The photo aspect is south. | | |

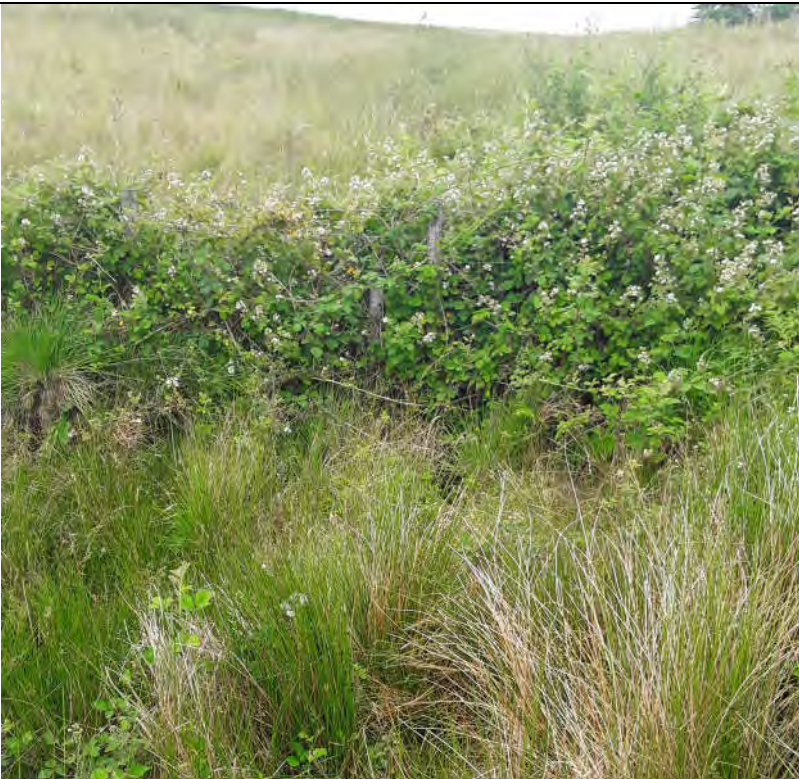
| <b>Photo No.</b><br>SW-28 DP | <b>Date:</b><br>12 July 2022 | |

| <b>Surface Water Feature SW-28 DP:</b><br>Continuation of SW27 DP, located north of the access track. Dry, grassy ditch.<br><br>The photo aspect is north. | | |

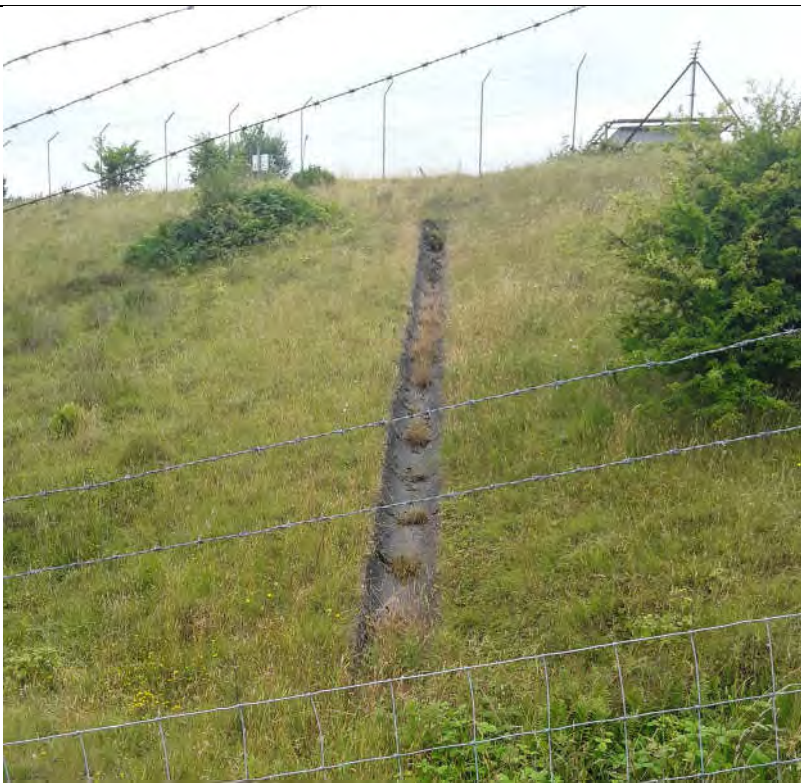
| Photo No.<br>SW-29 DP | Date:<br>12 July<br>2022 | |

| Photo No.<br>SW-29 DP | Date:<br>12 July<br>2022 | |
|---|---|---|
| <b>Surface Water Feature SW-29 DP:</b><br>Concrete lined spillway chute between SW31 and SW30. Approximately 20m long.<br><br>The photo aspect is north. | | |

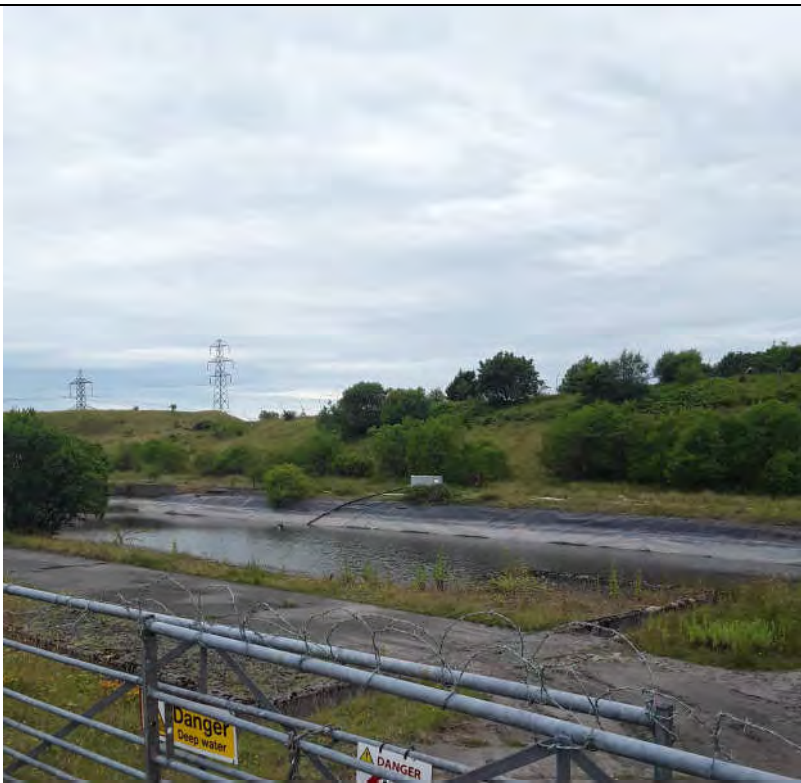
| Photo No.<br>SW-30 DP | Date:<br>12 July<br>2022 | |
|---|---|---|
| <b>Surface Water Feature SW-30 DP:</b><br>One of two holding lagoon, water storage areas, probably lined with low permeability material, drainage/runoff from restoration area. No water flowing observed at the time. Approximate measurements 25m wide, 130m length. No access.<br><br>The photo aspect is south west. | | |

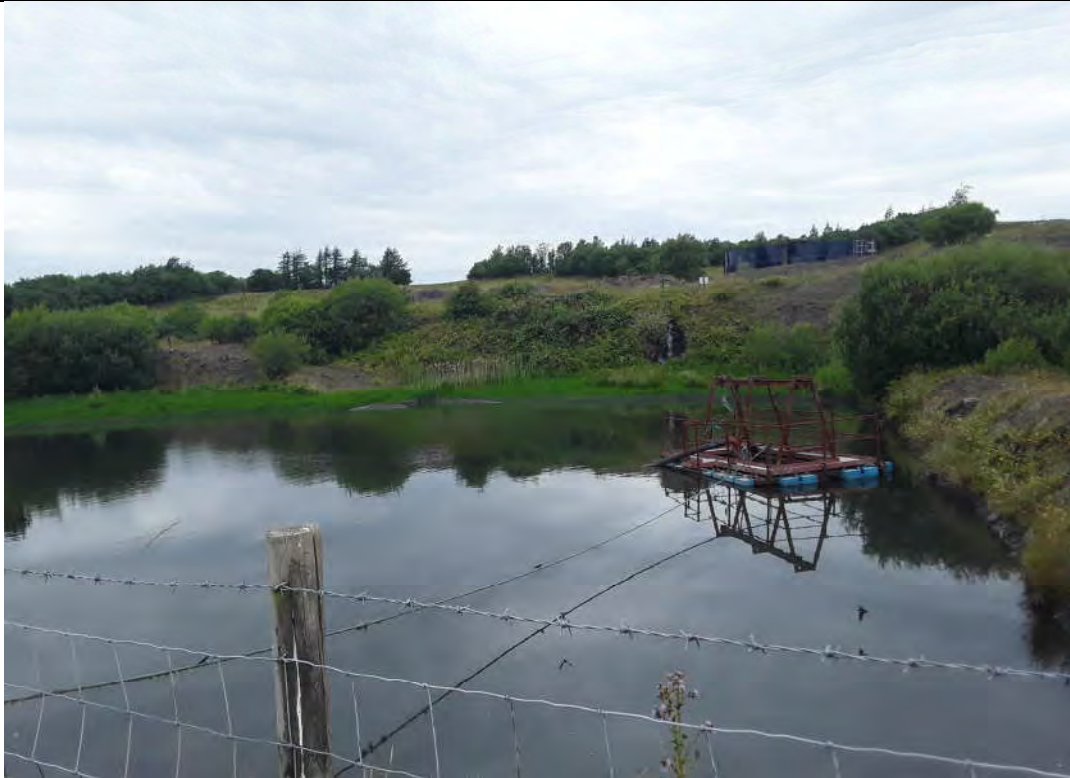
| Photo No. | Date: | |
|---|---|---|
| <b>Surface Water Feature SW-31 DP:</b><br>Holding lagoon, water storage areas, probably lined with low permeability material, drainage/runoff from restoration area. No water flowing observed at the time. Approximate measurements 40m wide, 45m length. No access. Pump not operational during walkover.<br><br>The photo aspect is north. | | |

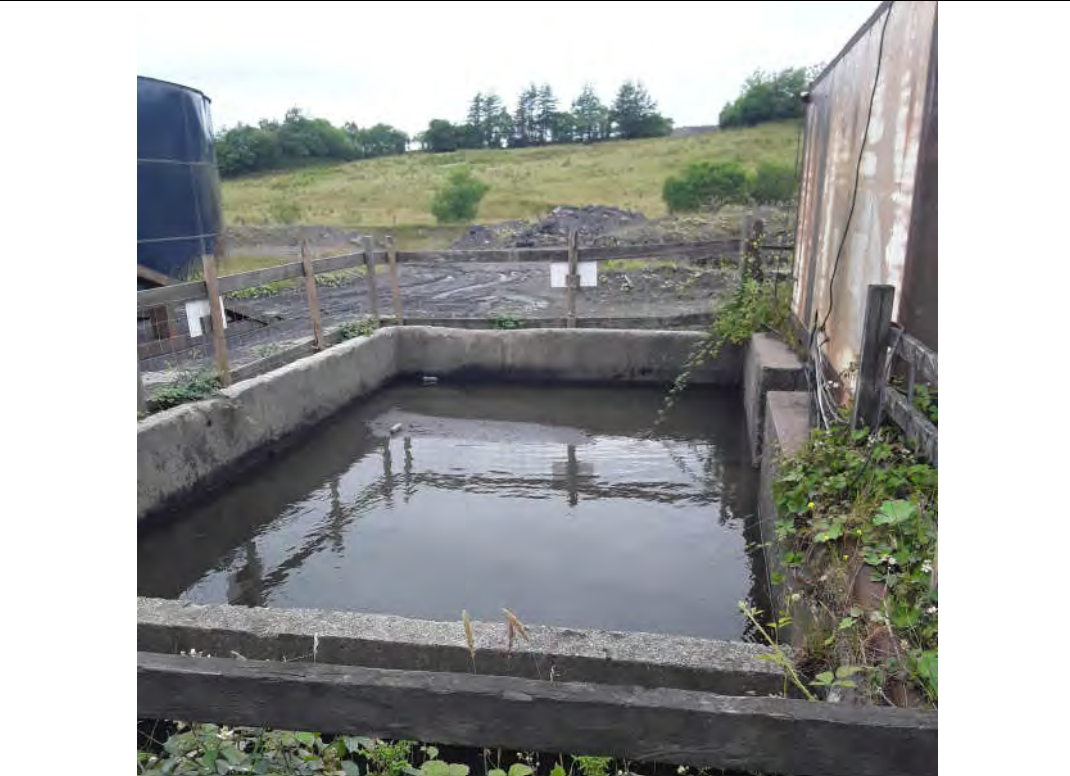
| Photo No. | Date: | |
|---|---|---|
| <b>Surface Water Feature SW-32 DP:</b><br>Holding lagoon, concrete lined drainage/runoff from restoration area. Possible wheel wash area. No water flowing observed at the time. Approximate measurements 10m wide, 5m length. No access. Pump not operational during walkover.<br><br>The photo aspect is west. | | |

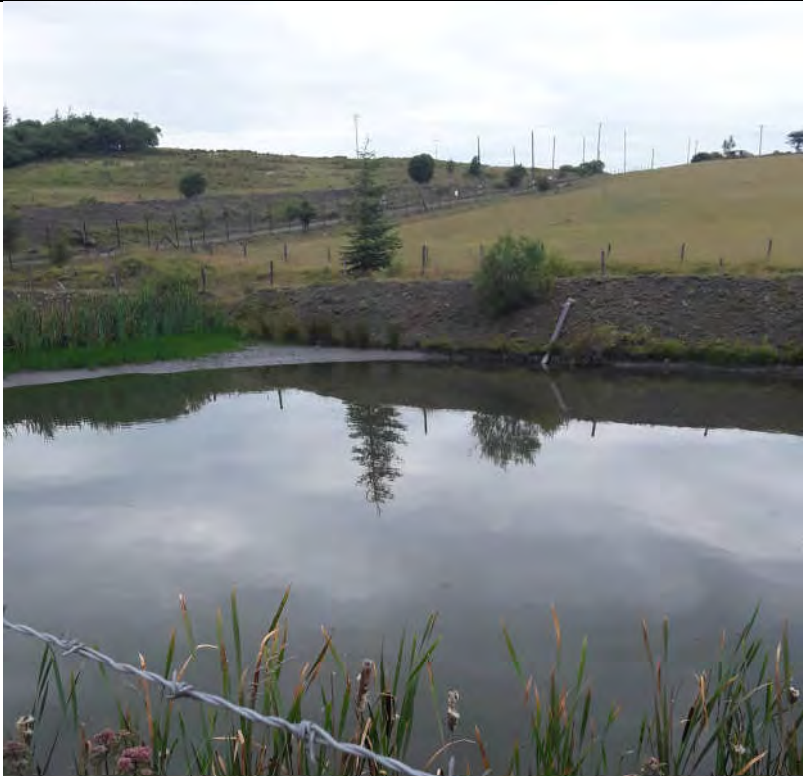
| Photo No.<br>SW-35 DP | Date:<br>12 July<br>2022 | |
|---|---|---|
| <b>Surface Water Feature SW-35 DP:</b><br>Holding lagoon, water storage area, probably lined with low permeability material, drainage/runoff from restoration area. No water flowing observed at the time. Approximate measurements 25m wide, 20 m length. No access. Not accessible<br><br>The photo aspect is north. | | |

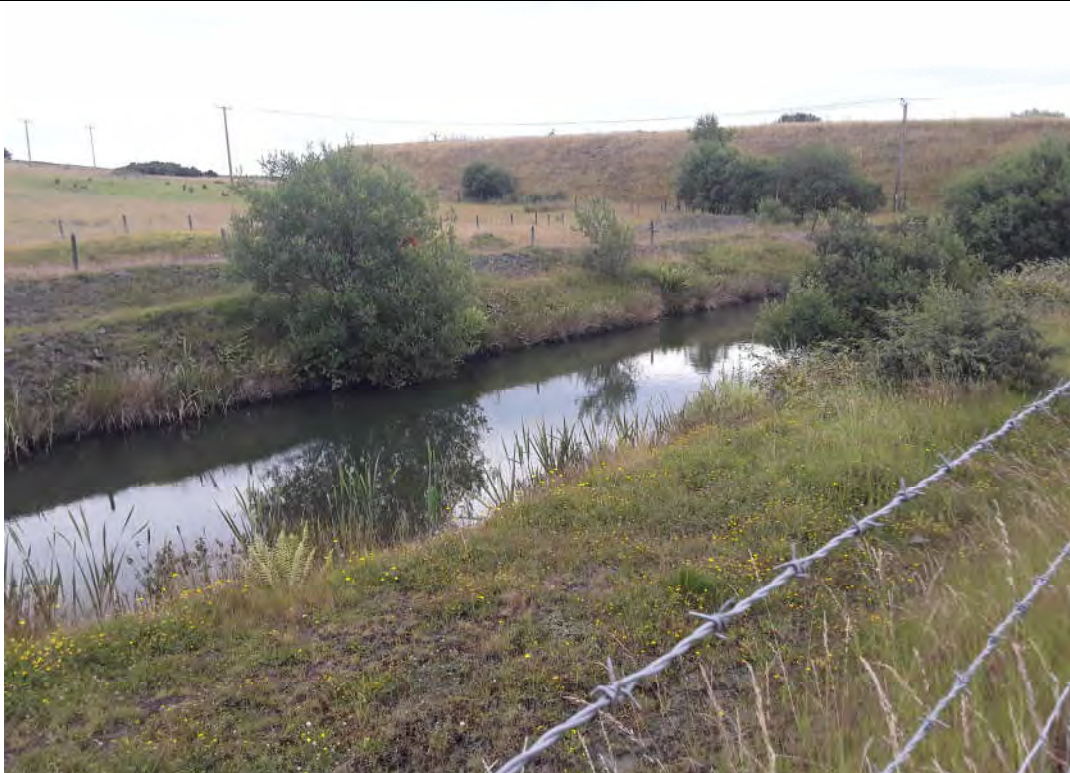
| Photo No.<br>SW-36 DP | Date:<br>12 July<br>2022 | |
|---|---|---|
| <b>Surface Water Feature SW-36 DP:</b><br>Holding lagoon, water storage area, probably lined with low permeability material, drainage/runoff from restoration area. No water flowing observed at the time. Approximate measurements 45m wide, 10 m length. No access. Not accessible<br><br>The photo aspect is north. | | |

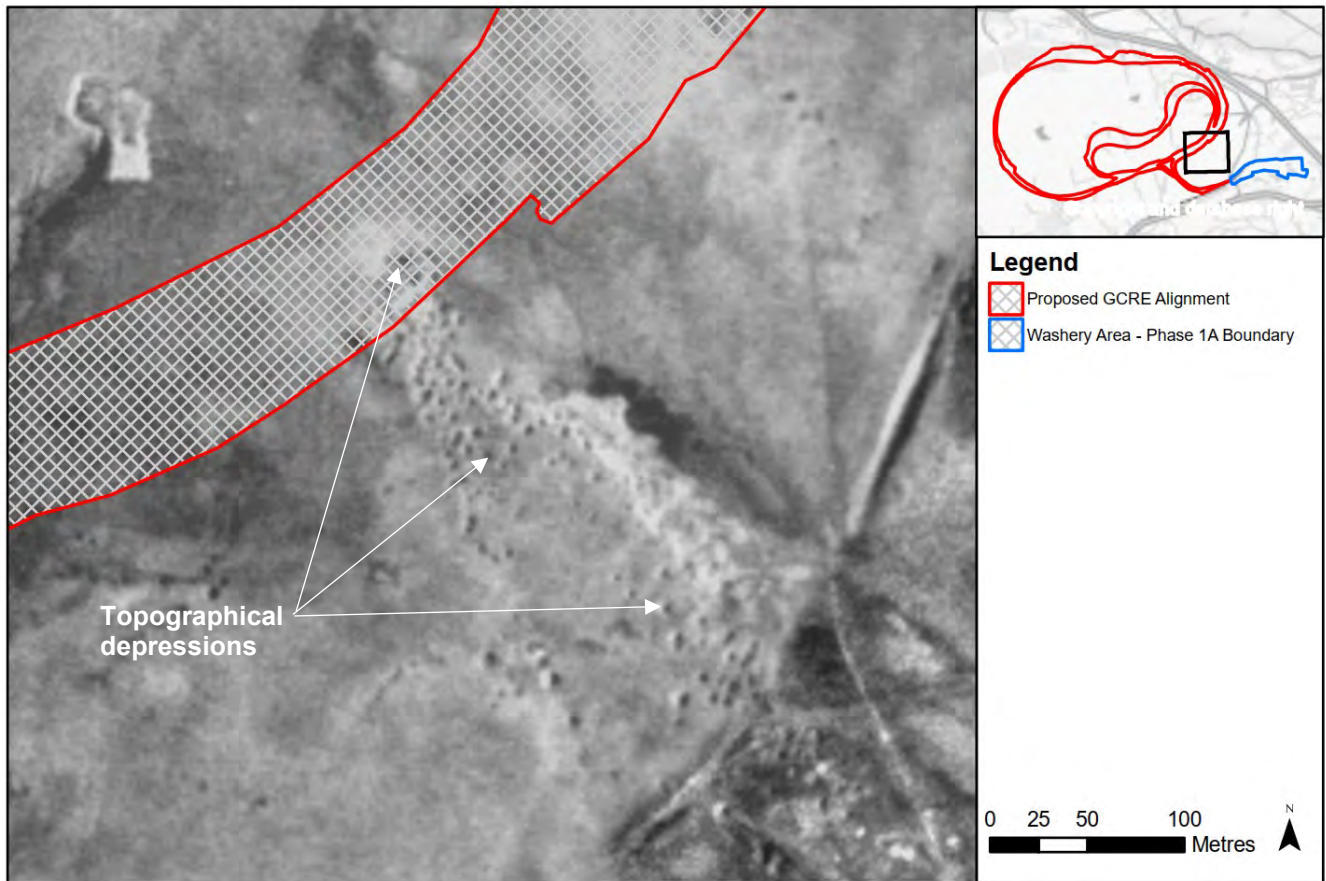
**Figure 3-7 - Example of potential evidence for bell pitting in the southeast of the alignment.**

Evidence of bell pitting onsite was observed in aerial imagery [1] as open bell pits or crown holes, these occur predominantly in the south of the site (Figure 3-7).
