# The former St. Catherines Church and Hall, Neath.

North and West elevations.

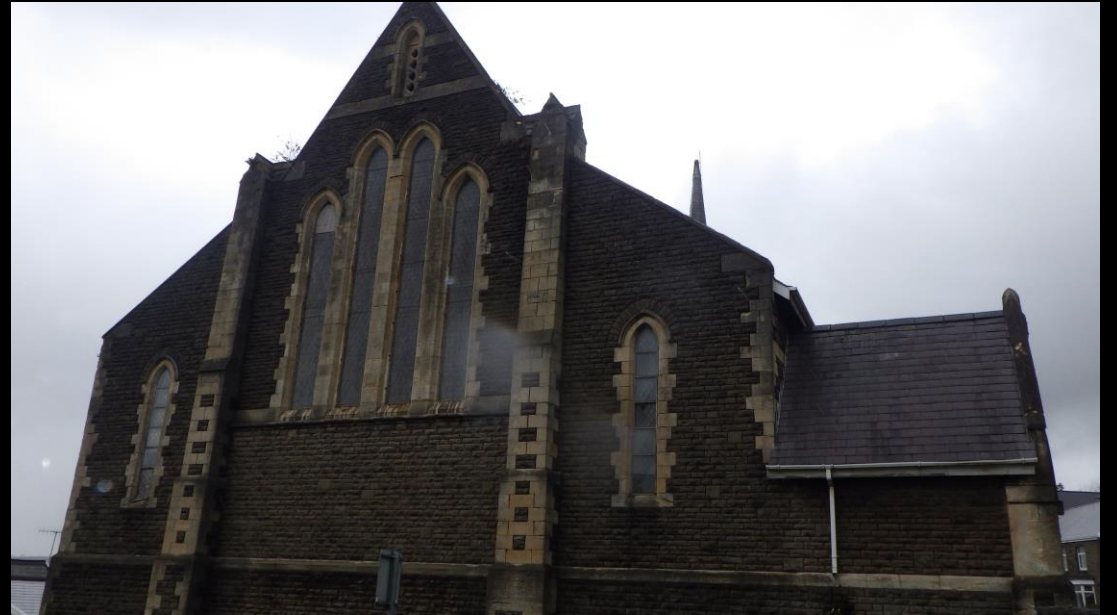
**Buddliah at high levels needs removing. Before major structural damage arises.**

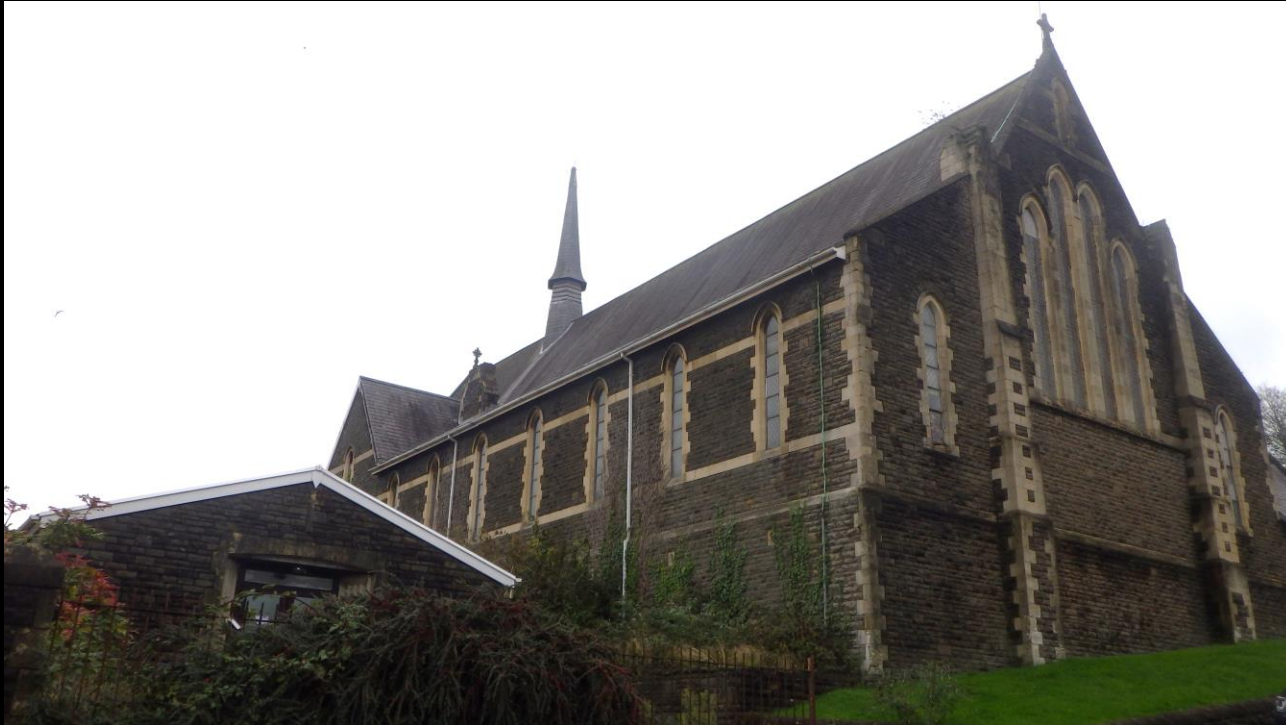
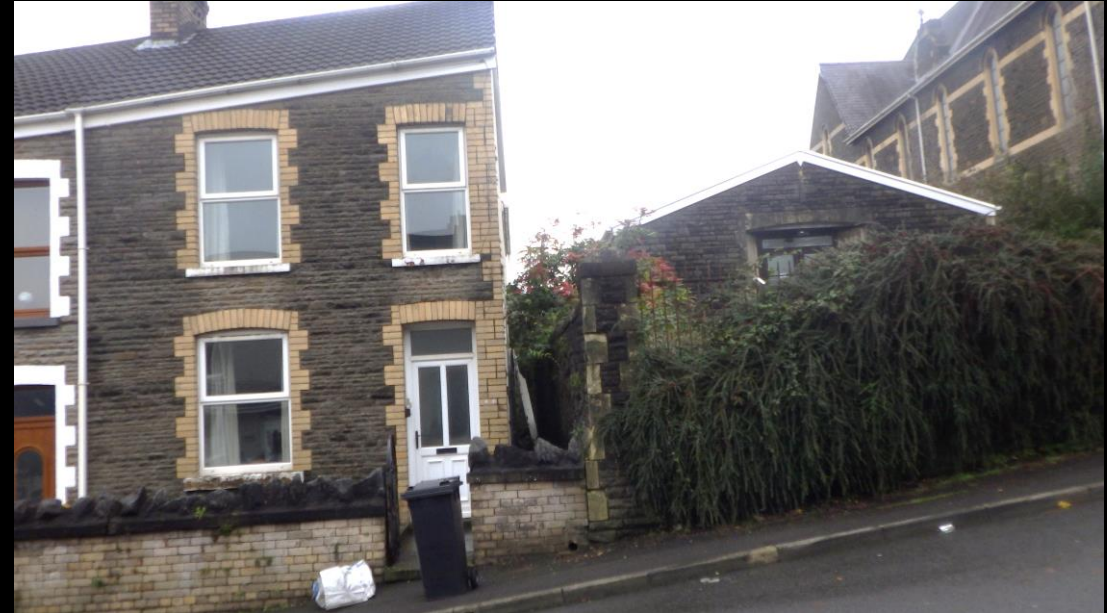
The Hall. Vegetation needs to be removed.

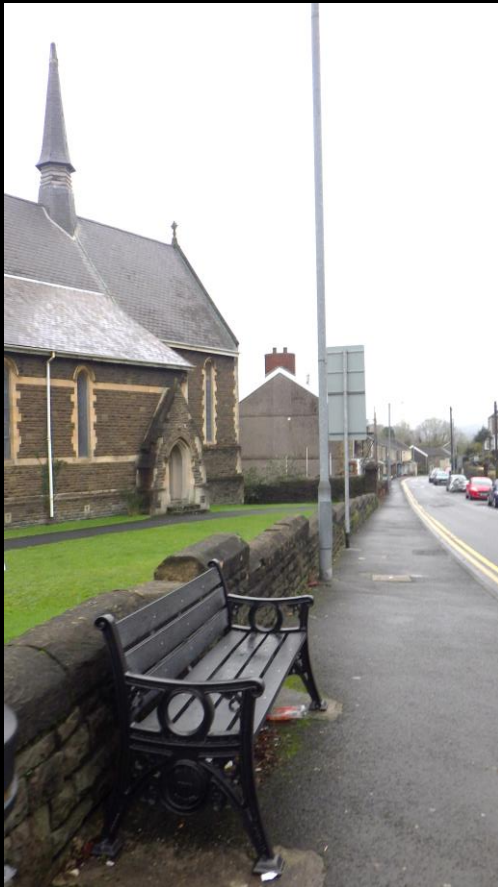
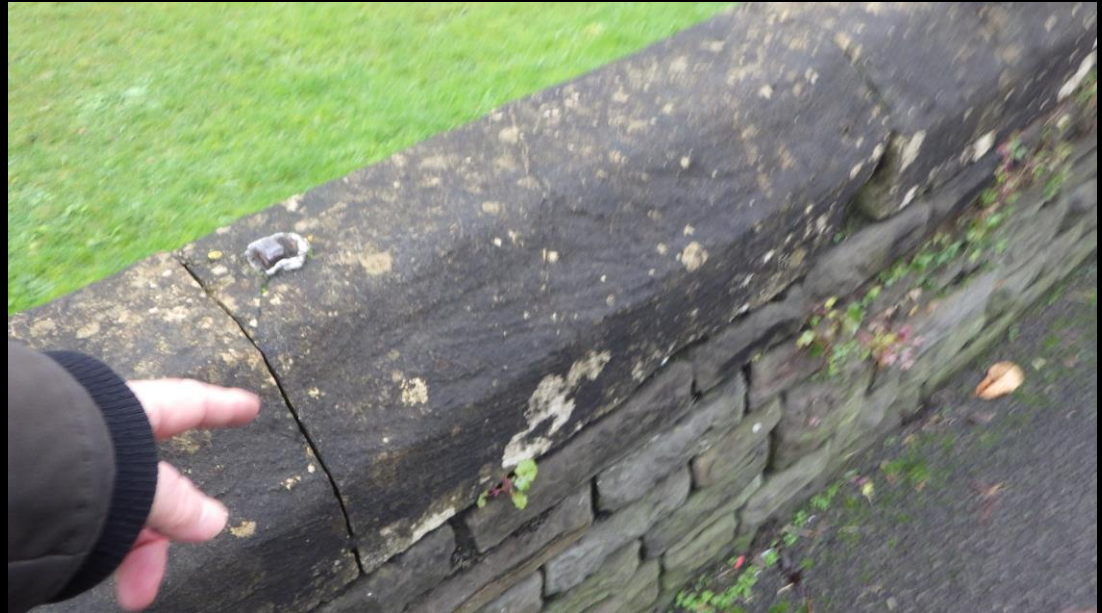
Repairs will be required to the boundary walls and pointing must be undertaken using a lime-based mortar to a planned maintenance programme, possibly commencing on the East boundary of rubble walling.

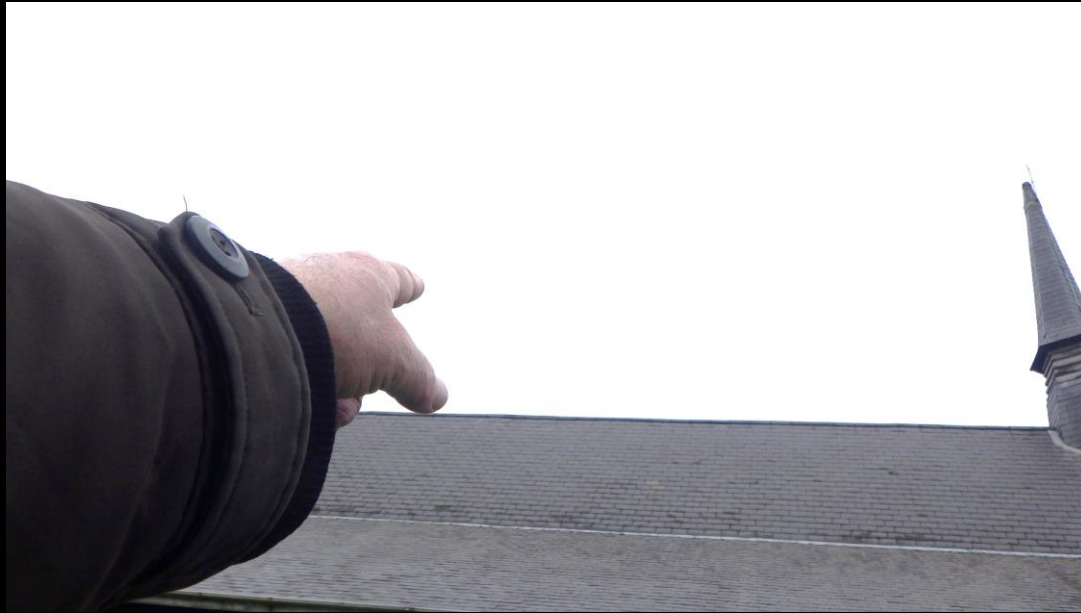
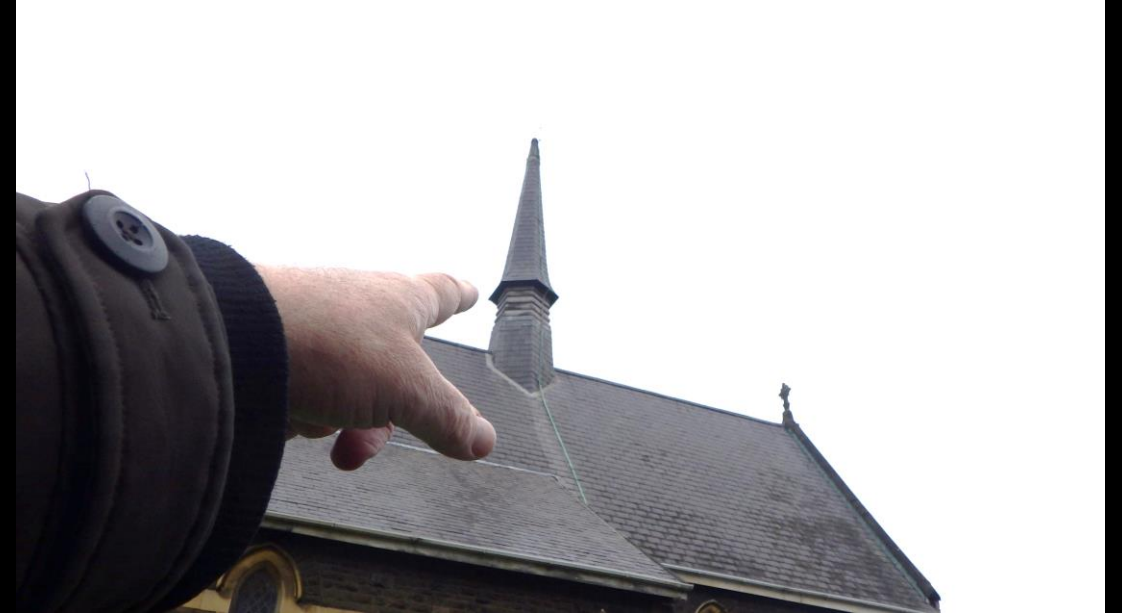
There are a number of slates becoming loose or have already slipped on the main roof surfaces to the chancel as they have to the bell tower. Matching slates will need to be sourced. A few are secured with tingles.

Slipping slates at high level, including to the bell-cote.

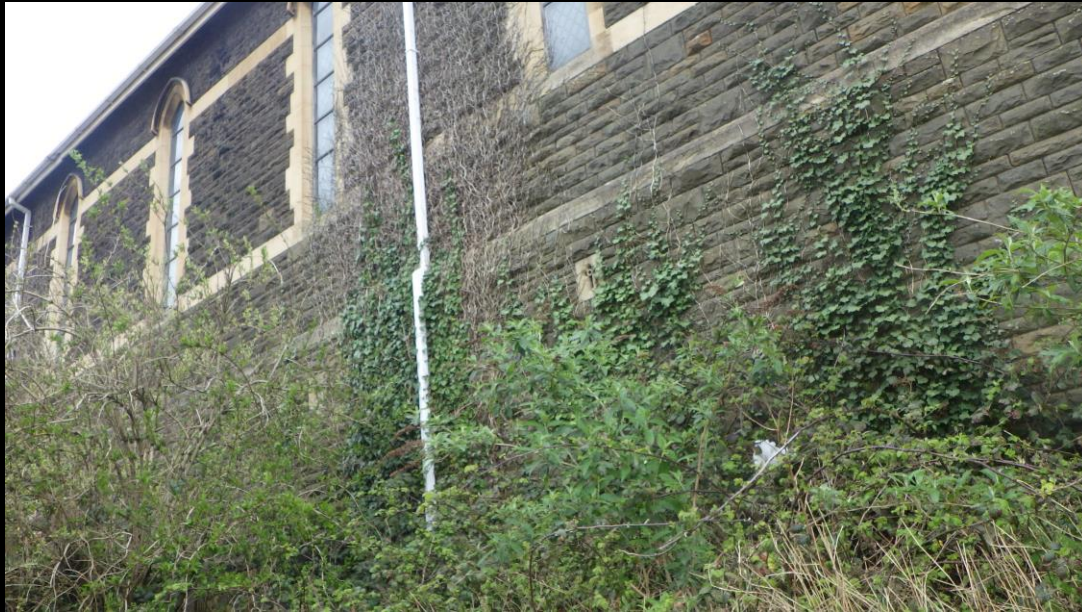
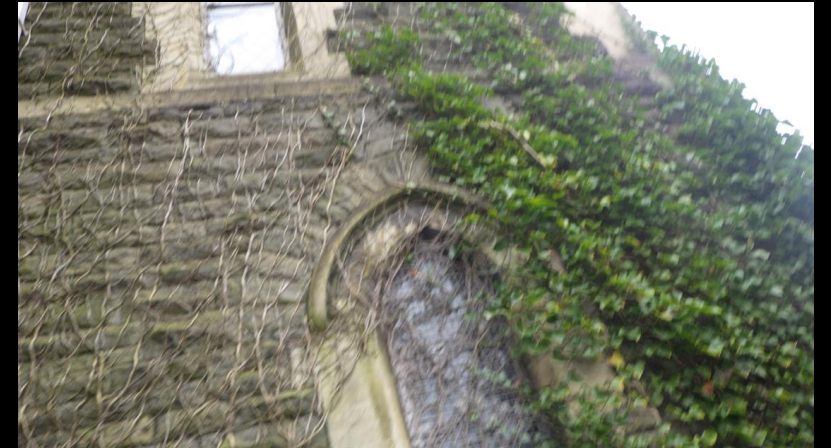
Close to the abutment with the Hall, vegetation has grown wild on the adjacent banking and needs cutting back. The ivy should be removed in accordance with SPAB guidelines.

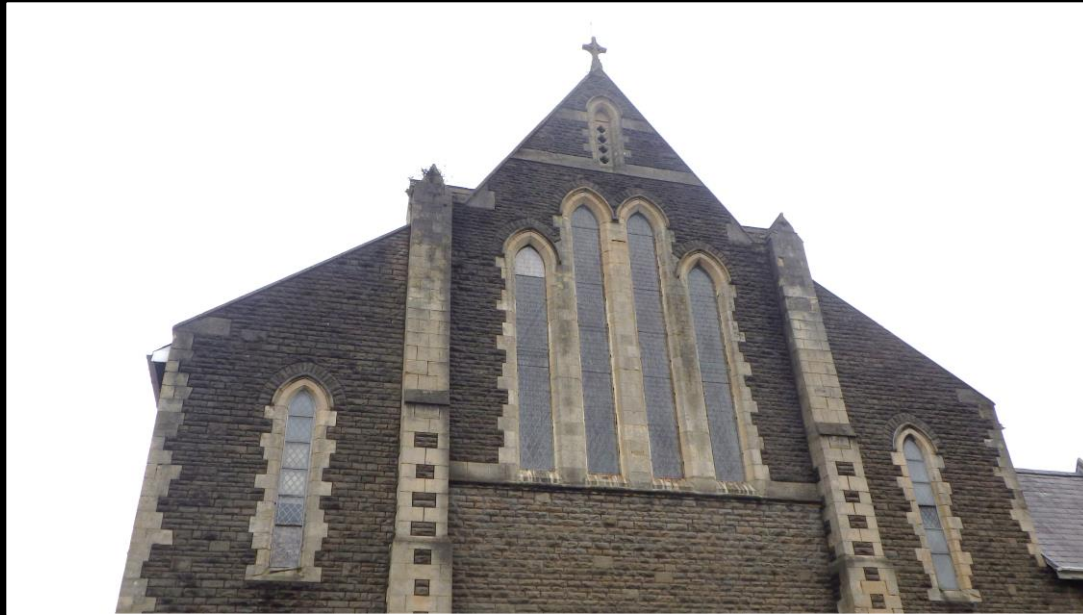
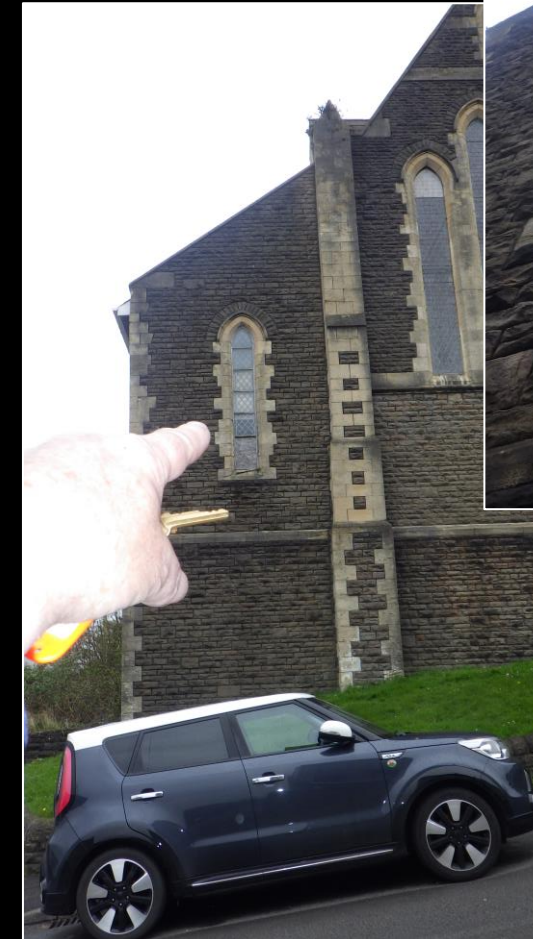
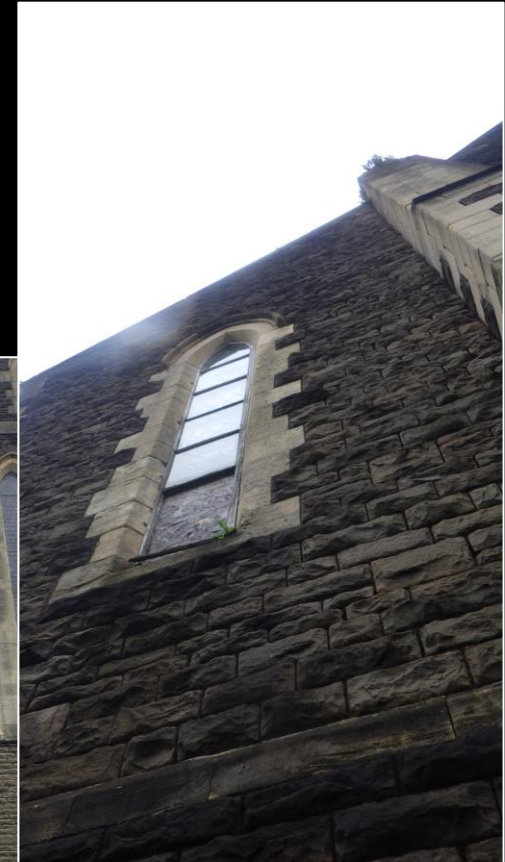
The West elevation. Repairs are necessary to the Lancet windows to the aisle and particularly that nearest the south-aisle where USB sheets have been inserted

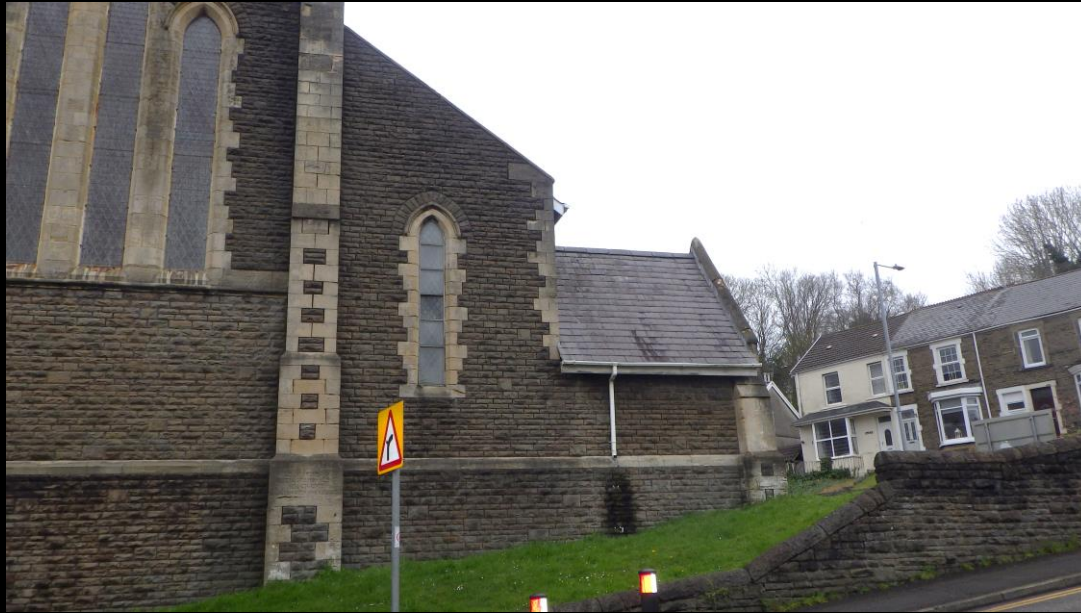
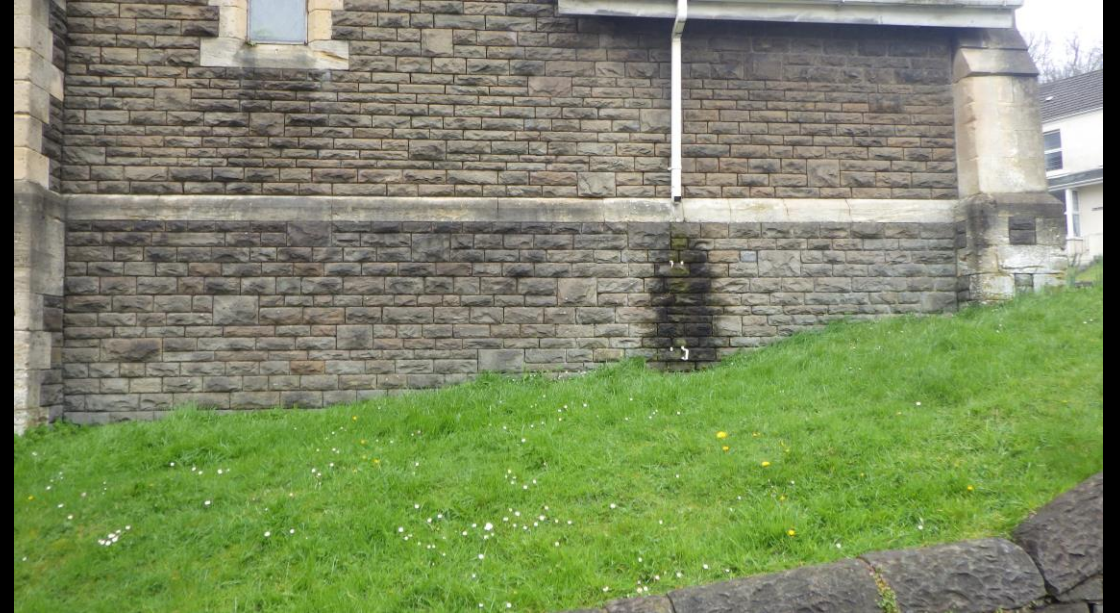
The existing rainwater downpipe on the porch needs to be reinstated. The church of Wales utilised white PVC rainwater gutters and downpiping which today would not be deemed acceptable. Whether listed building and planning consent was obtained in the past for these modifications needs to be clarified. Potentially you could become liable for replacing with cast sections if consent was not obtained and a planning permission not obtained since listing.

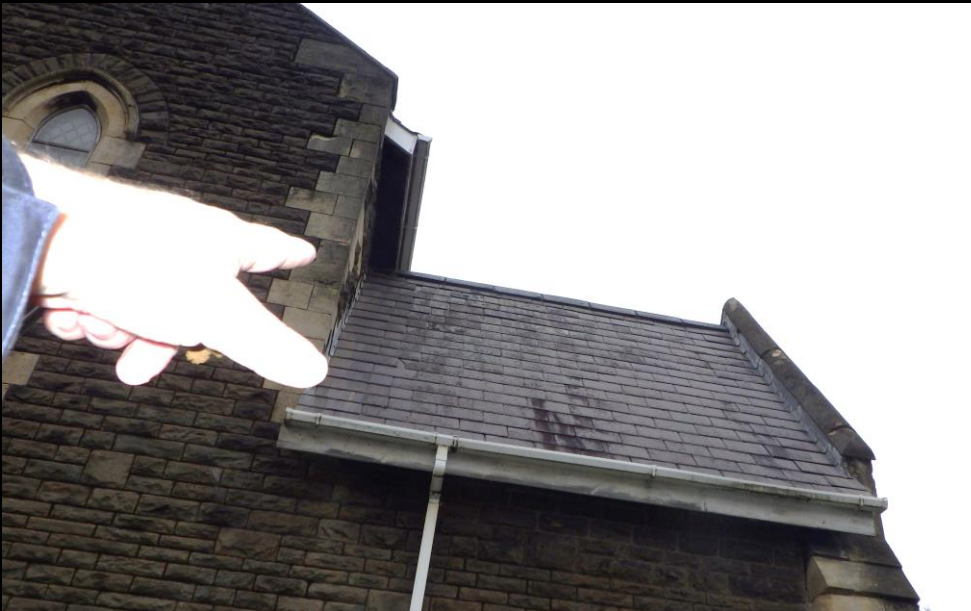
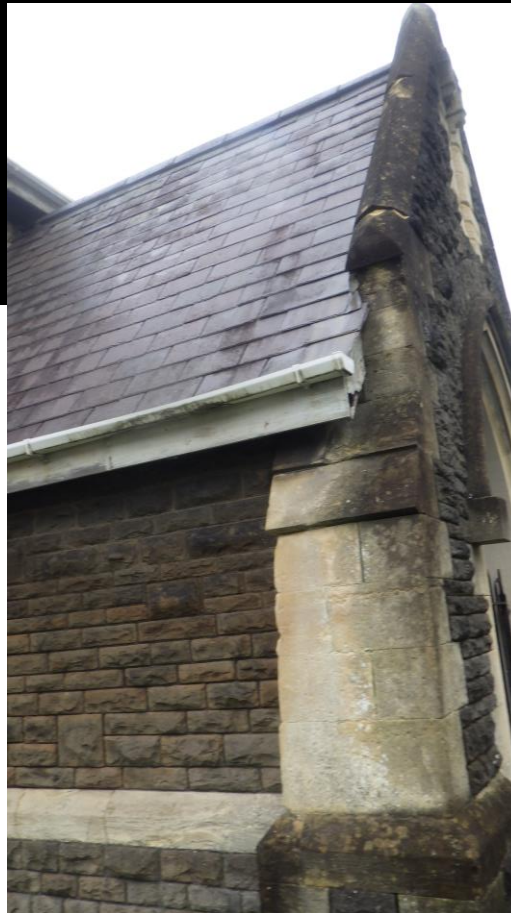
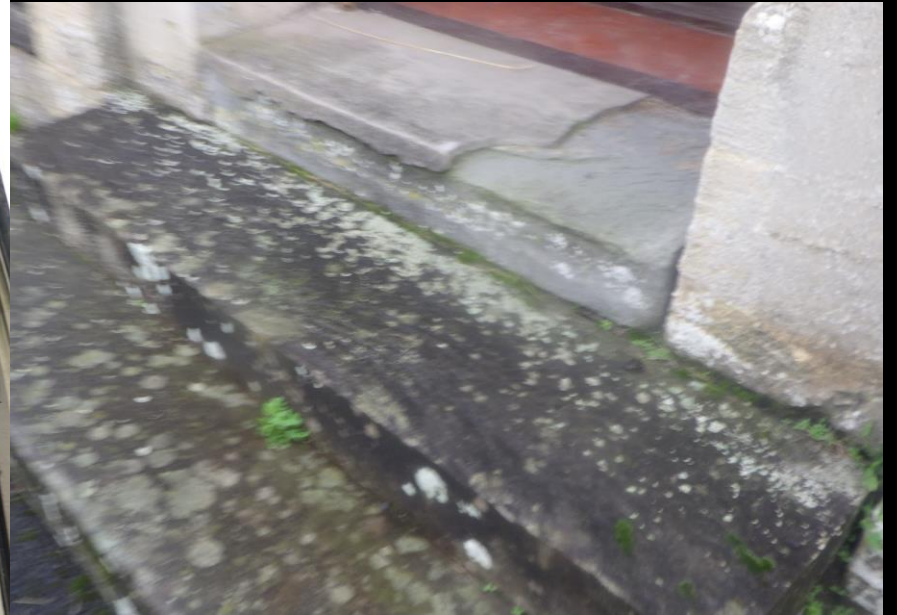
Spalling Bath stone and possibly some mortar patch repairs have been undertaken previously to the Bath stone coping details.

Some states have slipped to the porch and need replacring. The stepped threshold approaches to the church are not wheelchair friendly. The stone slab step at the porch entrance has been topped with concrete many years ago but is now delaminating. Redressing of the stonework carefully by hand bolstering is recommended.

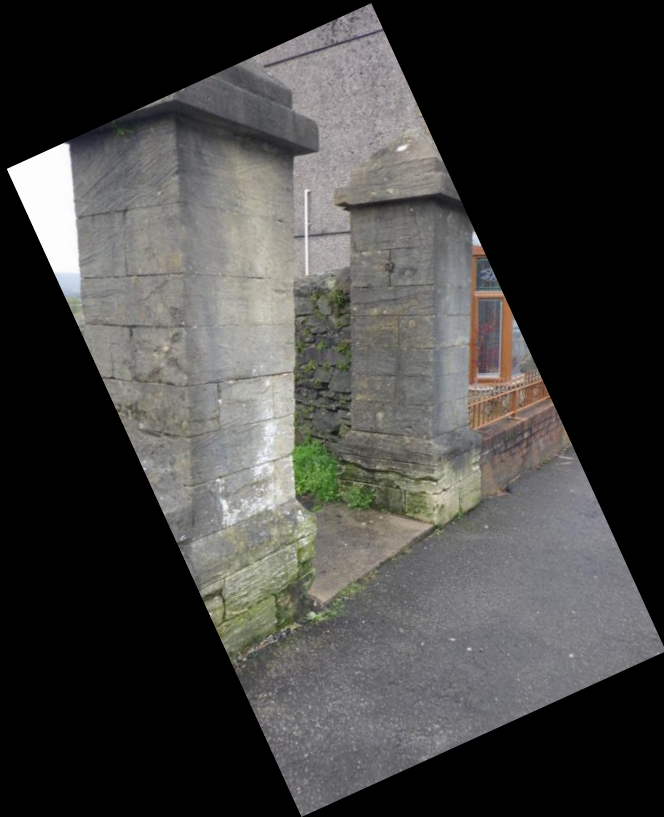
Some of the pillars have moved slightly and are leaning differently. Adjustments would be necessary to view the pillars or their hinge point fixings, in the event that gates are ever reinstated and remounted.

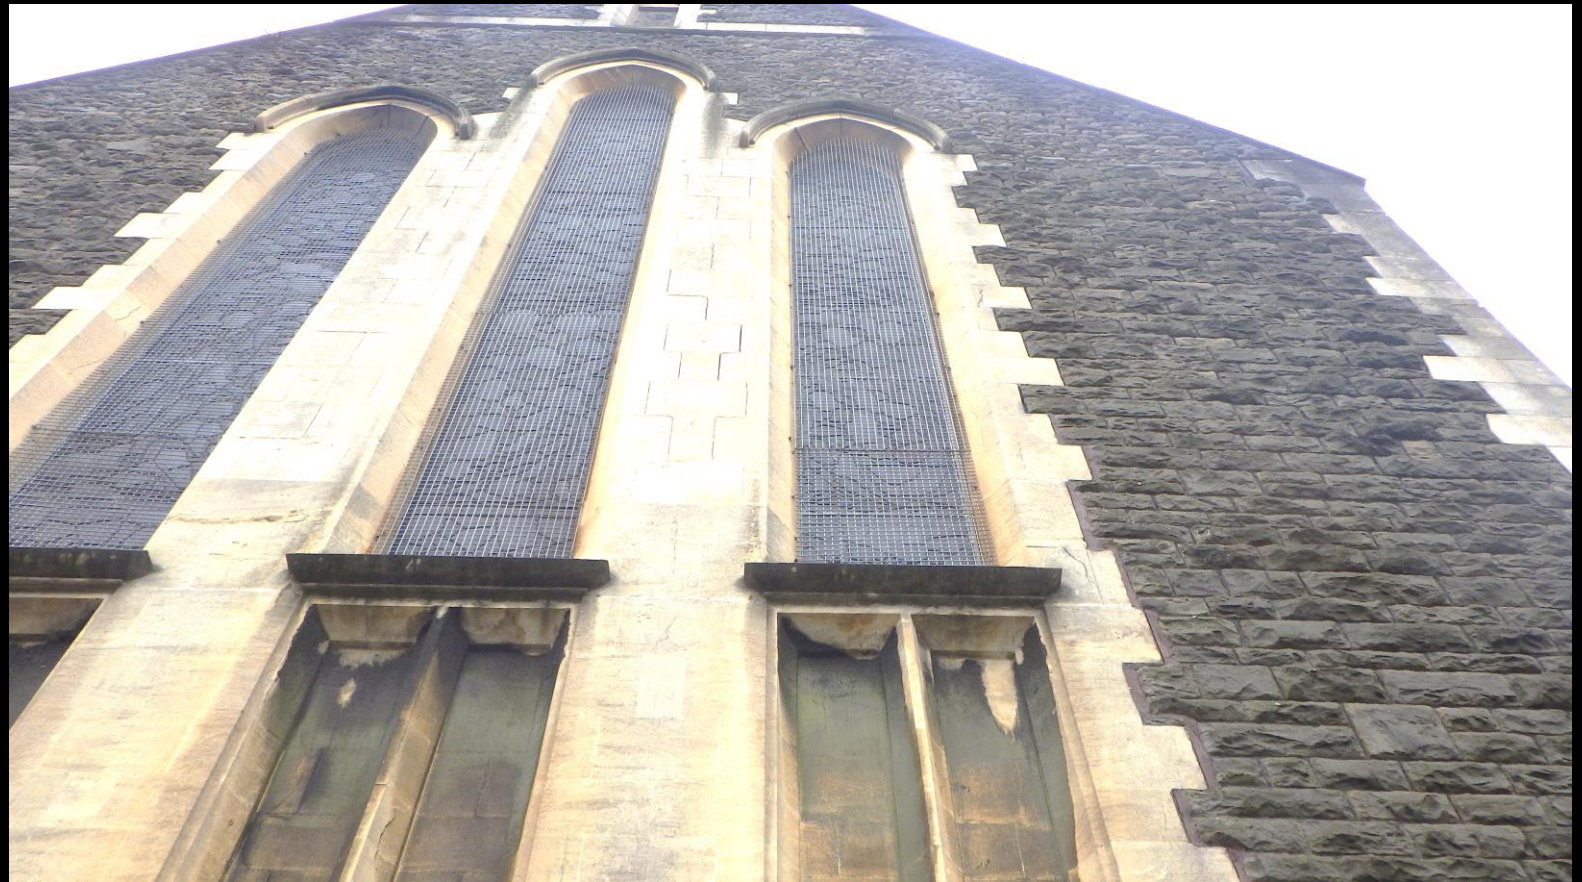
The East elevation wall which it is claimed crack-stitching has occurred. There are some possible locations for this but obvious signs cannot be clarified from ground level. We noted that some of the ashlar stonework and the associated quoin stones have moved due to differential thermal and moisture effects in the past. A crude brown sealant has been used to caulk some of the previously open joints. We have no details of exactly what was undertaken. When we met with Mr Adam Harris of RJ Chartered Surveyors recently, he indicated that the possible reference to underpinning of the wall made, may actually be a reference to a large concrete slab which sits adjacent. We cannot see that this is likely to be associated with an underpinning scheme. The Diocese should be asked if the scheme of this magnitude was undertaken and for the details of the faculty that should have been obtained. We suspect that the local parish or the Representative Body are simply confused about this large slab that might possibly have been placed there for an earlier oil storage tank or a temporary structure such as a store shed. However, without records or excavating we are not able to verify further. The wall does not appear to be structurally unstable in its current format and we would be surprised if a major underpinning exercise had been undertaken to this East elevation wall. Repointing of stonework at high level is required.

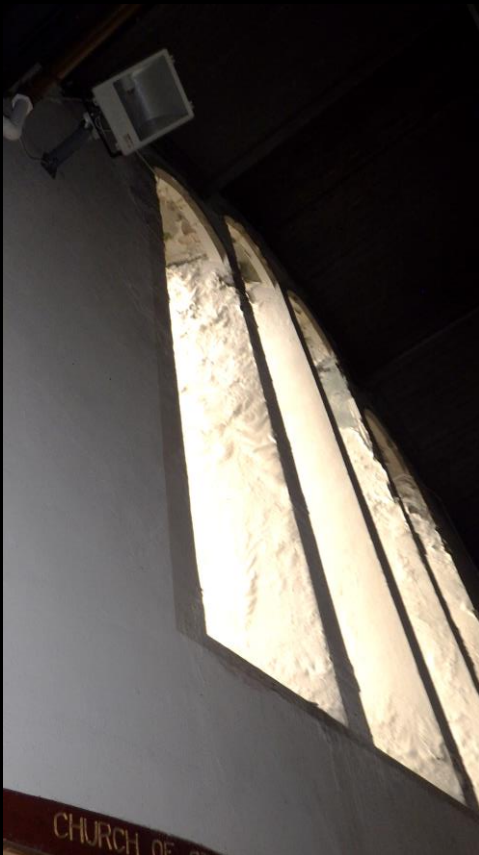
Significant water penetration is occurring via the Bath stone mullions and the splayed reveals of the East window. Repointing of the stonework externally, removing patch repaired plaster and making good with lime-based mortar, caulking around the windows and addressing the secret gutter/soaker abutments to the high level parapet walls above is required in addition to line mortar repointing externally with a Blaenavon dark mix lime-based mortar.

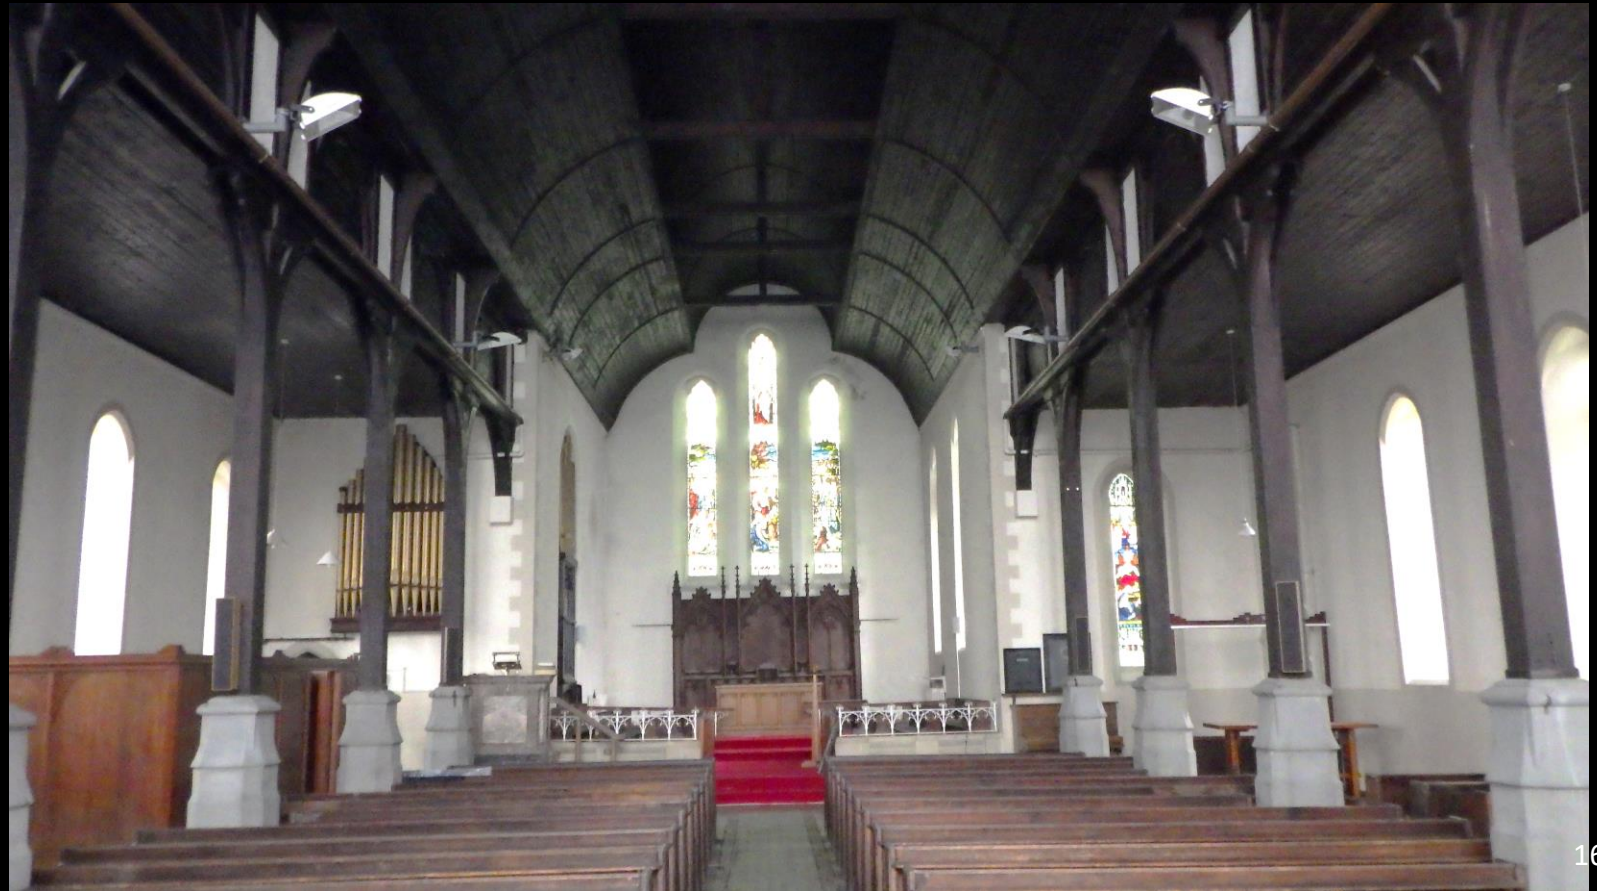
Rainwater has been penetrating at the intersection of the barrel vaulting of the Nave, South Aisle and chancel. High level access will be necessary to investigate. Some fungal decay is suspected and will need to be addressed urgently once scaffolding is available.

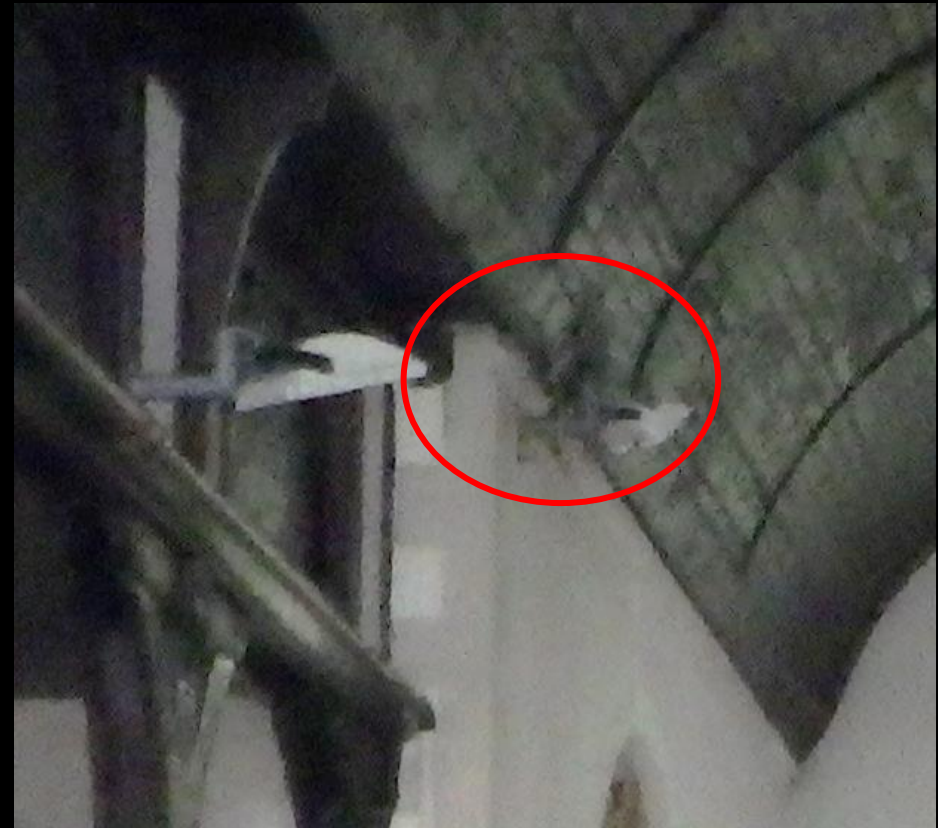
**Water damage at the valley intersection with the rear gable needs investigating and rectifying.**

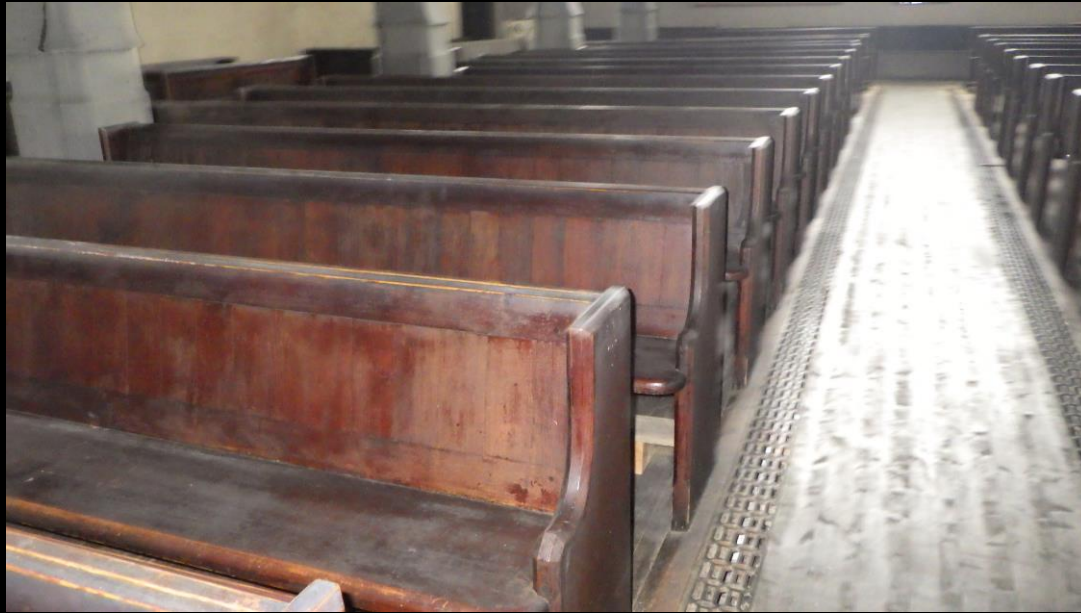
Interior of the church. Repairs have been made to the central aisle and some of the boarded areas on which the pews are mortice and tenoned into timming kerb details.

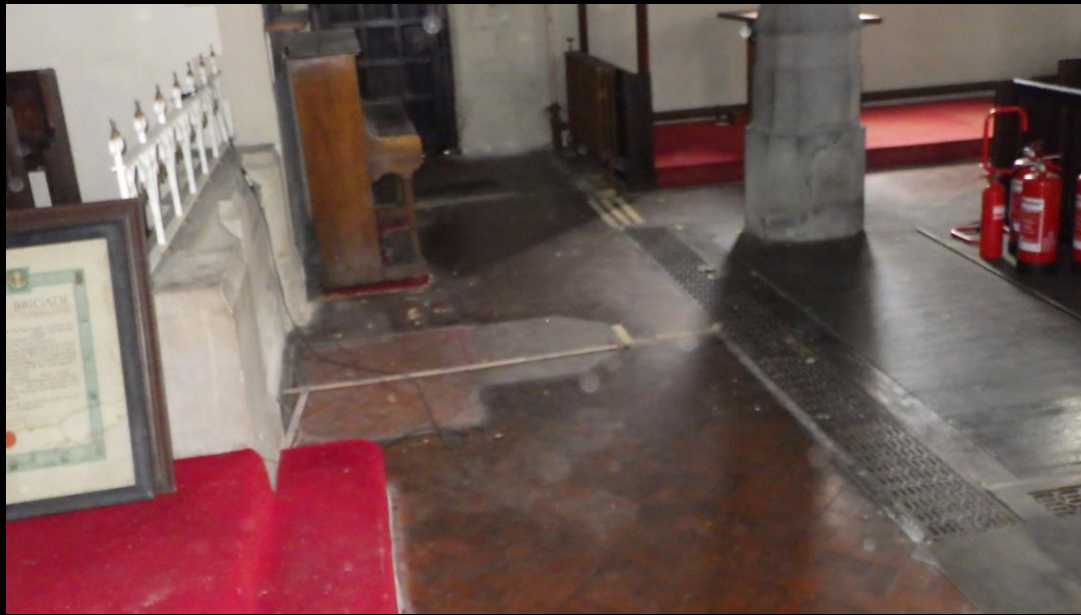
Repairs are required to the herringbone pattern quarry tile flooring where cracking has arisen.

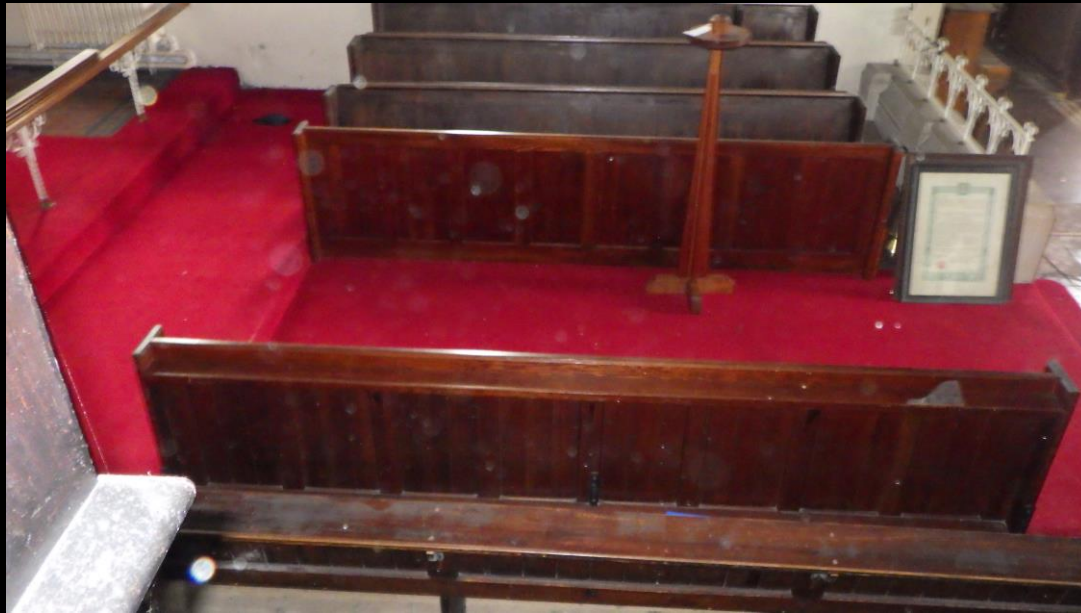
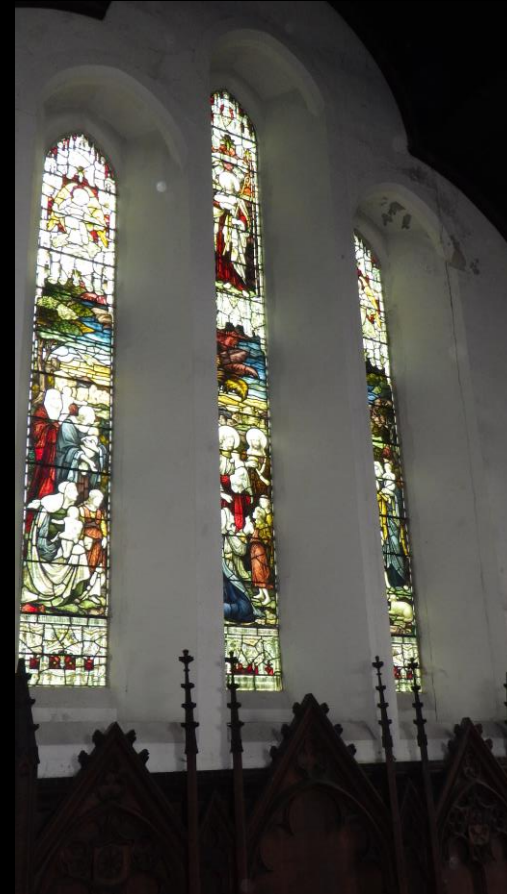
The attractive stained-glass Celtic Studios, West window. Some moisture penetration is arising from high level and again the secret gutter/soakers and wall parapets need to be cleaned and repaired.

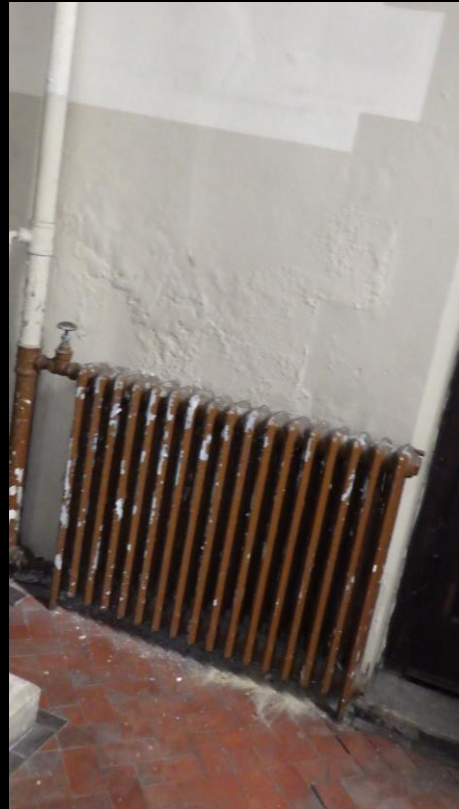
The Font has been crudely paint coated and we would recommend that this is removed using suitably benign paint strippers.

Centre: Moisture penetration is passing through some exterior walls. Damp is also due to rising dampness impacts at a lower level.

Below right: the organ and its maker's mark. It is highly likely that asbestos-based products will have been utilised within its blower box and possibly some of its piped and ducted mechanisms.

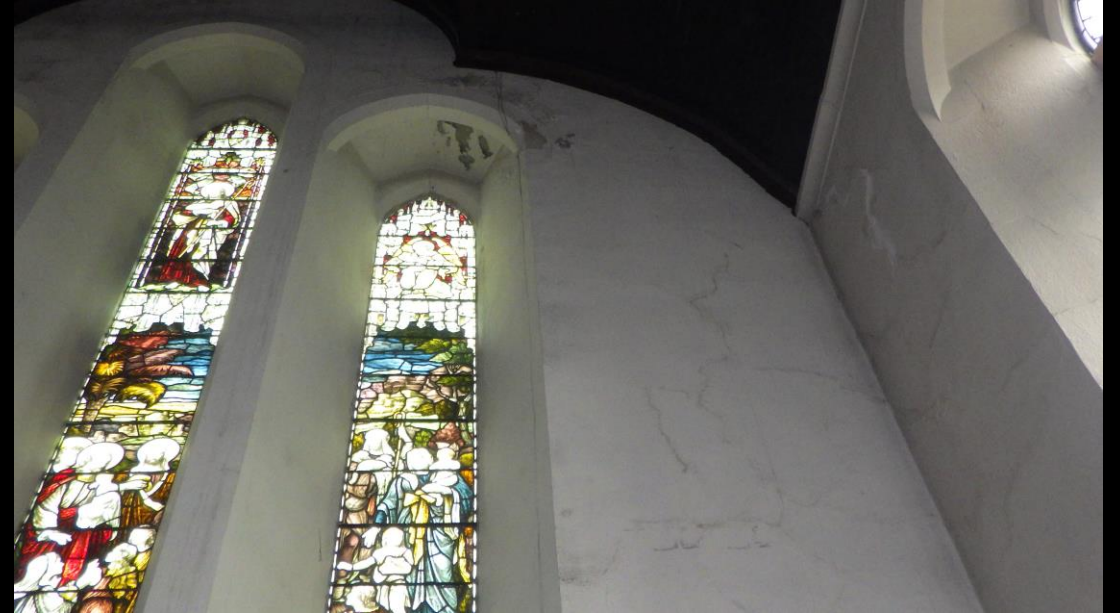
**The West window. Water penetration at high level. This as indicated, due to the parapet and flashing details above.**

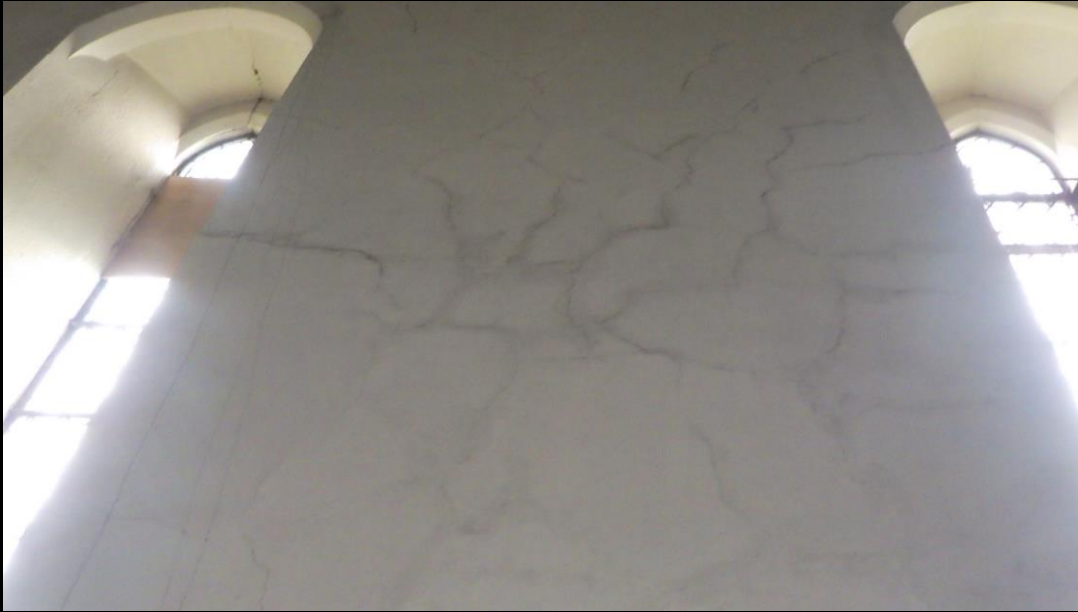
**Hairline cracking and crazing of wall plaster and paint finishes.**

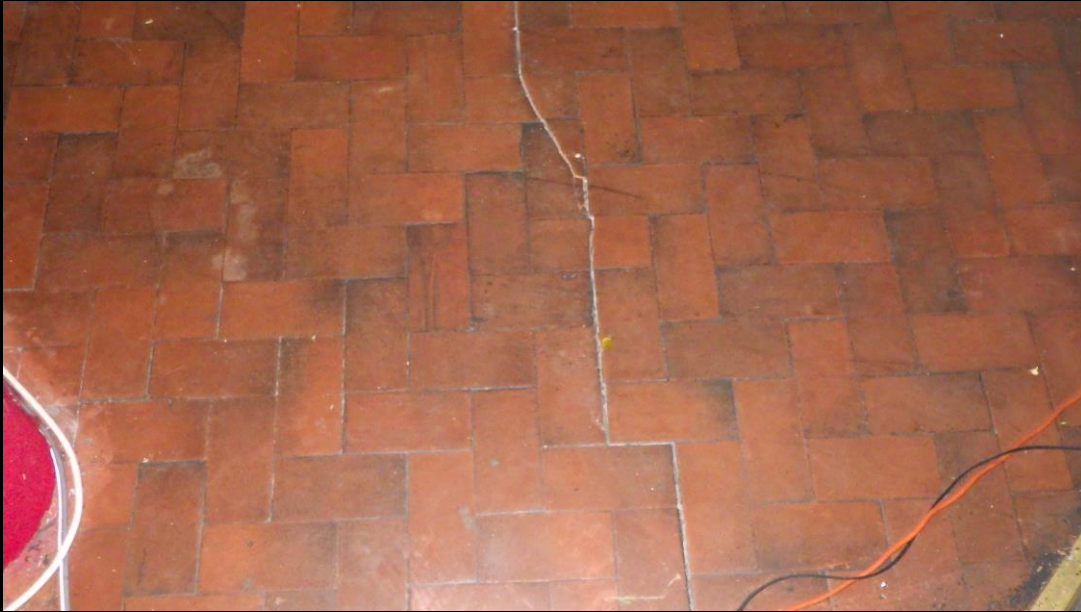
**Cracking to the briquette, herringbone pattern, quarry tile flooring, due to minor settlement.**

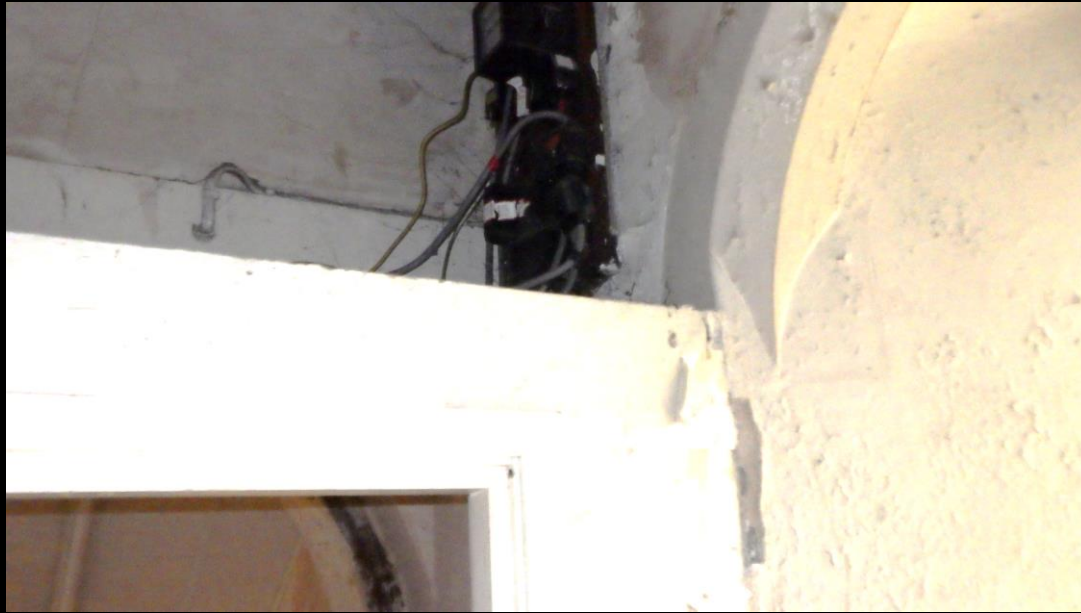
The electric meter and main fuses. Some of the consumer units and fused switches will need to be upgraded.

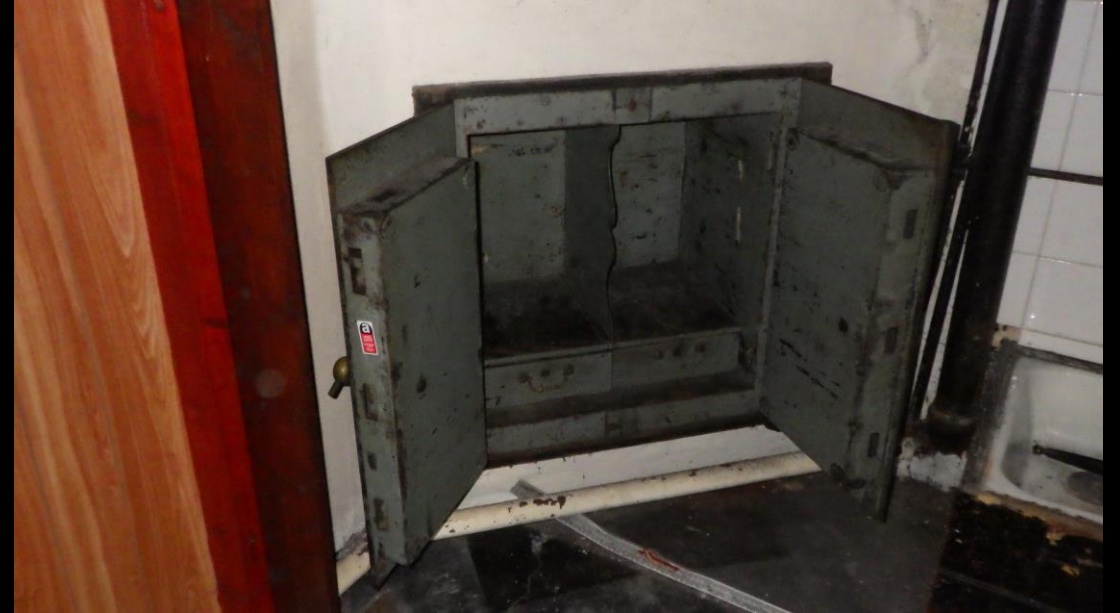
The church safe which has been inserted in to what we suspect is a former fireplace opening. We noted that the safe was labelled with asbestos signage. Its asbestos-based materials should not be disturbed unless it is removed safely by a Licensed specialist.

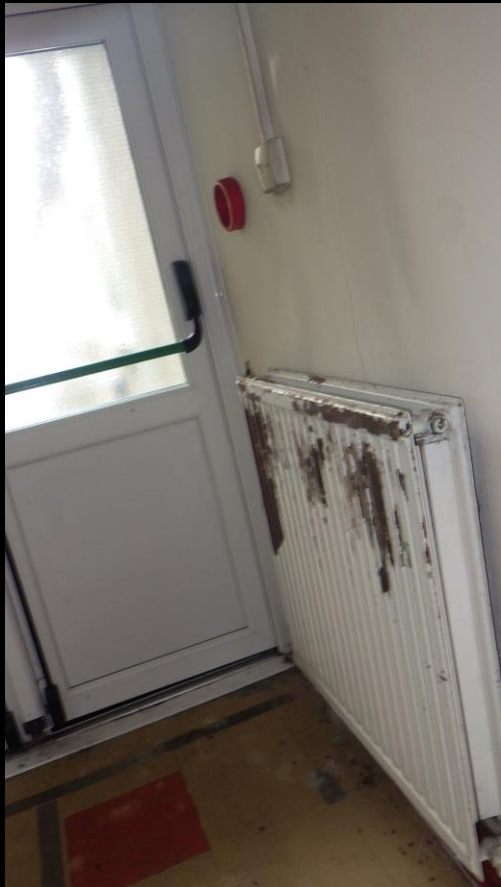
Below: The lobby link between the Church and Hall. The radiator is corroding and needs redecorating.
