# The former St. Catherines Church and Hall, Neath.

North and West elevations.

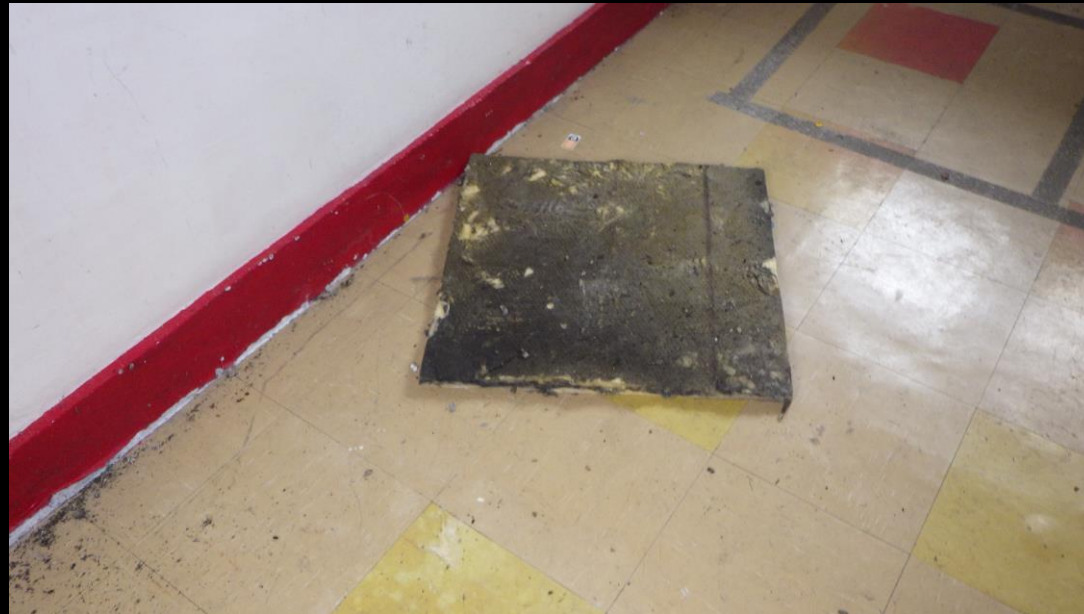
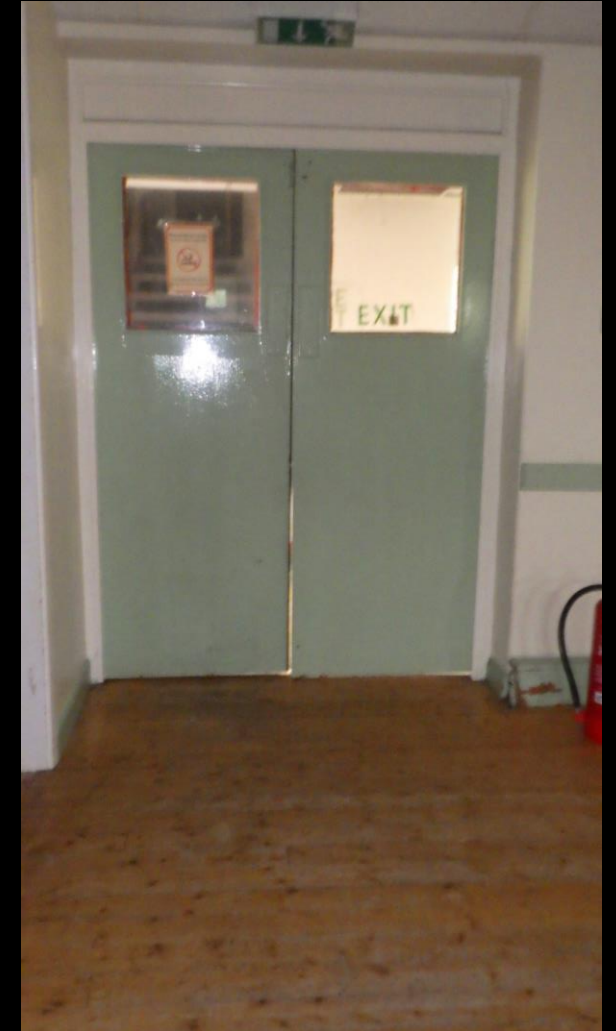
Centre: the fissured pattern vinyl and glass fibre lined ceiling tiles are damaged in many areas and deflecting in others. Replacement is becoming necessary throughout the Hall. We noted that in areas there had previously been a plasterboarded ceiling that is damaged above..

Right: the swing type fire doors fitted to the church hall do not meet modern fire safety standards.

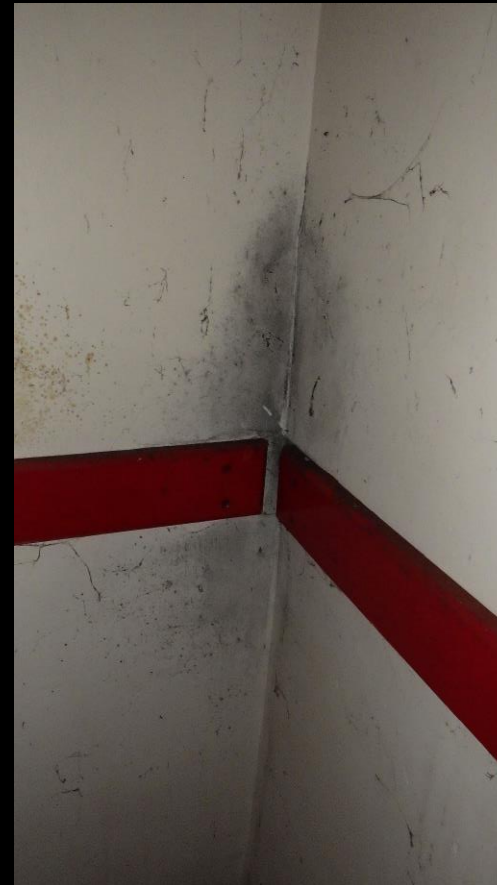
There are signs of mould in the far left corner of the storeroom that needs to be washed down and redecorated. The reason for this is rather unclear at present but significant dampness was not noted. This is possibly due to storage of equipment within this position at sometime in the past. It should be monitored however, and interventions made, if required.

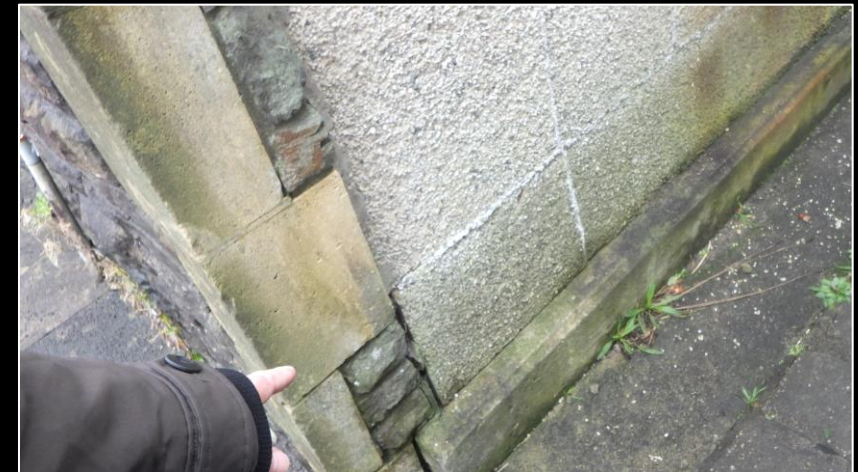
The front entrance approach to the Hall. As indicated the stonework to the front is purely a decorative façade. Moisture penetration is occurring internally within the Hall boiler room where this abuts the plaster-finished internal skin constructed within the Hall. Some of the applied cladding panels are misaligned and may need resecuring.

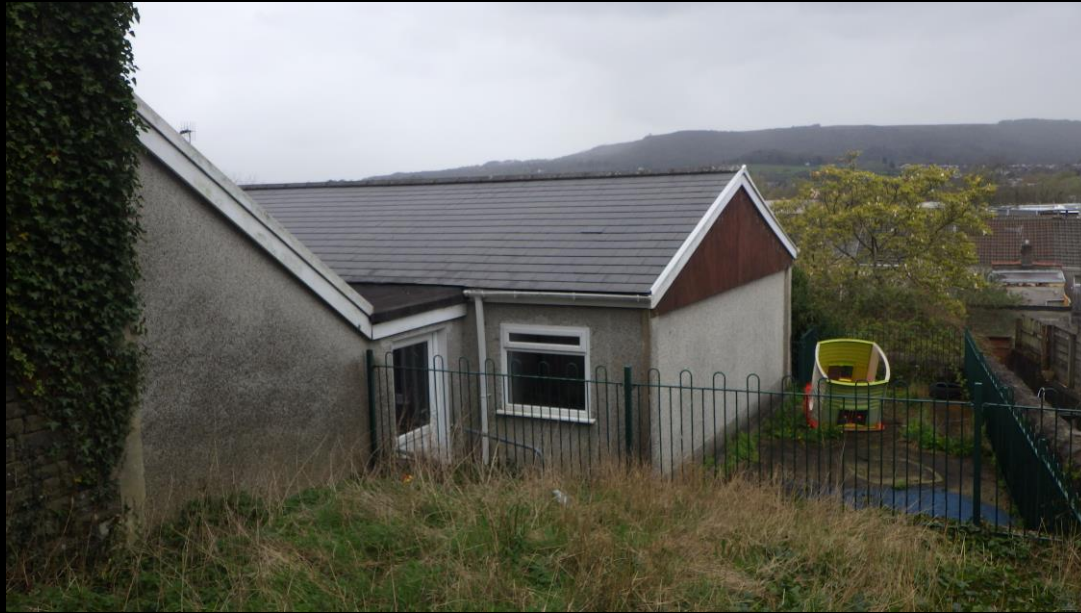
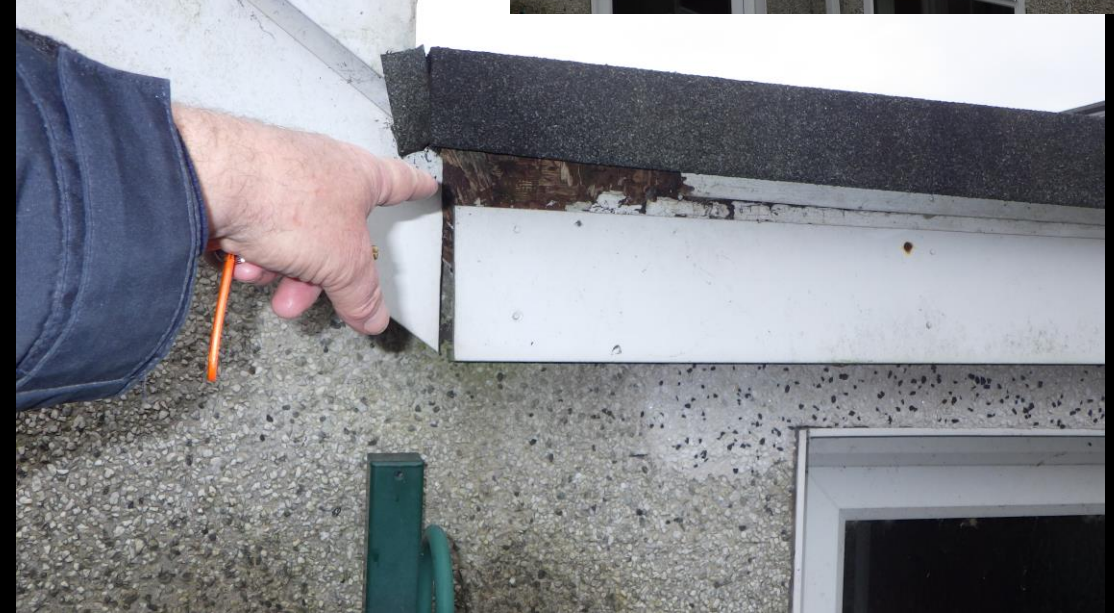
There is a flat felt roof section over the abutment rear lobby of the Hall and the stepped link into the vestry of the church.

Repairs are required to the bargeboard, fascia and soffit, detailing and within a relatively short time recovering of the flat felt roof is likely to be necessary.

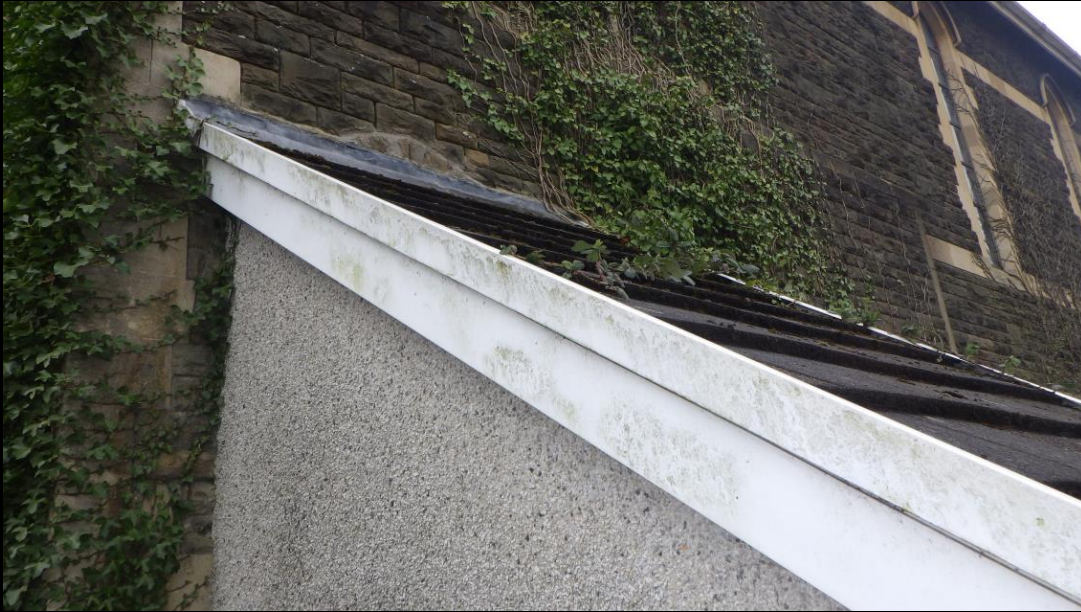
Ivy vegetation growing on the south elevation wall of the church needs to be removed. There is a concrete tiled roof to the linking stepped area. The lead cover flashings are inset partly into the former church opening. Detailing is poor and vulnerable at this point. Water stained wall plaster was evident internally at the abutment.

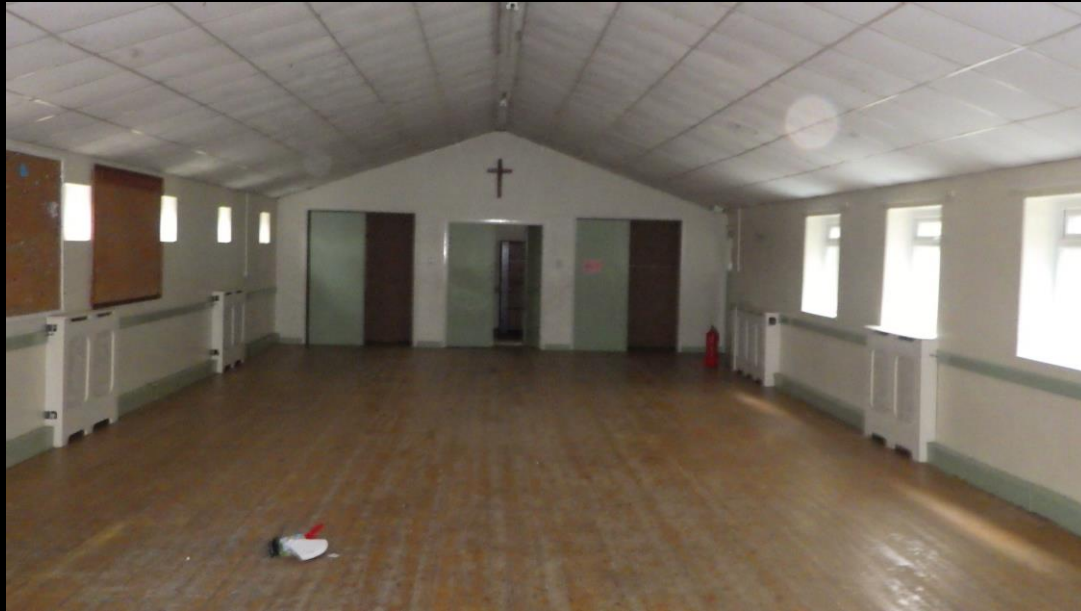
Hall. The floor needs refinishing.

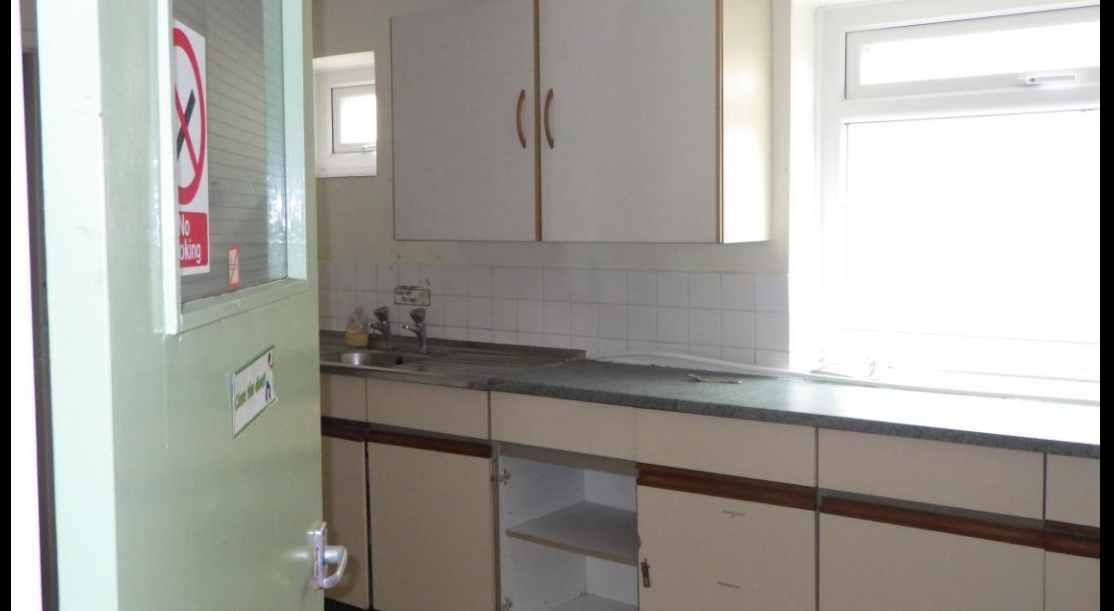
Kitchen. A replacement door needs to be fitted to the kitchen cupboard. Fire doors installed within the hallway are not to later standards and much will depend on your future remodelling of the whole building as to where changes will need to be made. This will be subject to obtaining planning and building regulation consents for all intended new uses.

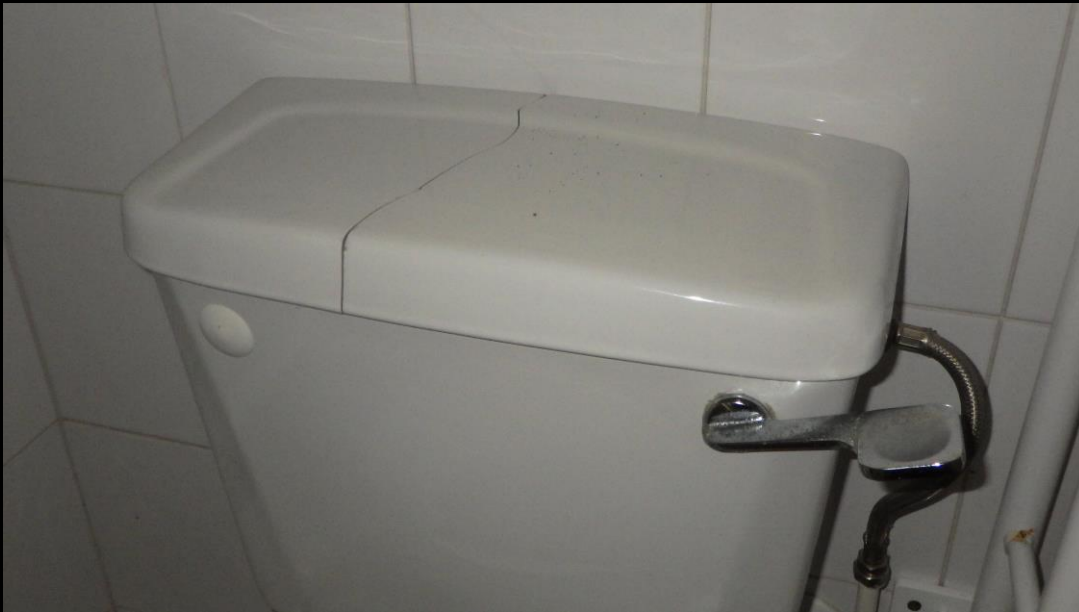
**There is a cracked top to the toilet cistern.**

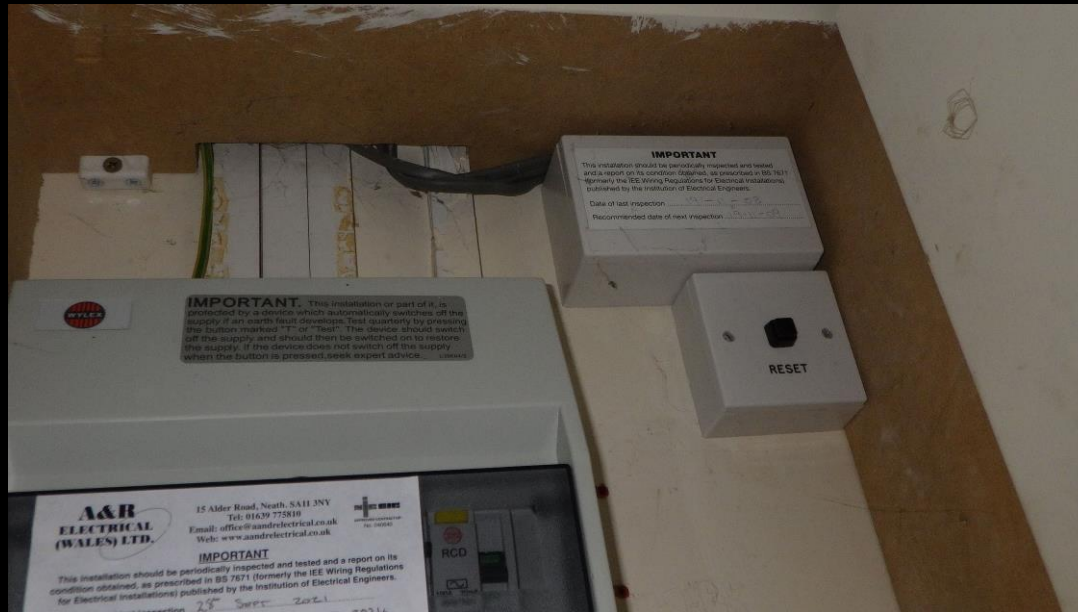
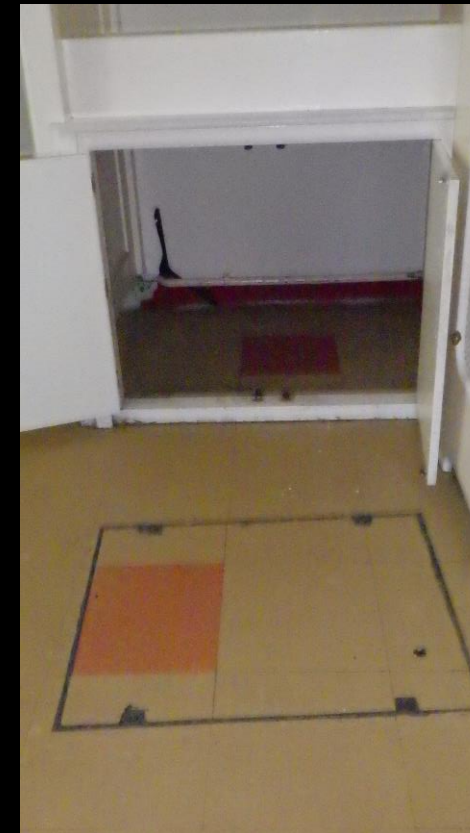
The electrical consumer unit within the hall is not to the latest standards and ideally would now be upgraded. Similar comments apply in the Church.

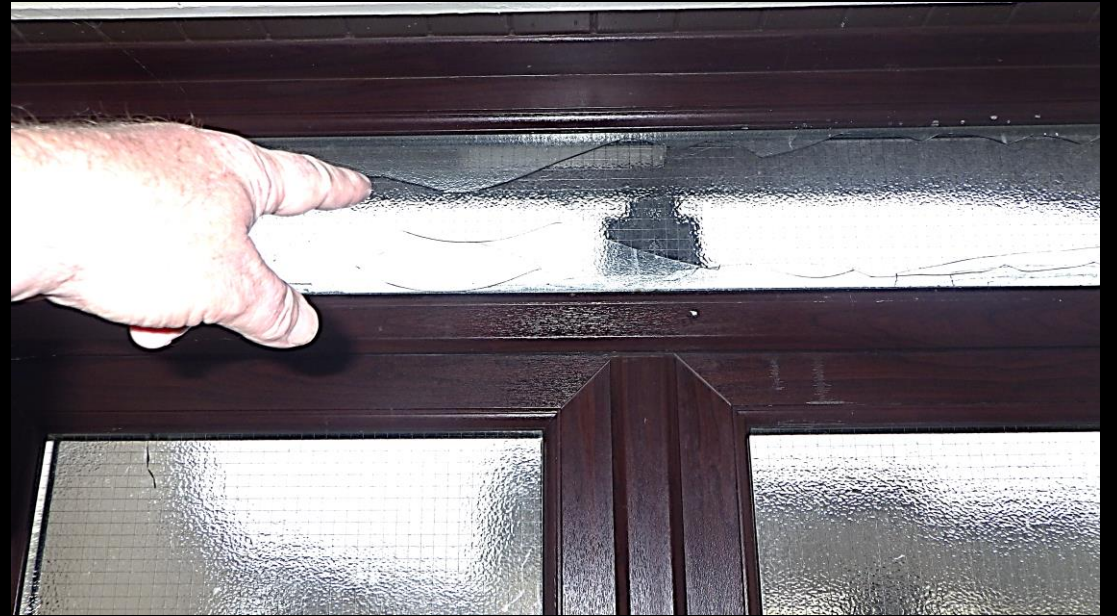
Cracked sealed glass unit that needs replacing.

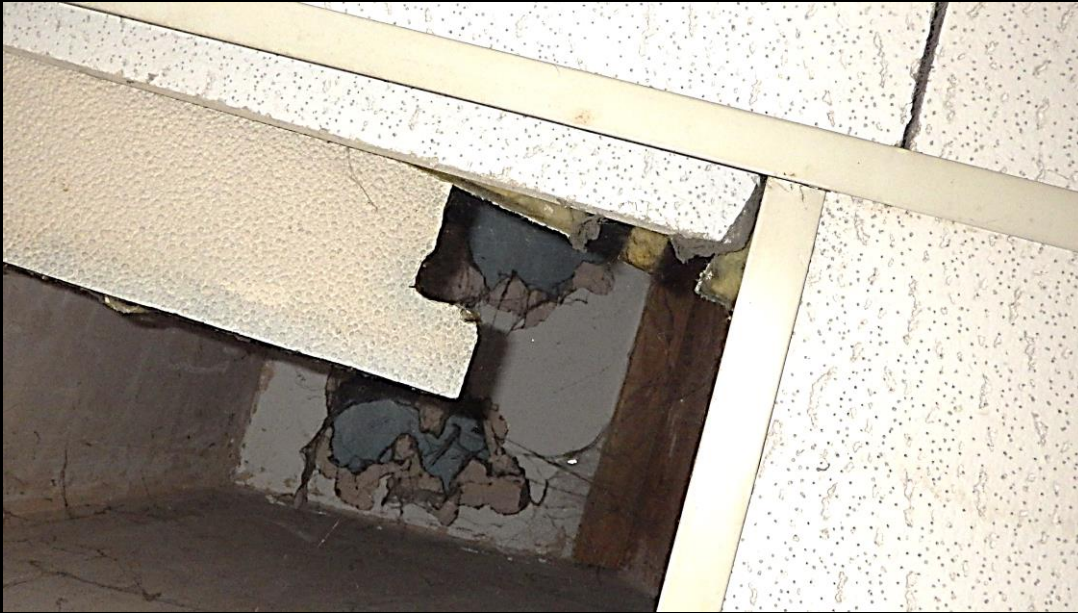
Above the ceiling tiled area within the entrance areas we noted an older plaster boarded ceiling that is damaged. Levels of thermal insulation will need upgrading.

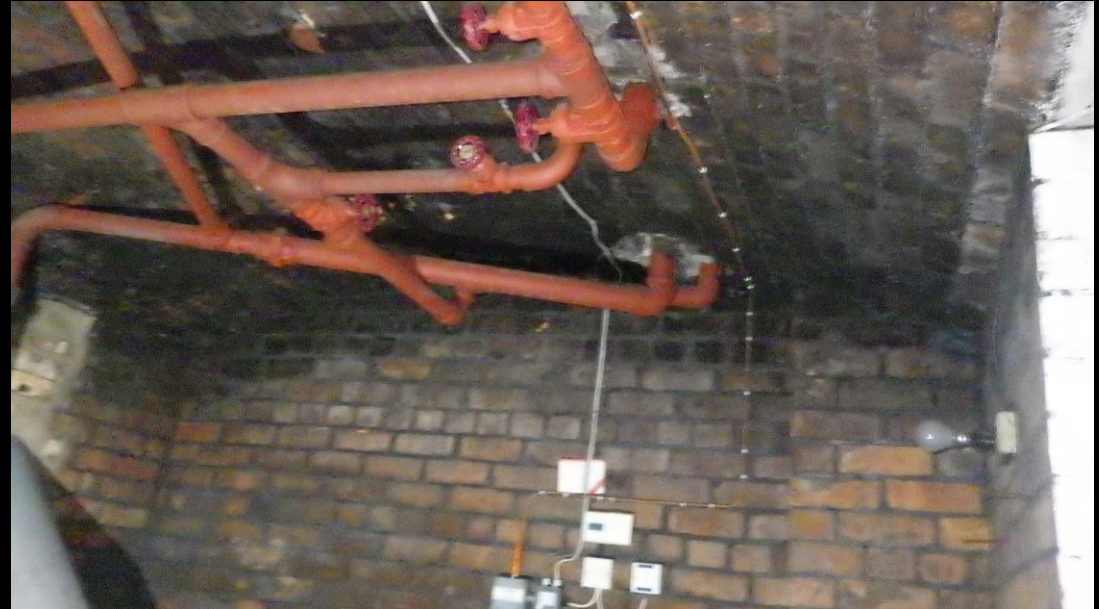
Pipes need insulating. The Gas boilers inspecting and servicing. Many gas fitters would recommend replacing. We suggest give the limited long term likely use that you enquire as to the availability of parts as replacement is unlikely to be cost viable.
