# **PROPOSED NEATH PORT TALBOT RENAL DIALYSIS UNIT.**

## **PRE-START CONDITION SURVEY OF ACACIA AVENUE**

Site Report – Wednesday 11<sup>th</sup> September 2024.

SCL Ref: P113

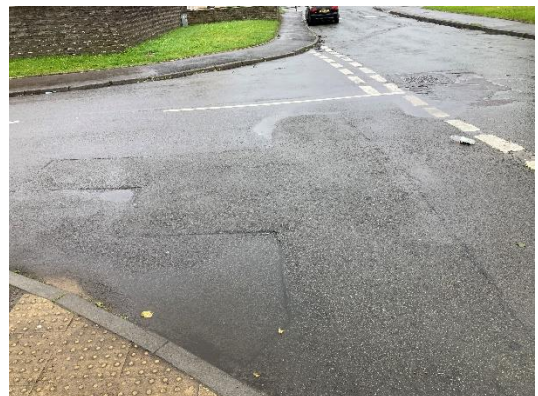
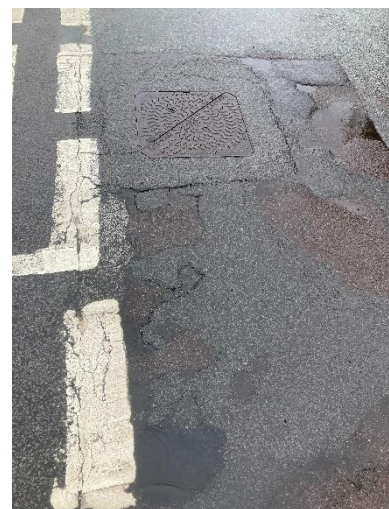
1:

Areas of the junction has been repaired in the past, and there is clear evidence of delamination of parts of the wearing course and settlement around the assumed combined sewer manhole.

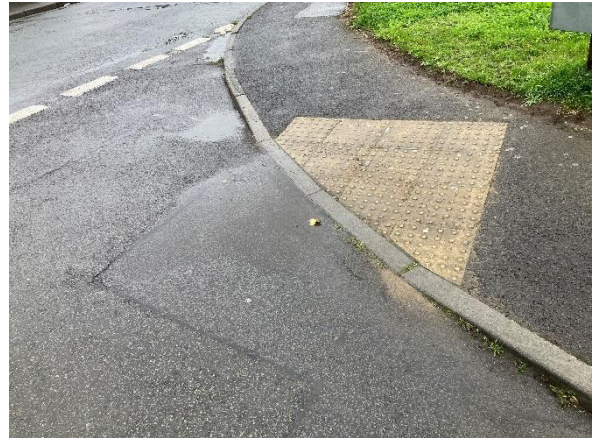
2:

The Western side of the T Junction has a modern tactile paved pedestrian drop kerb to the carriageway. This appears in good order, although we note there is no storm water drain on this side of the road and water does 'pond' near by.

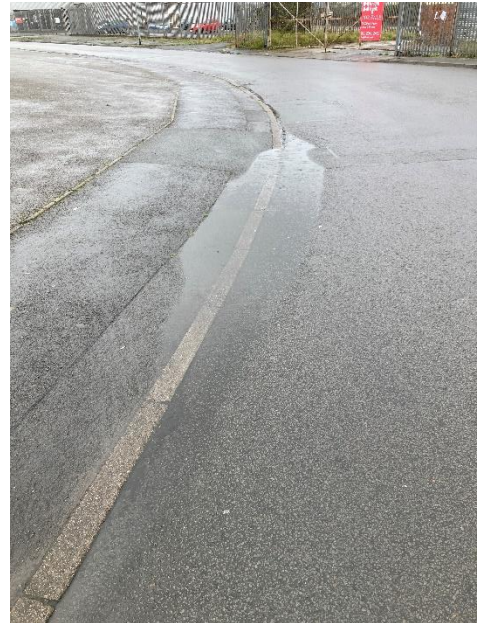
3:

Just along from the T Junction on the south East side of the road there is an area of dropped kerb that has a large quantity of standing water. Again we note that there is no storm water drain in this area of low lying roadway.

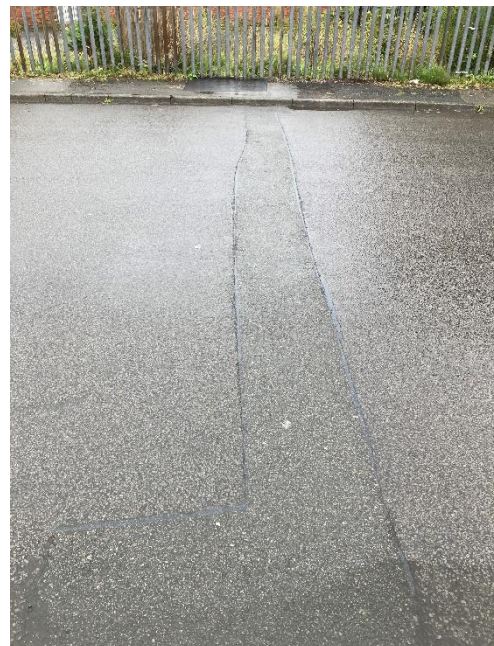
4:

Evidence of a previous service duct having been taken across the road width. The repair has been carried out well, although the 'banding' has failed in areas leaving the joint of new & old open to potential water ingress and freezing in the colder months, often a cause for delamination of the road wearing course and future potholes.

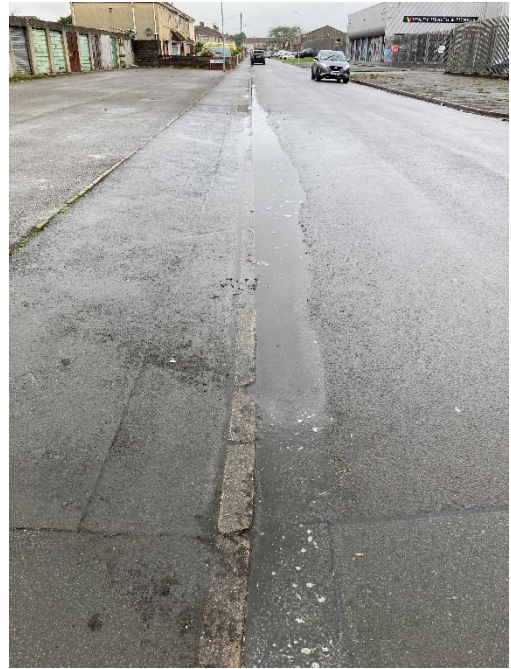
5:

To the southern side of Acacia Avenue there is a long run of dropped kerbs that would have accessed some now demolished domestic garages. This area as for much of the South side is not served adequately by storm water drainage and standing water was again evident and evidence of silt deposits from previous deeper water lines was seen on the pedestrian pathways.

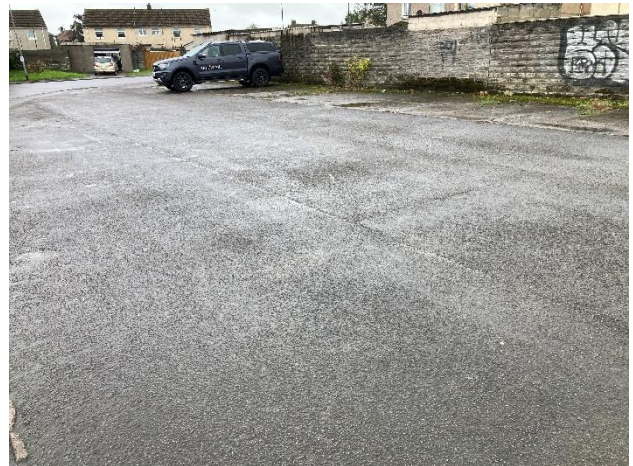
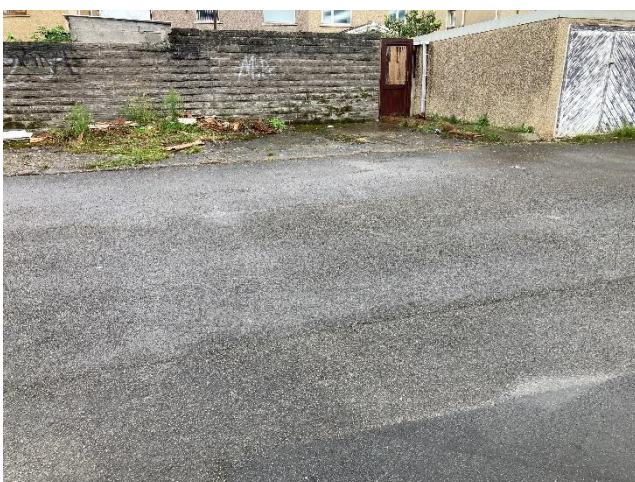
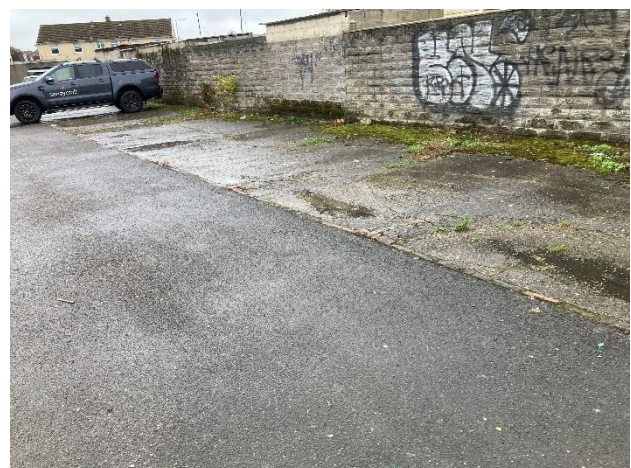
6:

General area of the old domestic garages. This area is of no consequence to the possible redevelopment of Stationary House, but is noted for context of the conditions of the adjacent areas.

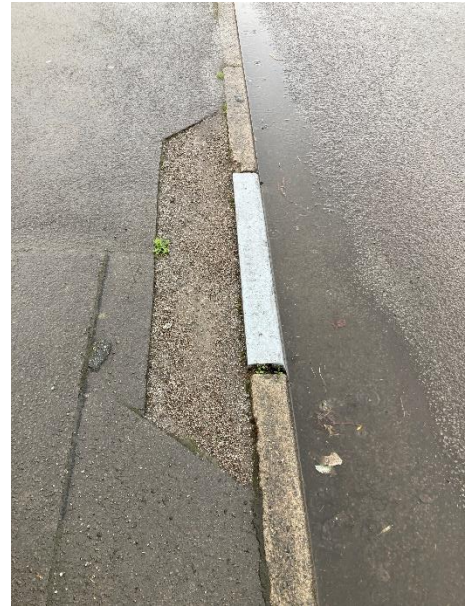
7:

Further along the carriageway, as the kerbs return to normal, is evidence of a previous kerb repair. It is clear that this has not been completed fully and still requires additional tarmac works

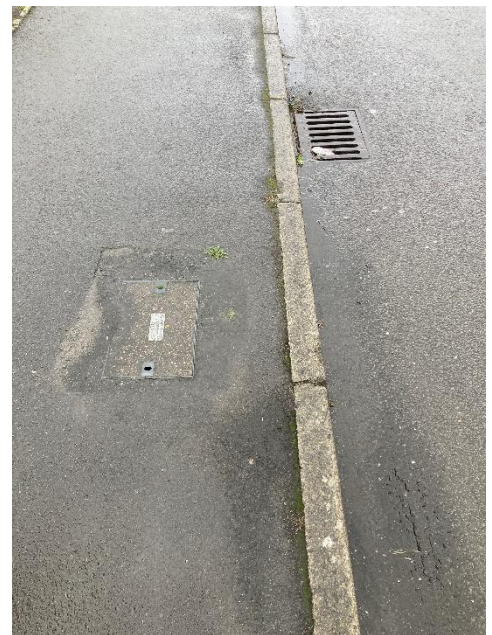
8:

In front of the remaining domestic garages on the South side of the carriageway there is a storm water gulley, however it appears this has remained solid on its concrete surround while the surrounding roadway has sunken and now water pools adjacent to it, rather than running away as is supposed to.

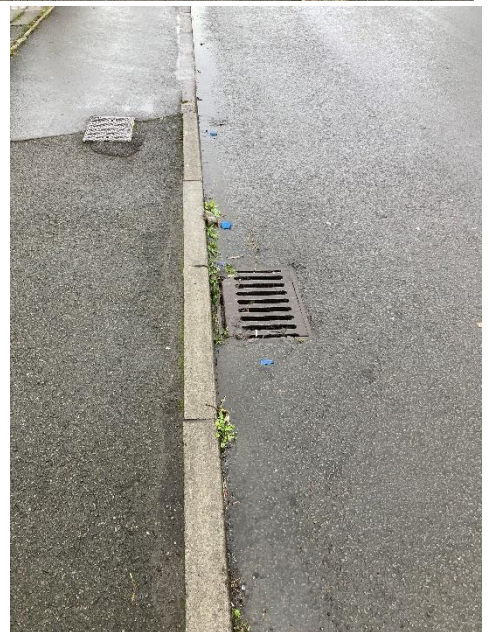
9:

The carriageway and footpath once you reach the domestic housing on the southern side of Acacia Avenue is generally in good area, with a variety of dropped kerbs all carried out to current road specification accessing a number of properties. At this point of the road domestic vehicles park outside their houses, with the road being wide enough to accommodate this on one side of the carriageway.

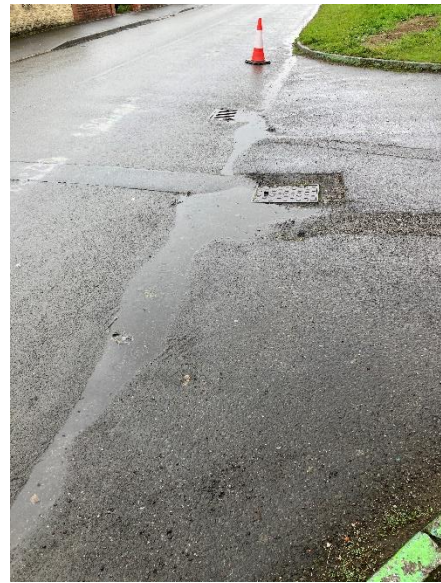
10:

At the first access point to the neighbouring land there is a storm water road gulley in a strange location within the middle of the entrance. There is also a manhole in very poor condition, with the carriageway collapsed on all sides. This area of depression is not allowing the surface water to drain efficiently to the existing storm water gulley.

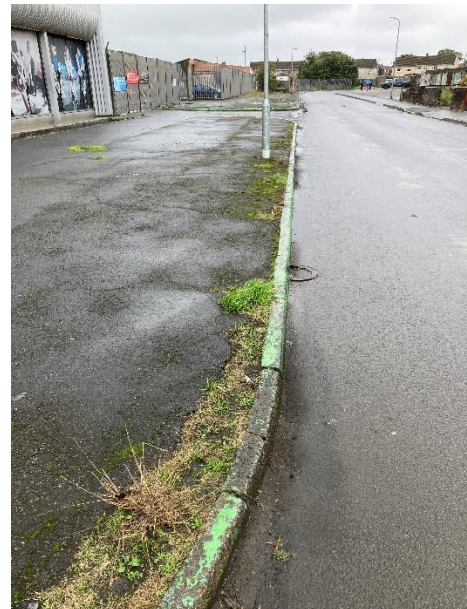
11:

A lot of the kerb line along the Northern side has at some point been painted, and is in varying states of repair as we proceed back towards Stationary House. There is a large amount of vegetation taken hold in the cracks and joints of the kerbs and tarmac footpath.

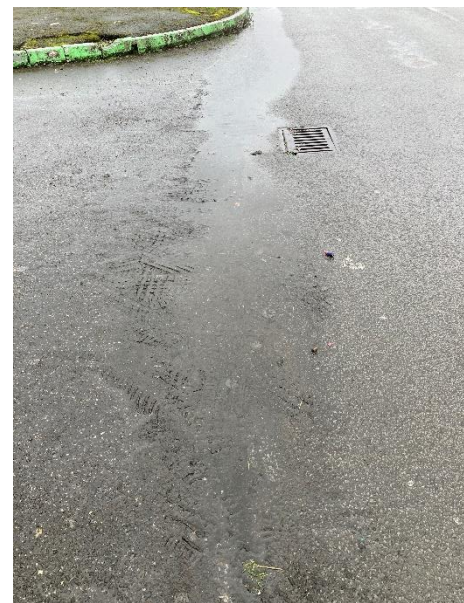
12:

The second entrance appears to have been abandoned by the neighbouring land owner and is fenced across at the point of the car park. This entrance again has a storm water road gulley in the middle of the roadway and is located too high compared to the surrounding tarmac surface and therefore little water is making to the drainage system.

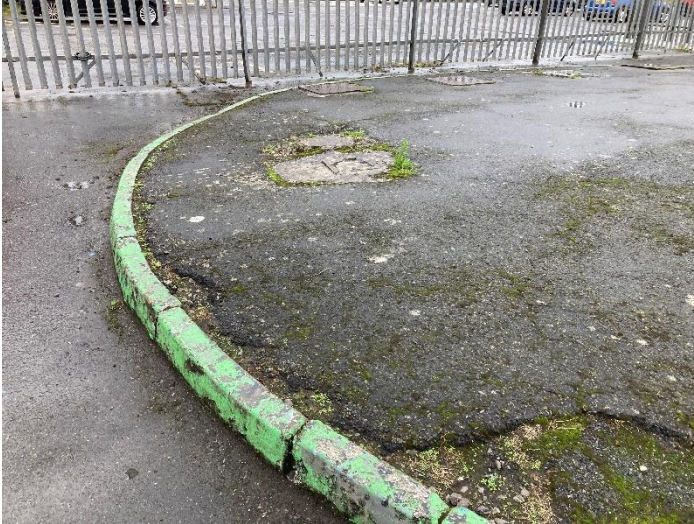
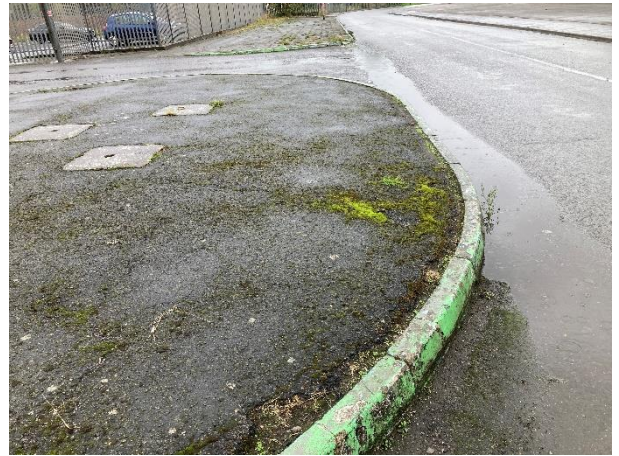
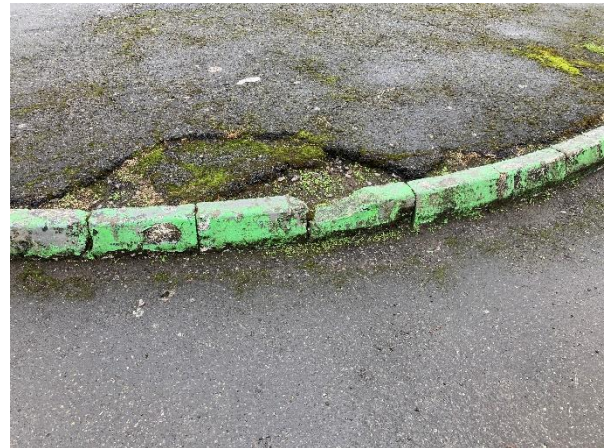
13:

The island formed by entrance two & three, is to a tarmacadam finish and is in a fair - poor condition, but with areas of missing earing course and general moss growth across it.

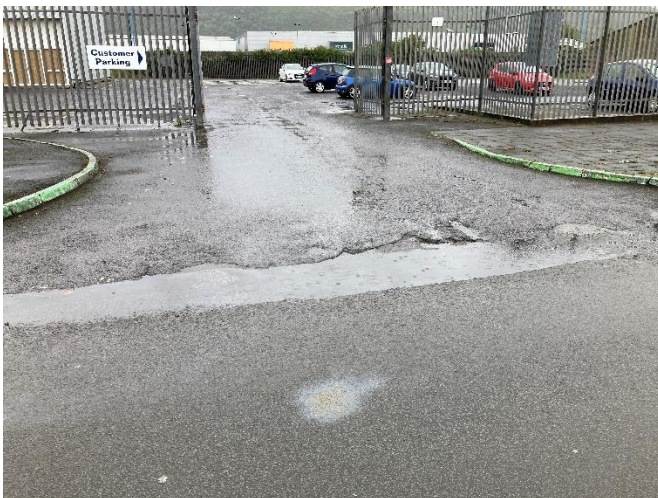
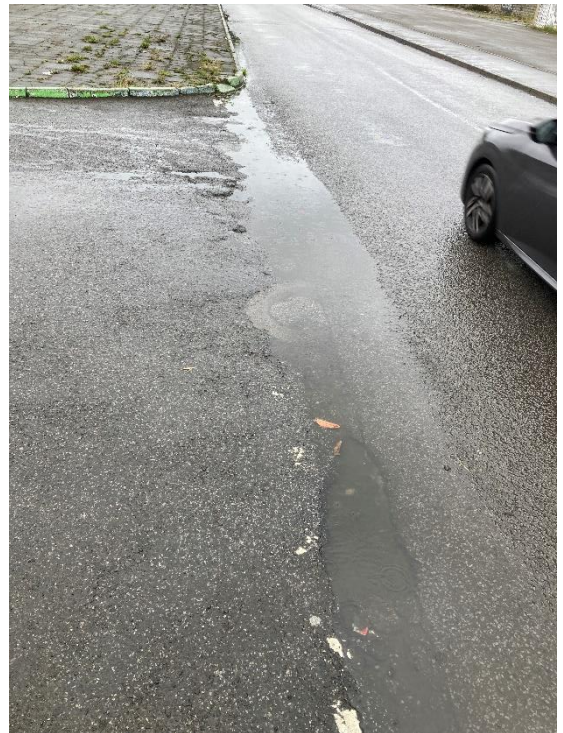
14:

The third entrance to the neighbouring land is in fair condition, but as for all cross overs noted within this report, it is holding a large quantity of storm water. This area appears low compared to surround areas and water is not draining to any of the adjacent road gulleys.

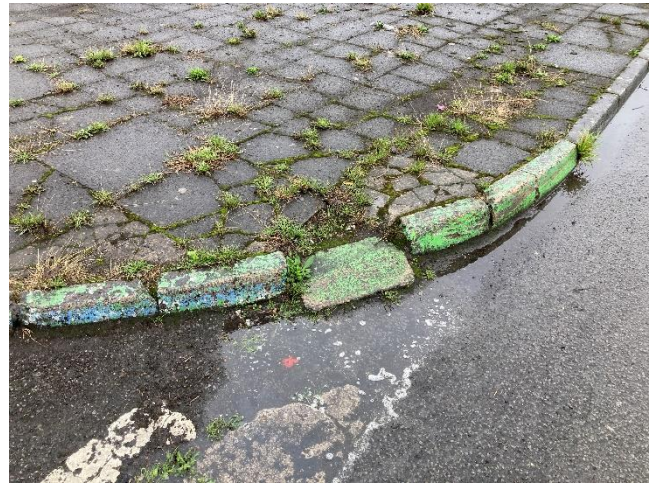
15:

The Right hand side of the third entrance has been damaged at some point in the past, likely with large vehicles bumping up on to the adjacent extended pavement area.

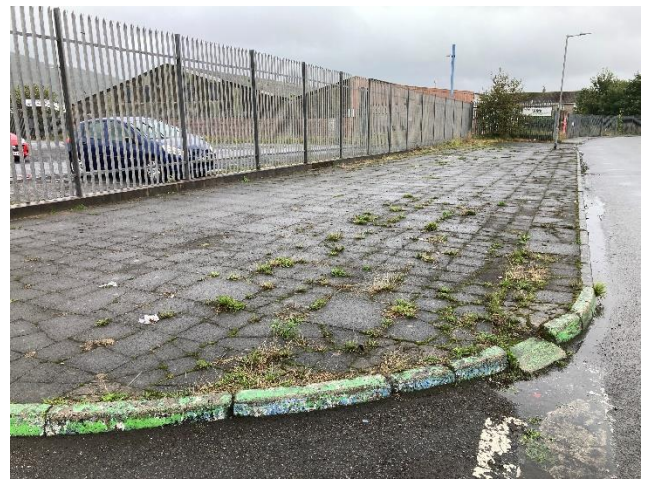
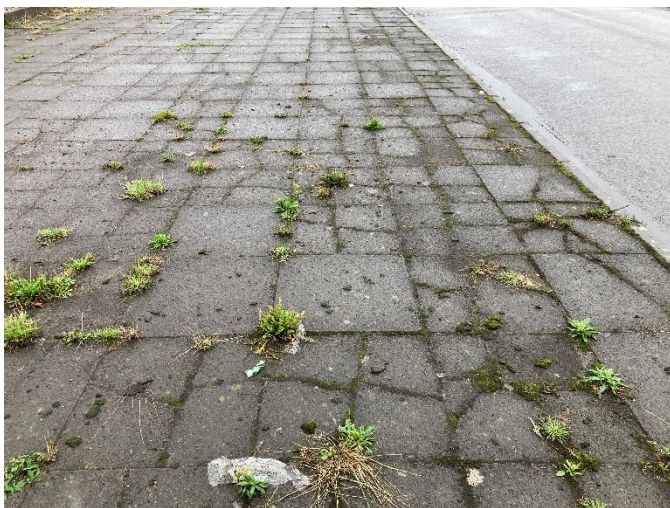
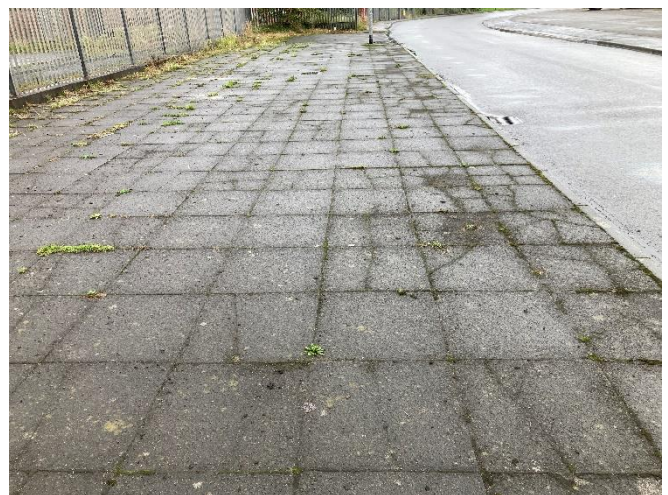
16:

The extended pavement directly adjacent to the land of Stationary House is in terrible condition and is in need of renewal. Given the extensive array of broken and dislodged paving slabs it would appear that this is due to vehicles using it as a parking area at some point in the past.

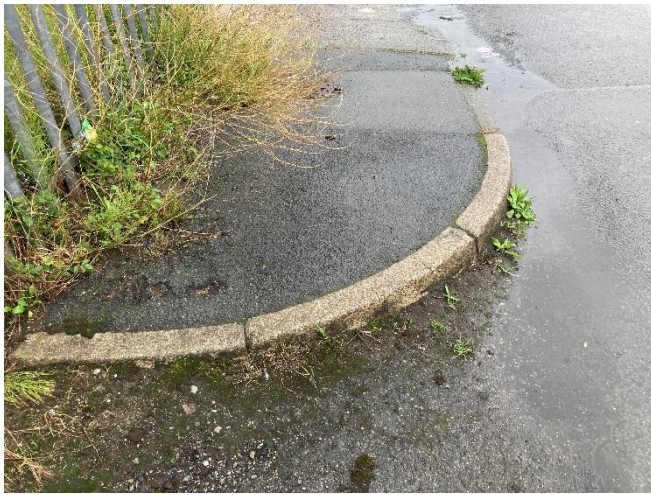
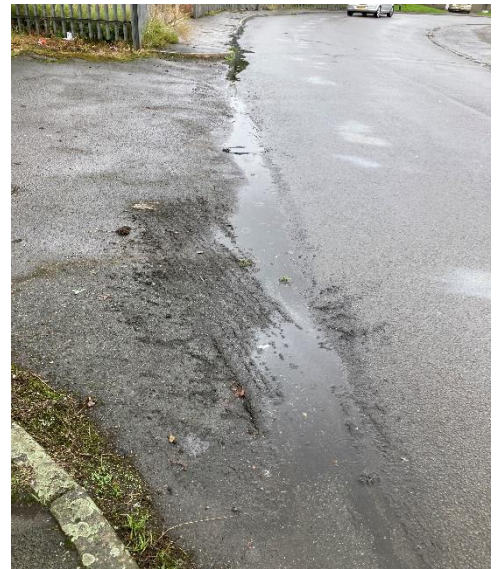
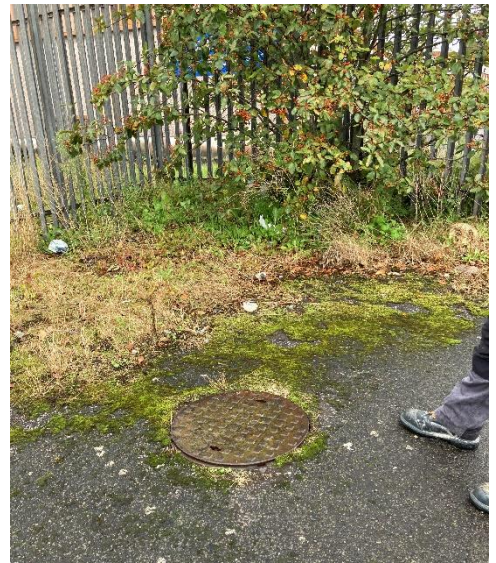
17:

The forth entrance on to the neighbouring land, is currently disused and fenced across at the land boundary. This forms the piece of pavement and roadway closest to Stationary House, and as can be seen by the silt deposits and vegetation must be subject to some localised flooding due to the poor locations of adjacent storm drains.

The kerbs to the south side of the entrance, appear to have been renewed recently, and the tarmac path is new.

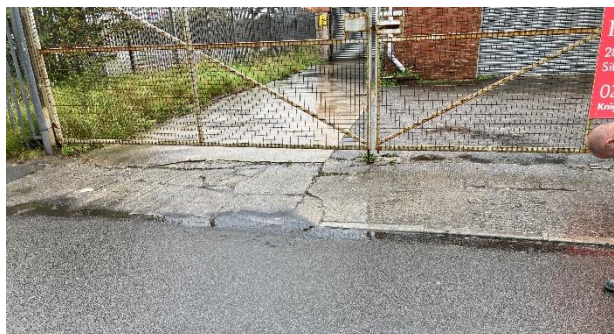
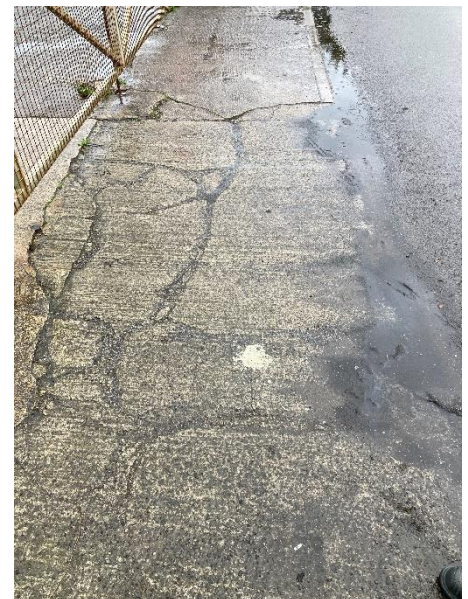
18:

The existing cross over for Stationary House is of concrete construction and is crazed with cracks for it's entirety. This area has already been noted within our planning application to be renewed at our expense and will be completed in a Tarmac surface more in keeping with the current footpath outside the site.

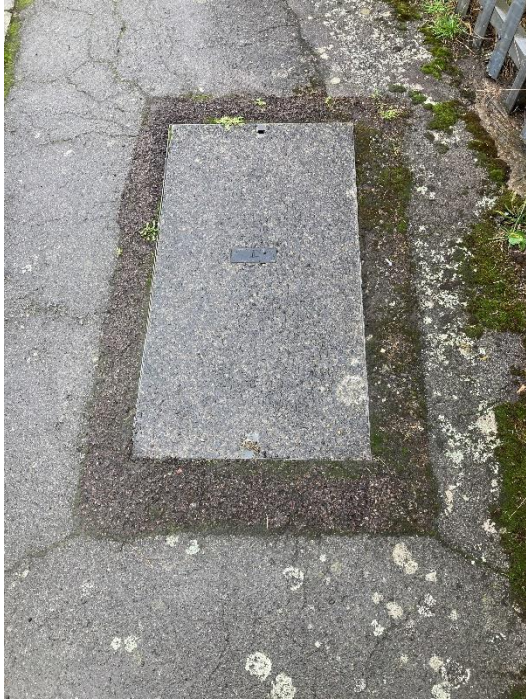
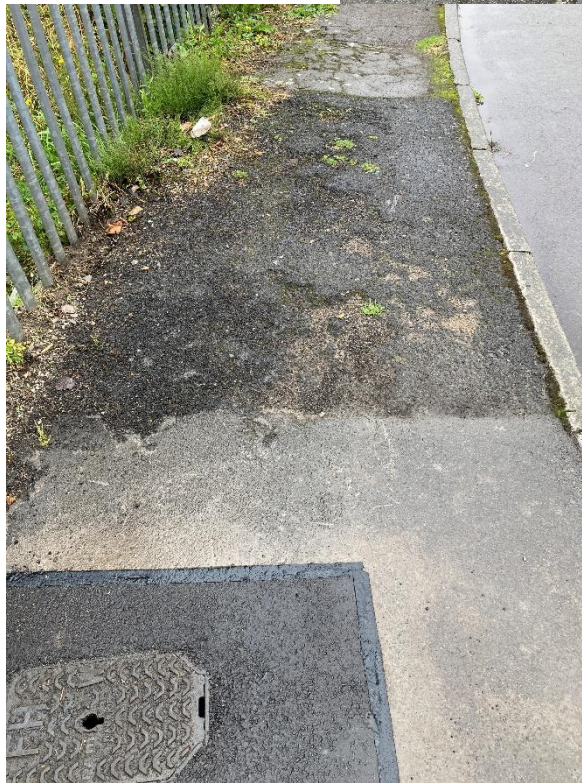
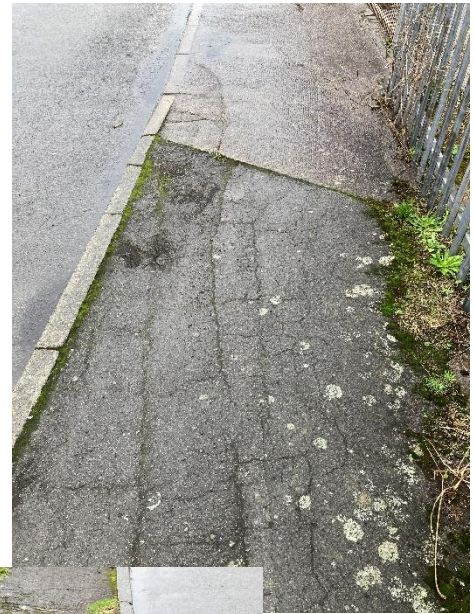
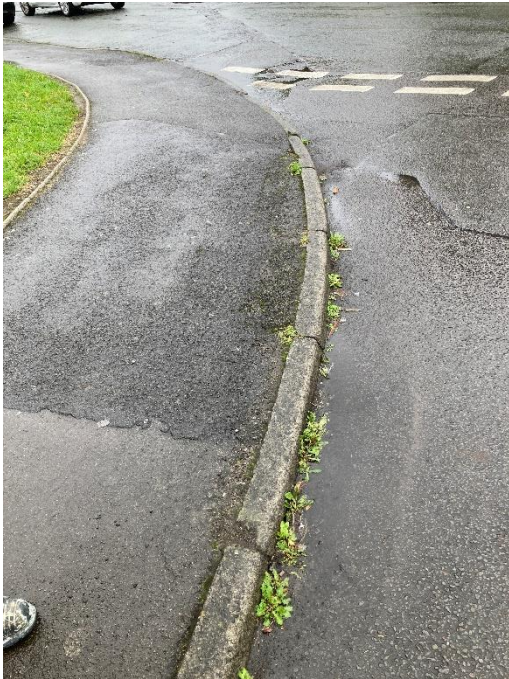
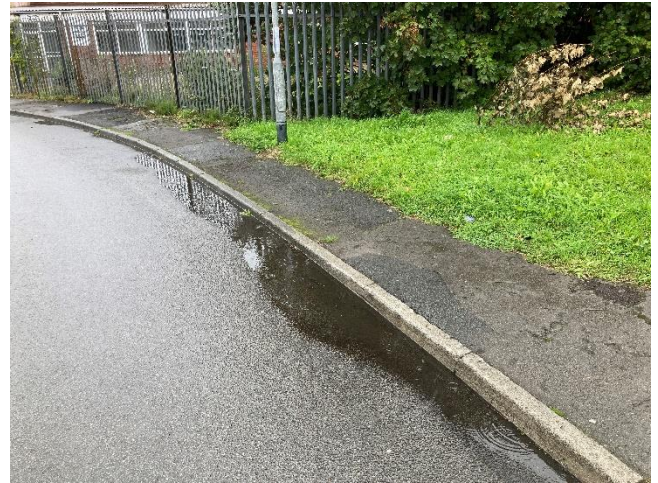
19)

The curtilage outside the pedestrian entrance of the site, is generally in poor condition. There are several service supply valves and access covers that are in various states of repair.

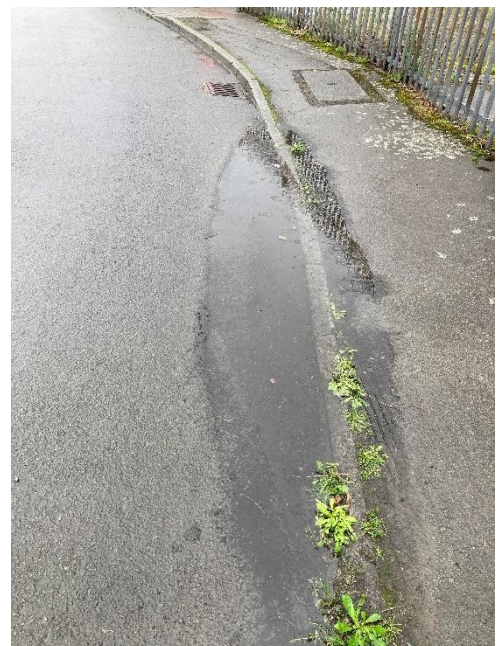
20:

As you progress away from the site heading back to the T Junction with 'Fairway' the footpath is crossed by several crossovers, but generally this area is in good condition.

However as with much of this area of the carriageway, it is clear that the settlement of the road surfaces has left the storm drains above the levels of many of the drop kerbs and localised standing water is evident.
