# Parc Pelenna Holiday Resort

## Phase 1 Ground Conditions Desk Study

*For Trivselhus UK*

*Doc ref:* 16044-HYD-XX-XX-RP-GE-1000

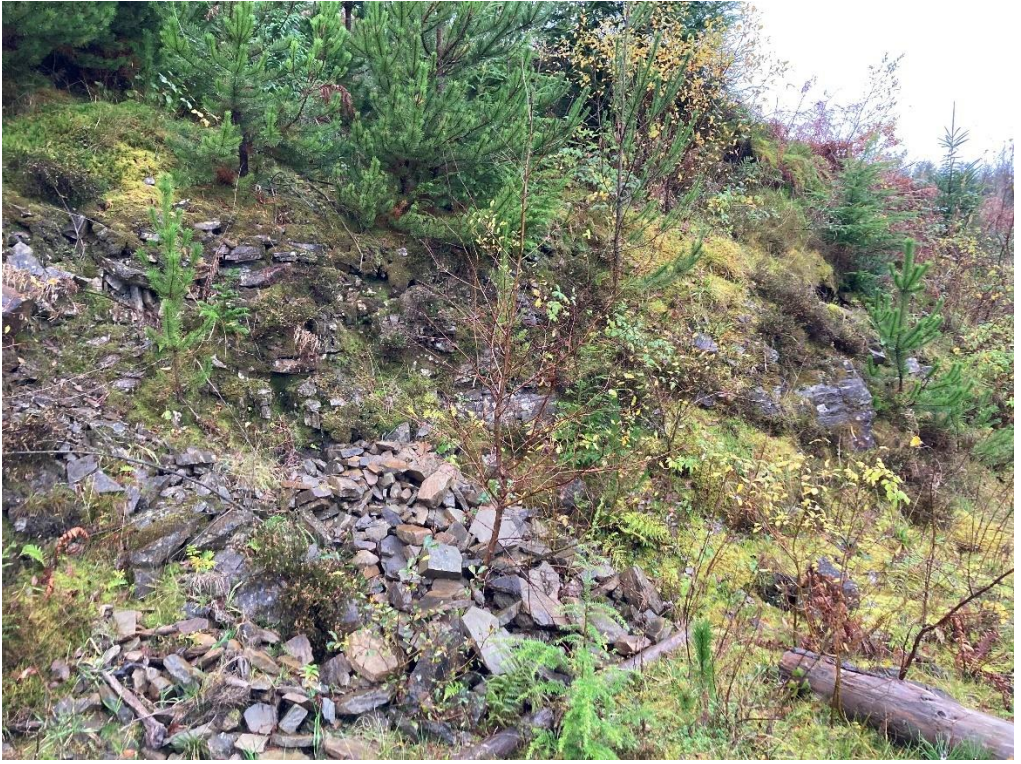
| <b>Desk Study<br/>Photograph 1</b> | |

| <b>Description:</b><br>Exposure of<br>superficial<br>weathered bedrock<br>~60-degree slope.<br>Likely cut during<br>track construction. | |

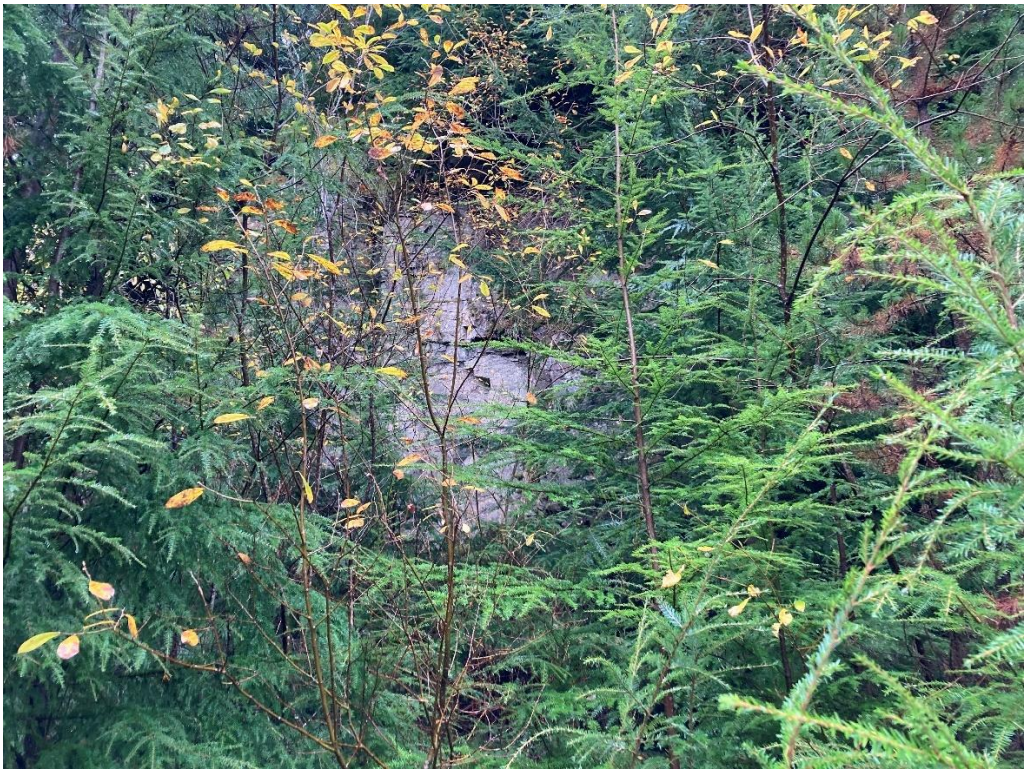
| <b>Desk Study<br/>Photograph 8</b> | |

| <b>Description:</b> walls of the disused quarry. 10m to 15m high, competent, thickly bedded sandstone. Vertical to sub-vertical wide joints. | |

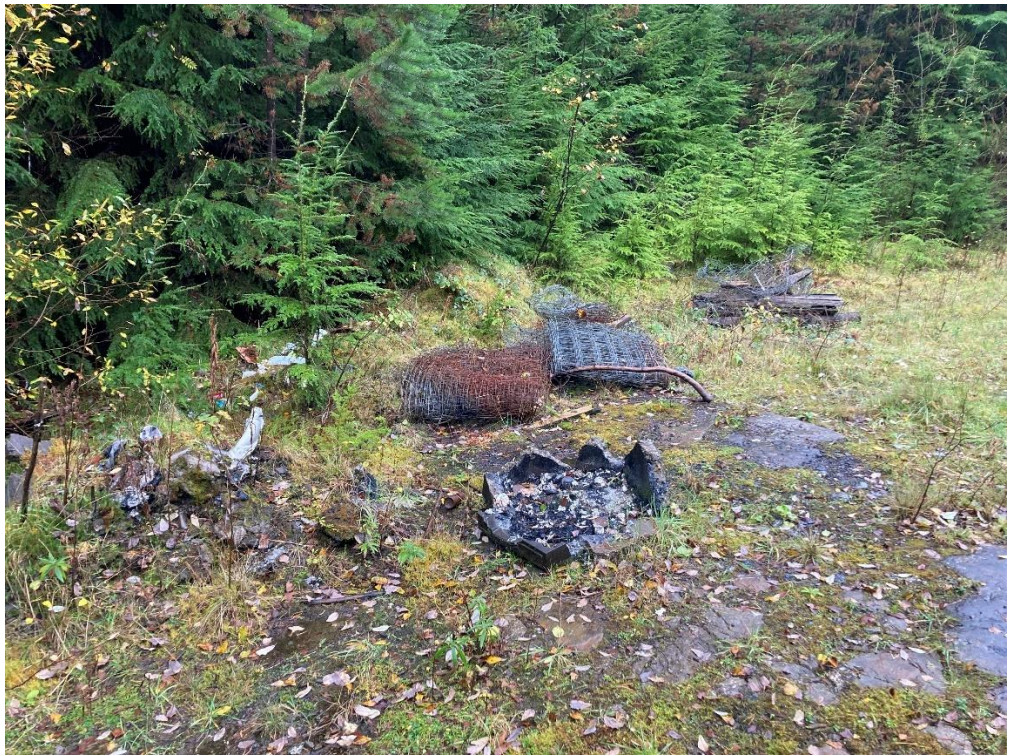
| <b>Desk Study<br/>Photograph 10</b> | |

| <b>Description:</b> pile of waste including burned paint cans, metals and plastics. | |

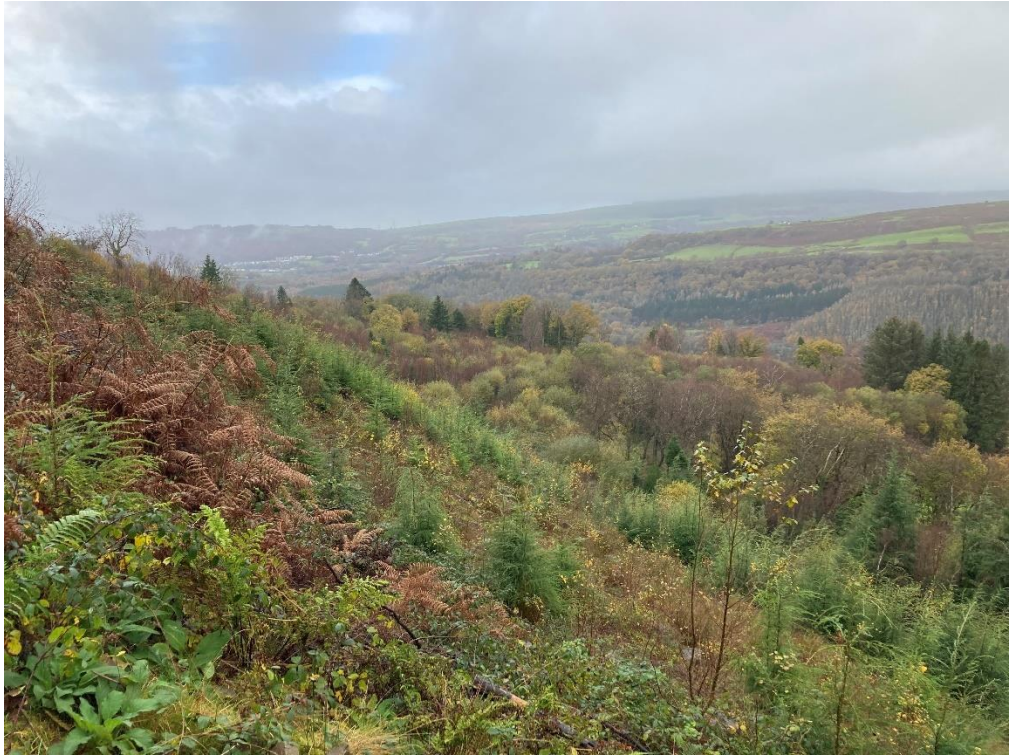
| <b>Desk Study<br/>Photograph 11</b> | |

| <b>Description:</b> Steep slope covered in tree stumps and conifer saplings. Slope was 45 to 70 degrees and steepens to the east. | |

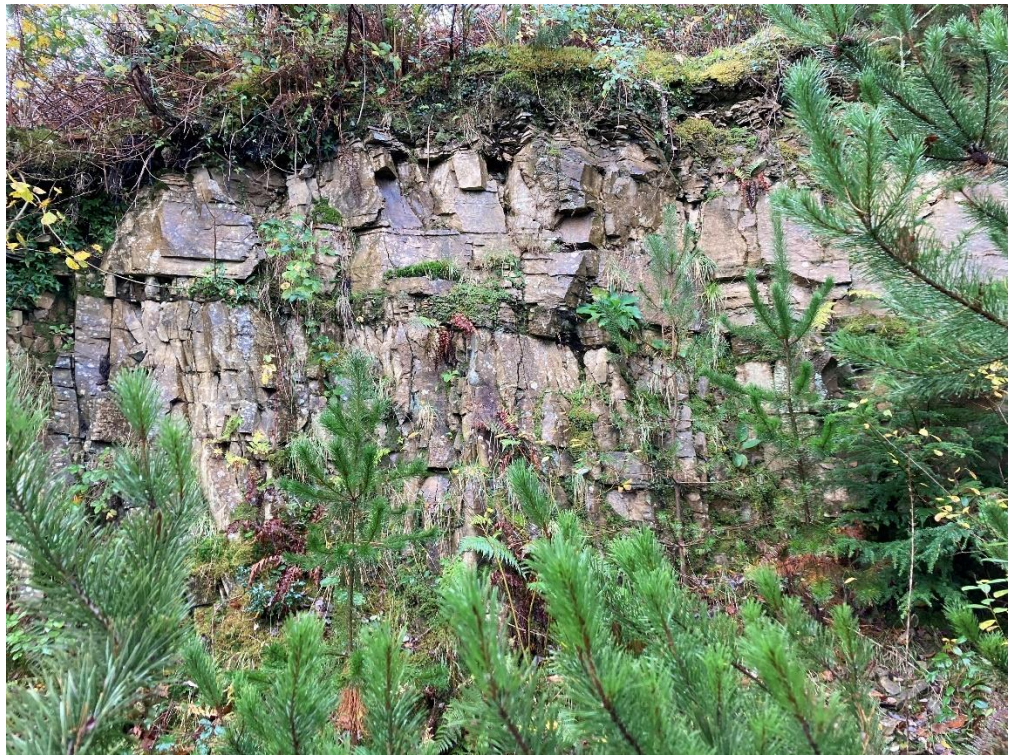
| <b>Desk Study<br/>Photograph 16</b> | |

| <b>Description:</b> bedrock exposure of vertically jointed with possible folding/faulting sandstone. Some conjugate jointing. Appeared unstable. | |

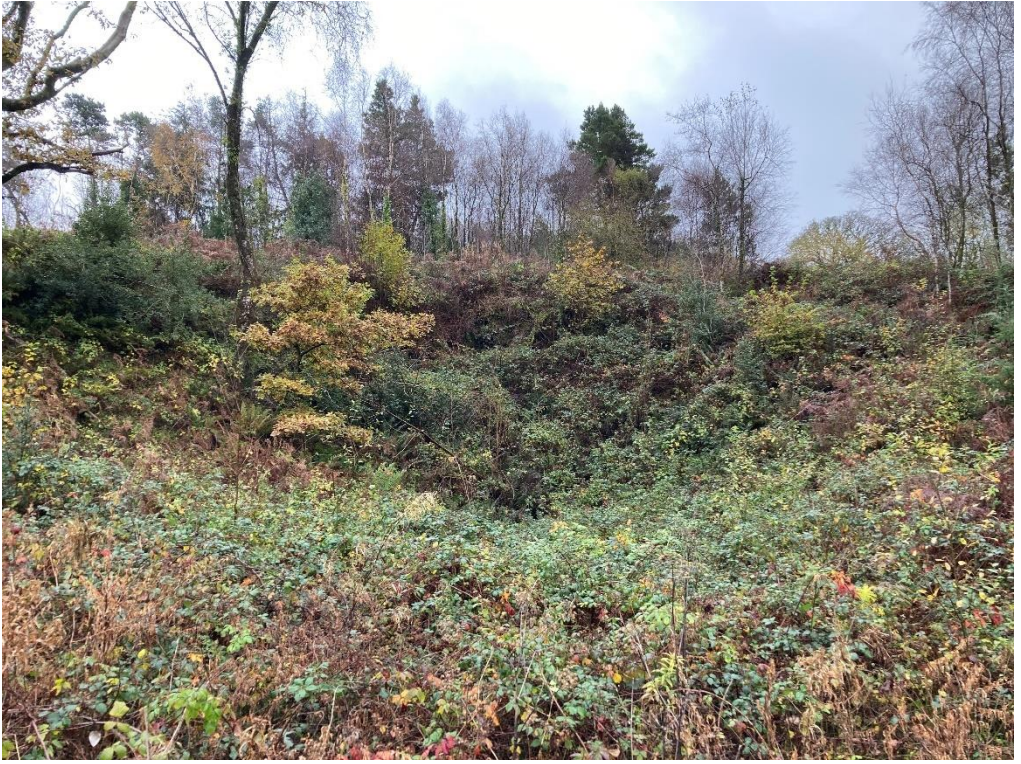
| <b>Desk Study<br/>Photograph 17</b> | |

| <b>Description:</b> Steep curved slope in the north of the site in the area of the former Cefn-mawr Colliery. Roughly 15m to 20m high and densely vegetated. | |

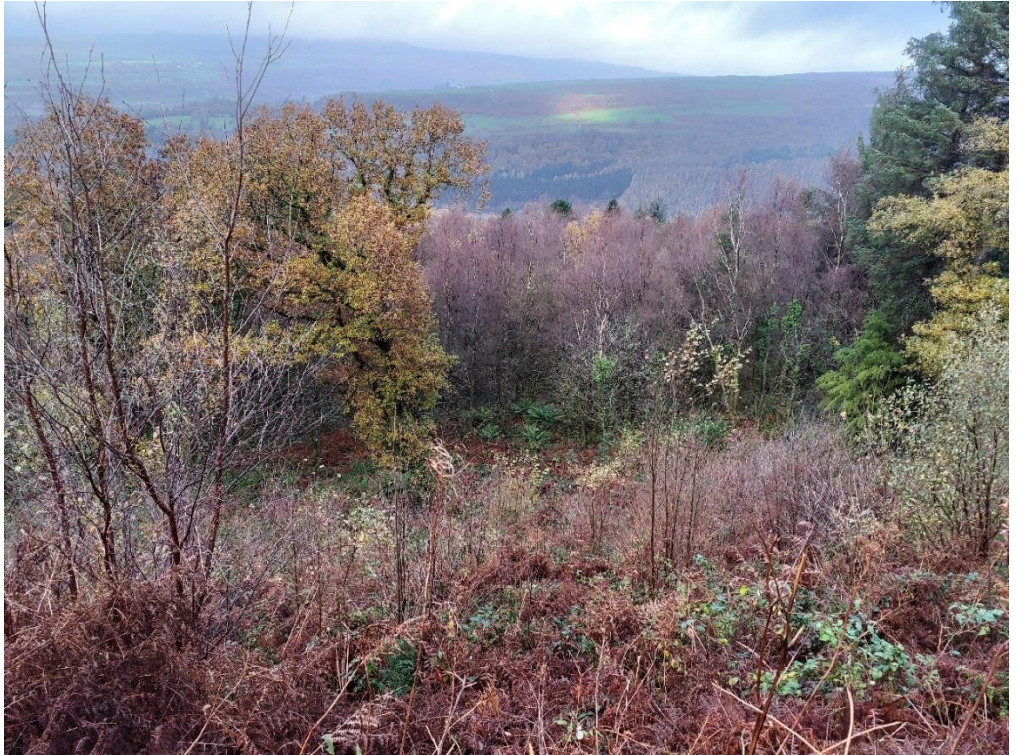
| <b>Desk Study<br/>Photograph 19</b> | |

| <b>Description:</b> Steep slope in the northwest roughly 20 to 40 degrees and densely vegetated. | |

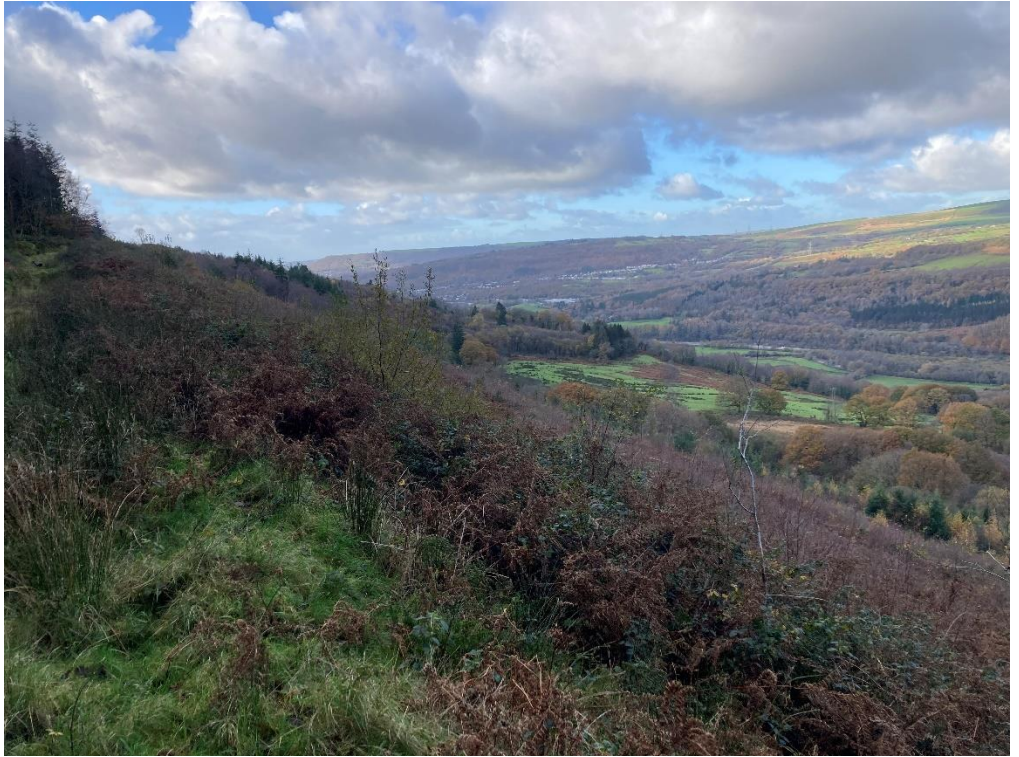
| <b>Desk Study<br/>Photograph 51</b> | |

| <b>Description:</b> Steep slope in the east of the site. 45 to 55 degrees, stable at the crest and becoming unstable at the toe. Covered in tree trunks and dense vegetation. | |

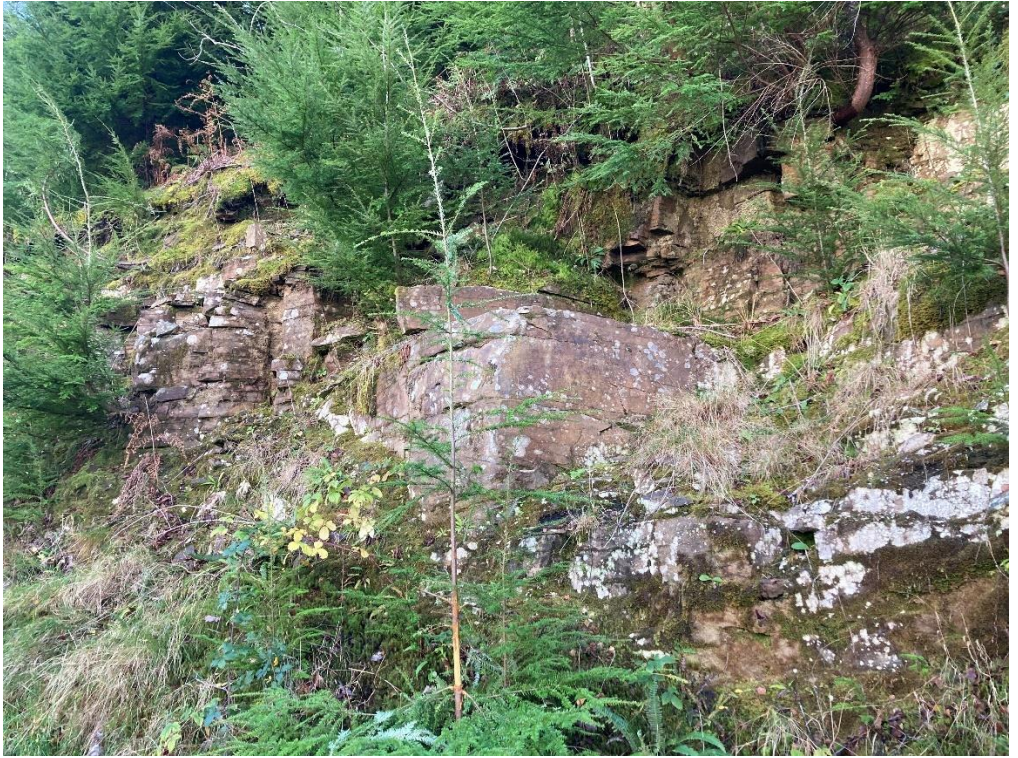
| <b>Desk Study<br/>Photograph 56</b> | |

| <b>Description:</b><br>Sandstone bedrock exposure. Thickly bedded with horizontal and vertical fractures and joints. Appeared unstable in places. Scree at the base. | |

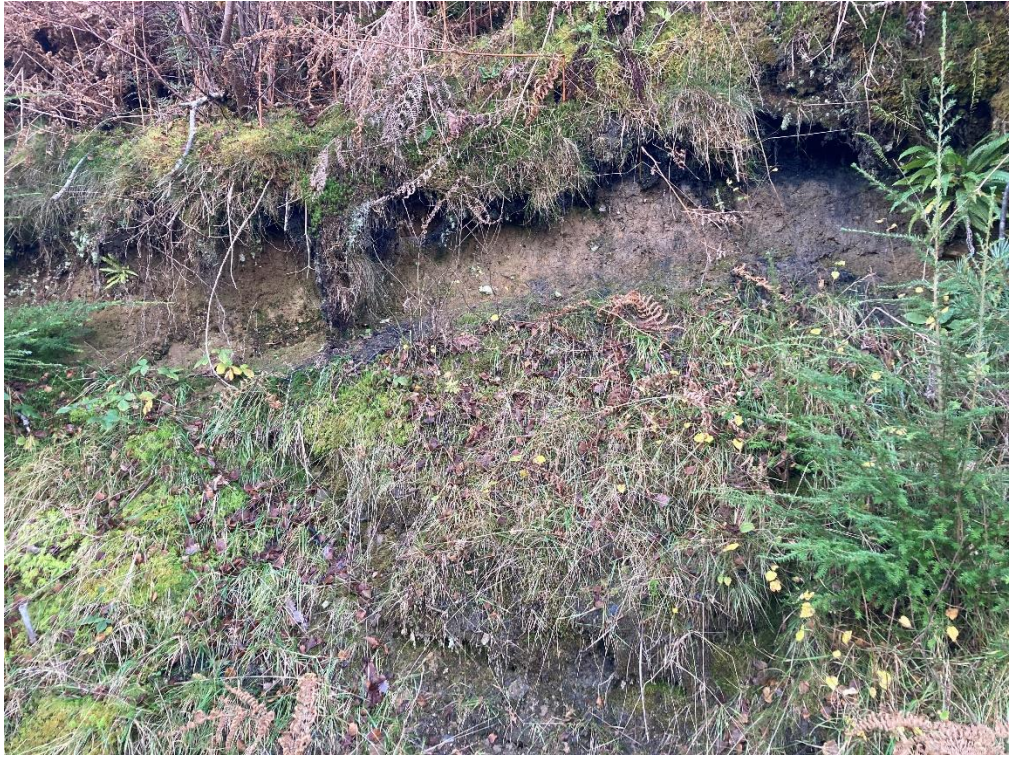
| <b>Desk Study<br/>Photograph 59</b> | |

| <b>Description:</b> Failure in the superficial weathered bedrock at the base of the slope. | |
