# **MONITORING REPORT SEPTEMBER 2024**

**For Neath Port Talbot CBC**

**Shoreline Management Wales (CEDM Ltd)**

**Post Construction Survey + 4 Years – Cliff Monitoring – SURVEY 6 (S6).**

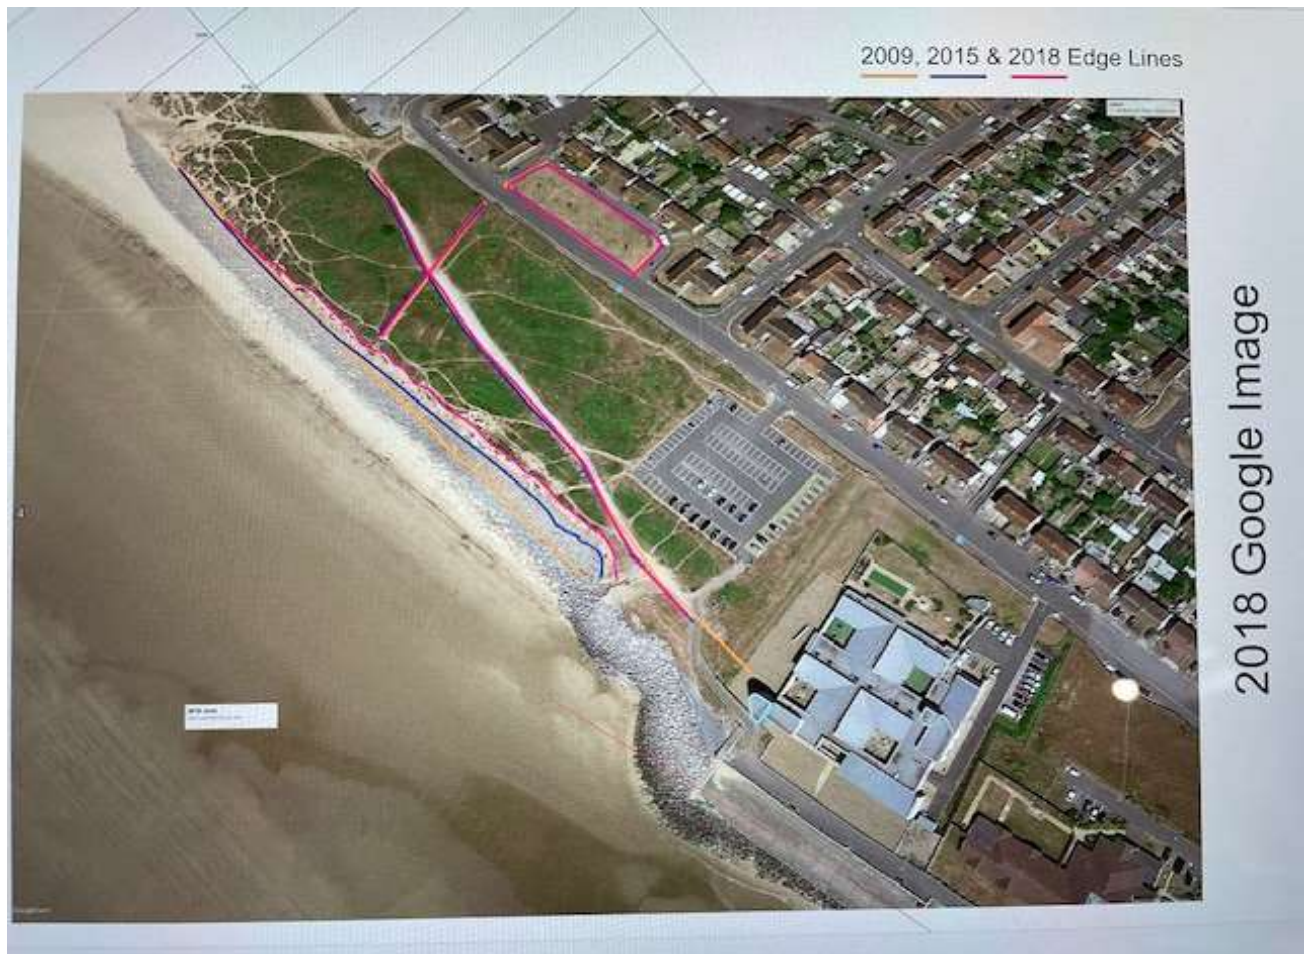
The Image of Google Earth Recession Analysis is presented on the next page:

*Erosion has been identified along the shoreline west of the defence which comprises industrial waste material. Erosion rates vary from 150mm / year at the western extremity to 1.3m/ year close to the promenade. The average rate of recession appears to be approximately 700mm / year. This ties in with the long-term trend for recession at the end of the existing promenade. Recession up to 2009 at the location was estimated to be over 20m. See Below Recession image from 2019 report:*

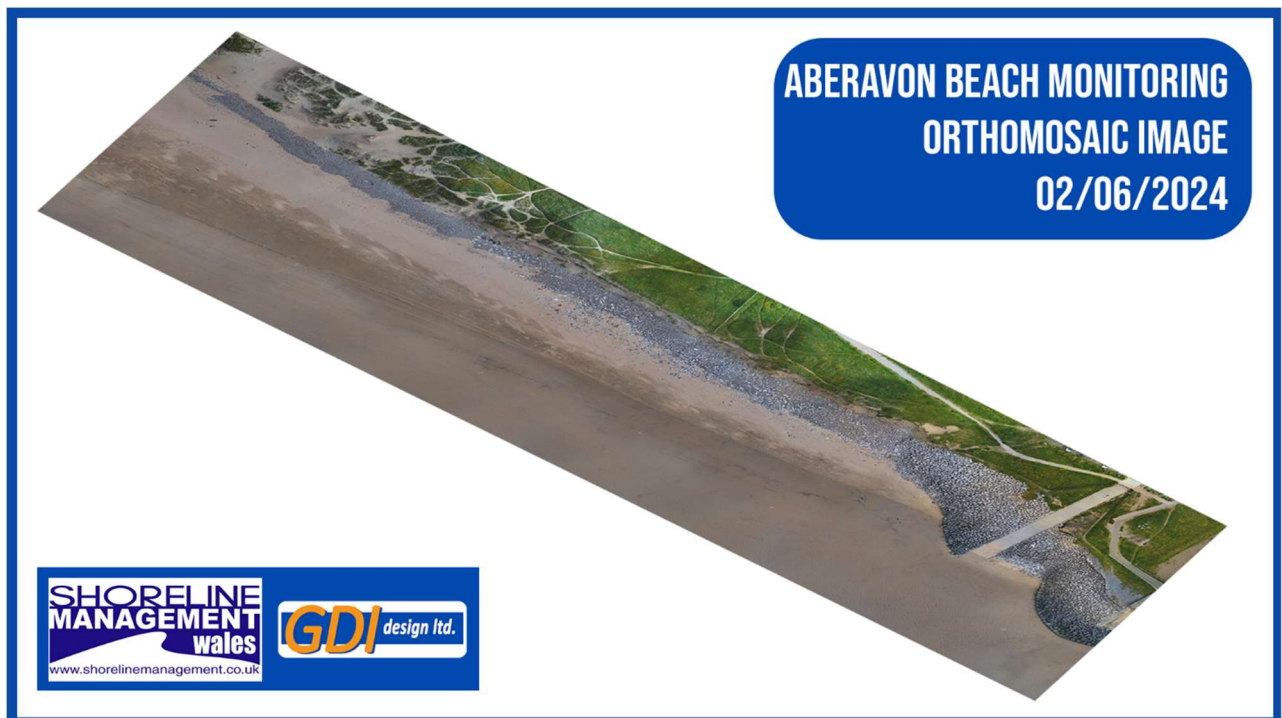
Plate 1 – Drone.

This image provides a good strategic view of the study area and how it relates to the recent coastal works and the Aberavon seafront. Note the effective promontory at the west end of the Aberavon seafront and the recessed position of the undefended shore in the study area.

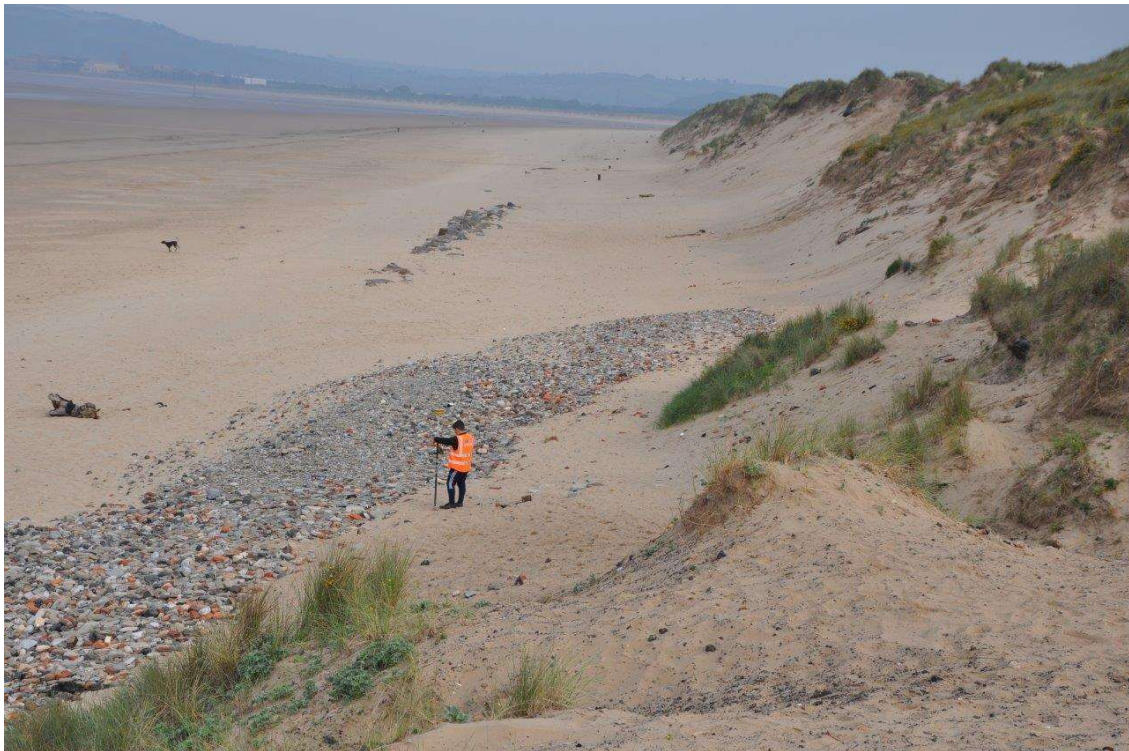
Plate 2 (4389) – Baglan Dune Recession – 2024.

This view shows the transition from the study shoreline to the Baglan dune system. Note the tapering out of the storm beach and the rock armour line seaward of the current dune toe. The rock armour line denotes the historic position of the dune toe. The extent of dune recession is evident. Text also applies to Plate 3 below.

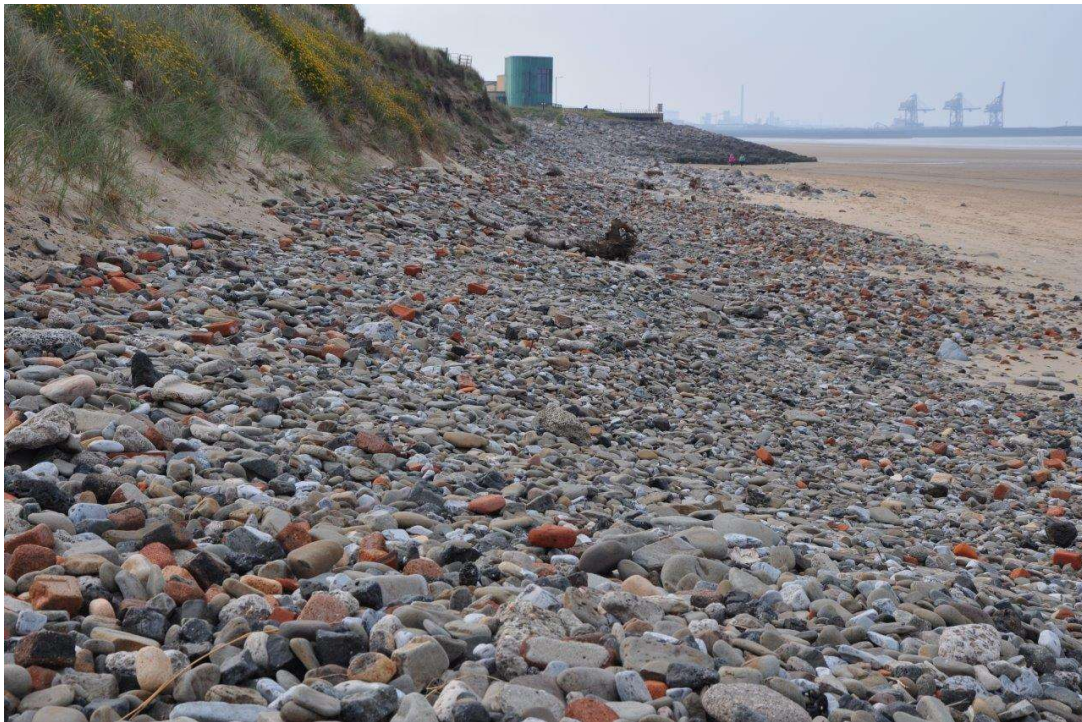
Plate 4 (4390) – Storm Beach.

Note the vegetation on the near vertical face indicating no recent erosion.

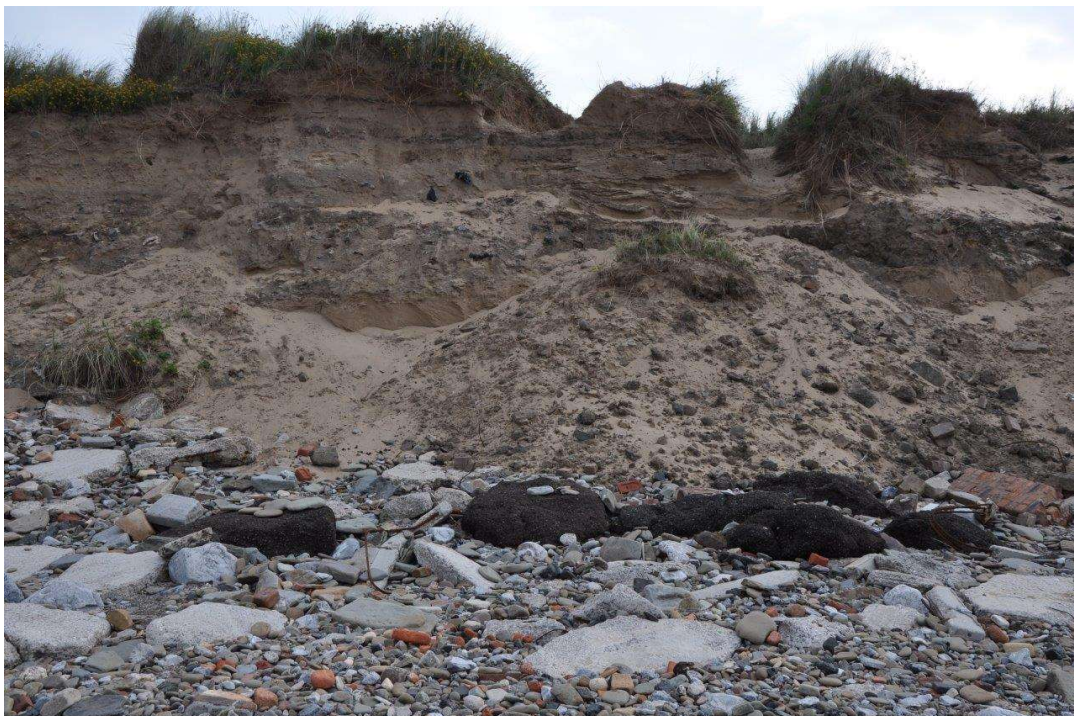
Plate 5 (4395) – ‘Dune’ face, Tarmac and Concrete.

This section of shoreline comprises sand that has slumped onto the storm beach and also shows the tarmac, concrete and masonry produced from the erosion.

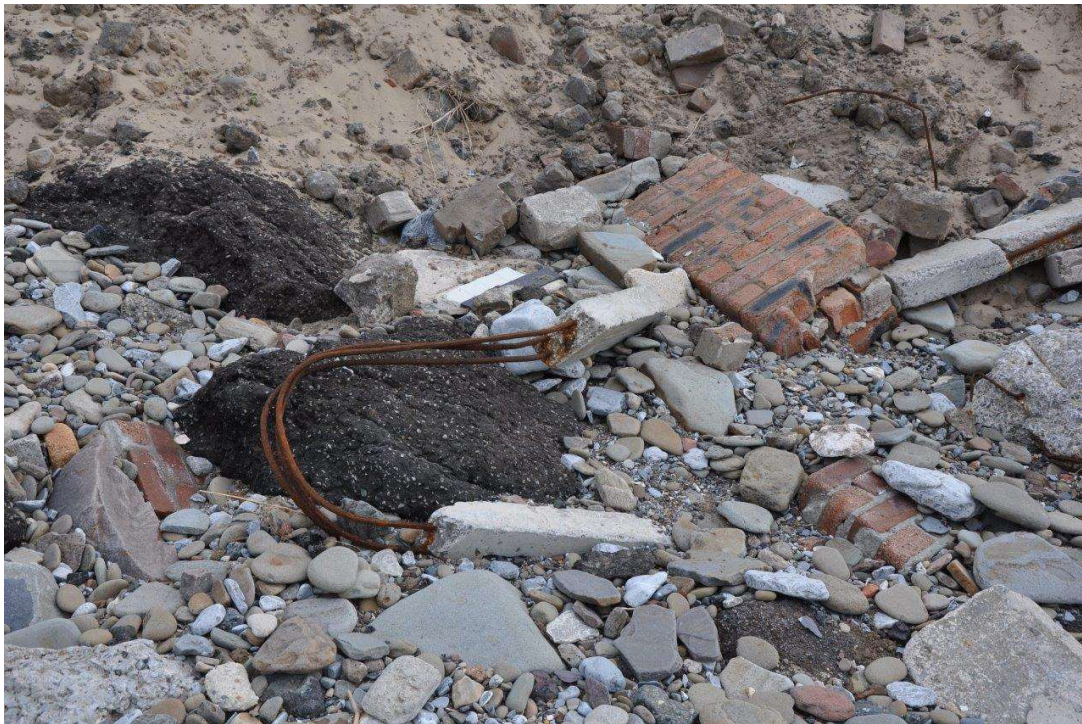
Plate 6 (4396) – Tarmac, Concrete, Steel and Masonry from Eroding Cliff.

5 – To undertake a walk over inspection of the storm beach prior to the start of the summer season to identify and deal with protruding steel or sharp objects that might be undesirable in a publicly accessible area.

Removal of sharp steel is recommended.

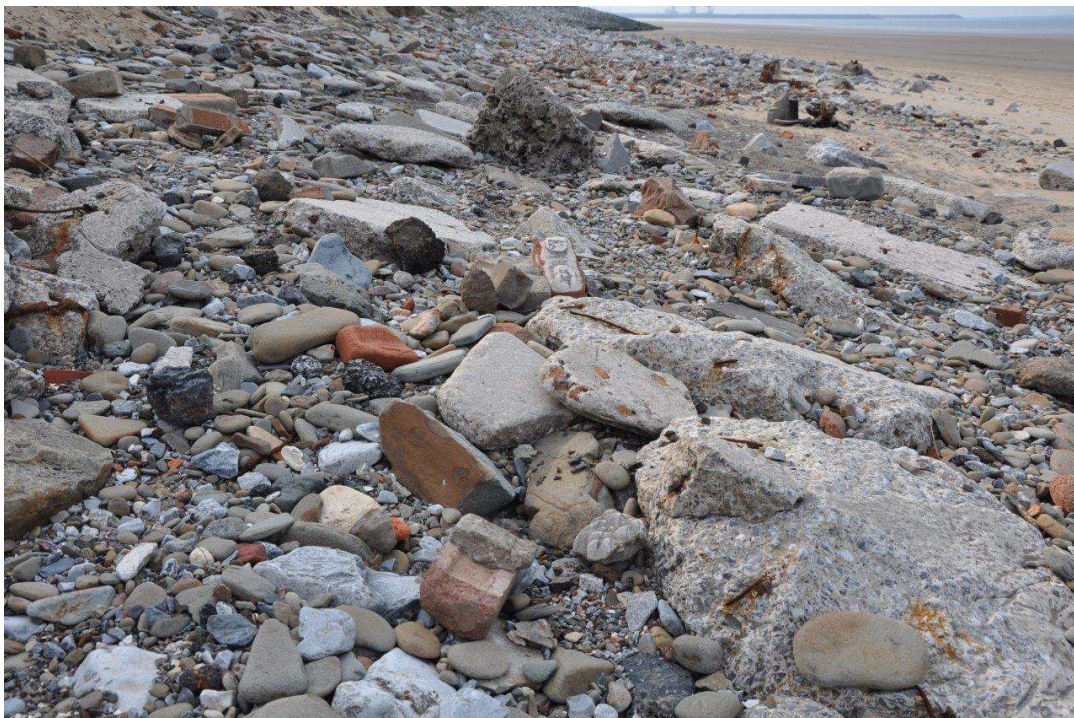
Plate 7 (4398) – Debris / Waste from Eroding Cliff.

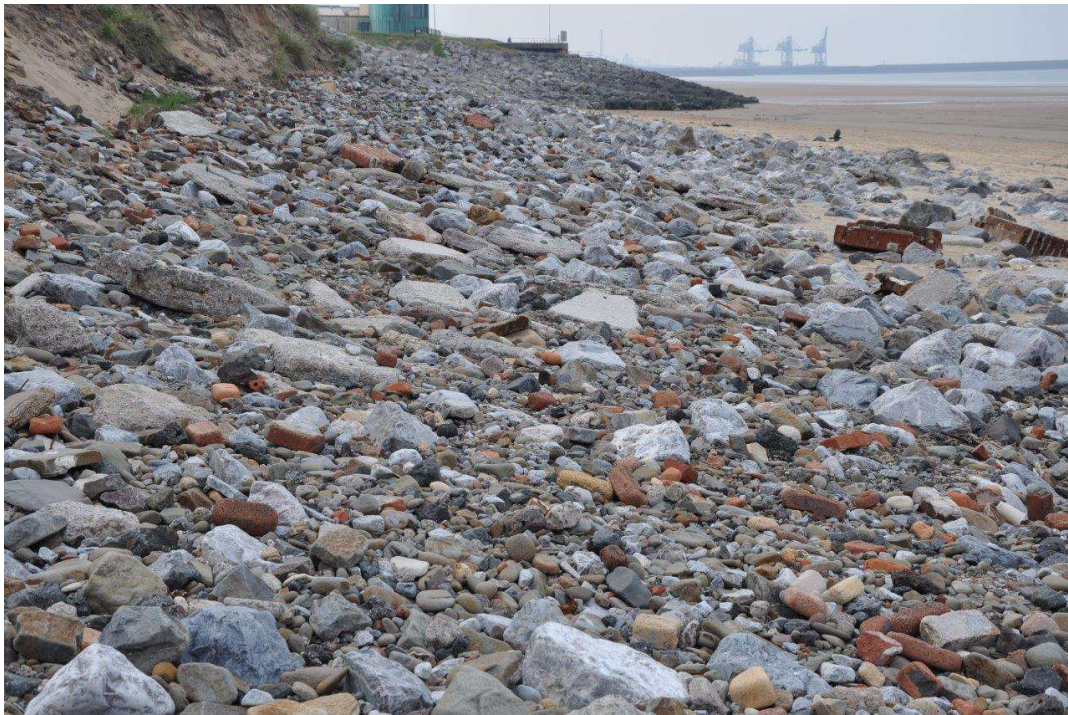
Plate 8 (4403) – Storm Beach – Cobble and Demolition Material.

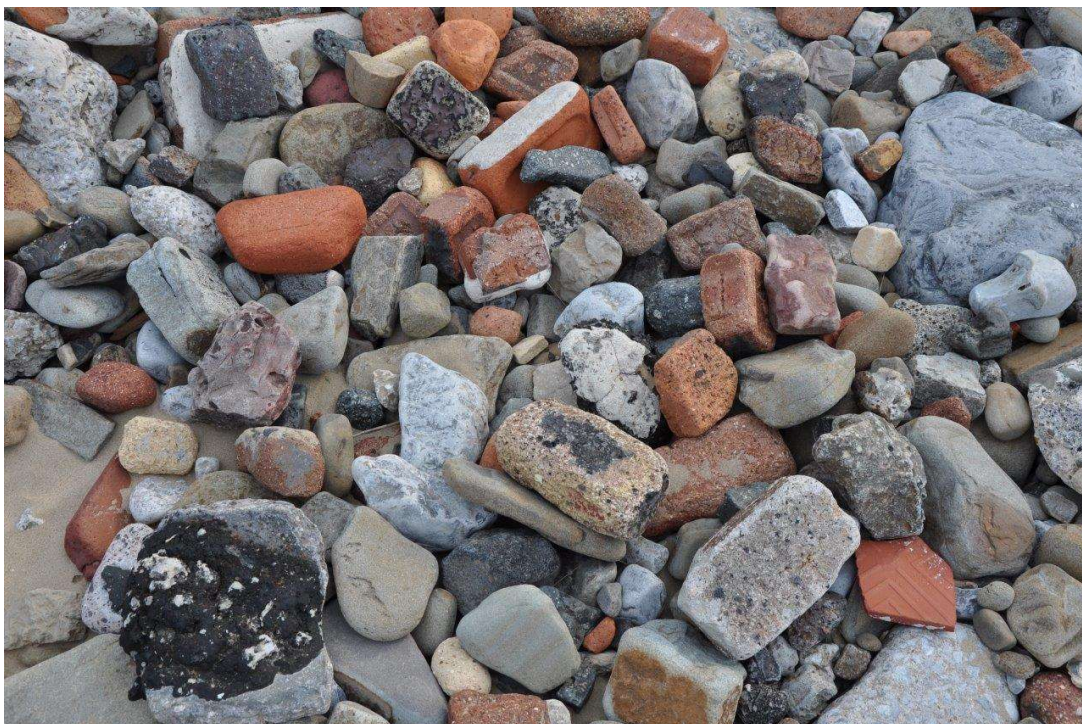
Plate 9 (4404) – Storm Beach Supplied by Eroding Cliff.

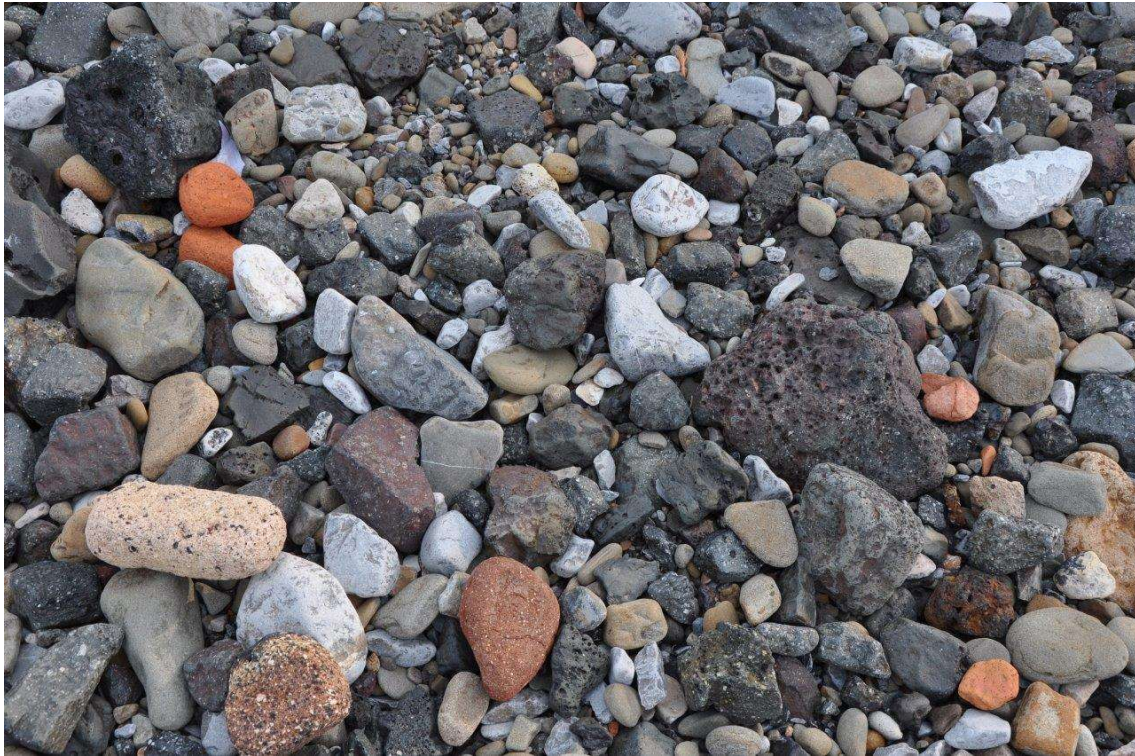
Plate 10 – (4415) Storm Beach Composition – Slag, Brick and natural stone.

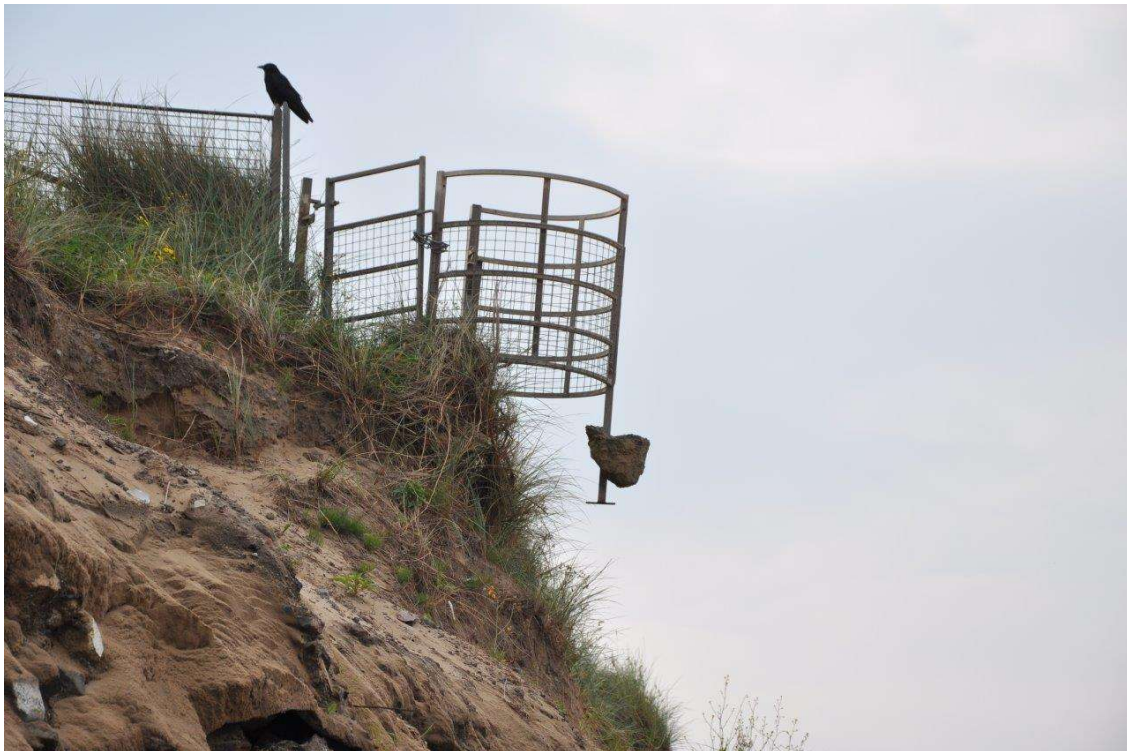
Plate 11 (4407) – Hanging Gate and Crow Perch.

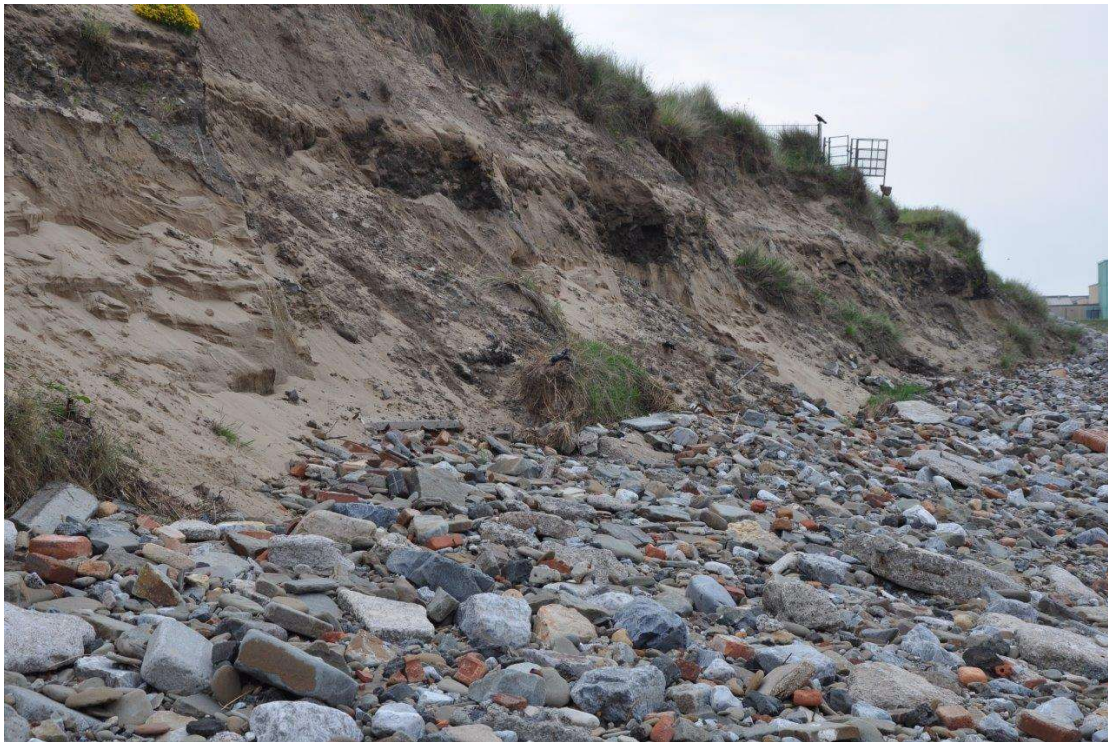
It is also worth noting, although it has been referred to in previous reports, that the face of the cliff includes a thick band of demolition material located some way up the cliff face and near the top in places. This band of demolition material will react differently to sand and this is evident in the images as the face of the 'cliff' which, in places, comprises different slope profiles. The band of demolition material can act as a berm or platform and may result in the erosion being slightly more erratic. It is worth noting that there is a risk that the former tip could contain contaminated material although potentially 'hot' material has not been observed. It should however be noted that if there were to be any contaminated material present, it is likely to be ad hoc and difficult to trace in a site investigation. The Authority can only reasonably be expected to react appropriately to material of concern as it is revealed in the eroding cliff or found on the foreshore. The potential risk could however be referred to, should it be necessary, to make a case for preventing further erosion of the shoreline.

Plate 12 - (4402) – Eroding Cliff – Note the band of debris part way up face and composition of storm beach.

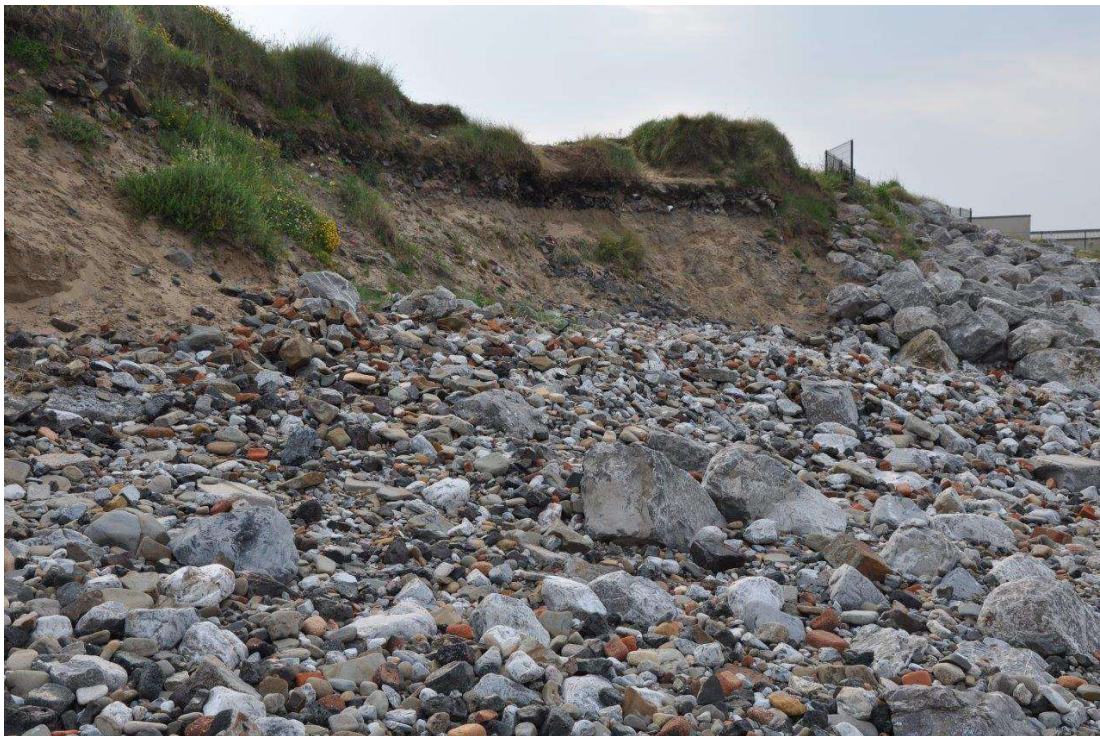
Plate 15 (4416) - Eroding Cliff Nr Transition – Note band of waste in eroding face.

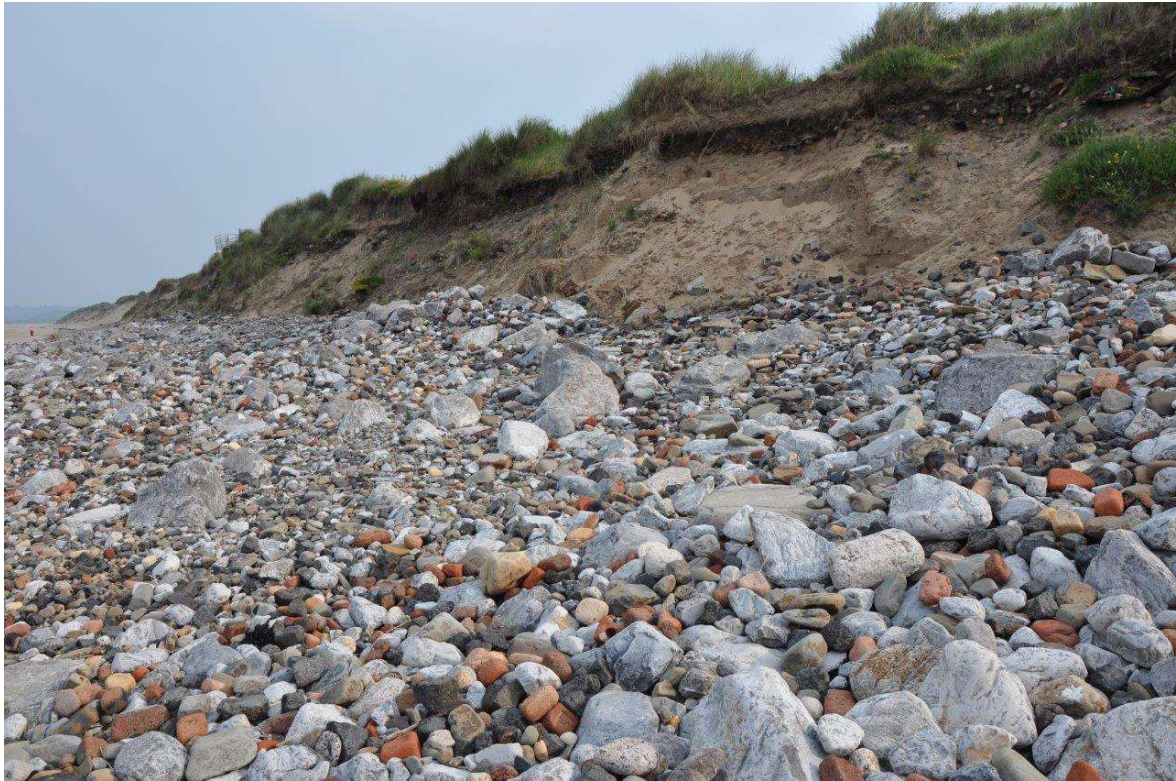
Plate 16 (4420) – Eroding Cliff and Storm Beach. Band of waste in eroding cliff.

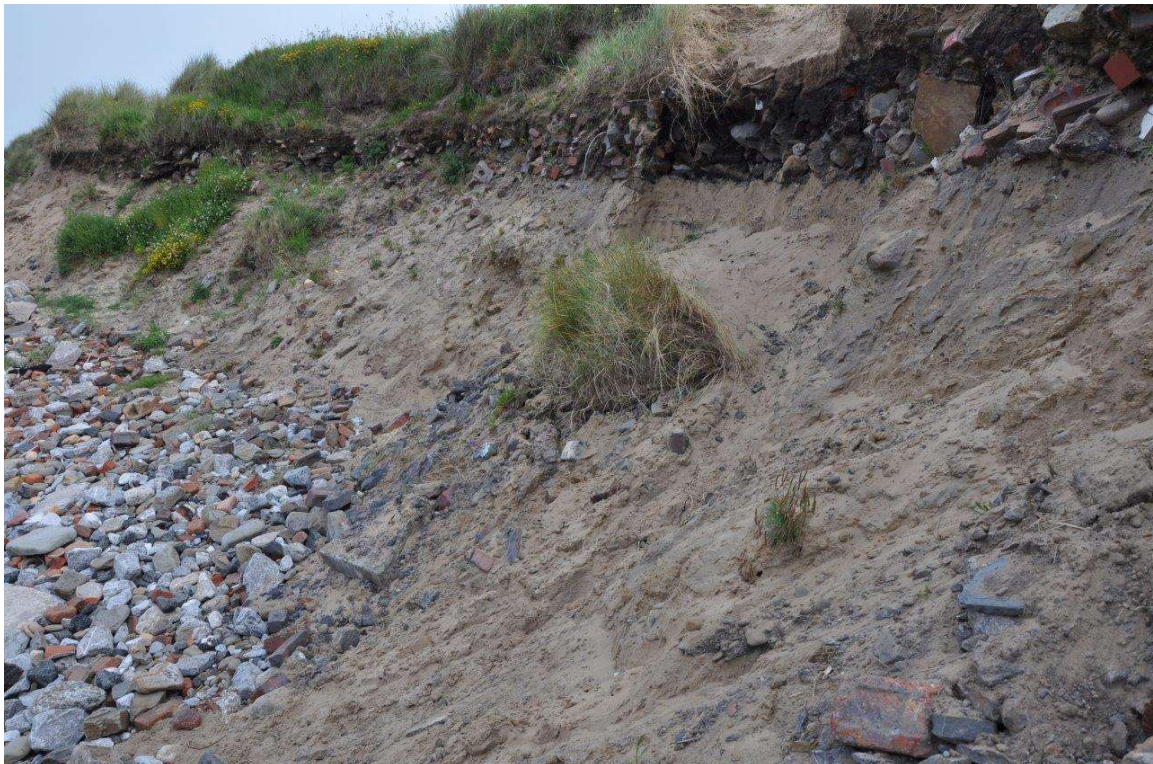
Plate 17 (4426) – Eroding Cliff / Recession Pocket and Band of Demolition Material.

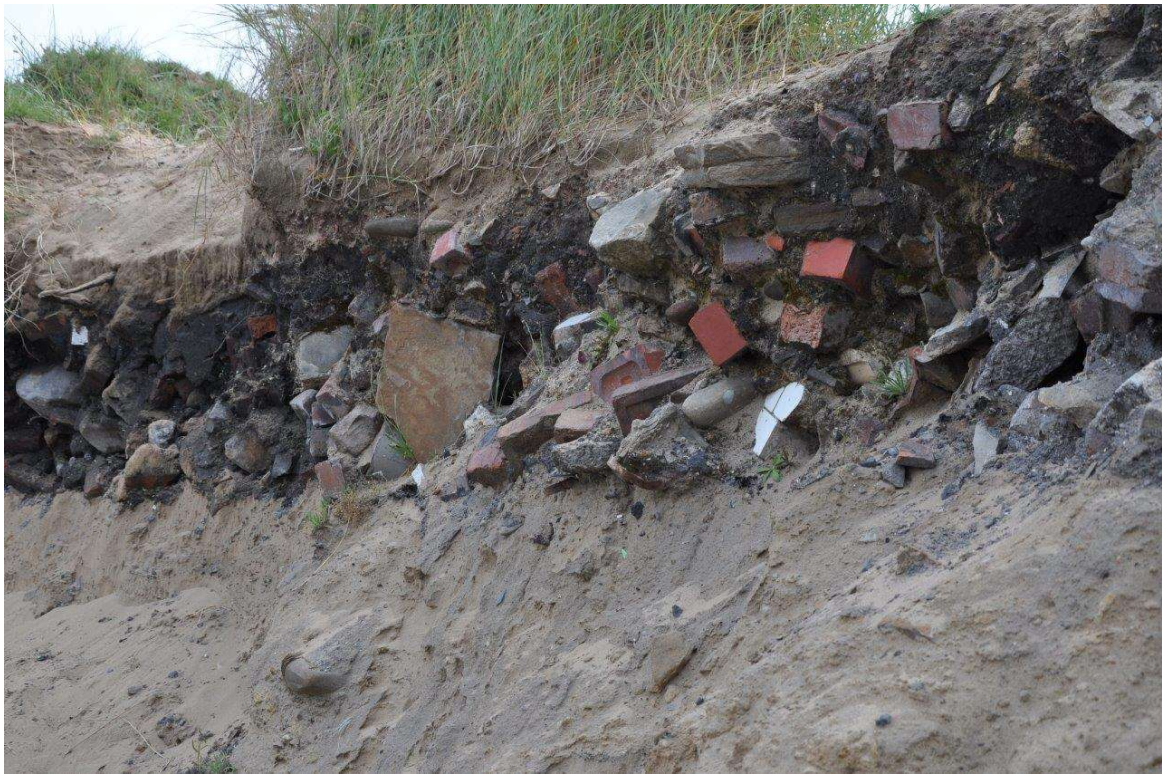
Plate 18 (4425) – Close up of Band of Demolition Material/ Industrial Waste.

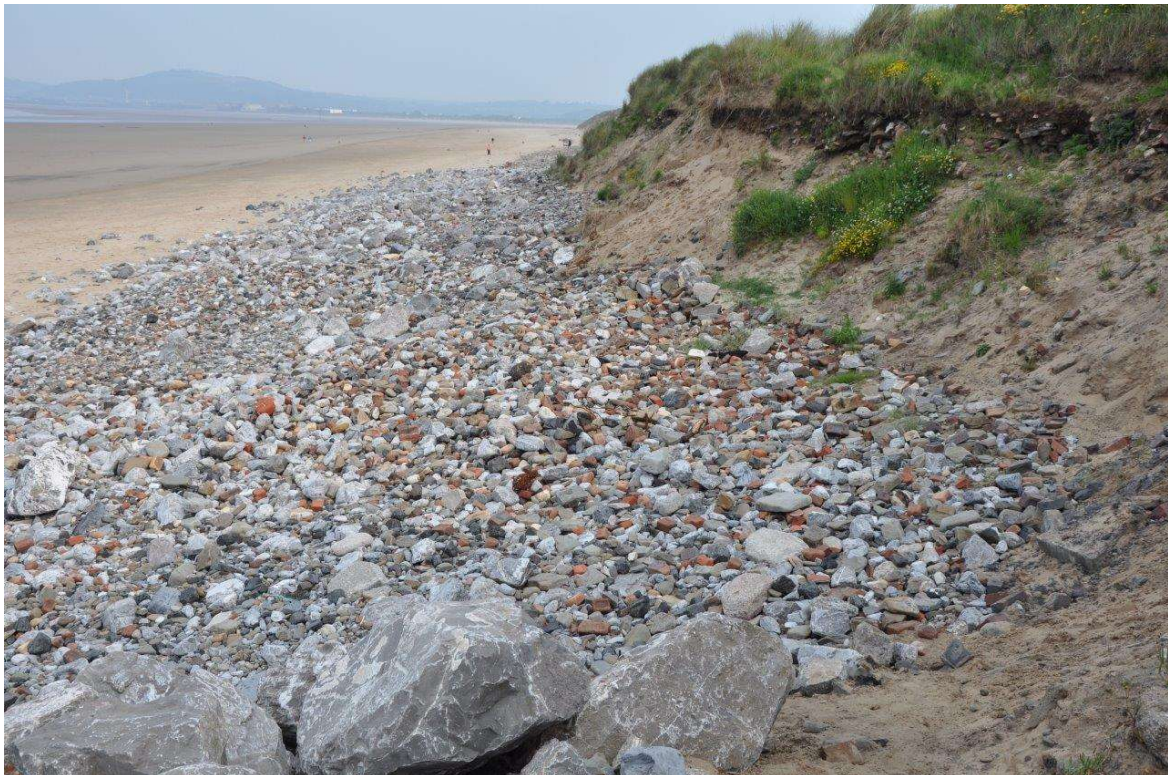
Plate 19 (4429) – Local Erosion Pocket with substantial storm beach providing increasing protection.
