# **BS5837:2012 Tree Survey & Arboricultural Constraints**

## **Report**

**Monastery Road**

**August 2024**

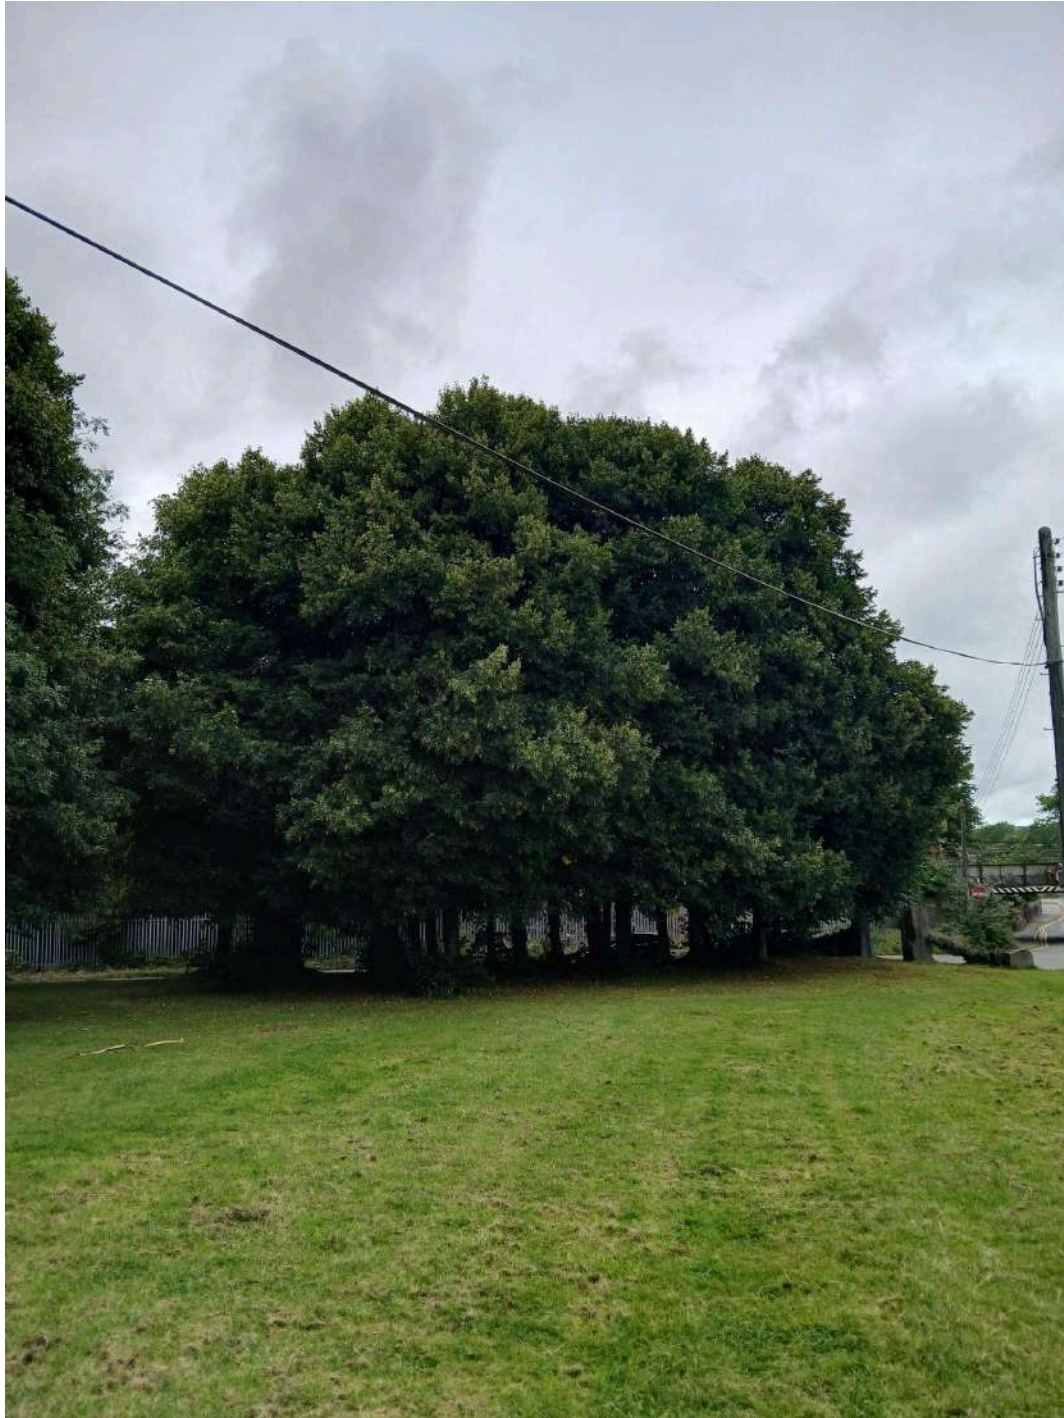
**IMAGE 1 Group of Lime trees on the northern end of the site.**

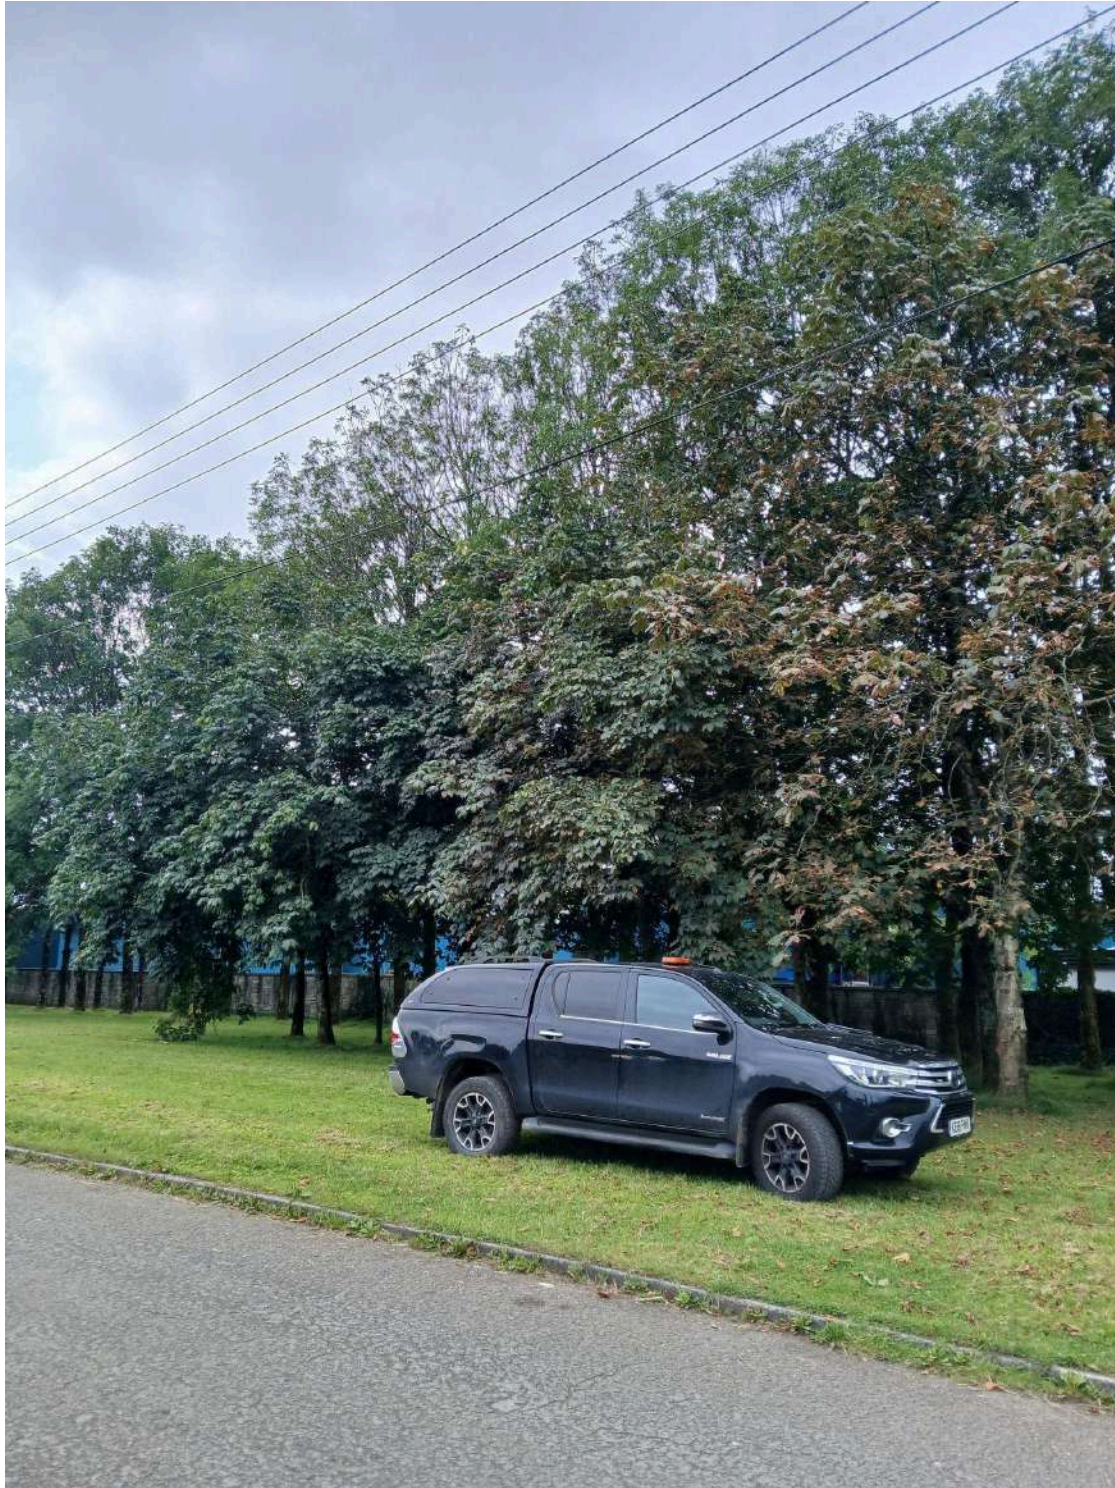
| 169 | Red Horse Chestnut | 7 | 22 | SM | 2.0 | 4.7 | 1.7 | 1.3 | 1.5 | U | Large bark wounds on main stem, remove tree |
| 170 | Red Horse Chestnut | 7 | 26 | SM | 1.7 | 2.7 | 2.0 | 0.7 | 2.5 | C2 | Canker on main stem, very poor form and suppressed by the adjacent trees |

5.3 Except for the trees in 5.2 above the remaining trees are in a good or acceptable condition. After the removal of the Ash trees the Horse Chestnuts 160 to 171 will be exposed to the prevailing wind and will be at an increased risk of wind throw. The removal of these trees would be advisable.

**Image 2 Horse chestnut tree numbers 160 to 171 (foreground) with diseased Ash (background).**

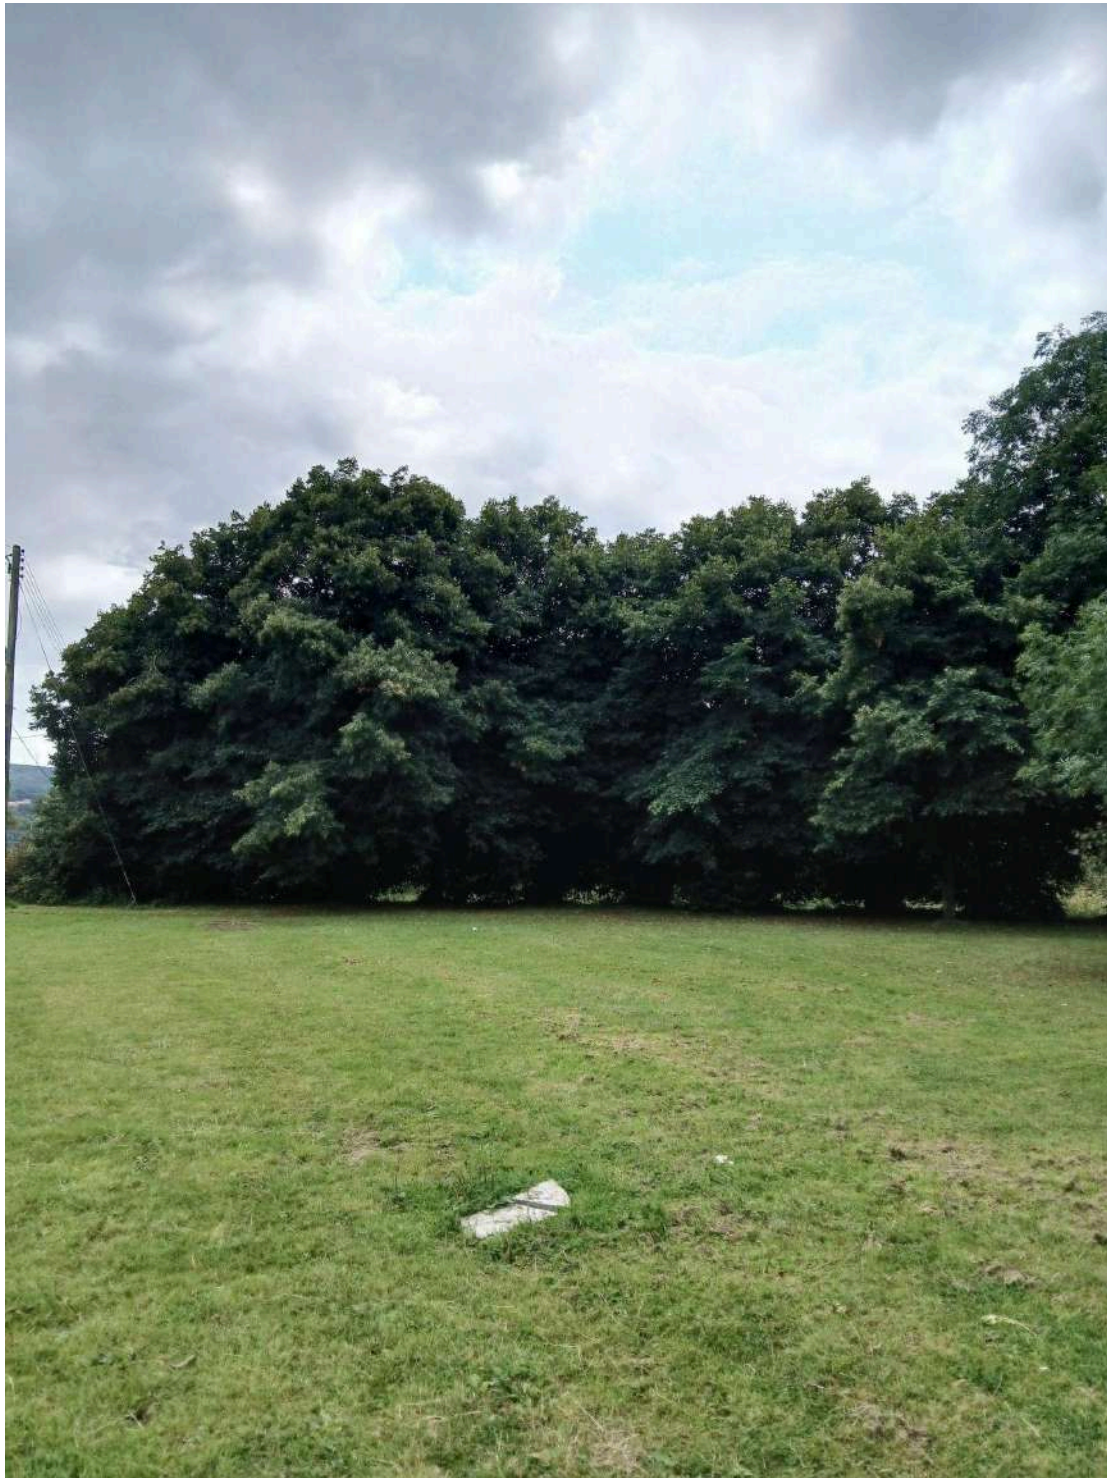
**Image 3 Group of lime trees on the southern end of the site.**

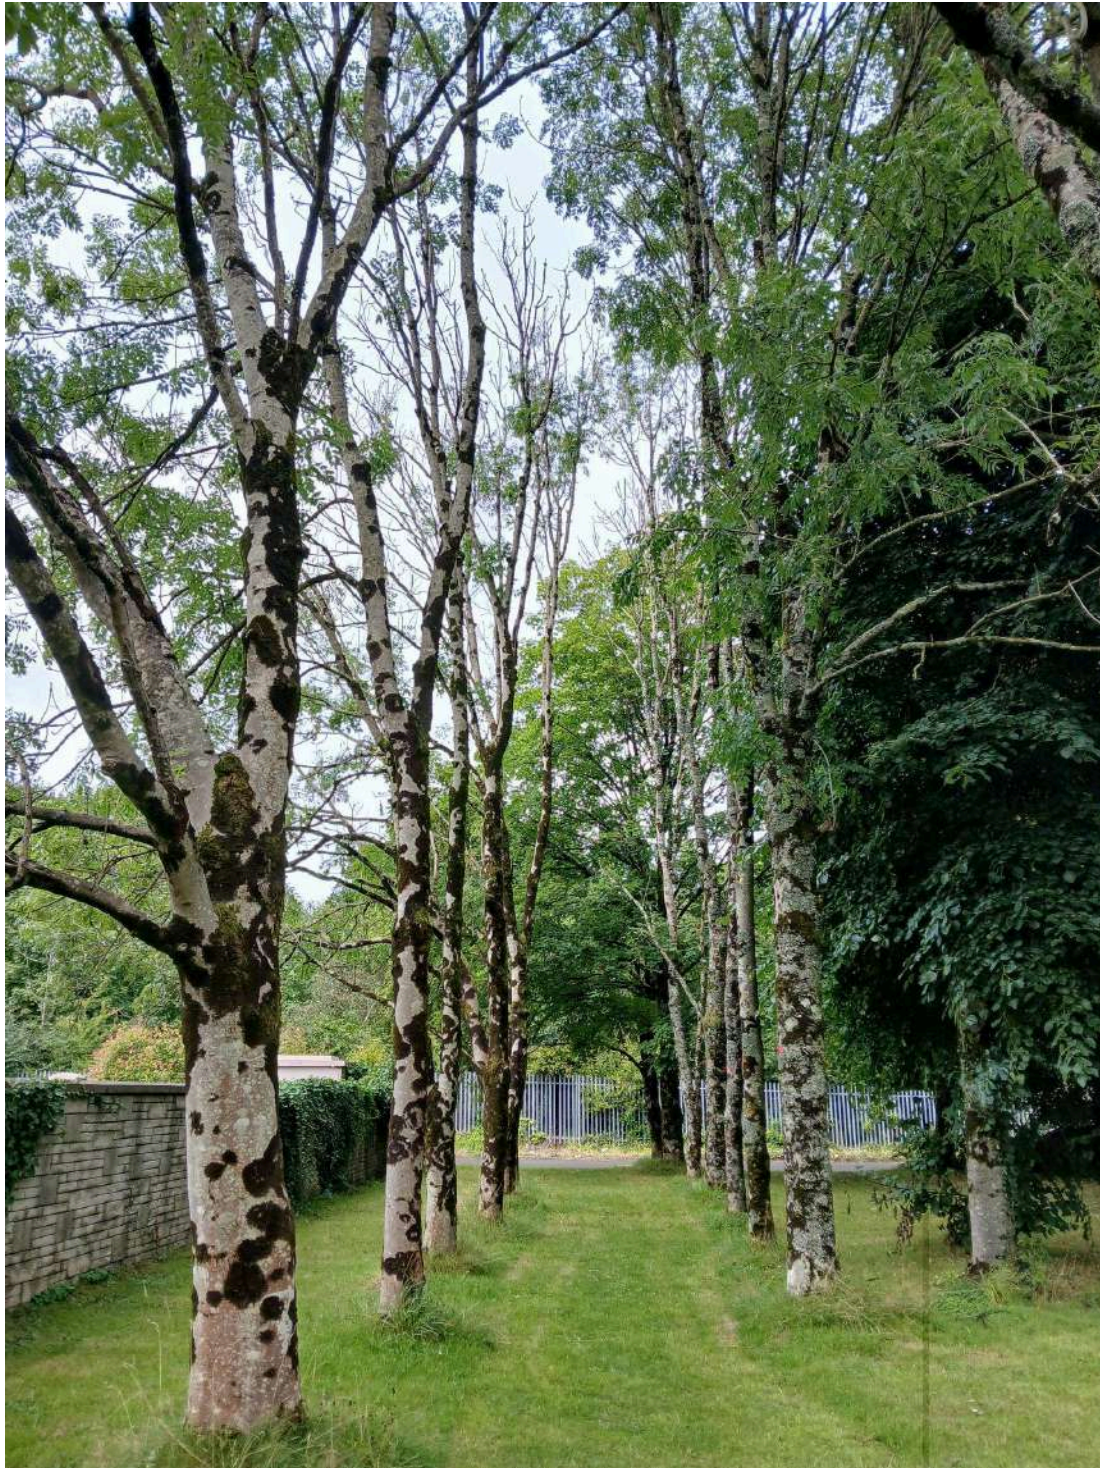
5.2 The Ash trees have a height range between 5 and 20 metres and have foliage density between 5 and 50%. Due to their condition and proximity to the existing and proposed structures it would be advisable if the 56 Ash trees and tree number 169 are removed.

**Image 4 Diseased Ash trees near western boundary**

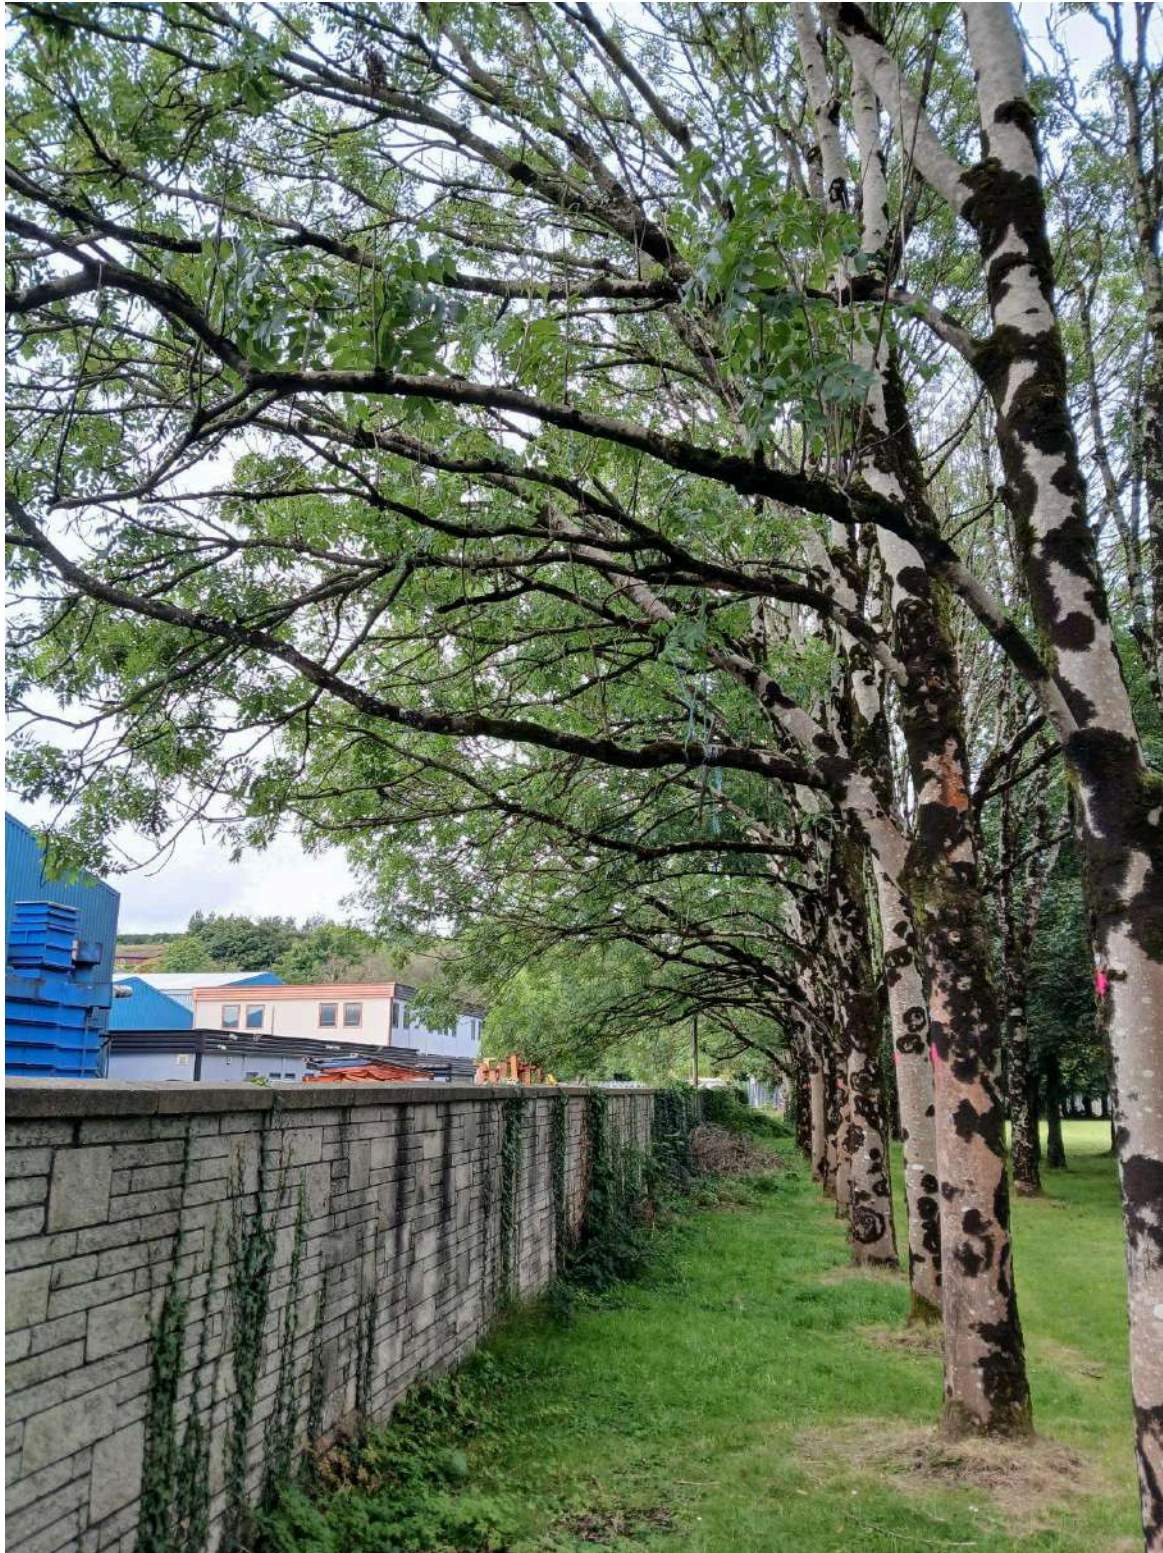
**Image 5 Boundary wall on western side of the site and overhanging Ash.**
