Report for Coed bach a'r cwm woodland off Longford rd, Neath Abbey  
prepared by Rhidian Waldron of Ein Cwmni Coed Ltd.

Rear of number 36 Ion glynfelin, Neath Abbey, SA10 7HU

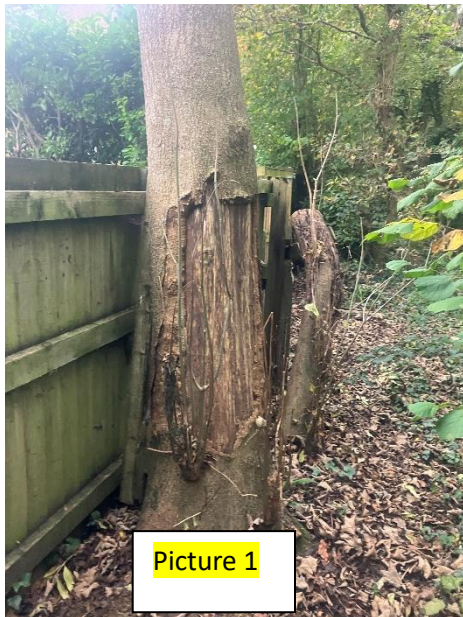
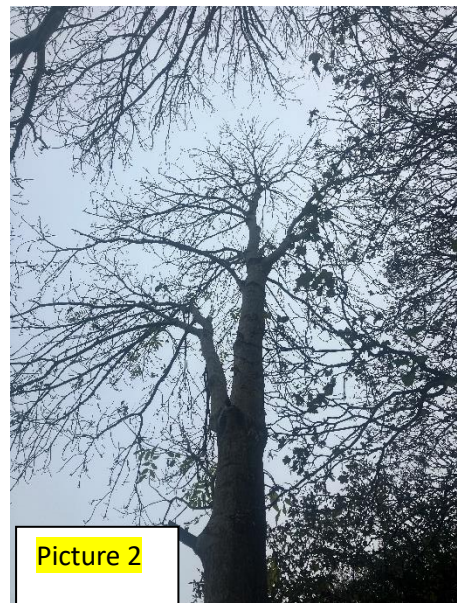
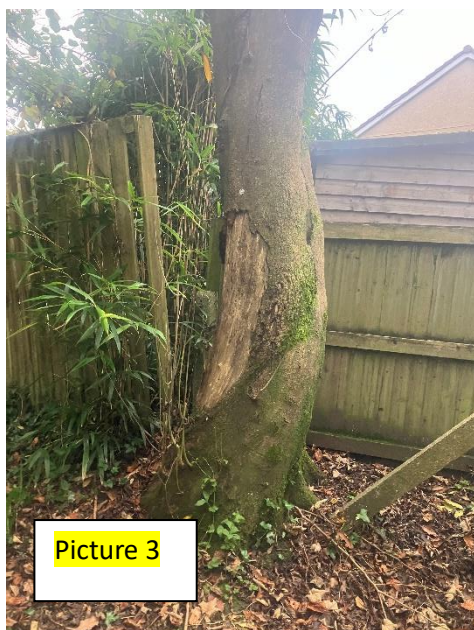
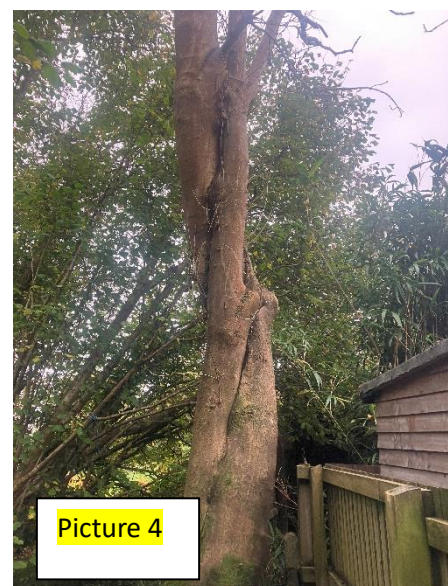
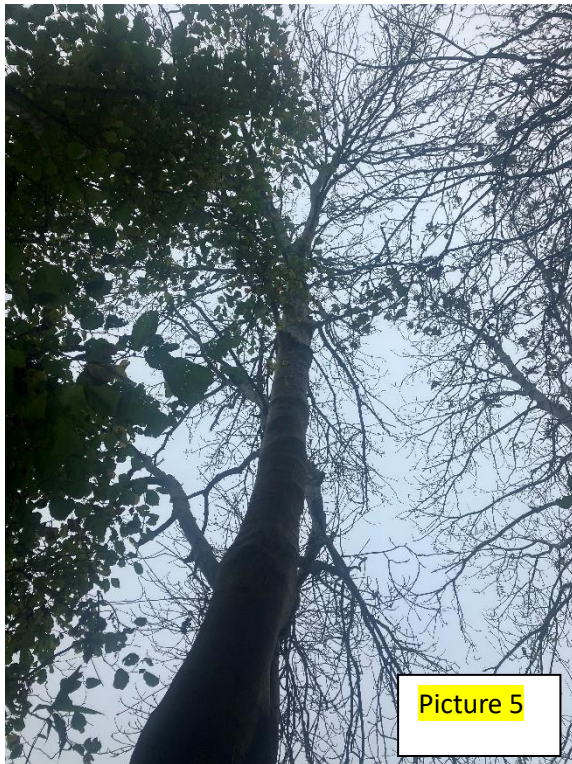
G1 Ash -2x Ash fell to ground level Pictures 1-5

Also two Ash trees (G1) which have early signs of Ash Dieback (*Hymenoscyphus fraxineus*) though not heavily infected at present, this will inevitably progress over the coming years causing the trees to become unsafe and a danger to those below/nearby. I would recommend they are removed. I have added some notes regarding these ash trees below with some images. I wouldn't recommend pruning the trees as they won't respond well to being pruned as the trees are already under stress. Any new growth would get infected by ADB, causing further stress to the trees. Currently the trees are in a condition where they are able to be worked on using rope and harness techniques. There is no access for a MEWP (Mobile Elevated Work Platform) so should they be allowed to decline in health they would become a danger for any arborist to climb. And with no space to straight fell the trees safely they would be very difficult to remove in the future.

I recommend the removal of these 2 Ash trees. The homeowner is concerned about the trees which are showing early signs of Ash Dieback (*Hymenoscyphus fraxineus*). Both trees have large wounds at the base which are on the tension side of the trees with all the weight over the garden/property. One of the trees has a very tight compression fork with a twisting growth pattern which isn't ideal as dysfunction and decay could arise from this union. Any pruning works will result in extra stress to the trees which are already under ADB stress and would also require us to revisit the trees in 2-5 years to inevitably remove them as is the nature of ADB the trees would decline in that time. The nature of ADB would cause these trees to start dropping dead branches into the garden of the homeowner which is also a concern for them.

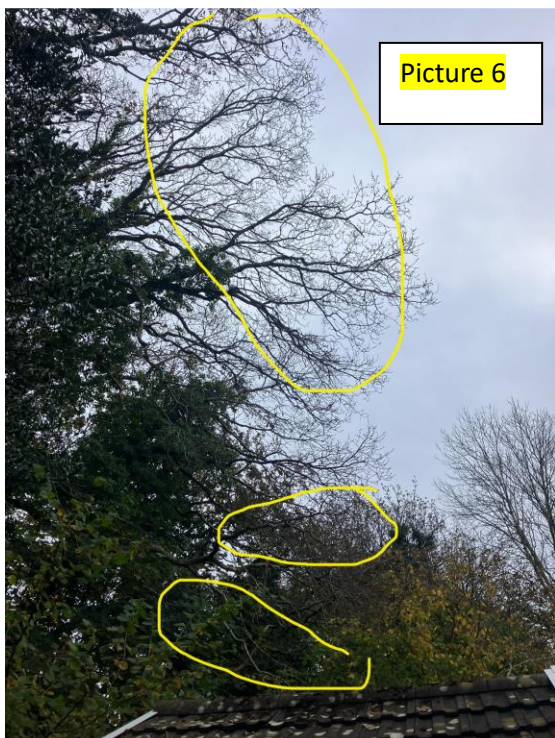
Picture 6

T1 Oak Reduce canopy over gardens 1.5-

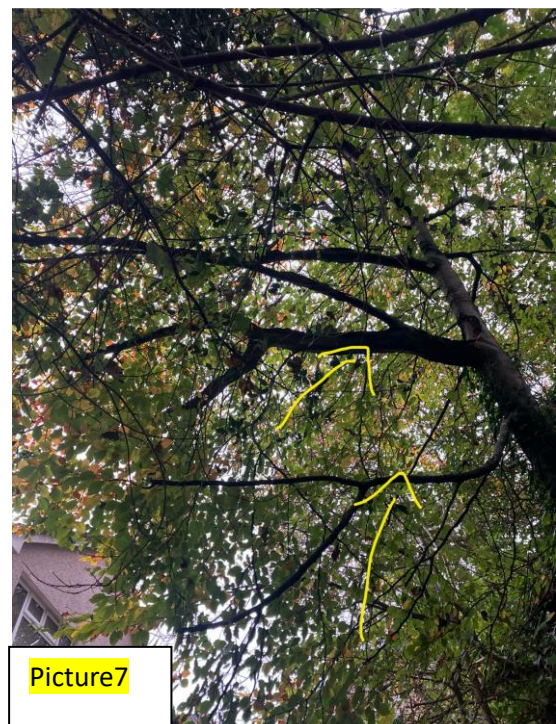
Picture7

T2 Beech Remove 2 limbs on 1x beech tree

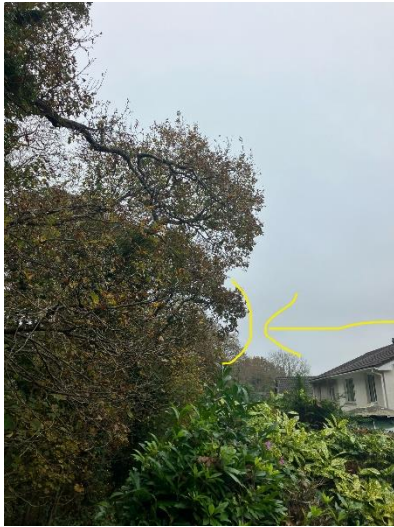
T3 oak reduce canopy overhanging boundary by 1.5-2m Picture 8

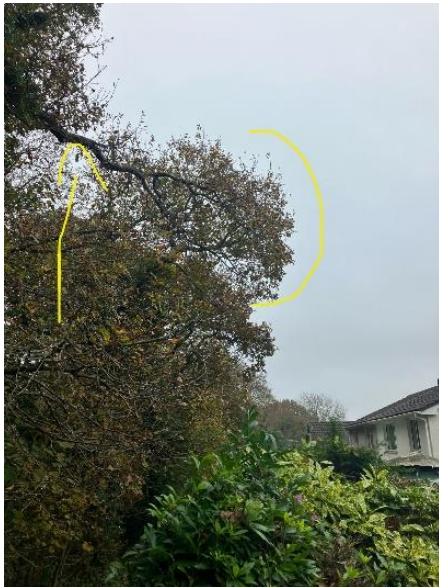
T4 oak growing toward conservatory - reduce overhang by 1.5m Picture 9. Picture 9 also shows limb of T8

overhang by 1.5m Picture 9. Picture 9 also Oak with hazard beam fracture.

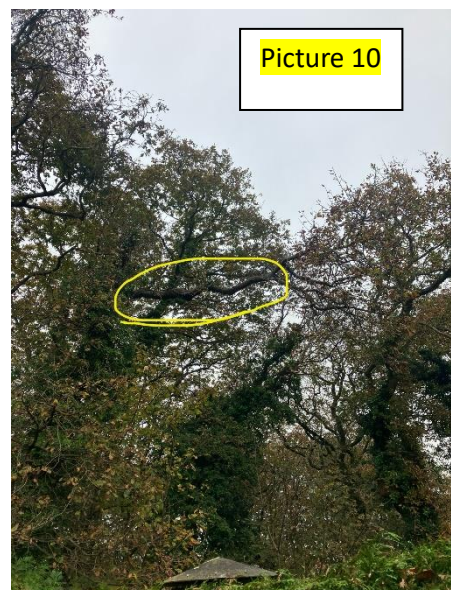
T5 shorter oak with previously failed main leader now only 1 limb remains containing hazard beam approx. 1m in length - remove limb back to growth point beyond fracture to retain as habitat. Picture 10

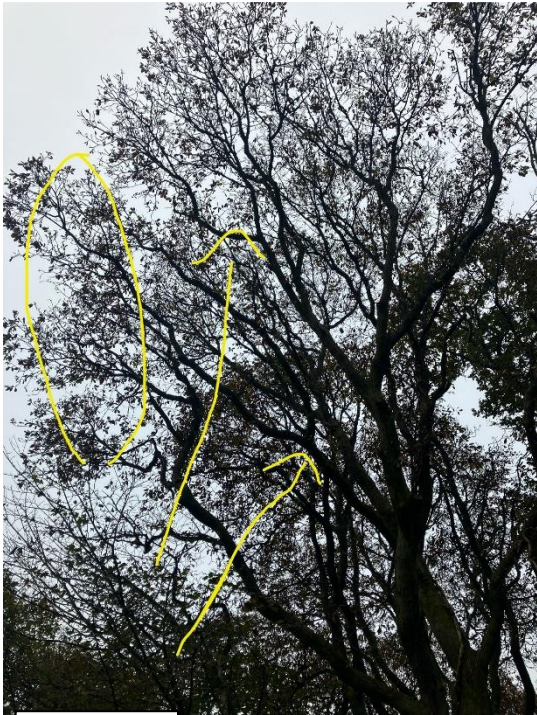
Picture 11

T6 Large leggy oak above footpath/street light at rear of number 52 lon glynfelin/172 Longford road

Remove 1 secondary and 2 tertiary branches, reduce remaining branches growing towards 172 Longford road by approx 1-1.5m Picture 11/12

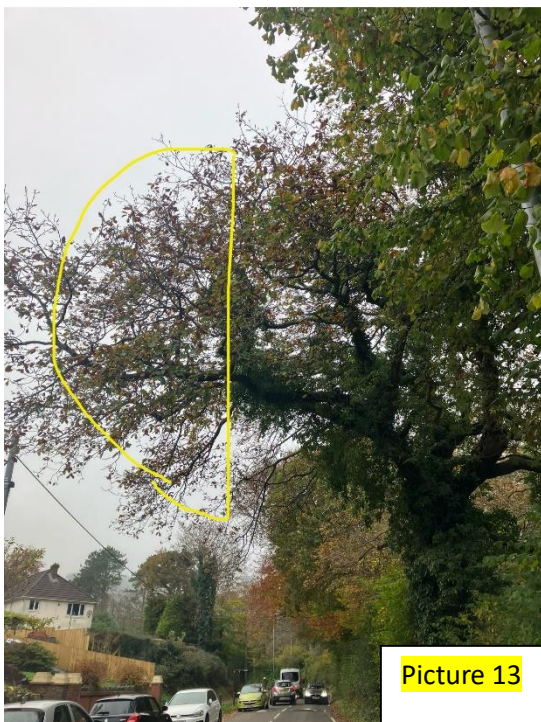
Picture 13

T7 Oak over Longford road, Neath Abbey

Reduce canopy over the road by approx. 2-2.5m to line up with centre line of the road. Picture 13/14.
