## HERITAGE ASSESSMENT

Project: Tyn Yr Heol House, 1 Henfaes Road, Tonna, Neath

Document issue: December 2024

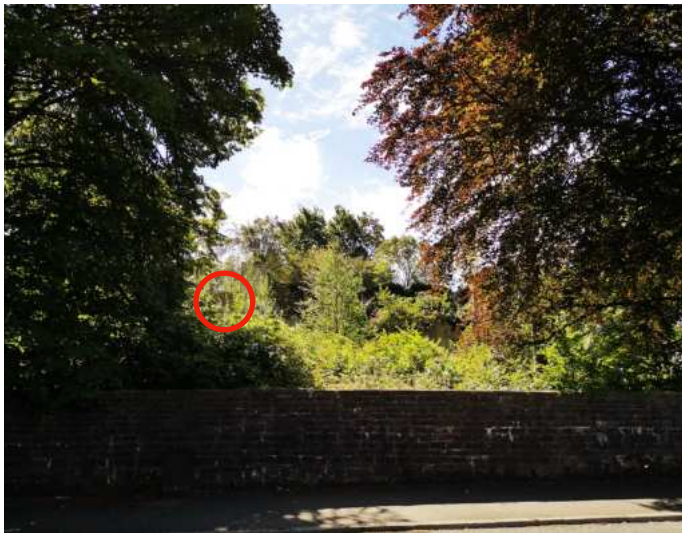
2. A similar view today; the Site seen from the road with wall to left of FF sash window marked as reference

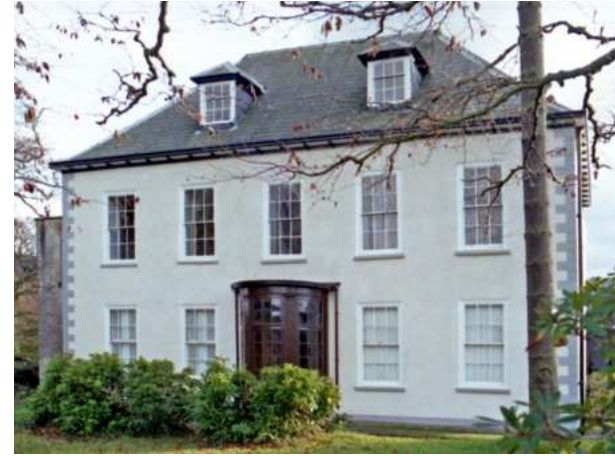
4. Tyn yr Heol House c.1980s; extension to side, cement render, lost stacks and replacement slate roof

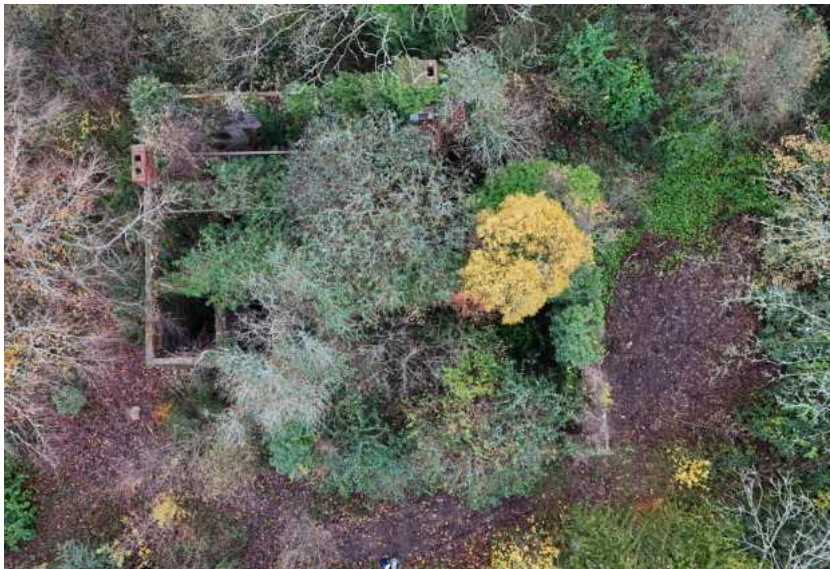
3. The standing remains of the main house 2024 (south to top of image)

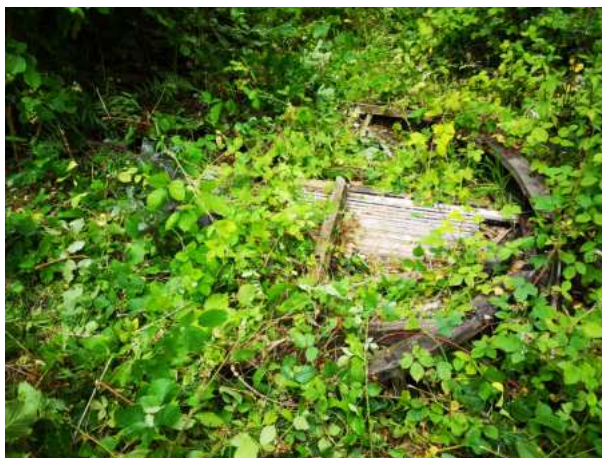
The semicircular central timber porch has perished and collapsed. Elements of this were seen on the ground.

10. The remains of the front porch with reeded pilaster;  
Sept 2019

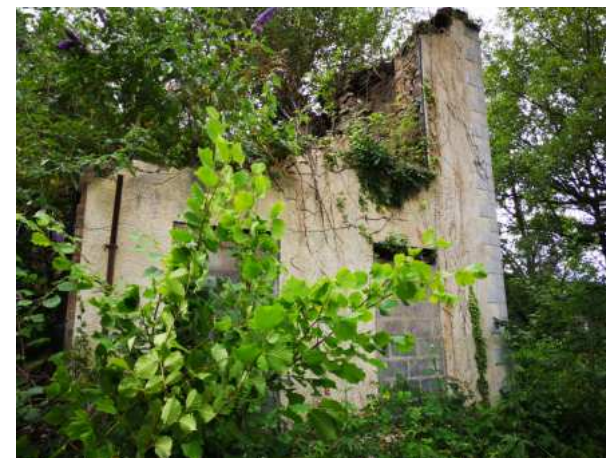
11. Right side of front elevation showing horizontal  
cracking along window tops; Sept 2019

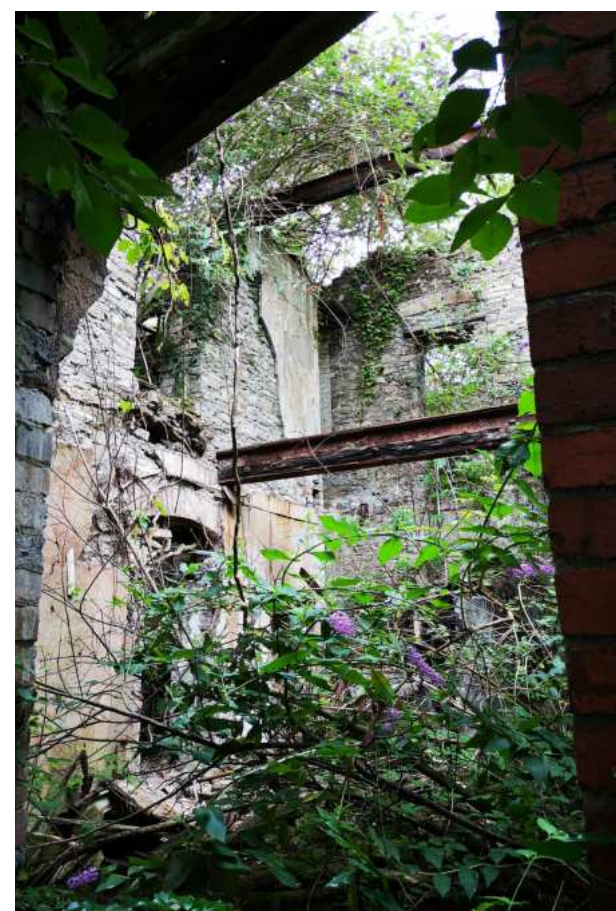
Within the rear section of the building, high level steel floor beams remain in place. The beams appear compatible with construction of the brick extension c.1930-50s and indicate that there was a substantial refit carried out to the whole of the property at that time.

14. Interior of the main house; corroded C20 steel floor beams; Sept 2019
