# Ty'n Yr Heol

**Structural Survey**  
**Addendum 2 – updated.**  
**16.12.2024**

Project Number: 9980

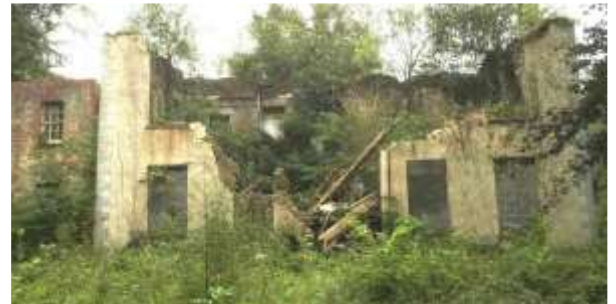
- 2.2 The principal, north elevation has all been lost. The upper storey and central section at ground floor has collapsed and the two remaining sections are fractured and free to fall. The harsh render is keeping the rubble walling together but will allow it to collapse as one large section. The wall heads of the remaining structure to this front section of the building are in poor condition and have been affected not just by weathering, but also through the growth of woody vegetation.

- 2.3 It is likely that at least the top meter of the walls will be in poor condition and will need to be removed and rebuilt.

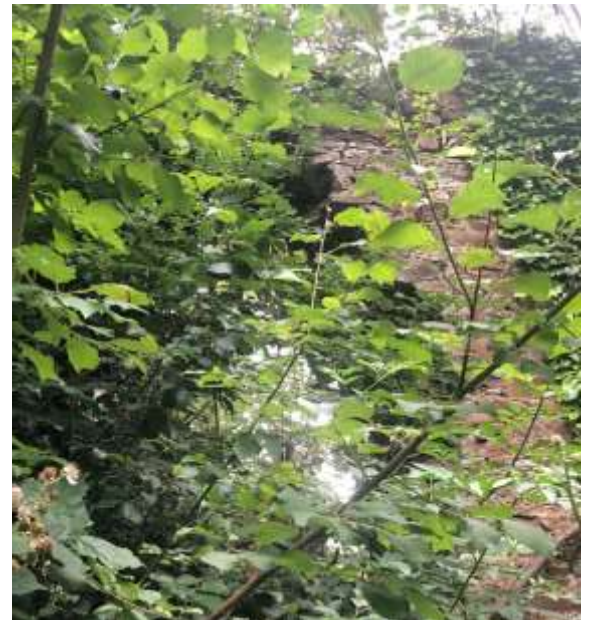
- 2.5 We were able to look into the heart of the wall to view the core work and found the walls to be well layered with stone of flat aspect ratio. The stone appeared stable but mortar was missing in areas, leaving stone on stone conditions. Water has washed out the binder within the mortars in areas where stormwater has had concentrated run off. This would suggest that vulnerable areas at roof level, alongside valleys, chimneys and exposed beam bearings are likely to be affected by the loss of mortars.

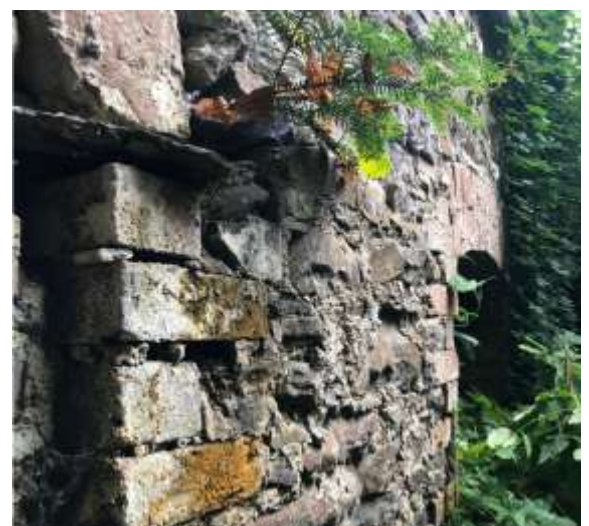
- 2.7 A section of rubble wall on the east side of the rear section of the building shows evidence of bulging, where it appears the masonry may be cleaving, or detaching from the inner section of the wall. This is likely due to storm water ingress and the proliferation of woody vegetation that is growing out of the wall and jacking the mortar joints.

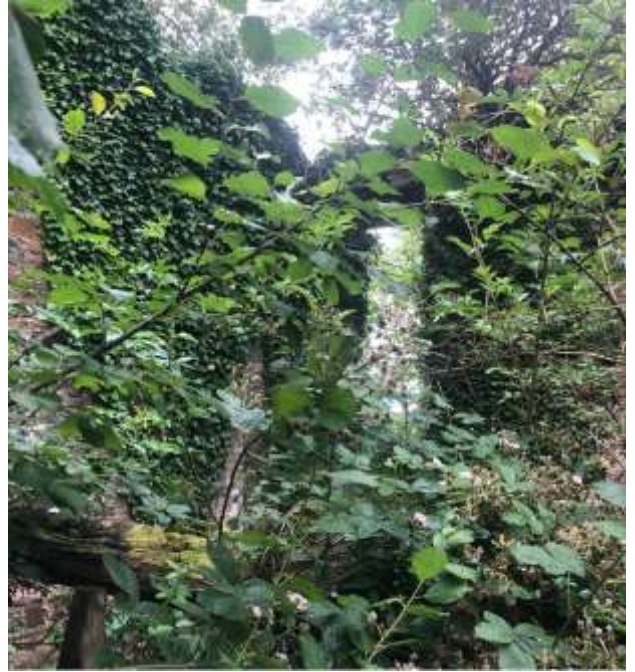
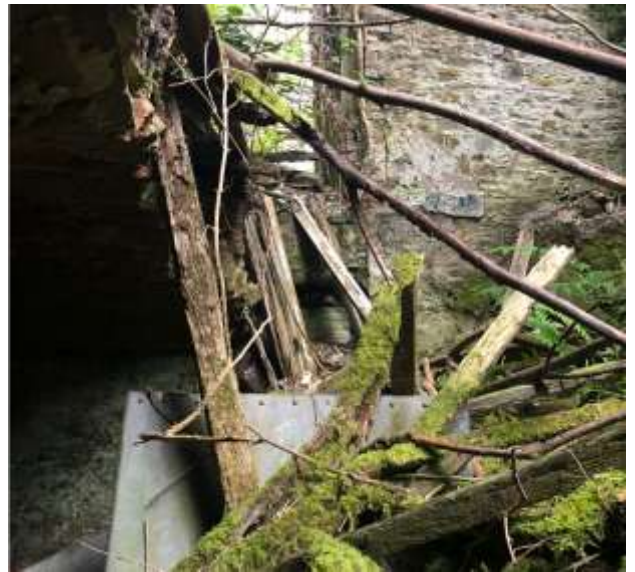
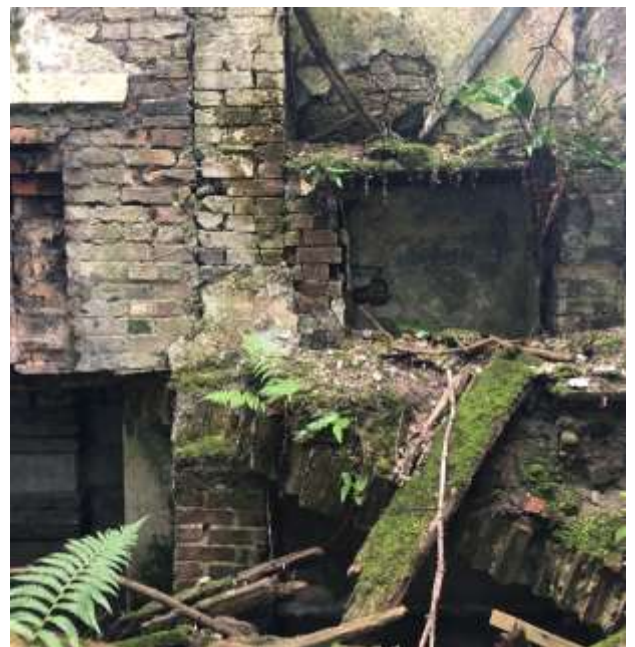
- 2.11 The brick vaults are lost. The small remaining sections will need to be removed in order to allow a new full basement arch to be constructed.
- 2.12 These sections of the building should be considered dangerous due to the risk of falling debris, the risk of collapse of the remaining section of vault and due to the uneven ground surfaces as voids below the ground floor are being exposed.

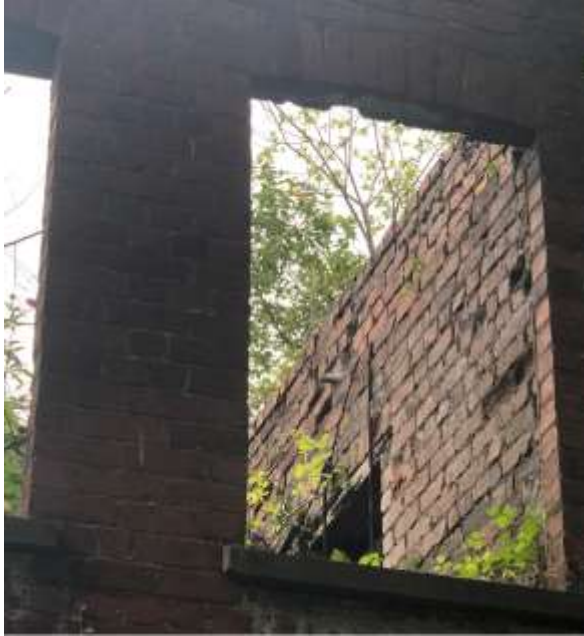
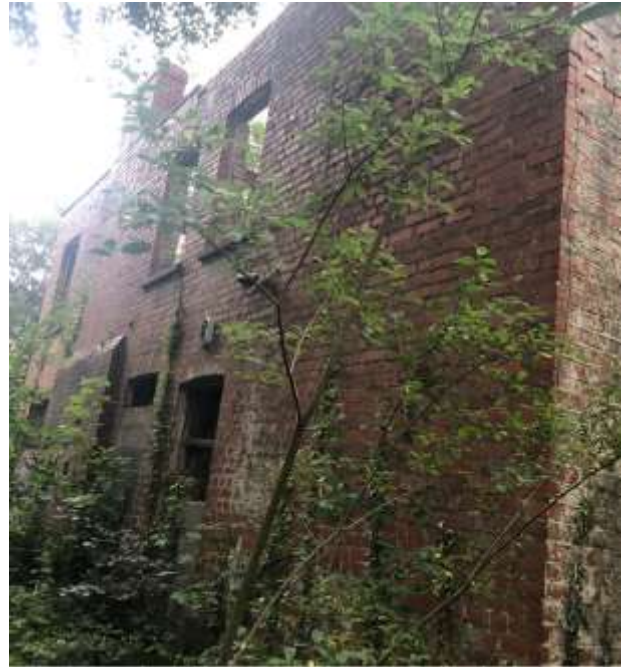
- 2.13 The later brick extension to the south east corner appears to be in better condition to the rubble masonry section. It is possible that these brick walls could be restrained by new scaffold whilst repairs are carried out.

- 2.14 The brick appears to be in relatively good condition with many of the flat brick arches over windows performing adequately.

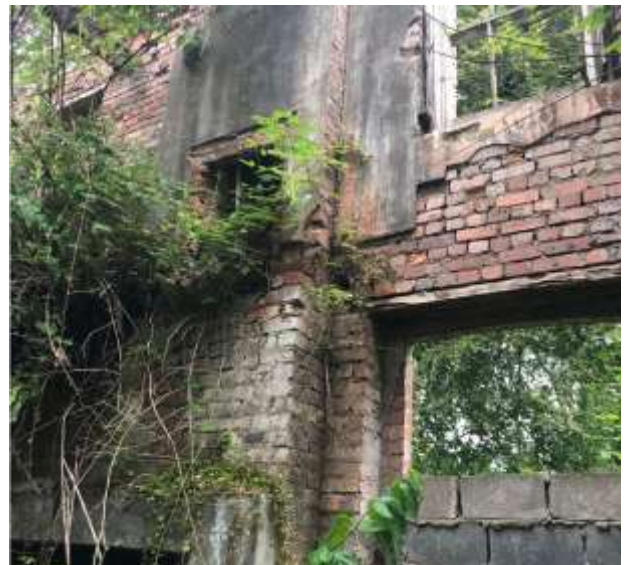
- 2.15 The rear wall section of the brick extension is in less good condition as the north east elevation. The internal timber lintels are unreliable but the brick is arching over the openings. Woody growth has caused local disturbances to the brick but this could be readily repaired.

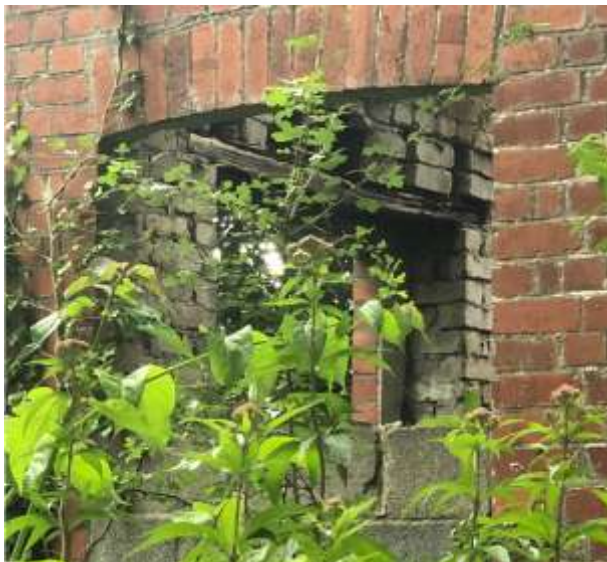
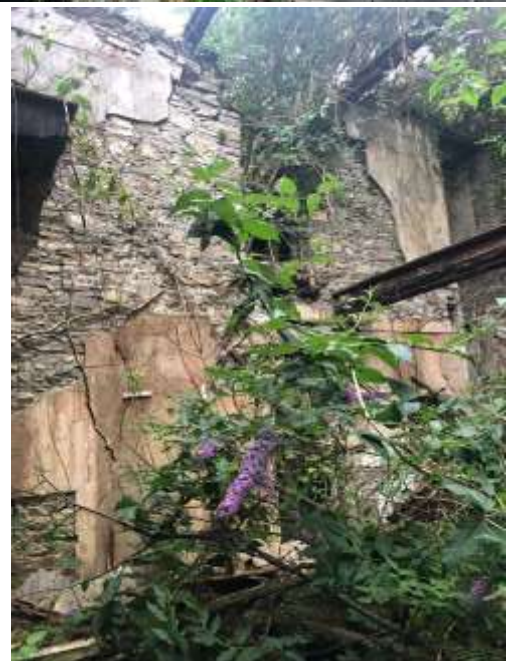
- 2.16 The steel beams at higher levels should be considered as dangerous as they are decayed and the bearings will have been broken down through weathering.

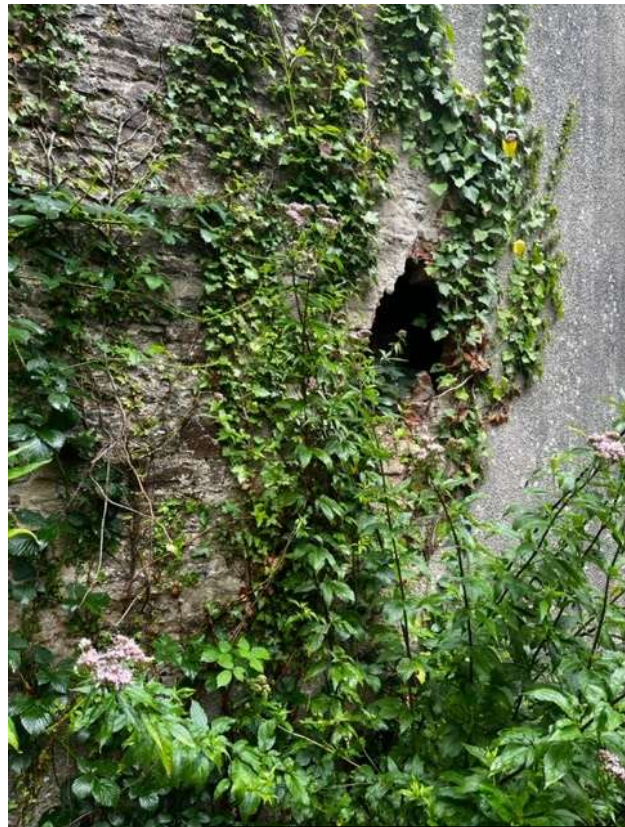
West elevation - July 2023

2. The West elevation appears to be bowing slightly. This could be due to detachment of the cementitious render, but we note this is a wall with flues with only a 100mm brick as the external face.

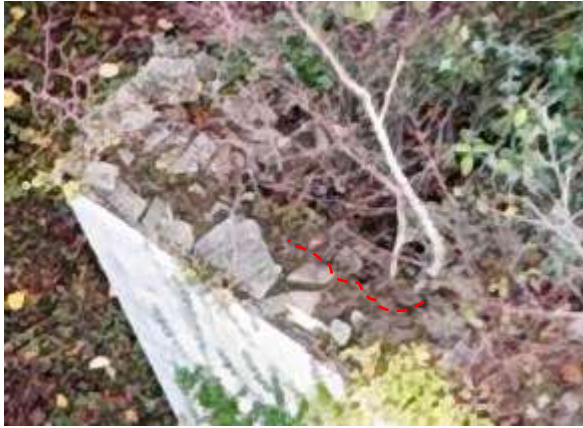
Photo from Drone footage showing the head of the west wall. The photo shows the heads of the wall to open to the elements and to be breaking down. There is a fracture seen in this picture that suggests the inner leaf is laminating away.

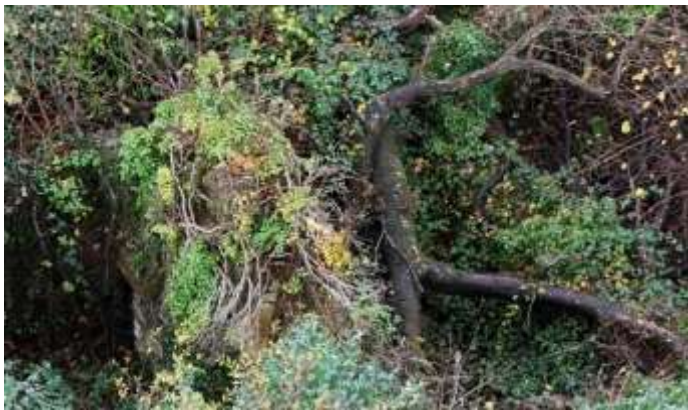
Drone footage showing damage caused by fallen trees to the east wall.

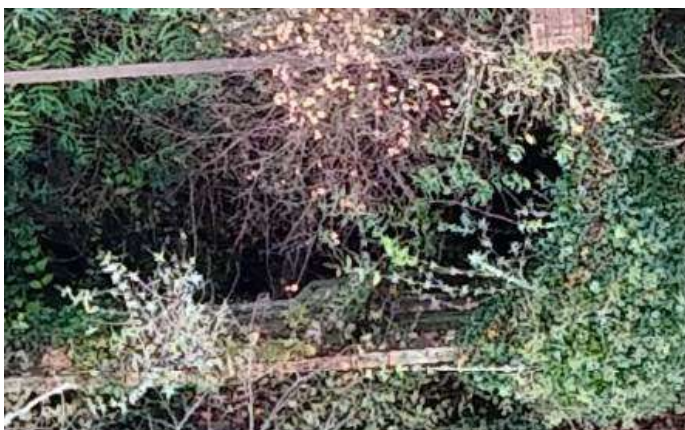
Drone footage showing slenderness at the head of the north, brick wall and steel beams in place
