## **ARBORICULTURAL REPORT**

**Location :** Golwg y Darren, Ynysydarren Road, Ystalyfera SA9 2DY

**Date of inspection :** 20th November 2024

**Consultant / Surveyor :** Nick Thomas Dip. Arb, Cert. Arb. RFS

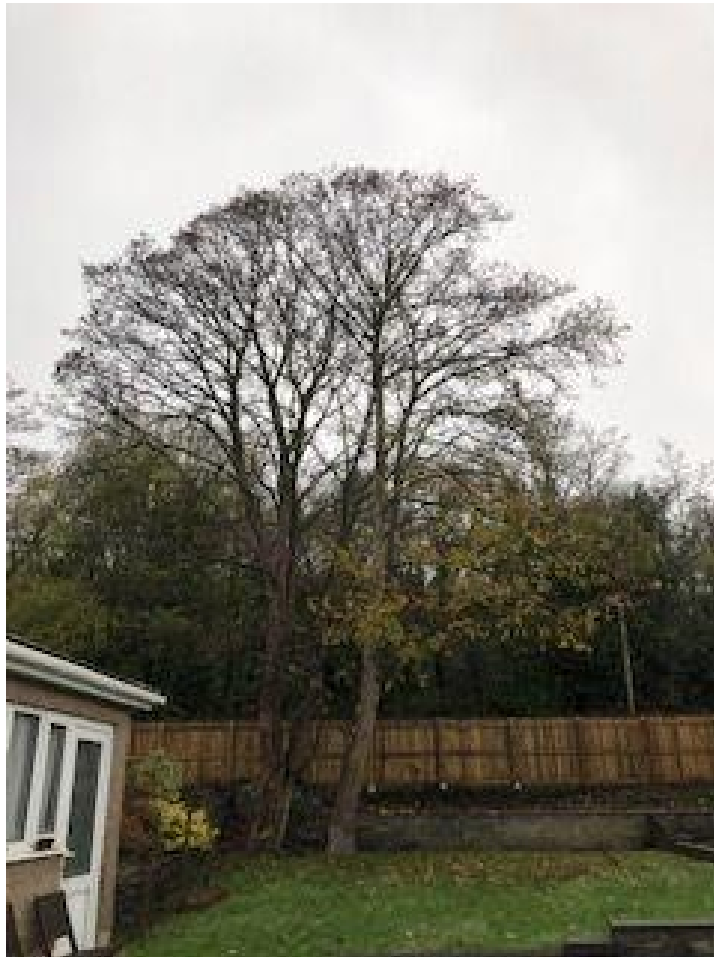
**IMAGE A : Trees 1449 and 1450**

At the request of the client Mr Stoneman the two Sycamore (*Acer pseudoplatanus*) shown in IMAGE A were inspected on the morning of the 20th November 2024.

Tree 1449. To improve its balance and form the branches on the trees northern side should be reduced by a maximum of 3 metres. The branches in the upper crown region should be reduced by 2 metres. If possible the constricting cable on the lower branch should be severed and removed.

Tree 1450. Reduce the entire crown by 2.5 to 3 metres.

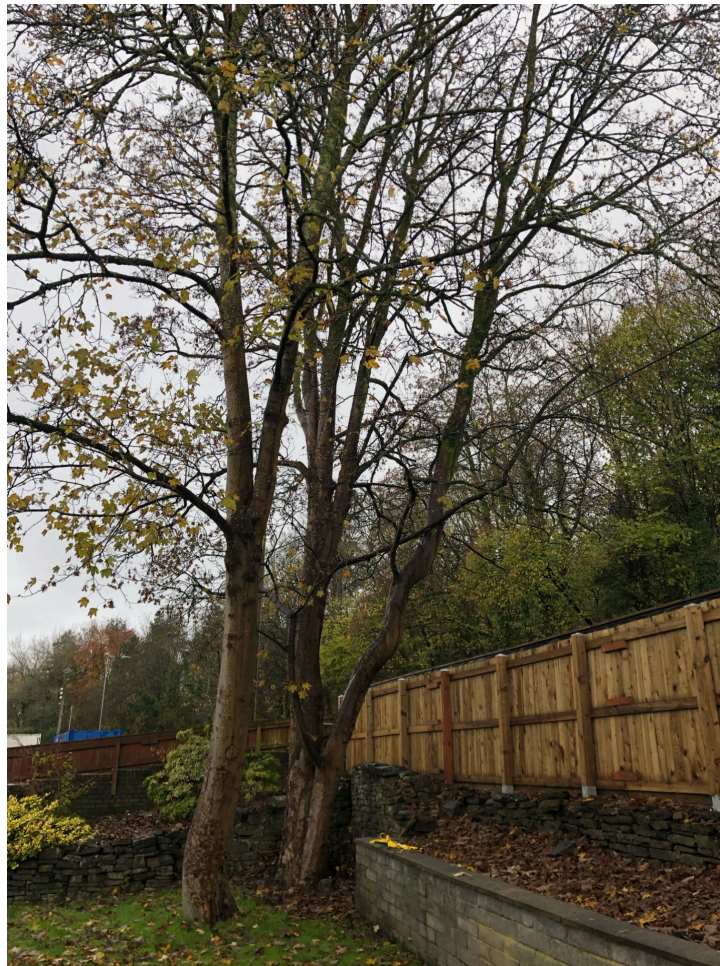
**IMAGE B**

The trees are growing on a level lawn area in the side garden of the property with an adjacent embankment which is retained by cement block and dry stone walls. These walls support a shrub planted area and the timber boundary fence shown in IMAGE B. A section of the trees crowns overhang the adjacent Ynysydarren Road.

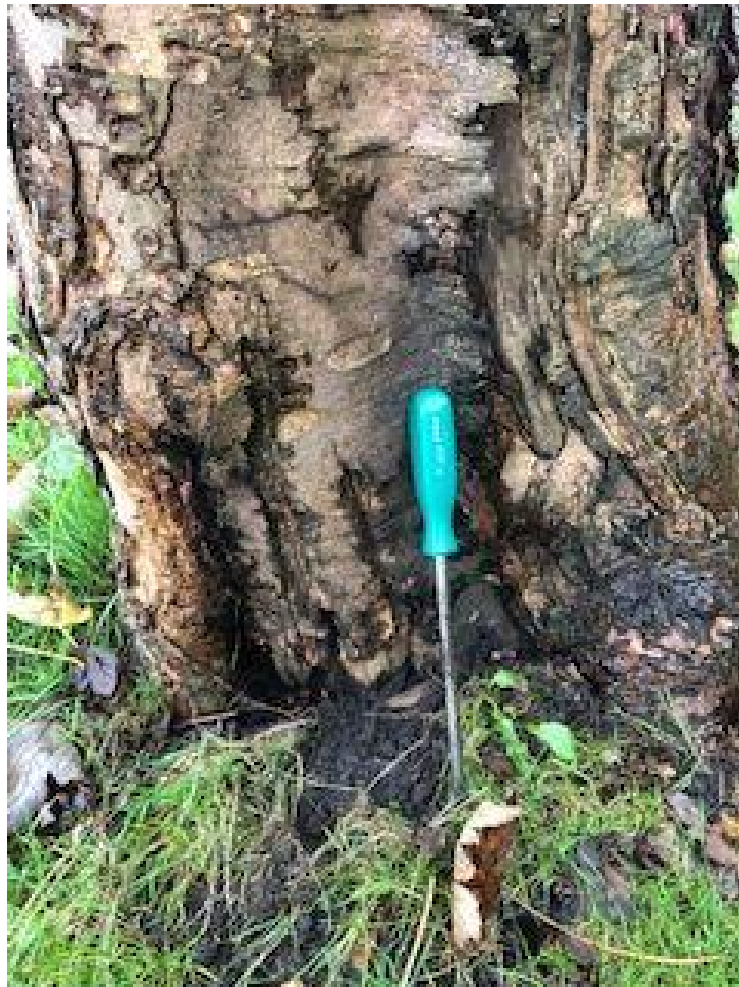
Due to the trees low vigour and below average extension growth the trees physiological condition has been classified as poor. There is a small area of decay which is on the main stems northern side near ground level - IMAGE C. This decay appears to have compartmentalised. As there are no buttress roots visible near ground level it appears that the original ground level has been raised.

**IMAGE C : Area of decay at the base of tree 1449.**

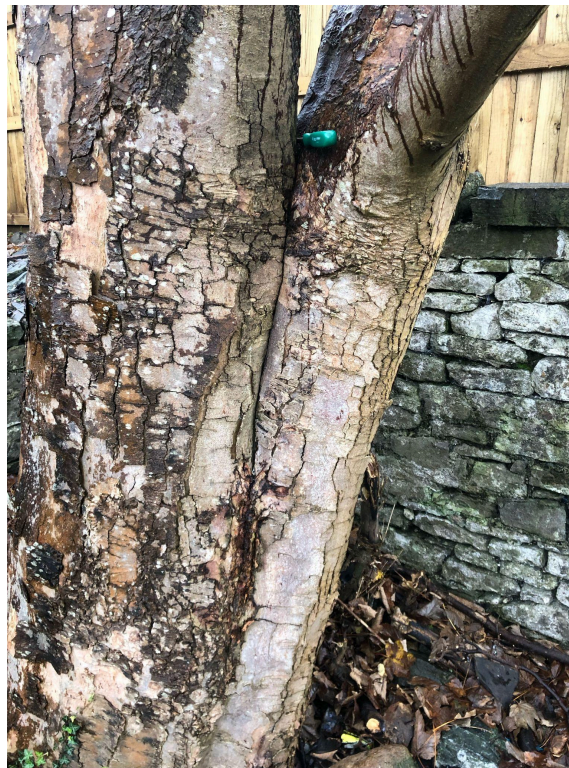
This tree is 12.1 metres from the bungalow with a lean and crown weight to the north. Due to the trees low vigour and below average extension growth the trees physiological condition has been classified as poor but there is no significant evidence of disease or decay. As shown in IMAGE D the trees main stem divides at 1.63 metres above ground level with 1.18 metres of included bark. The trees structural condition has been classified as fair.

**IMAGE D** : Dividing stem with included bark.
