# **Retrospective application for the demolition of a dwelling and the construction of a replacement detached dwelling**

**The Paddock  
Access to Dyffryn Farm  
Dyffryn  
SA10 7BQ**

**Structural Survey Report**

Report Ref: PO-06912

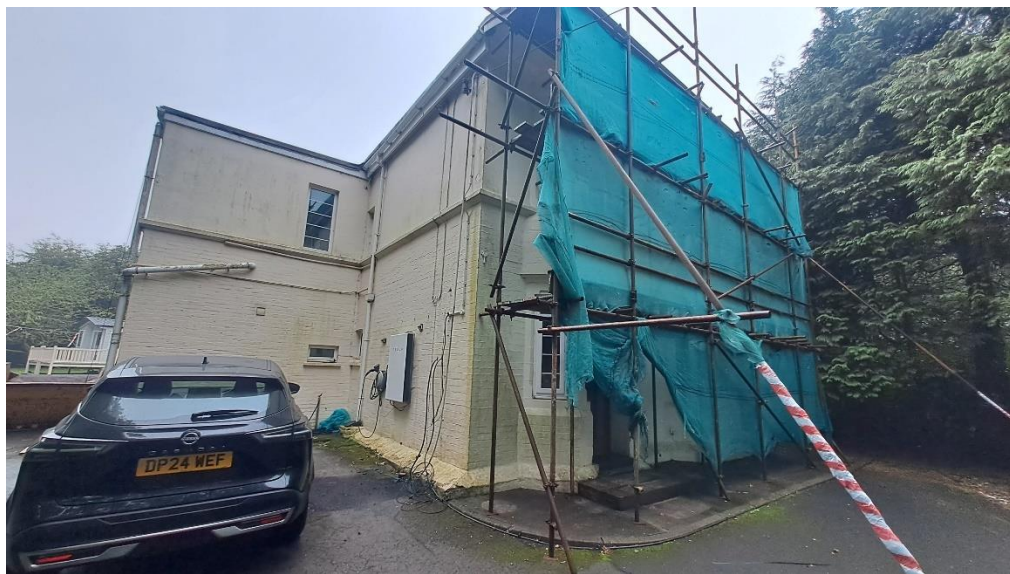
*Photograph 1 – Front Elevation*

The property is a two-storey detached house at Neath Port Talbot. The property is currently undergoing a wholesale refurbishment. Photograph 1 illustrates the front elevation of the property.

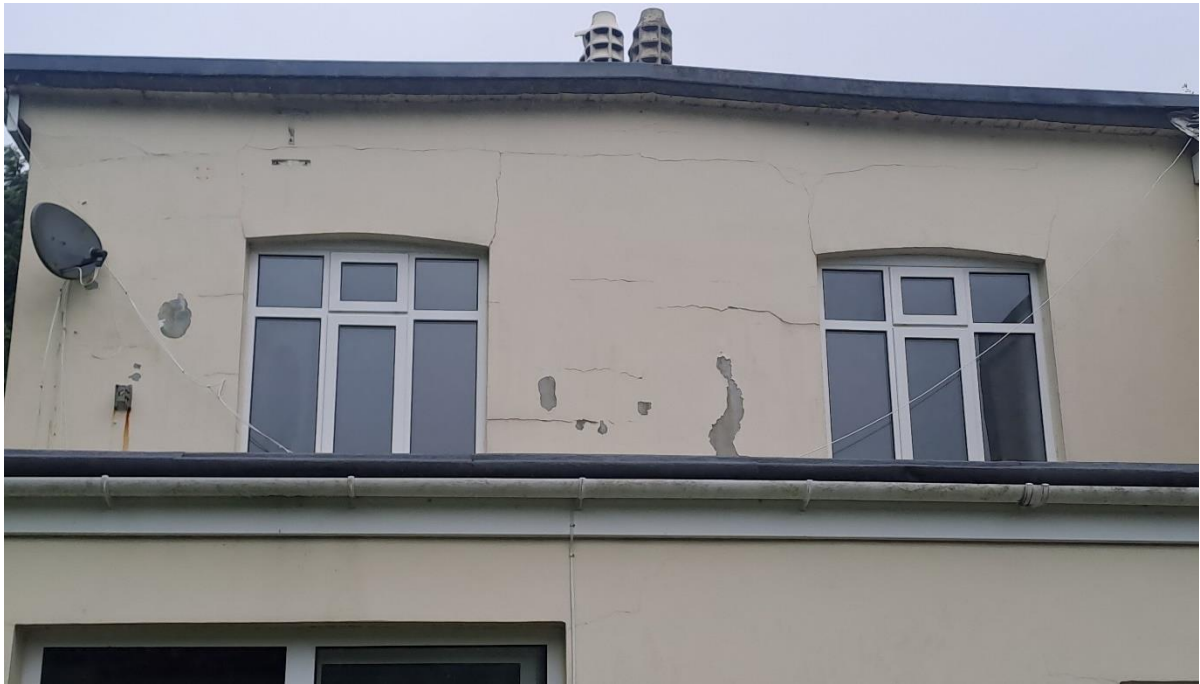
The external elevations of the property show good line and level, with signs of cracking across all elevations to the render. The cracking comprises a variety of horizontal, vertical and diagonal cracking, typically upto Category 2. Diagonal cracking to the right-hand side can be indicative of subsidence due to foundation movement, horizontal cracks can be indicative of internal wall tie corrosion whereby the mortar joints are pushed apart due to corrosion of the wall ties. Render also ages with time, becomes brittle and can be impacted by seasonal thermal and ground movements.

**Photograph 5 – Rear elevation, cracking**

The Render does seem to be life expired for several contributory reasons and should be replaced. However, it is our recommendation that further investigations are undertaken to assess the condition of the property to enable it to be considered a structurally stable in the long-term considering it is undergoing a costly refurbishment.

We recommend that the wall ties are investigated to the rear elevation to confirm condition. It is also recommended that trial holes are excavated to the elevations along with soil sampling for lab analysis. This investigation will confirm the risk to the property of subsidence due to the condition of the ground along with the presence of the established trees.

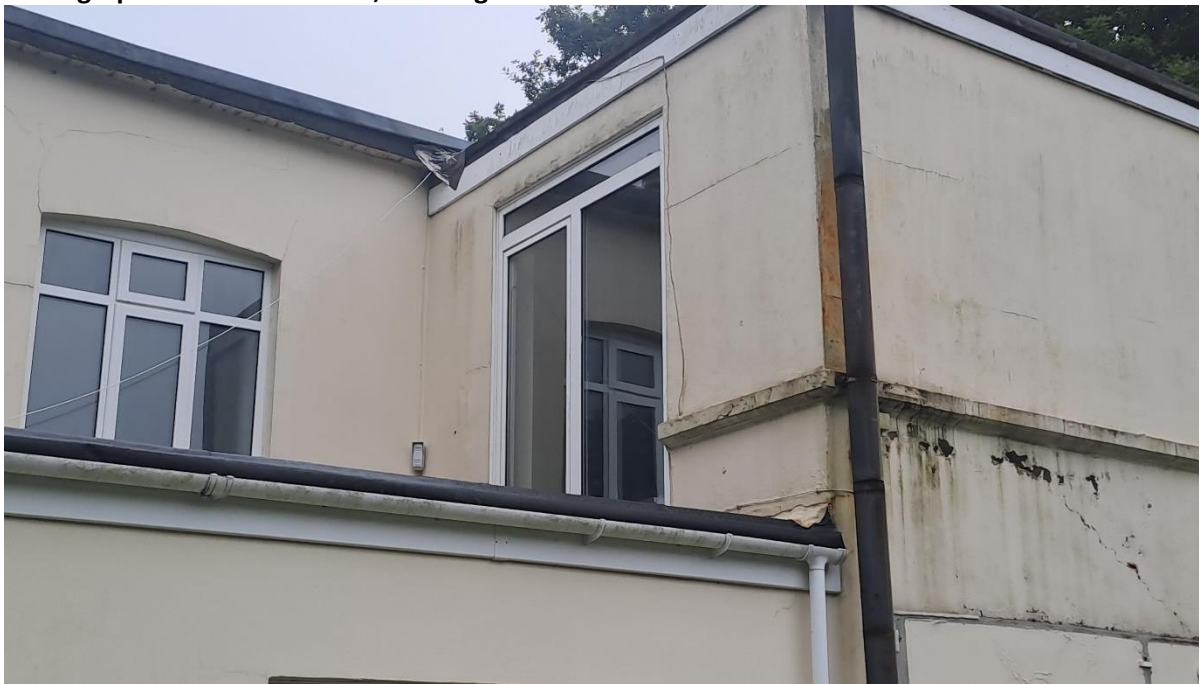
**Photograph 6 – Rear elevation, cracking**

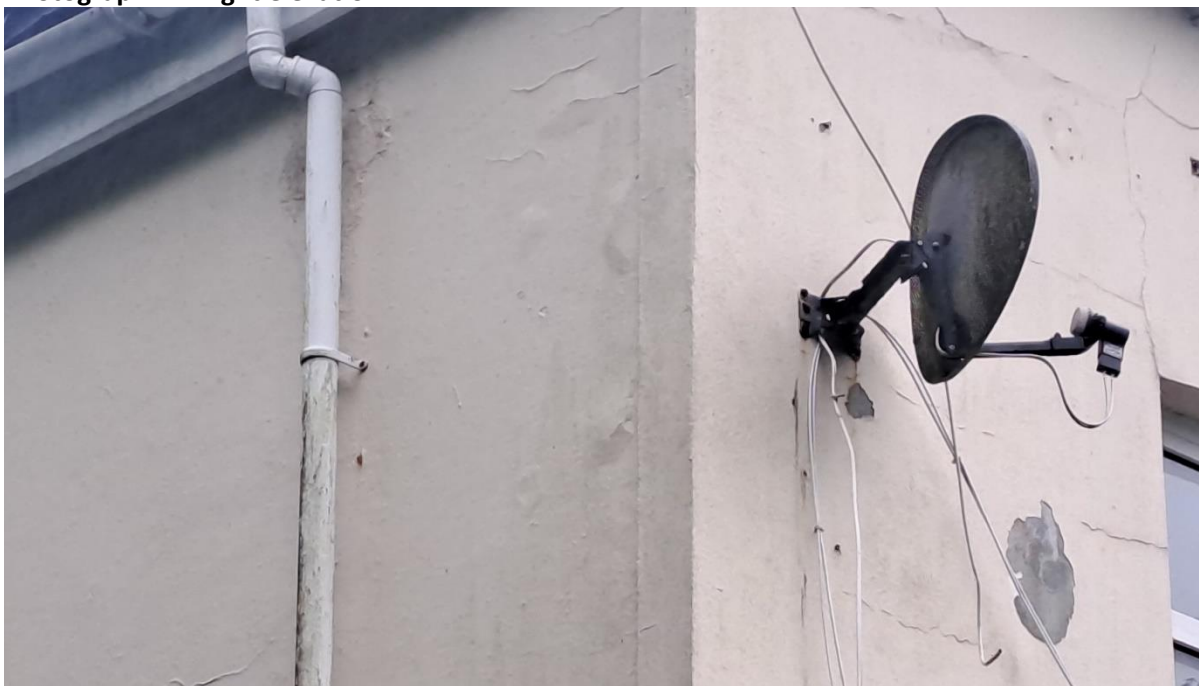
**Photograph 8 – Blistering render**

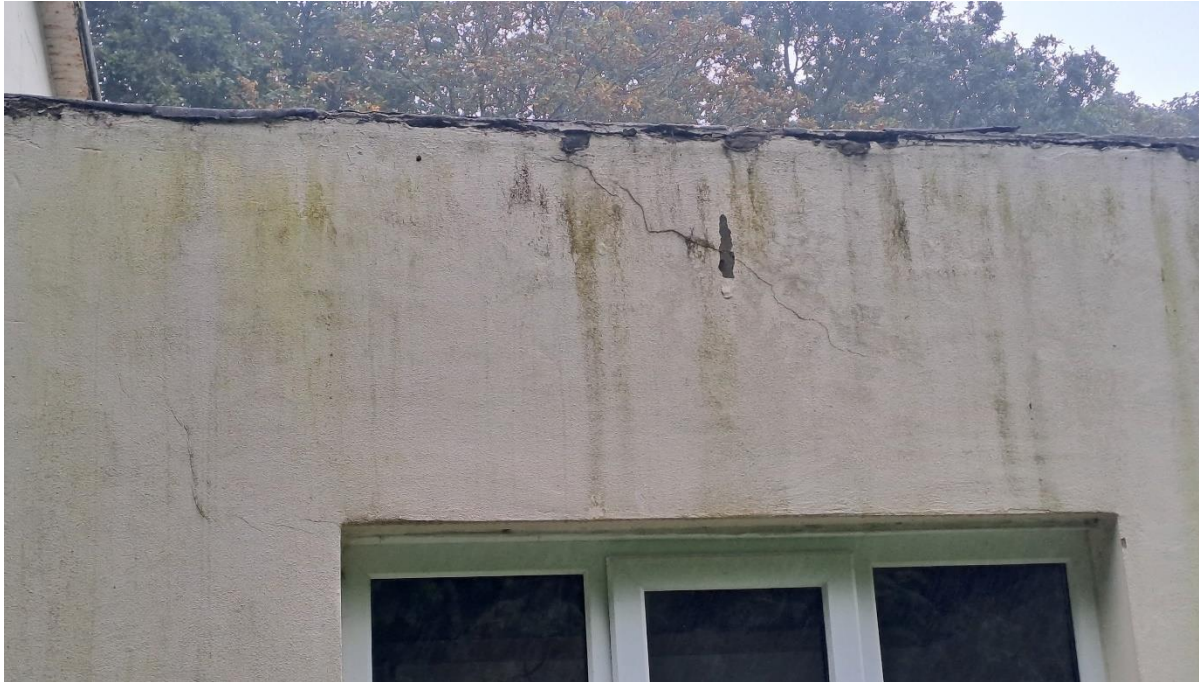
**Photograph 9 – Diagonal Cracking**

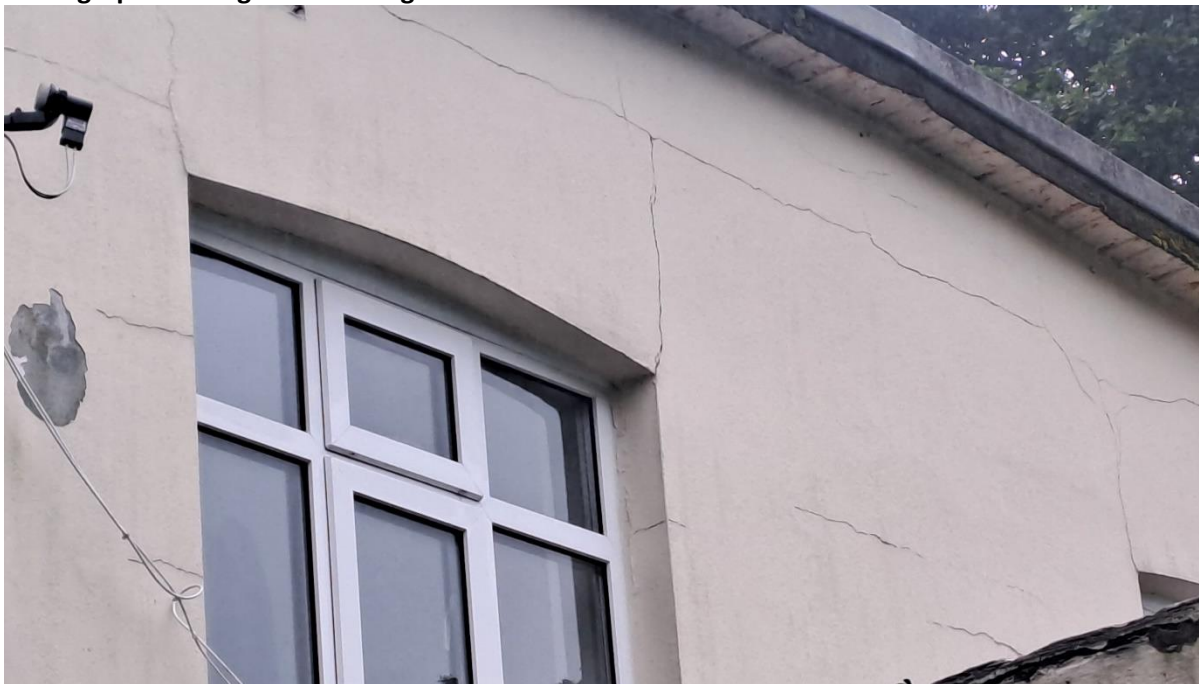
**Photograph 10 – Render cracking**

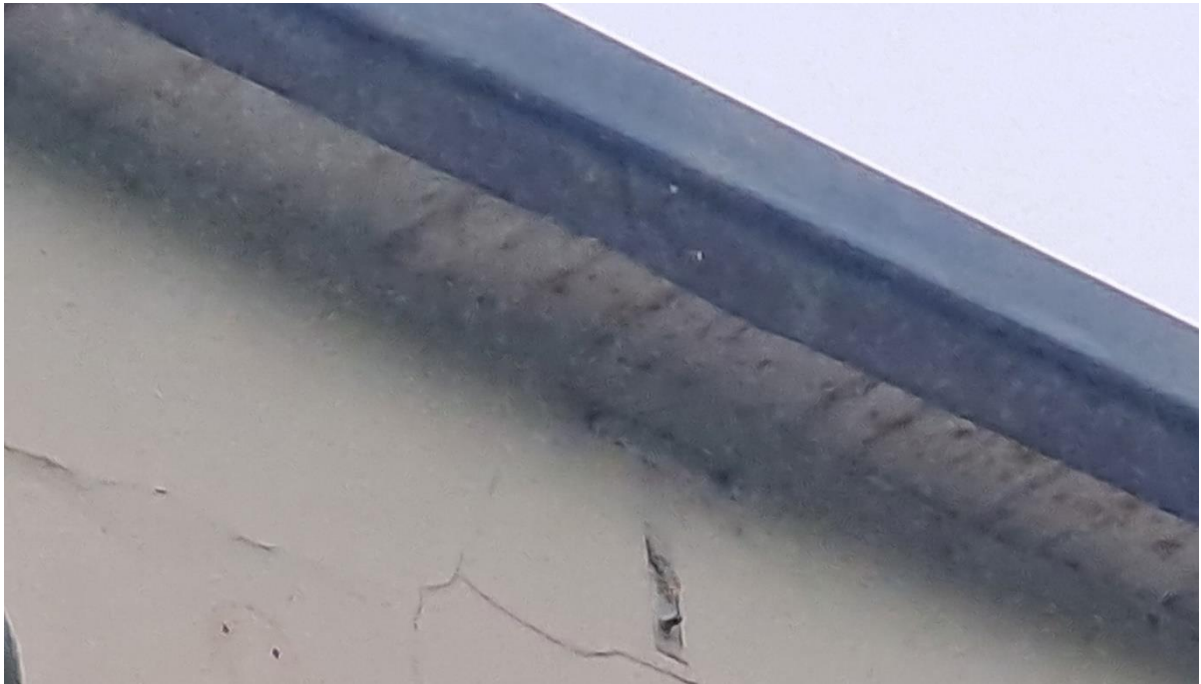
The ability of an 85-90mm thick slab to support roof loading can also be questioned. Particularly considering the condition of the reinforcing bars showing signs of significant corrosion which significantly reduces the strength of the roof. It is not possible to easily repair corroded steelwork and there is the added complication of carbonation on concrete. Reinforced concrete can be impacted by Carbonation. Carbonation is the phenomenon whereby carbon dioxide within the atmosphere impacts the alkalinity of the concrete which can make the concrete vulnerable to steel corrosion. The rate of carbonation on concrete is typically the square root of the age of the property. If a property was 64 years old, the potential depth of carbonation is 8mm. In this instance, the cover to the reinforcement can be as little as 10mm which is likely due to workmanship and construction tolerances. Considering the presence of carbonation, the steel reinforcement is at risk of accelerated corrosion.

**Photograph 11 – Corrosion staining to steel reinforcement within the roof**

Considering the property is undergoing a wholesale refurbishment, the roof should be considered as life expired and should be considered for demolition and replacement. The cost provided in Section 4 is a broad estimate due to the decision as to which type of roof should be installed.

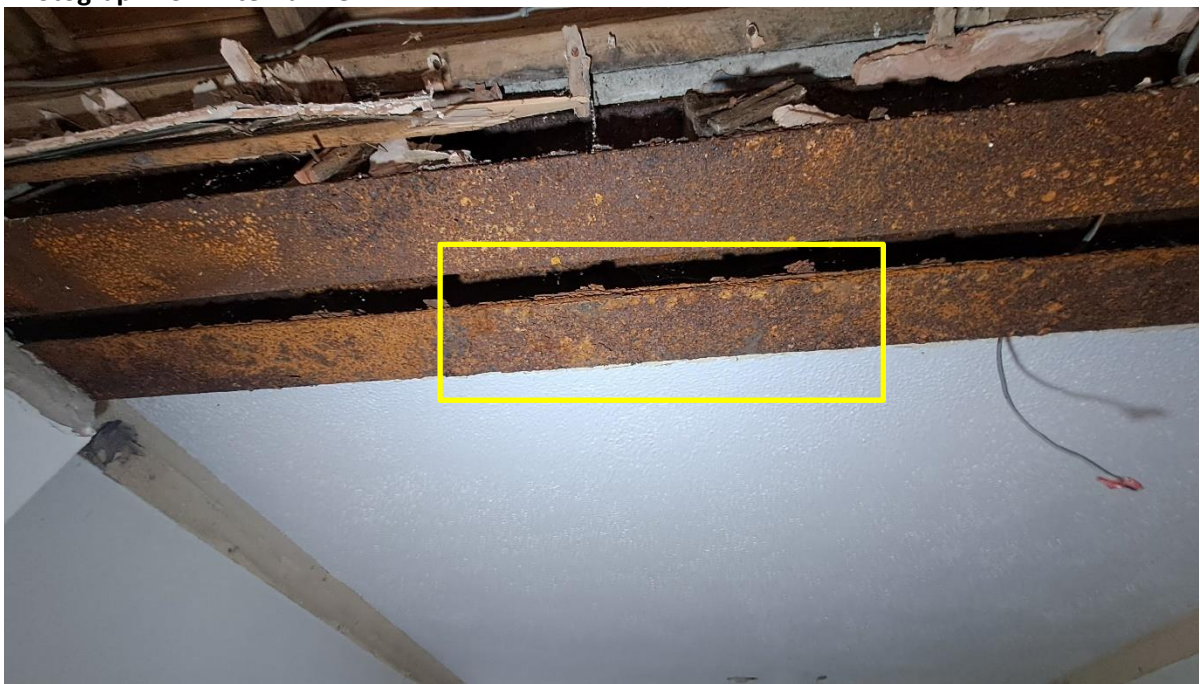
To the rear room, the two steel beams that are supporting the rear external wall was showing significant corrosion with signs of delamination of the bottom flange which has the effect of reducing the capacity of the beam. These beams require removal and replacement as there is a risk of beam and wall failure at some point. This point is not easily predicted. See Photograph 14.

**Photograph 14 – Section loss corrosion to steel beams supporting rear of property**

- There are steel supporting beams that require immediate replacement due to the corrosion levels and the fact they are supporting the rear of the property.

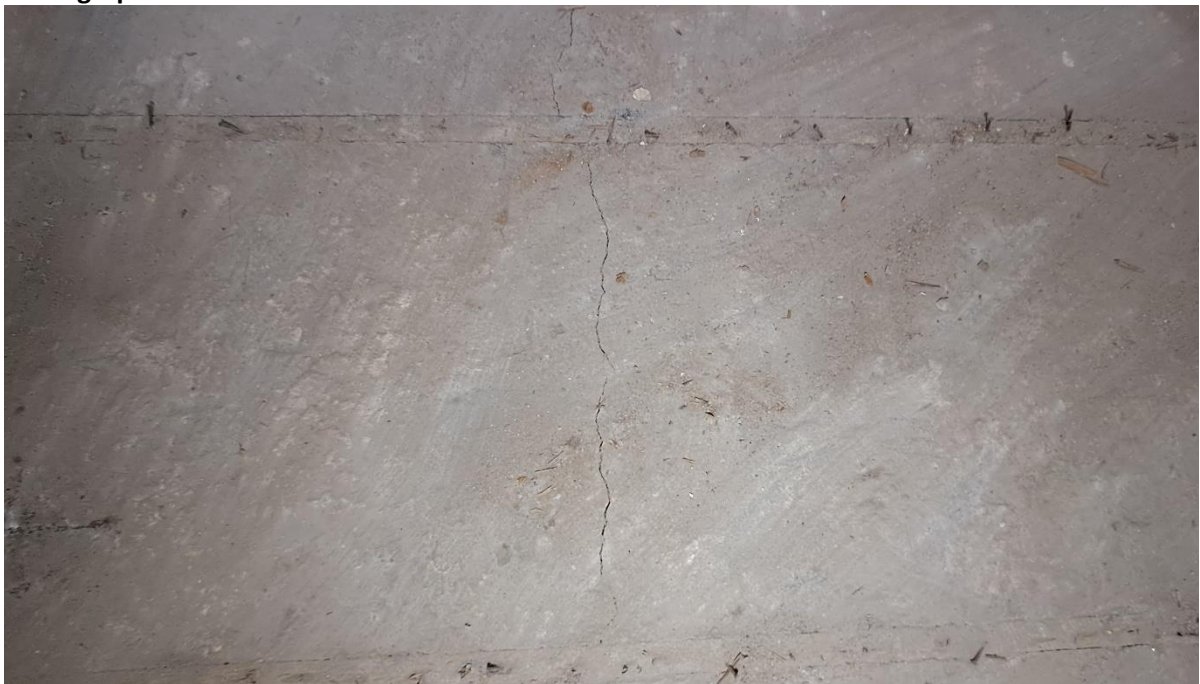
**Photograph 16 – Ground slab**

The floors were typically level showing little sign of structural distress through sagging (deflection) or localised failure of joists. The concrete ground slab had a lateral Category 2 crack which can be associated with age and general movement of the property. The cover

to reinforcement within the slab was measured at 33mm which is sufficient to resist the effects of carbonation for a significant period. See Photograph 16, 17 and 20.

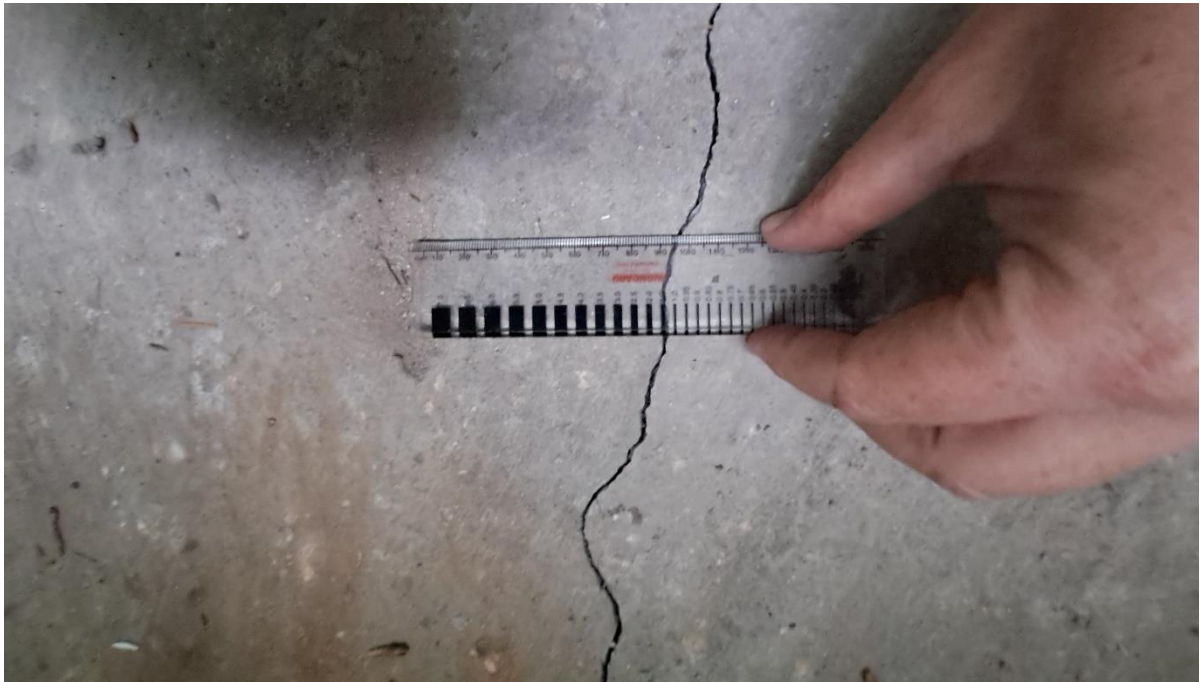
**Photograph 17 – Concrete cracking in ground slab**

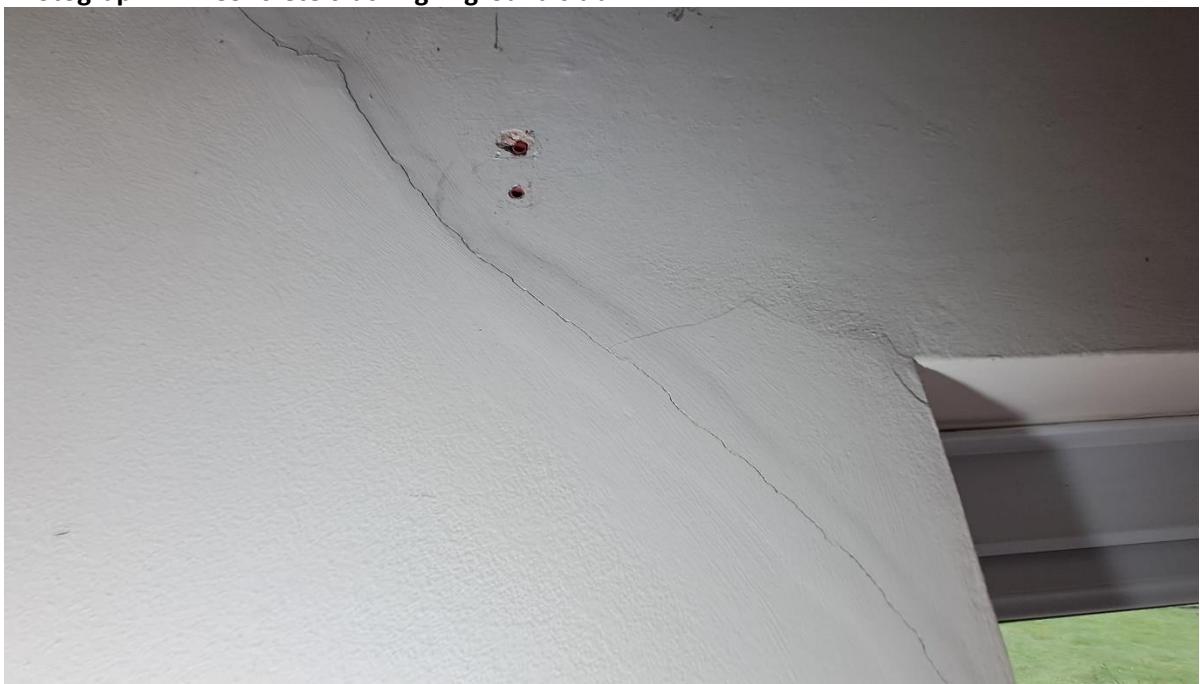
The majority of the walls were exposed. To the front of the property, there was evidence of diagonal cracking within the wall which had evidence of previous filling but with the crack reopening. This can be considered as evidence of ongoing progressive movement. Due to the significant quantity of established trees surrounding the property, there is the possibility that water demand from the trees is impacting the property. Following the refurbishment, there is the possibility that cracking may reappear. See Photograph 18.

**Photograph 18 – Existing cracking**

- Due to internal and external cracking, with some cracking seeming to be progressive, We recommend that the wall ties are investigated to the rear elevation to confirm condition. It is also recommended that trial holes are excavated to the elevations along with soil sampling for lab analysis. This investigation will confirm the risk to the property of subsidence due to the condition of the ground along with the presence of the established trees.

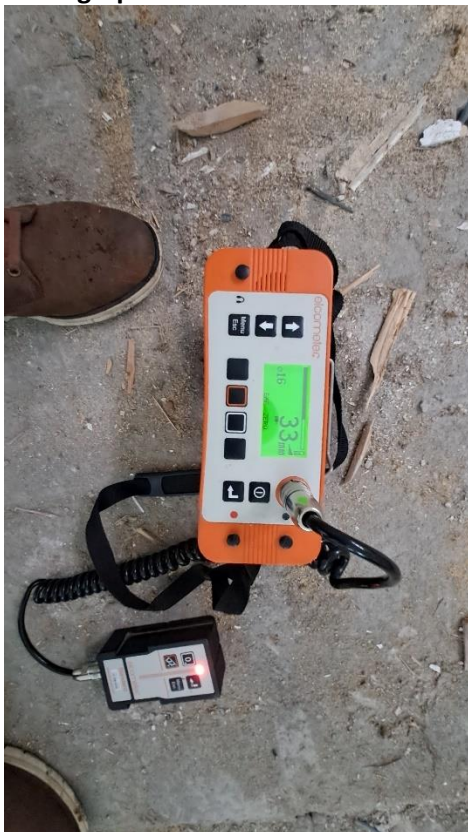
**Photograph 20 – Covermeter survey**

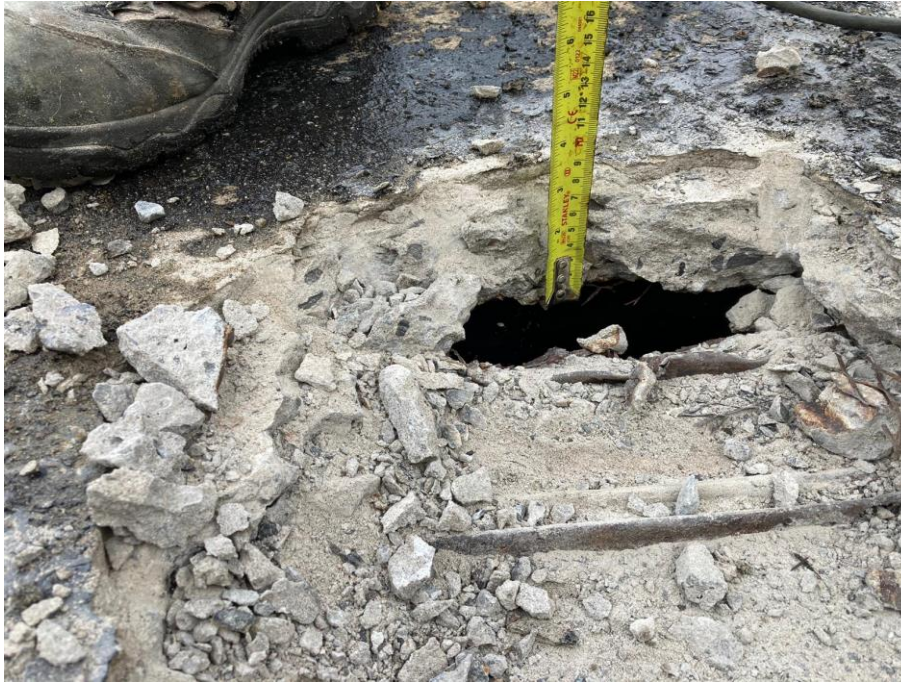
The roof to the majority of the property is constructed from a reinforced concrete slab which has been measured at 85-90mm thick with mild steel reinforcing bars at regular spacing throughout. The depth of slab would not be designed at this thickness nowadays, with a minimum slab thickness typically 150-200mm which gives sufficient availability of cover to the reinforcing bars to be robust and have longevity.

**Photograph 23 – Concrete roof depth 80-100mm**

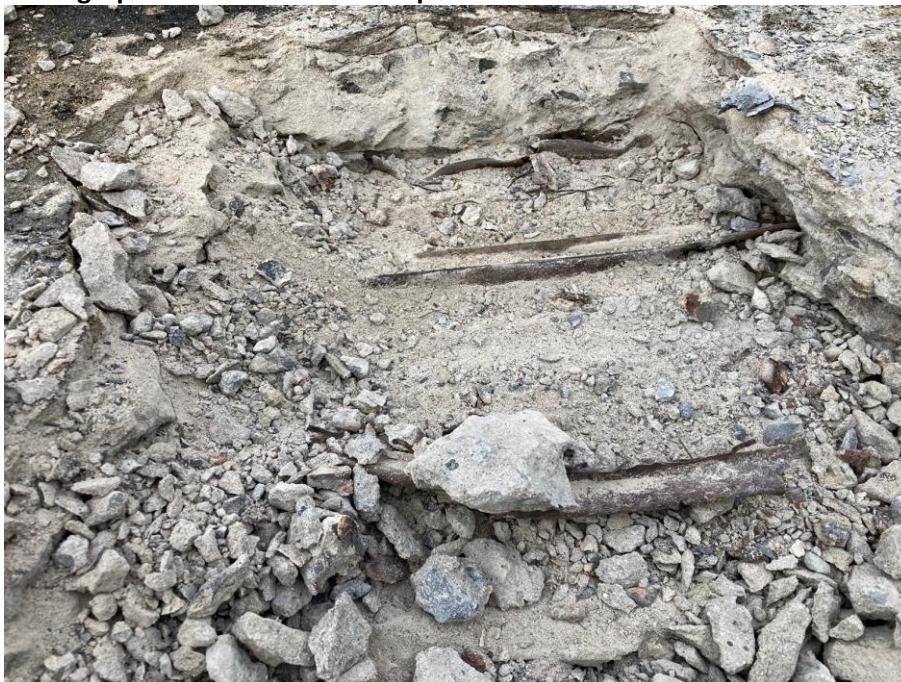
**Photograph 24 – Corroded steel within roof structure**

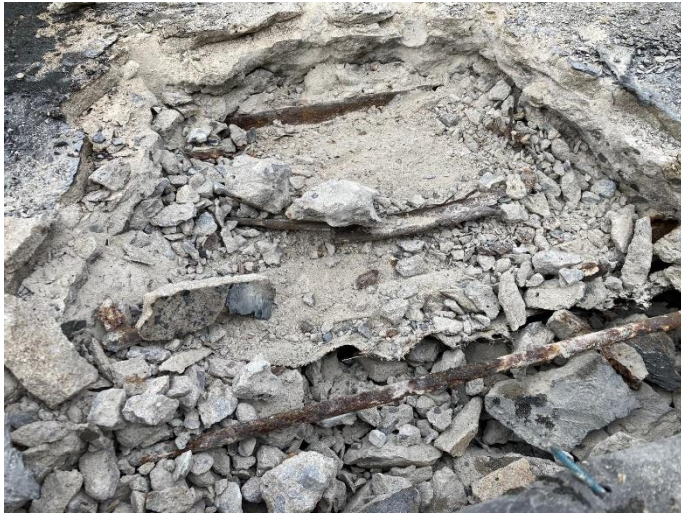
**Photograph 25 – Corroded steel within roof structure**
