## Method Statement

### Neath Masonic Hall

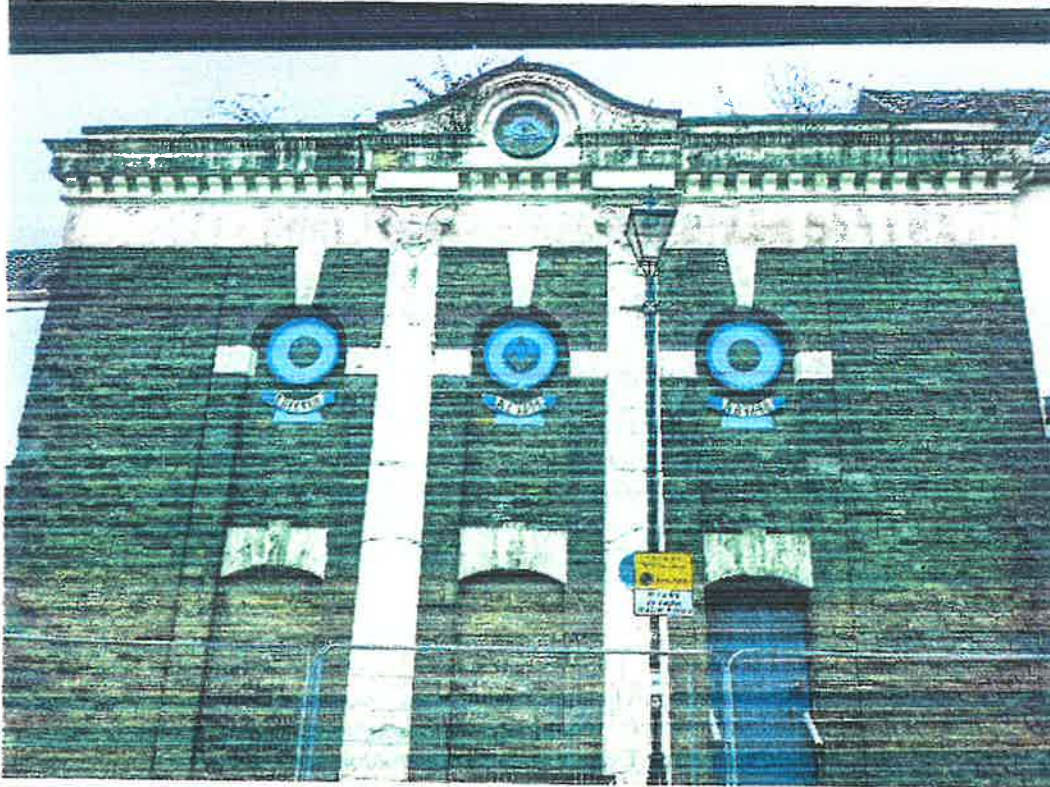
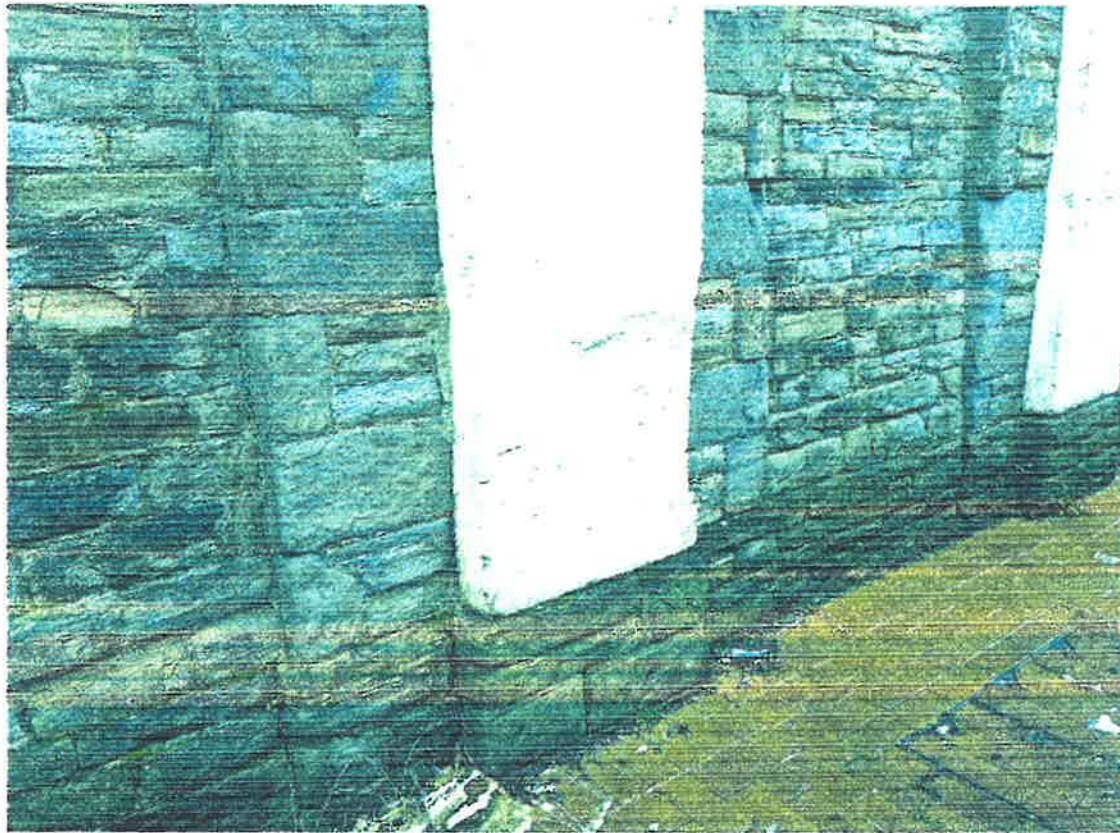
The Bath stone masonry has been painted over in the past and has started to blister in various areas. Generally, this happens when the stonework has become dirty, carbonated, or damaged with the repairs carried out using a general filler, such as a cement-based mortar. The paint is then used to mask this over and make the masonry look clean. Unfortunately, this does not help the oolitic limestone beneath as it is prevented from breathing adequately. It is impossible to determine the amount of damage that has occurred. Especially until the paint has been stripped off the surface to show the stone below.

Any damaged stone will need to be cut out and replaced by indenting the damage with new matching Bath stone.

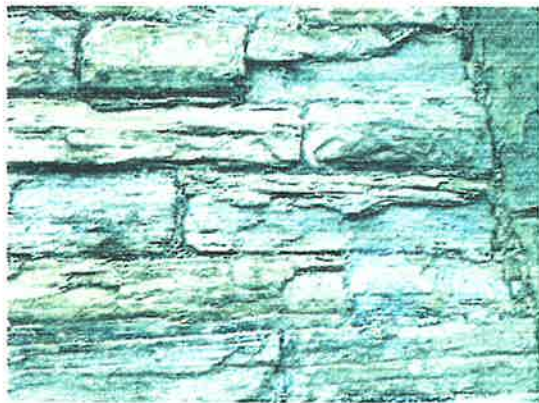
The pennant stone needs to be checked over and defrassed. Much of the rubble has weathered over the years with temperature expansion, contraction, frost, and rain erosion. This allows many of the stone faces to start peeling away. Much of it has become loose and therefore becomes a hazard to the public as it detaches from the surface. Defrassing is the process of removing these flakes, and pieces of loose stone before they have a chance to fall. In many areas the pointing has become soft leaving many open and defective joints. This is particularly bad to the 'plinth' areas of the wall where it has also been affected by salt on the road/pathway. Once the stonework has been fully defrassed the wall will need all of its defective masonry joints raked out and refilled with a matching lime mortar. Care must be taken to leave no ledges and water traps where moisture can settle. There has been an estimation of 40% of the wall is in need of repointing. The new mortar for repointing will be as close as possible to the existing both in colour and in aggregate content. The new mortar will always show a slightly lighter colour difference to the original until the lime content has toned back.

There are a number of quoins that will need to be replaced/repared as the weathering process has left them without structural integrity or significant sections missing.

5/ Defras the pennant random rubble stone. Using hand tools, test and remove all loose flakes and stone faces where there is a risk of detachment.

7/ Replace/indent all identified elements of Pennant stone noted for repair.

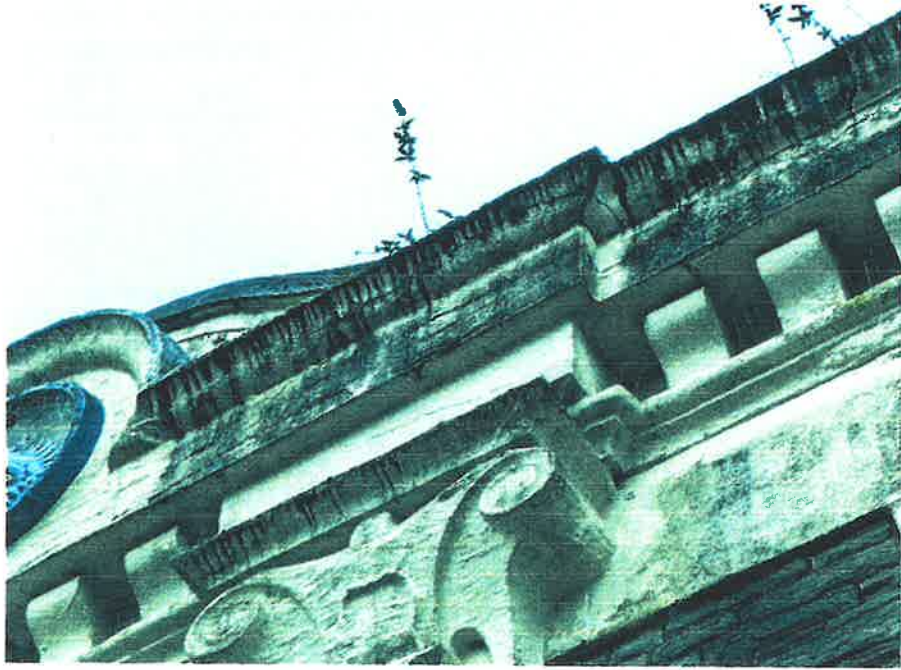
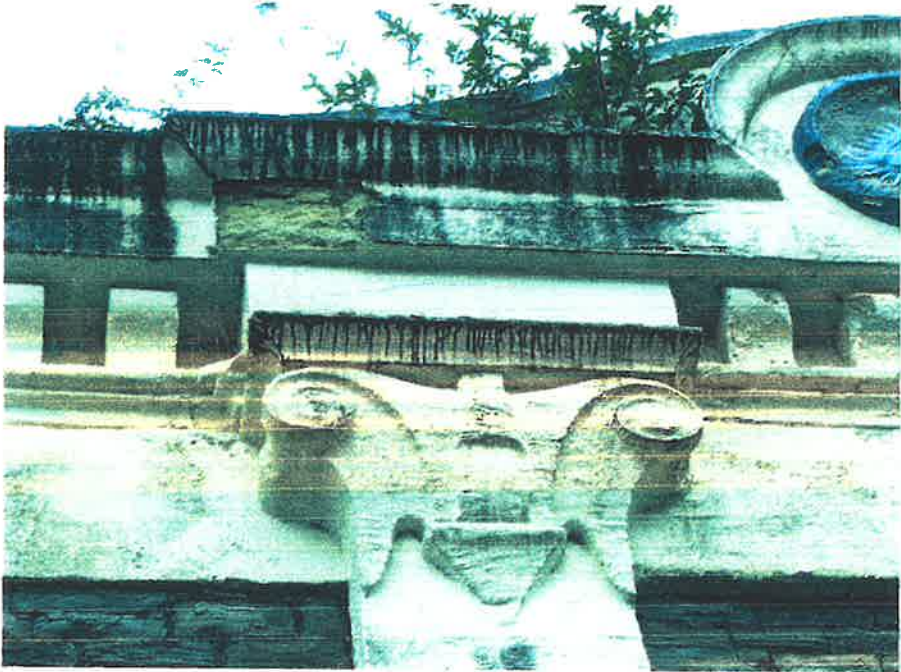
No visual inspection was able to be undertaken to the damaged caused by the roots from the Buddleia infestation. This is especially the case with view to the parapet walls and the structure behind. These plants will need to be treated with a suitable biocide to kill off all roots. If this does not happen, and any roots are left alive, the plants will be back within a short period of time. There may be some need to dismantle areas of the masonry, remove the root systems, and rebuild. I cannot determine this until a full, up-close inspection can be carried out.

2/ Use a glyphosate herbicide on the plant growth to the façade and leave for a recommended time period for the plants to die back. This may not work fully the first time and may need a second application. Once the plant has died back, remove the branches and stems. Remove as much root as possible. The masonry elements may need dismantling and rebuilding where the plant growth has caused separation to the components.

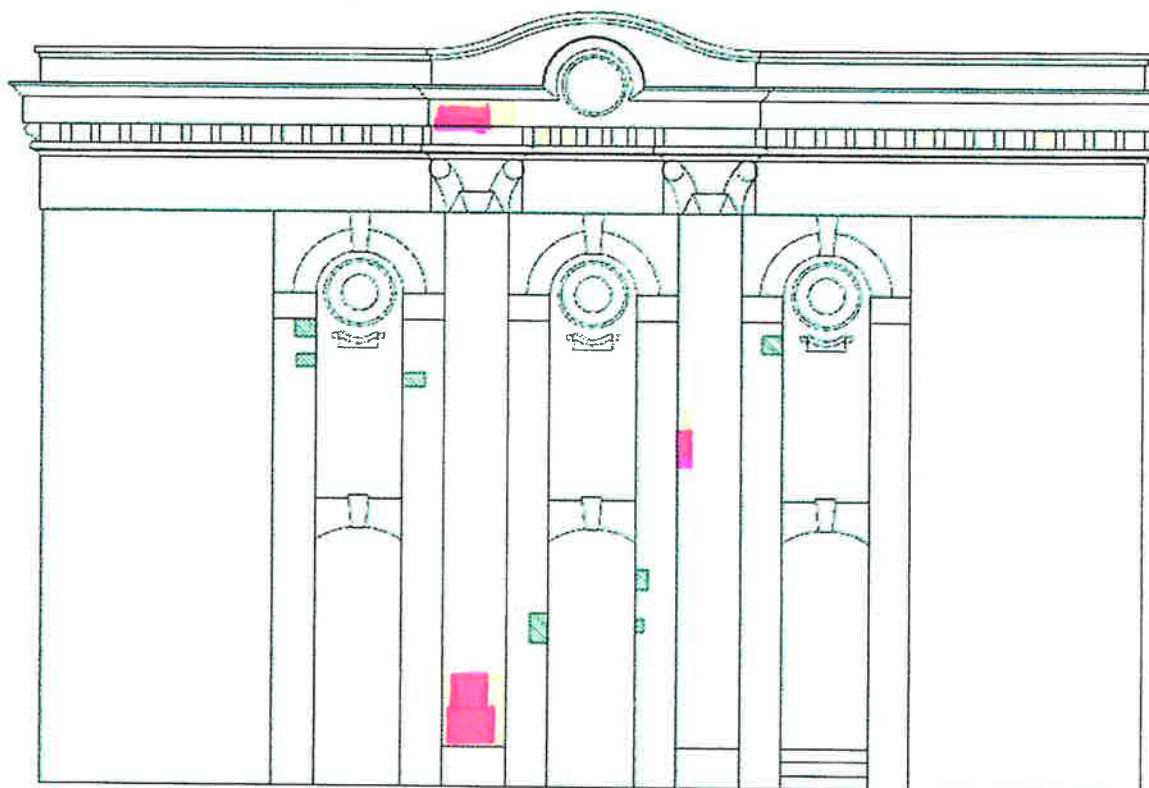
The diagram above shows the approximate areas of the damaged stone that is in need of replacement or indenting. The red indicates where Bath oolitic limestone has been damaged and the green is where the pennant stone requires attention. This may vary slightly once the high-level masonry has been inspected in greater detail.

6/ Replace/indent all identified elements of Bath stone noted for repair. All stone is to be pinned in place with stainless steel threaded bar and resin.
