# **ARBORICULTURAL REPORT**

## **Health and Condition Survey**

**Rear of 107/109 March Hywel  
Cilfrew  
Neath**

**Date: April 2025**

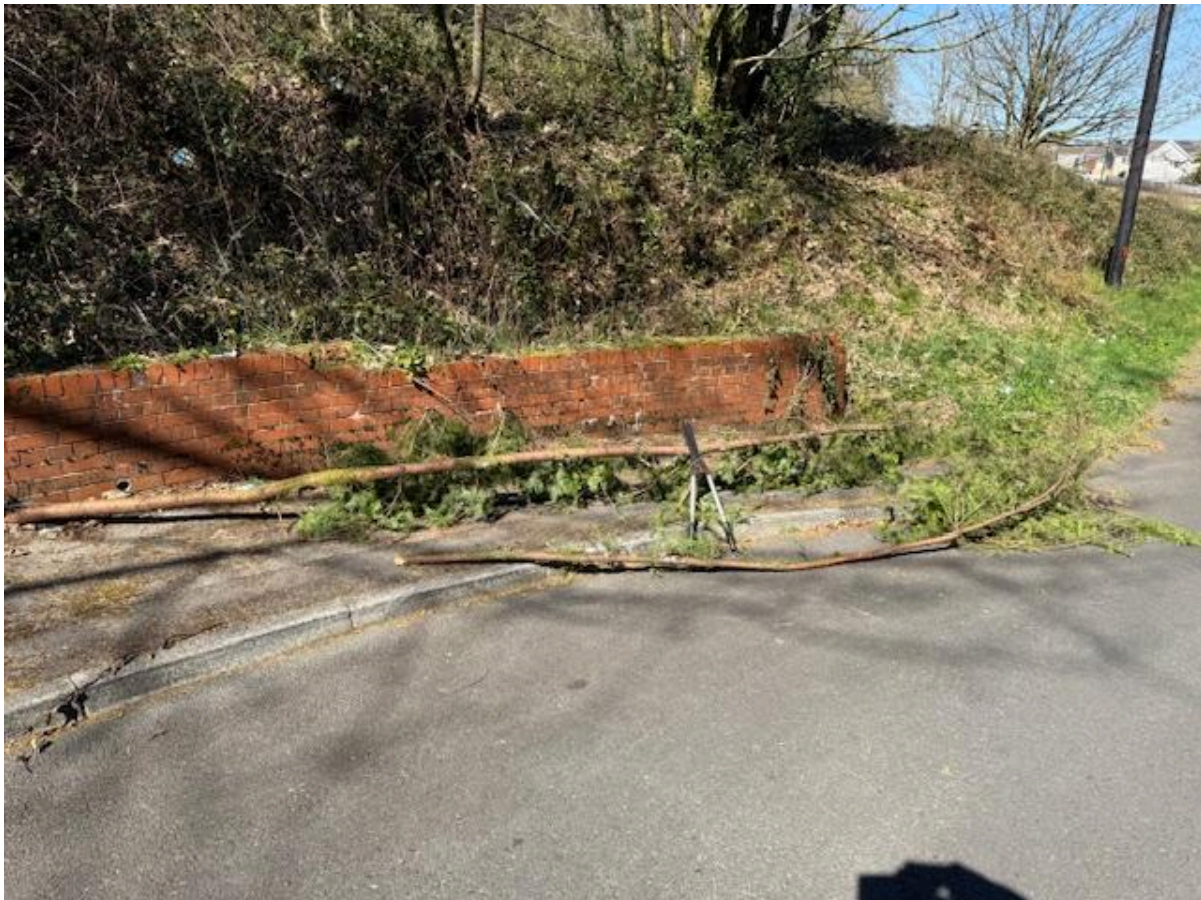
2.5 At their nearest point the trees are five metres from the house of 107 March Hywel and the branches overhang the roof by a number of metres. This is causing significant light reduction and maintenance issues and has resulted in debris such as leaves and branches falling onto the roof, rear garden areas and highway. As shown in IMAGE A a number of these branches were in excess of six metres in length.

**IMAGE A: Some of the fractured branches**

1. If these trees are not removed they will continue to increase in height which will increase their wind resistance and the risk of further branch failures and possibly stem or root failure. Due to the above facts I would recommend that the 62 conifers are removed to near ground level.

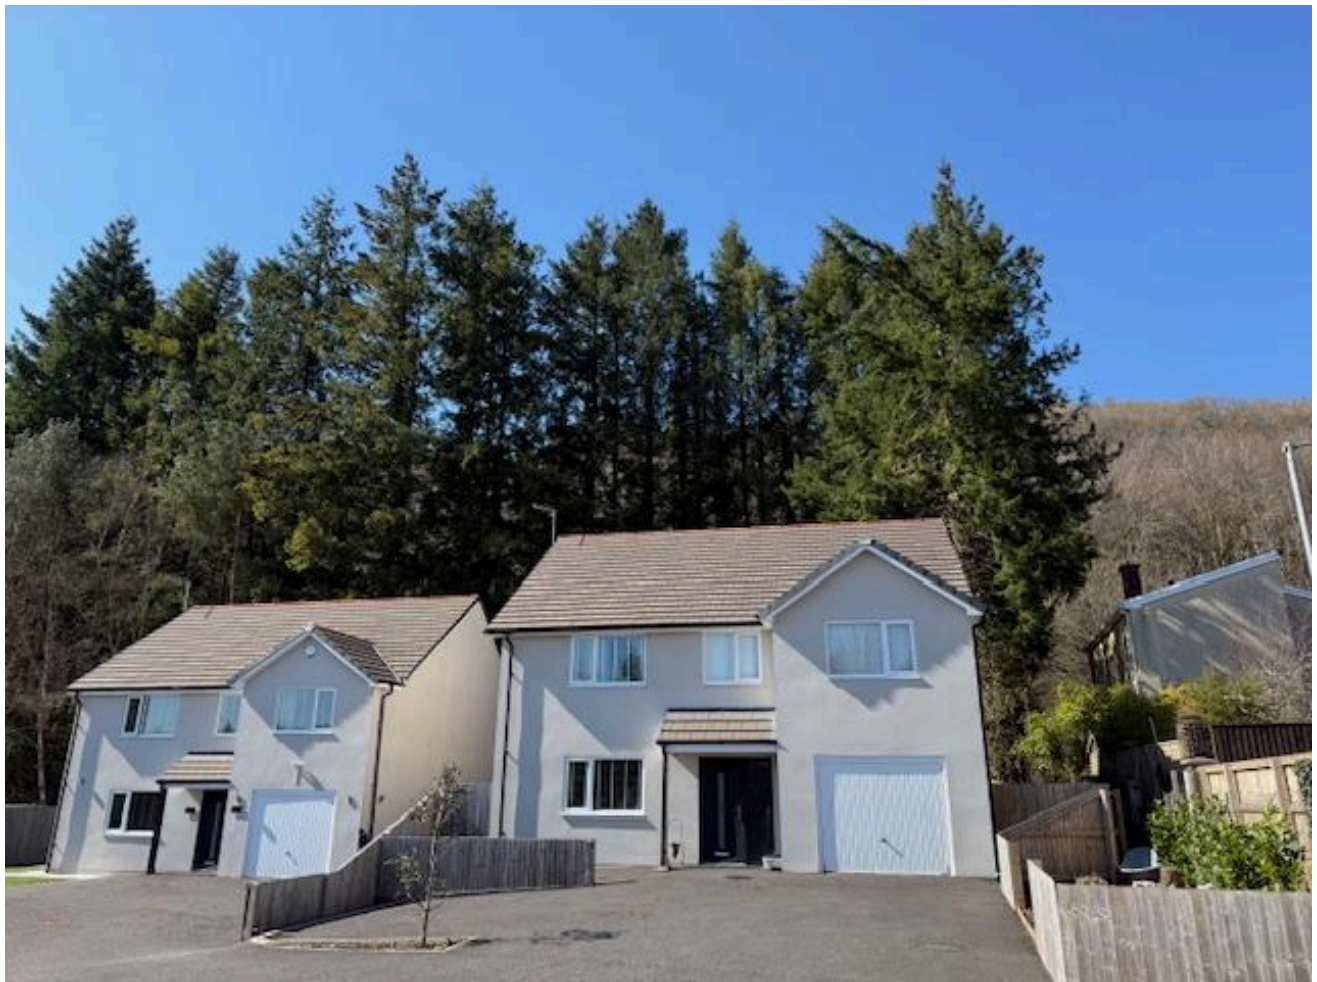
2.7 As shown in IMAGE B below the trees are a significant height above the roof of the two dwellings. Due to their species, increasing growth and wind exposure the trees are now shedding large branches on a regular basis.

**IMAGE B: The group of trees to the rear of the houses**

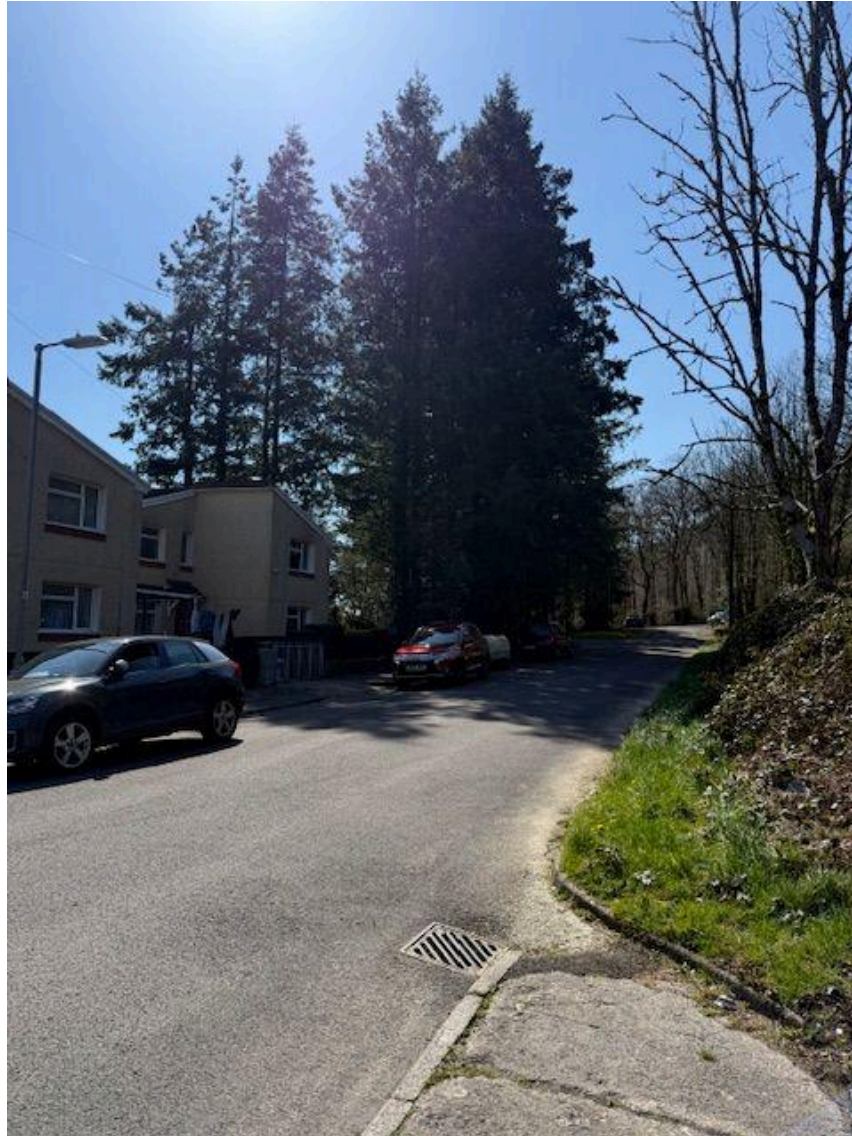
**IMAGE C: The trees looking south**
