## Drainage Survey Report

**Job Number : 18075**

**Project Name: Former Swelco Factory, Cwmgors**

**Company: Bluefield Land**

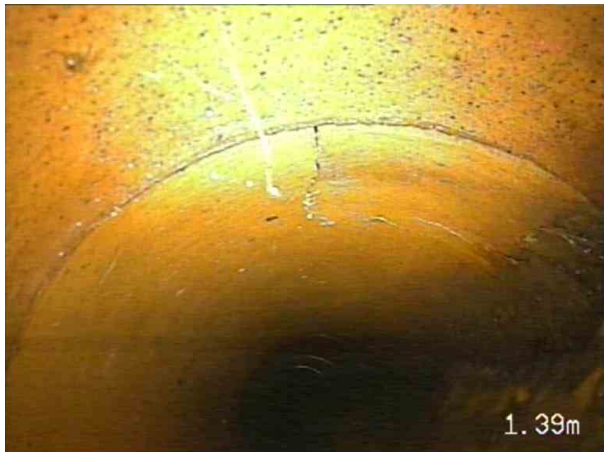
| Scale: 1:120 | Position [m] | Code | Observation | MPEG | Photo | Grade |
|---|---|---|---|---|---|---|
| | 1.39 | FLJ | Fracture, longitudinal at joint at 4 o'clock | 00:00:46 | 1 | 3 / 2 |

1, 00:00:46, 1.39 m  
Fracture, longitudinal at joint at 4 o'clock

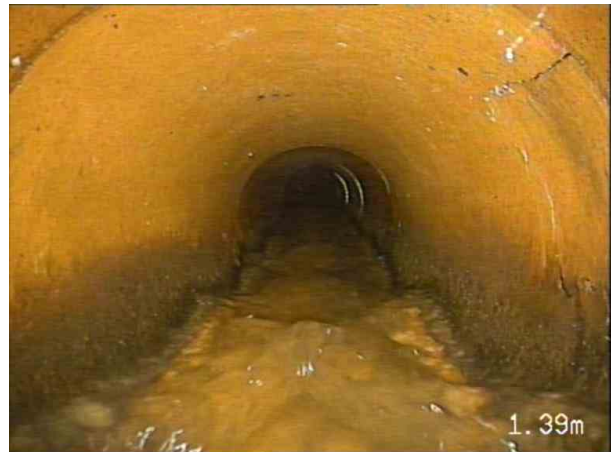
| Scale: 1:120 | Position [m] | Code | Observation | MPEG | Photo | Grade |
|---|---|---|---|---|---|---|
| | 1.39 | FLJ | Fracture, longitudinal at joint at 2 o'clock | 00:00:52 | 2 | 3 / 2 |

2, 00:00:52, 1.39 m  
Fracture, longitudinal at joint at 2 o'clock

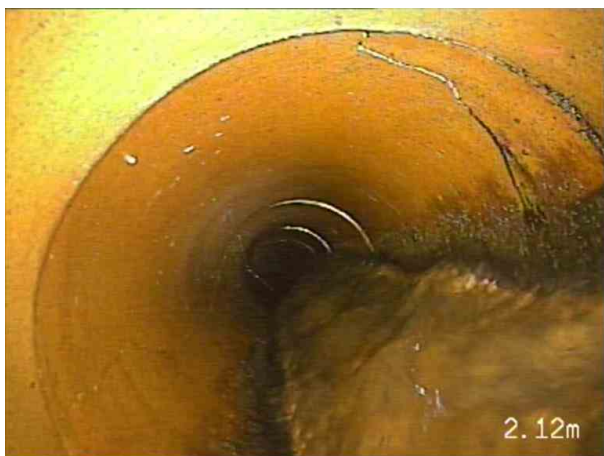
| Scale: 1:120 | Position [m] | Code | Observation | MPEG | Photo | Grade |
|---|---|---|---|---|---|---|
| | 2.12 | FCJ | Fracture, circumferential at joint from 2 o'clock to 4 o'clock | 00:01:10 | 3 | 3 / 2 |

3, 00:01:10, 2.12 m  
Fracture, circumferential at joint from 2 o'clock to 4 o'clock

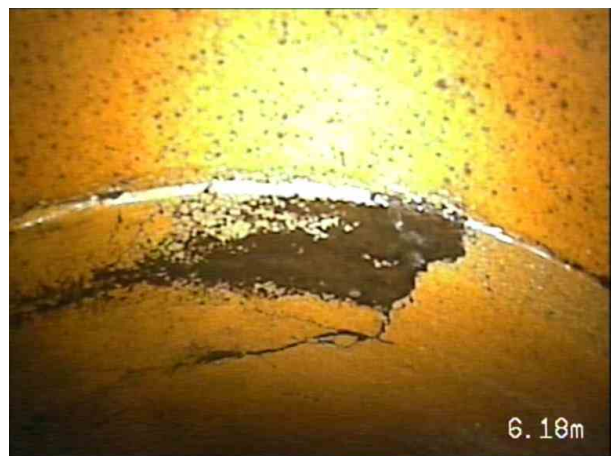
| Scale: 1:120 | Position [m] | Code | Observation | MPEG | Photo | Grade |
|---|---|---|---|---|---|---|
| | 6.18 | FSJ | Fracture, spiral at joint from 8 o'clock to 10 o'clock | 00:02:32 | 4 | 4 / 2 |

4, 00:02:32, 6.18 m  
Fracture, spiral at joint from 8 o'clock to 10 o'clock

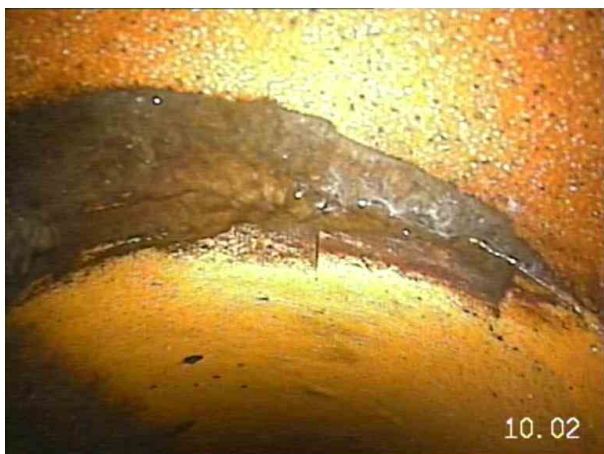
| Scale: 1:120 | Position [m] | Code | Observation | MPEG | Photo | Grade |
|---|---|---|---|---|---|---|
| | 10.02 | FLJ | Fracture, longitudinal at joint at 10 o'clock | 00:03:33 | 5 | 3 / 2 |

5, 00:03:33, 10.02 m  
Fracture, longitudinal at joint at 10 o'clock

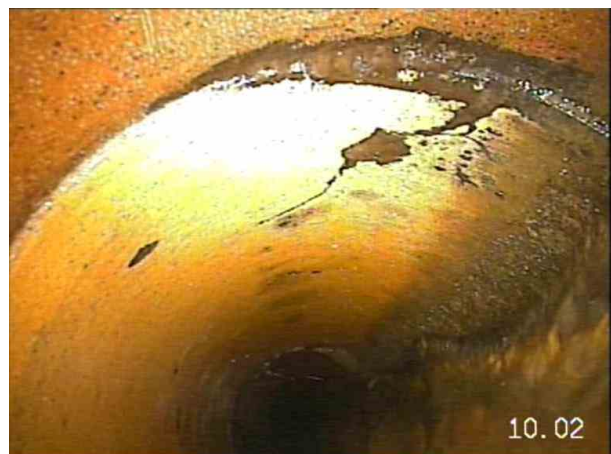
| Scale: 1:120 | Position [m] | Code | Observation | MPEG | Photo | Grade |
|---|---|---|---|---|---|---|
| | 10.02 | FSJ | Fracture, spiral at joint from 1 o'clock to 3 o'clock | 00:03:50 | 6 | 4 / 2 |

6, 00:03:50, 10.02 m  
Fracture, spiral at joint from 1 o'clock to 3 o'clock

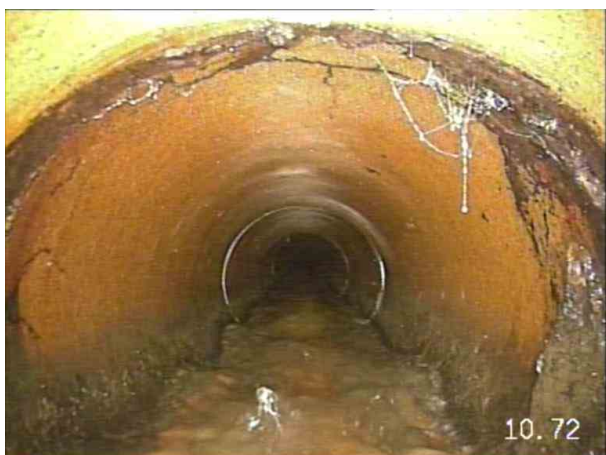
| Scale: | 1:120 | Position [m] | Code | Observation | MPEG | Photo | Grade |
|---|---|---|---|---|---|---|---|
| | | 10.72 | FCJ | Fracture, circumferential at joint from 9 o'clock to 2 o'clock | 00:04:14 | 7 | 3 / 2 |

7, 00:04:14, 10.72 m  
Fracture, circumferential at joint from 9 o'clock to 2 o'clock

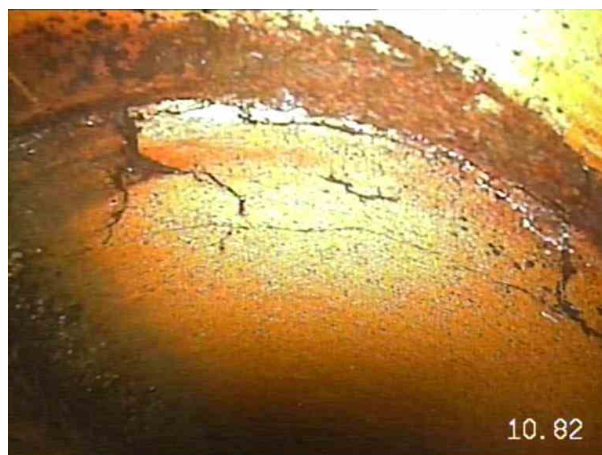
| Scale: | 1:120 | Position [m] | Code | Observation | MPEG | Photo | Grade |
|---|---|---|---|---|---|---|---|
| | | 10.82 | FLJ | Fracture, longitudinal at joint at 9 o'clock | 00:04:26 | 8 | 3 / 2 |

8, 00:04:26, 10.82 m  
Fracture, longitudinal at joint at 9 o'clock

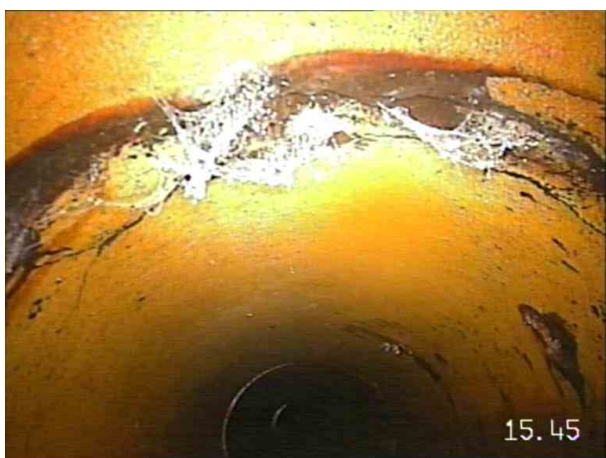
| Scale: | 1:120 | Position [m] | Code | Observation | MPEG | Photo | Grade |
|---|---|---|---|---|---|---|---|
| | | 15.45 | FCJ | Fracture, circumferential at joint from 10 o'clock to 2 o'clock | 00:05:37 | 9 | 3 / 2 |

9, 00:05:37, 15.45 m  
Fracture, circumferential at joint from 10 o'clock to 2 o'clock

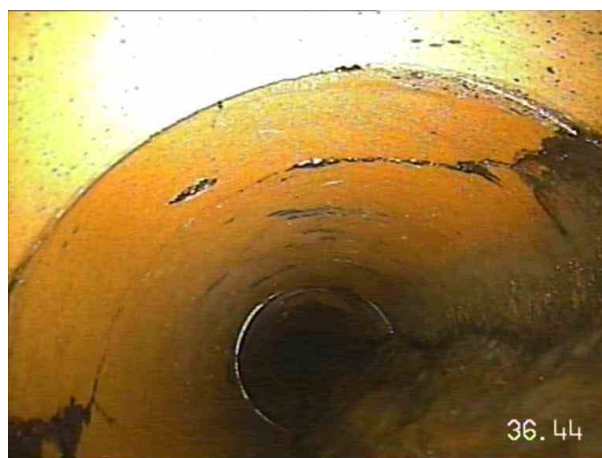
| Scale: | 1:120 | Position [m] | Code | Observation | MPEG | Photo | Grade |
|---|---|---|---|---|---|---|---|
| | | 36.44 | FLJ | Fracture, longitudinal at joint at 3 o'clock | 00:10:36 | 10 | 3 / 2 |

10, 00:10:36, 36.44 m  
Fracture, longitudinal at joint at 3 o'clock

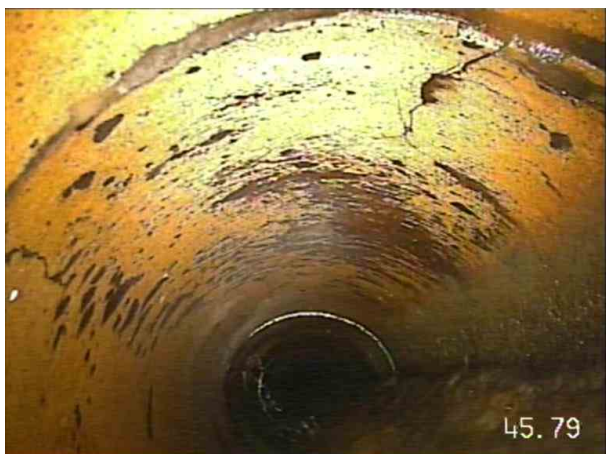
| Scale: | 1:120 | Position [m] | Code | Observation | MPEG | Photo | Grade |
|---|---|---|---|---|---|---|---|
| | | 45.79 | FLJ | Fracture, longitudinal at joint at 3 o'clock | 00:12:27 | 11 | 3 / 2 |

11, 00:12:27, 45.79 m  
Fracture, longitudinal at joint at 3 o'clock

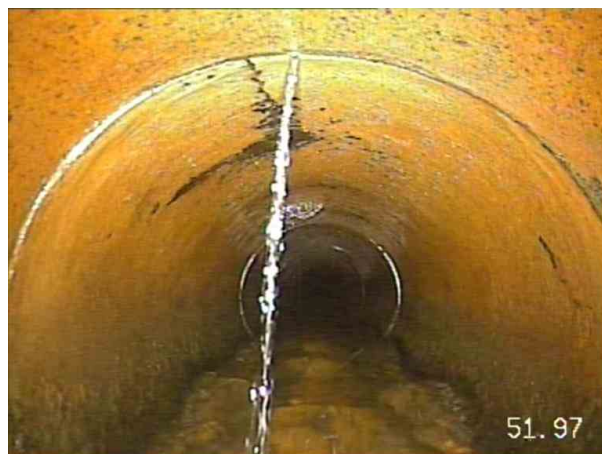
| Scale: 1:120 | Position [m] | Code | Observation | MPEG | Photo | Grade |
|---|---|---|---|---|---|---|
| | 51.97 | IR | Infiltration, running at 12 o'clock | 00:13:56 | 12 | |

12, 00:13:56, 51.97 m  
Infiltration, running at 12 o'clock

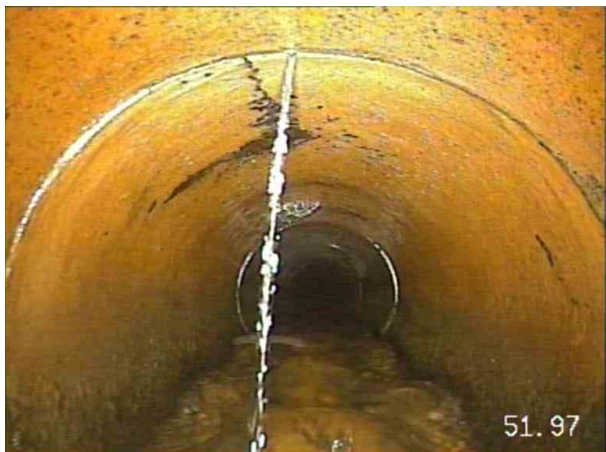
| Scale: 1:120 | Position [m] | Code | Observation | MPEG | Photo | Grade |
|---|---|---|---|---|---|---|
| | 51.97 | FLJ | Fracture, longitudinal at joint at 11 o'clock | 00:13:59 | 13 | 3 / 2 |

13, 00:13:59, 51.97 m  
Fracture, longitudinal at joint at 11 o'clock

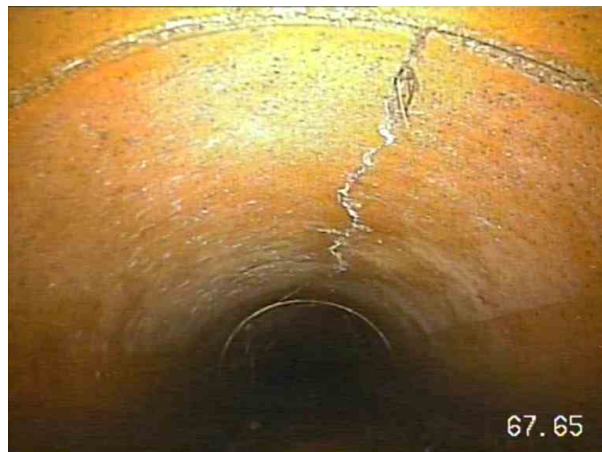
| Scale: 1:120 | Position [m] | Code | Observation | MPEG | Photo | Grade |
|---|---|---|---|---|---|---|
| | 67.65 | FLJ | Fracture, longitudinal at joint at 12 o'clock | 00:16:59 | 14 | 3 / 2 |

14, 00:16:59, 67.65 m  
Fracture, longitudinal at joint at 12 o'clock

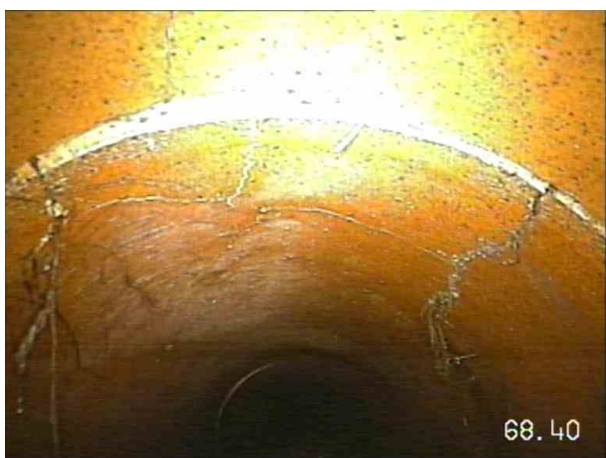
| Scale: | 1:120 | Position [m] | Code | Observation | MPEG | Photo | Grade |
|---|---|---|---|---|---|---|---|
| | | 68.40 | FSJ | Fracture, spiral at joint from 12 o'clock to 1 o'clock | 00:17:40 | 15 | 4 / 2 |

15, 00:17:40, 68.40 m  
Fracture, spiral at joint from 12 o'clock to 1 o'clock

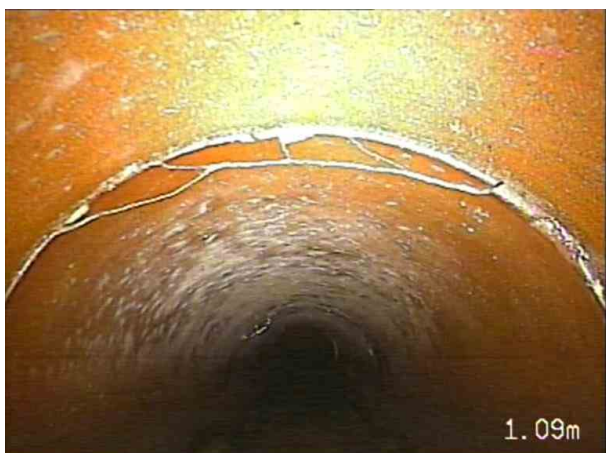
| Scale: 1:230 | Position [m] | Code | Observation | MPEG | Photo | Grade |
|---|---|---|---|---|---|---|
| | 1.09 | FMJ | Fractures, multiple at joint from 10 o'clock to 1 o'clock | 00:00:21 | 1 | 4 / 2 |

1, 00:00:21, 1.09 m  
Fractures, multiple at joint from 10 o'clock to 1 o'clock

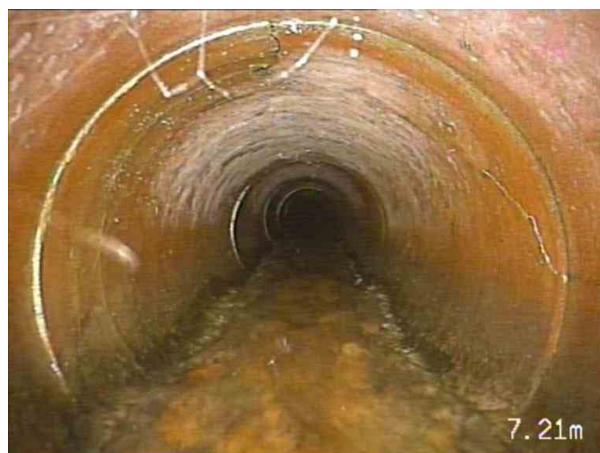
| Scale: 1:230 | Position [m] | Code | Observation | MPEG | Photo | Grade |
|---|---|---|---|---|---|---|
| | 7.21 | FLJ | Fracture, longitudinal at joint at 12 o'clock | 00:01:25 | 2 | 3 / 2 |

2, 00:01:25, 7.21 m  
Fracture, longitudinal at joint at 12 o'clock

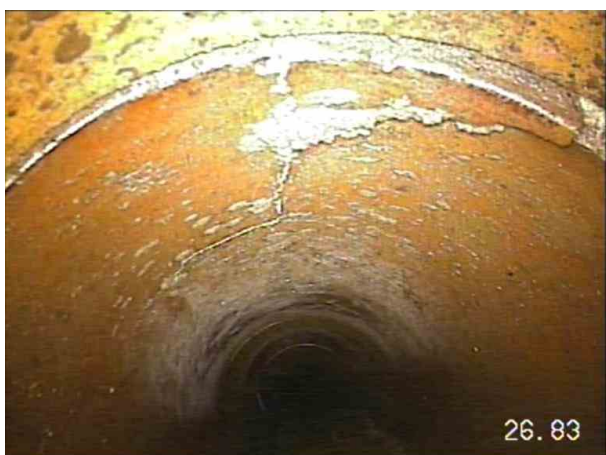
| Scale: | 1:230 | Position [m] | Code | Observation | MPEG | Photo | Grade |
|---|---|---|---|---|---|---|---|
| | | 26.83 | BJ | Broken pipe at joint from 1 o'clock to 2 o'clock | 00:04:00 | 3 | 4 |

3, 00:04:00, 26.83 m  
Broken pipe at joint from 1 o'clock to 2 o'clock

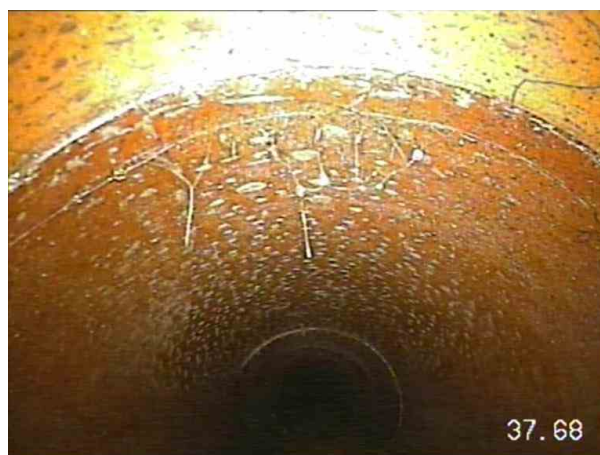
| Scale: | 1:230 | Position [m] | Code | Observation | MPEG | Photo | Grade |
|---|---|---|---|---|---|---|---|
| | | 37.68 | FSJ | Fracture, spiral at joint from 10 o'clock to 2 o'clock | 00:06:18 | 4 | 4 / 2 |

4, 00:06:18, 37.68 m  
Fracture, spiral at joint from 10 o'clock to 2 o'clock

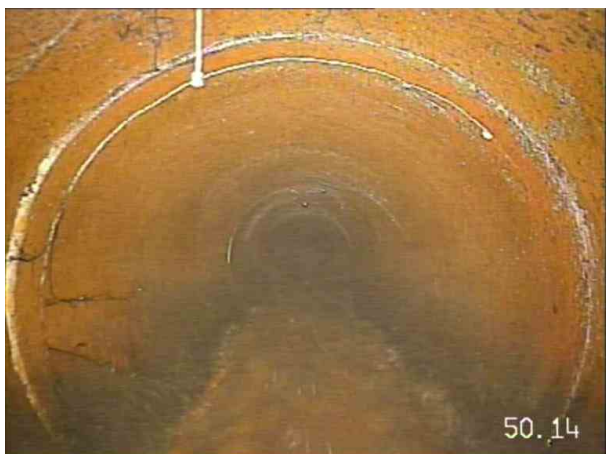
| Scale: | 1:230 | Position [m] | Code | Observation | MPEG | Photo | Grade |
|---|---|---|---|---|---|---|---|
| | | 50.14 | FCJ | Fracture, circumferential at joint from 7 o'clock to 2 o'clock | 00:08:21 | 5 | 3 / 2 |

5, 00:08:21, 50.14 m  
Fracture, circumferential at joint from 7 o'clock to 2 o'clock

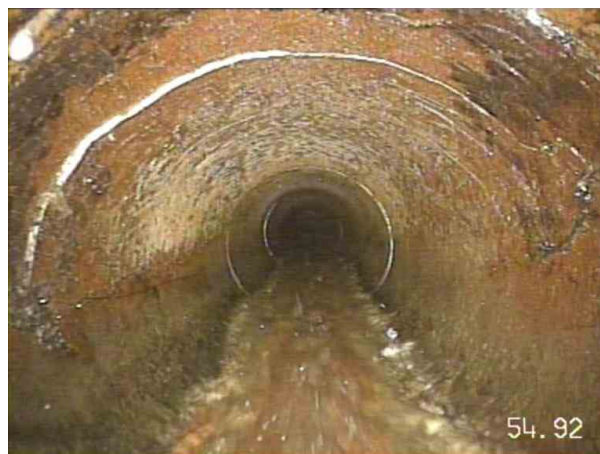
| Scale: | 1:230 | Position [m] | Code | Observation | MPEG | Photo | Grade |
|---|---|---|---|---|---|---|---|
| | | 54.92 | BJ | Broken pipe at joint from 8 o'clock to 2 o'clock | 00:09:33 | 6 | 4 |

6, 00:09:33, 54.92 m  
Broken pipe at joint from 8 o'clock to 2 o'clock

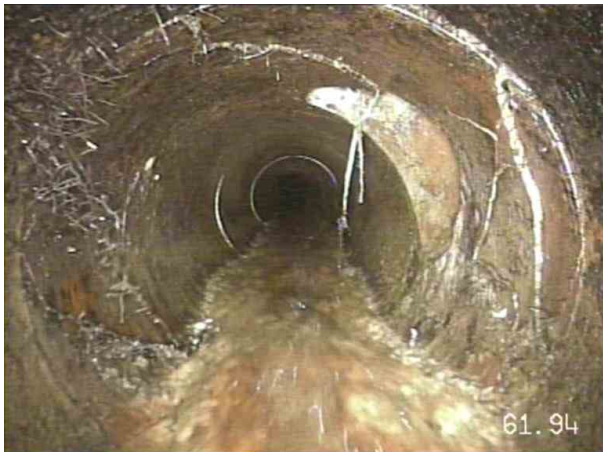
| Scale: | 1:230 | Position [m] | Code | Observation | MPEG | Photo | Grade |
|---|---|---|---|---|---|---|---|
| | | 61.94 | BJ | Broken pipe at joint from 2 o'clock to 4 o'clock | 00:10:41 | 7 | 4 |

7, 00:10:41, 61.94 m  
Broken pipe at joint from 2 o'clock to 4 o'clock

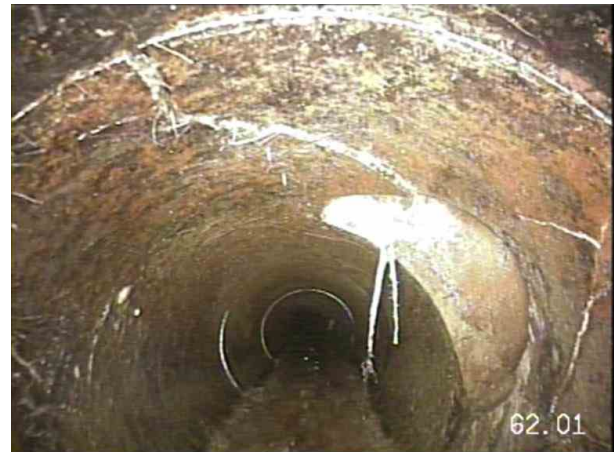
| Scale: | 1:230 | Position [m] | Code | Observation | MPEG | Photo | Grade |
|---|---|---|---|---|---|---|---|
| | | 62.01 | BJ | Broken pipe at joint from 11 o'clock to 4 o'clock | 00:10:50 | 8 | 4 |

8, 00:10:50, 62.01 m  
Broken pipe at joint from 11 o'clock to 4 o'clock

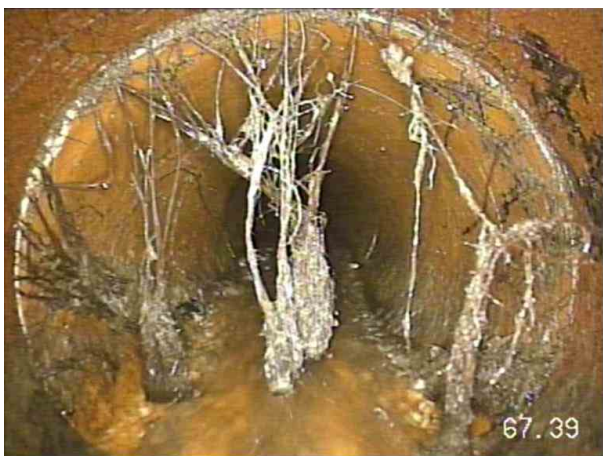
9, 00:11:58, 67.39 m  
Roots, mass, 10% cross-sectional area loss

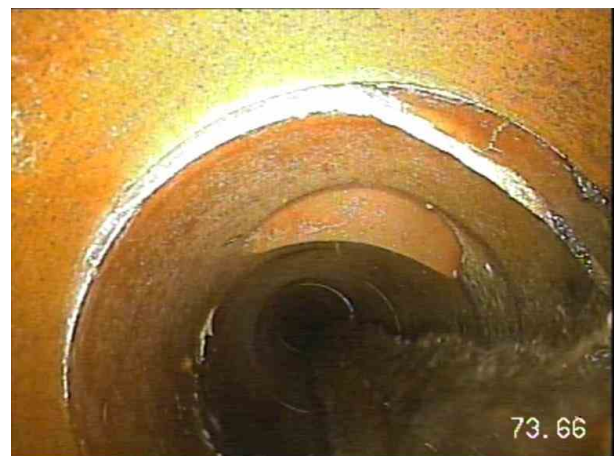
| Scale: | 1:230 | Position [m] | Code | Observation | MPEG | Photo | Grade |
|---|---|---|---|---|---|---|---|
| | | 73.66 | BJ | Broken pipe at joint from 2 o'clock to 5 o'clock | 00:12:56 | 10 | 4 |

10, 00:12:56, 73.66 m  
Broken pipe at joint from 2 o'clock to 5 o'clock

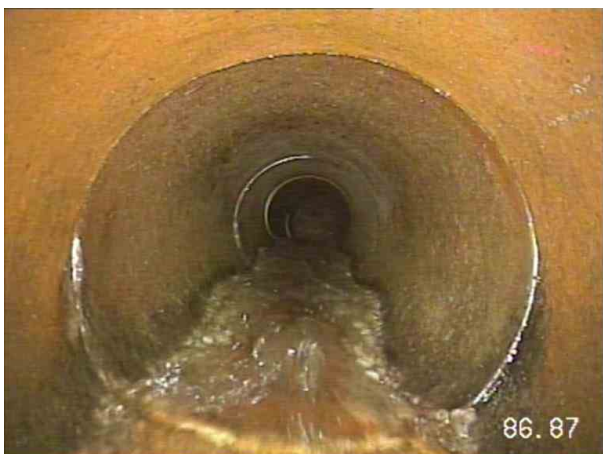
| Scale: | 1:230 | Position [m] | Code | Observation | MPEG | Photo | Grade |
|---|---|---|---|---|---|---|---|
| | | 86.87 | IRJ | Infiltration, running at joint at 9 o'clock | 00:14:29 | 11 | |

11, 00:14:29, 86.87 m  
Infiltration, running at joint at 9 o'clock

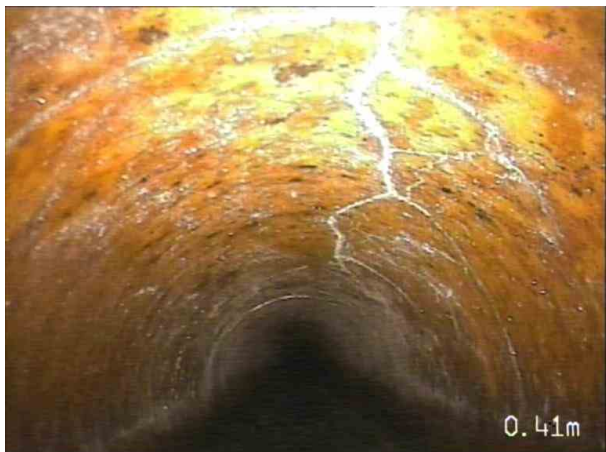
1, 00:00:25, 0.45 m

| Scale: 1:158 | Position [m] | Code | Observation | MPEG | Photo | Grade |
|---|---|---|---|---|---|---|
| | 0.45 | CMJ | Cracks, multiple at joint from 10 o'clock to 3 o'clock | 00:00:25 | 1 | 3 / 2 |

Cracks, multiple at joint from 10 o'clock to 3 o'clock
