## **PRELIMINARY ROOST ASSESSMENT FOR PRESENCE OF BAT ROOSTS:**

92 Cimla Crescent, Cimla, Neath SA11 3NP

Date of Survey: 4<sup>th</sup> June 2025

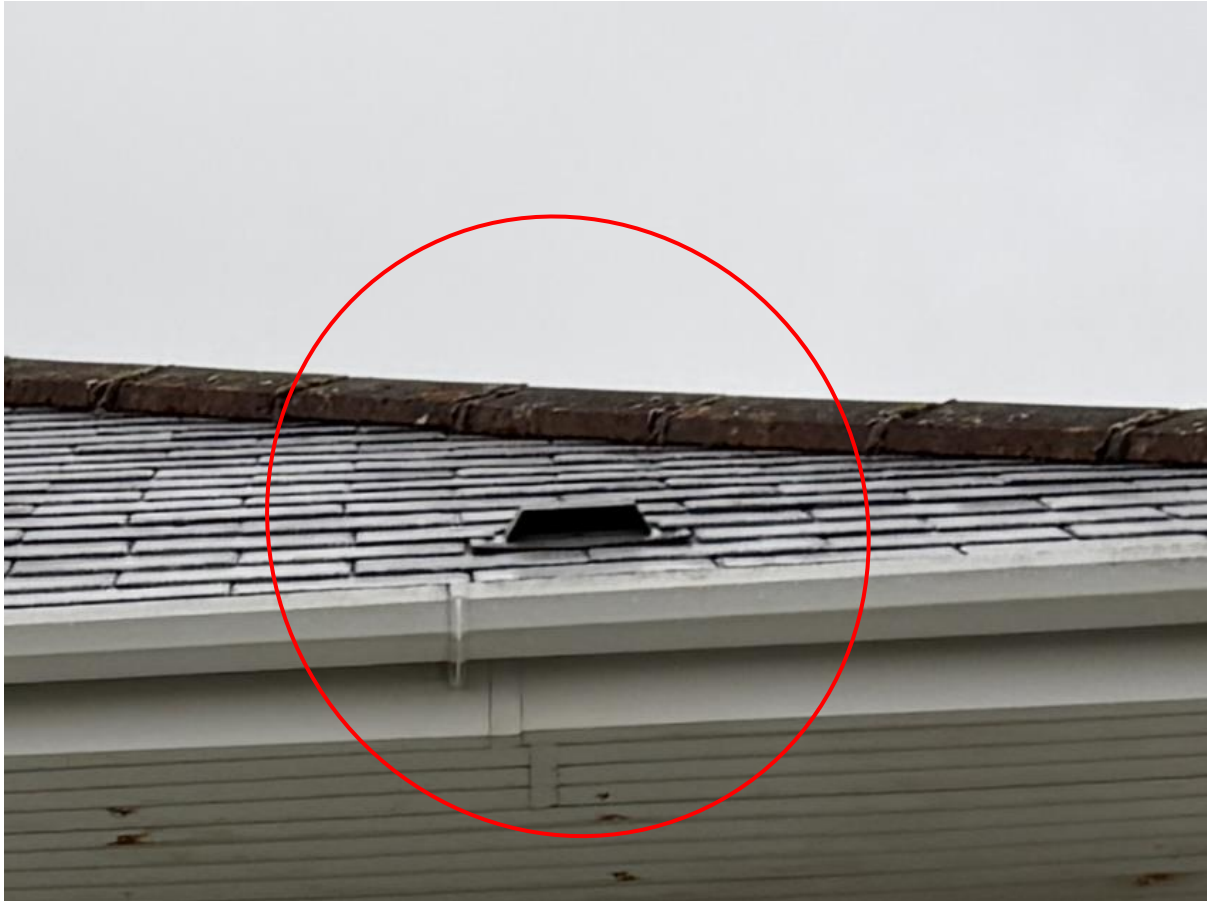
However, there are roof vents which could potentially provide bat access but on closer inspection was covered in spider's webs indicating no use of the gaps and did not allow access into the wider roof void due to the presence of an internal grill.

*Figure 4: Vents with internal grill on the eastern and western aspect of the Roof Covering*

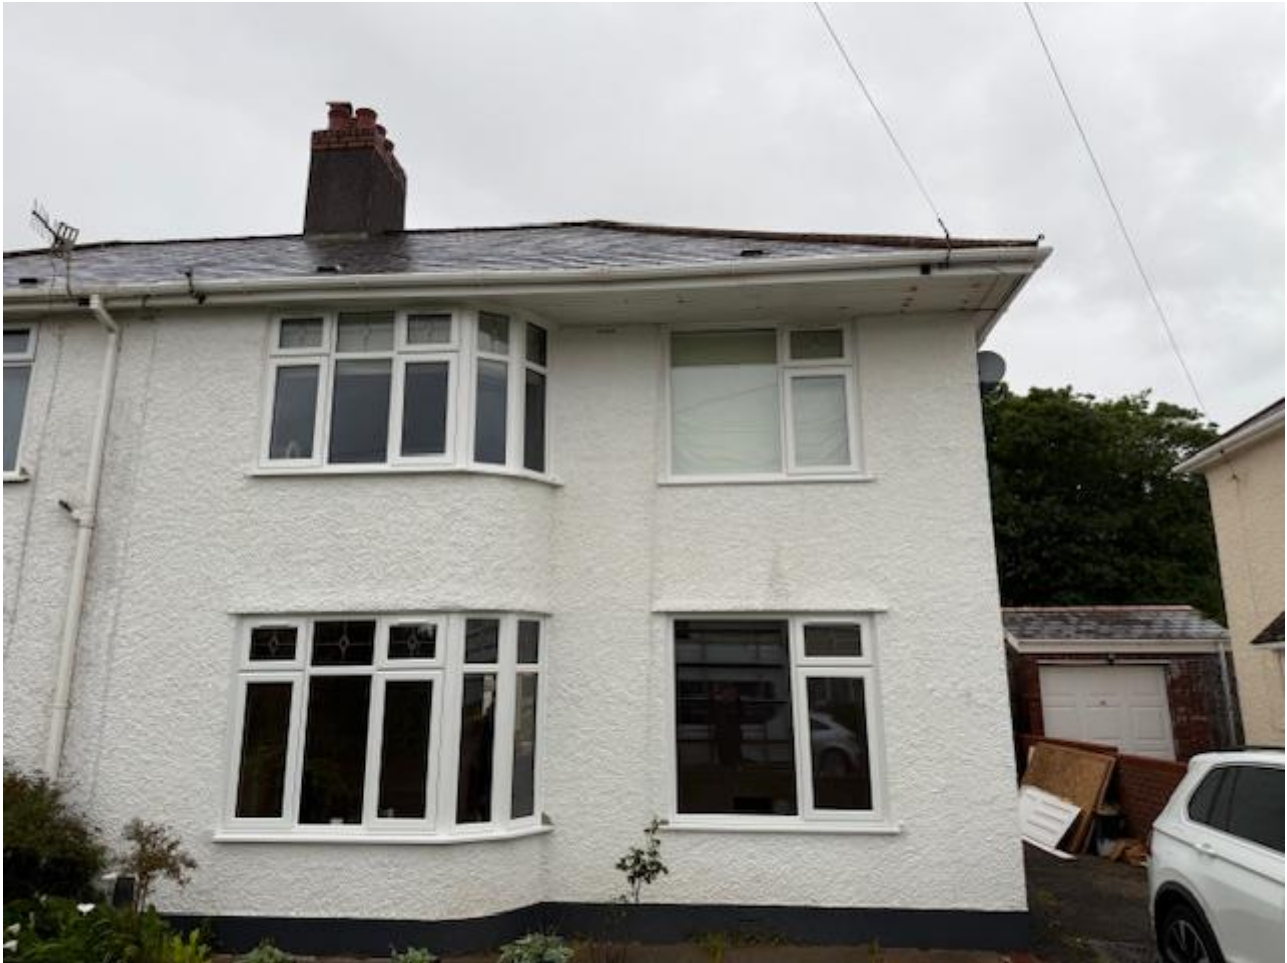
*Figure 5: Roof Surfaces and Walls - front aspect (West aspect)*

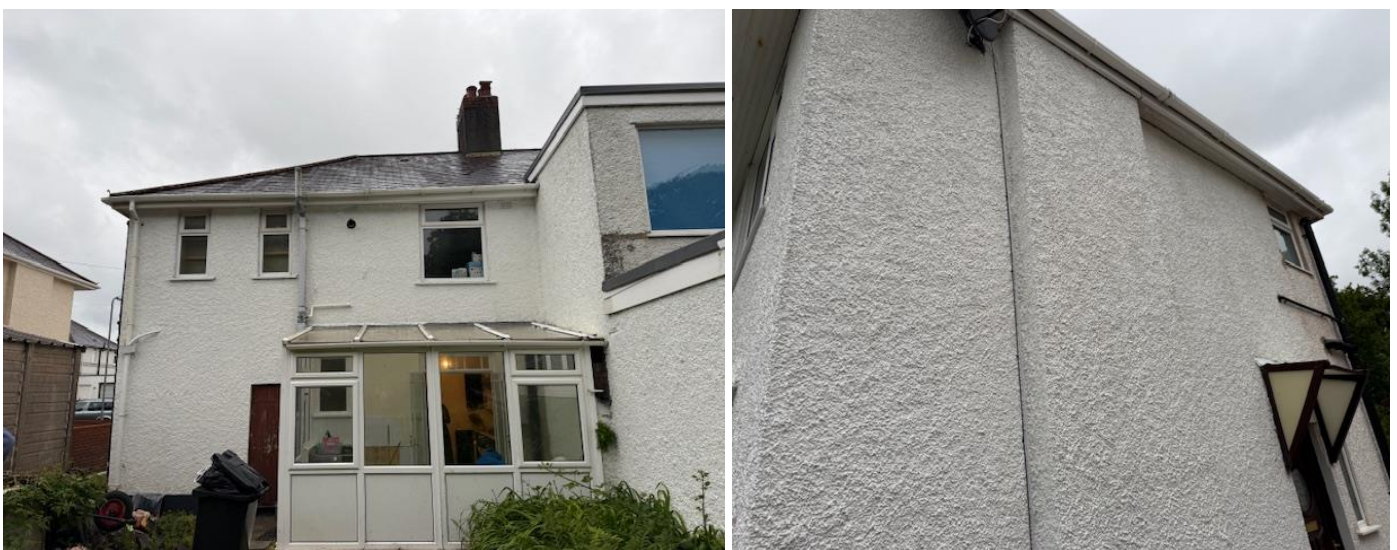
*Figure 6: Roof Surfaces and Walls - eastern and southern aspects*

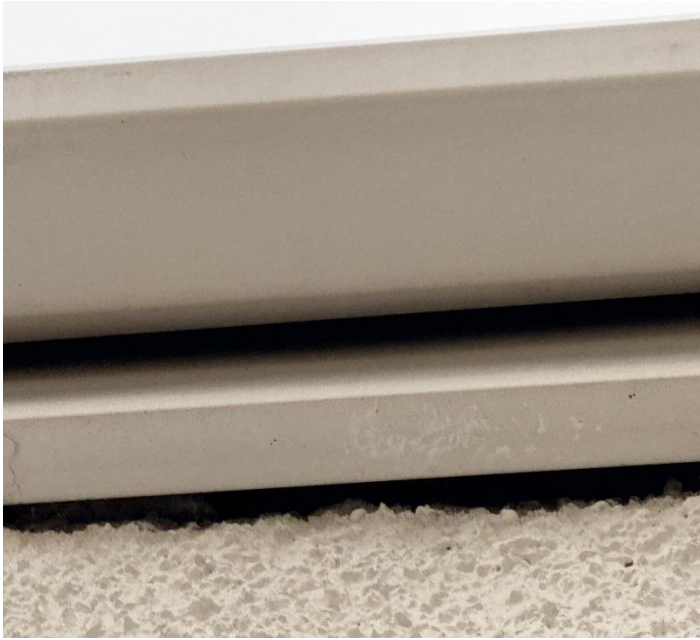
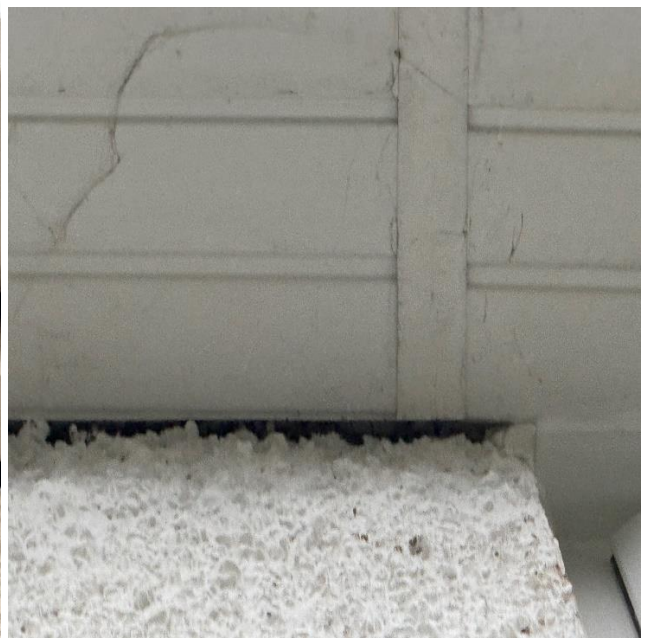
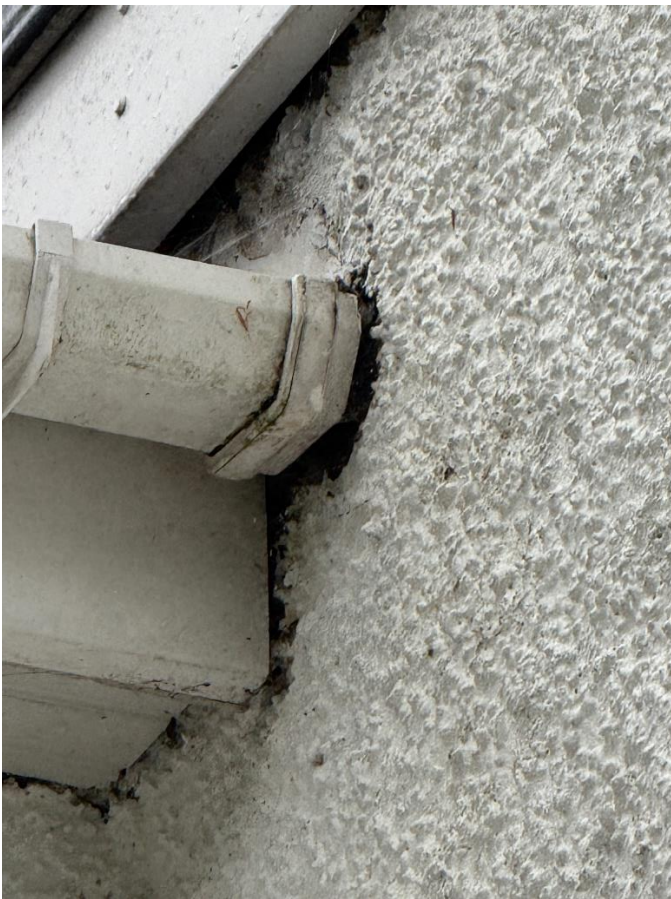
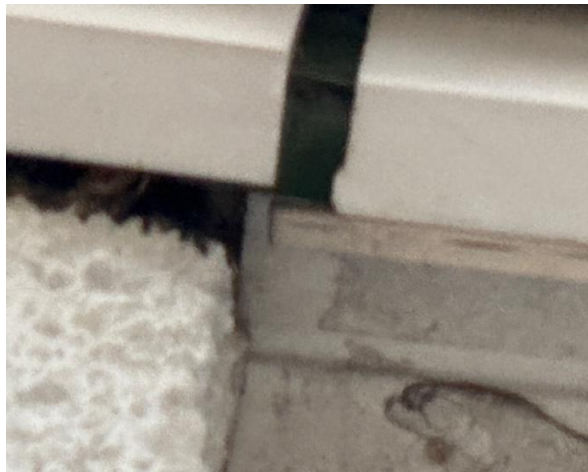
In addition to this, there is a gap in the UPVC fascia on the gable end of the frontage (south). The gap could be inspected at close hand with an endoscope and although it was apparent that gap was not deep enough as the UPVC had been installed over the top of the old wooden fascia.

The fascias were inspected at close hand using a high-powered torch and were all found to be in a good state of repair and tight fitting against the pebble-dash walls. There were two potential access points to the area behind the fascia boards, but did not lead into the roof.

*Figure 7: Checked PRF Gaps in soffits and fascia*

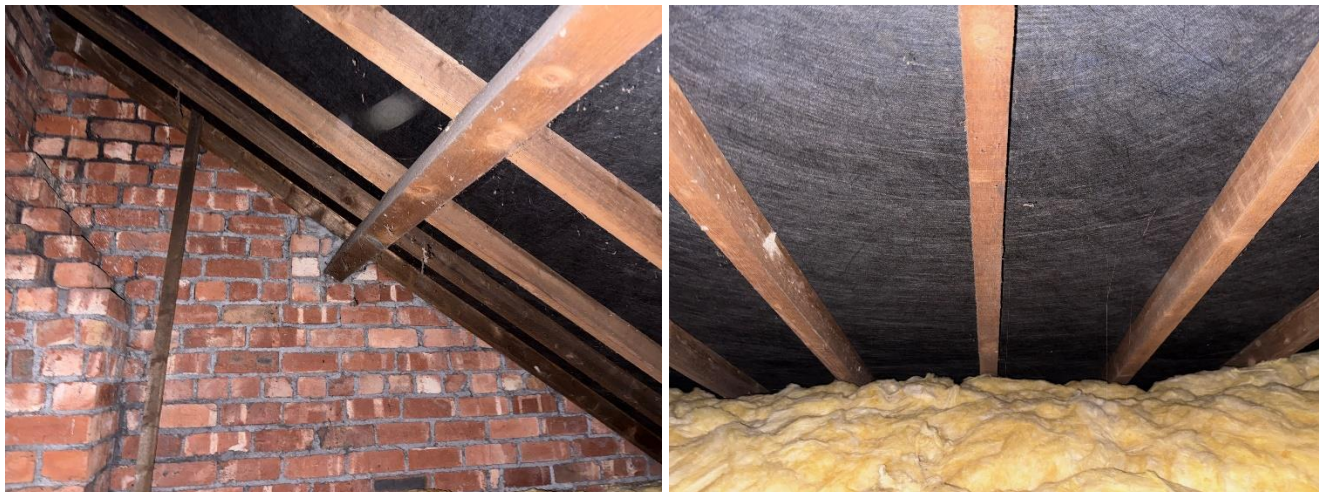
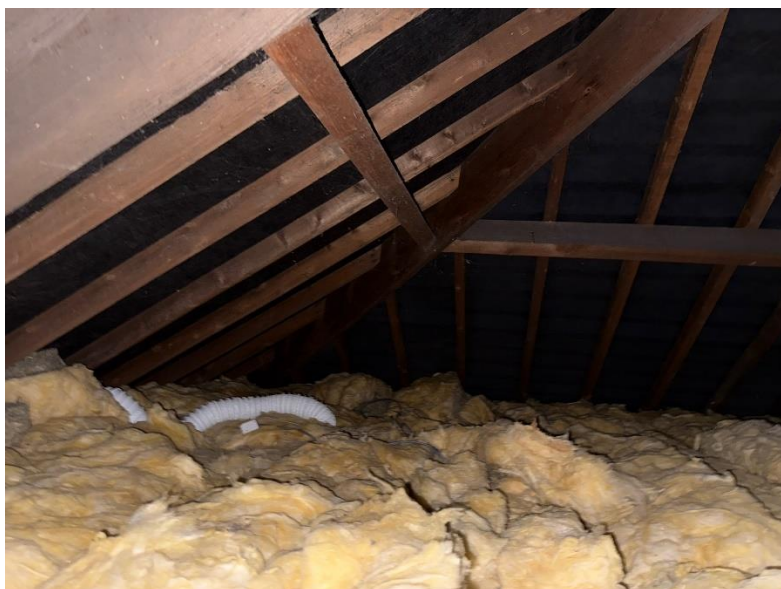
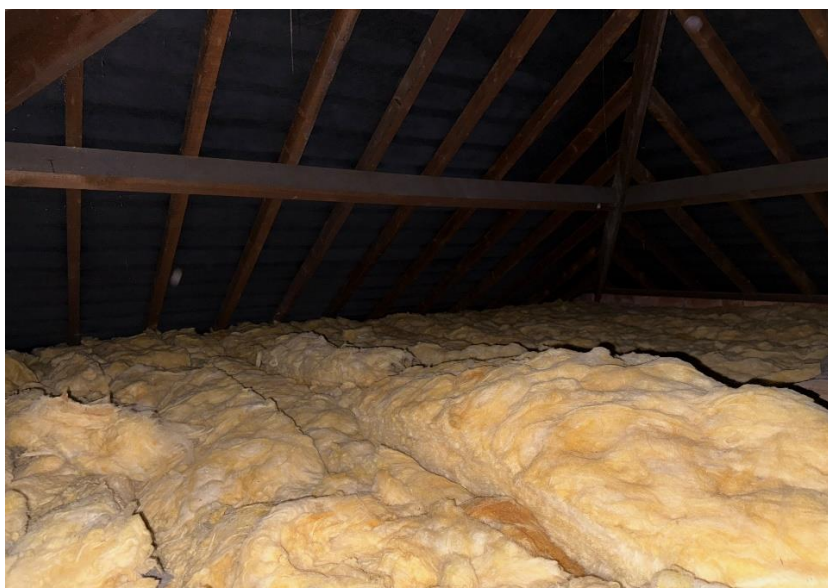
The roof void was found to be fully lined with new breathable membrane, which considering the age of the house shows the recent re-roofing works by previous occupants. The membrane was intact and taught with no bulges or signs of stretching from movement of bats between the roof covering and the membrane. The roof supports were clean and showed no signs or scratching or staining (when exposed to UV light). The insulation within the void showed no signs of recent disturbance, and no scat or urine staining (when exposed to UV light) or foraging remains consistent with use by bats, were noted.

In addition to this, no access point large enough to support the use by bats through the roof covering to the roof void were noted from the inside of the roof void. **No evidence of current or historic inhabitation of the apex roof void by any vertebrate species (i.e. bats, birds, squirrels etc.) was found during the inspection.**

*Figure 8: First floor roof void and bedrooms within the historic roof space*
