VALE CONSULTANCY  
18529-SK01  
GROUND FLOOR PLAN  
SHOWING STRUCTURE  
ABOVE (NOT TO SCALE)

VALE CONSULTANCY  
18529- SK02  
FIRST FLOOR PLAN  
SHOWING STRUCTURE  
ABOVE (NOT TO SCALE)

VALE CONSULTANCY  
18529-SK04  
FRONT ELEVATION-  
SHOWING DEFECTS  
REMEDIES (NOT TO SCALE)

VALE CONSULTANCY  
18529 - SK05  
SIDE ELEVATION -  
SHOWING DEFECT REMEDIES  
(NOT TO SCALE)

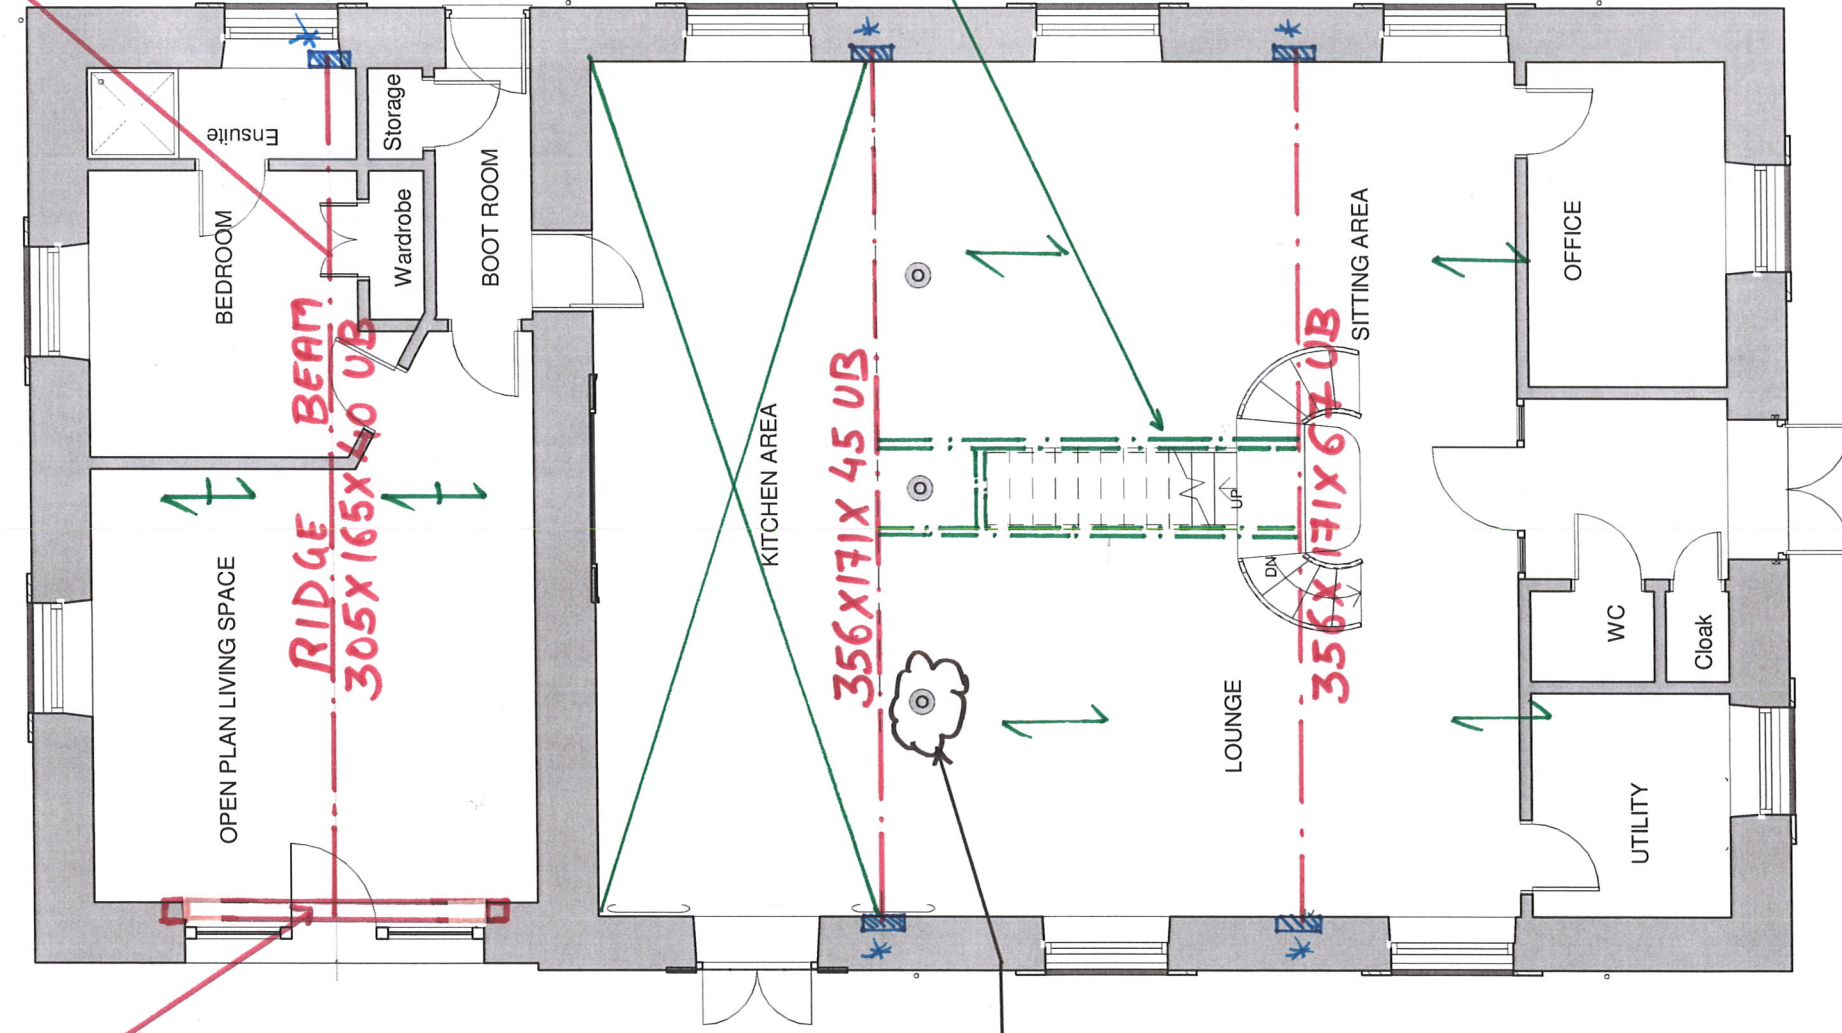
RIDGE STEEL REQUIRED  
 IF FULLY VAULTED  
 ROOF ZONE PREFERRED,  
 OTHERWISE TIMBER  
 TRUSSES CAN REMAIN  
 SUBJECT TO ADDITIONAL  
 INSPECTION ONCE  
 ROOF OPENING WORKS  
 HAS BEEN DONE.

→ CONTRACTOR TO CHECK FOR  
 SUITABILITY OF EXISTING  
 STONWORK FOR STEEL BEARING.  
 IF UNSUITABLE, COLUMNS MAY  
 BE REQUIRED.

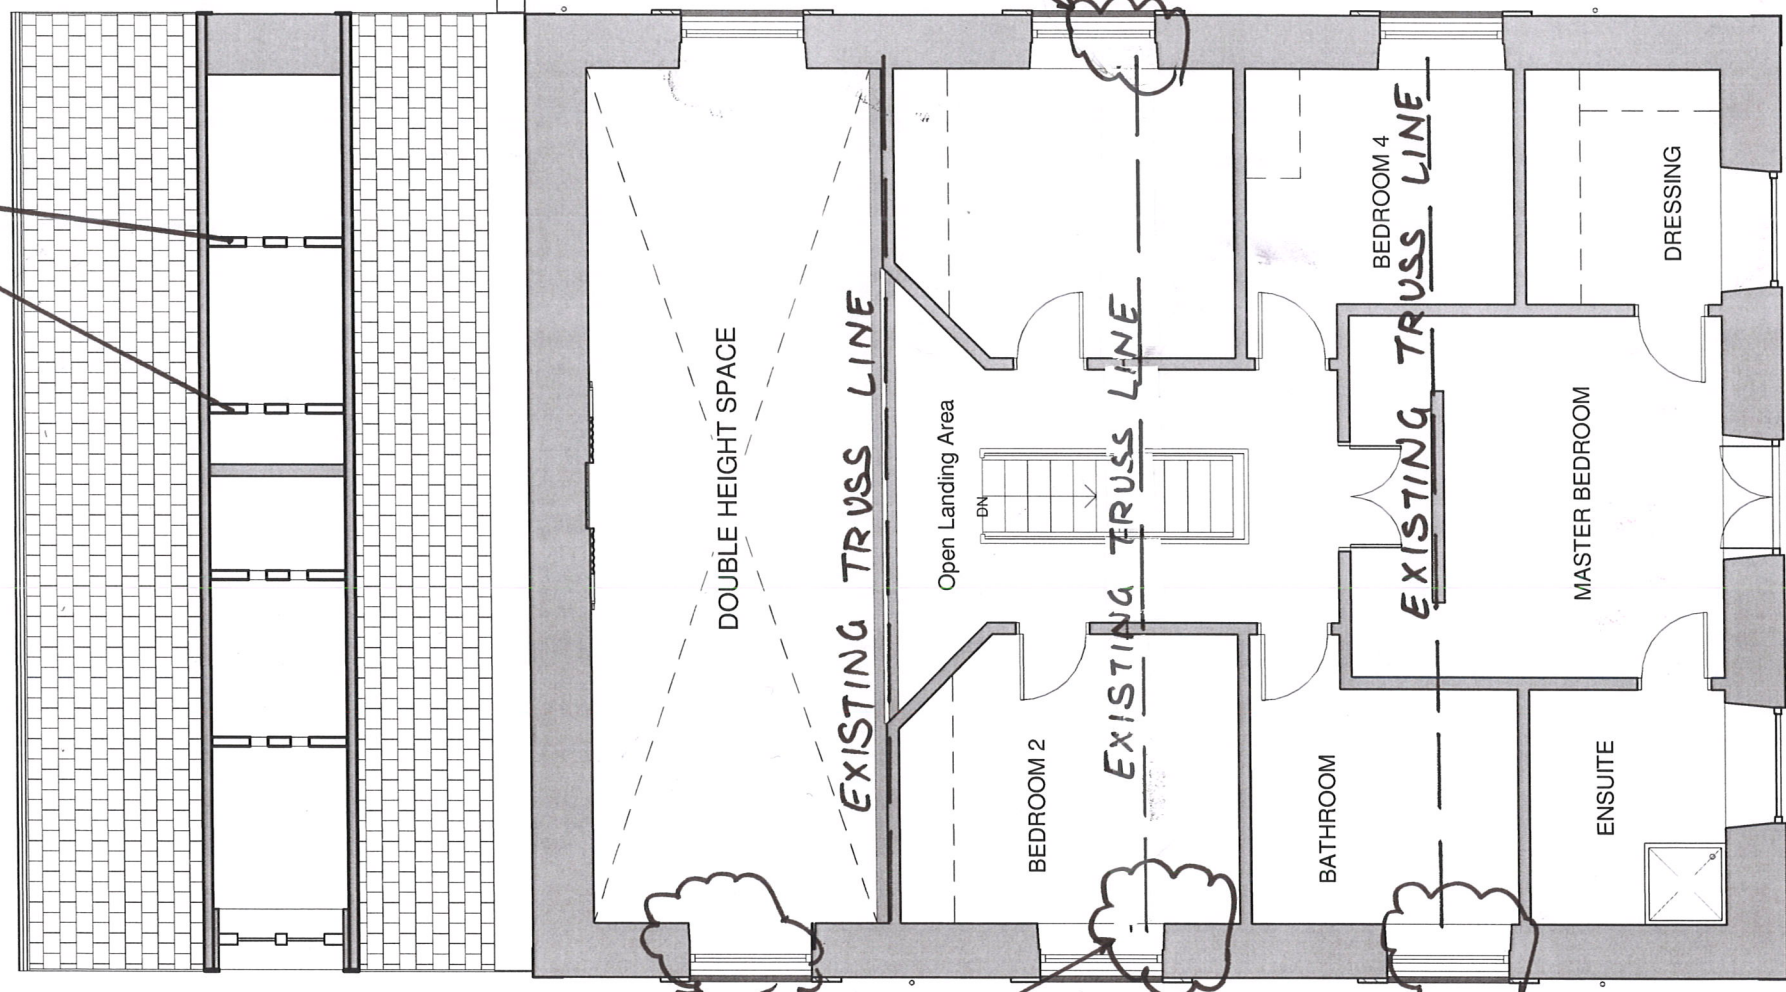
EXISTING TRUSSES  
ARE IN GOOD CONTION,  
COULD BE RETAINED  
(OR USE RIDGE BEAM  
AS SHOWN IN SK01)  
FURTHER OPENING OF  
ROOF REQUIRED AND  
RAFTERS TO BE  
CHECKED.

MOVEMENT NOTED-  
FROM INSPECTION  
IT IS POSSIBLE EXISTING  
LINTEL IS DEFLECTED  
CAUSING THE TRUSS  
TO DROP.  
FURTHER OPENING UP  
OF ROOF REQUIRED.

MINOR SIGNS OF  
MOVEMENT,  
LINTEL TO BE  
REPLACED IF  
NECESSARY, FURTHER  
OPENING OF ROOF  
REQUIRED.

PLASTER TO BE  
REMOVED,  
LINTEL INSPECTED  
AND REPLACED, IF  
NECESSARY.

PLASTER TO BE  
REMOVED,  
LINTEL INSPECTED  
AND REPLACED  
IF NECESSARY.

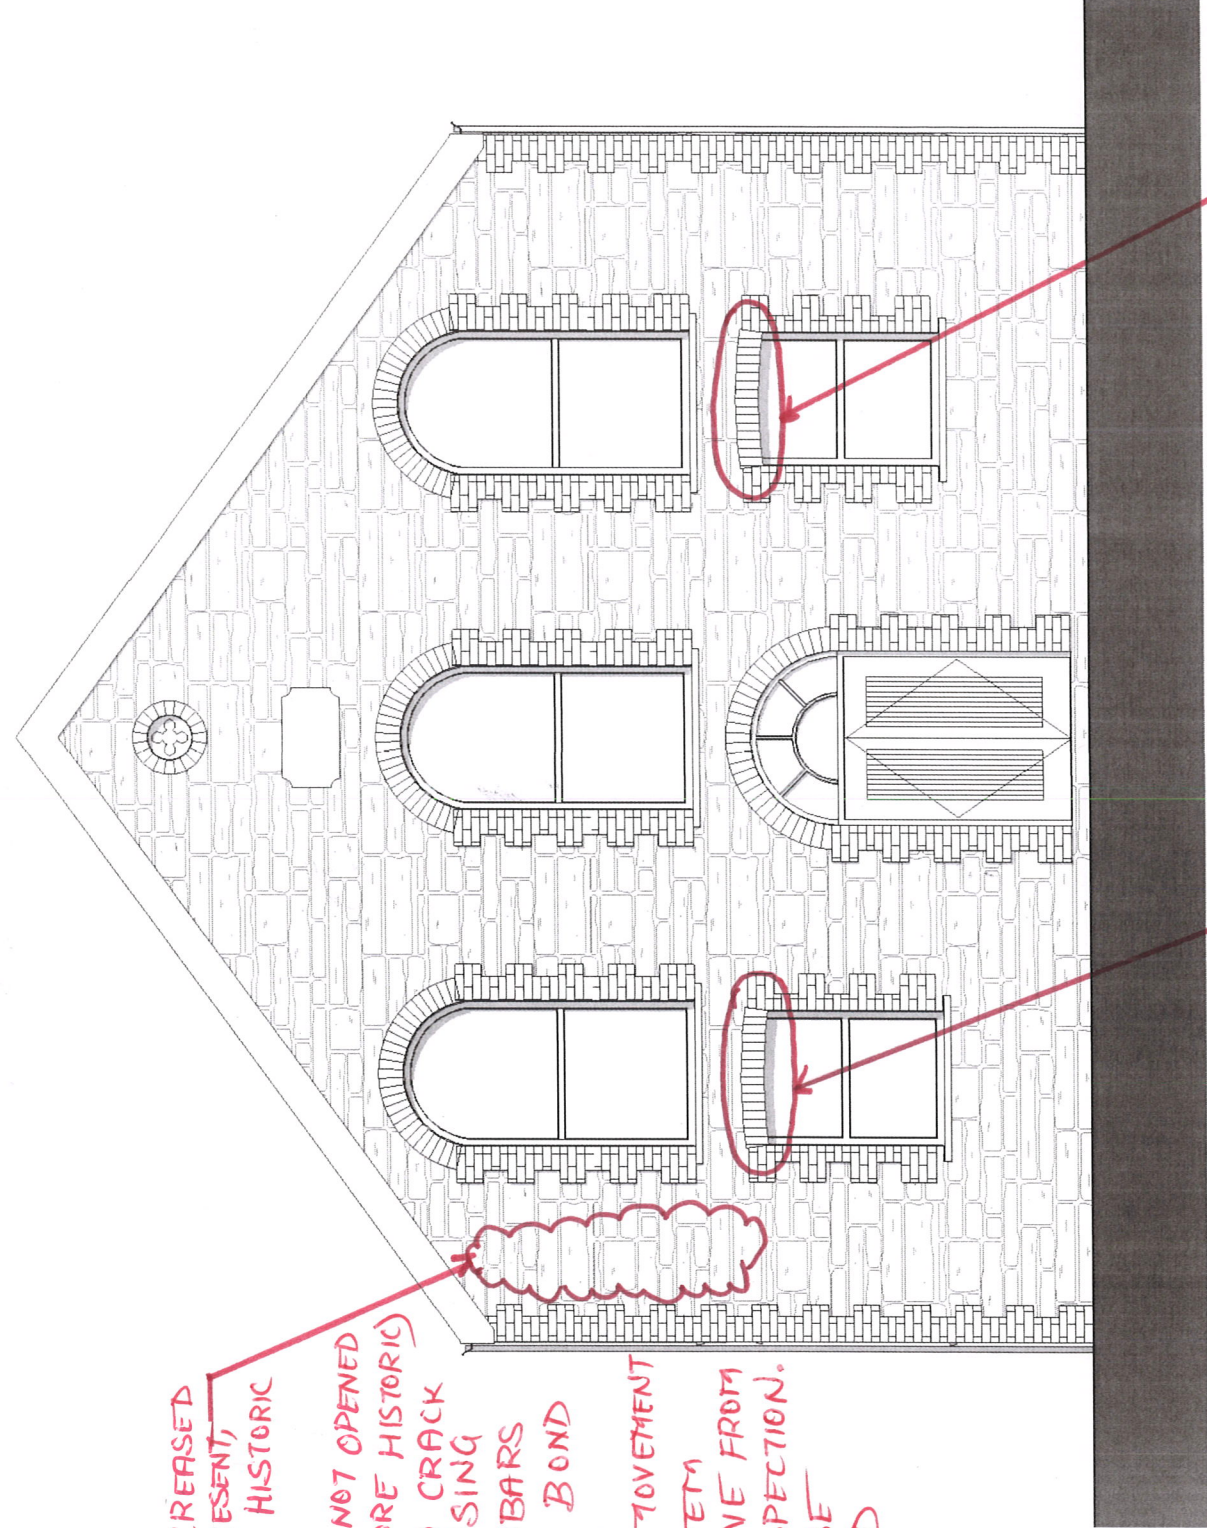
LINE OF INCREASED  
MORTAR PRESENT,  
INDICATING HISTORIC  
CRACK.  
(CRACK HAS NOT OPENED  
UP THEREFORE HISTORIC)  
RECOMMEND CRACK  
STITCHING USING  
HELIFIX HELIBARS  
TO SUITABLY BOND  
STONEWORK.  
STONEWORK MOVEMENT  
DOESN'T SEEM  
PROGRESSIVE FROM  
INITIAL INSPECTION.  
AREA TO BE  
MONITORED

BOWING / MOVEMENT OF  
STONEWORK ABOVE WINDOW  
PRESENT.  
LINTEL BELOW HAS DROPPED  
AND NEEDS TO BE REPLACED.  
STONEWORK ABOVE TO BE  
TAKEN OUT AND REBUILT.

BOWING / MOVEMENT  
OF STONEWORK ABOVE  
WINDOW PRESENT.  
LINTEL ABOVE HAS  
DROPPED AND NEED  
TO BE REPLACED.  
STONEWORK ABOVE TO  
BE TAKEN OUT AND  
REBUILT.

NOTE:-  
\* LOCALISED REPOINTING OF  
STONEWORK REQUIRED.

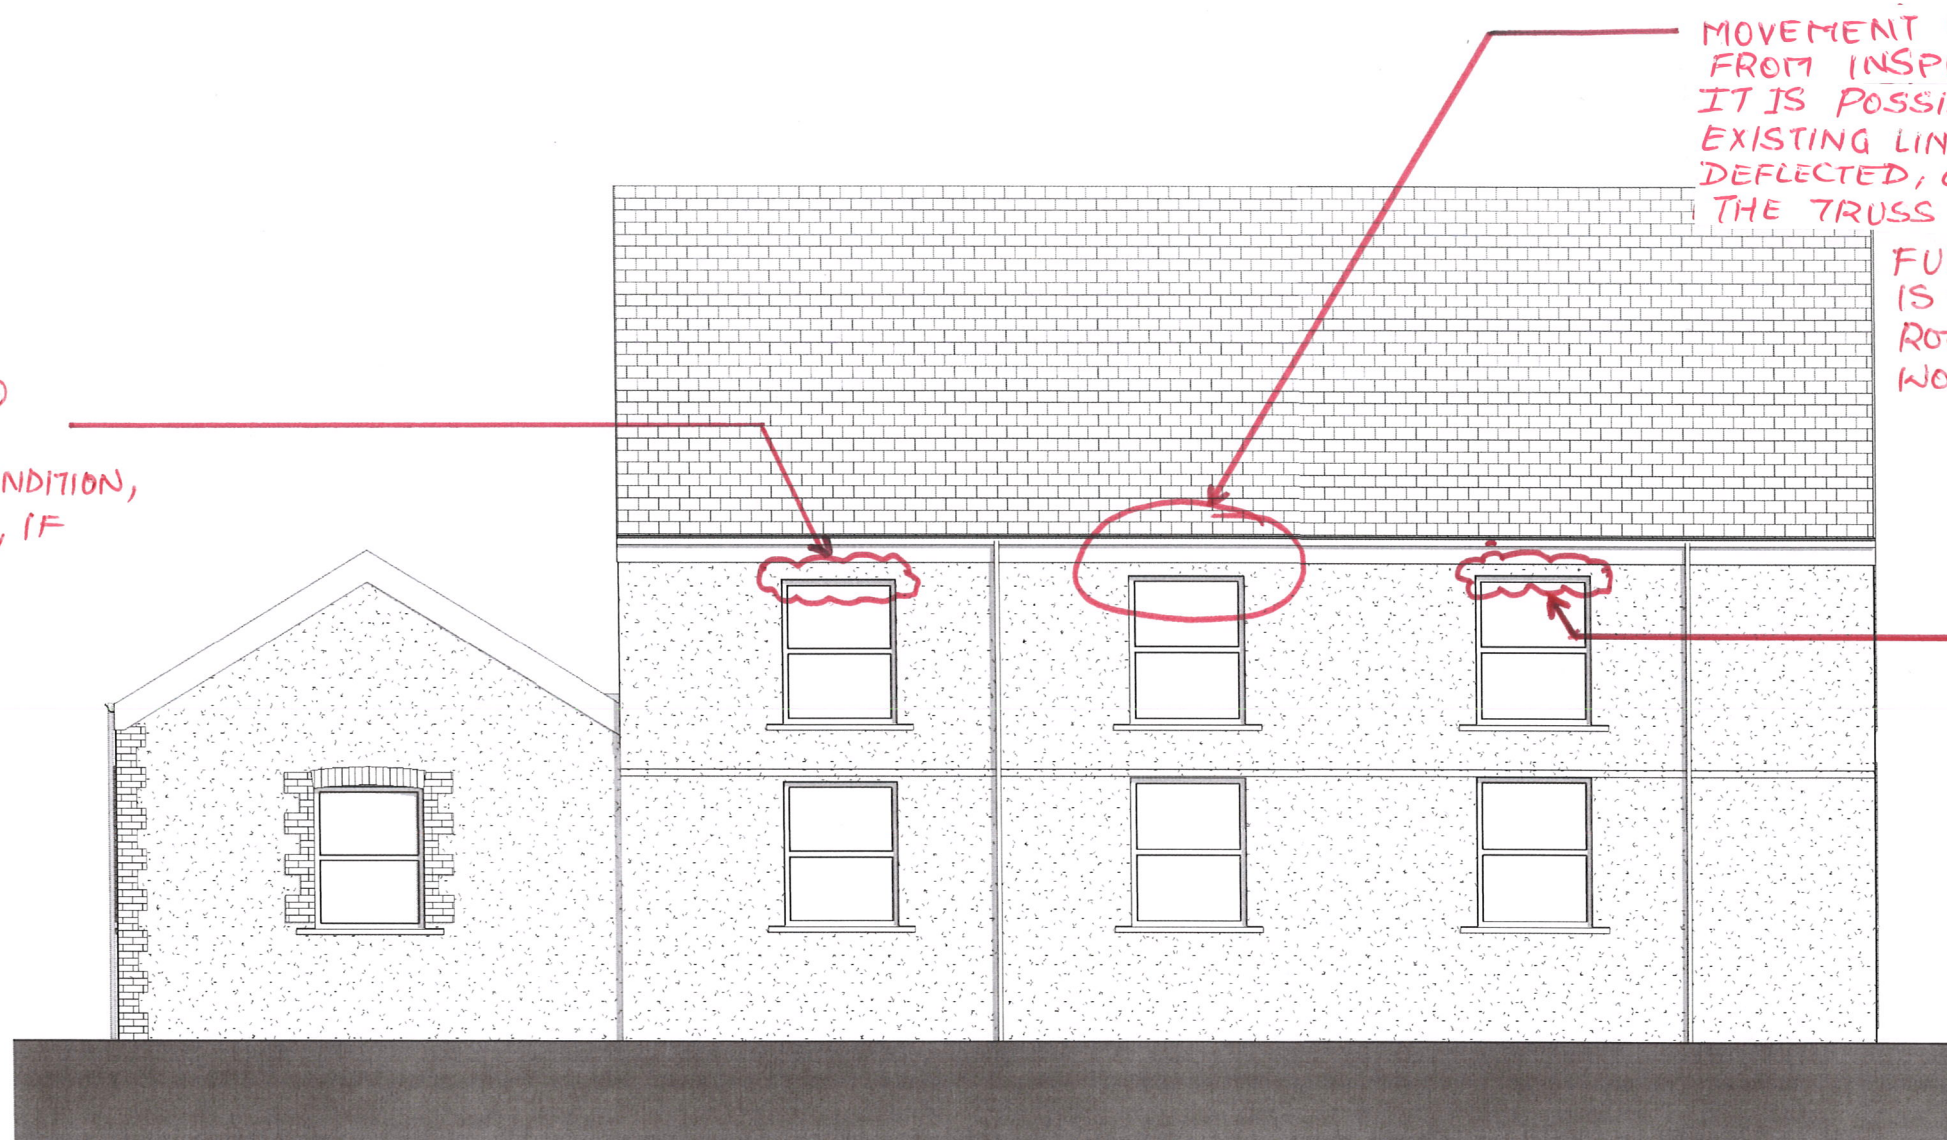
MOVEMENT NOTED -  
FROM INSPECTION  
IT IS POSSIBLE THAT  
EXISTING LINTEL IS  
DEFLECTED, CAUSING  
THE TRUSS TO DROP.

PLASTER WORK TO  
BE REMOVED TO  
ASSESS LINTEL CONDITION,  
TO BE REPLACED, IF  
REQUIRED.

FURTHER INSPECTION  
IS REQUIRED AFTER  
ROOF OPENING UP  
WORK HAS BEEN DONE.

PLASTER WORK TO  
BE REMOVED TO  
ASSESS LINTEL CONDITION,  
TO BE REPLACED IF  
REQUIRED.
