# ASBESTOS DEMOLITION SURVEY

| CLIENT | HARSCO Metals Group Ltd |
| SITE | Metal Recovery Plant<br>Tata Steel UK Ltd<br>Port Talbot Works<br>South Wales<br>SA13 2NG |

| Report Ref: | H-11027 | Surveyed & Reviewed By: | Marc Shears |

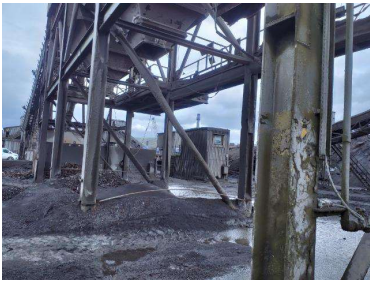
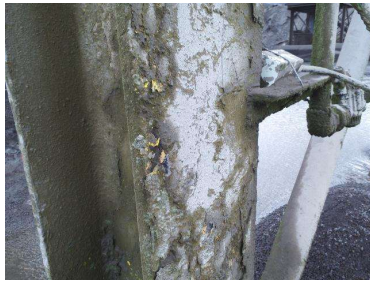
| LOC No | Sample No | Photo No | Building Address | Location | Area Surveyed |
|---|---|---|---|---|---|
| Position | Product | Asbestos Type | Approx. Quantity | Comments | |
| Paint covering to steelwork throughout | Asbestos Not Detected | AND | | | |

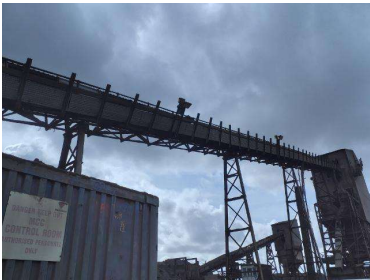
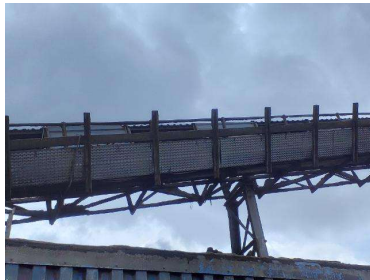
| LOC No | Sample No | Photo No | Building Address | Location | Area Surveyed |
|---|---|---|---|---|---|
| 002 | | 662808 | Metal Recovery Plant | Ground Floor | Conveyor No 8 |

| LOC No | Sample No | Photo No | Building Address | Location | Area Surveyed |
|---|---|---|---|---|---|
| High level conveyor no 8 | No Access Gained | No Access | | No safe access to high level conveyor no 8. Structurally unsafe | |

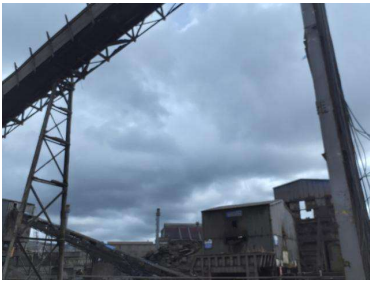
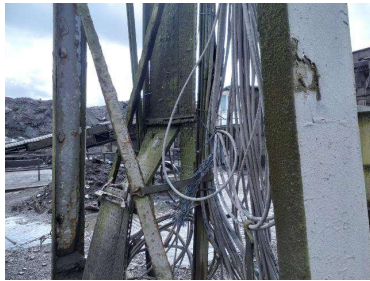
| LOC No | Sample No | Photo No | Building Address | Location | Area Surveyed |
|---|---|---|---|---|---|
| Position | Product | Asbestos Type | Approx. Quantity | Comments | |
| Paint covering to low level conveyor structural support columns | Asbestos Not Detected | AND | | | |

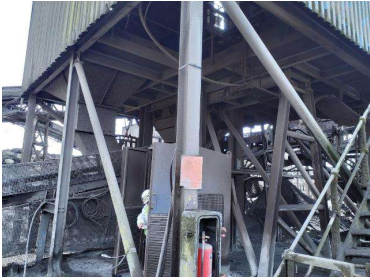
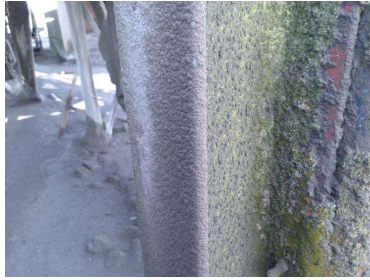
| LOC No | Sample No | Photo No | Building Address | Location | Area Surveyed |
|---|---|---|---|---|---|
| Paint covering to structural steelwork throughout | Asbestos Not Detected | AND | | | |

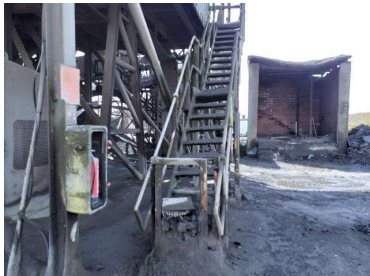
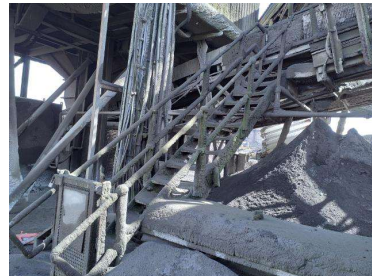
| LOC No | Sample No | Photo No | Building Address | Location | Area Surveyed |
|---|---|---|---|---|---|
| Levels 1 and 2 | No Access Gained | No Access | | No safe access to levels 1 and 2. Structurally unsafe and barriered off. | |

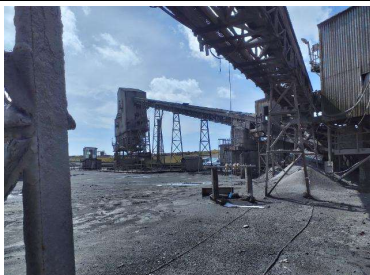
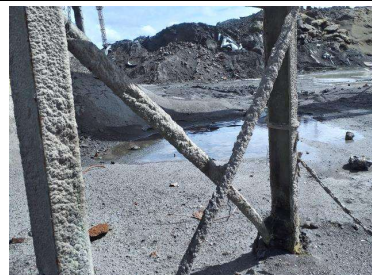
| LOC No | Sample No | Photo No | Building Address | Location | Area Surveyed |
|---|---|---|---|---|---|
| 009 | S005 | 662882 | Metal Recovery Plant | Ground Floor | Conveyor No 6 |

| LOC No | Sample No | Photo No | Building Address | Location | Area Surveyed |
|---|---|---|---|---|---|
| Paint covering to low level conveyor structural support columns and conveyor | Asbestos Not Detected | AND | | | |

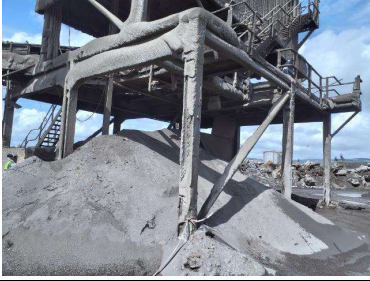
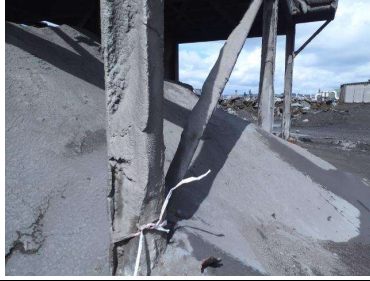
| LOC No | Sample No | Photo No | Building Address | Location | Area Surveyed |
|---|---|---|---|---|---|
| Paint covering to structural steelwork throughout | Asbestos Not Detected | AND | | | |

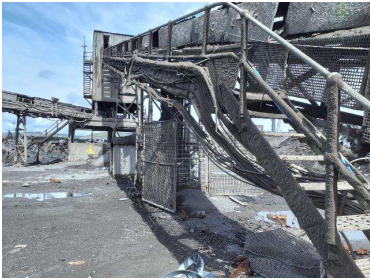
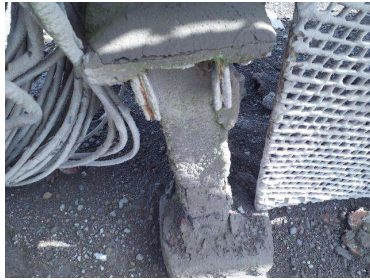
| LOC No | Sample No | Photo No | Building Address | Location | Area Surveyed |
|---|---|---|---|---|---|
| 011 | S007 | 662876 | Metal Recovery Plant | 2nd Floor | Conveyor No 5 |

| LOC No | Sample No | Photo No | Building Address | Location | Area Surveyed |
|---|---|---|---|---|---|
| Paint covering to conveyor structural supports and steelwork | Asbestos Not Detected | AND | | | |

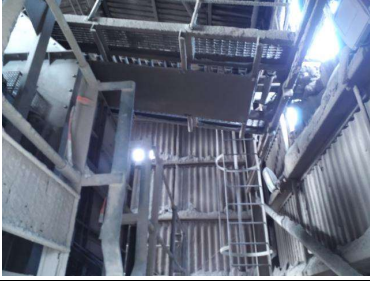
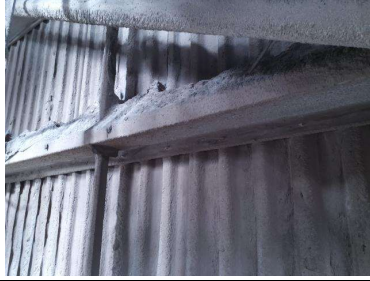
| LOC No | Sample No | Photo No | Building Address | Location | Area Surveyed |
|---|---|---|---|---|---|
| Paint covering to steelwork throughout | Asbestos Not Detected | AND | | | |

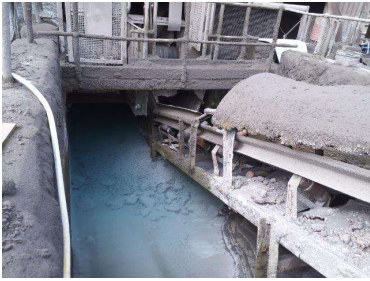
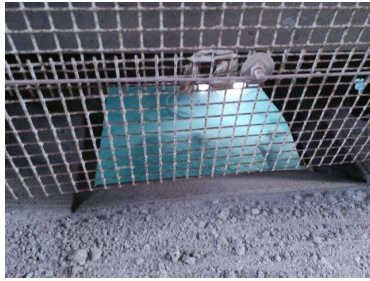
| LOC No | Sample No | Photo No | Building Address | Location | Area Surveyed |
|---|---|---|---|---|---|
| 012A | | 662902 | Metal Recovery Plant | -1 | Main Magnet Conveyor 2 And 4 Building |

| LOC No | Sample No | Photo No | Building Address | Location | Area Surveyed |
|---|---|---|---|---|---|
| Basement area | | No Access | | No safe access to Basement Area due water egress | |

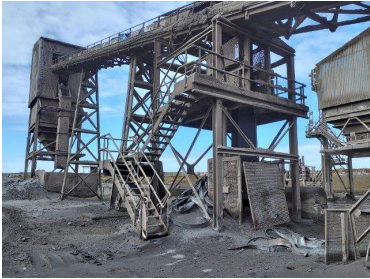
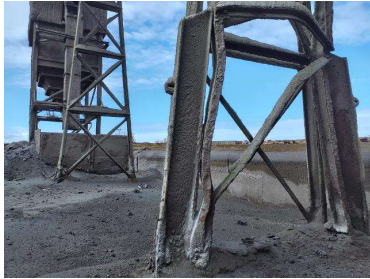
| LOC No | Sample No | Photo No | Building Address | Location | Area Surveyed |
|---|---|---|---|---|---|
| Paint covering to conveyor structural supports and steelwork | Asbestos Not Detected | AND | | | |

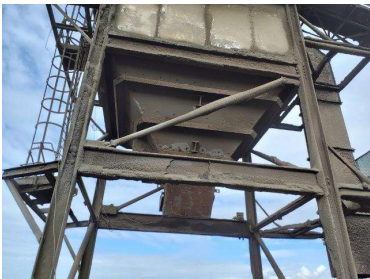
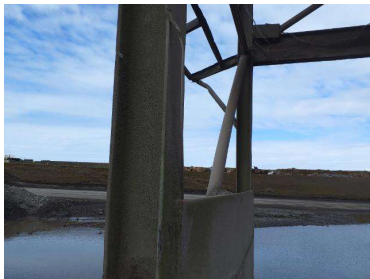
| LOC No | Sample No | Photo No | Building Address | Location | Area Surveyed |
|---|---|---|---|---|---|
| 015 | S010 | 662917 | Metal Recovery Plant | Ground Floor | Non FE Hopper |

| LOC No | Sample No | Photo No | Building Address | Location | Area Surveyed |
|---|---|---|---|---|---|
| Paint covering to steelwork throughout | Asbestos Not Detected | AND | | | |

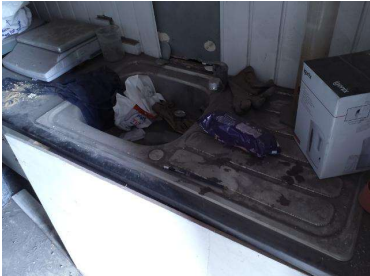
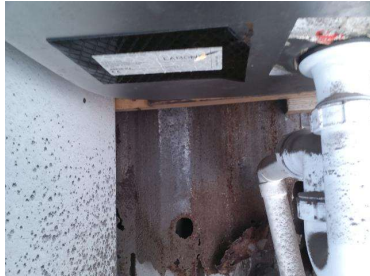
| LOC No | Sample No | Photo No | Building Address | Location | Area Surveyed |
|---|---|---|---|---|---|
| Sink pad | Asbestos Not Detected | AND | | | |
