# Demolition Survey

Llangatwg Comprehensive School  
Main Road  
Cadoxton  
Neath

# 1.0 Executive summary:

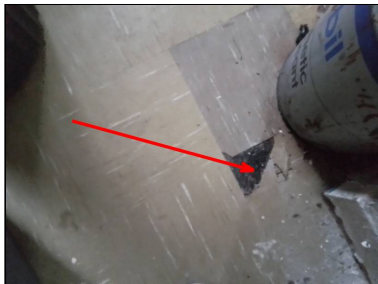
| | Survey Date: | Lead Surveyor | Survey Type | Floor | Inspection No. |
|---|---|---|---|---|---|
| Surveyor comments | Label, Arrange removal and dispose of as hazardous waste (in accordance with CAR 2012 & ACoP) prior to refurbishment/demolition works; some damage present and/or vulnerable to further damage, but not causing an immediate hazard. | | | | |

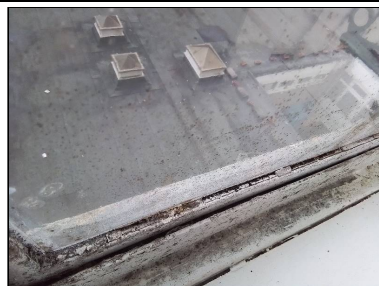
| | Survey Date: | Lead Surveyor | Survey Type | Floor | Inspection No. |
|---|---|---|---|---|---|
| | 27 May 2025 to 28 May 2025 | Simon Cook | Demolition Survey | 2nd Floor | 28 |

| | Survey Date: | Lead Surveyor | Survey Type | Floor | Inspection No. |
|---|---|---|---|---|---|
| Surveyor comments | Label, Arrange removal and dispose of as hazardous waste (in accordance with CAR 2012 & ACoP) prior to refurbishment/demolition works; some damage present and/or vulnerable to further damage, but not causing an immediate hazard. | | | | |

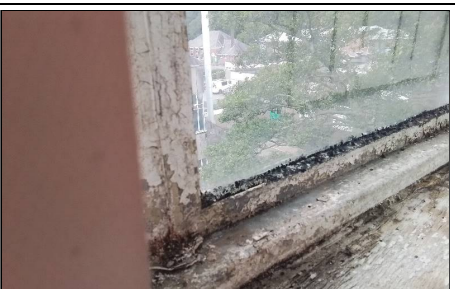
| | Survey Date: | Lead Surveyor | Survey Type | Floor | Inspection No. |
|---|---|---|---|---|---|
| | 27 May 2025 to 28 May 2025 | Simon Cook | Demolition Survey | 2nd Floor | 36 |

| | Survey Date: | Lead Surveyor | Survey Type | Floor | Inspection No. |
|---|---|---|---|---|---|
| Surveyor comments | Label, Arrange removal and dispose of as hazardous waste (in accordance with CAR 2012 & ACoP) prior to refurbishment/demolition works; some damage present and/or vulnerable to further damage, but not causing an immediate hazard. | | | | |

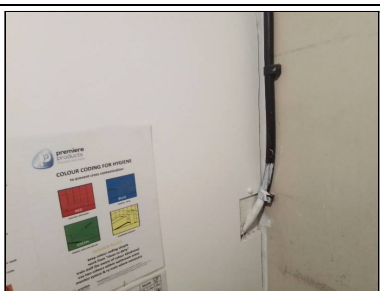
| | Survey Date: | Lead Surveyor | Survey Type | Floor | Inspection No. |
|---|---|---|---|---|---|
| Surveyor comments | Label, Arrange removal and dispose of as hazardous waste (in accordance with CAR 2012 & ACoP) prior to refurbishment/demolition works; some damage present and/or vulnerable to further damage, but not causing an immediate hazard. | | | | |

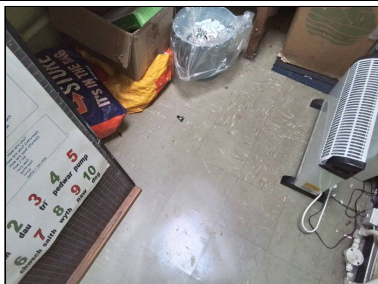
| | Survey Date: | Lead Surveyor | Survey Type | Floor | Inspection No. |
|---|---|---|---|---|---|
| Surveyor comments | Label, Arrange removal and dispose of as hazardous waste (in accordance with CAR 2012 & ACoP) prior to refurbishment/demolition works; some damage present and/or vulnerable to further damage, but not causing an immediate hazard. | | | | |

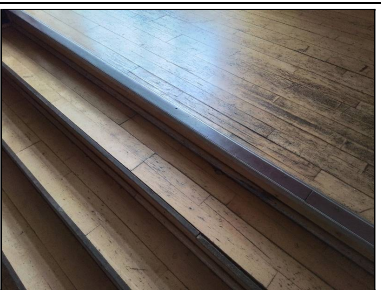
| | 27 May 2025 to 28 May 2025 | Simon Cook | Demolition Survey | Ground Floor | 60 |

| Surveyor comments | Label, Arrange removal and dispose of as hazardous waste (in accordance with CAR 2012 & ACoP) prior to refurbishment/demolition works; some damage present and/or vulnerable to further damage, but not causing an immediate hazard. | | | | |

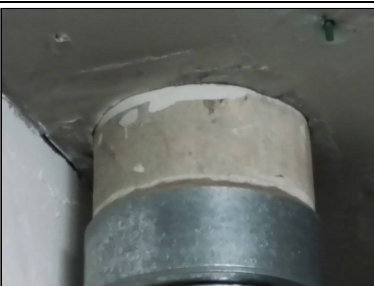
| Surveyor comments | Walls & Ceiling Encapsulated | | | | |

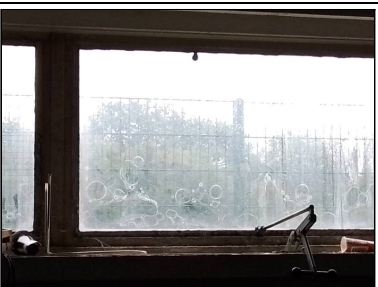
| | Survey Date: | Lead Surveyor | Survey Type | Floor | Inspection No. |
|---|---|---|---|---|---|
| | 27 May 2025 to 28 May 2025 | Simon Cook | Demolition Survey | Ground Floor | 94 |

| | Survey Date: | Lead Surveyor | Survey Type | Floor | Inspection No. |
|---|---|---|---|---|---|
| Surveyor comments | Label, Arrange removal and dispose of as hazardous waste (in accordance with CAR 2012 & ACoP) prior to refurbishment/demolition works; some damage present and/or vulnerable to further damage, but not causing an immediate hazard. | | | | |

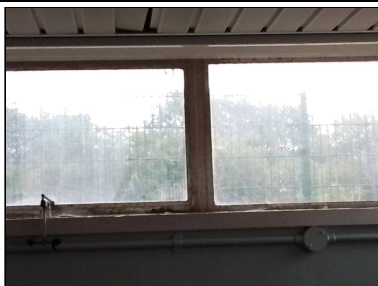
| | Survey Date: | Lead Surveyor | Survey Type | Floor | Inspection No. |
|---|---|---|---|---|---|
| | 27 May 2025 to 28 May 2025 | Simon Cook | Demolition Survey | Ground Floor | 96 |

| | Survey Date: | Lead Surveyor | Survey Type | Floor | Inspection No. |
|---|---|---|---|---|---|
| Surveyor comments | Label, Arrange removal and dispose of as hazardous waste (in accordance with CAR 2012 & ACoP) prior to refurbishment/demolition works; some damage present and/or vulnerable to further damage, but not causing an immediate hazard. | | | | |

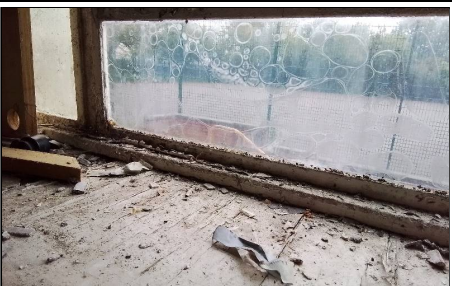
| | Survey Date: | Lead Surveyor | Survey Type | Floor | Inspection No. |
|---|---|---|---|---|---|
| | 27 May 2025 to 28 May 2025 | Simon Cook | Demolition Survey | Ground Floor | 98 |

| | Survey Date: | Lead Surveyor | Survey Type | Floor | Inspection No. |
|---|---|---|---|---|---|
| Surveyor comments | Label, Arrange removal and dispose of as hazardous waste (in accordance with CAR 2012 & ACoP) prior to refurbishment/demolition works; some damage present and/or vulnerable to further damage, but not causing an immediate hazard. | | | | |

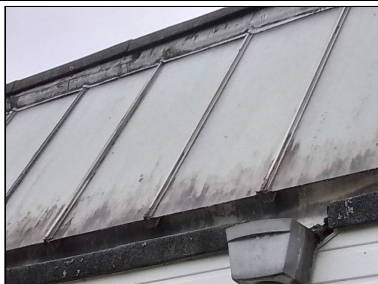
| Surveyor comments | Label, Arrange removal and dispose of as hazardous waste (in accordance with CAR 2012 & ACoP) prior to refurbishment/demolition works; some damage present and/or vulnerable to further damage, but not causing an immediate hazard. | | | | |

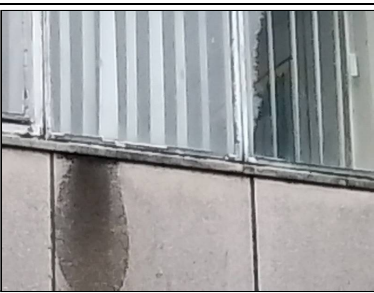
| | 27 May 2025 to 28 May 2025 | Simon Cook | Demolition Survey | External | 110 |

| Surveyor comments | Presumed To Extend Throughout Building | | | | |
