Re: Afan Way, Port Talbot

We can confirm that we have received the recent NRW comments referenced P2024/0339, dated 17 July 2024 and Environmental Health Consultation response referenced P2024/0039.

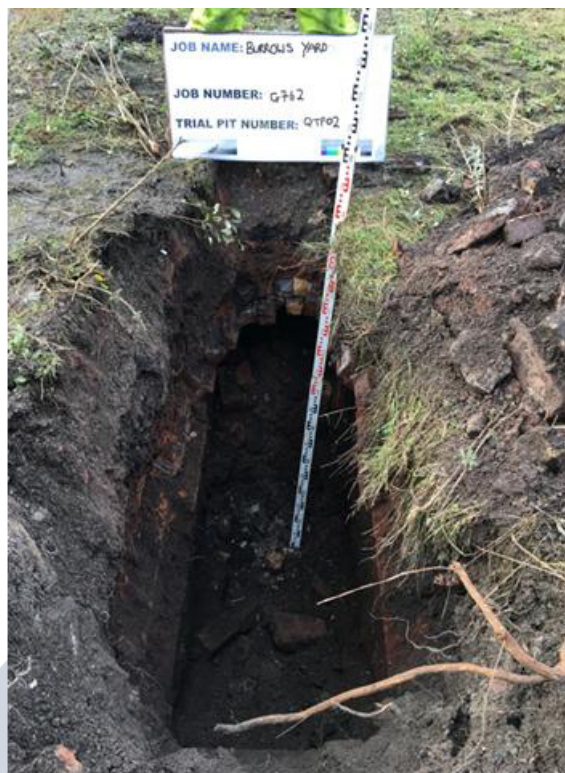
Possible evidence of a culvert was noted in the Quantum Investigation in TP02 as presented below, it is not definitive that it was a culvert or other substructure, and was clearly redundant/backfilled. The concern from NRW is the PFS in the eastern section of site which is indicated to be the source of any contamination, the supplementary investigation (GRO-21252-5257) focuses on this area and found no elevated contaminants of concern. Based on no contaminants of concern being present at the source, it is considered investigation of the culvert/substructure is best dealt with during the enabling works.

Possible evidence of a culvert was noted in the Quantum Investigation in TP02 as presented below. No further evidence of the culvert was encountered or if it actually was a culvert or other substructure. It is considered investigation of the culvert/substructure is best dealt with during the enabling works.

Possible Culvert identified in TP02 during the Quantum Investigation
