# **ARBORICULTURAL REPORT**

## **Health and Condition Survey**

**62 Woodlands Park Drive**

**Date: July 2025**

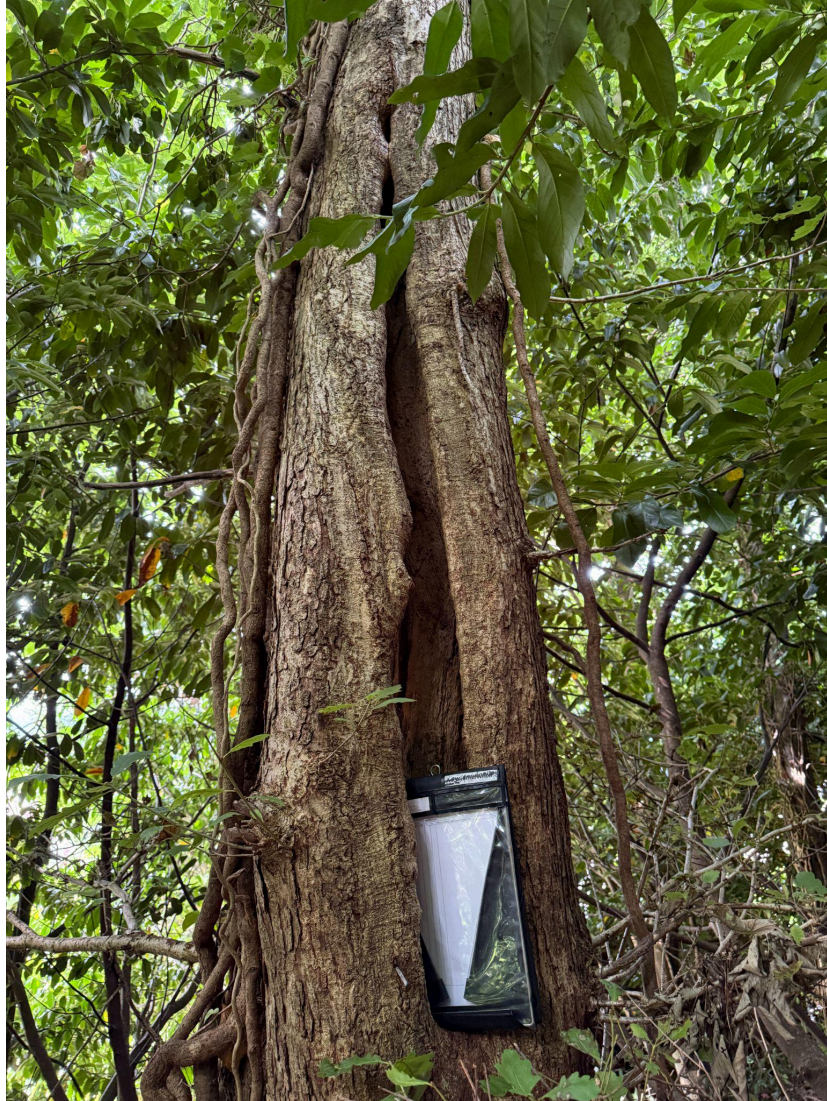
| 967 | Sessile Oak | SM | VL | P | D | Sparse foliage and a very poor form. Two metre vertical bark wound with decay on north side of the main stem at 2.5 metres above ground level - IMAGE 1. Reduce crown by 5 metres. | 1 | H |

**IMAGE 1 : Bark wound and cavity on tree 967**

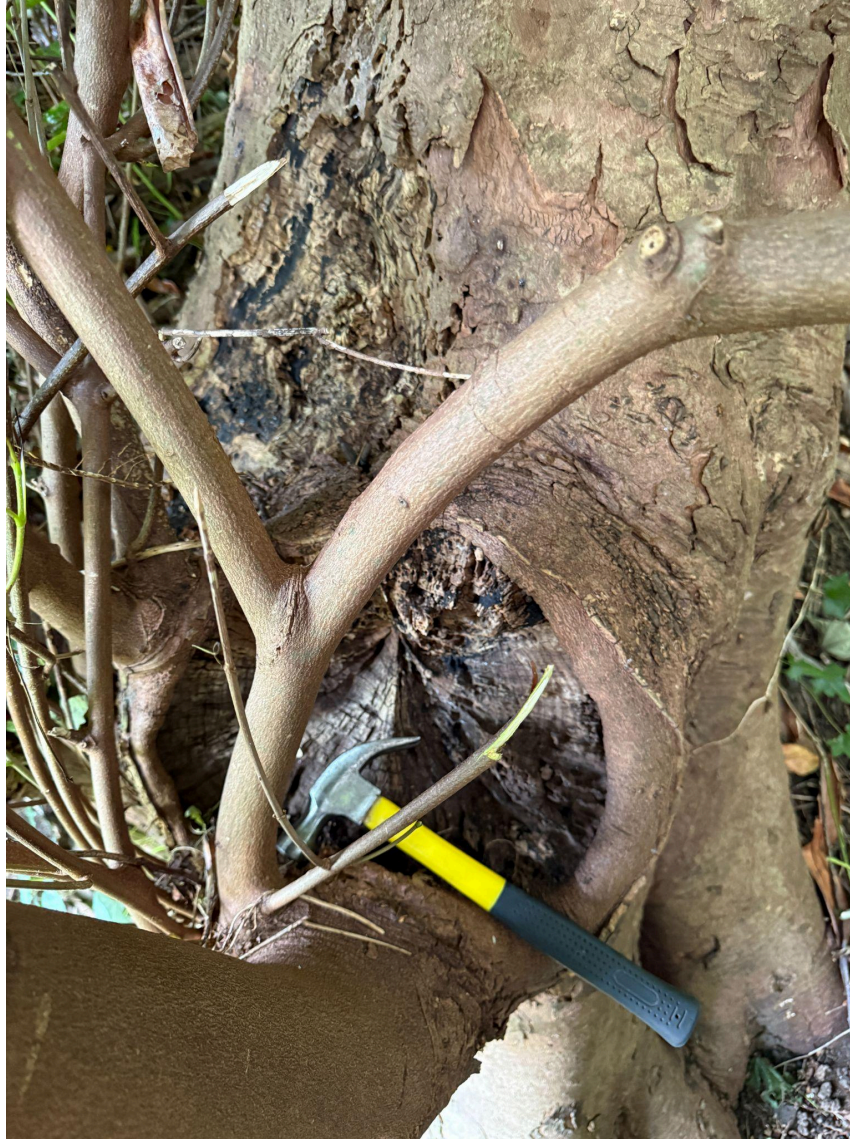
| 977 | Sycamore | SM | L | F | D | A regrown pollard with an asymmetric crown and a very poor form. Bark necrosis and a small compartmentalising basal cavity - IMAGE 2 on the south facing side due to previous branch removal. Branch shedding occurring due to decay around the old pruning wounds. Re-pollard and remove all decayed sections. | 1 | H |

**IMAGE 2 : Bark necrosis and basal decay on tree 977**
