## **Structural Appraisal Report**

Barn at The Rise, Glyncastle, Resolven

February 2025

Type of report: Structural Appraisal

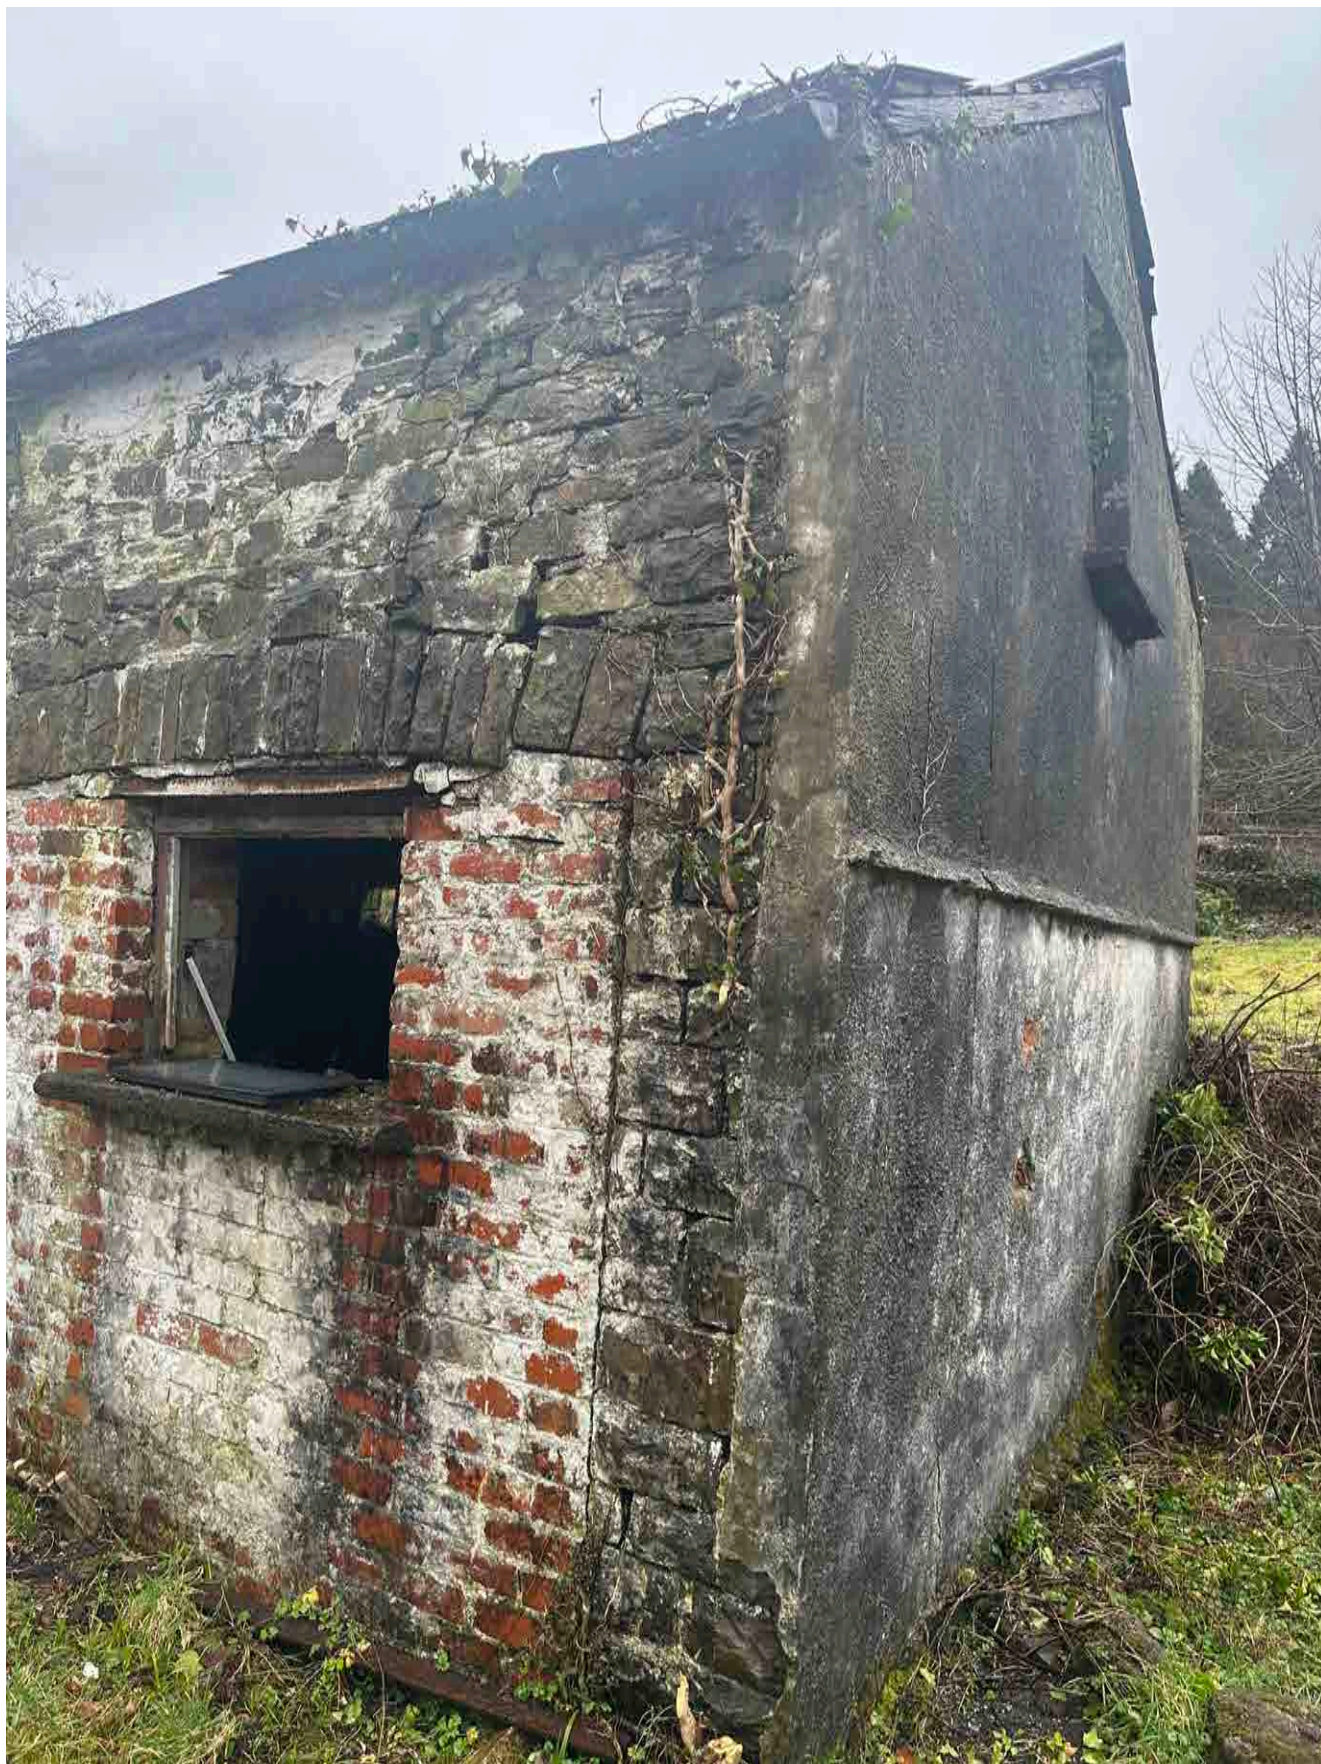
The southern end of the front walls shows signs of leaning, indicating potential structural issues that need to be addressed to ensure safety and stability.

West corner showing leaning brick panel and cracks in the stone masonry above.

The brick wall at the southwestern side of the front face leans slightly. This section is constructed from brick. This section should be rebuilt as it is too far out of plumb. The new wall should be adequately tied into existing walls. It is recommended to reuse the original stone masonry units wherever possible during reconstruction. In the interests of conservation and sustainability, reclaimed materials should be considered for use in the rebuilding process. Repointing of masonry is required in several areas. Lintels above doors and windows should be replaced.

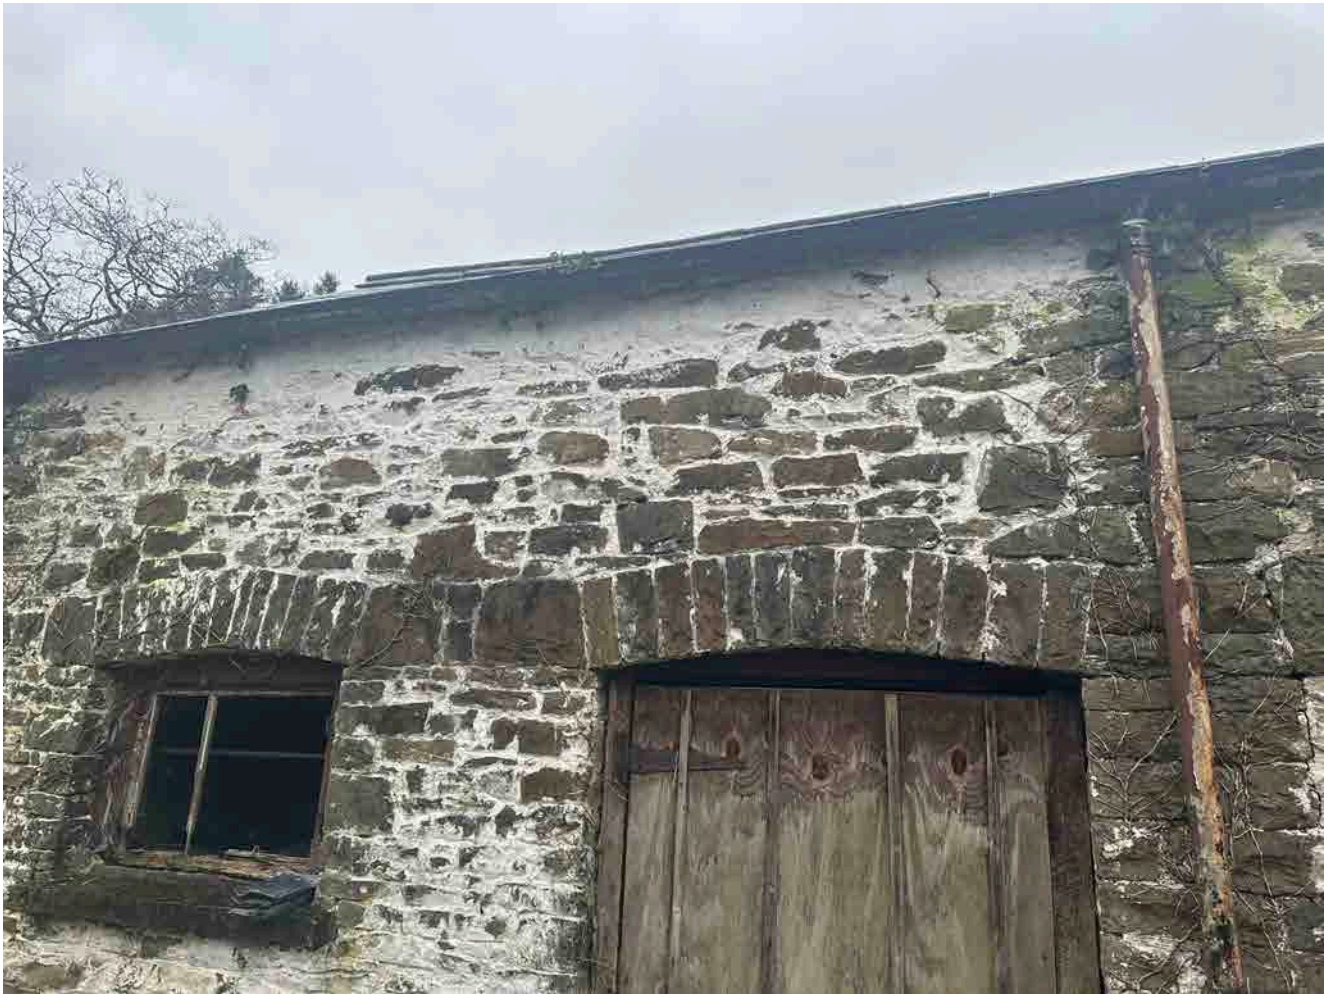
Stone masonry above opeinings in the northwestern face of the building.

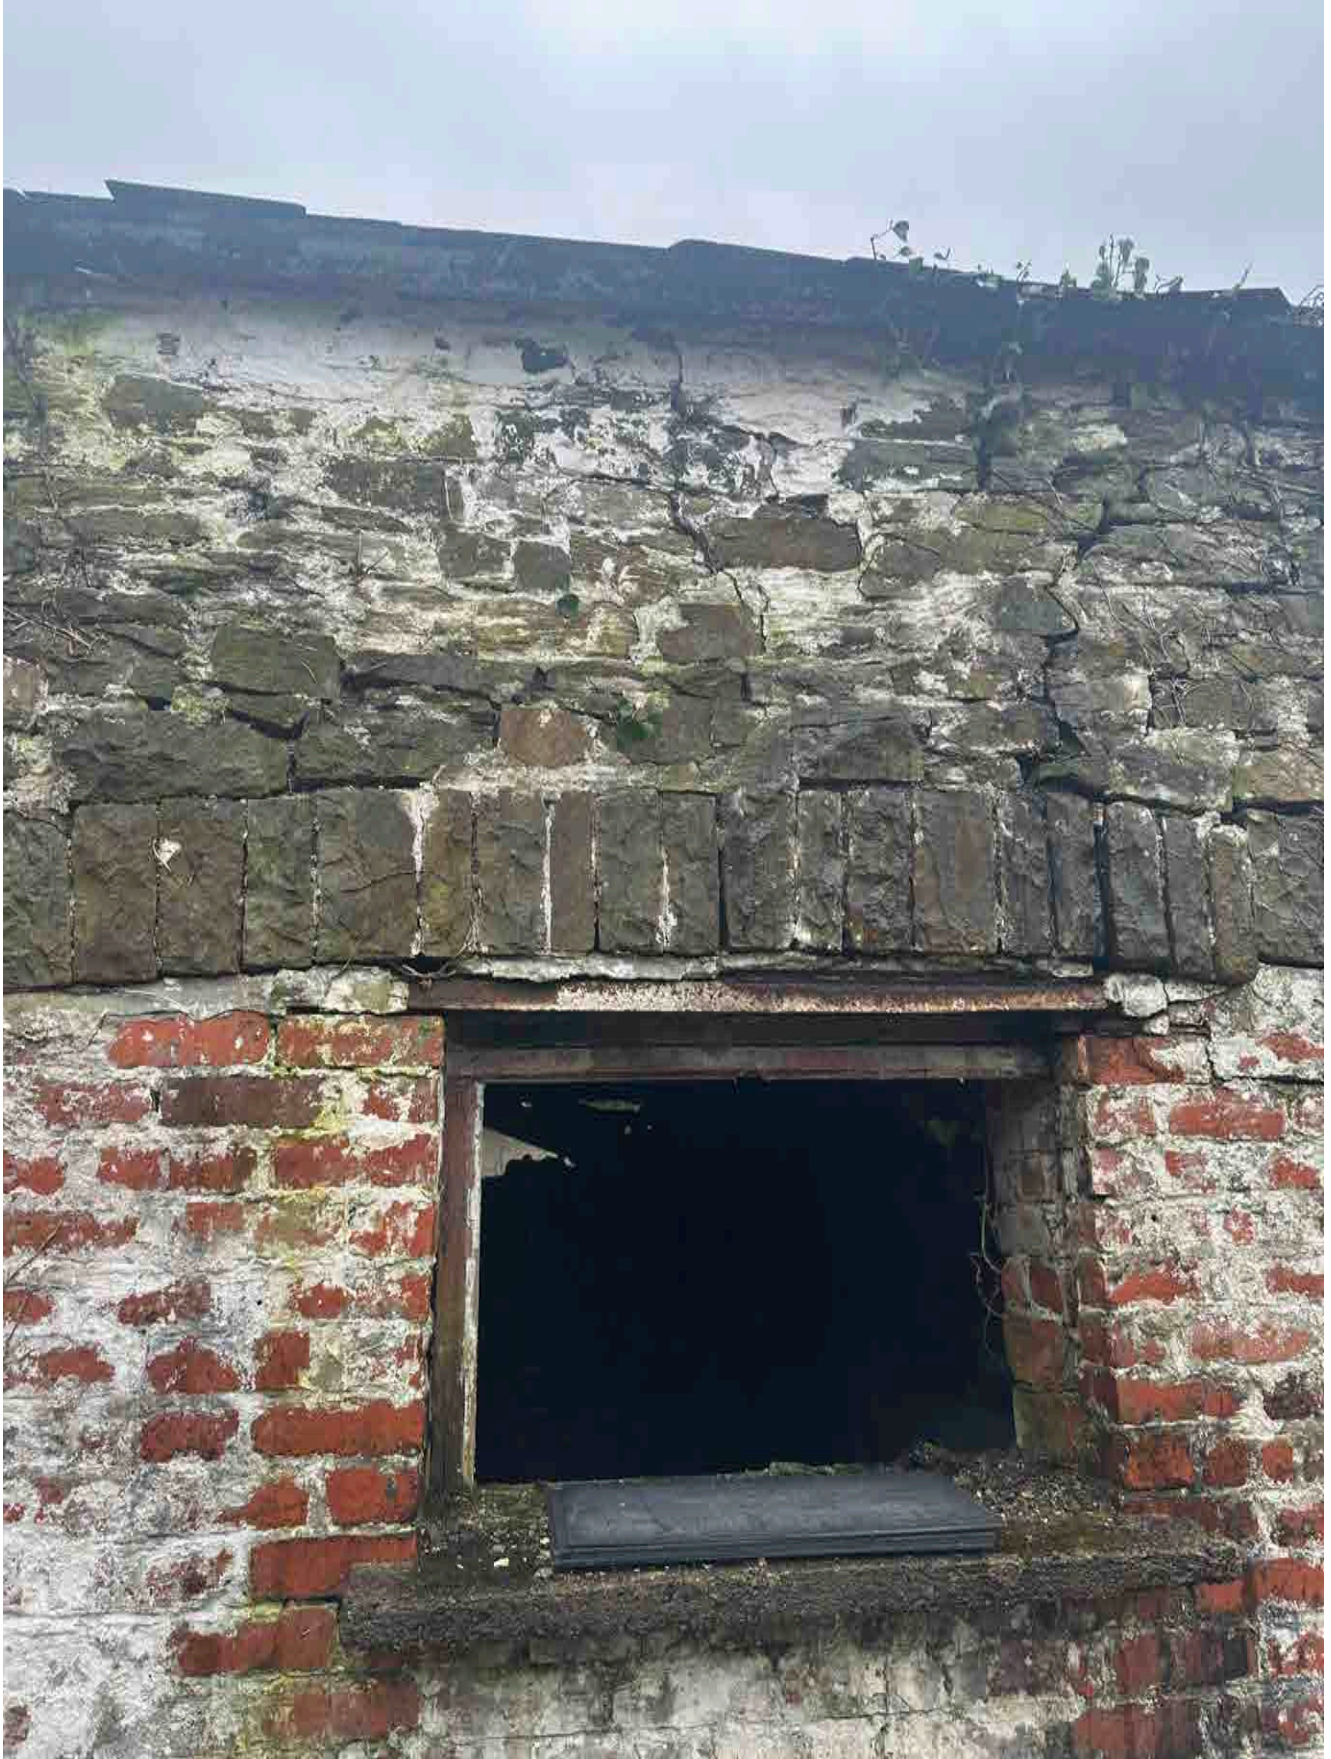
Cracked masonry above opening in the north western face. Repointing is required here once rebuilding of the brick panel is completed.

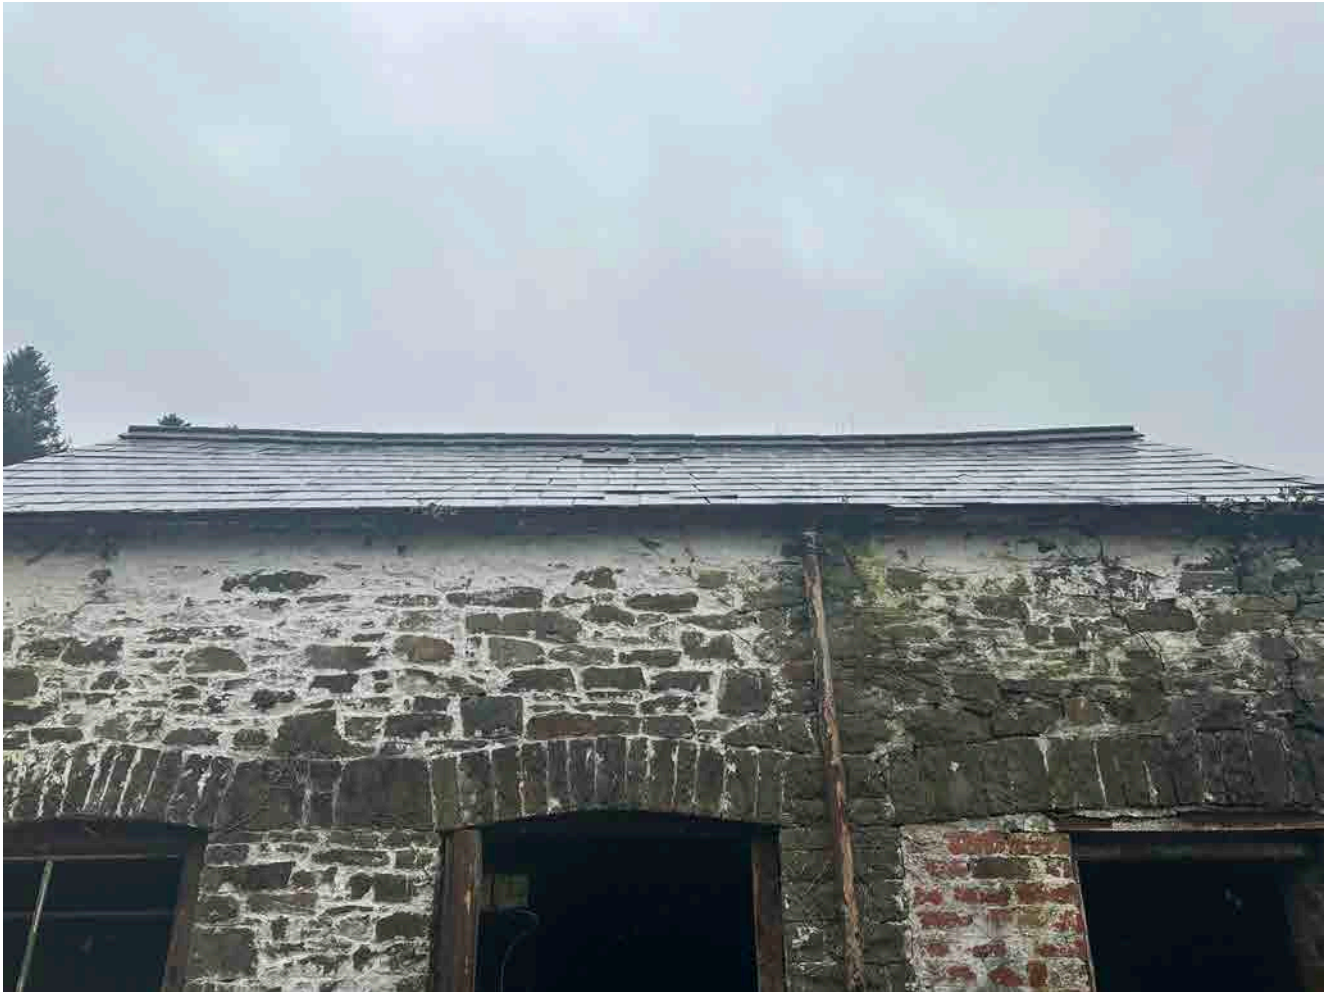
The barn roof structure appears to be in good condition.

The roof appears to be mainly level with no sagging. Some tiles need to be replaced.

The roof structure also appears to be in reasonable condition. Further analysis by a structural engineer will be required once development proposals for the building have been completed. Potential remedial works could involve installing new joists, beams, and roofing materials to ensure they meet current building standards.

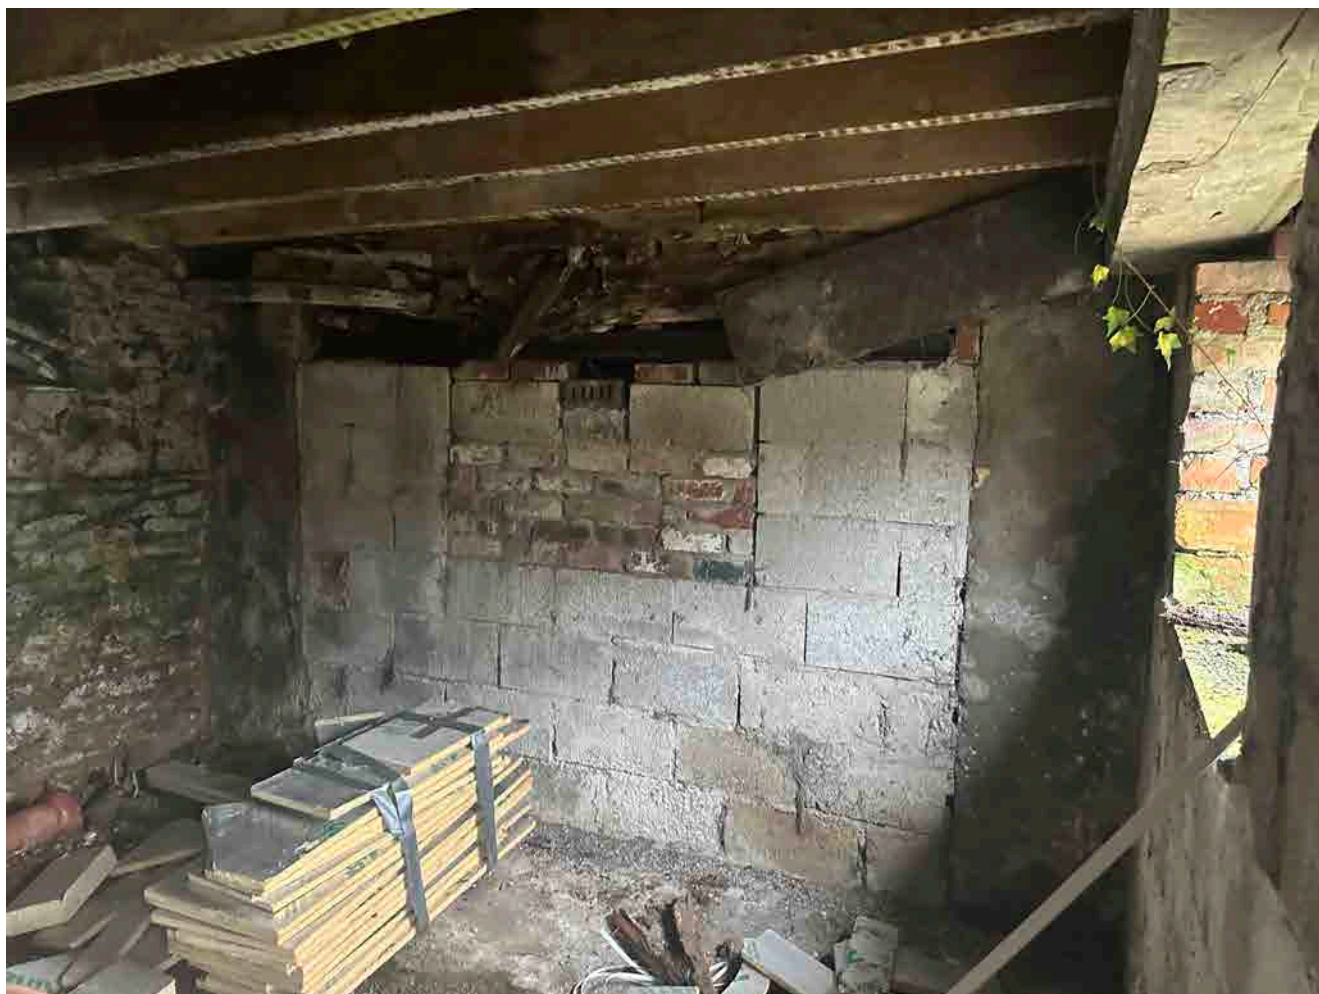
South west gable from the inside of the building. Some strengthening work has already been carried out in this section.

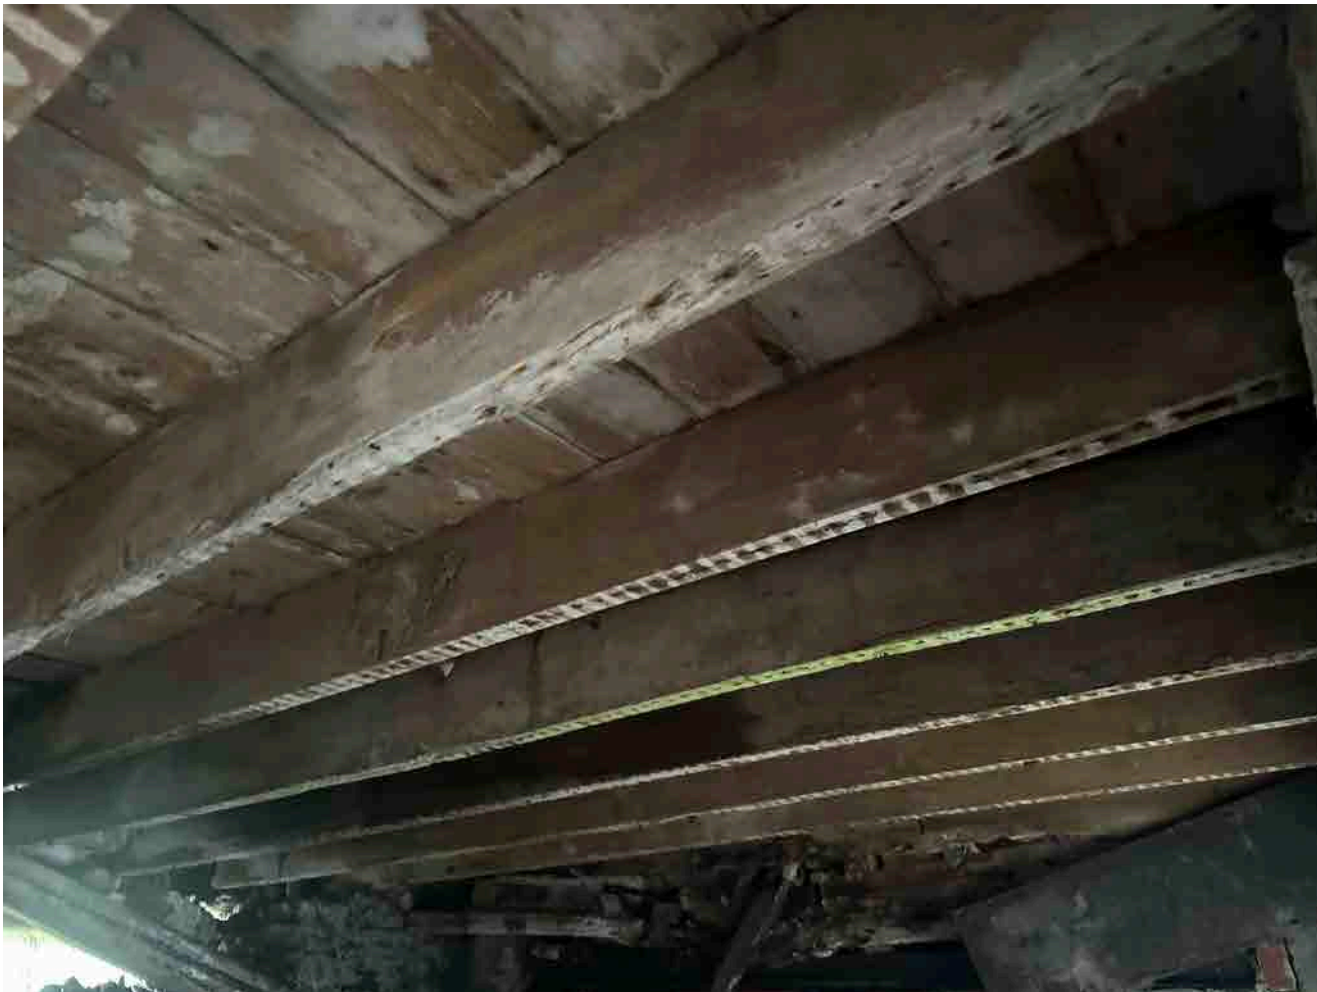
Underside of first floor joists.

The first floors structure in the barn are in a reasonably good condition but is not adequate for use as a floor in a domestic building.

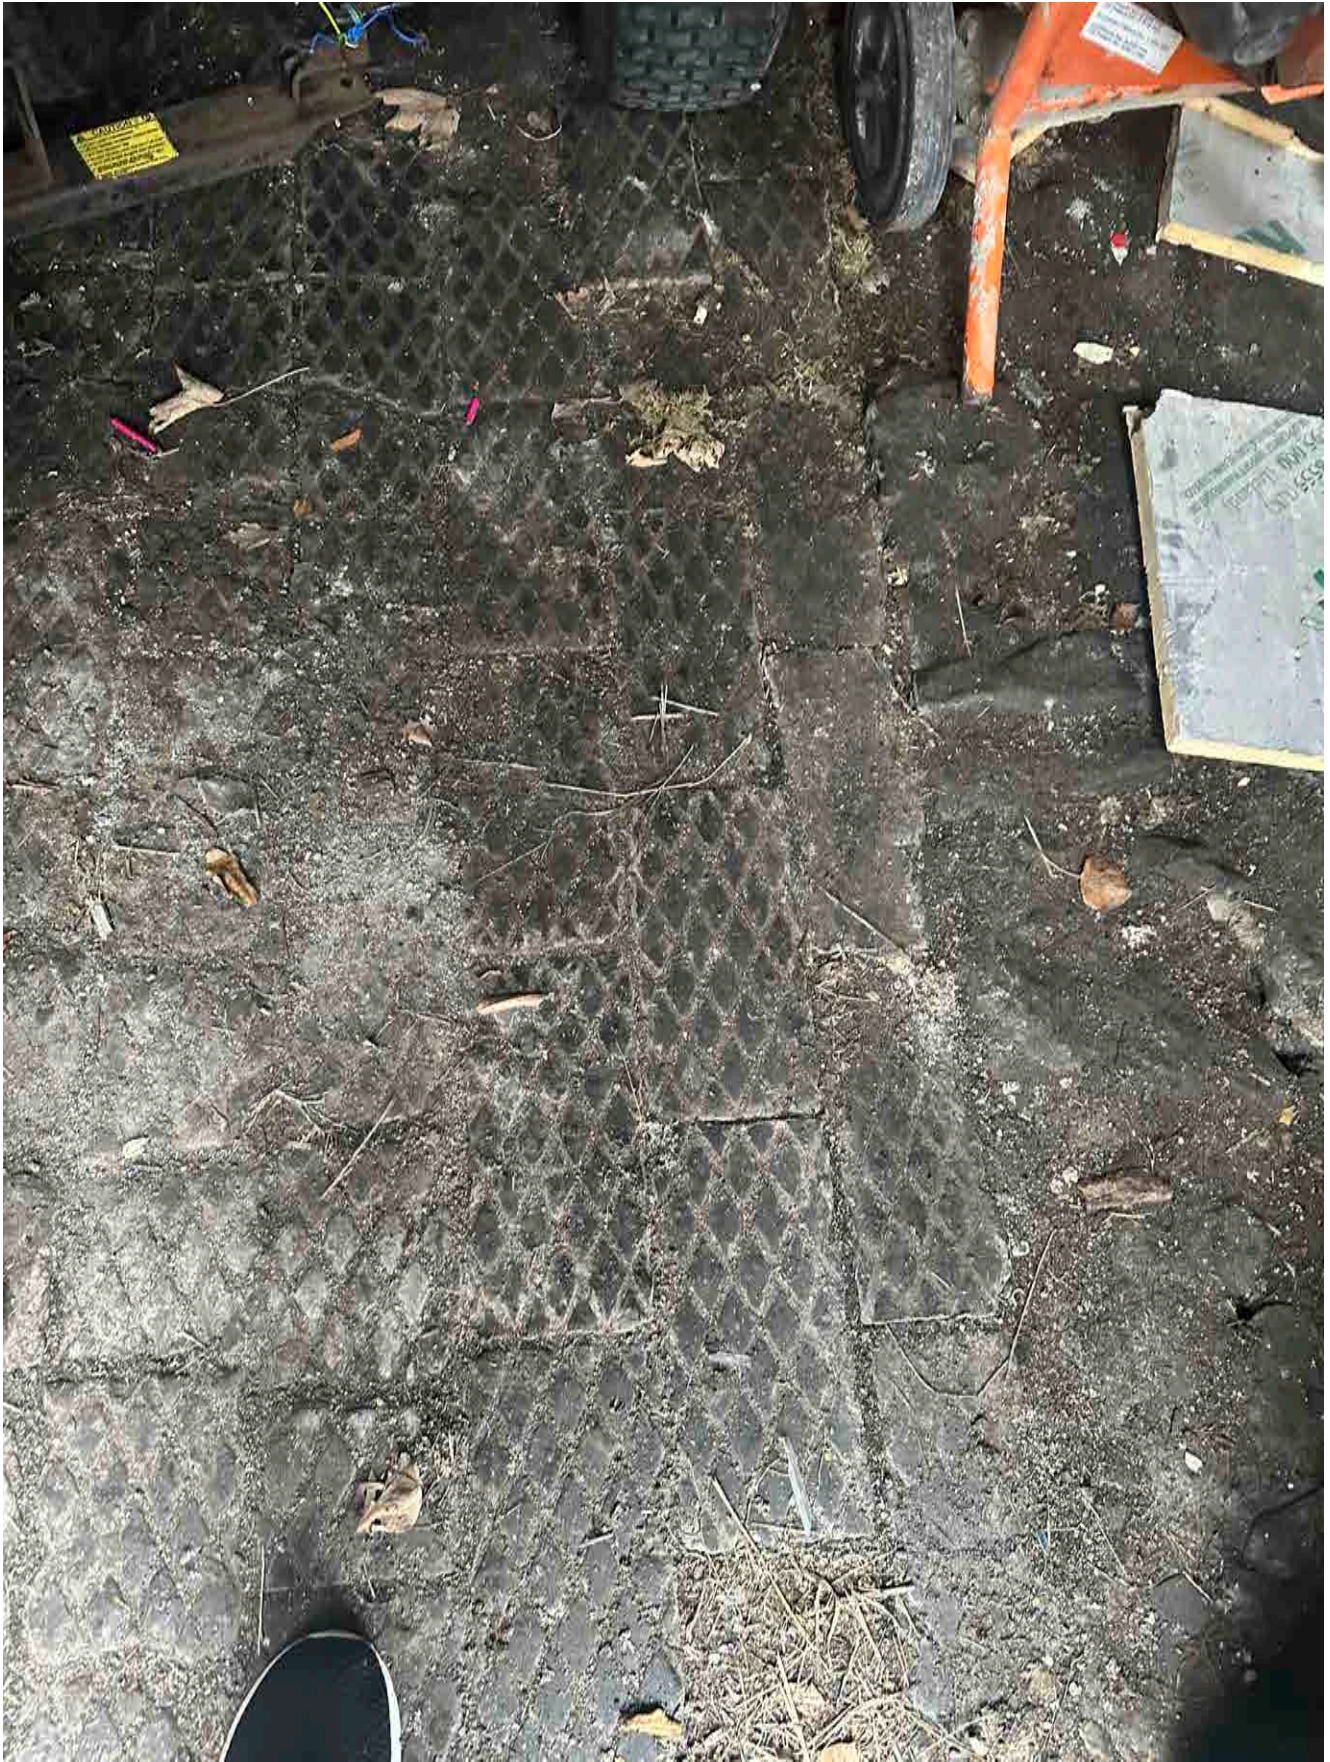
Existing floor structure is in good condition in this area but may require improvement to make it suitable for a domestic use.
