# ASBESTOS DEMOLITION SURVEY

Lower Pontneddfechan, Pontneathvaughan Rd, Glynneath, Neath SA11 5NR

ALL110354/25/JG-1

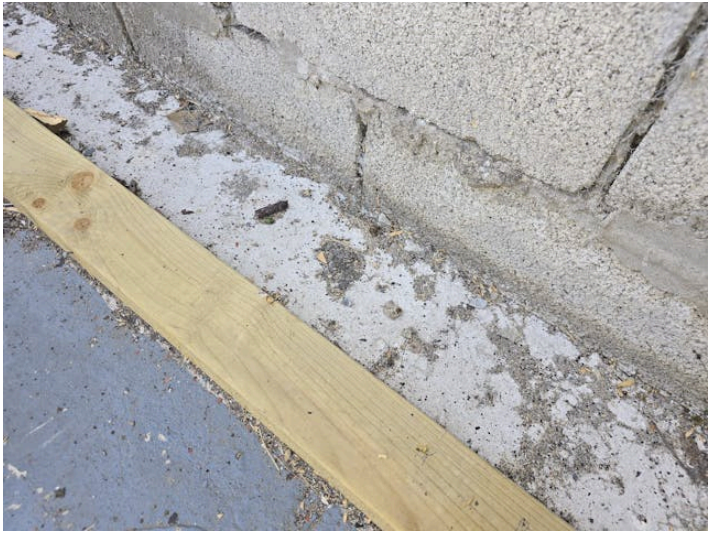
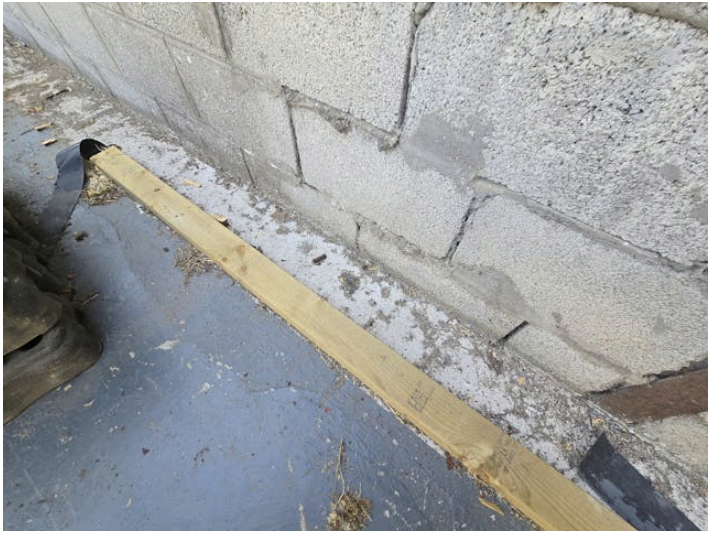
| Location | 03 - RHS Barn | Item | Cement Debris To Floor (LHS Wall) |
| Material | Cement | Extent | Small Amount, Widespread |
| Strategy / Sample Id | Sample / 110354/05 | Fibre Type | Chrysotile |

| Product Type (or Debris from Product) | 1 | Extent of Damage / Deterioration | 3 |

| Recommendation | Remove | | |

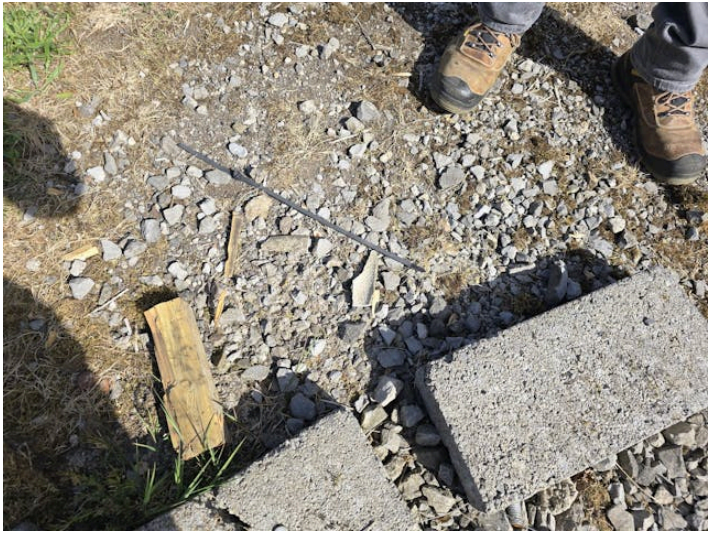
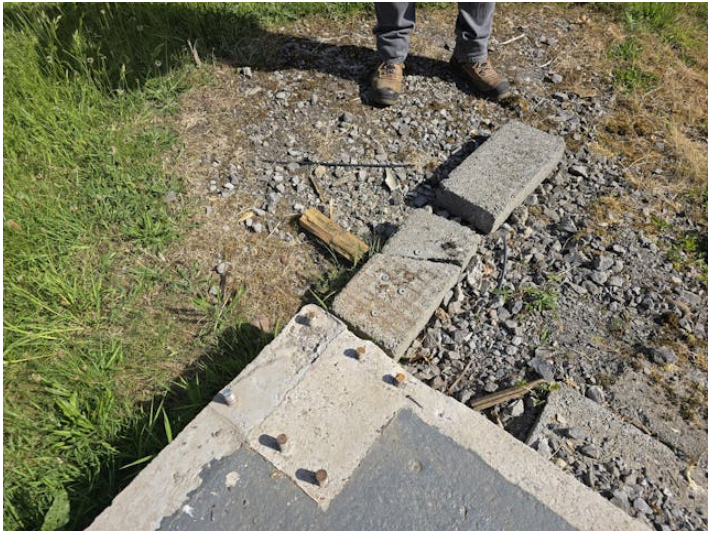
| Location | 03 - RHS Barn | Item | Cement Debris To Front |
| Material | Cement | Extent | Small Amount, Widespread |
| Strategy / Sample Id | Strongly Presume / 110354/06 | Presumed Fibre Type | Chrysotile |

| Product Type (or Debris from Product) | 1 | Extent of Damage / Deterioration | 3 |

| Recommendation | Remove | | |

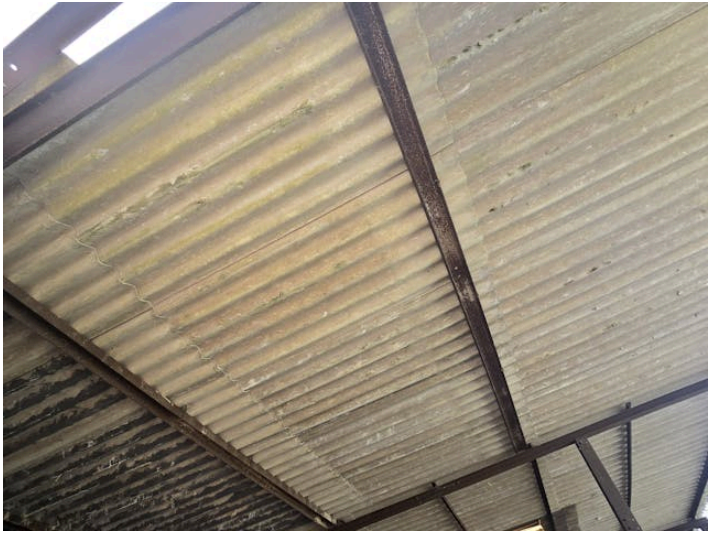
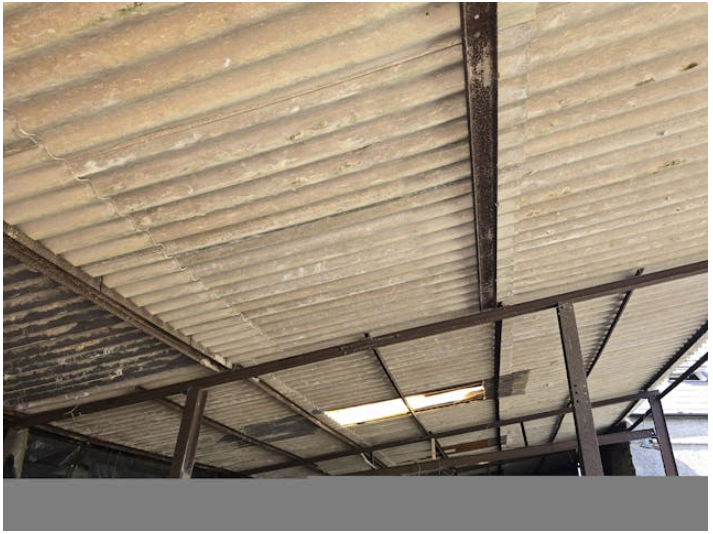
- Cement Roof / 0/04 Middle Barn, 0/04 Middle Barn Externals - This ACM was found to the roof of the barn. At the time of inspection the ACM had a medium amount of damage, with many parts of the material delaminating. We would recommend that these are removed by a licensed contractor due to the amount present.

| Location | 04 - Middle Barn | Item | Cement Roof |
| Material | Cement | Extent | 120 m. sq. |
| Strategy / Sample Id | Sample / 110354/07 | Fibre Type | Chrysotile |

| Product Type (or Debris from Product) | 1 | Extent of Damage / Deterioration | 2 |

| Recommendation | Remove | | |

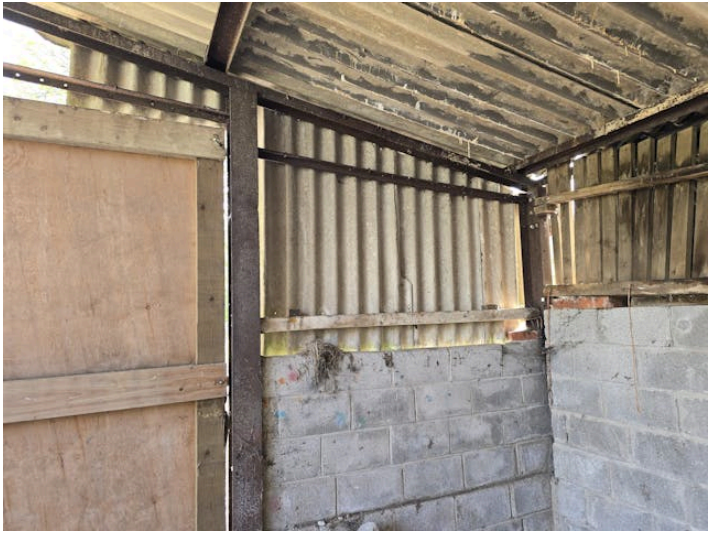
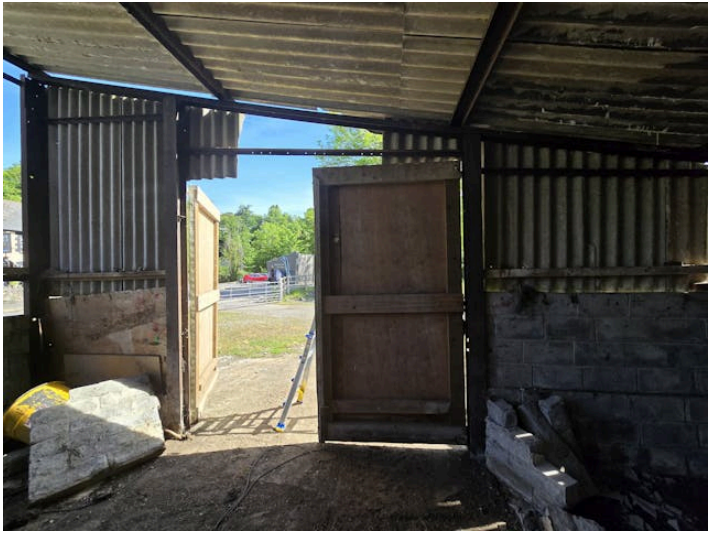
- Cement Walls / 0/04 Middle Barn, 0/04 Middle Barn Externals - This ACM was found to the walls of the barn. At the time of inspection the ACM had a medium amount of damage, with many parts of the material delaminating. We would recommend that these are removed by a licensed contractor due to the amount present.

| Location | 04 - Middle Barn | Item | Cement Walls |
| Material | Cement | Extent | 15 m. sq. |
| Strategy / Sample Id | Sample / 110354/08 | Fibre Type | Chrysotile |

| Product Type (or Debris from Product) | 1 | Extent of Damage / Deterioration | 2 |

| Recommendation | Remove | | |

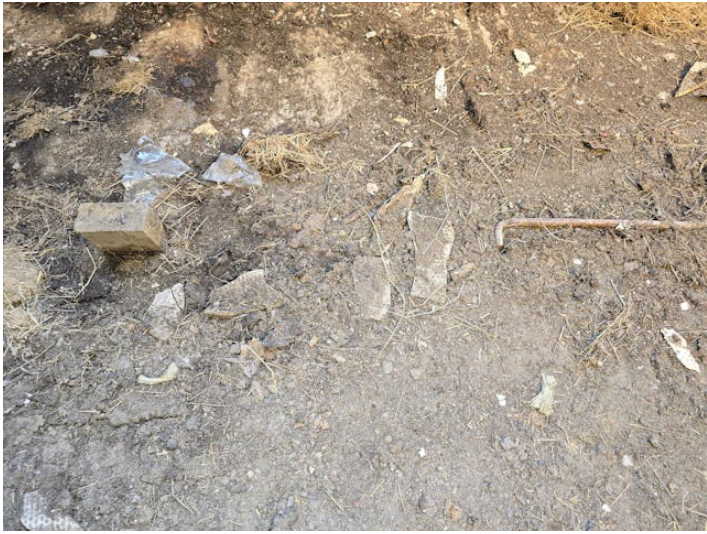
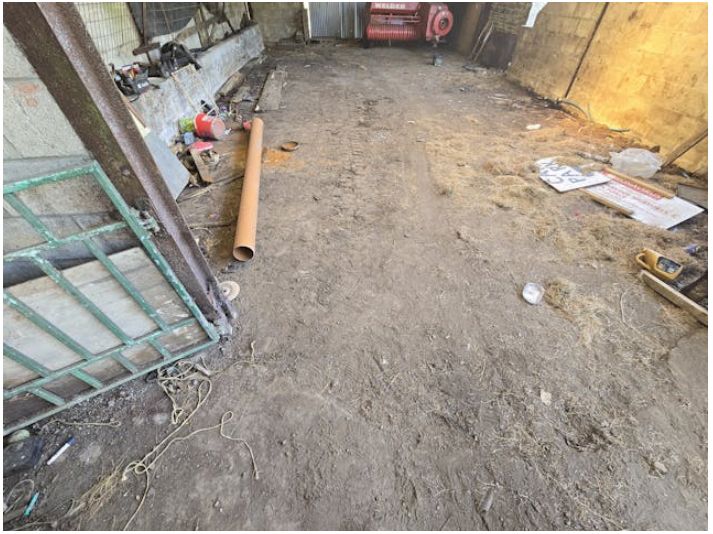
| Location | 04 - Middle Barn | Item | Cement Debris To Floor |
| Material | Cement | Extent | Large Amounts, Widespread |
| Strategy / Sample Id | Sample / 110354/10 | Fibre Type | Chrysotile |

| Product Type (or Debris from Product) | 1 | Extent of Damage / Deterioration | 3 |

| Recommendation | Remove | | |

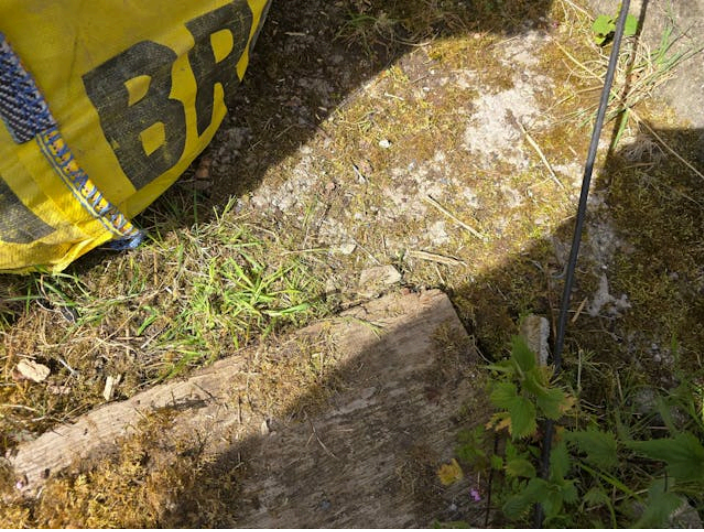
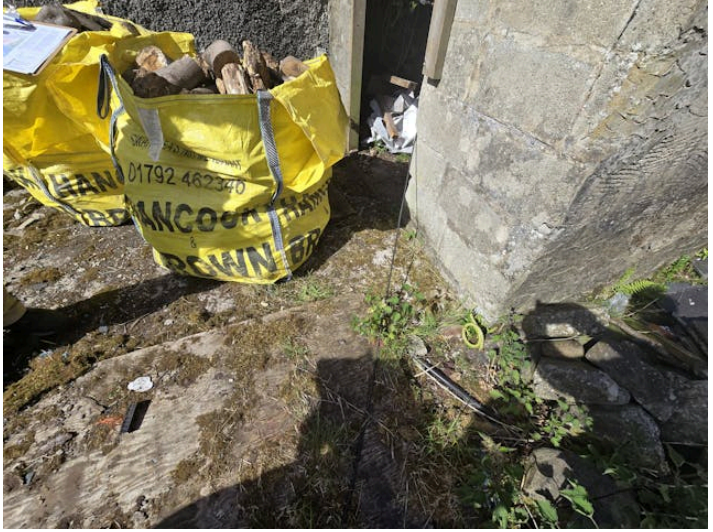
| Location | 02 - Lean-to | Item | Cement Debris to Entrance |
| Material | Cement | Extent | Small Amount, Localised Spread |
| Strategy / Sample Id | Sample / 110354/03 | Fibre Type | Chrysotile |

| Product Type (or Debris from Product) | 1 | Extent of Damage / Deterioration | 3 |

| Recommendation | Remove | | |

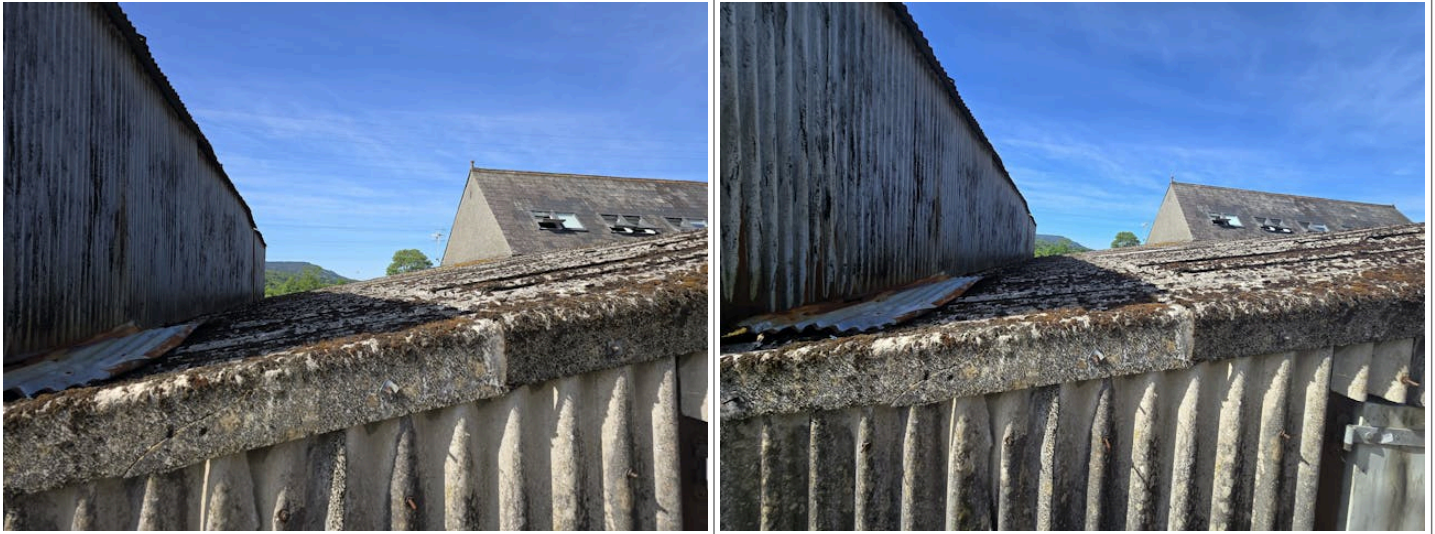
| Location | 04 - Middle Barn | Item | Cement Roof |
| Material | Cement | Extent | 120 m. sq. |
| Strategy / Sample Id | Strongly Presume / 110354/11 | Presumed Fibre Type | Chrysotile |

| Product Type (or Debris from Product) | 1 | Extent of Damage / Deterioration | 2 |

| Recommendation | Remove | | |

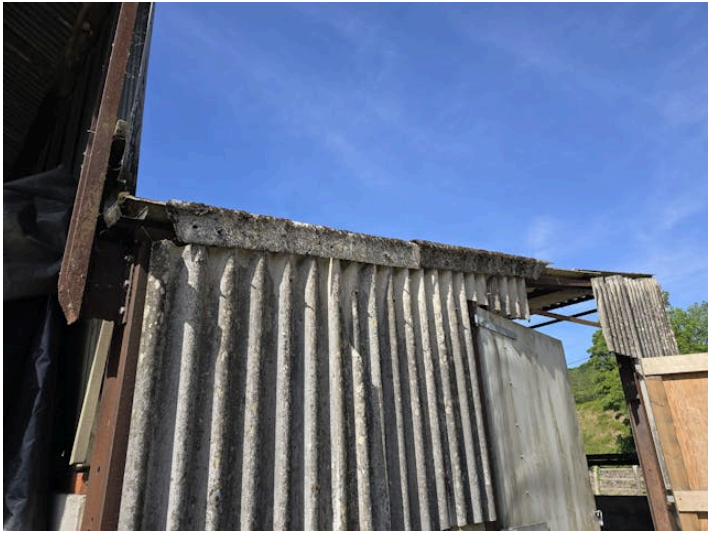
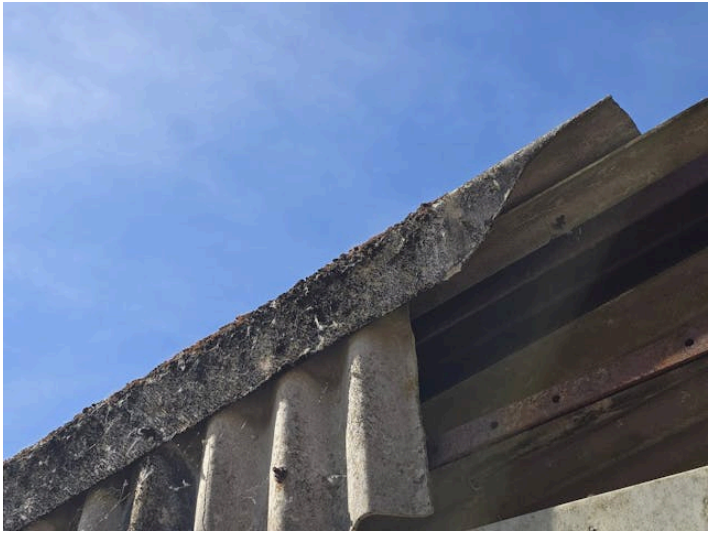
- Cement Barge Boards / 0/04 Middle Barn Externals - This ACM was found to the gable ends of the barn. At the time of inspection the ACM had a medium amount of damage, with many parts of the material delaminating. We would recommend that these are removed by a licensed contractor due to the amount present.

| Location | 04 - Middle Barn | Item | Cement Barge Boards |
| Material | Cement | Extent | 10 Linear Metres |
| Strategy / Sample Id | Sample / 110354/12 | Fibre Type | Chrysotile |

| Product Type (or Debris from Product) | 1 | Extent of Damage / Deterioration | 2 |

| Recommendation | Remove | | |

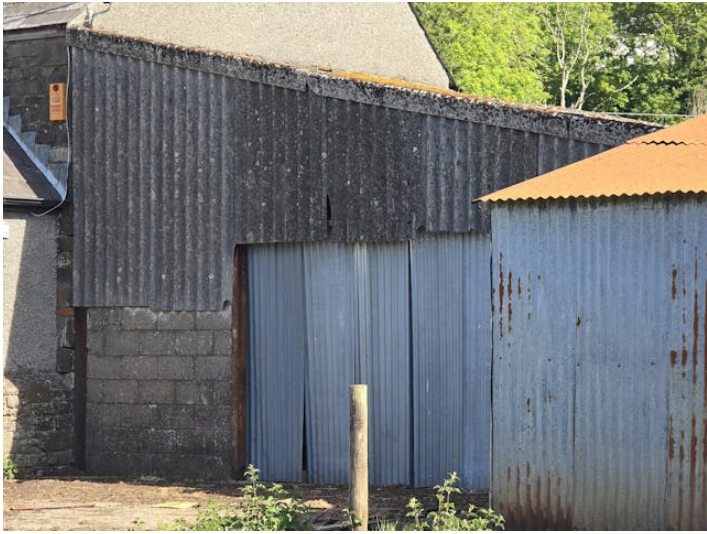
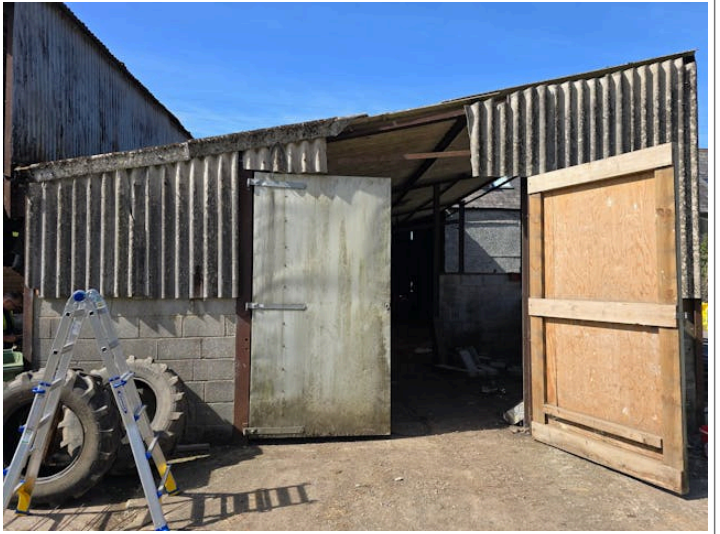
| Location | 04 - Middle Barn | Item | Cement Walls |
| Material | Cement | Extent | 15 m. sq. |
| Strategy / Sample Id | Strongly Presume / 110354/13 | Presumed Fibre Type | Chrysotile |

| Product Type (or Debris from Product) | 1 | Extent of Damage / Deterioration | 2 |

| Recommendation | Remove | | |

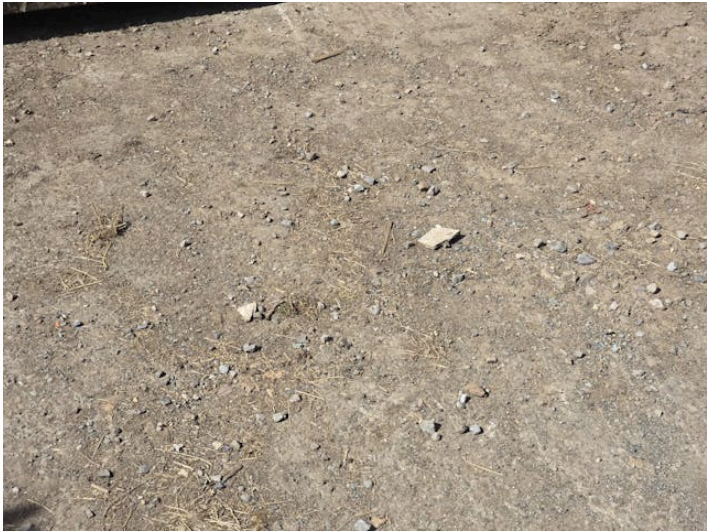
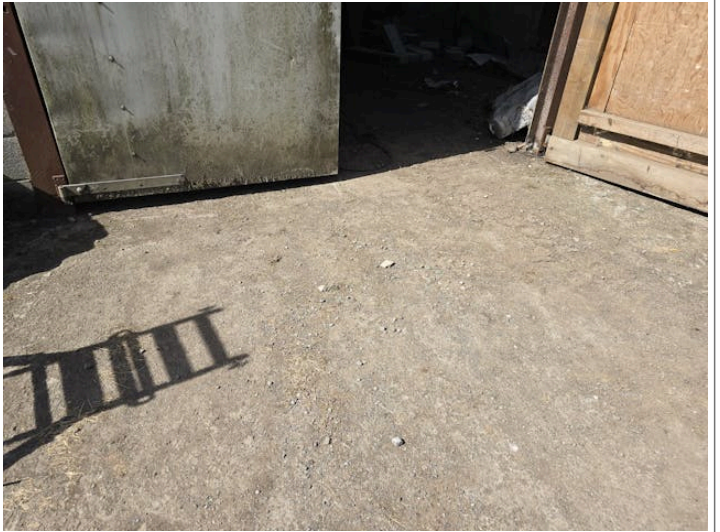
| Location | 04 - Middle Barn | Item | Cement Debris To Floor |
| Material | Cement | Extent | Large Amounts, Widespread |
| Strategy / Sample Id | Strongly Presume / 110354/14 | Presumed Fibre Type | Chrysotile |

| Product Type (or Debris from Product) | 1 | Extent of Damage / Deterioration | 3 |

| Recommendation | Remove | | |

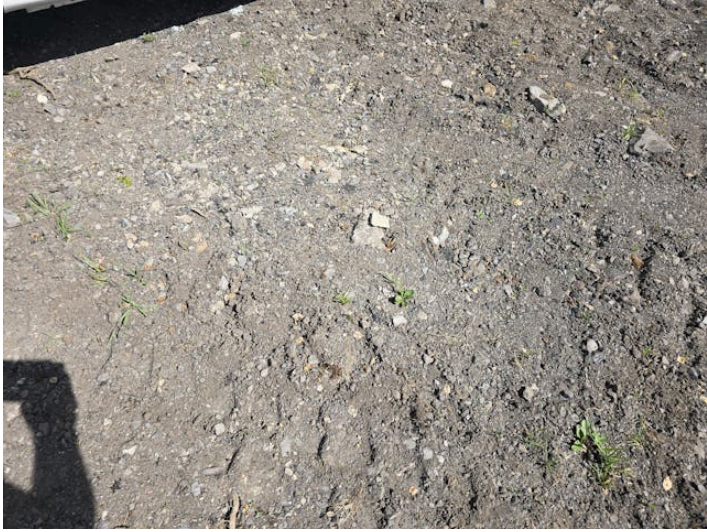
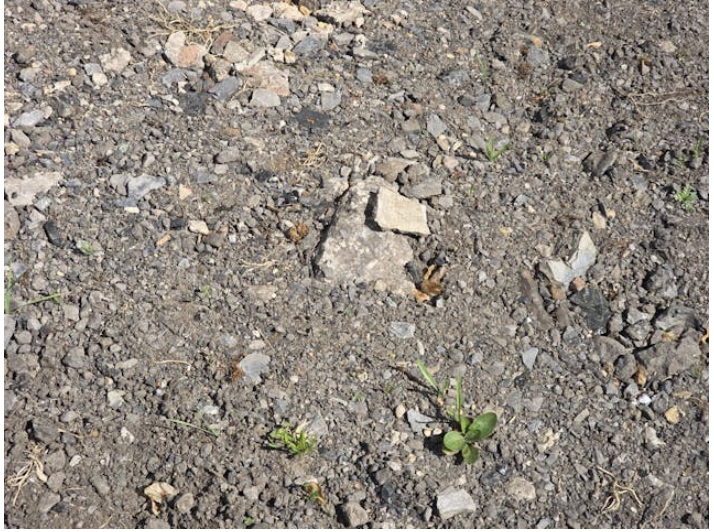
| Location | External Elements | Item | Cement Debris To Floor |
| Material | Cement | Extent | Sporadically Throughout Area |
| Strategy / Sample Id | Sample / 110354/15 | Fibre Type | Chrysotile |

| Product Type (or Debris from Product) | 1 | Extent of Damage / Deterioration | 3 |

| Recommendation | Remove | | |

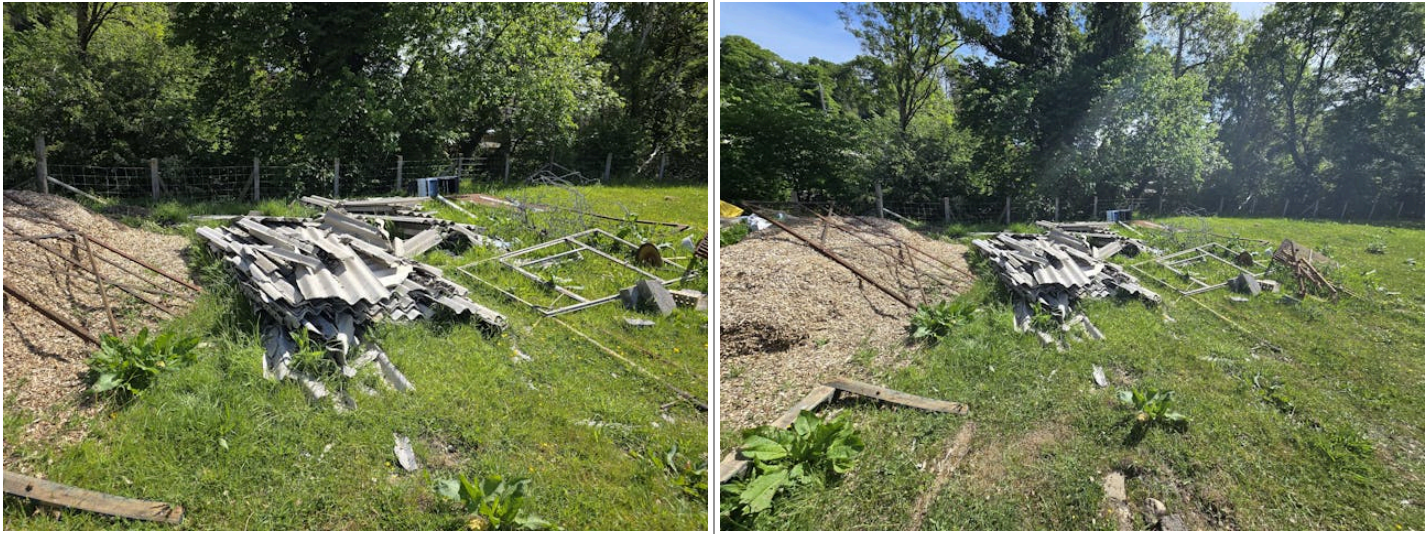
- Cement Sheets To Floor / External Elements Externals - This ACM was found on the floor a short distance away from the outbuildings. At the time of inspection these sheets had a high amount of damage. We would recommend that these are removed by a licensed contractor due to the amount present.

| Location | External Elements | Item | Cement Sheets To Floor |
| Material | Cement | Extent | Large Amount, Localised Spread |
| Strategy / Sample Id | Sample / 110354/16 | Fibre Type | Chrysotile |

| Product Type (or Debris from Product) | 1 | Extent of Damage / Deterioration | 3 |

| Recommendation | Remove | | |
