# Pre-Construction Road Condition Survey Suitability Report

Gelli Bwch Farm. Jersey Marine

**Prepared By:** MP Whelan

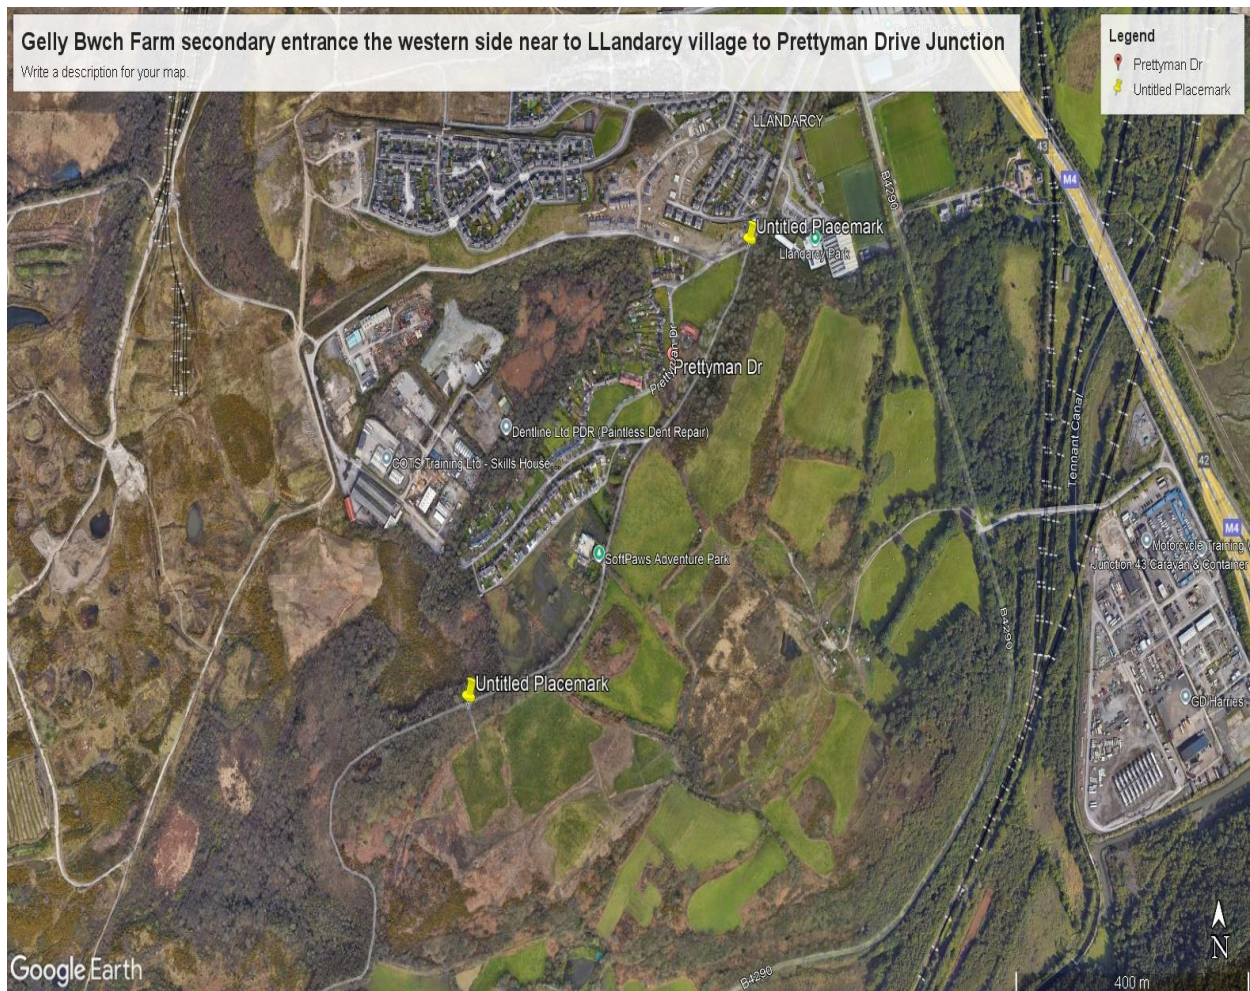
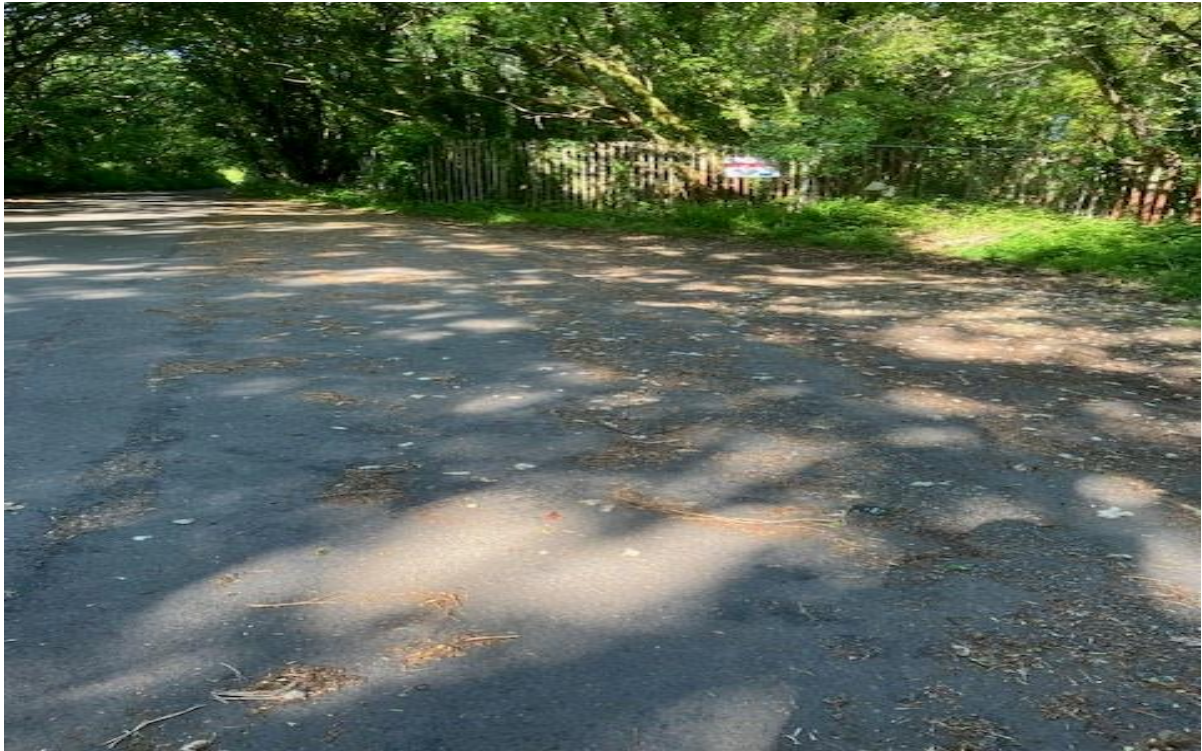
Secondary Entrance to Gelli Bwch Farm on the unclassified highway on the western side near to Llandarcy village dropping down to Prettyman Drive Junction Llandarcy

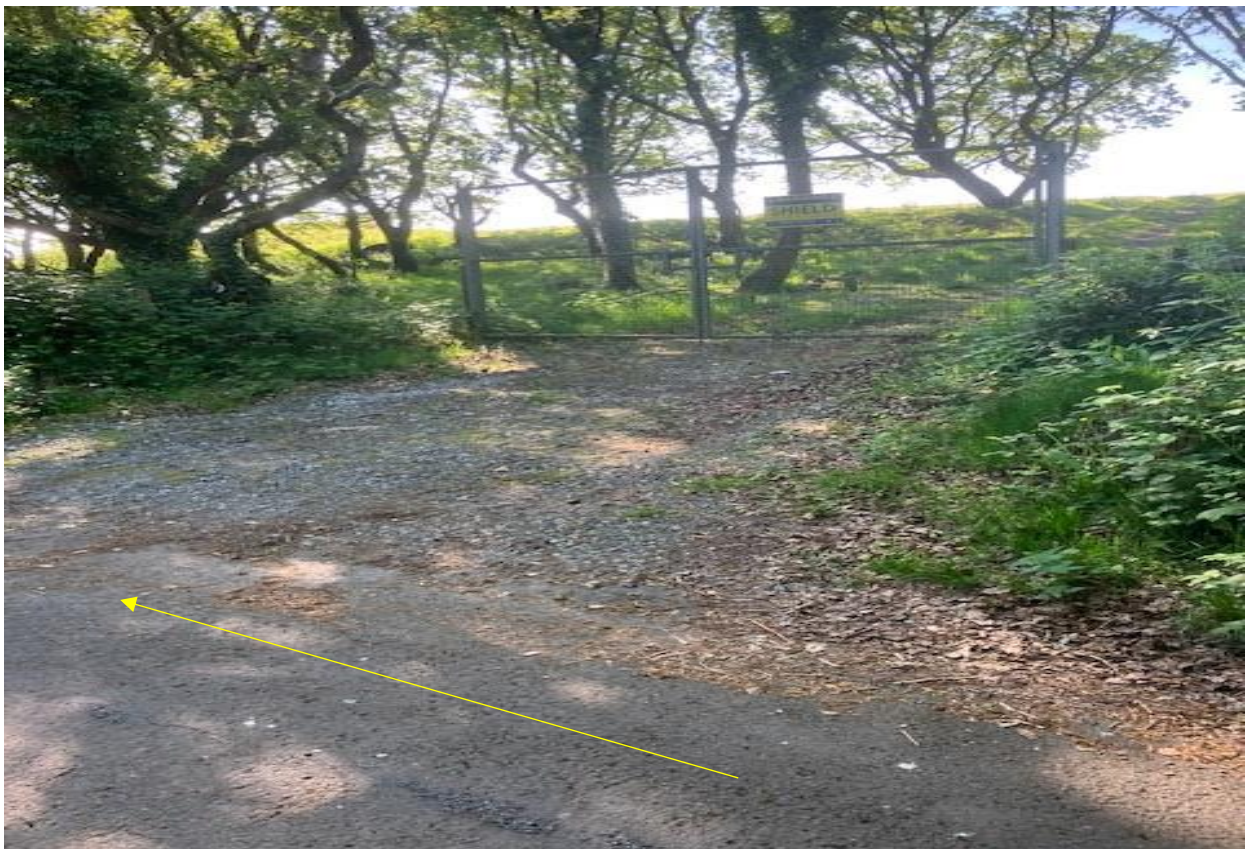
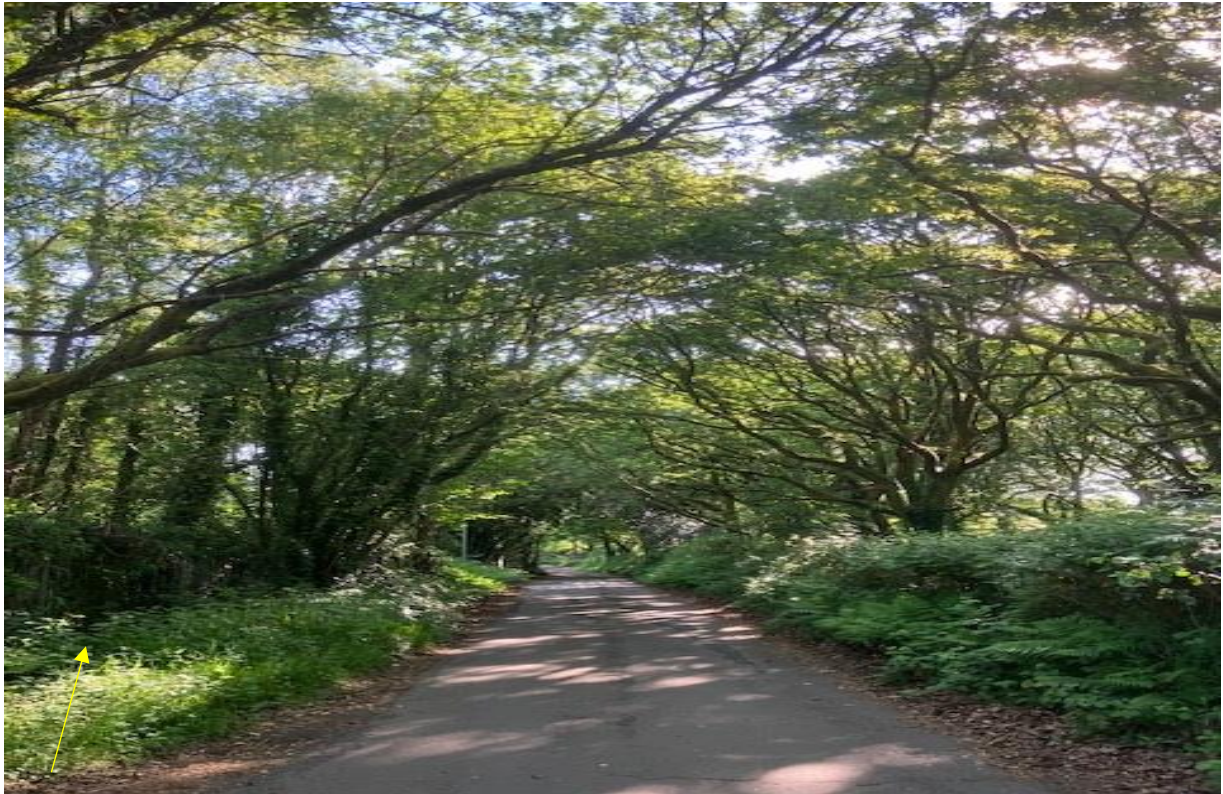
Minimum road width over section = 3.6

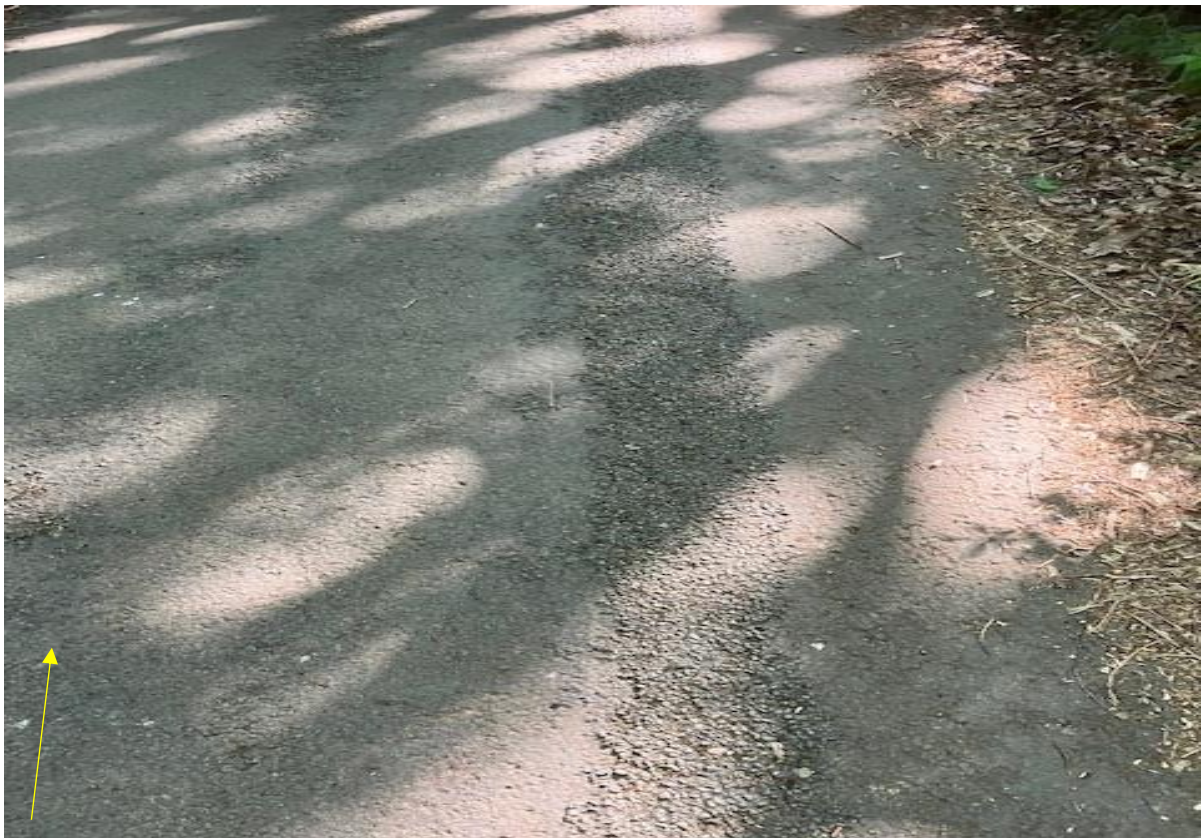
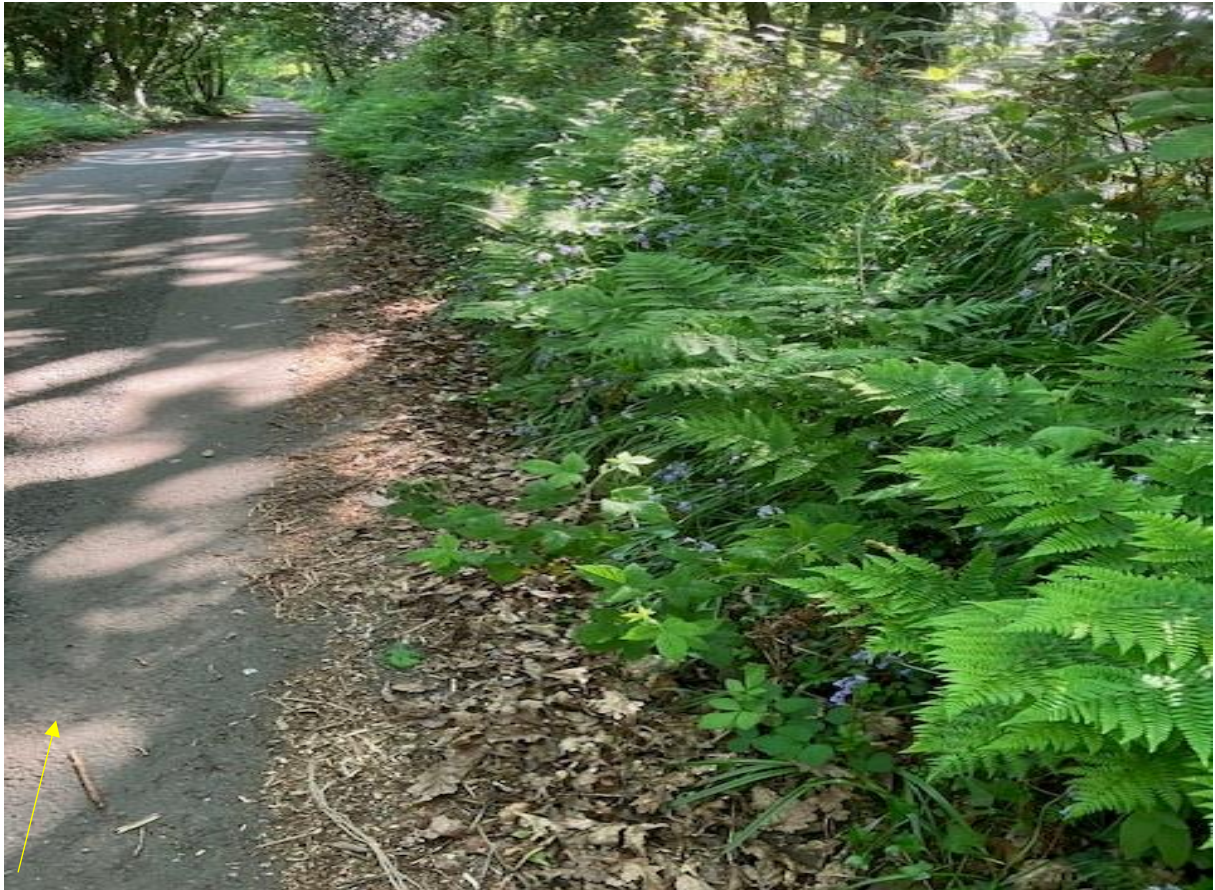
Damage – Edge cracking was viewed (left- and Right-hand side of road)

There is minor cracking which has been viewed in several areas, this is due to there being no formal solid edge detail (kerbing) to the lane.

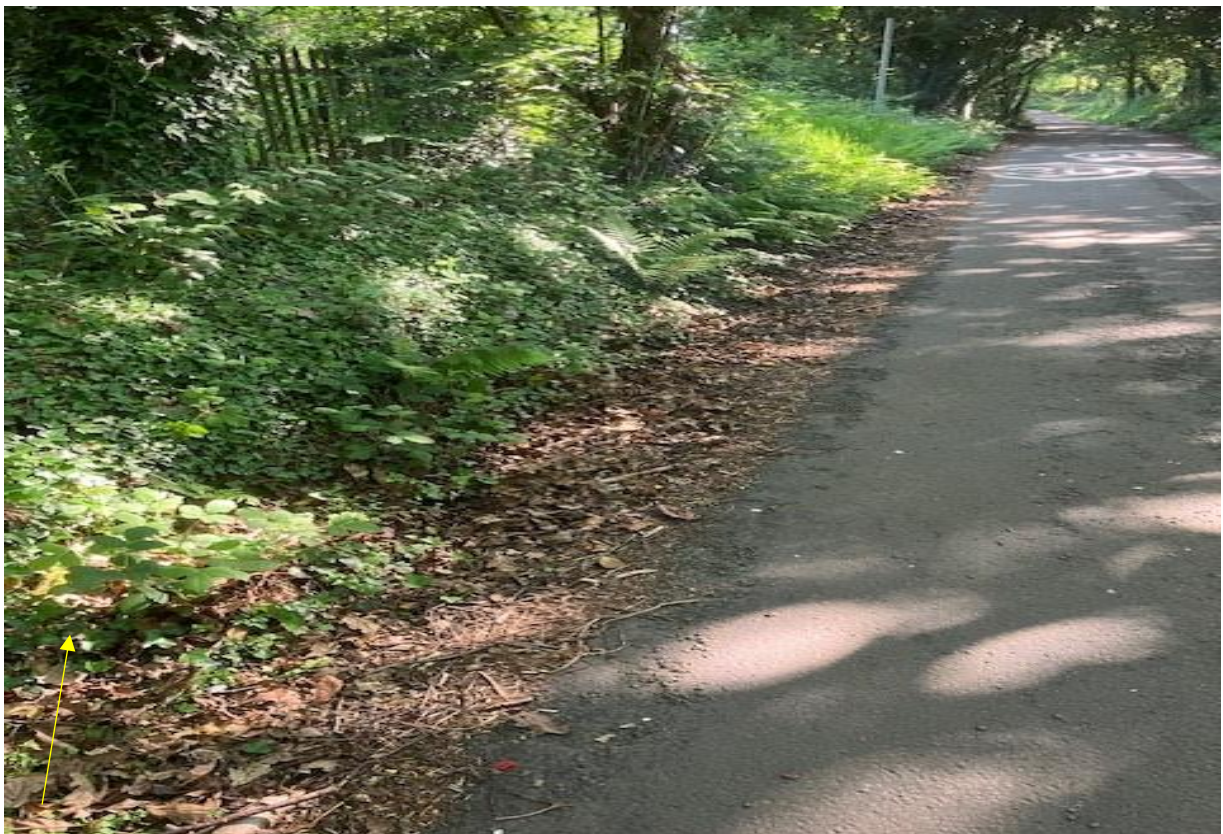
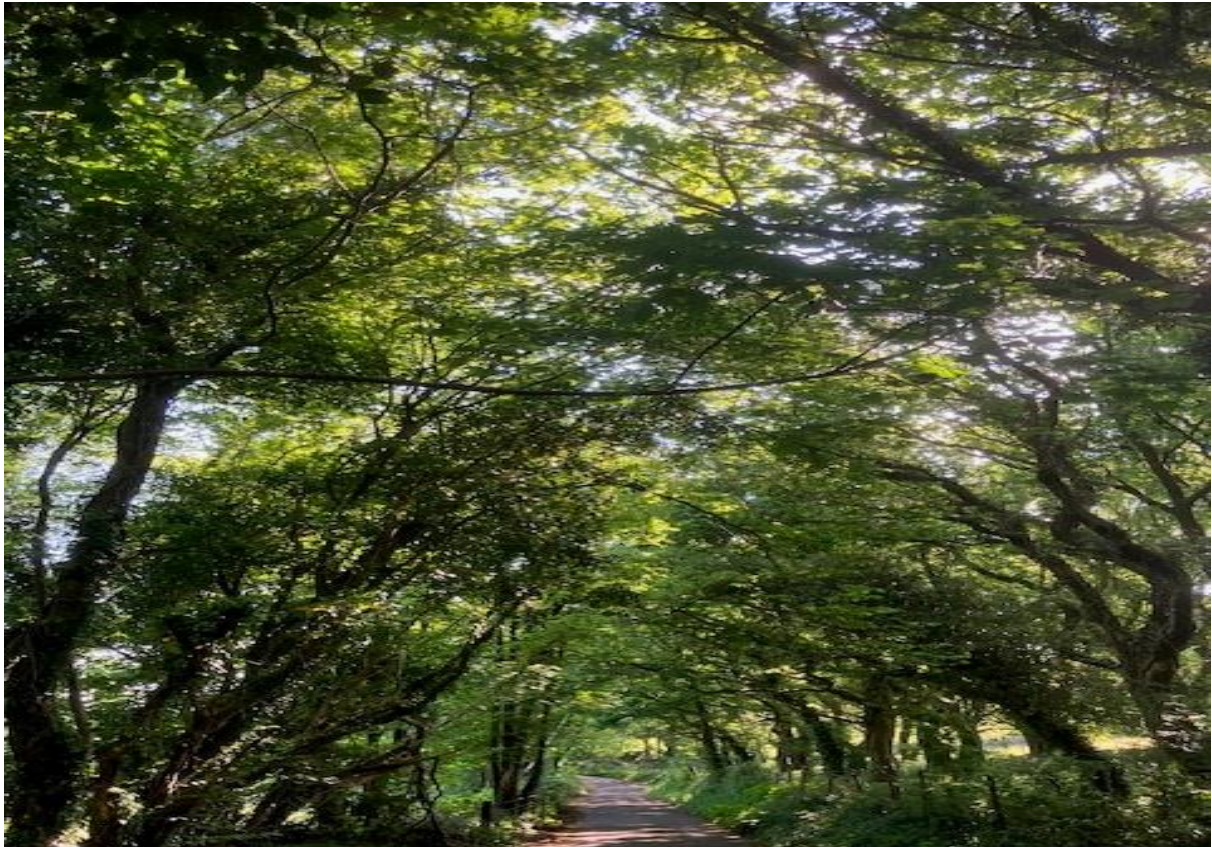
No formal solid edge detail (kerbing) to any part of the lane. Over-hang of trees above road.

Minimum road width over section = 4.2

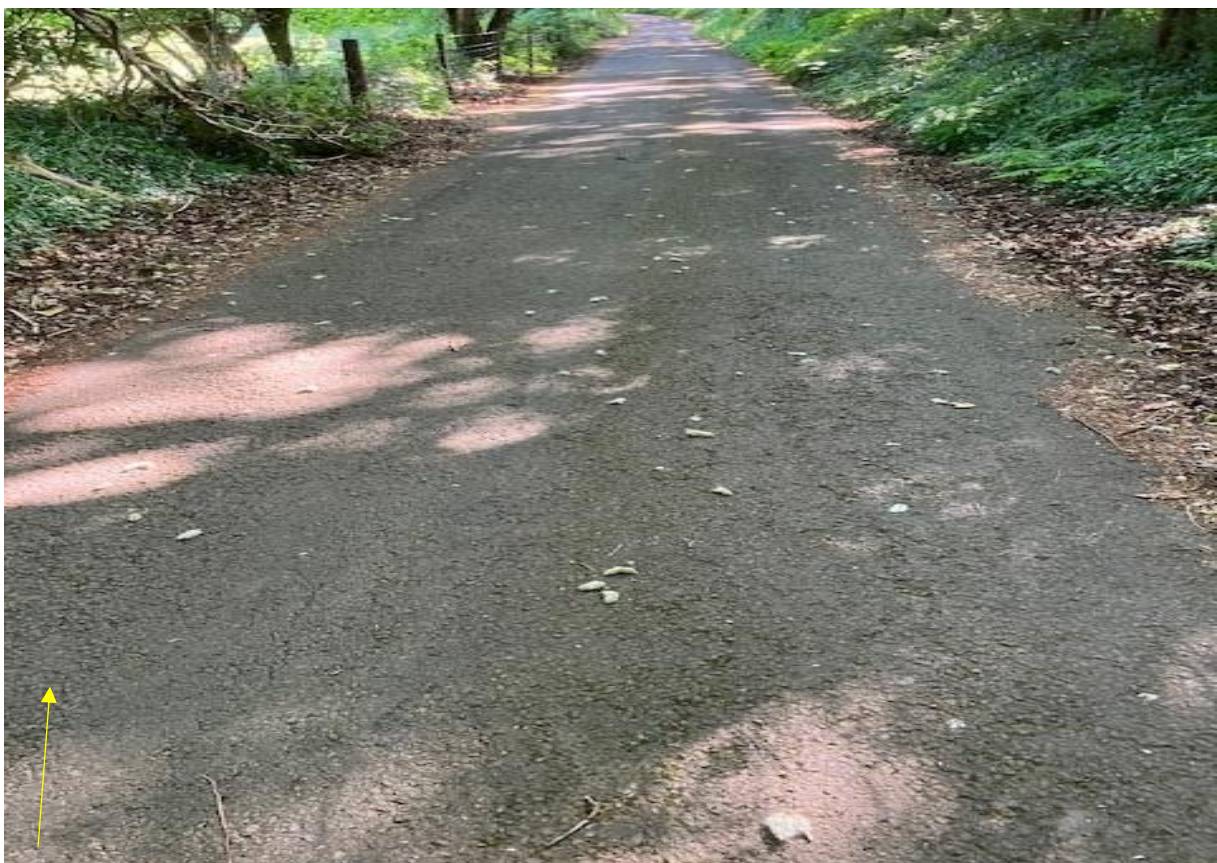
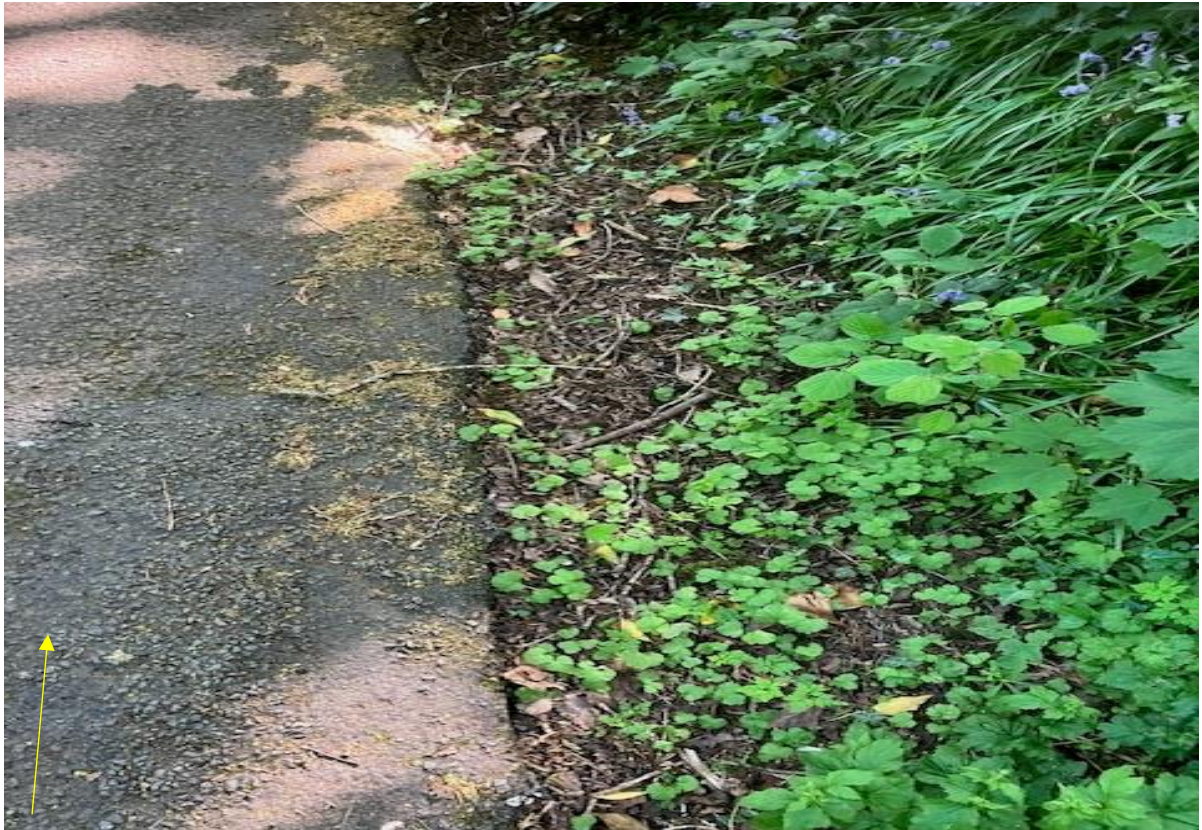
Various Rutt's along Lane and area where large vehicles can pull in for oncoming vehicles to pass

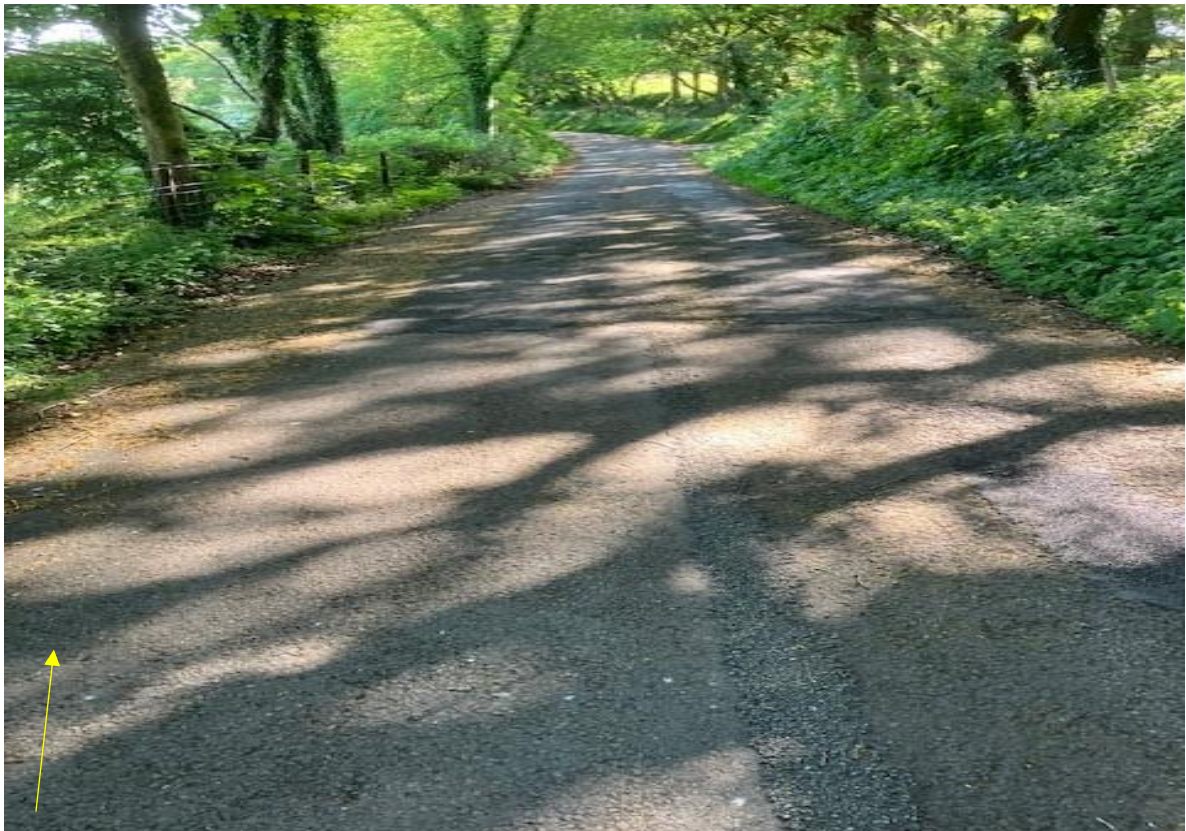
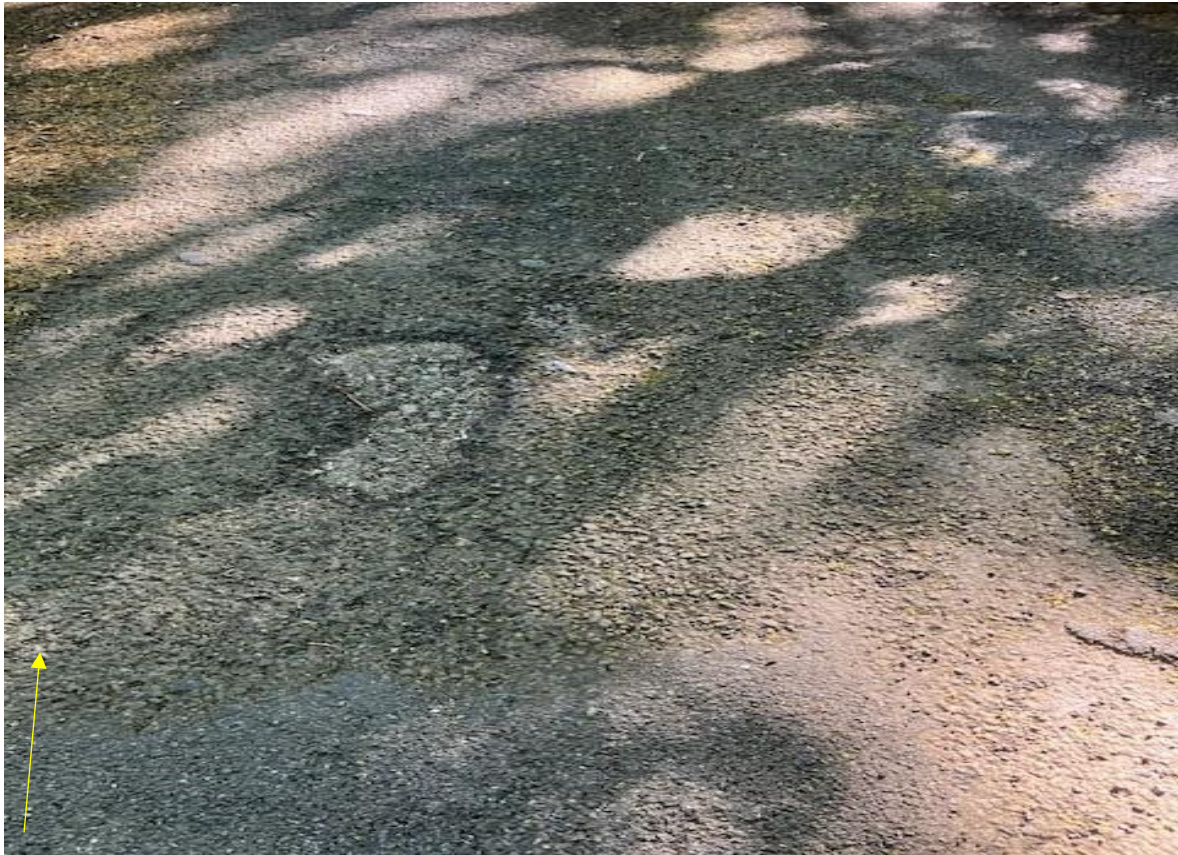
The new Tarmac has in the main been placed upon the previous road surface below

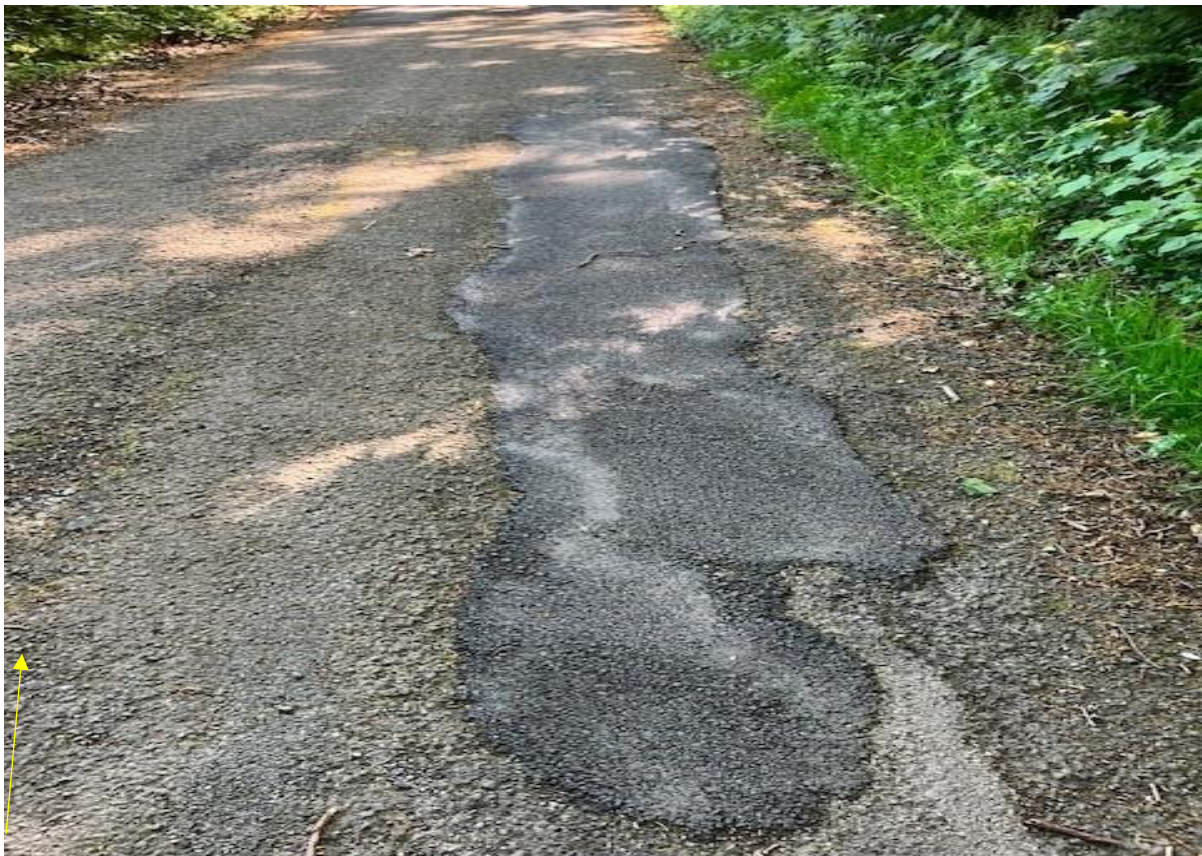
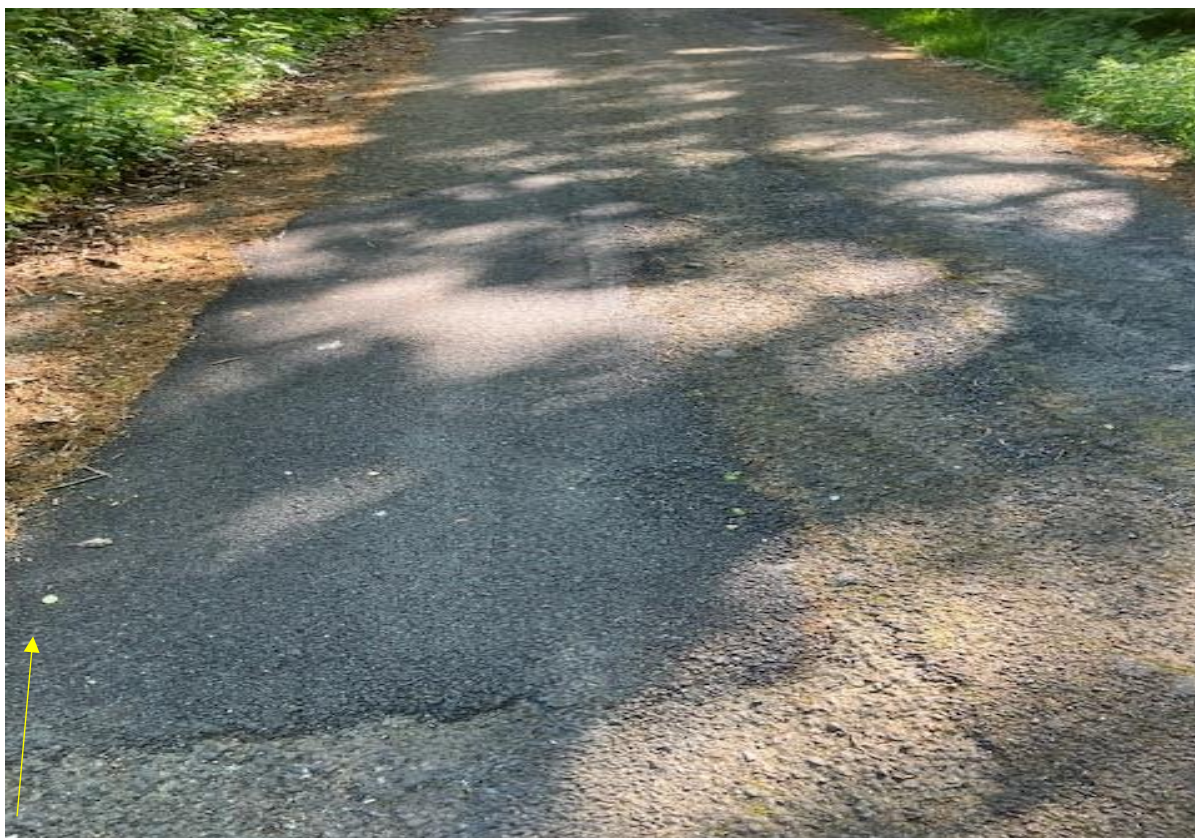
Minimum road width over section = 3.8

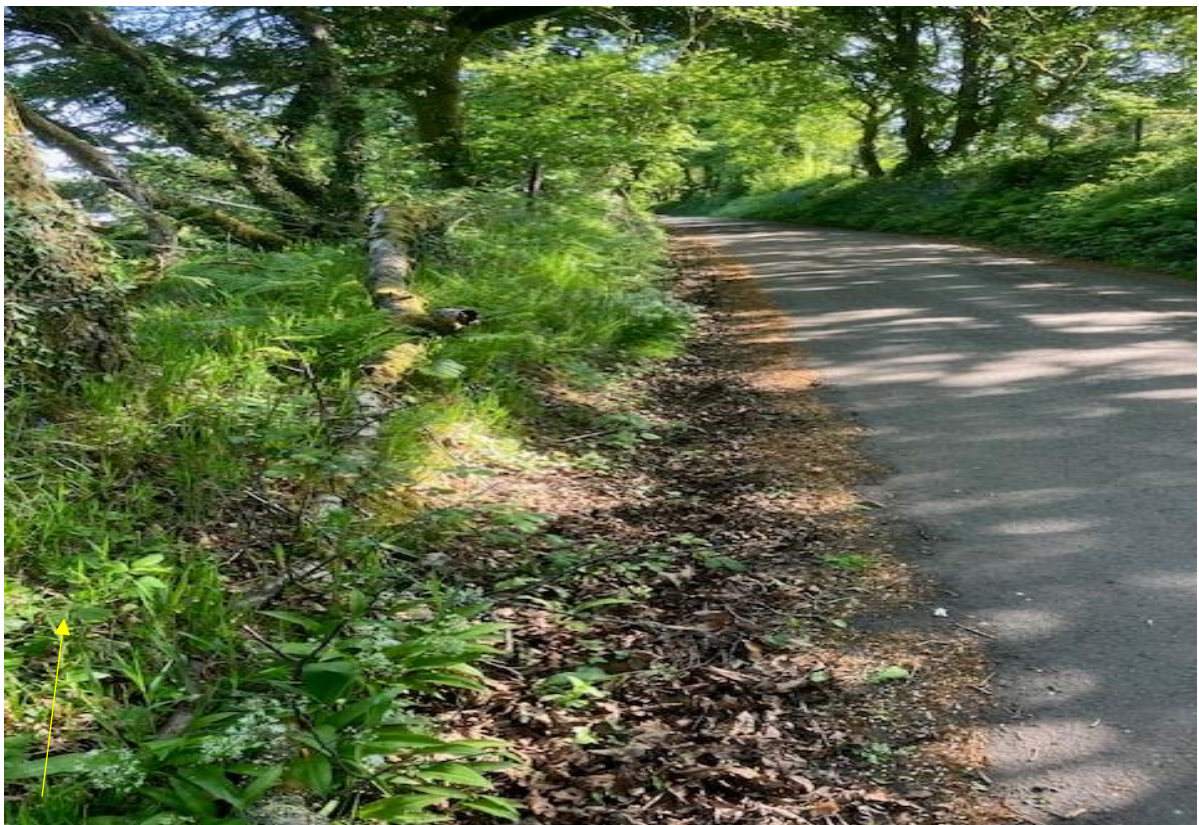
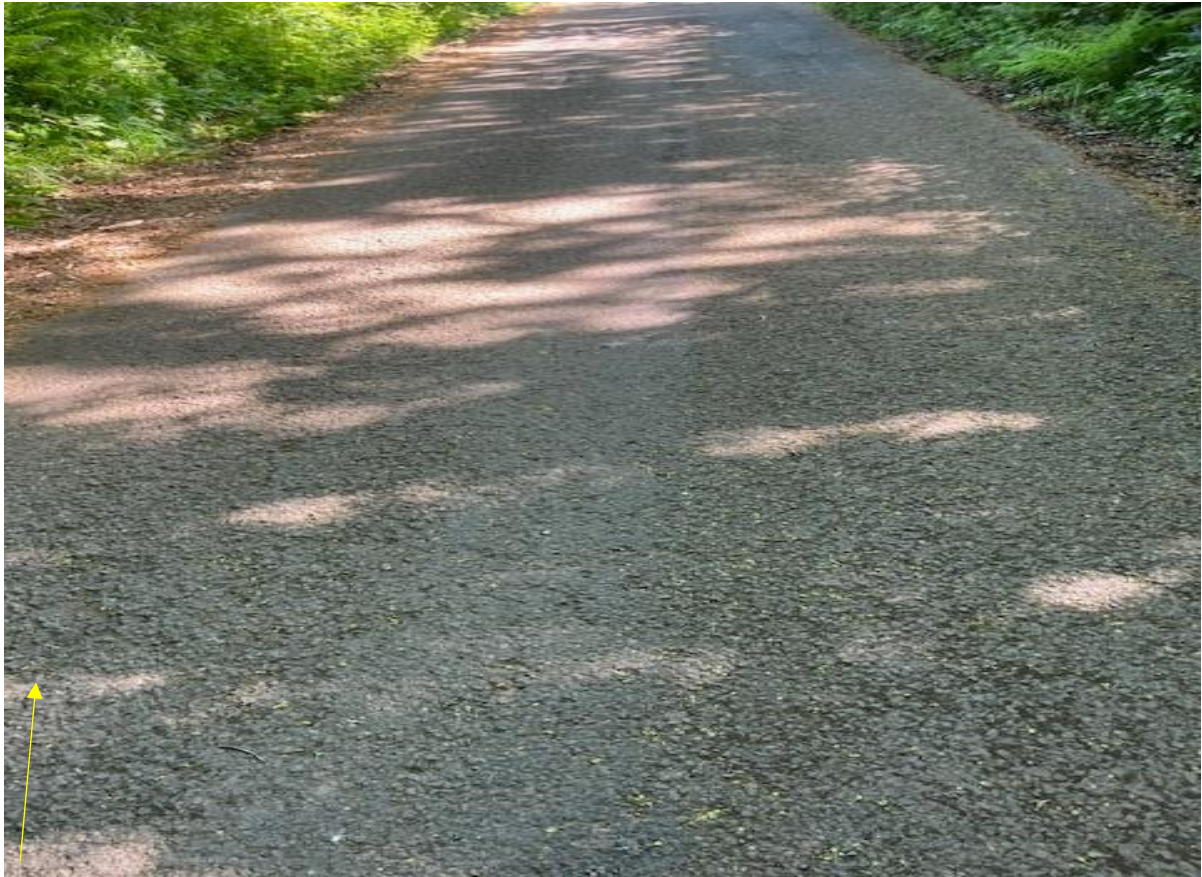
Minimum road width over section = 3.4

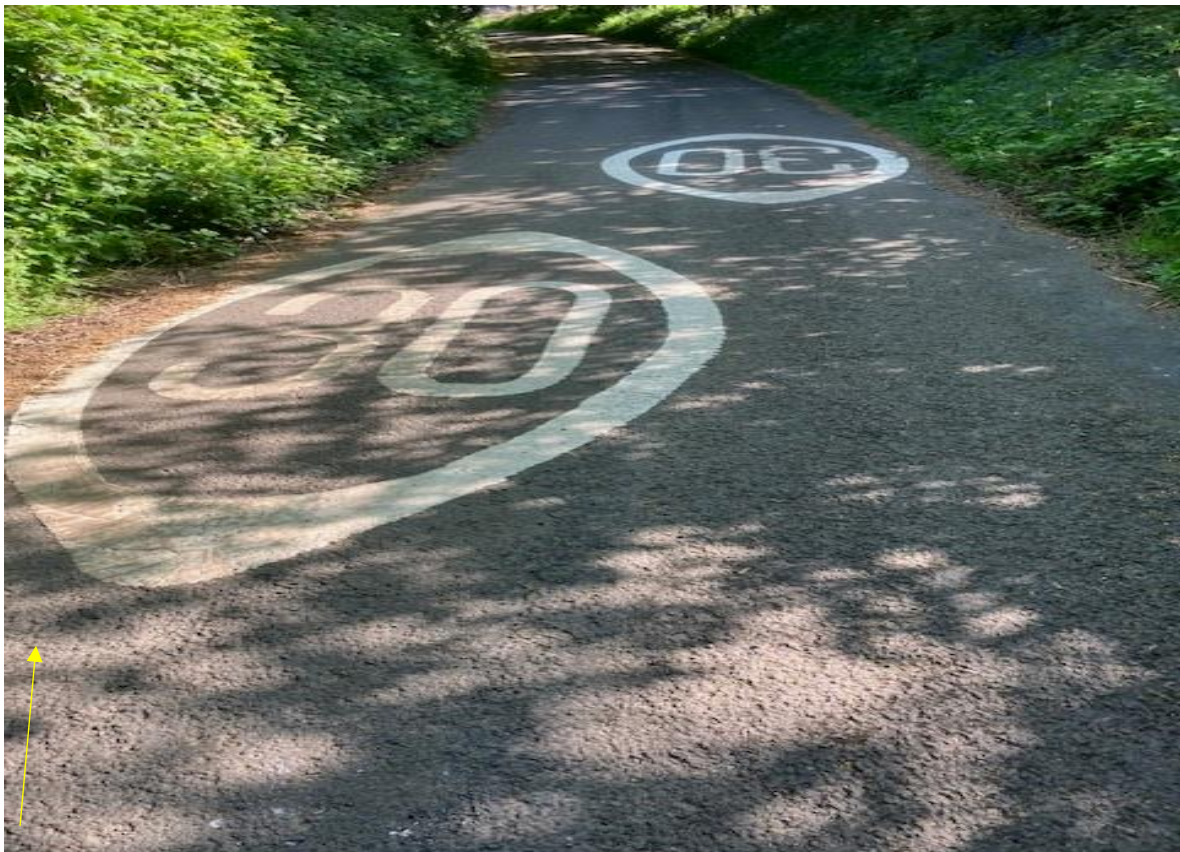
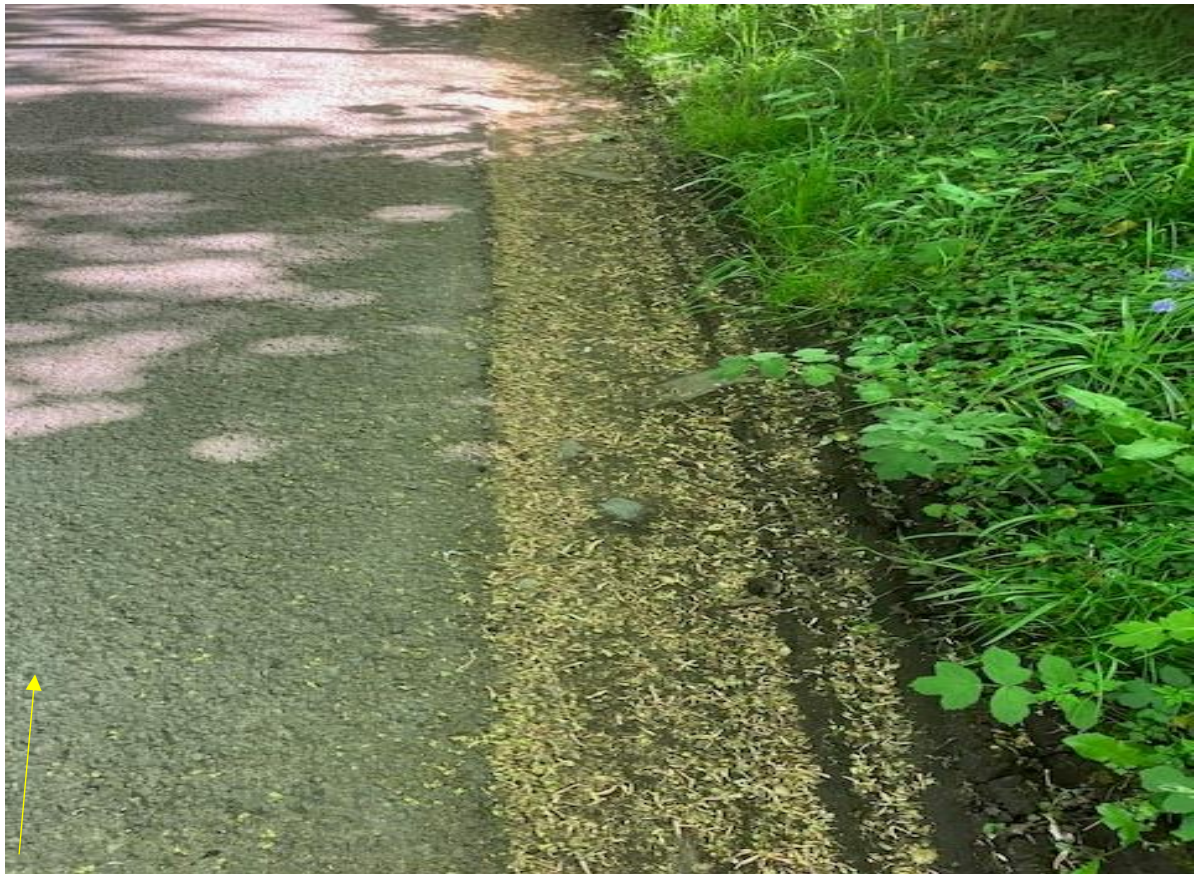
Rut was viewed from vehicles (left hand side of road)

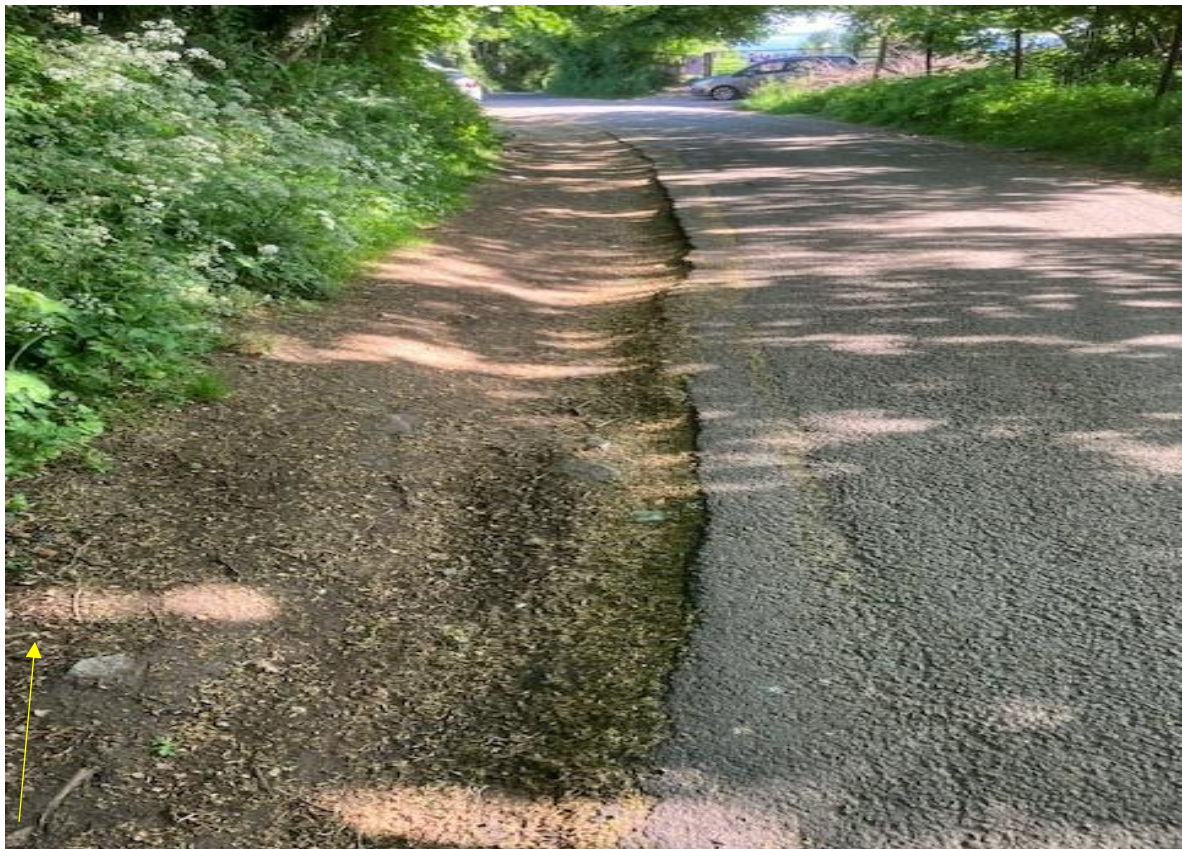
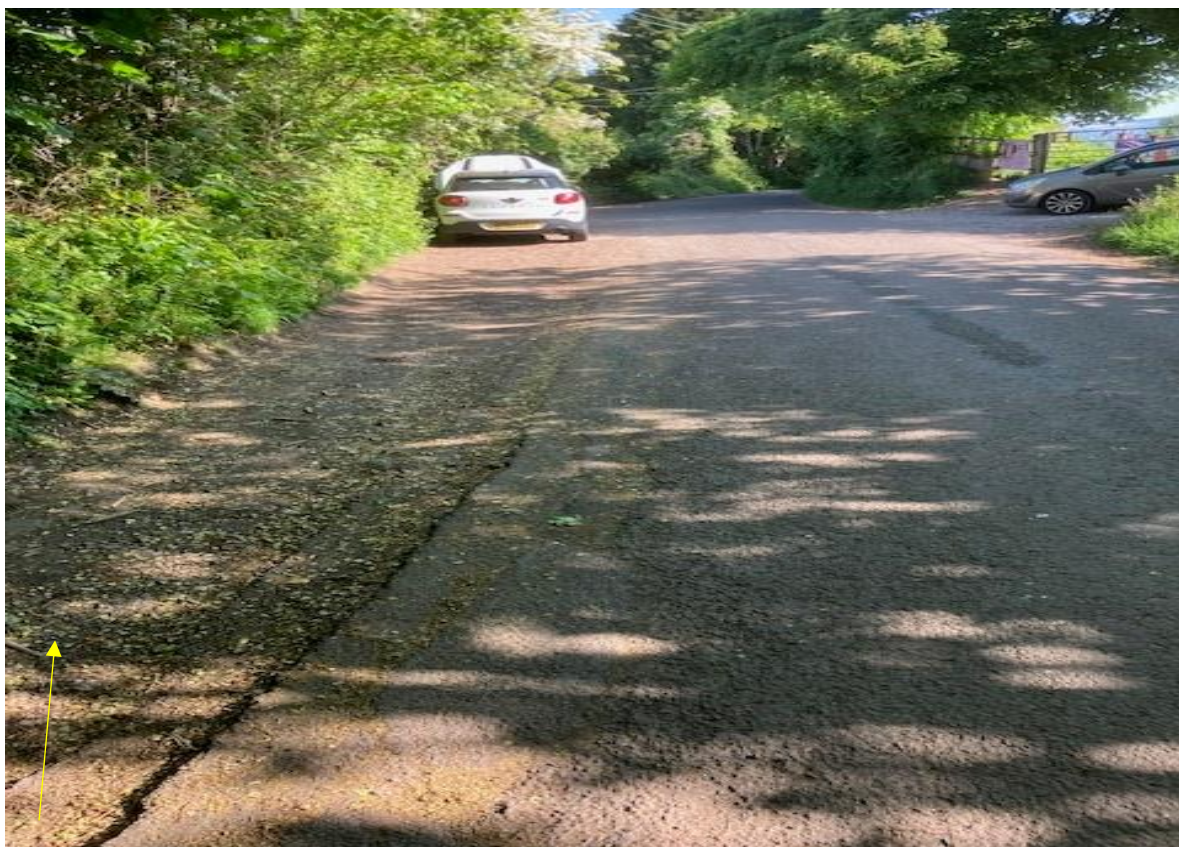
Rutts where vehicles have been parking minimum Rd width 4.6

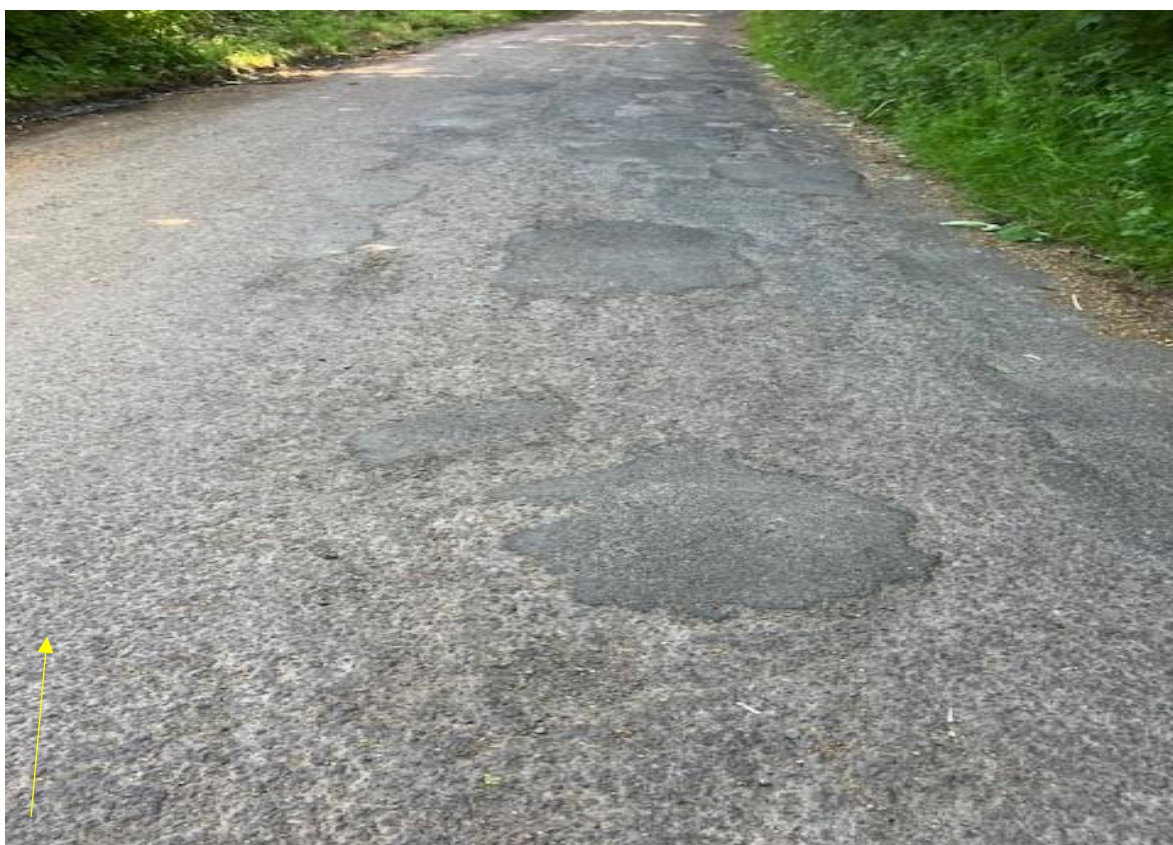
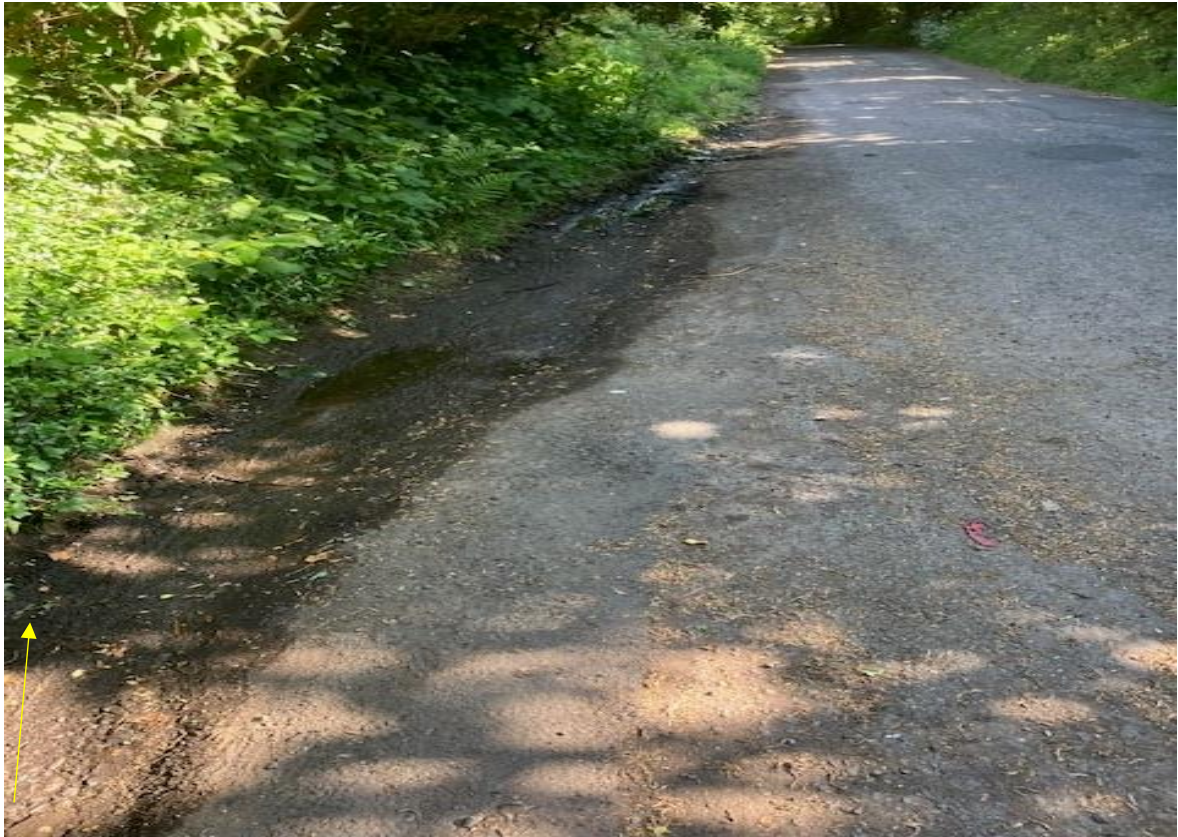
Repairs carried out on top of existing tarmac
