# Pre-Construction Road Condition Survey Suitability Report

Gelli Bwch Farm. Jersey Marine

**Prepared By:** MP Whelan

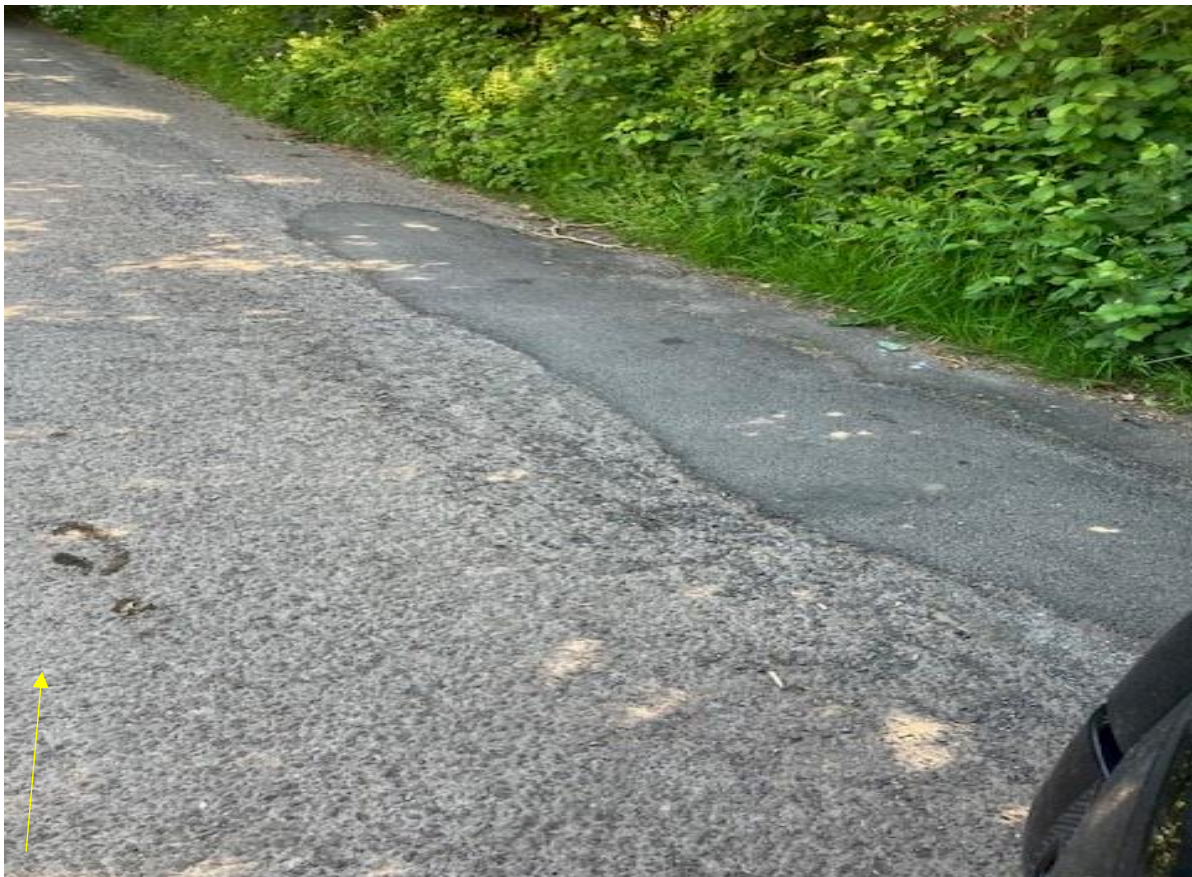
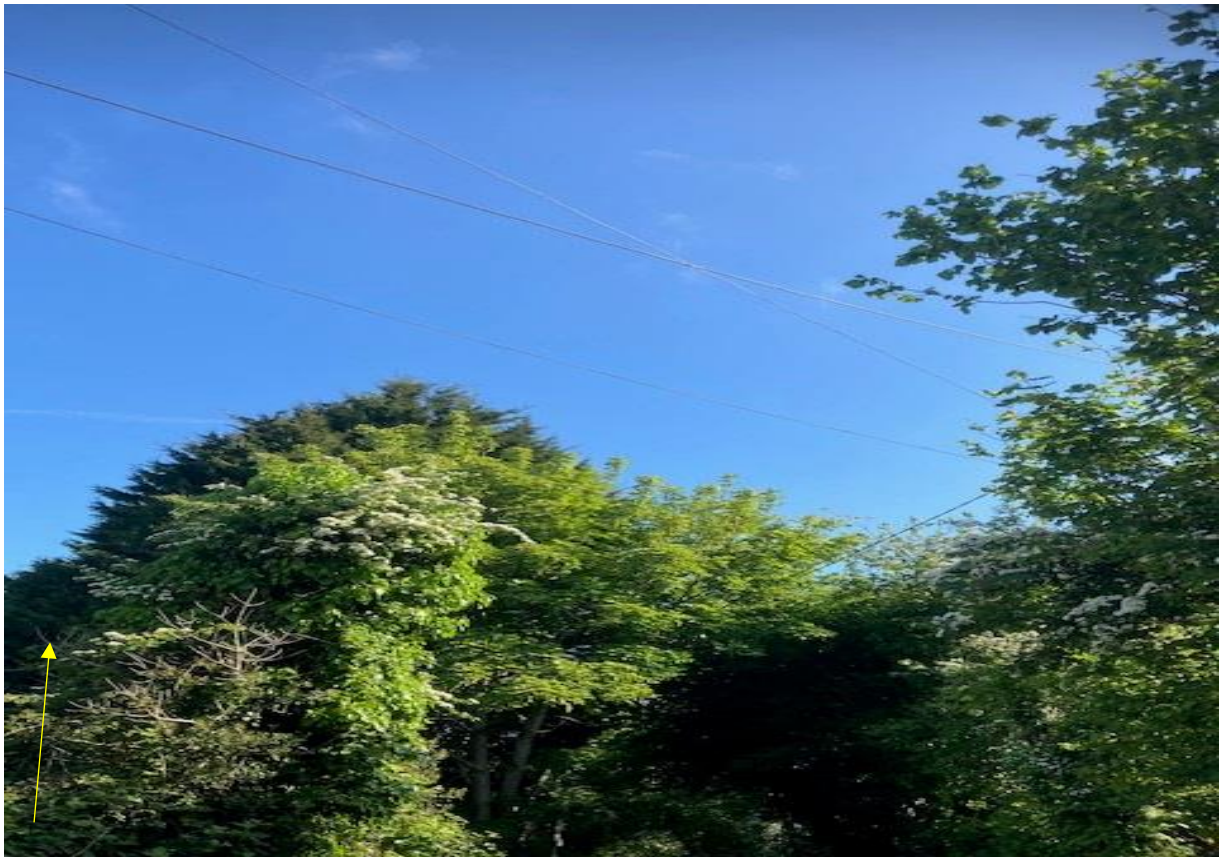
Overhead powerlines and trees above

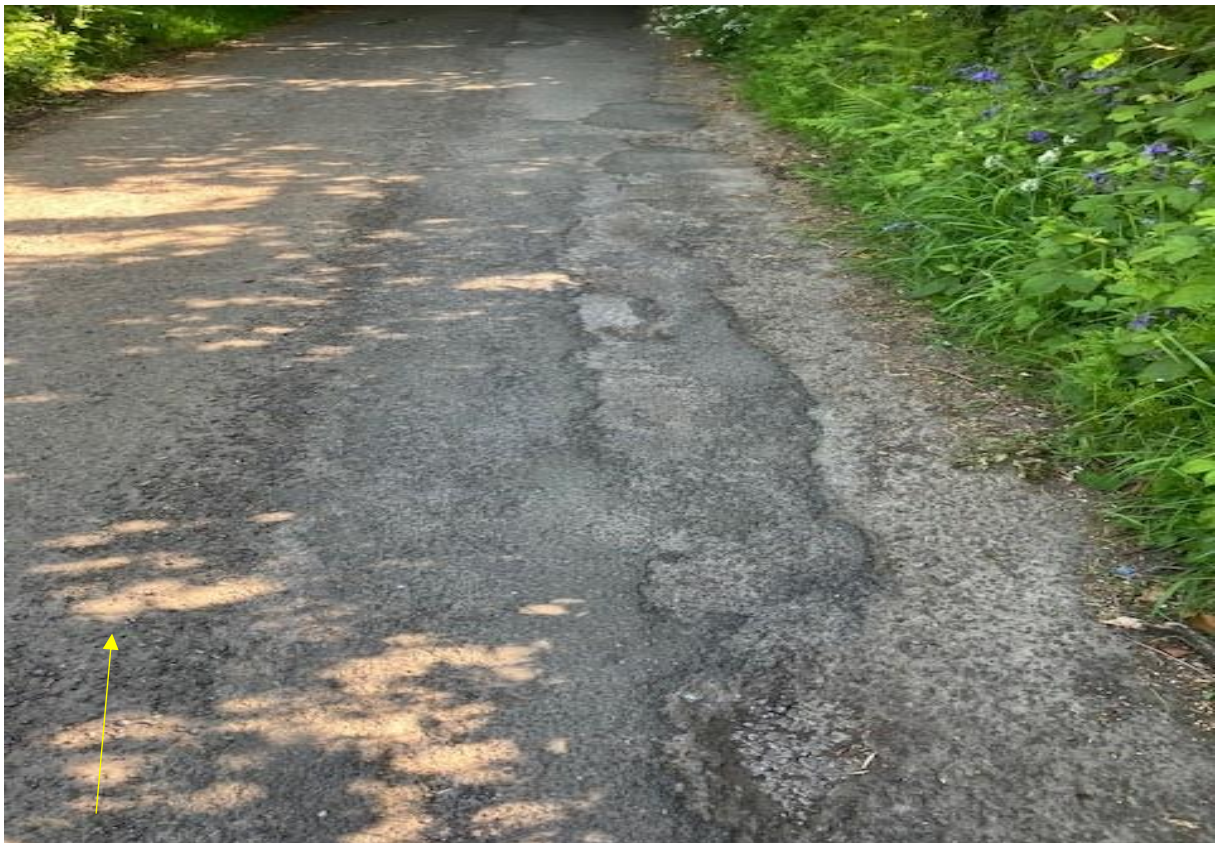
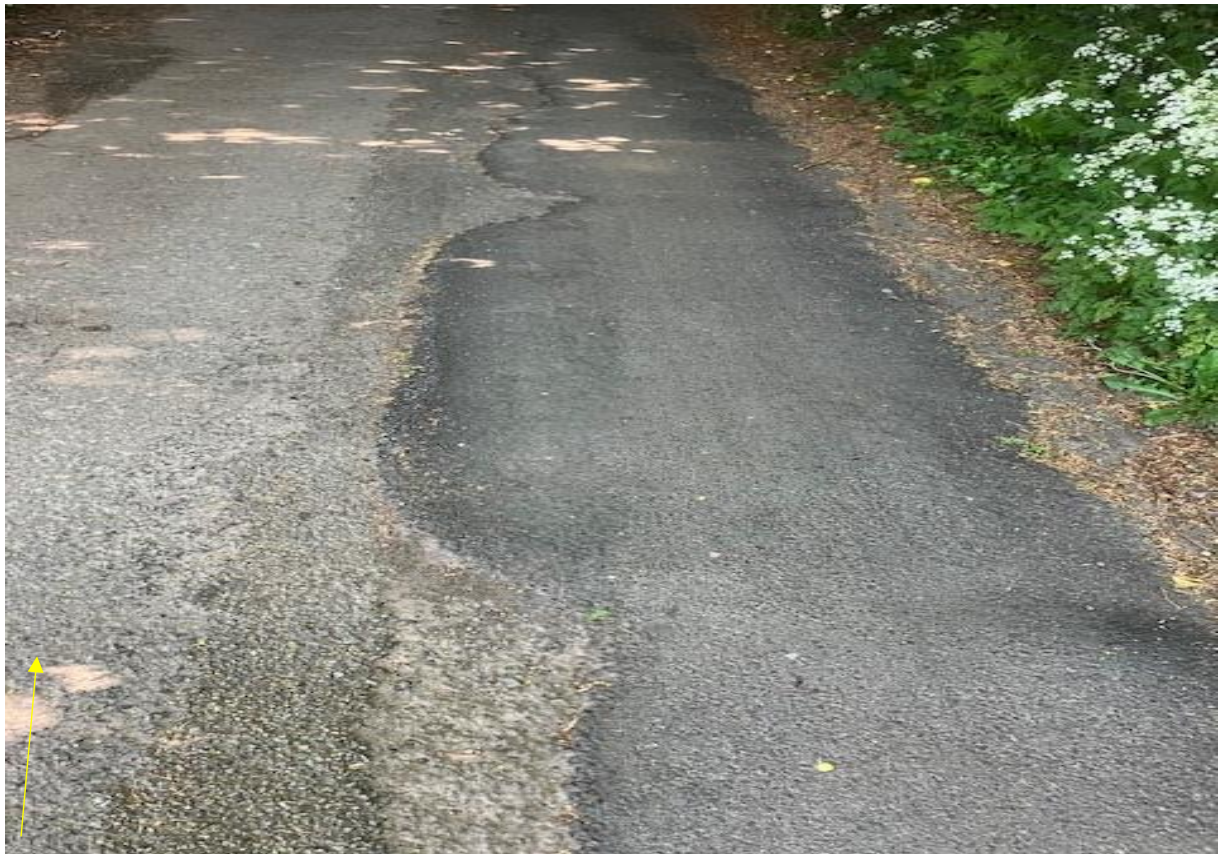
Repairs carried out on top of existing tarmac

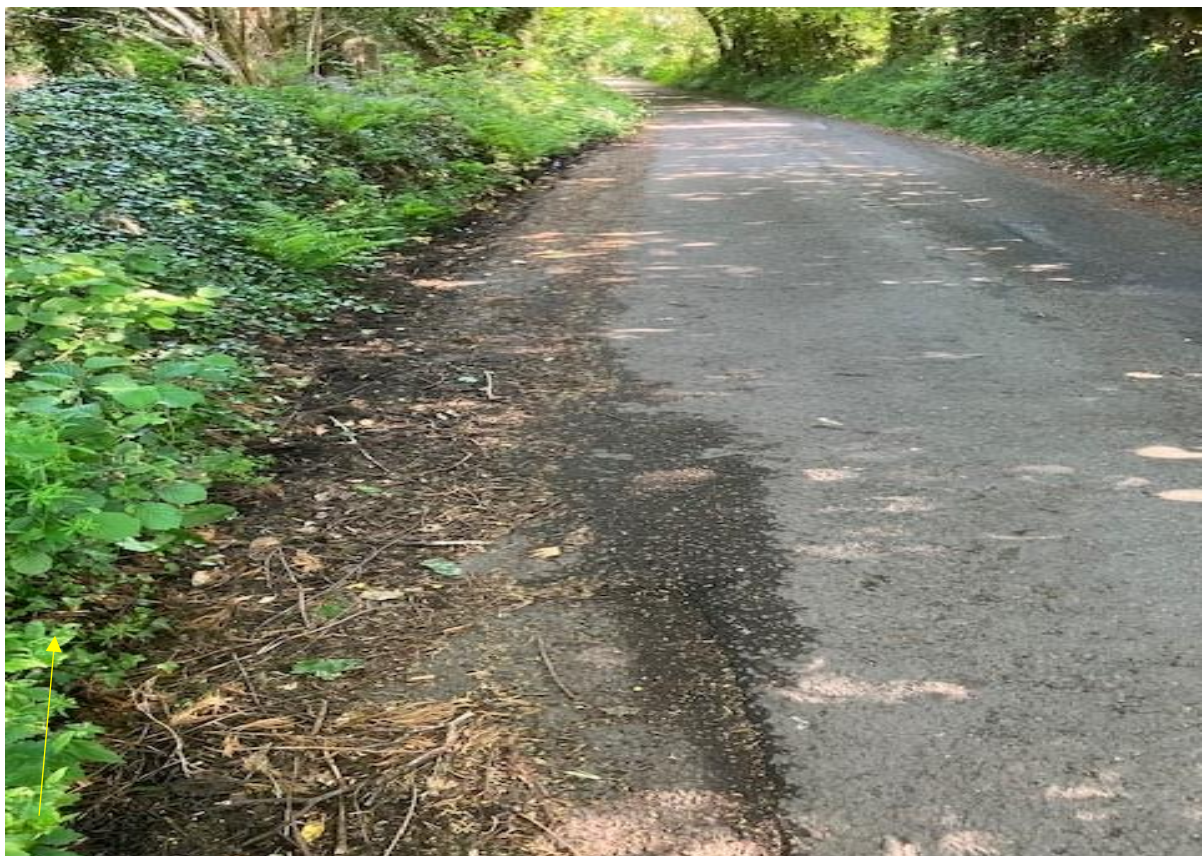
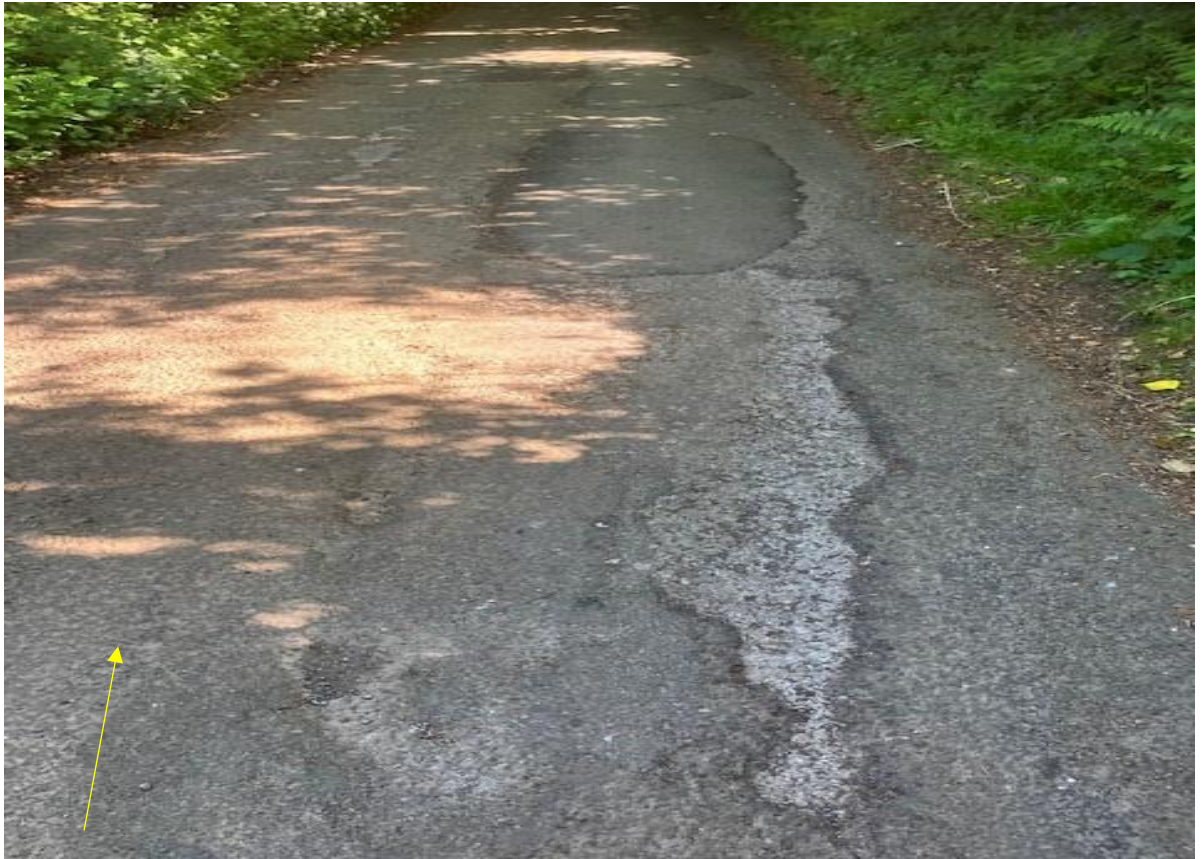
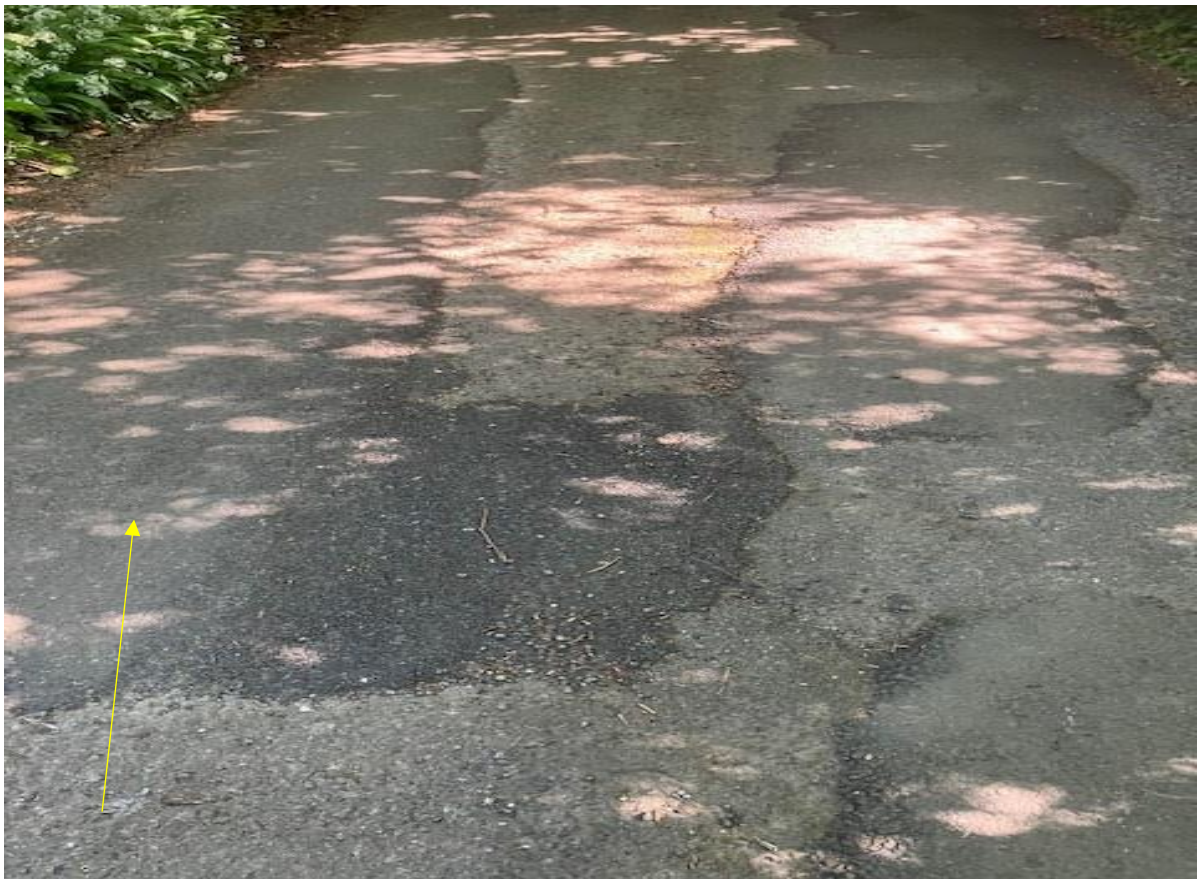
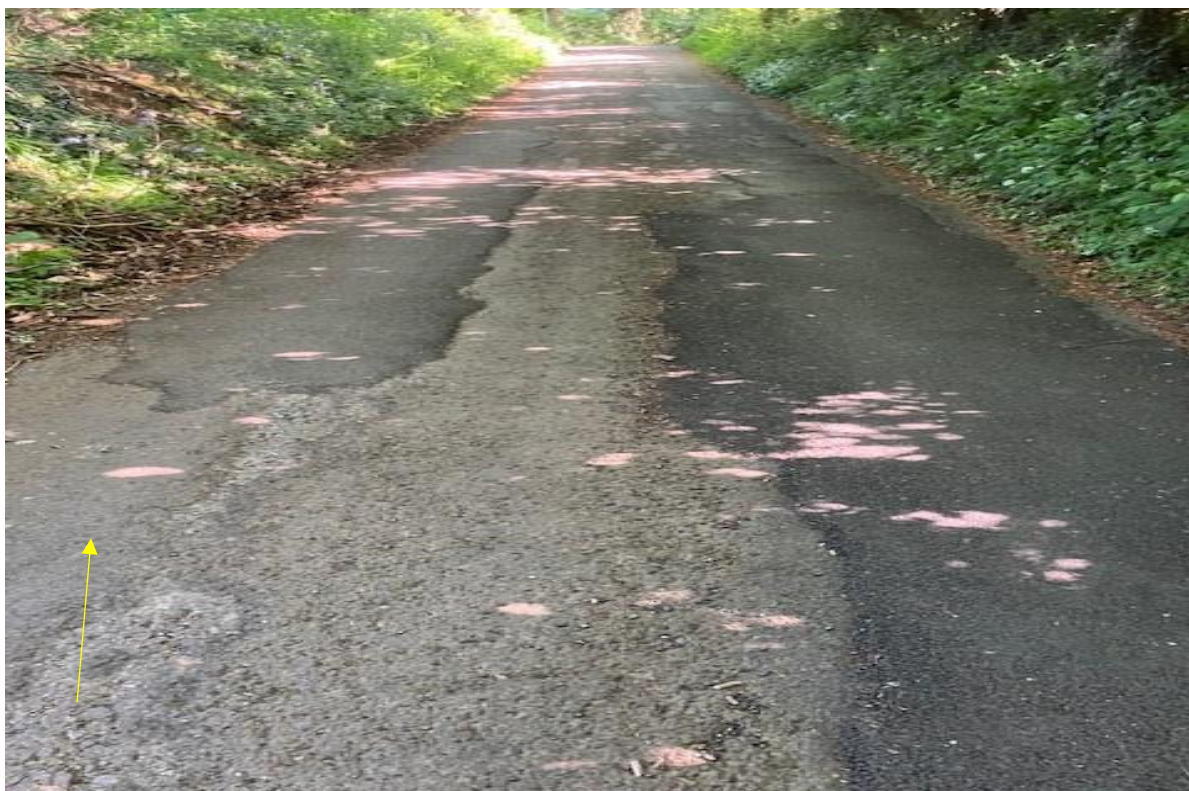
Various repairs have been carried out on top of existing tarmac

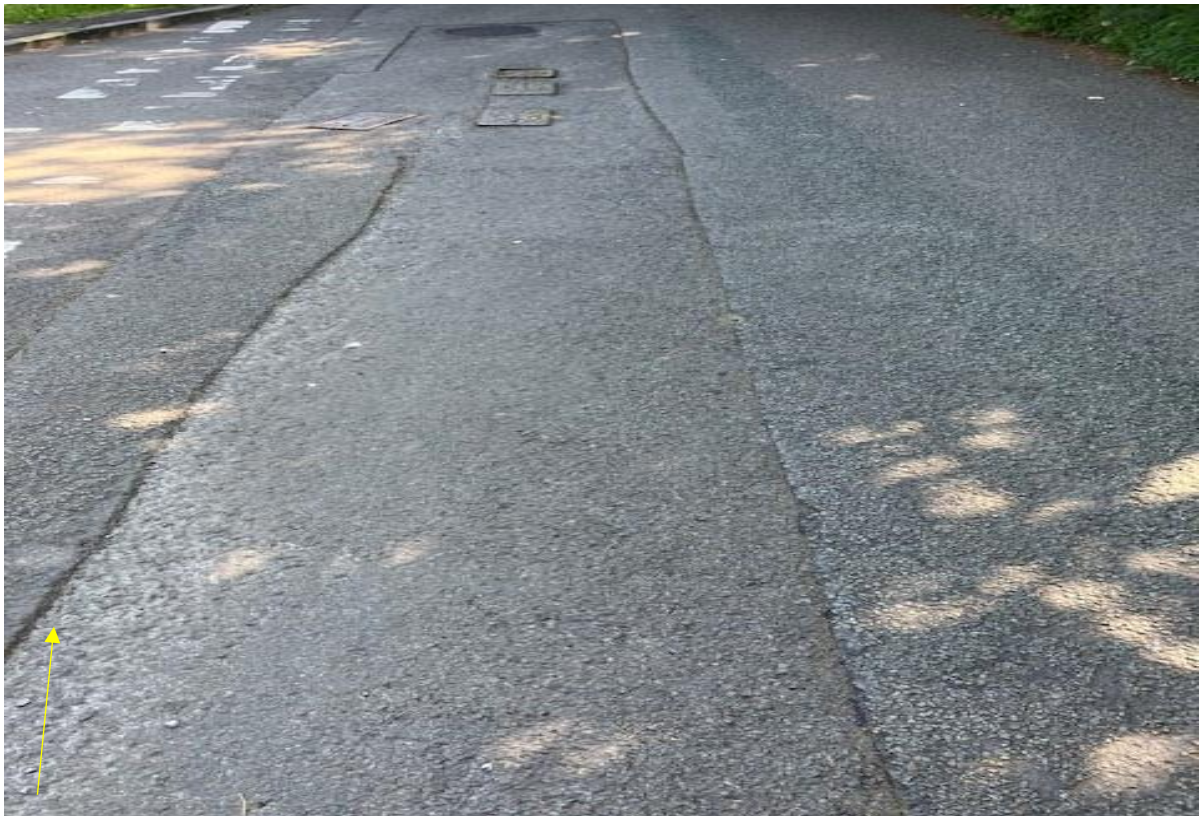
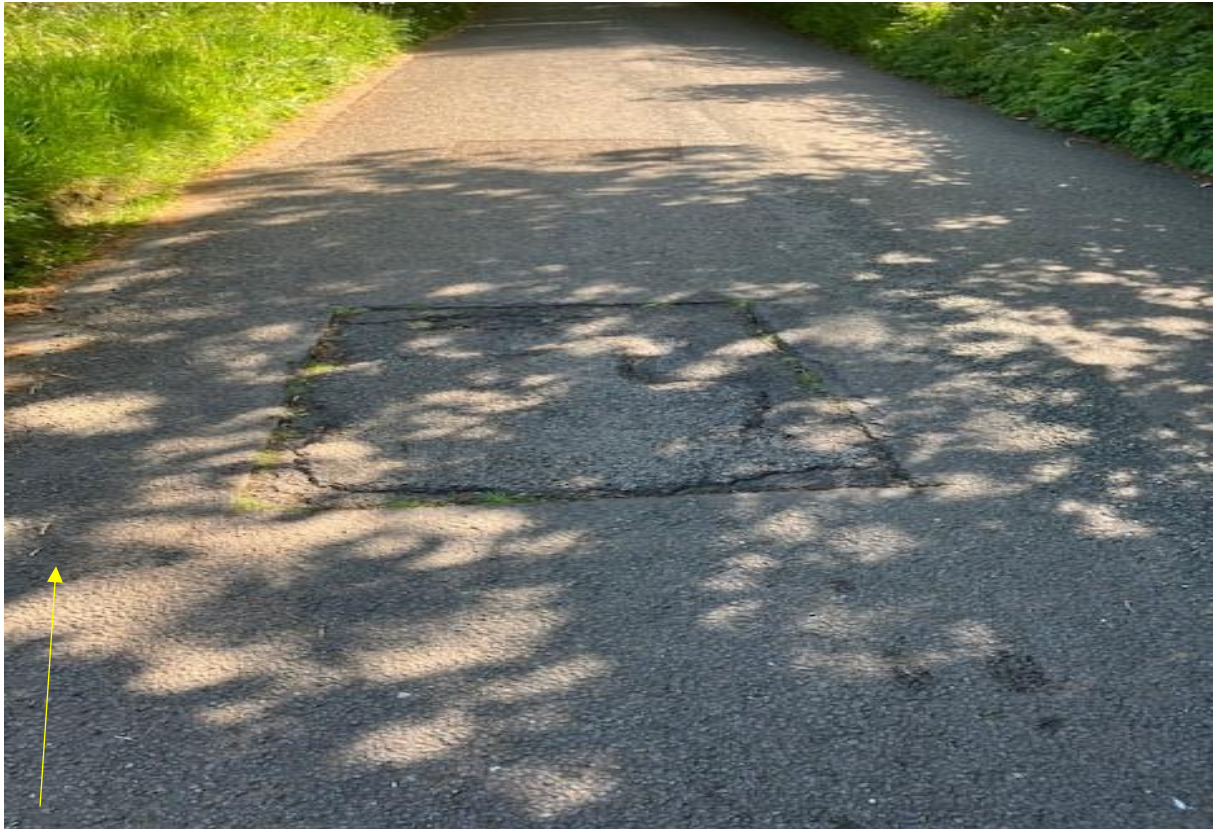
Minimum Road width 4.4

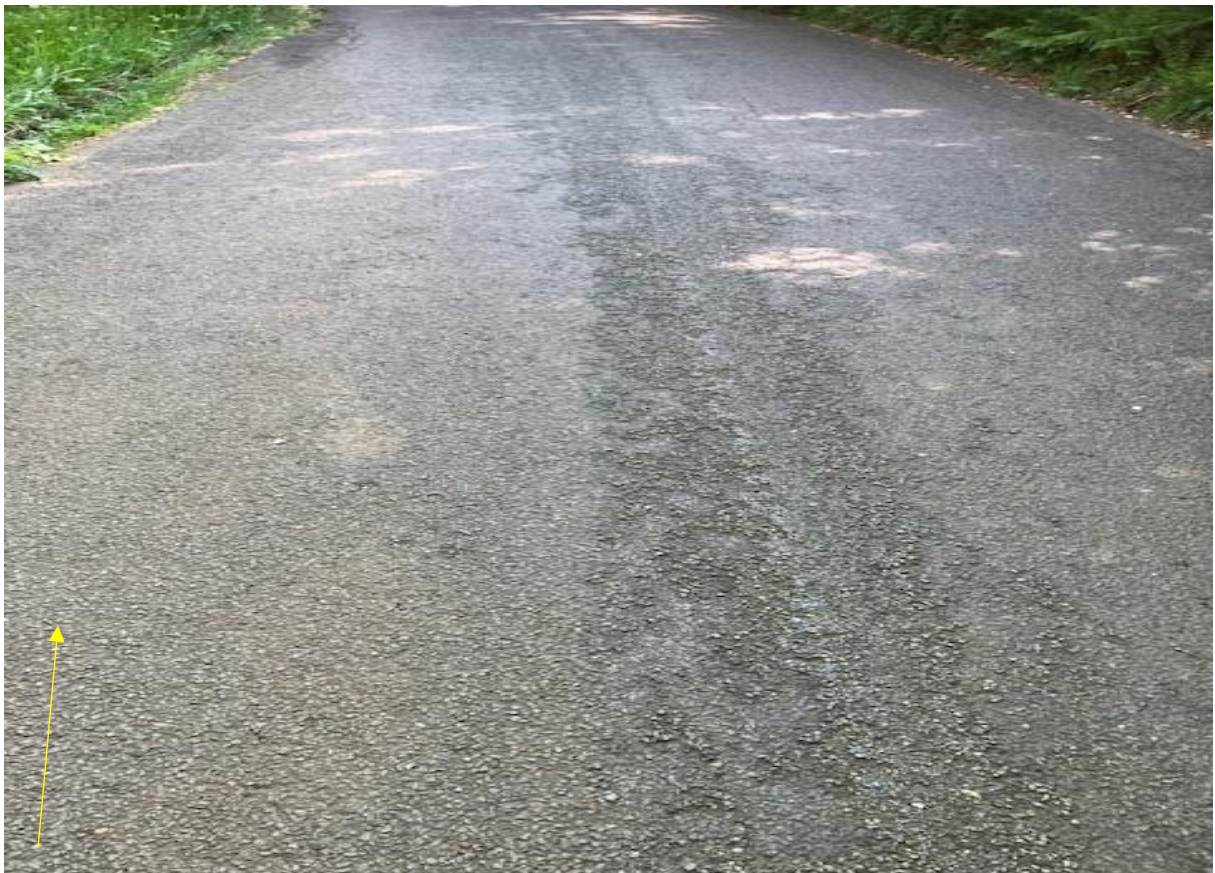
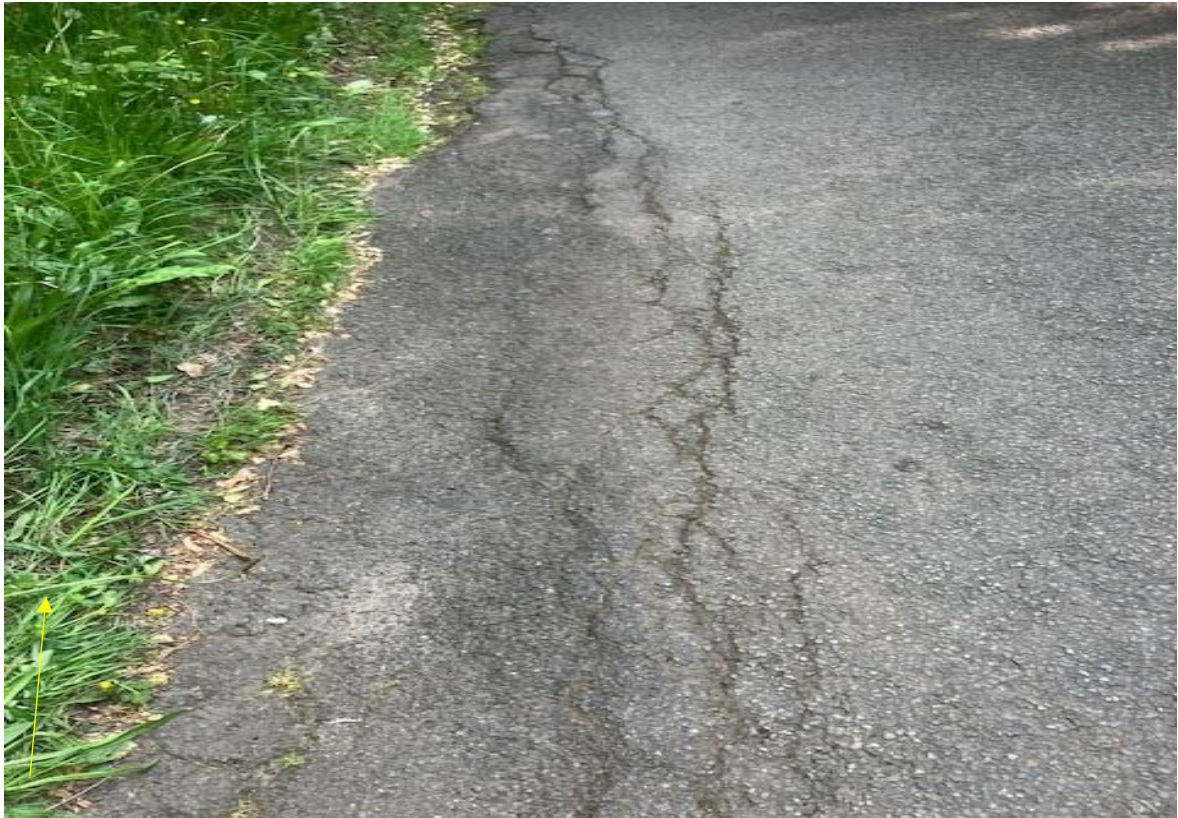
Various cracks noted above

There is minor cracking which has been viewed in several areas, this is due to there being no formal solid edge detail (kerbing) to the lane.
