# GeoShield Verification Report 01

GEO105283

Nant Y Cafn Business Park  
Seven Sisters,  
Neath,  
SA10 9EY

Ground Floor Slab of Proposed Industrial Building - Full Line Out

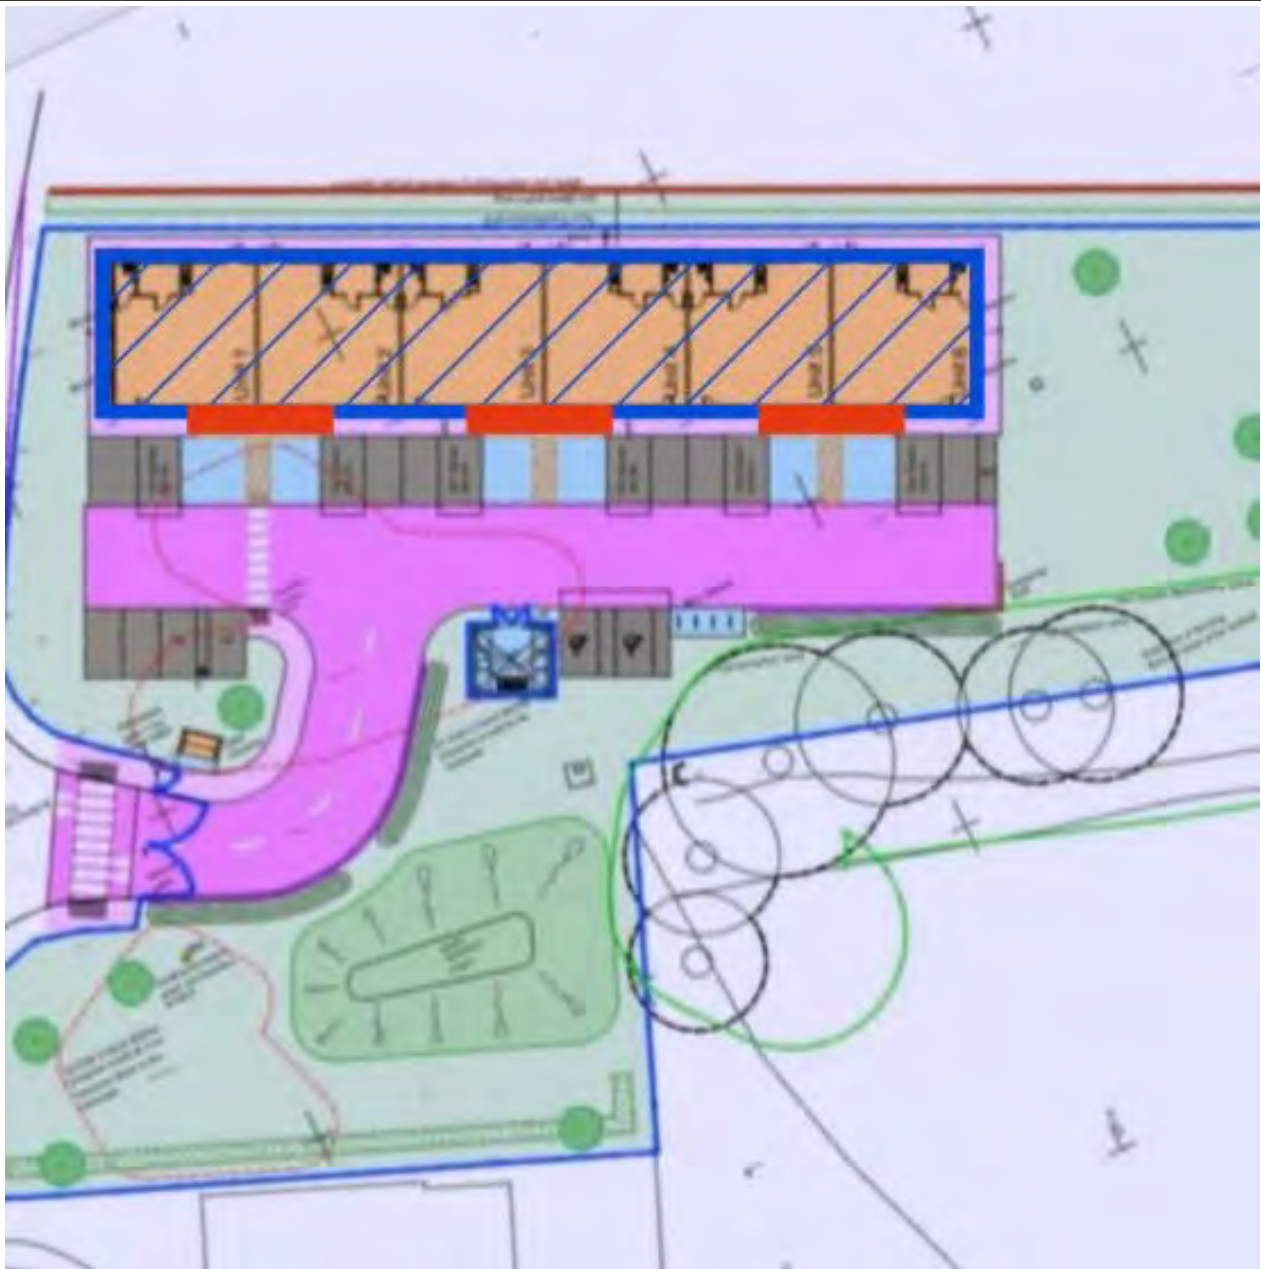
The photograph above shows a plan layout of the site. The area highlighted in blue shows where the verification inspection took place on site today. The area highlighted in red are outstanding remediations for the roller shutter doors that will be sealed at a later date.

Outstanding remediations: Service pipes will need to be sealed internally at a later date.

Shutter doors will need to be sealed at a later date.

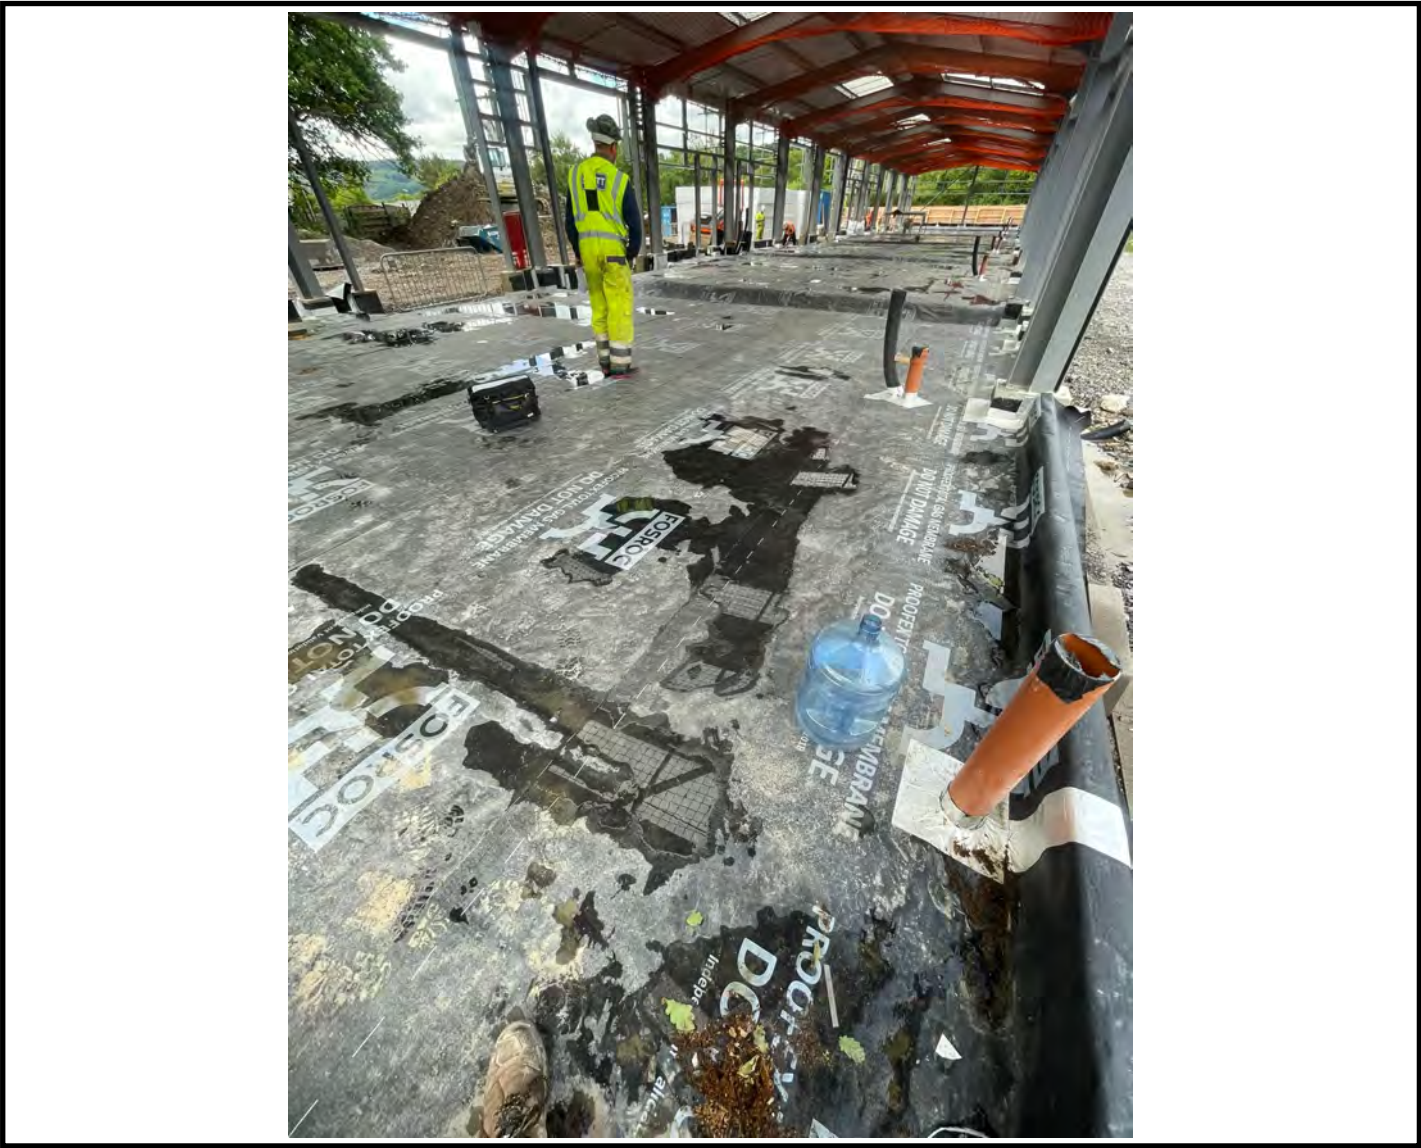
The photograph above displays an overview of the area where today's verification inspection took place on site.

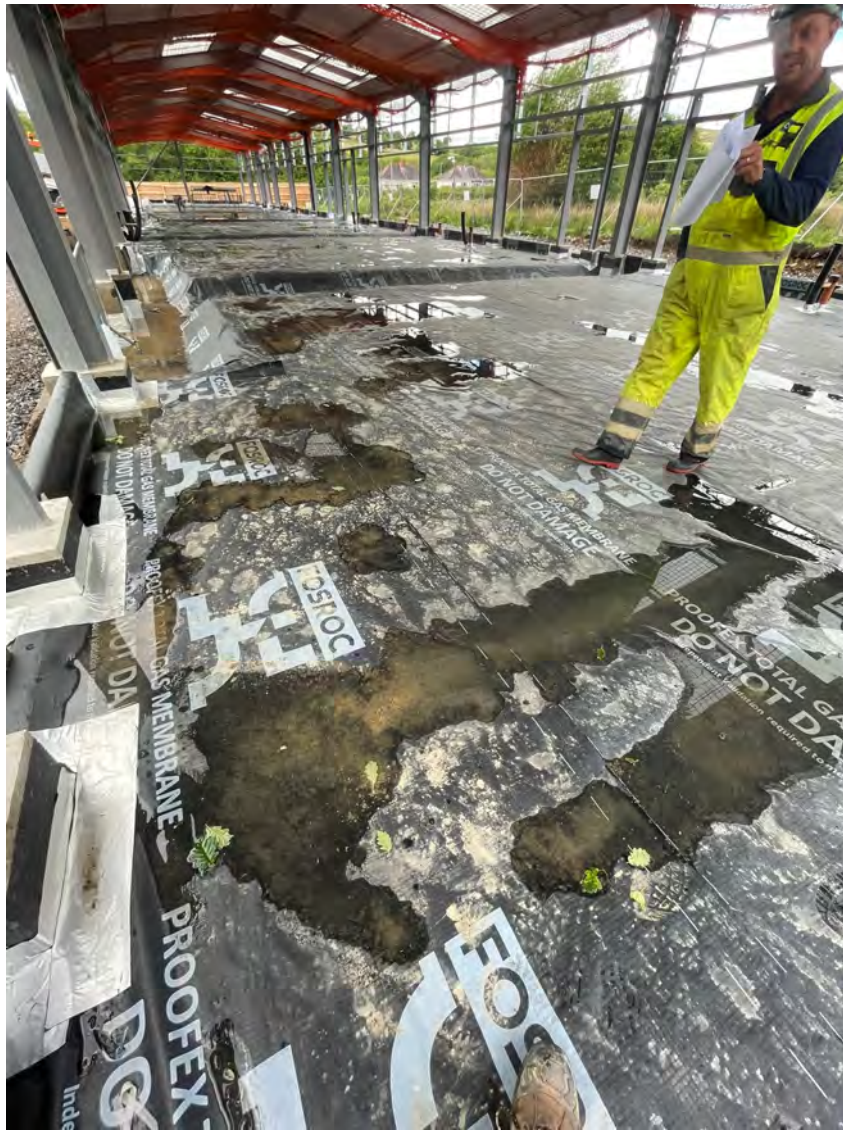
The photograph above displays an overview of the area where today's verification inspection took place on site.

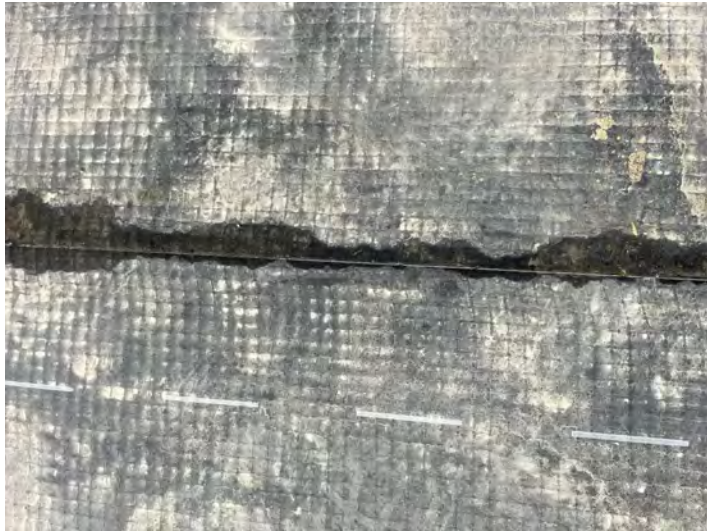
A complete line out of the Fosroc Proofex Total Gas Membrane has been installed across the entire referenced area. All lap joints between the adjacent sheets of Fosroc Proofex Total Gas Membrane have been overlapped and sealed using double sided butyl tape.

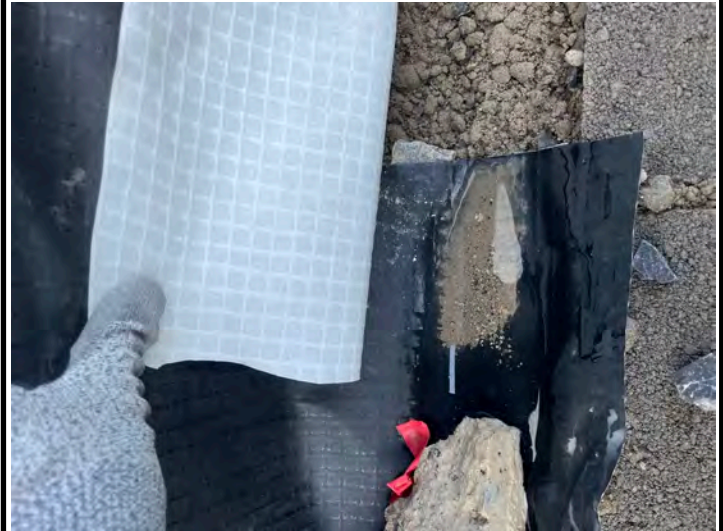
All lap joints between the adjacent sheets of Fosroc Proofex Total Gas Membrane have been overlapped a minimum of 100mm. Double sided butyl tape was installed between adjacent sheets of Fosroc Proofex Total Gas Membrane Installed in accordance with manufacturer's specifications.

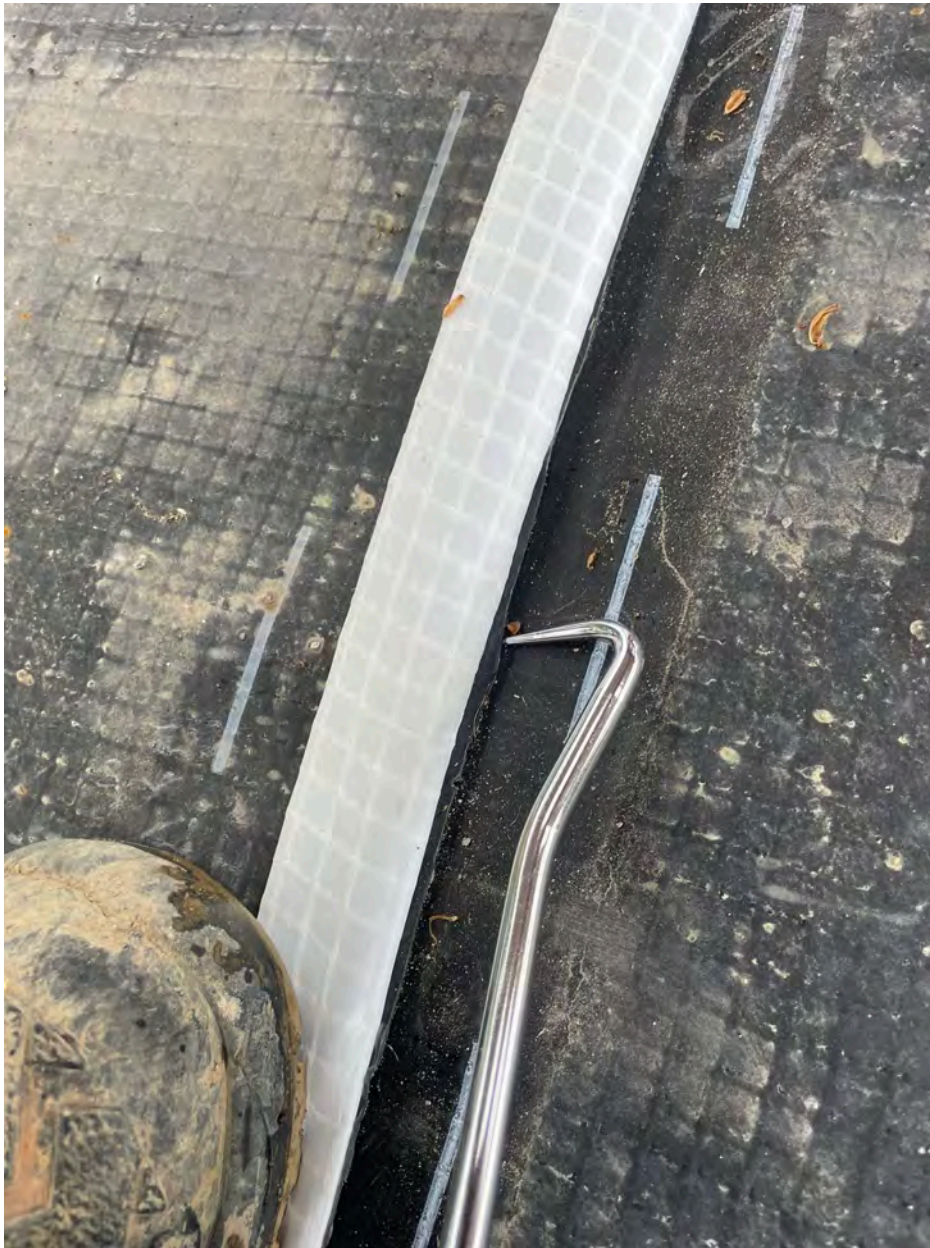
The above photograph displays a mechanical point stress test, also known as a pick and probe test, being conducted upon a welded lap joint of the Fosroc Proofex Total Gas Membrane. All lap joints were subjected to thorough mechanical point stress testing. No faults or defects were identified at the time of inspection.

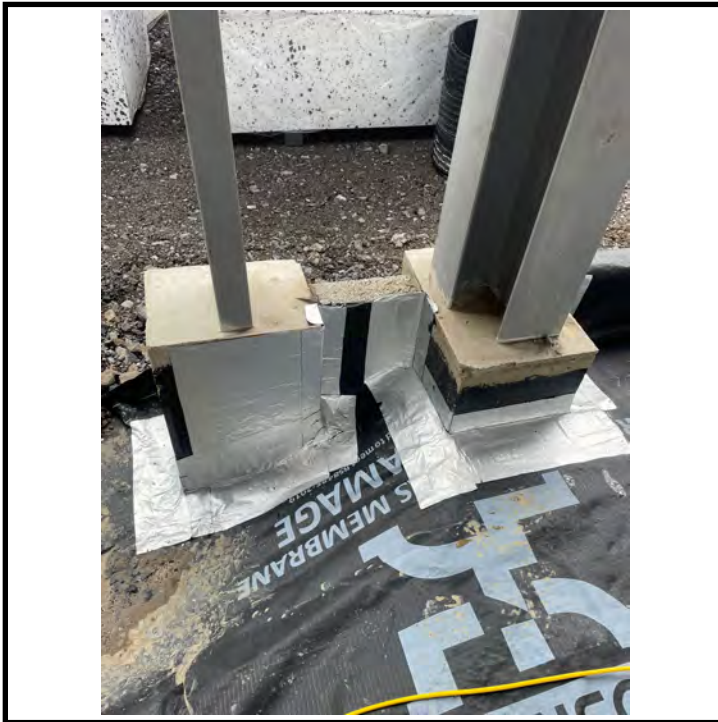
Throughout the installation of the Fosroc Proofex Total Gas Membrane to the area referenced, there were a number of upstand columns that have been sealed in accordance with manufacturer's specifications and design guidelines. This has been achieved using sheets of Fosroc Proofex 3000MR.

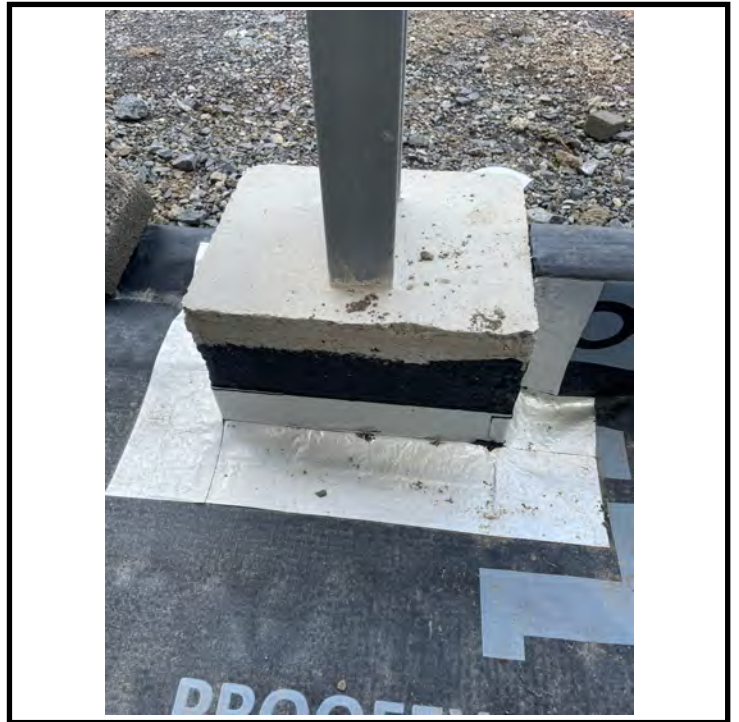
The installers have first coated the upstand column with a primer, once this has thoroughly dried, the Fosroc Proofex Total Gas Membrane is cut tight around the base of each upstand column. Next, strips of Fosroc Proofex 3000MR are placed around the column and onto the Fosroc Proofex Gas Membrane.

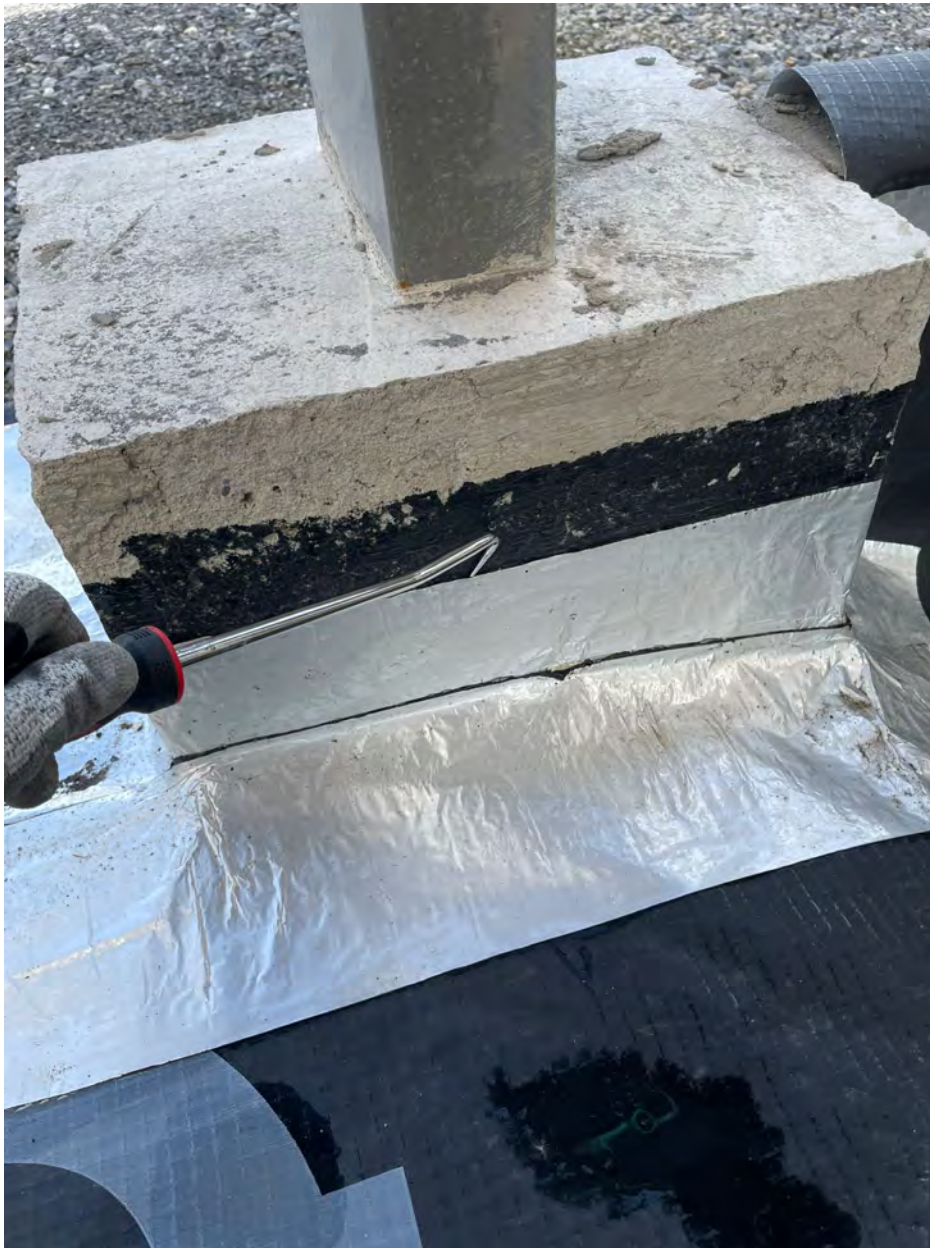
Sufficient downward and rolled pressure is applied to aid in adherence, creating a secure bond between the upstand column and the Fosroc Proofex Total Gas Membrane. All upstand columns throughout the referenced area were subjected to thorough mechanical point stress testing where a probe was run along all edges of the Fosroc Proofex 3000MR. No faults or defects were identified during today's visit.

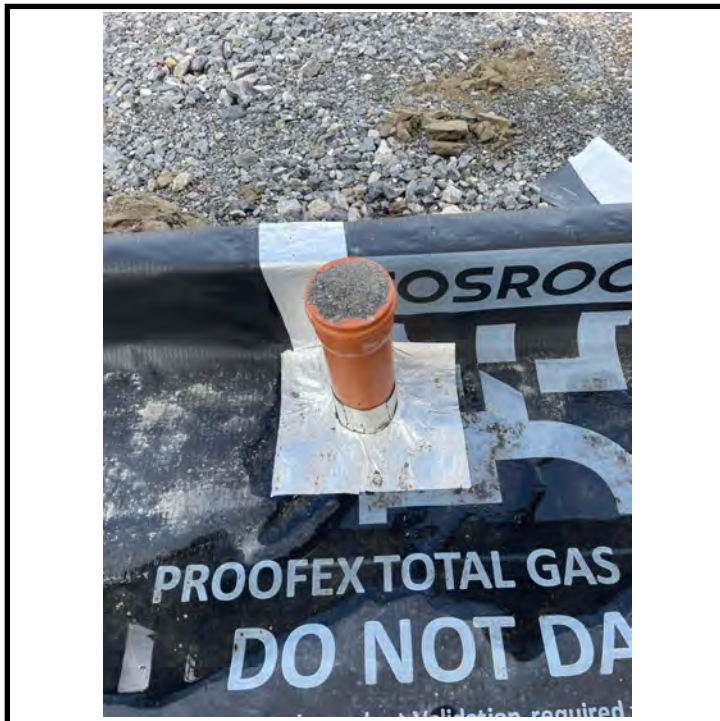
Throughout the installation of the Fosroc Proofex Total Gas Membrane to the referenced area, there were a number of pipe penetrations that have been sealed in accordance with manufacturer's specifications and design guidelines. This has been achieved using Fosroc Proofex 3000MR which is a self adhesive

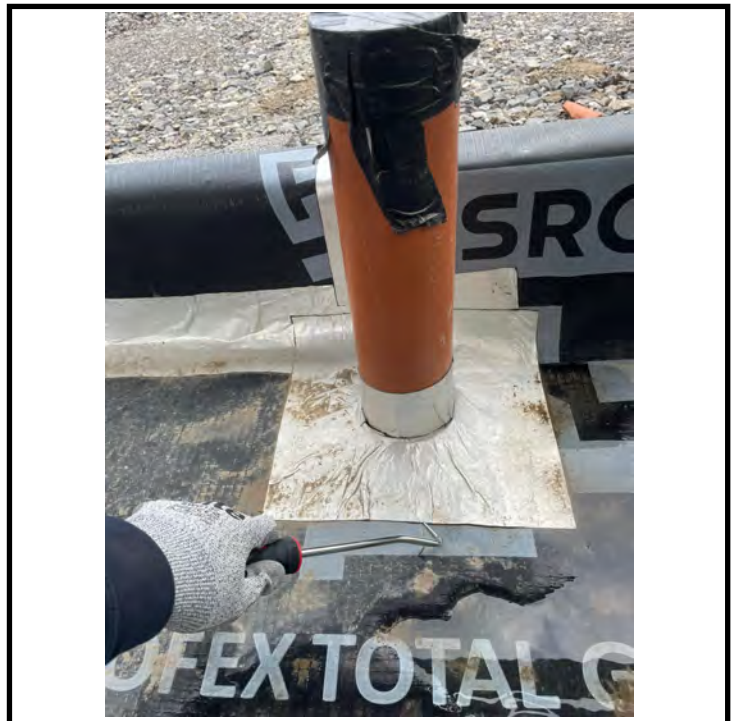
membrane. The installers have first cut the Fosroc Proofex Total Gas Membrane tight around the base of each pipe penetration to minimise voided areas. Next, strips of Fosroc Proofex 3000MR are placed intricately in a top hat formation around the pipe penetration and onto the Fosroc Proofex Total Gas Membrane.

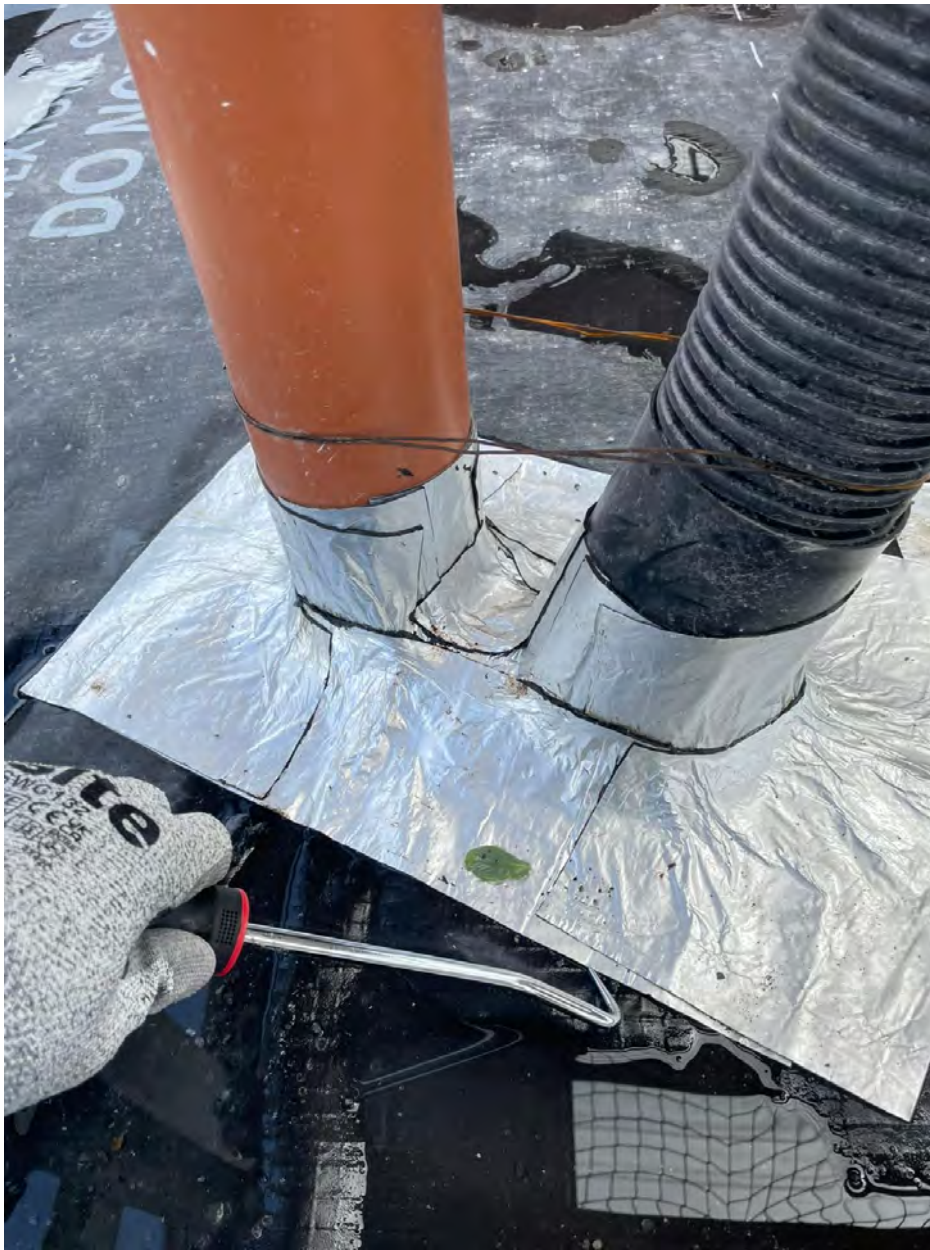
Heat and rolled pressure is applied to activate the bitumen backing, creating a secure bond between the pipe penetration and the Fosroc Proofex Total Gas Membrane. All pipe penetrations throughout the referenced area were subjected to thorough mechanical point stress testing where a probe was run along all edges of the Fosroc Proofex 3000MR. There were a number of service pipes which are still to be sealed and will be verified at a future visit.

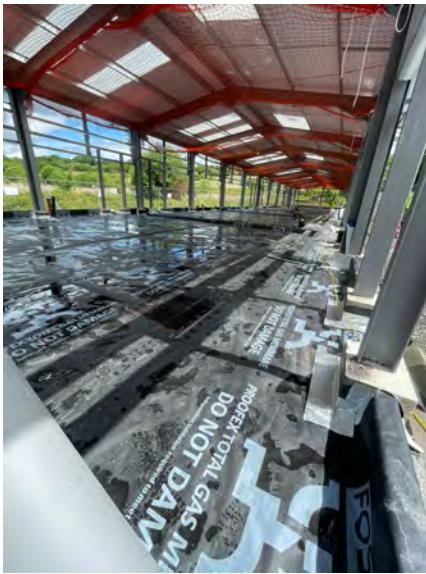
Overview of the area where the Fosroc Proofex Total Gas Membrane has been installed.

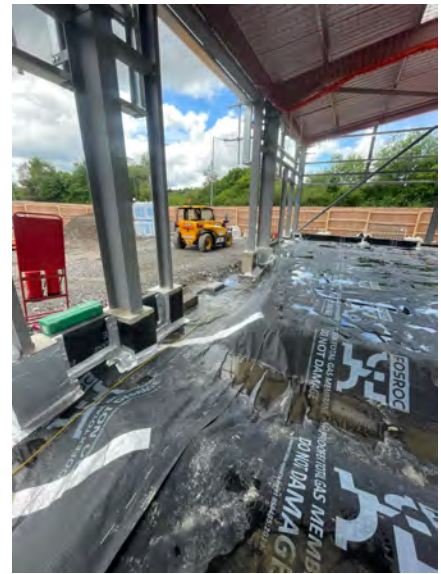
Overview of the area where the Fosroc Proofex Total Gas Membrane has been installed.

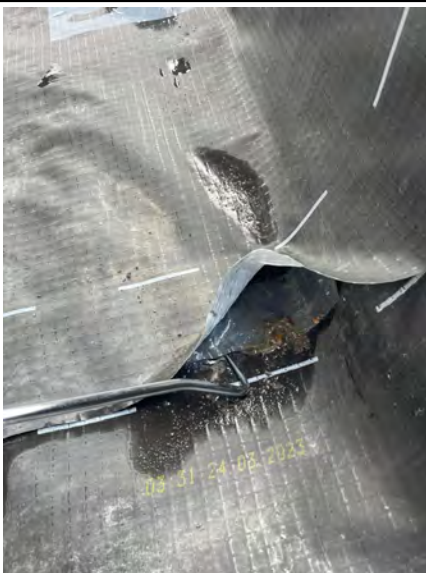
Pick and probe test on a taped lap joint.

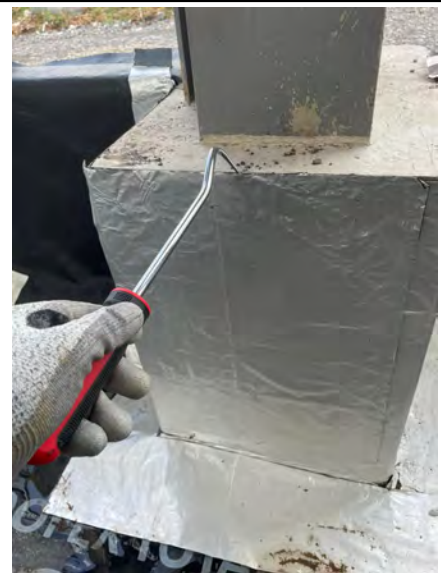
Pick and probe test to the Fosroc Proofex 3000MR.

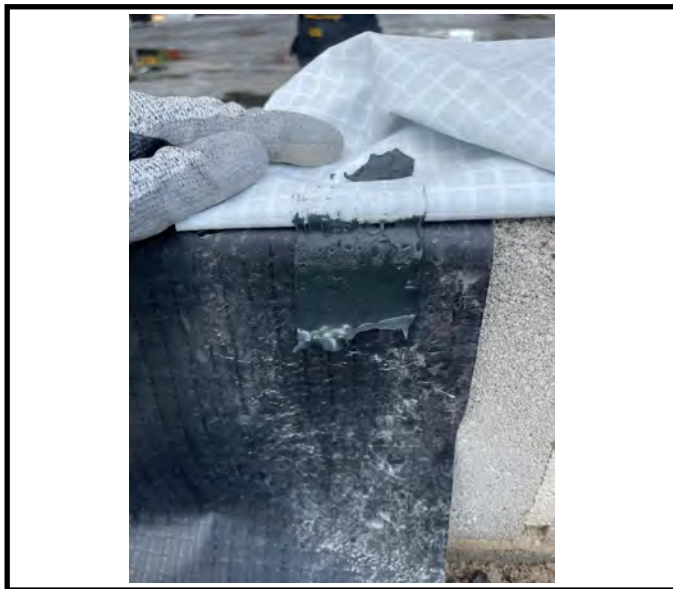
A photograph showing evidence that double sided butyl tape has been used.

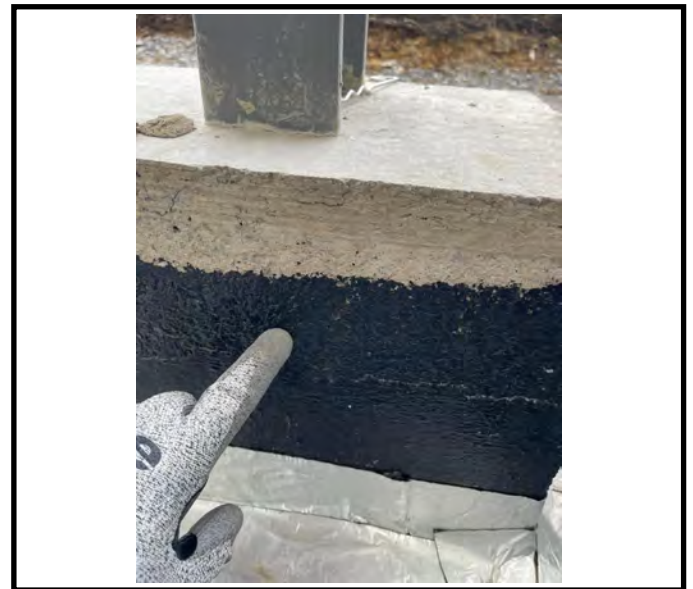
A photograph showing a primed column.

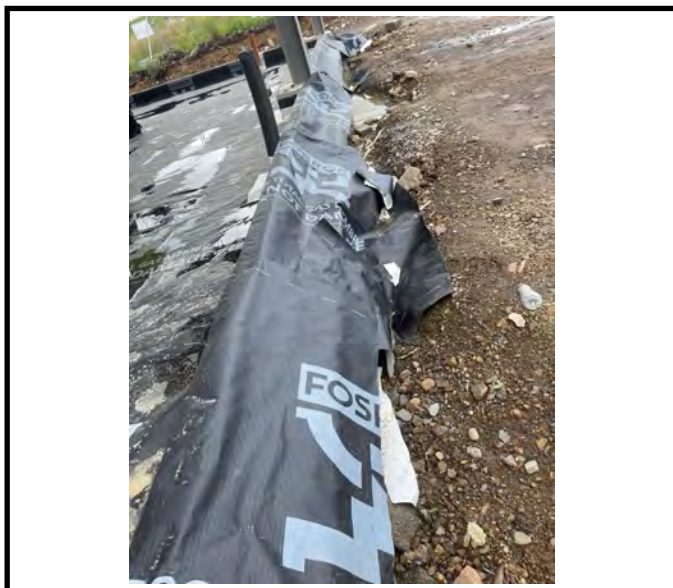
Installers have installed the Fosroc Proofex Total Gas Membrane tight to the perimeter walls.

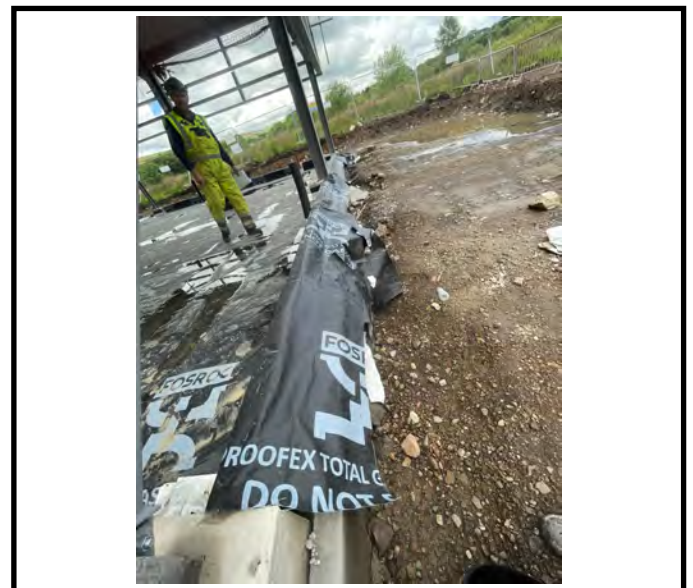
Installers have installed the Fosroc Proofex Total Gas Membrane tight to the perimeter walls.
