**BHPL Designers Responses to RSA Recommendations - 31.10.25**

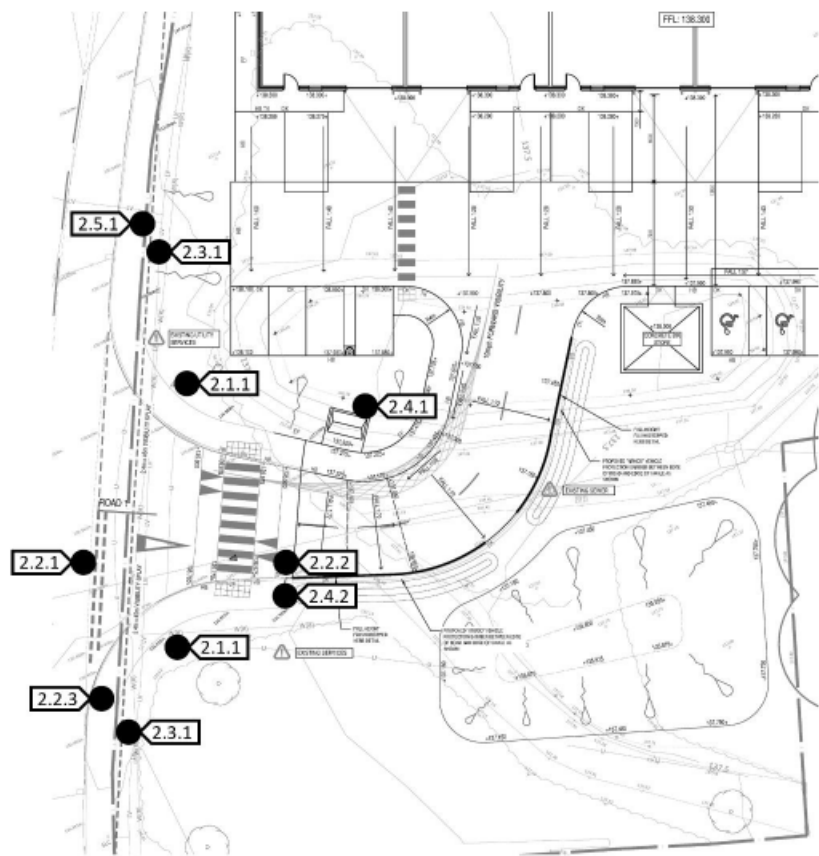
**Appendix 3      Key plan**

Comments made in order raised withing Audit. Key plan showing location of each comment is given below (extract from Appendix 3 of the RSA).

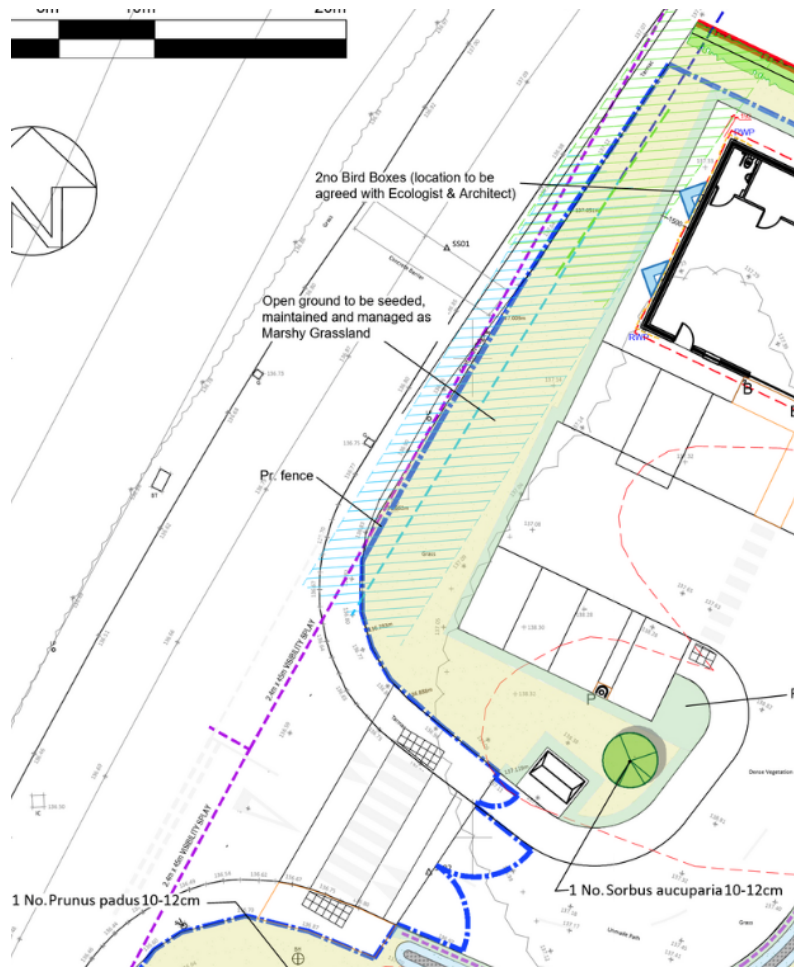
| 2.1.1 | <p><b>Summary</b> Visibility for pedestrians waiting to cross the road (looking towards the main road) crosses the landscaping/planting areas at the back-edge of the footway on both sides of the carriageway and could be obstructed as the planting matures.</p> <p><b>Location</b> Tactile paving at either end of the crossing across the site access</p> <p>It is noted from the plans provided that the visibility for pedestrians waiting to cross the road (looking towards the main road) crosses the landscaping areas at the back-edge of the footway on both sides of the carriageway. As the planting/landscaping matures, this could obstruct visibility for pedestrians and could lead to pedestrians stepping into the carriageway injudiciously, when it is unsafe to do so, increasing the potential for a pedestrian to be hit by a passing vehicle.</p> <p><b>Recommendation</b></p> <p>It is recommended that low level planting is specified within the visibility splays, and that regular maintenance is undertaken to ensure the landscaping/planting does not grow beyond 650mm in height.</p> | |

**Designers’ Response: 2.1.1** Soft landscaping has been designed to be low level marshy grassland which is to be maintained in the future by NPTC; see extract from Landscape Architects’ design proposals given below in confirmation.

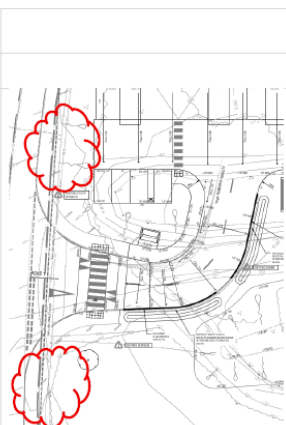
| 2.2.3 | <p><b>Summary</b> Surface water ponding on the footway on the approach to the site, which during freezing weather could turn to ice, creating a slip hazard for pedestrians.</p> <p><b>Location</b> Footway on the eastern side of the main road (south of the access to the site).</p> | |
| <p>It was noted from the site visit that there is evidence of uneven settlement and ponding on the footway leading to the site. During freezing weather, this surface water could turn to ice thereby creating a slip hazard for pedestrians travelling along the footway.</p> <p><b>Recommendation</b></p> <p>It is recommended that the surface of the footway is replaced/re-laid.</p> | | |

**Designers' Response 2.2.3** – It has been agreed that the main contractor, Andrew Scott Construction Ltd., will resurface this area as recommended.

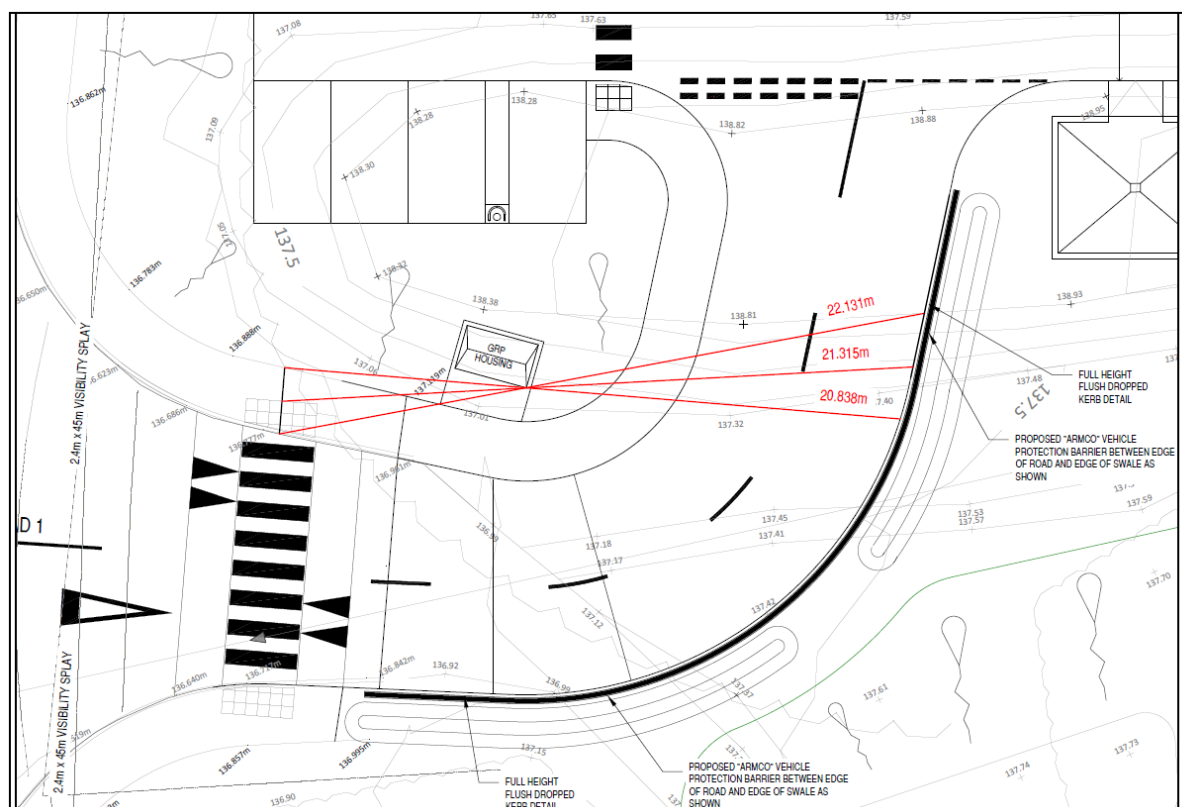
| <b>2.4.1 Summary</b> In the absence of any specific details, it is difficult to determine whether the proposed electricity sub-station sits within the visibility splay for pedestrians (travelling north to south) waiting to cross the road.<br><b>Location</b> Proposed crossing across the access | |
| <p>It is noted from the plans provided that it is proposed to provide a structure (possibly electricity sub-station) to the north of the footway on the northern edge of the access into the site. In the absence of any specific information, it is difficult to determine whether the structure sits within the visibility splay for pedestrians (travelling north to south) waiting to cross the road. Insufficient visibility could lead to pedestrians stepping into the carriageway injudiciously, when it is unsafe to do so, increasing the potential for a pedestrian to be hit by a passing vehicle.</p> <p><b>Recommendation</b></p> <p>It is recommended that the required visibility, based on the posted speed limit, is determined and plotted and, if necessary, site the proposed structure outside of the visibility splay.</p> | |

**Designers Response 2.4.1** – see below for constructed forward visibility splays for pedestrians and cyclists stopping at northern end of crossing point. DOT Local Transport Note 1/20 gives recommendations on visibility splays, Section 5.8 “Visibility Splays” and Table 5-5 gives forward lines for various speed limits. For 30mph the Y dimension = 31m and for 20mph = 17m. Arguably the new minor access road is 20mph and therefore the minimum distance of 20.7m is deemed acceptable.

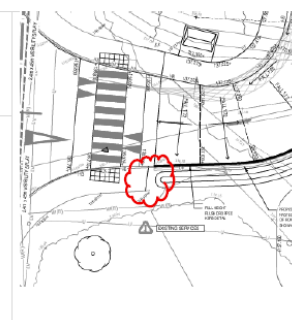
| 2.4.2 | <p><b>Summary</b> The proposed footway on the southern side of the access terminates immediately east of the proposed crossing, and there is nothing to indicate to blind or partially sighted pedestrians that the footway terminates.</p> <p><b>Location</b> Footway along the southern edge of the access road.</p> |
| | <p>It is noted from the plans provided that the footway along the southern edge of the access road terminates immediately east. However, there is nothing to indicate to blind or partially sighted pedestrians that the footway terminates. This could lead to confusion for blind/partially sighted pedestrians and could result in pedestrians stepping into the carriageway injudiciously, away from the crossing, when it is unsafe to do so, into the path of passing vehicles, or could result in pedestrians stepping in to the swale.</p> <p><b>Recommendation</b></p> <p>It is recommended that the appropriate tactile paving is provided before the end of the footway together with planting to prevent pedestrians from entering the swale.</p> |

**Designers' Response 2.4.2** – Buff Blister paving will be installed as per data sheet below, size 400x400mm.
