## Ground Gas Protection System Verification Report

Site: Plots 1-4 Pearson Way, Neath

Job No: 16819

**REPORT REFERENCE** : **GVR-16819**

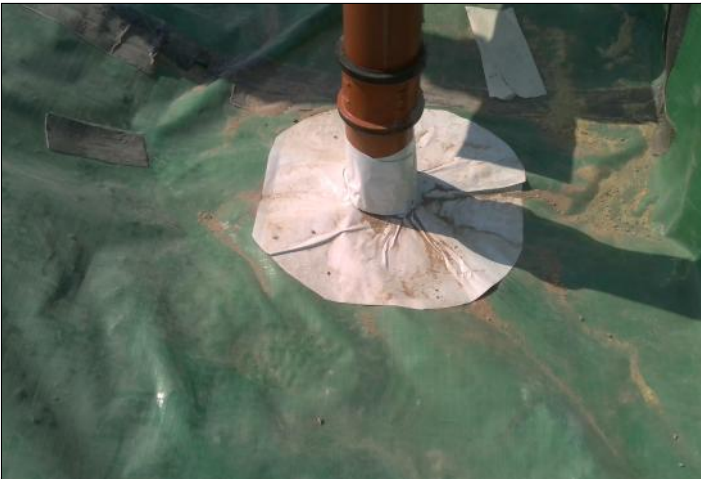
| 1 | | 2 | |

| No. | Item | Comments |
|---|---|---|
| 1.7 | Service entries seals | one service entry on membrane, SAM used, good seal |

| Photographs | |
|---|---|
| 1 | service entry sealing |

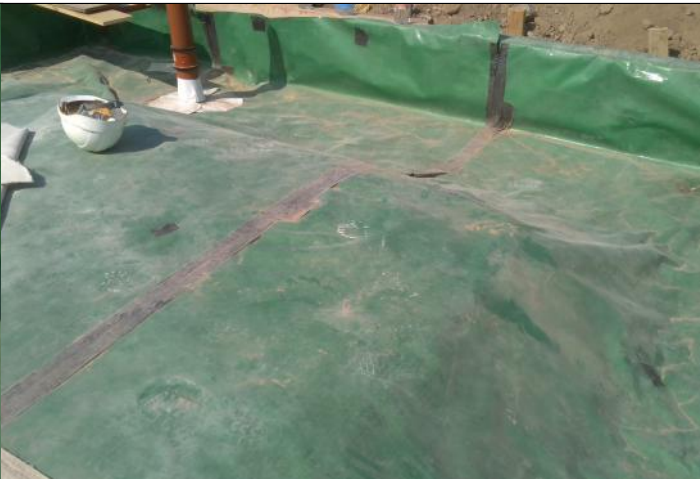
| Photographs | |
|---|---|
| 2 | full area |

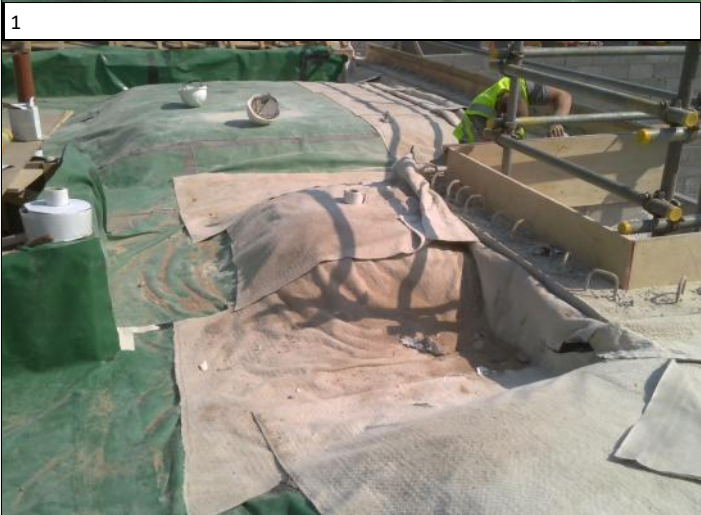
| 3 | | 4 | |

| Photographs | |
|---|---|
| 3 | full area |

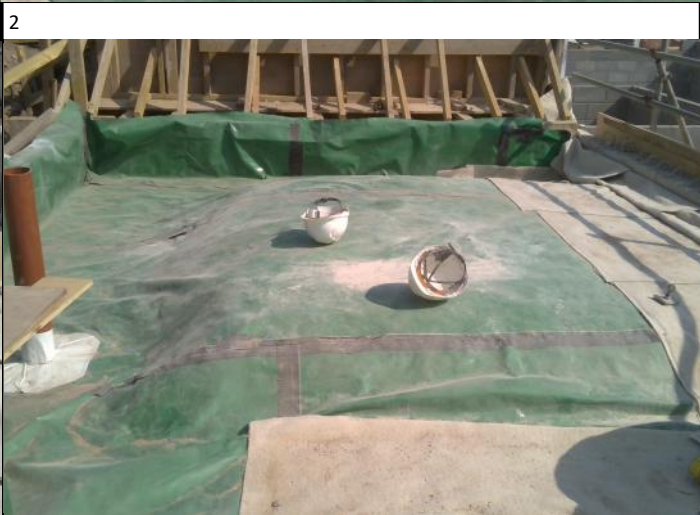
| Photographs | |
|---|---|
| 4 | full area |

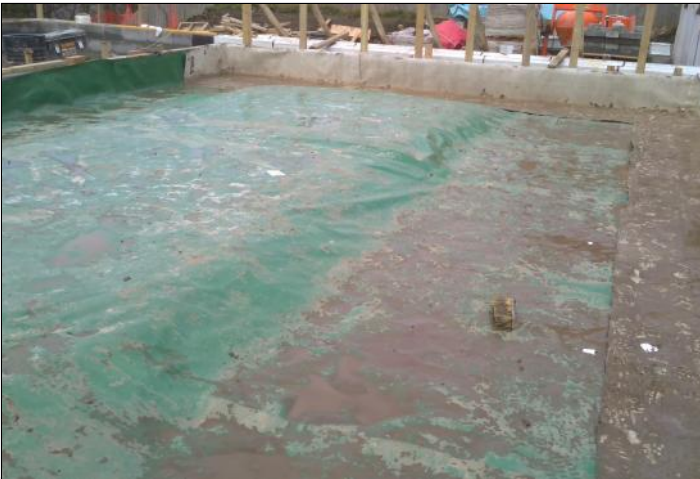
| Photographs | |
|---|---|
| 1 | full plot lower |

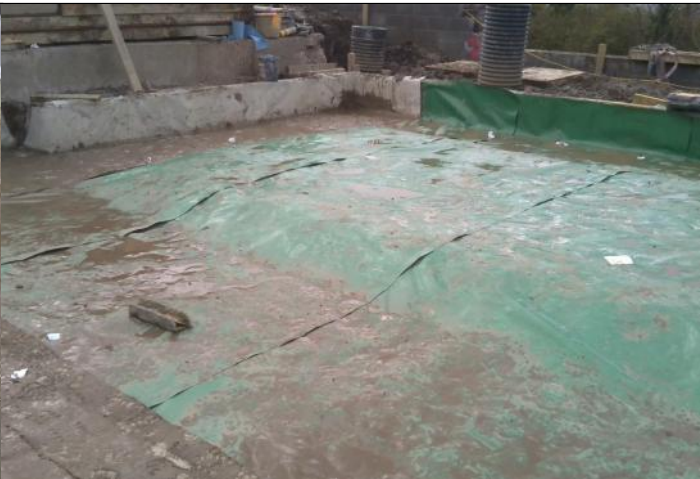
| Photographs | |
|---|---|
| 2 | full plot lower |

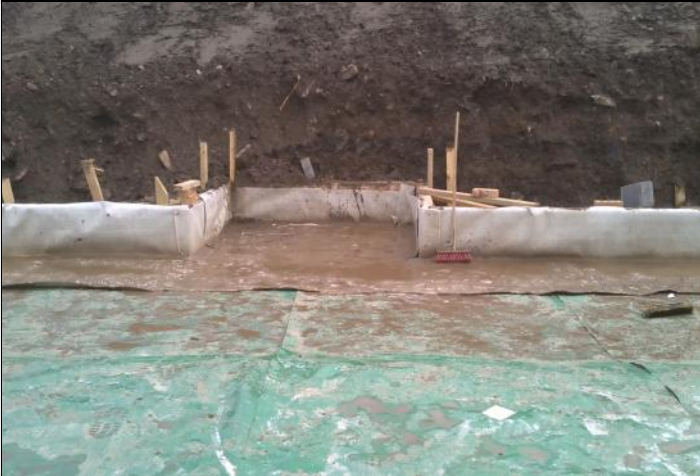
| Photographs | |
|---|---|
| 3 | full plot lower |

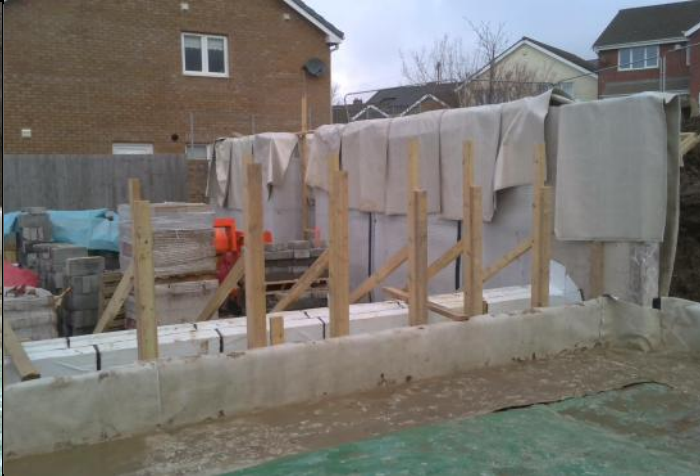
| Photographs | |
|---|---|
| 4 | full plot lower |

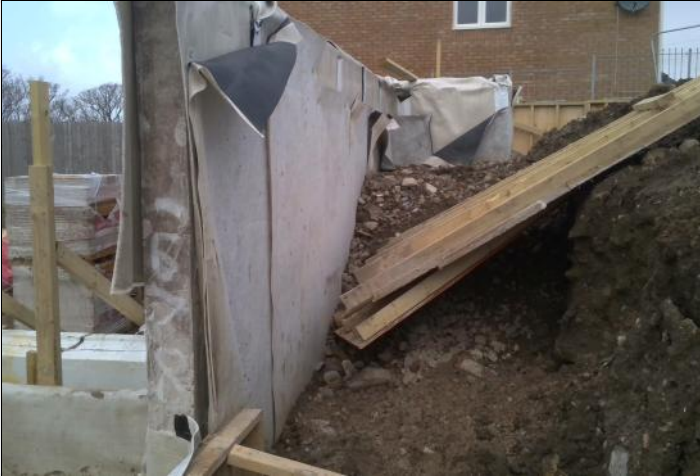
| Photographs | |
|---|---|
| 5 | plot 1 retaining wall external |

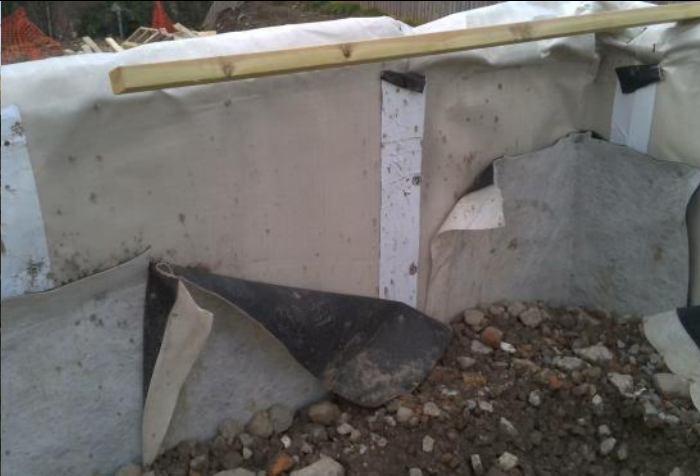
| Photographs | |
|---|---|
| 6 | plot 1 retaining wall external |

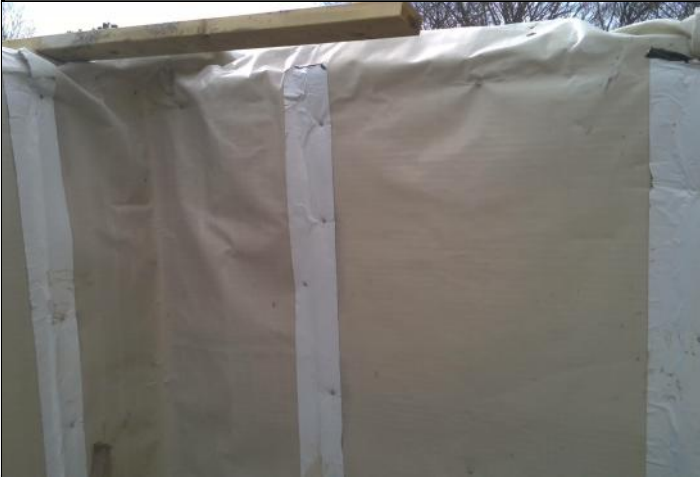
| Photographs | |
|---|---|
| 7 | plot 1 retaining wall external tape sealing x2 |

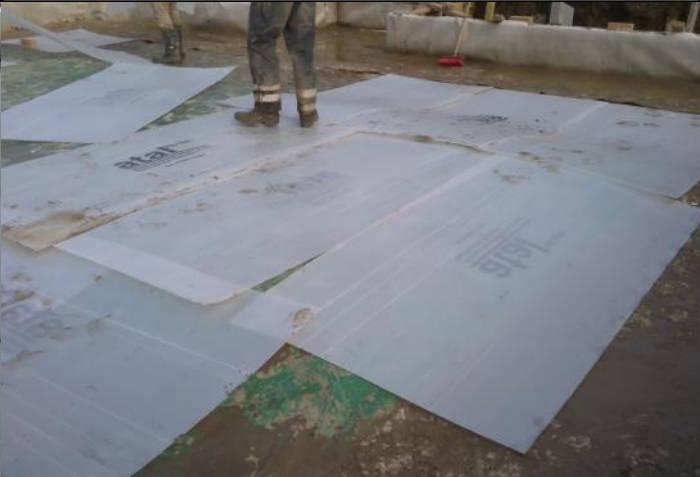
| Photographs | |
|---|---|
| 8 | placement of protection boards post inspection |

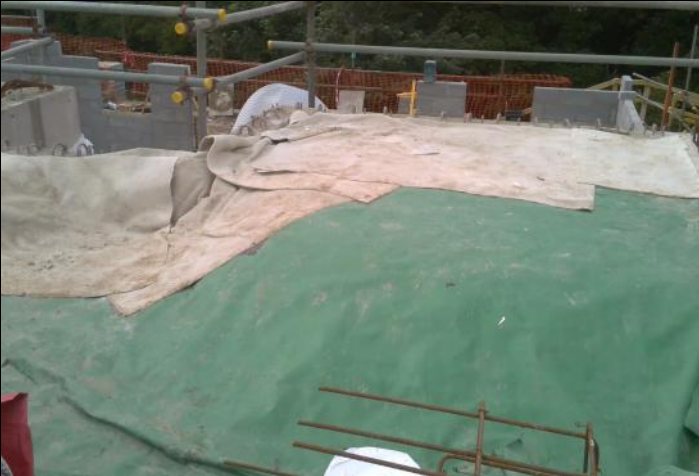
| Photographs | |
|---|---|
| 9 | full plot upper |

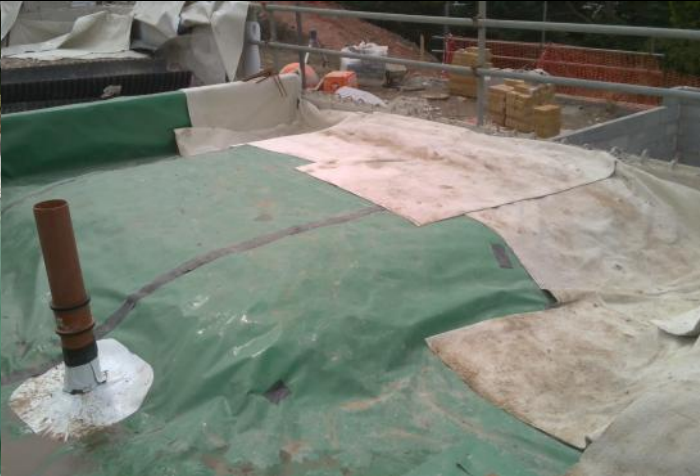
| Photographs | |
|---|---|
| 10 | full plot upper |

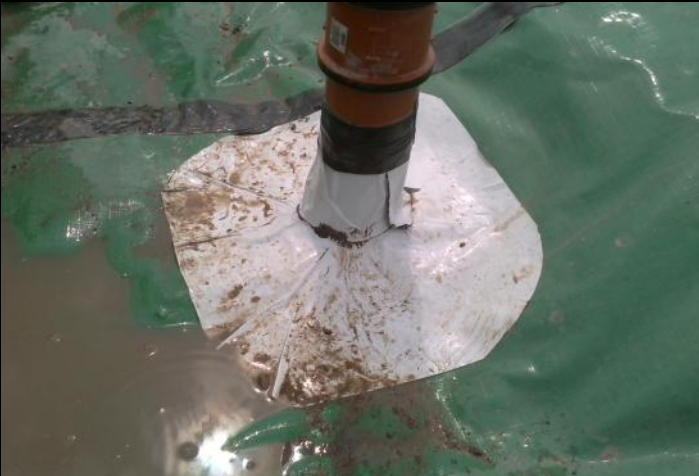
| No. | Item | Comments |
|---|---|---|
| 1.7 | Service entries seals | one service entry on Bentofix, sealed as designed with bentonite paste solution. One service entry on upper level sealed with SAM. Good detail, PASS |

| Photographs | |
|---|---|
| 11 | service entry sealing upper |

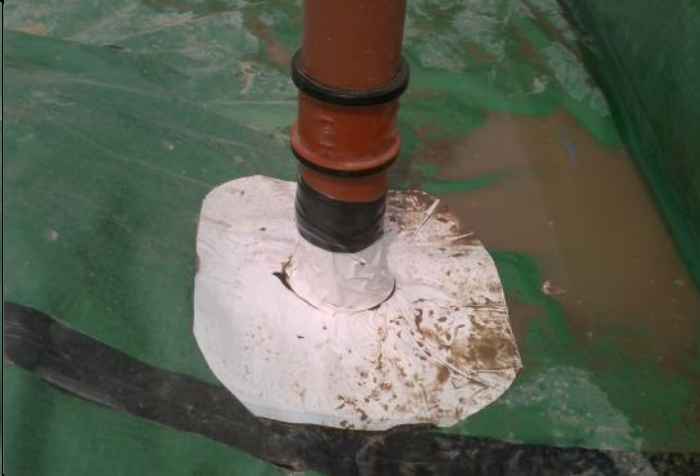
| Photographs | |
|---|---|
| 12 | service entry sealing upper |
