### Asbestos Survey Report

Tata Steel  
Redundant Morfa Coke Ovens  
HAA  
HAA Structure-Feed Hoppers & Conveyor 1290  
Port Talbot Steel Works  
SA13 2NG

| Survey No | Date of Survey | Survey Type | Prepared by | Authorised by |
|---|---|---|---|---|
| 5938 SC | 22/04/2025 | Demolition Survey | Derek Williams | Anthony Avery |

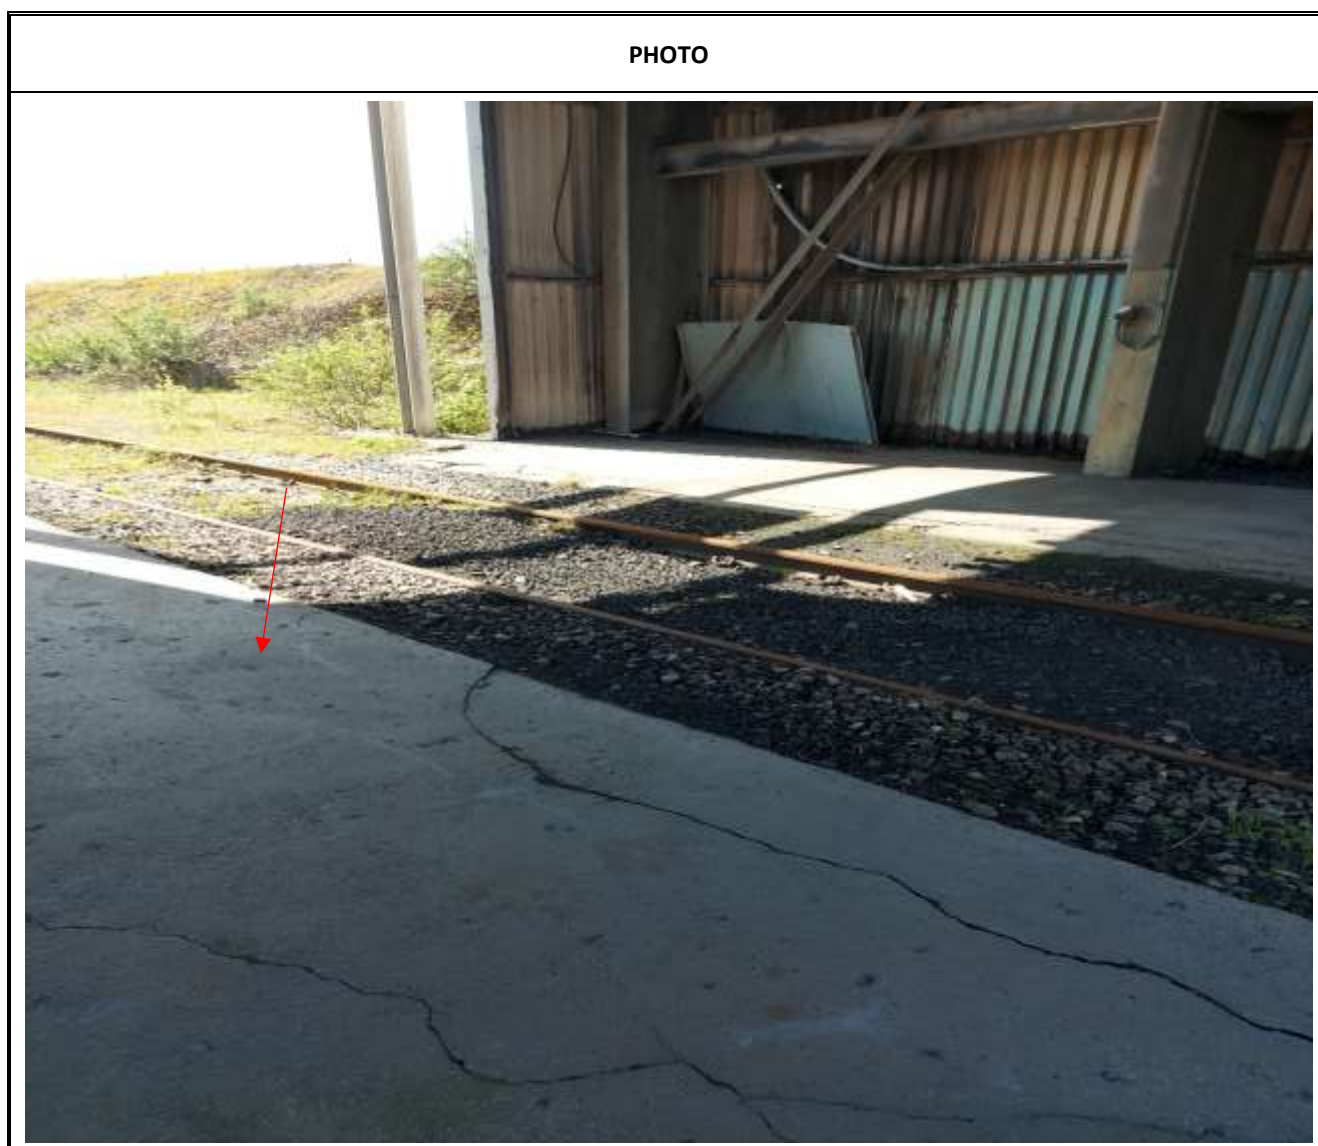
| <b>Comments</b> | <b>No Asbestos Detected</b> |

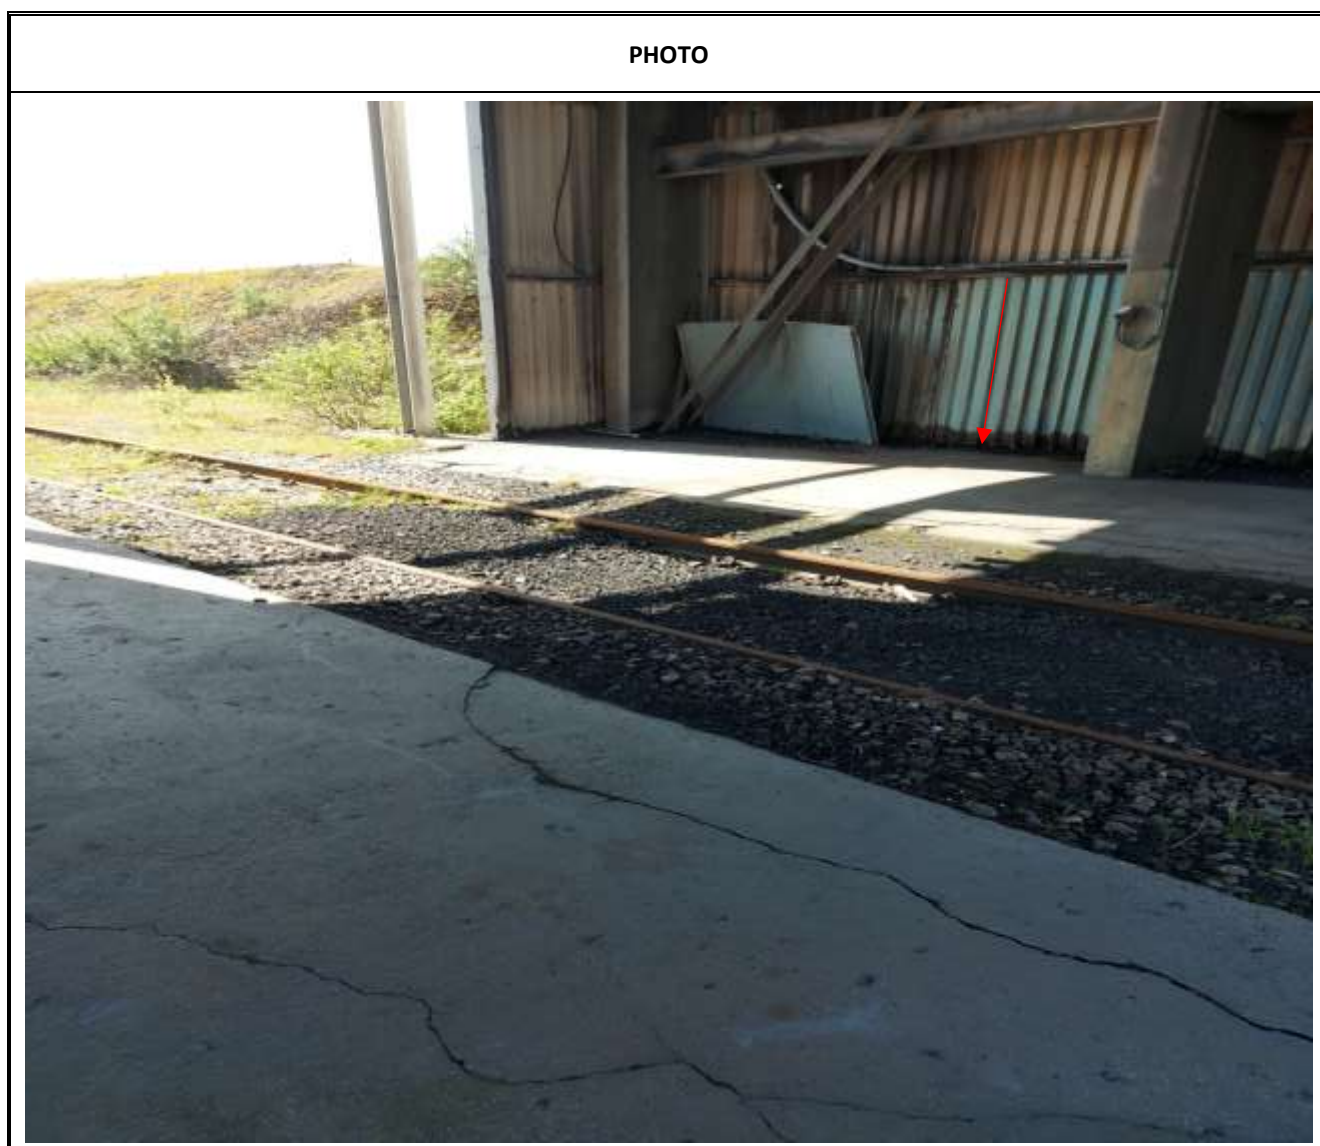
| <b>Site</b> | HAA Structure-Feed Hoppers & Conveyor 1290 | <b>Sample No.</b> | W176525 -S02 |

| <b>Comments</b> | <b>No Asbestos Detected</b> |

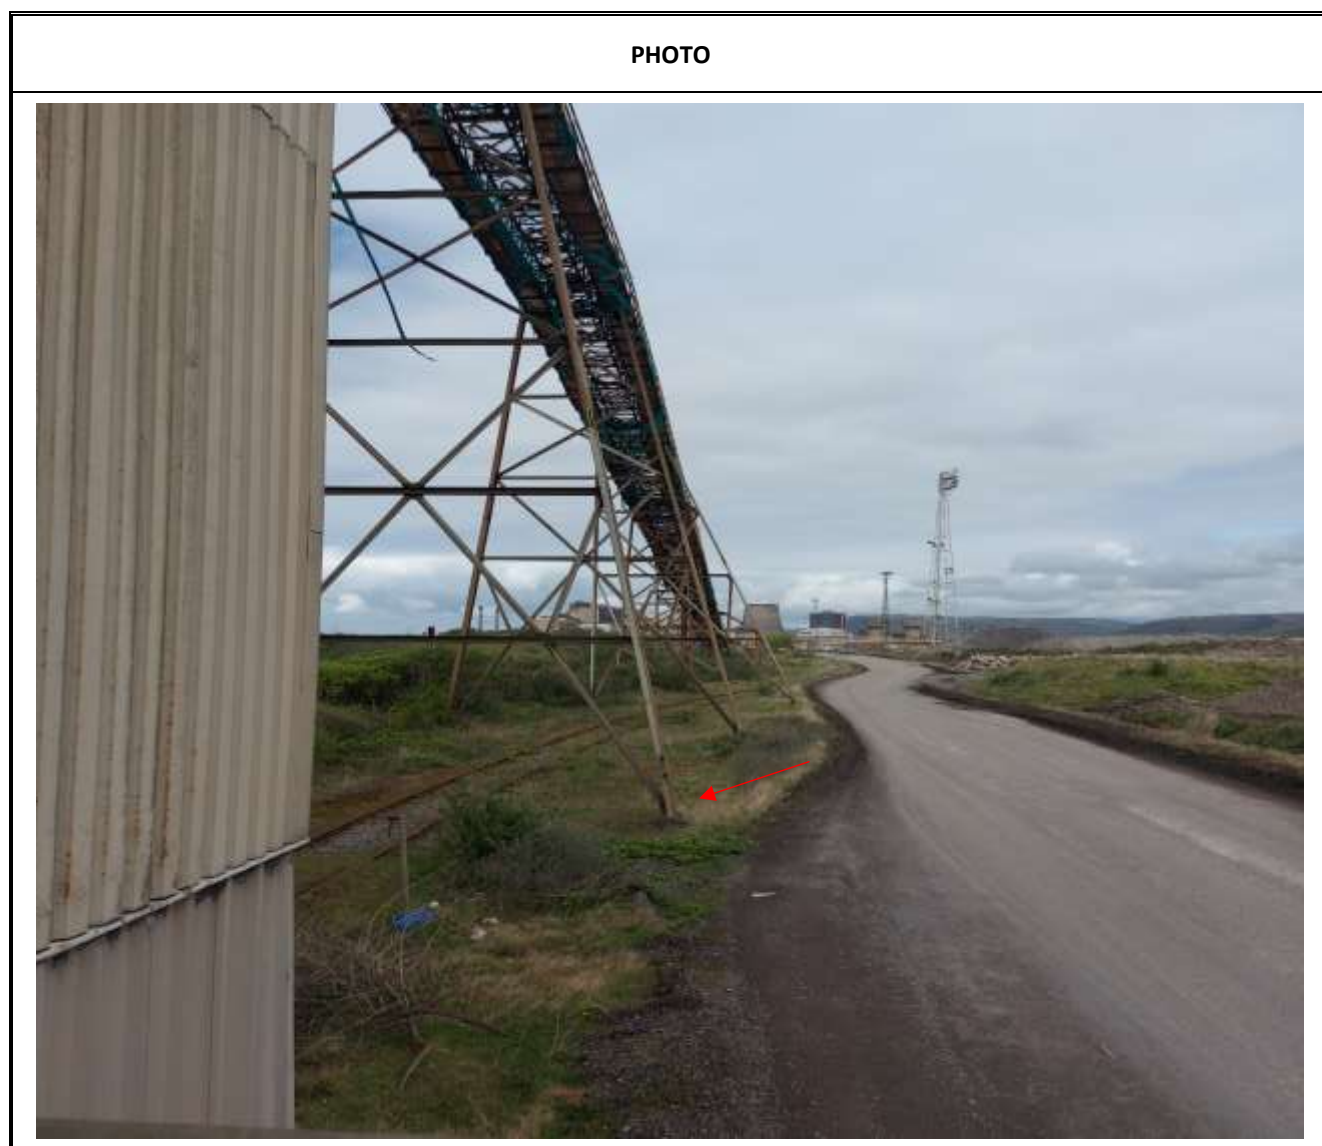
| <b>Site</b> | HAA Structure-Feed Hoppers & Conveyor 1290 | <b>Sample No.</b> | W176525 -VS02a |

| <b>Comments</b> | <b>No Asbestos Suspected</b> |

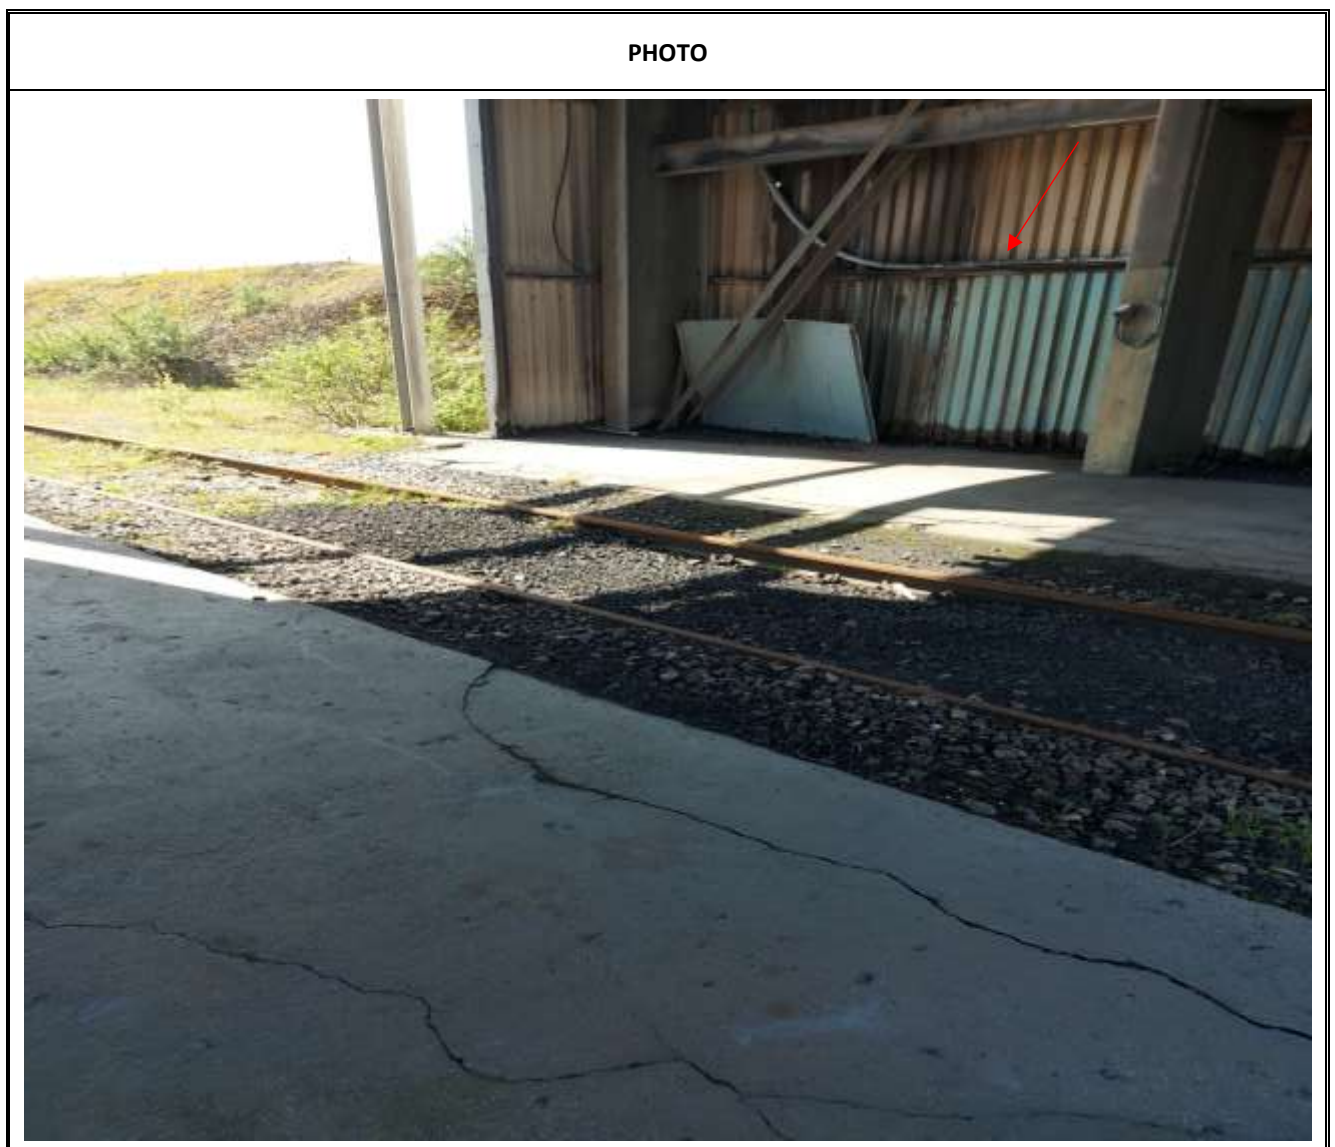
| <b>Site</b> | HAA Structure-Feed<br>Hoppers & Conveyor<br>1290 | <b>Sample No.</b> | W176525<br>-S03 |

| <b>Comments</b> | <b>No Asbestos Detected</b> |

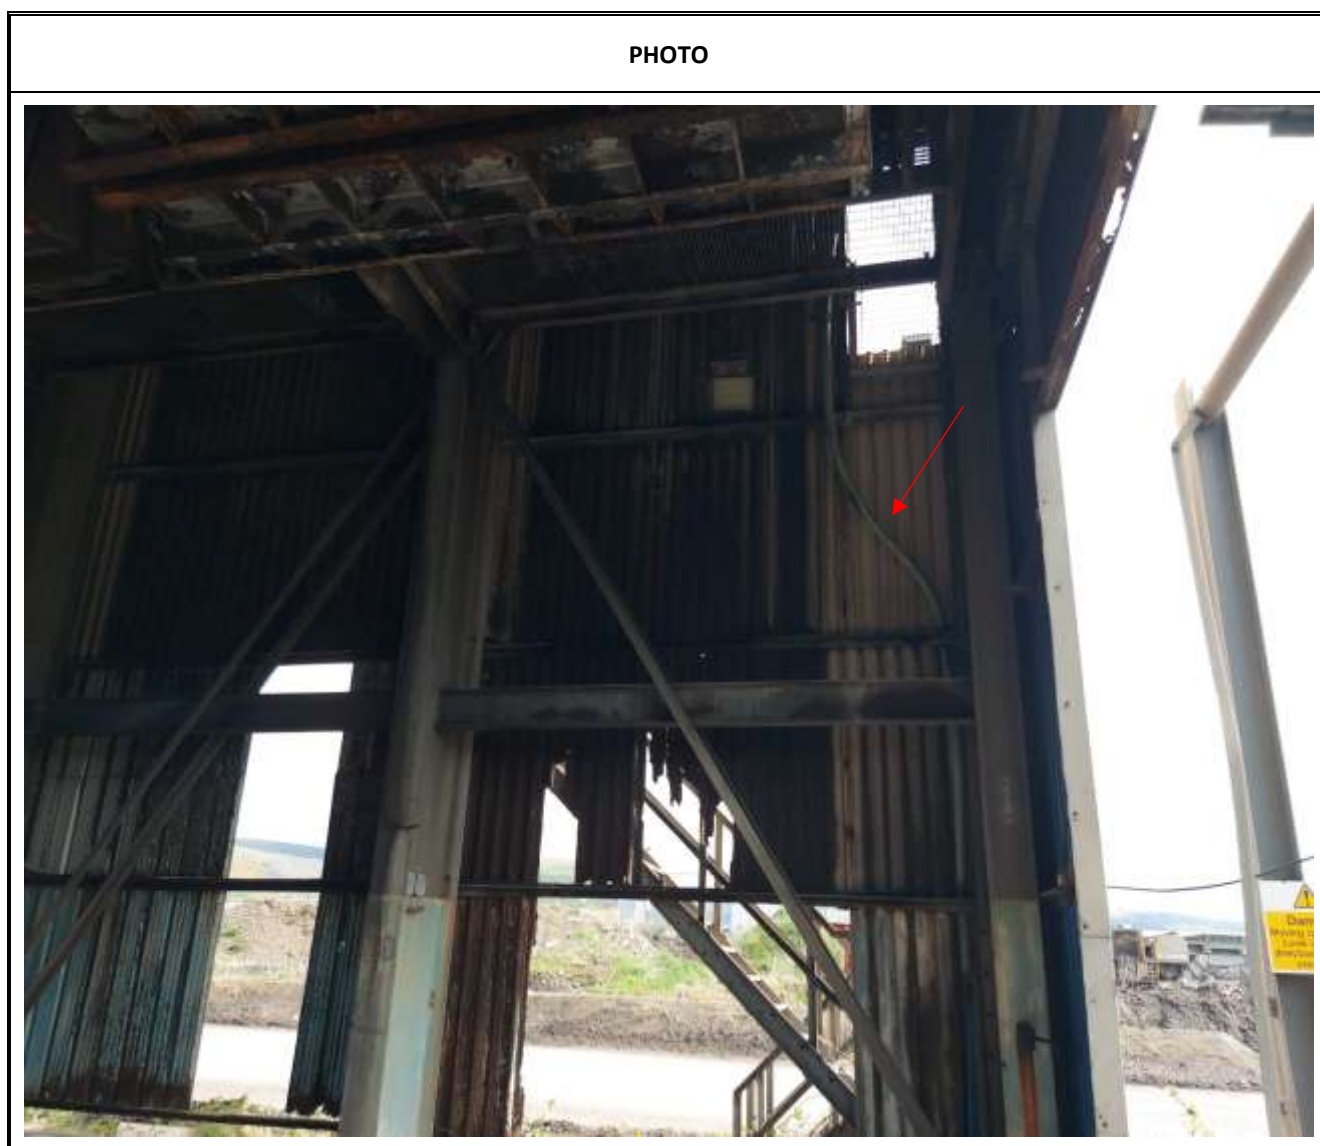
| <b>Site</b> | HAA Structure-Feed Hoppers & Conveyor 1290 | <b>Sample No.</b> | W176525 -VS03a |

| <b>Comments</b> | <b>No Asbestos Suspected</b> |

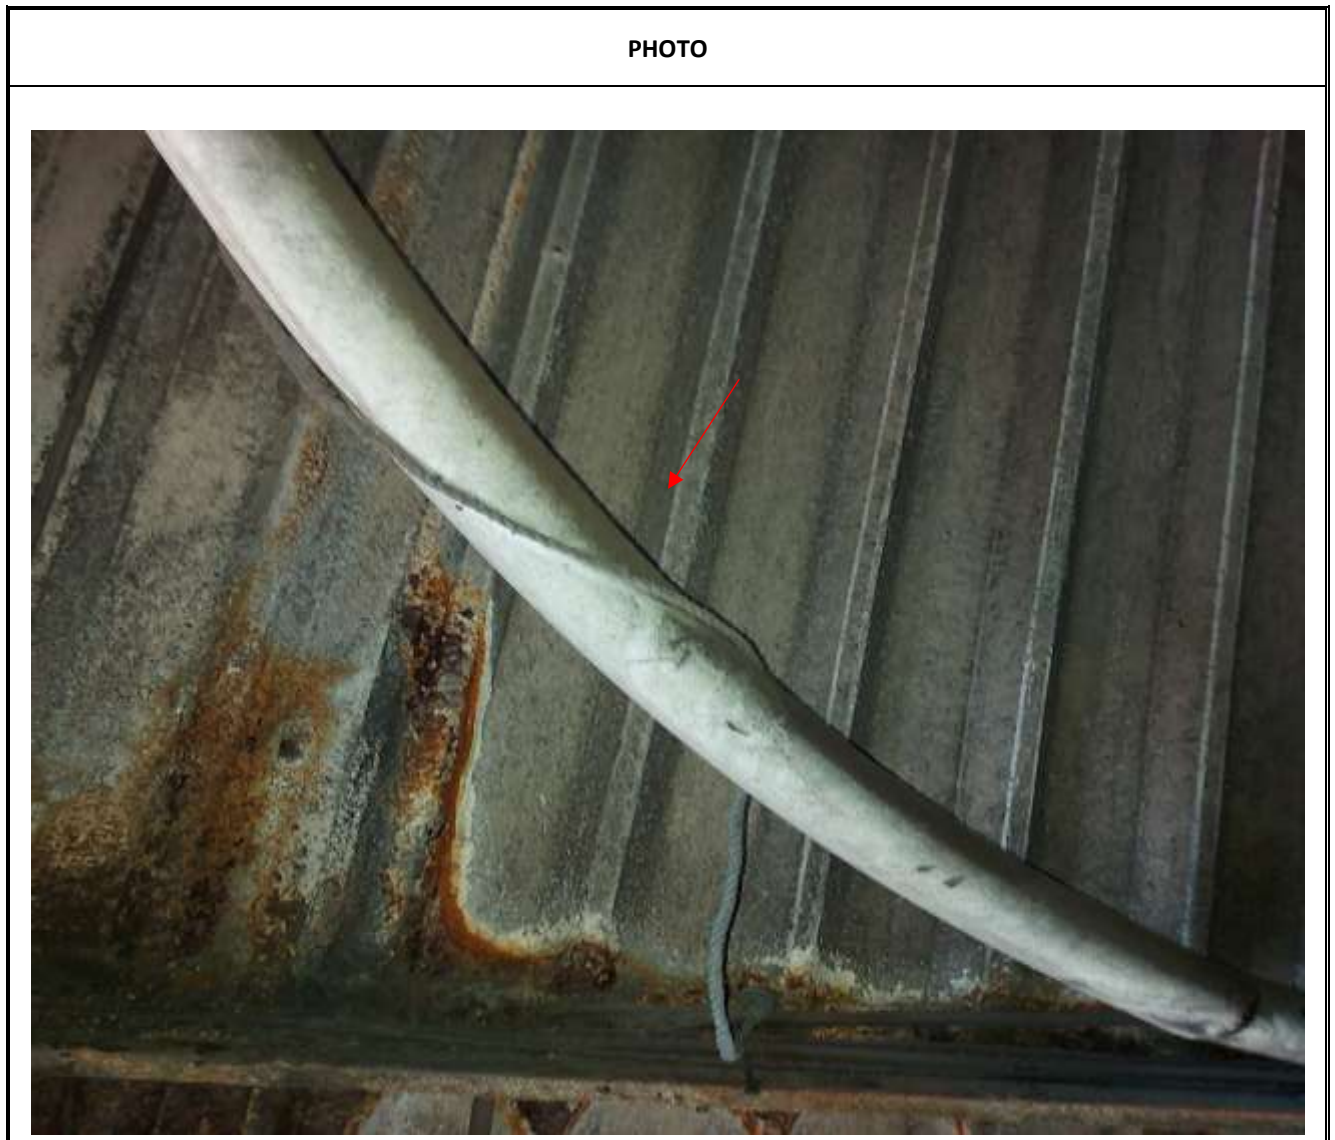
| <b>Site</b> | HAA Structure-Feed<br>Hoppers & Conveyor<br>1290 | <b>Sample No.</b> | W176525<br>-VS03b |

| <b>Comments</b> | <b>No Asbestos Suspected</b> |

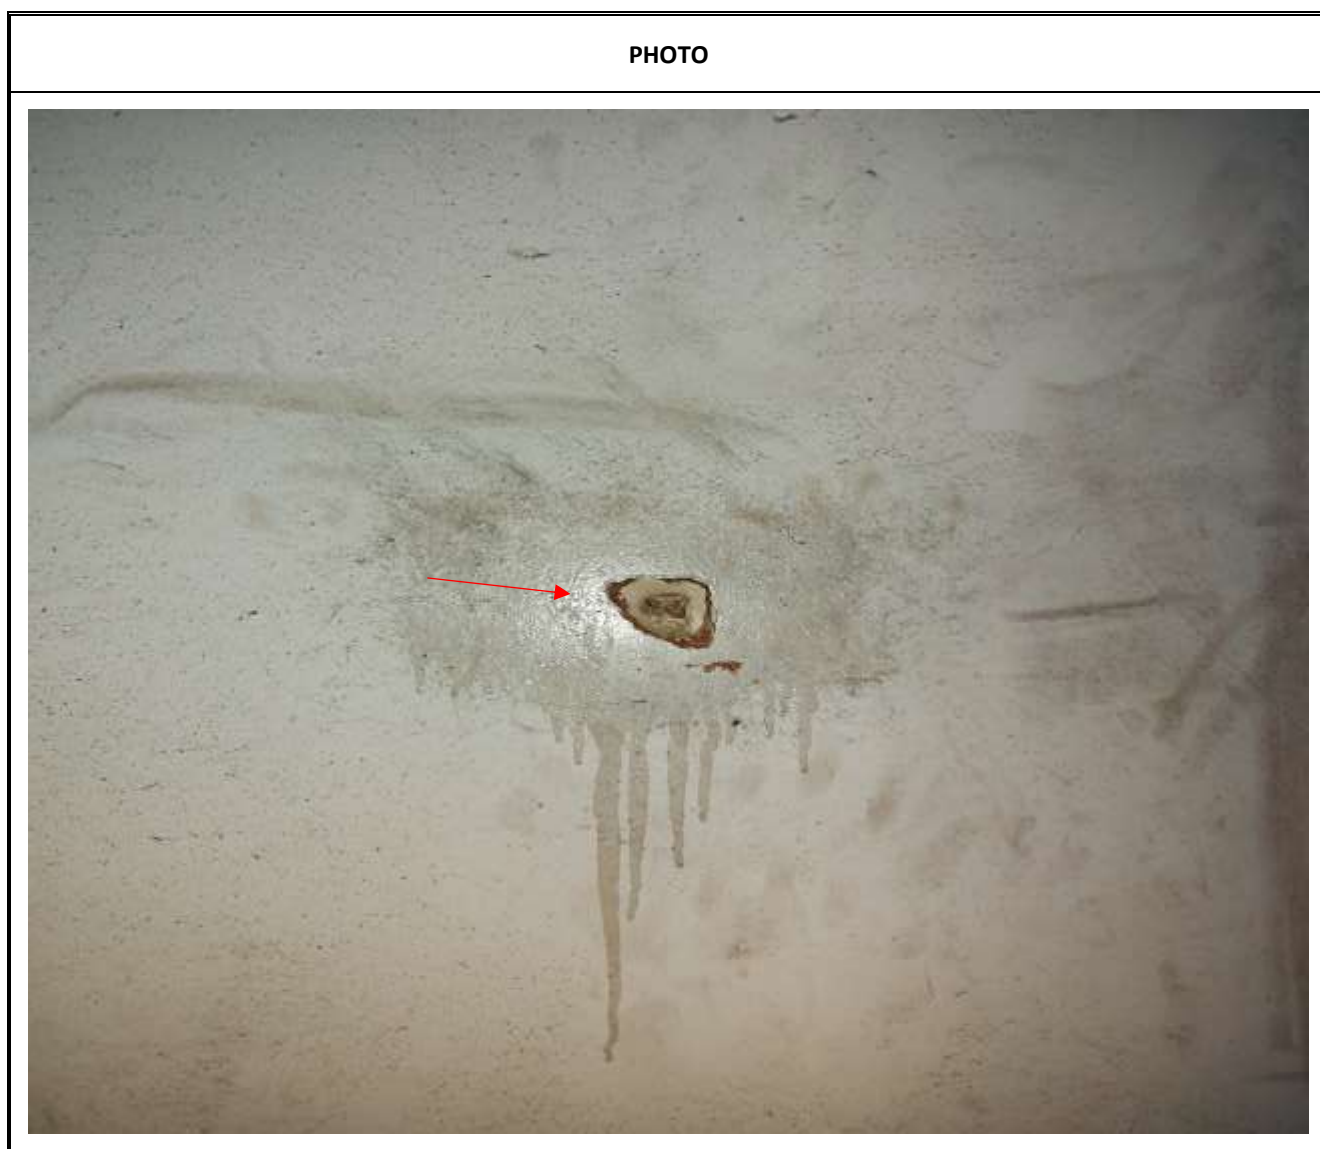
| <b>Site</b> | HAA Structure-Feed Hoppers & Conveyor 1290 | <b>Sample No.</b> | W176525-S05 |

| <b>Comments</b> | <b>No Asbestos Detected</b> |

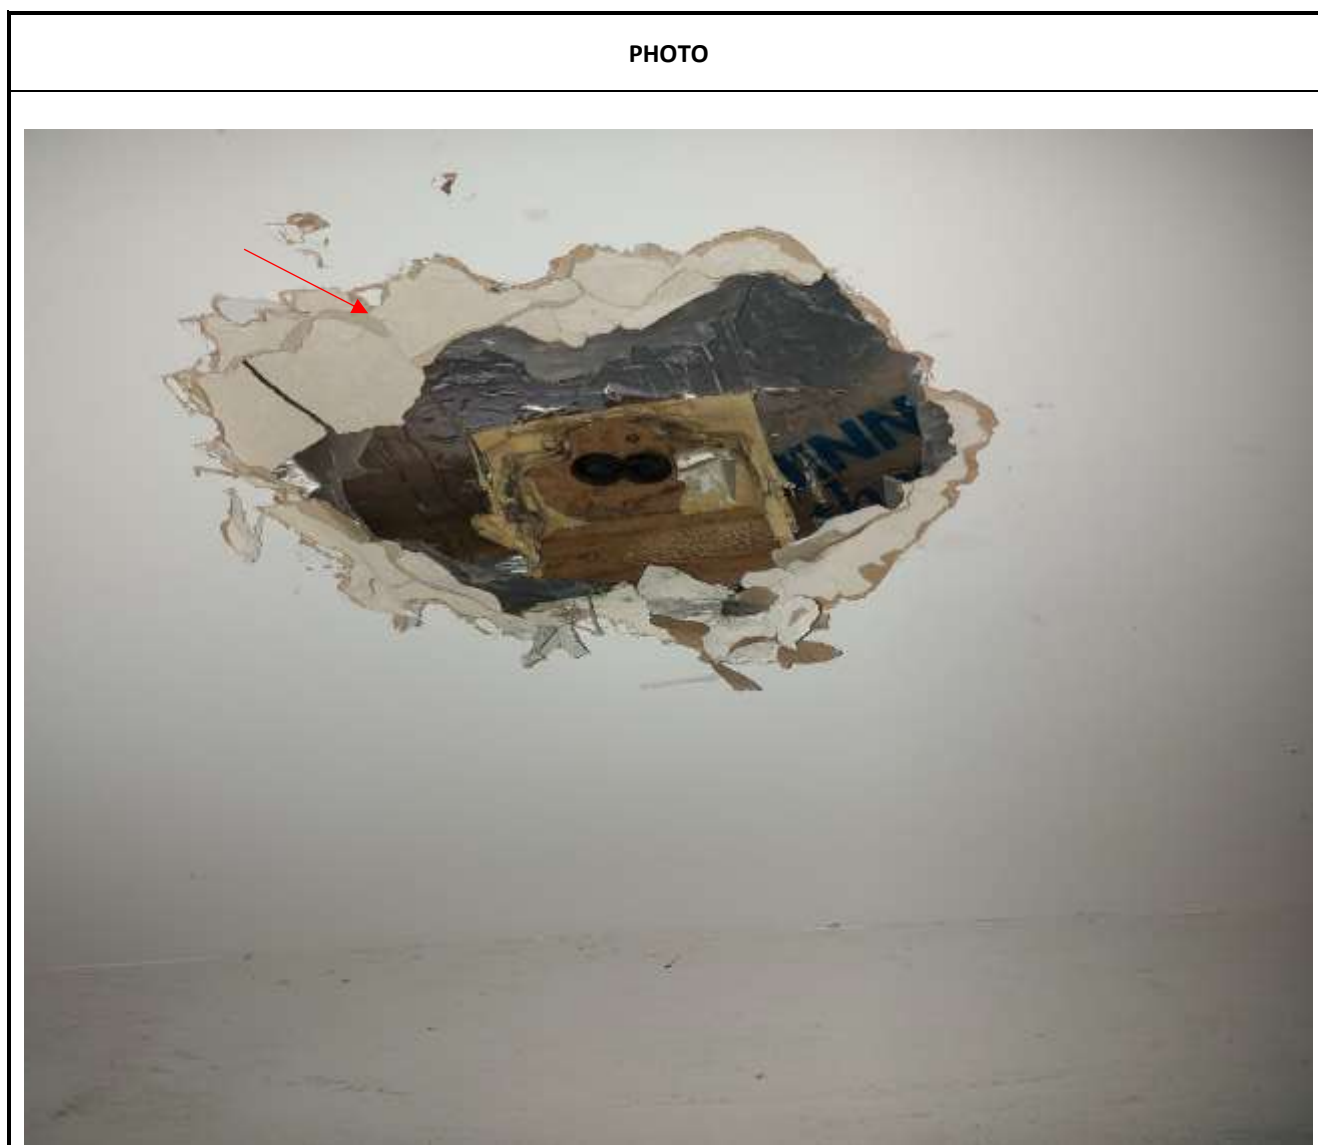
| <b>Site</b> | HAA Structure-Feed<br>Hoppers & Conveyor<br>1290 | <b>Sample No.</b> | W176525<br>-S06 |

| <b>Comments</b> | <b>No Asbestos Detected</b> |

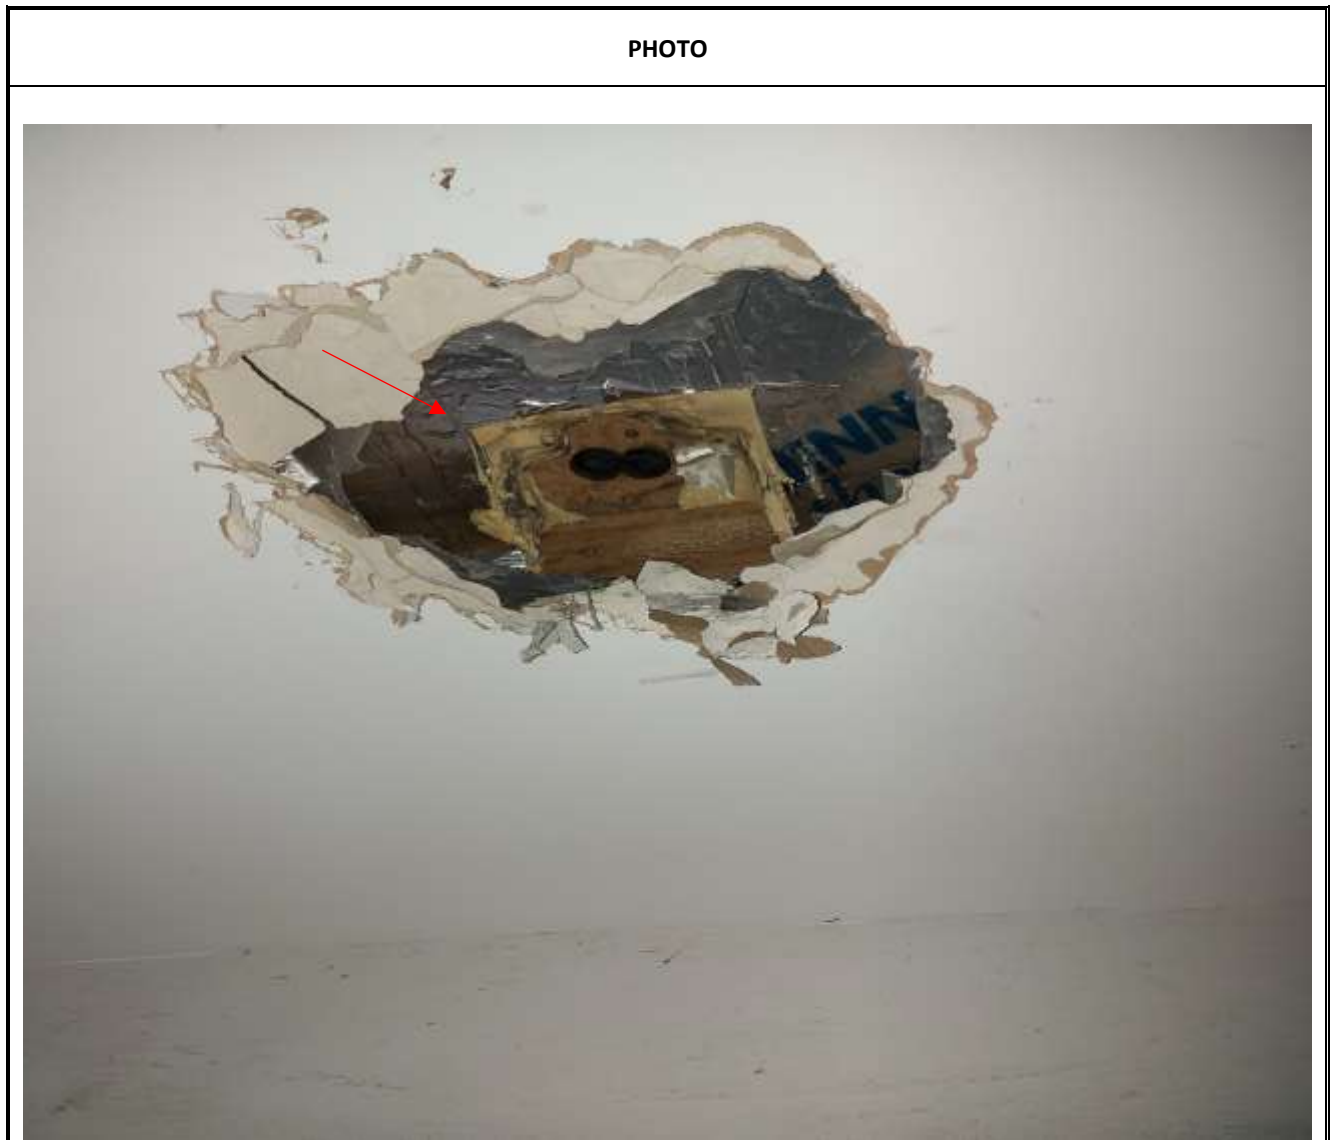
| <b>Site</b> | HAA Structure-Feed<br>Hoppers & Conveyor<br>1290 | <b>Sample No.</b> | W176525<br>-S07 |

| <b>Comments</b> | <b>No Asbestos Detected</b> |

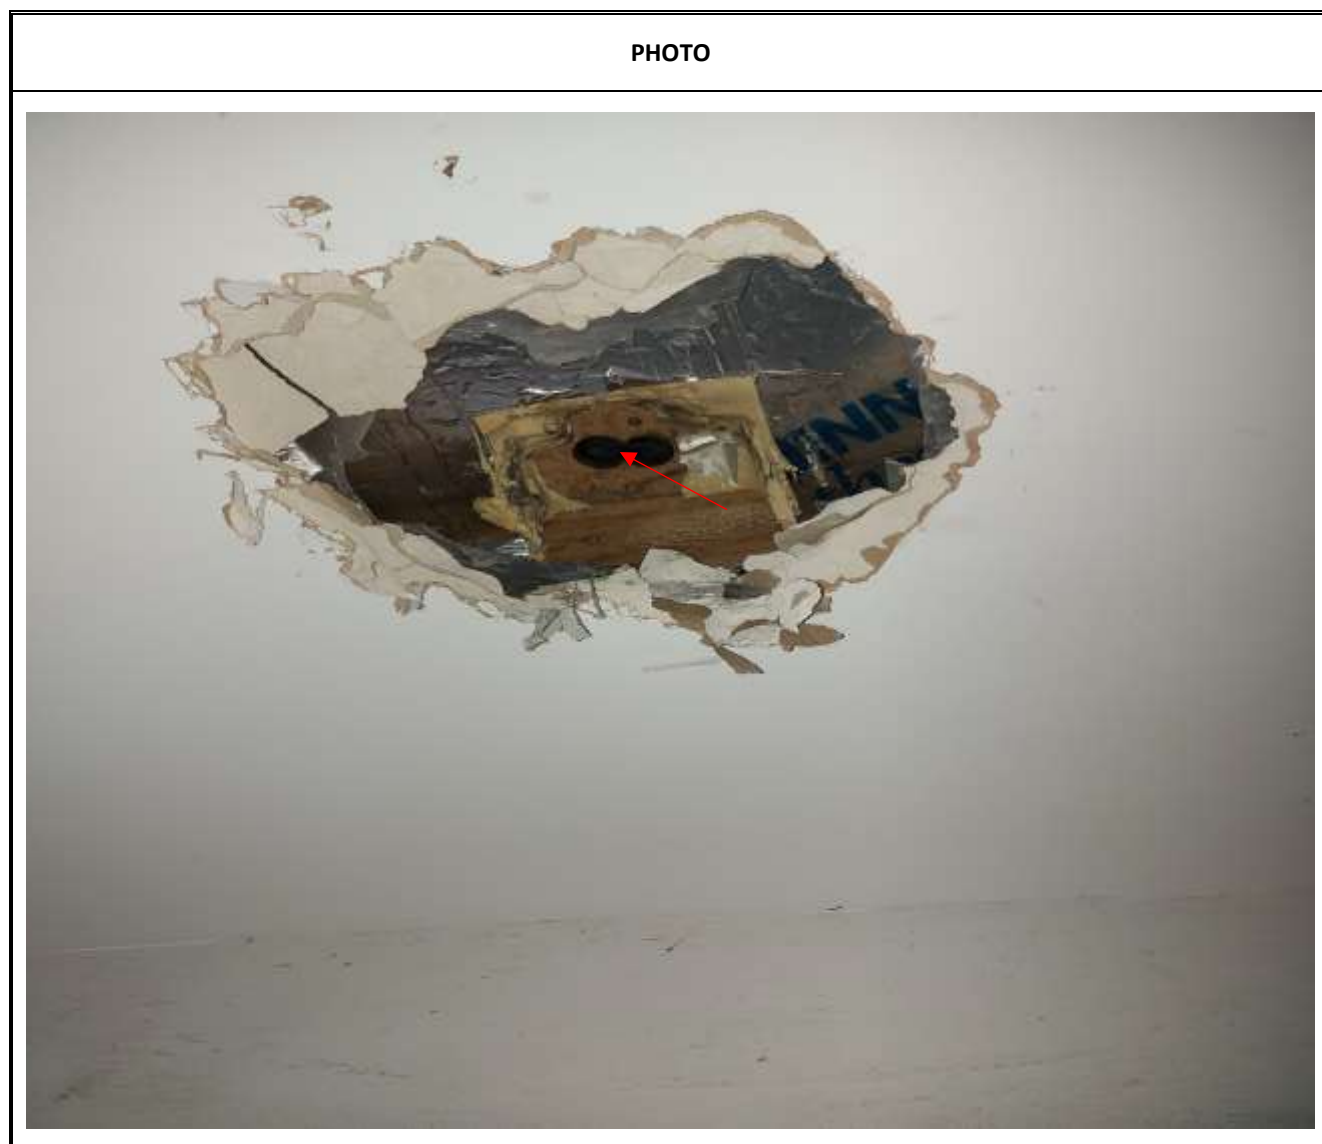
| Site | MCO HAA Structure-Feed Hoppers & Conveyor 1290 | Sample No. | W176525-S08 |

| <b>Asbestos Product Type</b> | <b>Area(s)</b> | <b>Licensed Contractor Required</b> | <b>Comments (See section 9)</b> |
|---|---|---|---|
| Felt Bitumen | S08-Redundant Morfa Coke Ovens-HAA Building-1 <sup>st</sup> Floor Annex-Roofing Material-Felt Bitumen | No | Sampled |

| <u>Analytical Ref No:</u> | <u>Sample No:</u> | <u>Location:</u> | <u>Product Type:</u> | <u>Quantity/Extent:</u> | <u>Condition:</u> | <u>Asbestos Type:</u> | <u>Sampled Presumed Strongly Presumed</u> |
|---|---|---|---|---|---|---|---|
| W176525 | S08 | S08-Redundant Morfa Coke Ovens-HAA Building-1 <sup>st</sup> Floor Annex-Roofing Material-Felt Bitumen. | Felt Bitumen | 8m <sup>2</sup> | Good | Chrysotile | Sampled. |

| Comments | Asbestos Detected-Any planned work on this item must only be carried out by suitably trained competent persons. |

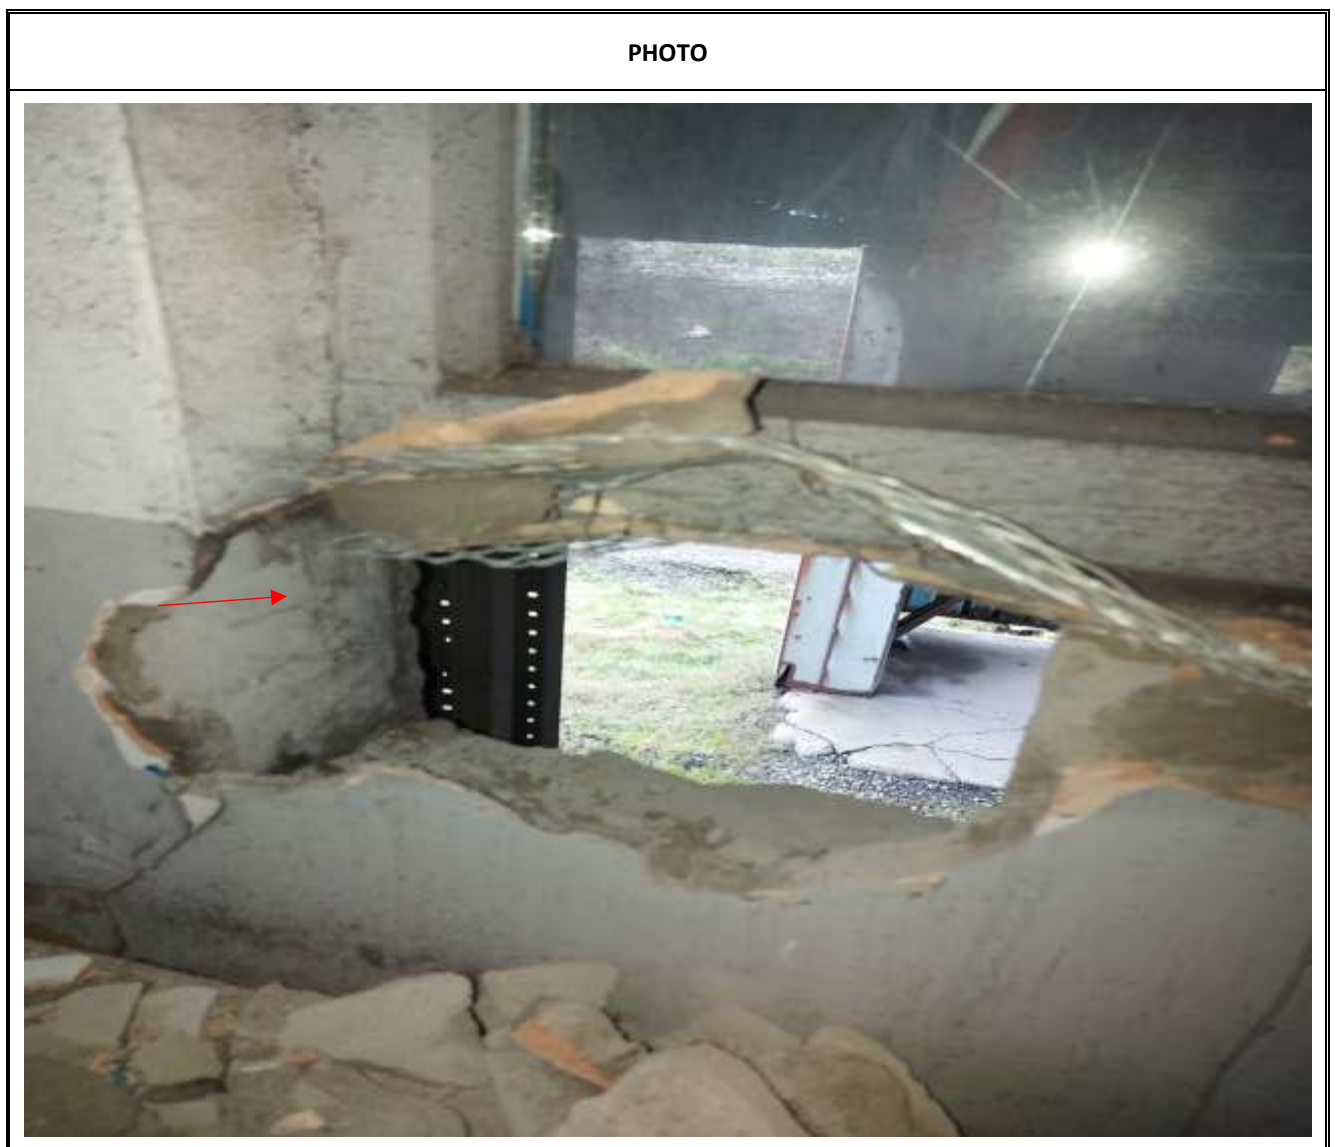
| <b>Site</b> | HAA Structure-Feed Hoppers & Conveyor 1290 | <b>Sample No.</b> | W176525 -S09 |

| <b>Comments</b> | <b>No Asbestos Detected</b> |

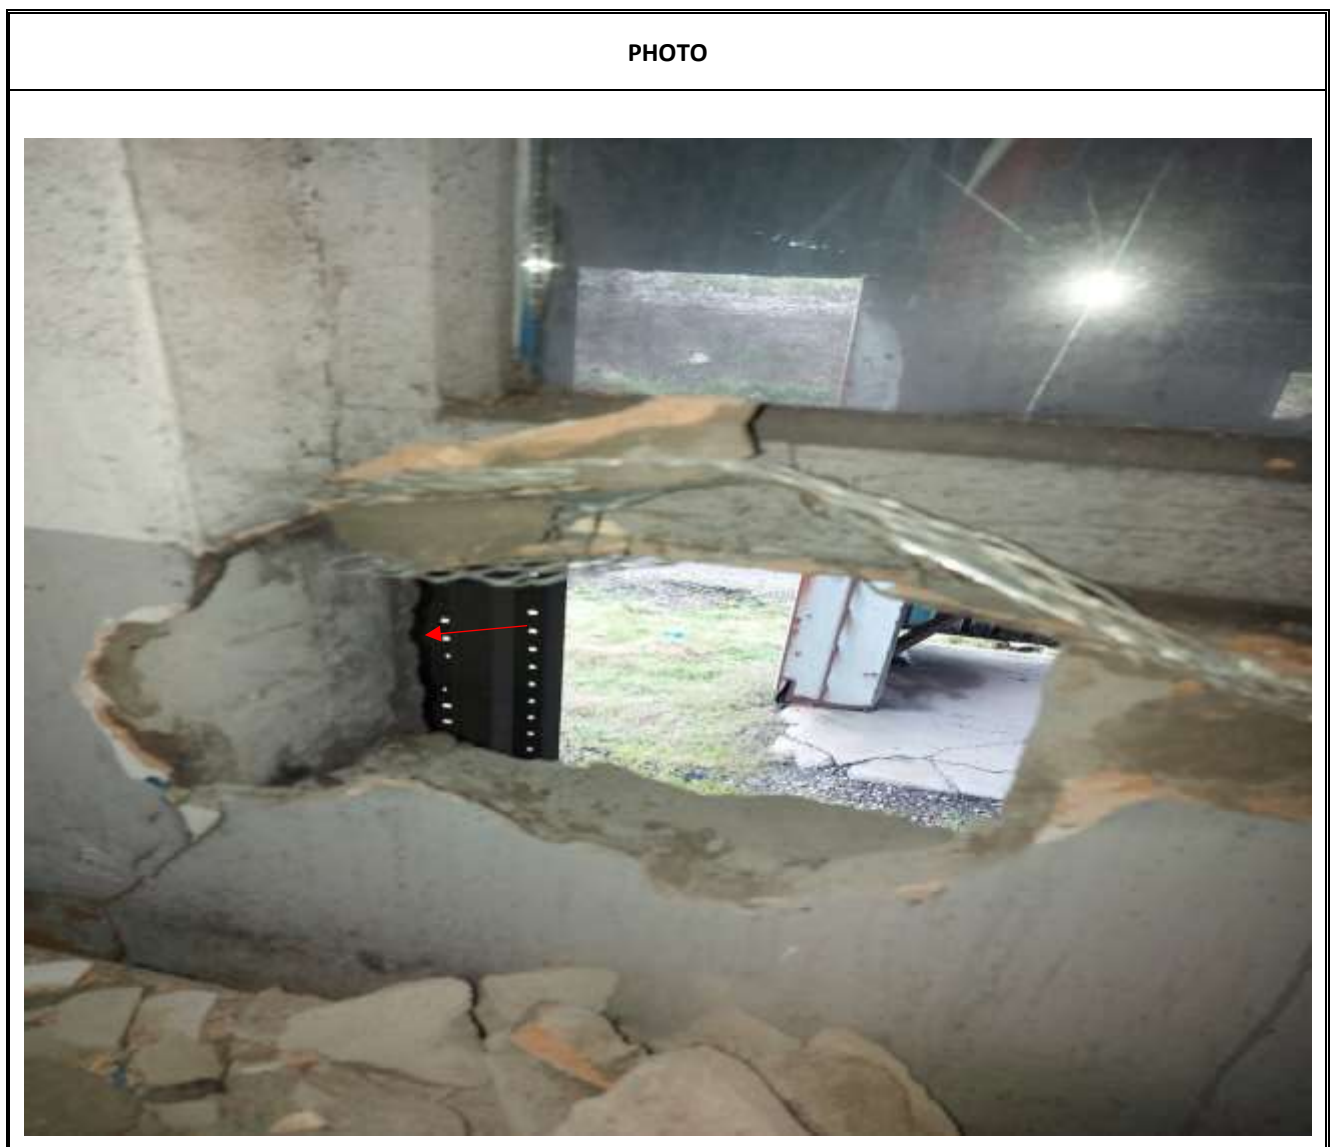
| Site | HAA Structure-Feed Hoppers & Conveyor 1290 | Sample No. | W176525-S10 |

| Comments | <b>No Asbestos Detected</b> |

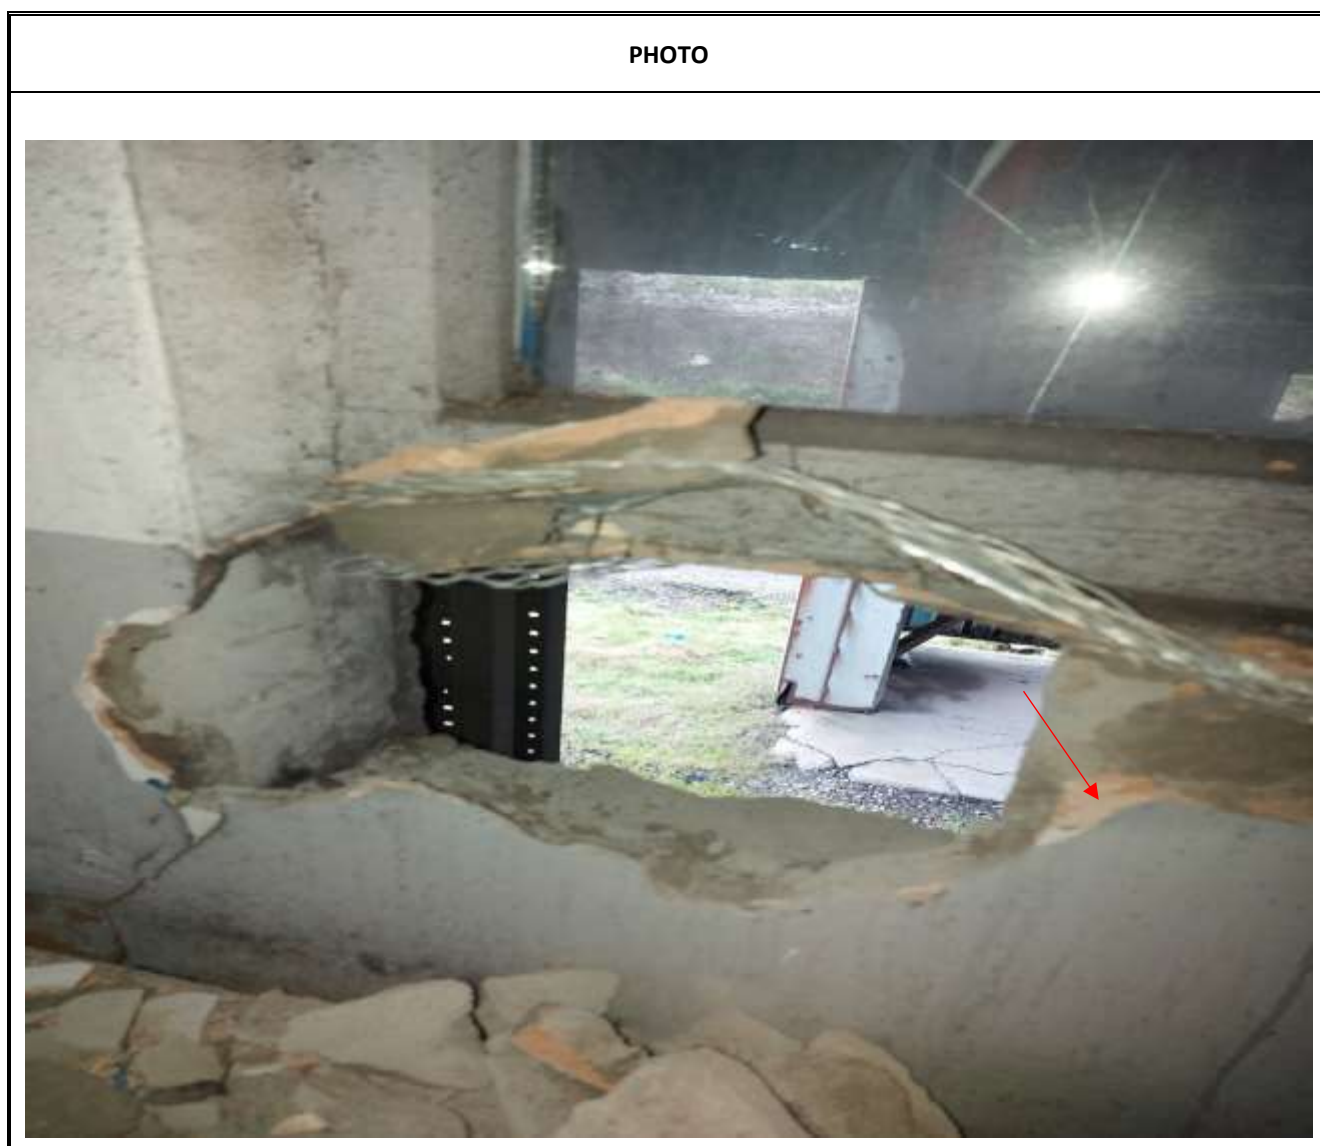
| Site | HAA Structure-Feed Hoppers & Conveyor 1290 | Sample No. | W176525 -S11 |

| Comments | <b>No Asbestos Detected</b> |

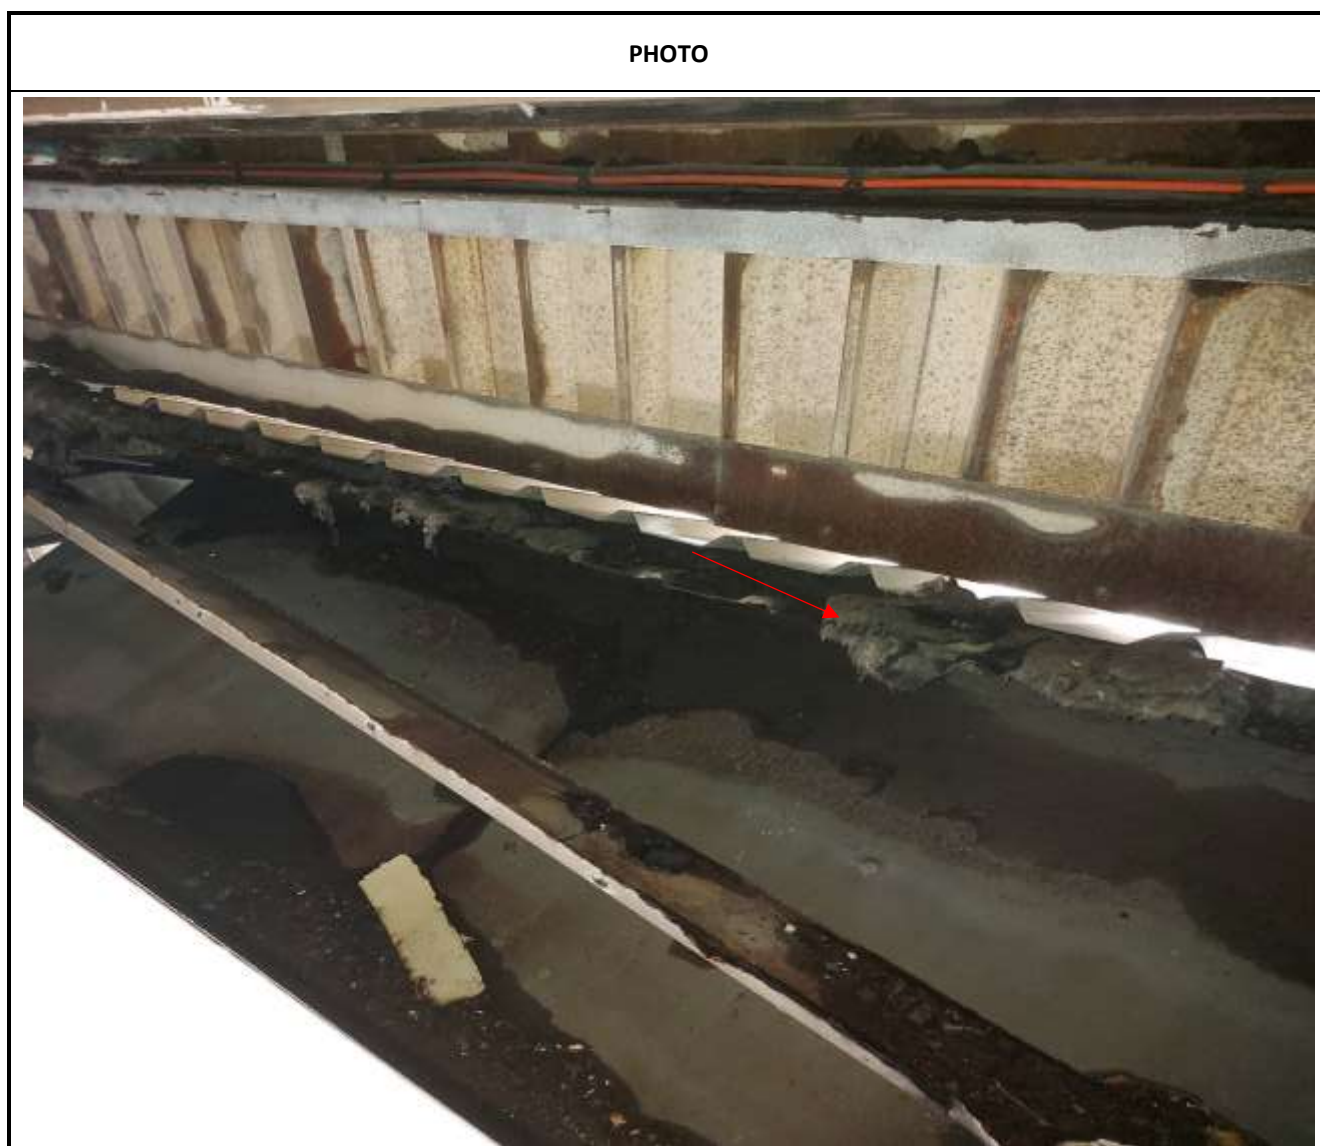
| <b>Site</b> | HAA Structure-Feed Hoppers & Conveyor 1290 | <b>Sample No.</b> | W176525-S12 |

| <b>Comments</b> | <b>No Asbestos Detected</b> |
