### Asbestos Survey Report

Tata Steel  
Redundant Morfa Coke Ovens  
HAA  
HAA Structure-Feed Hoppers & Conveyor 1290  
Port Talbot Steel Works  
SA13 2NG

| Survey No | Date of Survey | Survey Type | Prepared by | Authorised by |
|---|---|---|---|---|
| 5938 SC | 22/04/2025 | Demolition Survey | Derek Williams | Anthony Avery |

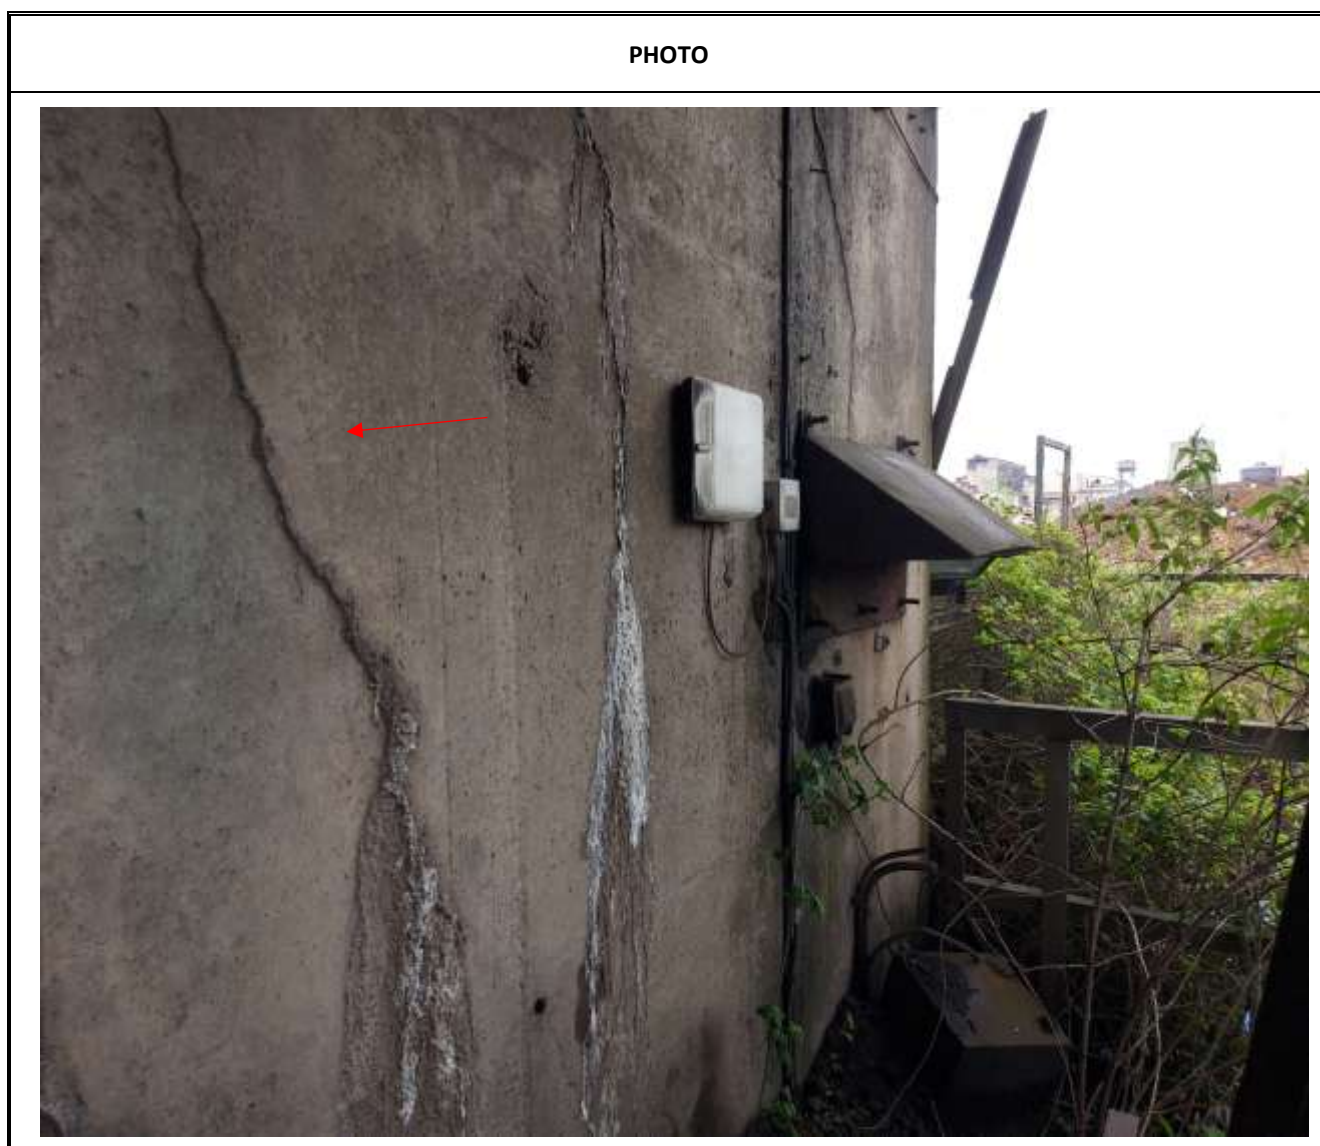
| <b>Site</b> | HAA Structure-Feed Hoppers & Conveyor 1290 | <b>Sample No.</b> | W176525-S13 |

| <b>Comments</b> | <b>No Asbestos Detected</b> |

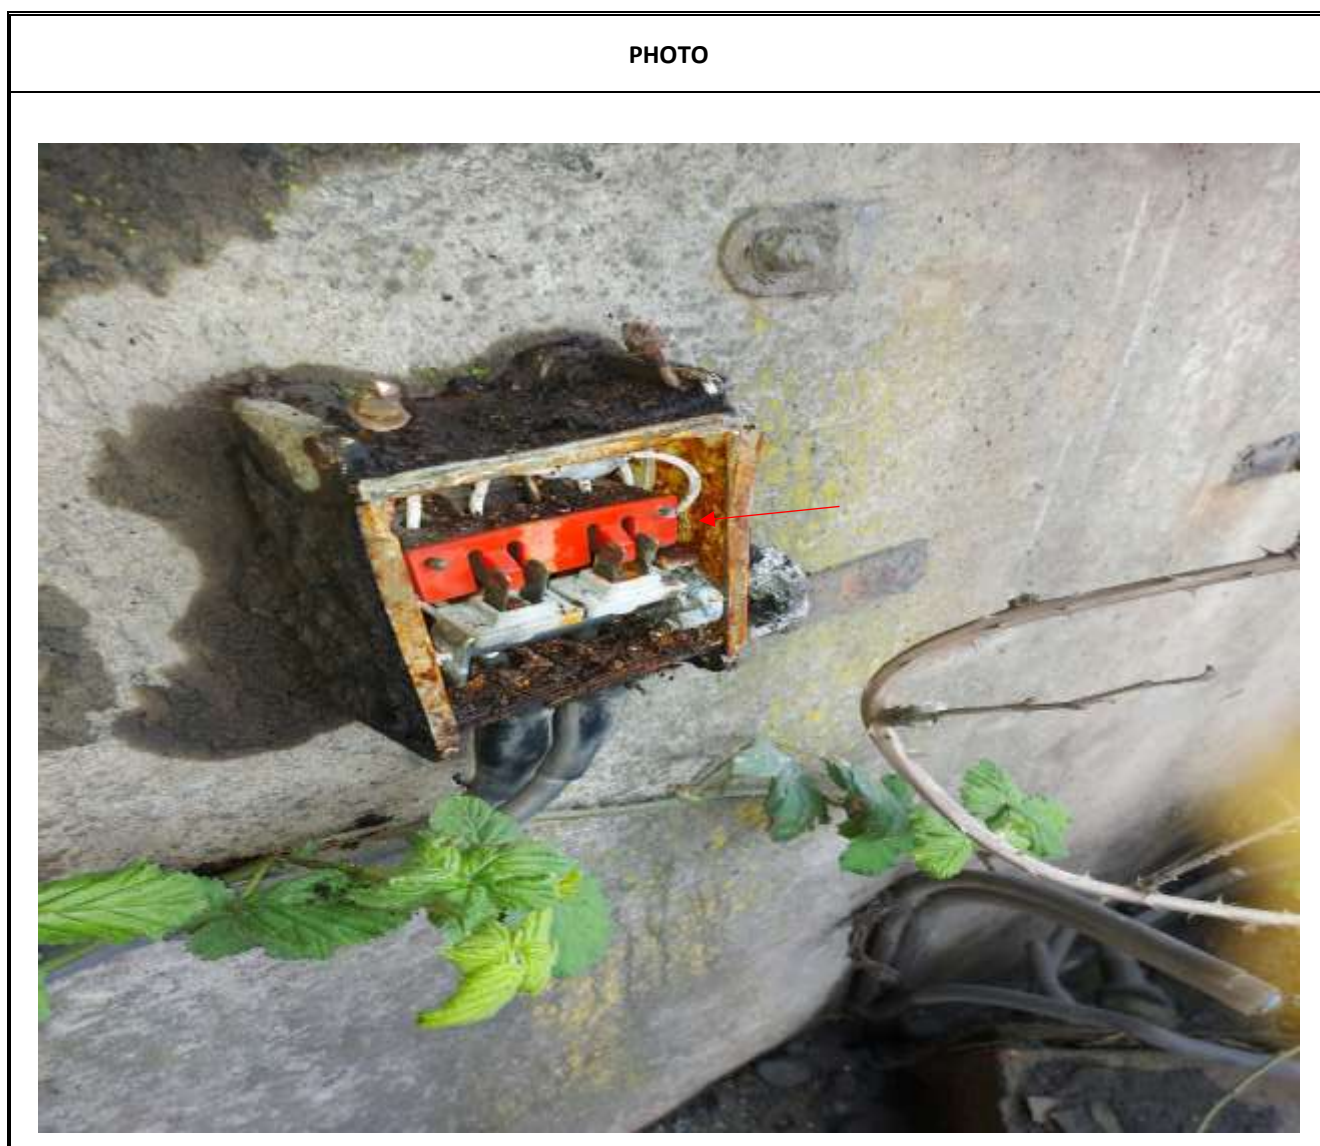
| <b>Site</b> | HAA Structure-Feed Hoppers & Conveyor 1290 | <b>Sample No.</b> | W176525 -S14 |

| <b>Comments</b> | <b>No Asbestos Detected</b> |

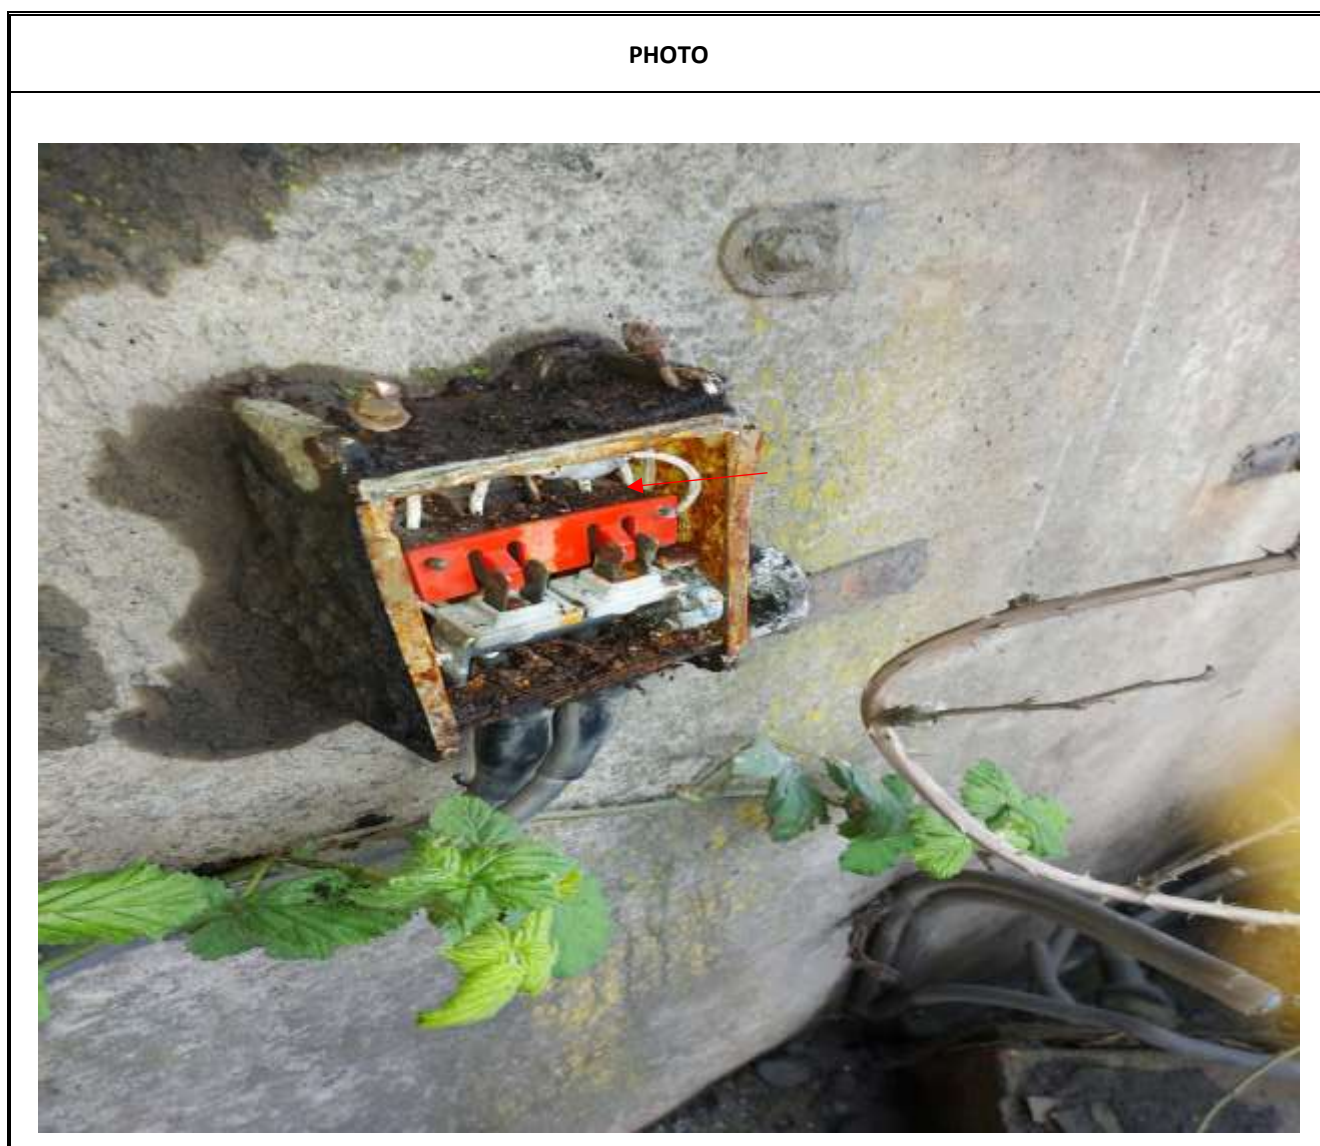
| <b>Site</b> | HAA Structure-Feed Hoppers & Conveyor 1290 | <b>Sample No.</b> | W176525 -S15 |

| <b>Comments</b> | <b>No Asbestos Detected</b> |

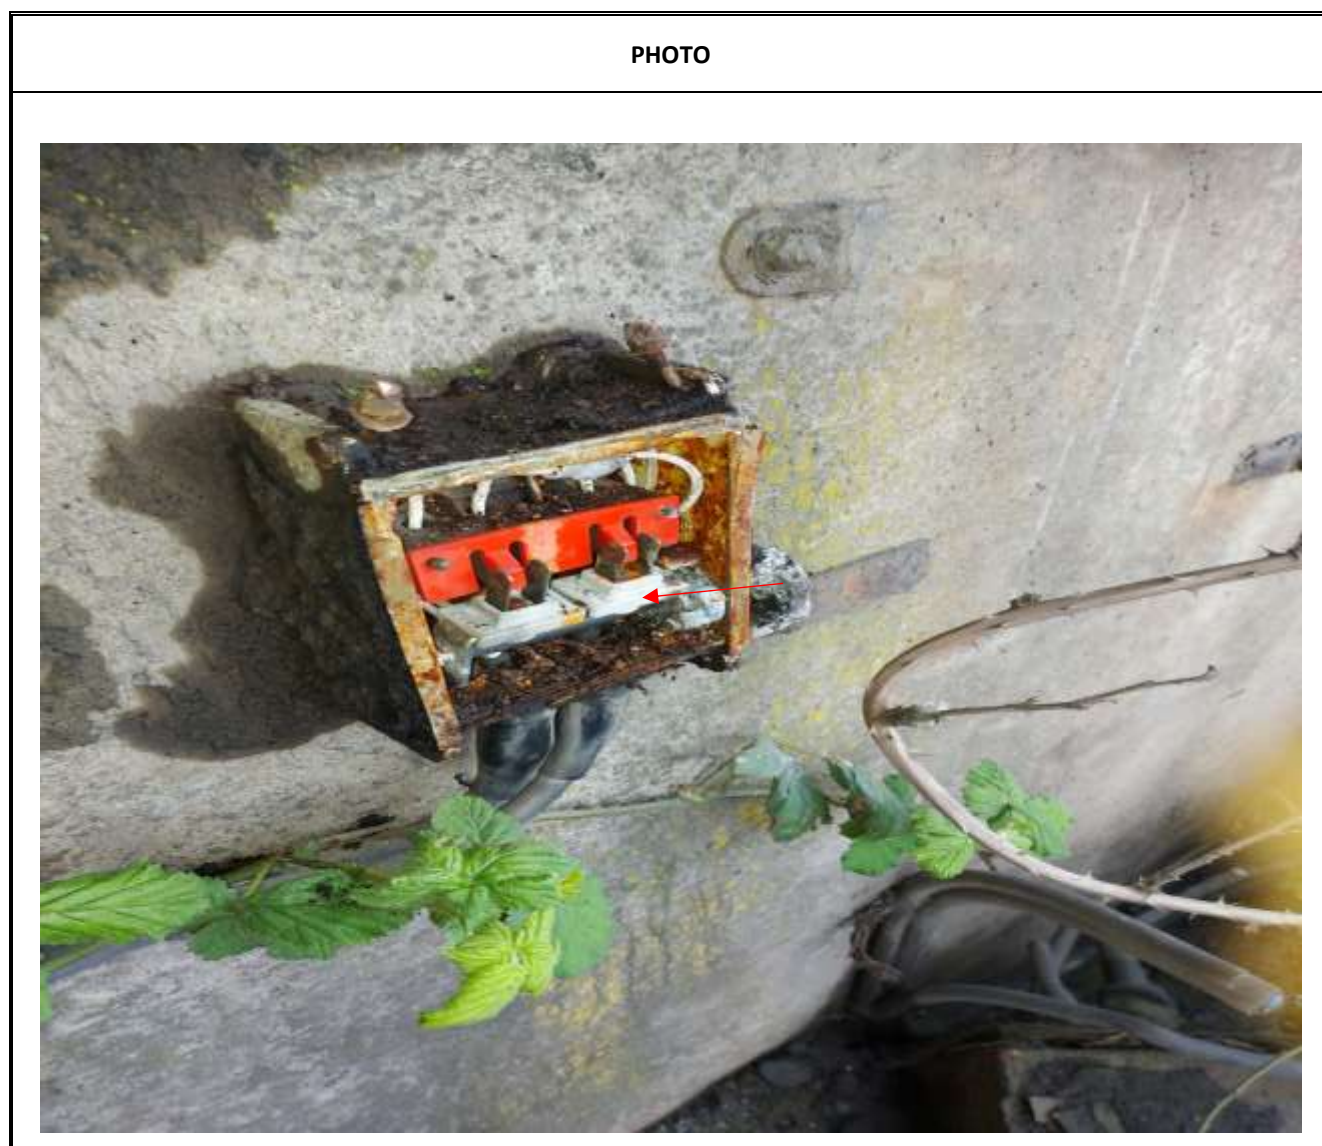
| <b>Site</b> | HAA Structure-Feed Hoppers & Conveyor 1290 | <b>Sample No.</b> | W176525 -S16 |

| <b>Comments</b> | <b>No Asbestos Detected</b> |

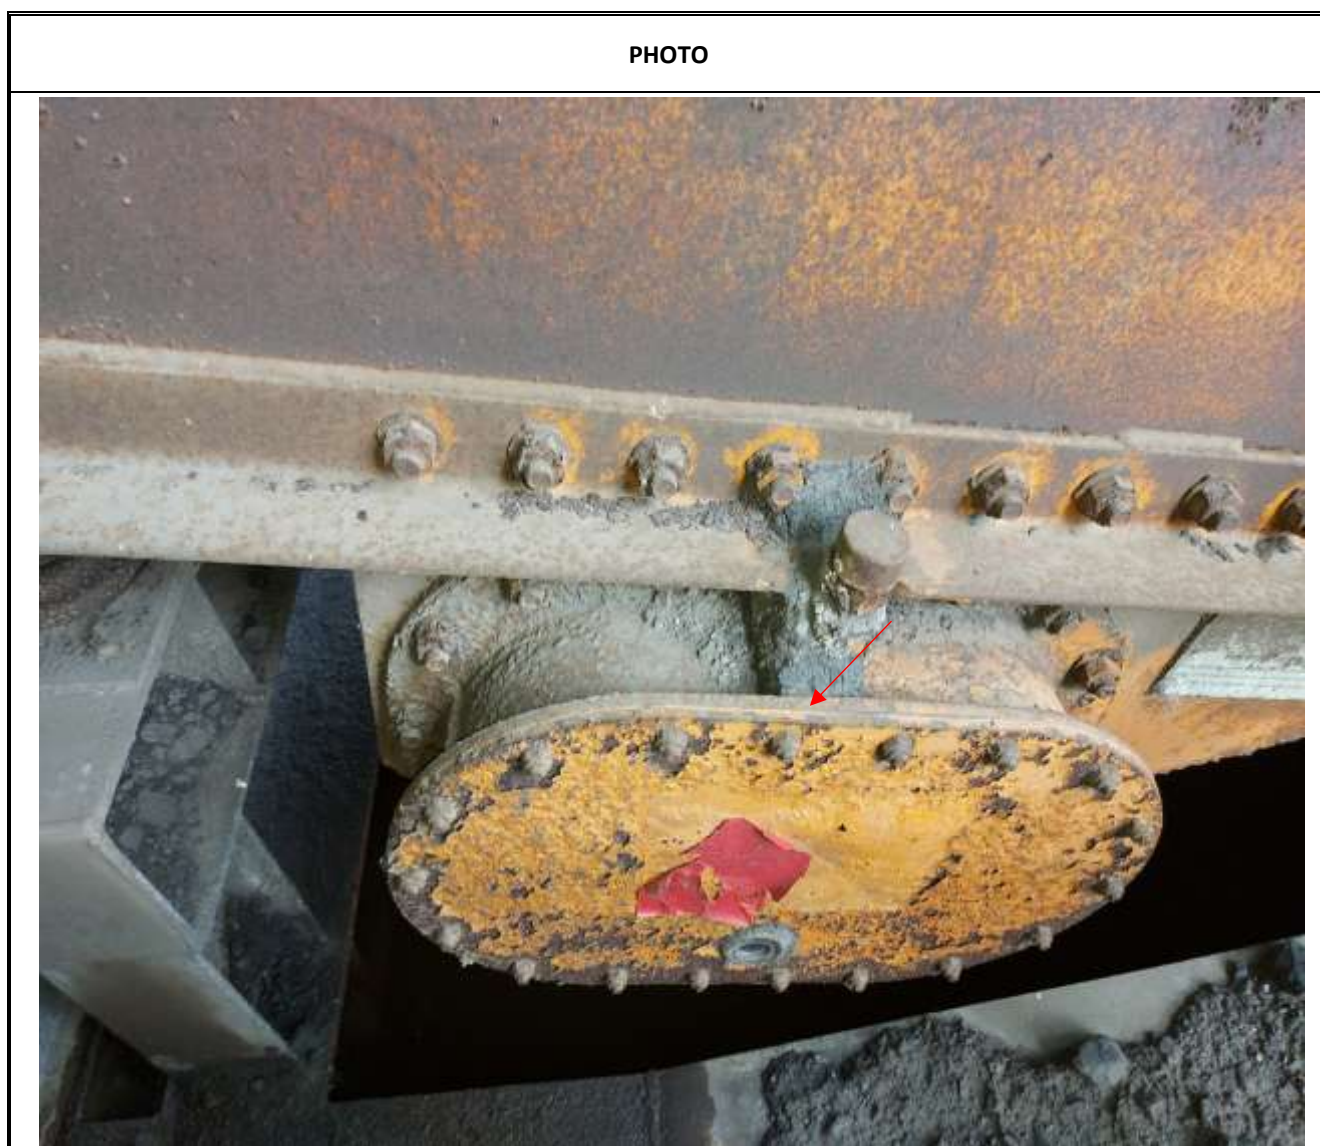
| Site | HAA Structure-Feed Hoppers & Conveyor 1290 | Sample No. | W176525 -S17 |

| Comments | <b>No Asbestos Detected</b> |

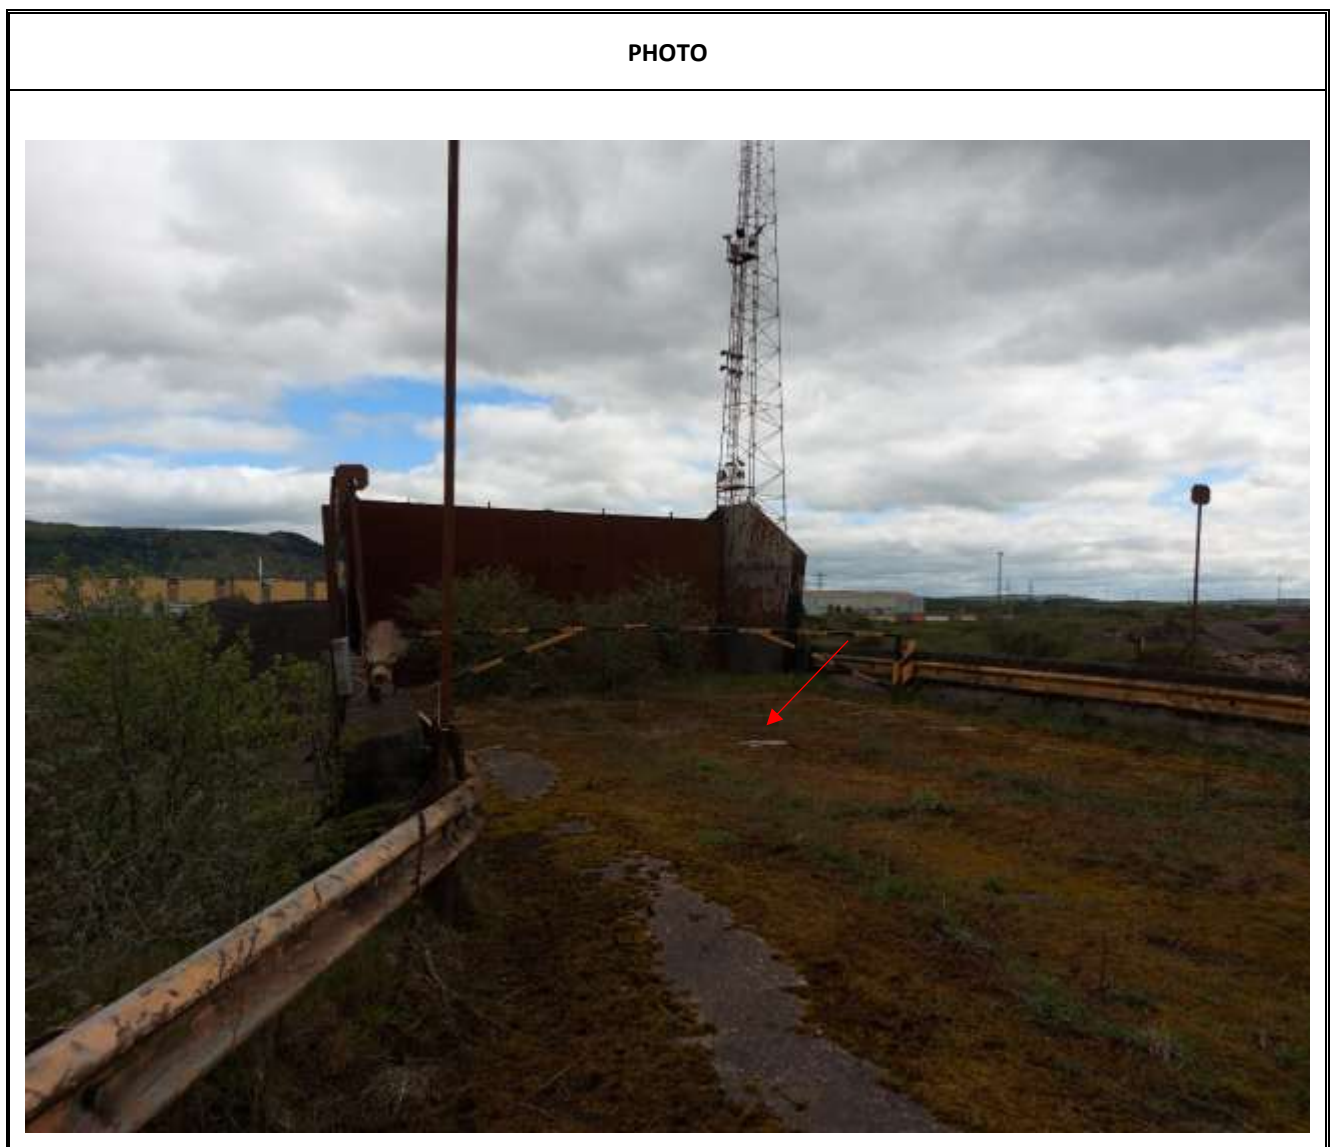
| <b>Site</b> | HAA Structure-Feed Hoppers & Conveyor 1290 | <b>Sample No.</b> | W176525 -S18 |

| <b>Comments</b> | <b>No Asbestos Detected</b> |

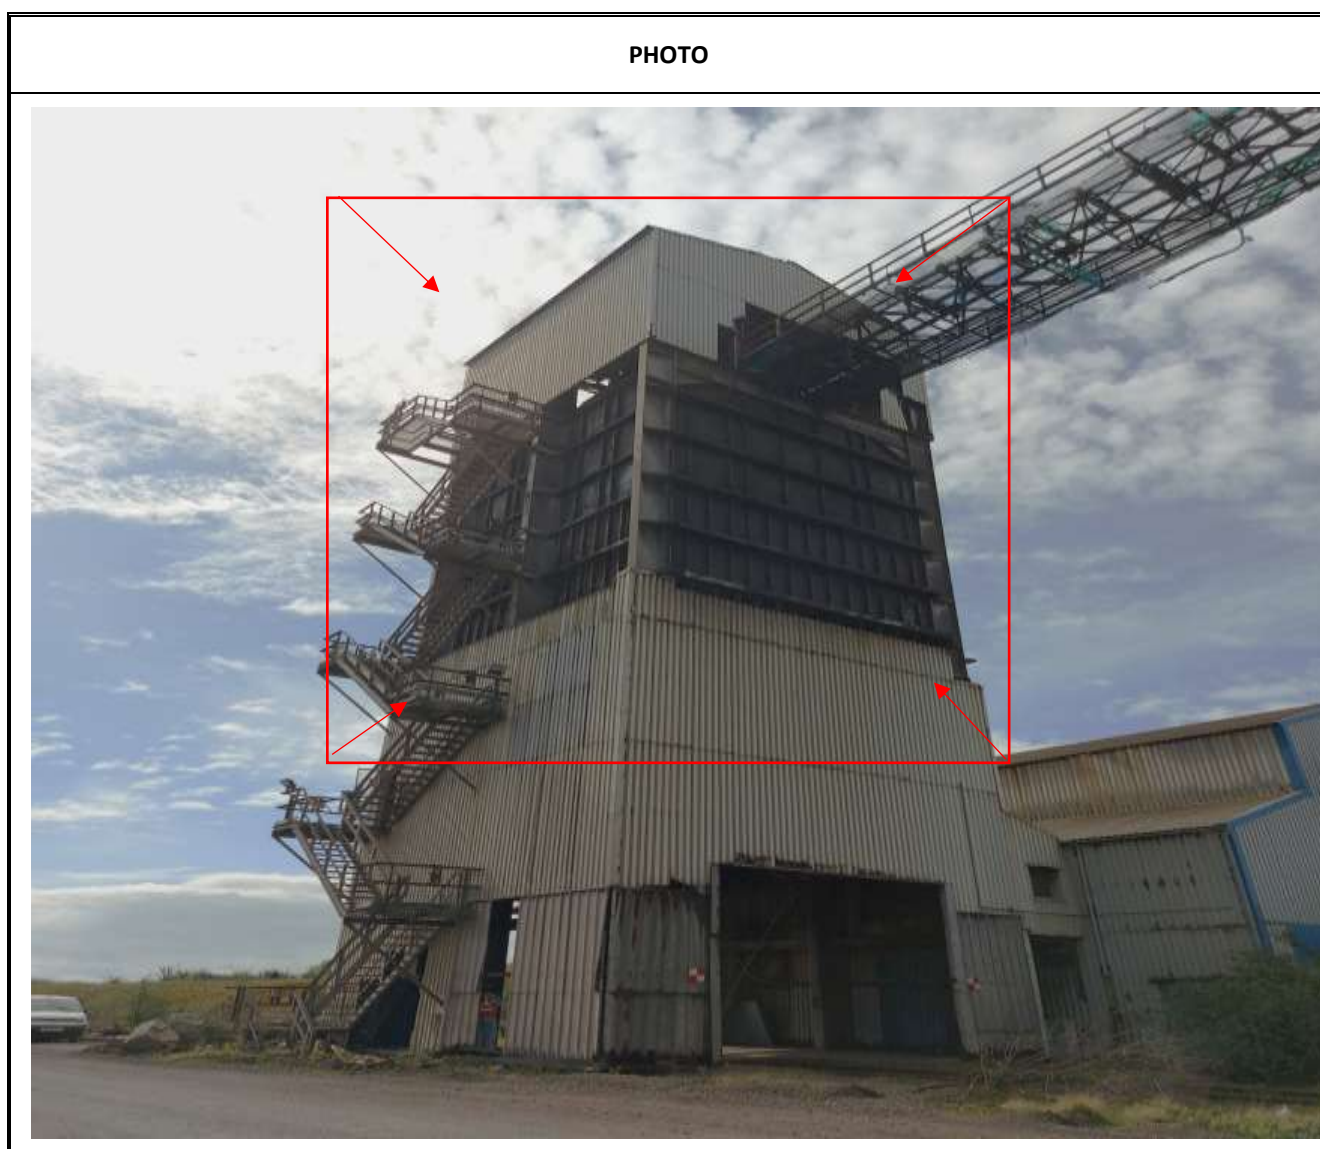
| Site | MCO HAA Structure-Feed Hoppers & Conveyor 1290 | Sample No. | P1 |

| <b>Asbestos Product Type</b> | <b>Area(s)</b> | <b>Licensed Contractor Required</b> | <b>Comments (See section 9)</b> |
|---|---|---|---|
| Insulating Board | P1-Redundant Morfa Coke Ovens-HAA Structure-Upper- Level Floors-All Areas-Asbestos Insulating Board | Yes | Presumed |

| <u>Analytical Ref No:</u> | <u>Sample No:</u> | <u>Location:</u> | <u>Product Type:</u> | <u>Quantity/Extent:</u> | <u>Condition:</u> | <u>Asbestos Type:</u> | <u>Sampled Presumed Strongly Presumed</u> |
|---|---|---|---|---|---|---|---|
| N/A | P1 | P1-Redundant Morfa Coke Ovens-HAA Structure-Upper- Level Floors-All Areas-Asbestos Insulating Board. | Insulating Board | Throughout | Poor | Crocidolite | Presumed-No safe access-Further inspections required. |

| Comments | Presumed to Contain Asbestos Until Proven Otherwise-Unsafe Areas-No Safe Access to Conduct a Survey-Further Inspections Required. |

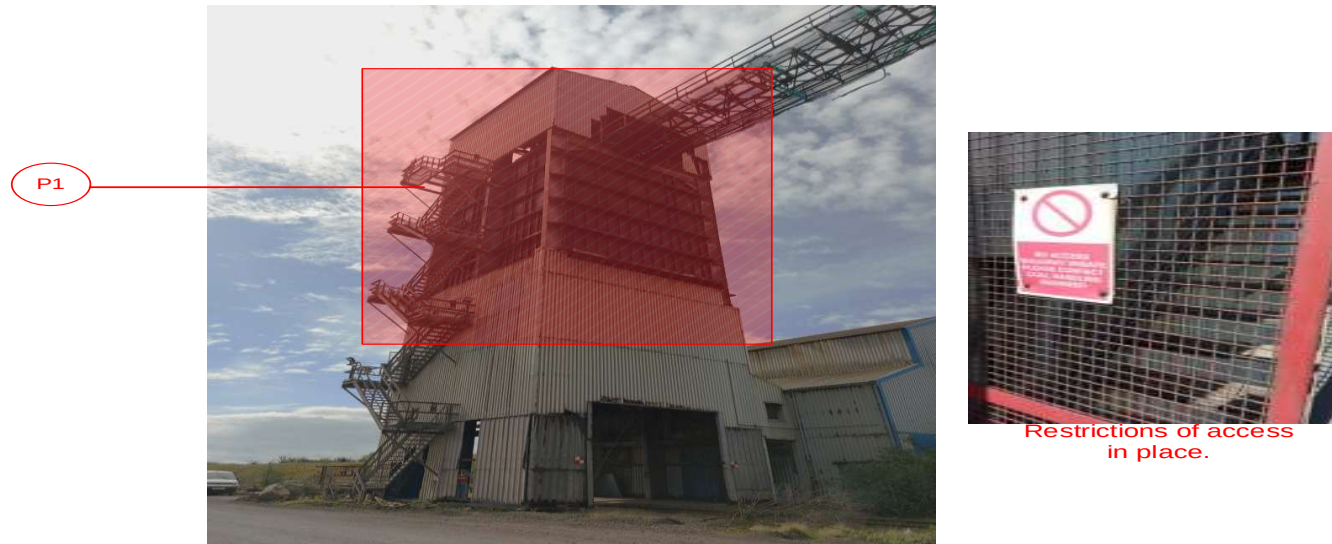
# 5938 SC-Redundant Morfa Coke Ovens-HAA-Upper Level Floors-Sample & Inspection Locations

Please note; The upper floor levels of the structure, its plant & equipment could not be inspected. There was no safe access- Walkways unsafe-All items within this area must be presumed to contain asbestos until proven otherwise-Further inspections required.

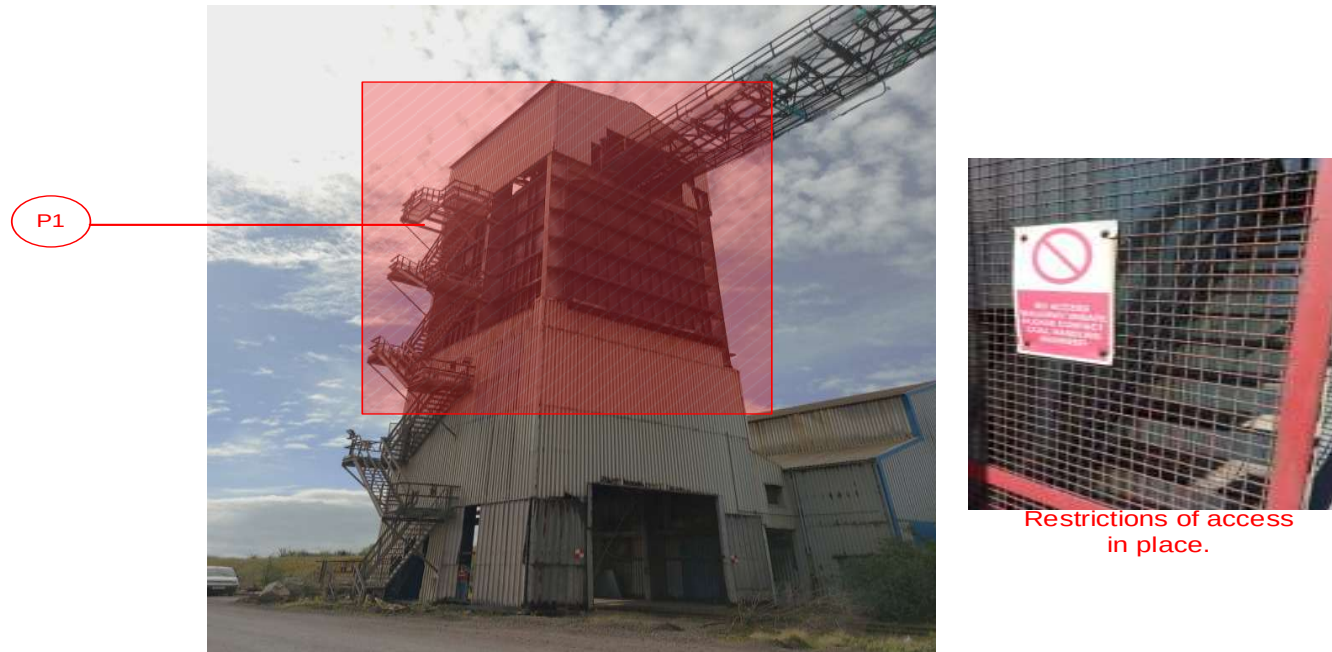
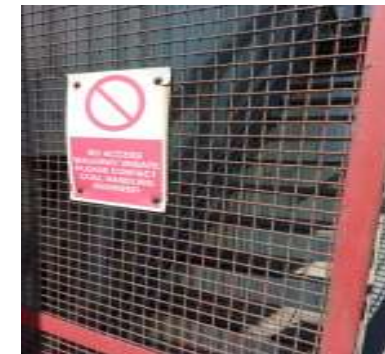
# 5938 SC-Redundant Morfa Coke Ovens-HAA-Upper Level Floors-Asbestos Locations

Restrictions of access in place.

Please note; The upper floor levels of the structure, its plant & equipment could not be inspected. There was no safe access- Walkways unsafe-All items within this area must be presumed to contain asbestos until proven otherwise-Further inspections required.
