## MONOLITHIC ENVIRONMENTAL SERVICES LTD.

### Lead Sampling-Report

Tata Steel  
Port Talbot Steel Works  
MCO HAA Areas  
SA13 2NG

| Survey No | Date of Survey | Survey Type | Prepared by | Authorised by |
|---|---|---|---|---|
| 5938 SC | 22/04/2025 | Paint Sampling | Derek Williams | Chris Avery |

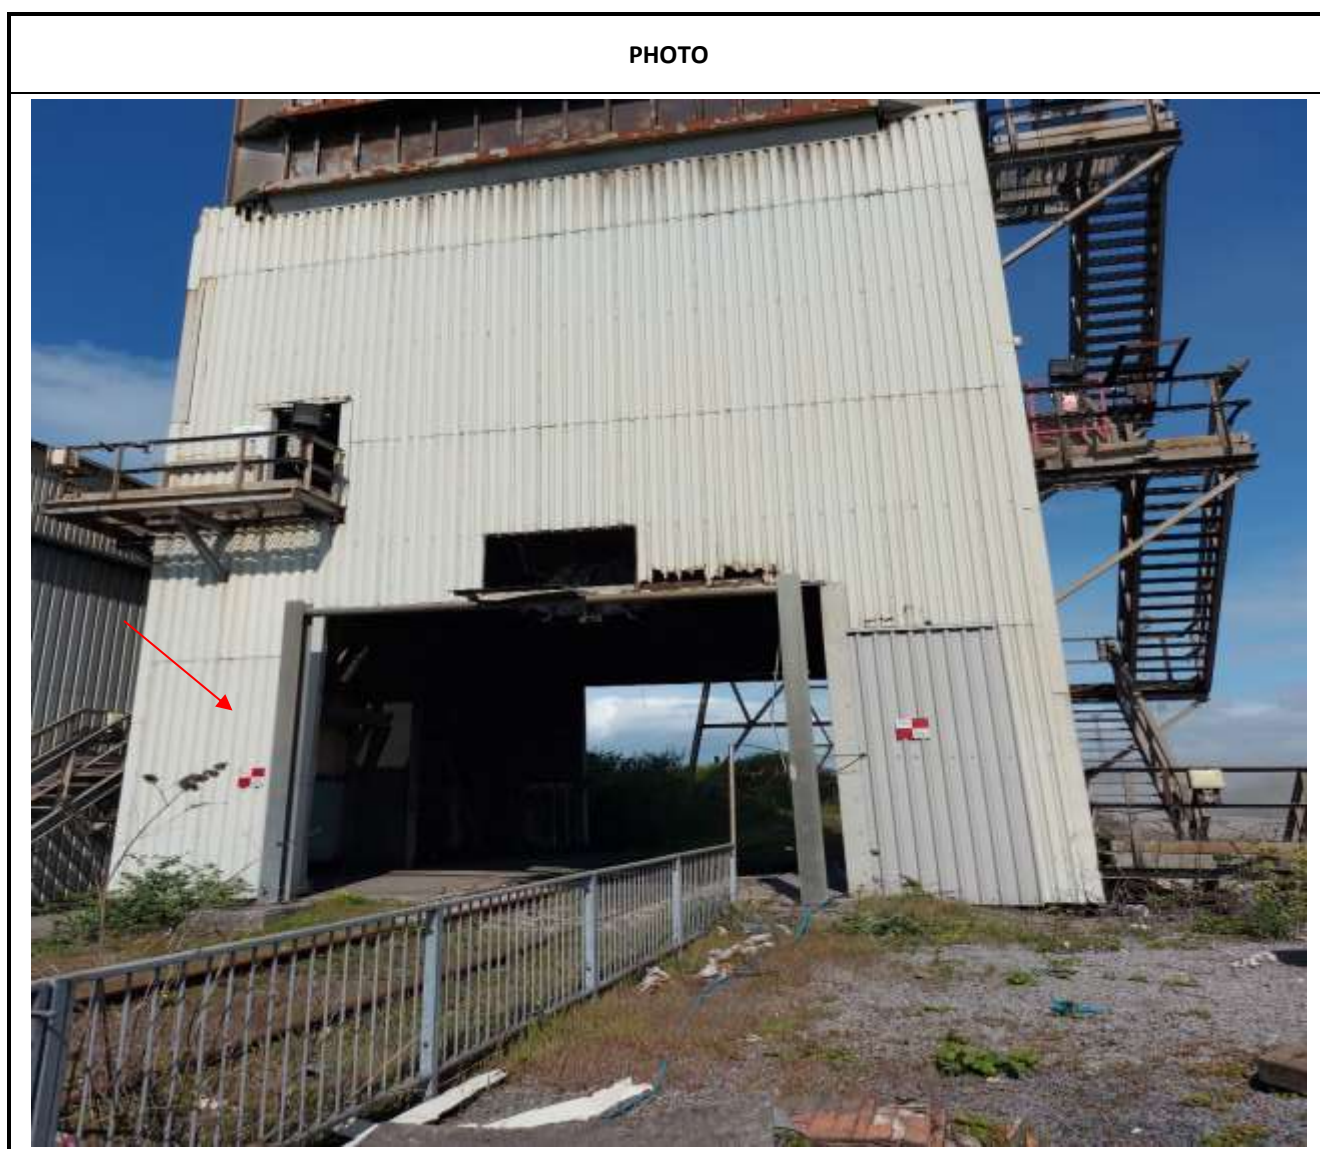
| Site | MCO HAA Areas | Sample No. | EN312290/1-LS01 |

| Location & Description of sample | LS01-HAA Building-Box Profile Sheeting-Paint | | |

| Material Identification | | | | | |
|---|---|---|---|---|---|
| Lead Detected | Yes | Material Type | Paint | Quantity | 0.004 |

| Comments | Lead Detected |

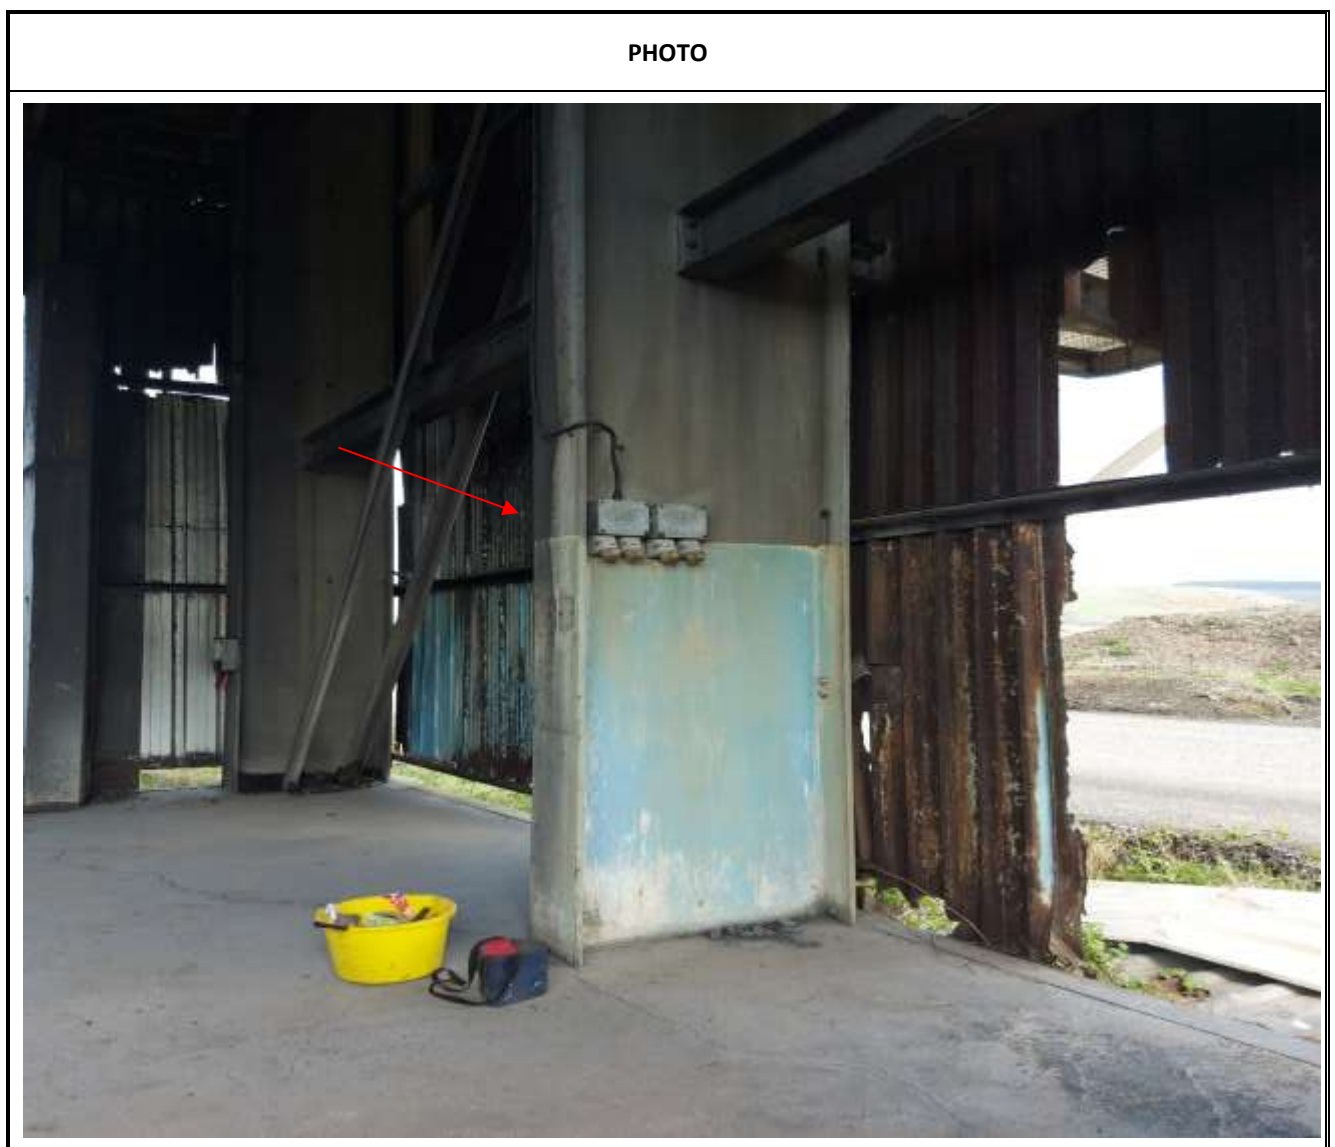
| Site | MCO HAA Areas | Sample No. | EN312290/2-LS02 |

| Location & Description of sample | LS02-HAA Building-Structural Steel Column | | |

| Material Identification | | | | | |
|---|---|---|---|---|---|
| Lead Detected | Yes | Material Type | Paint | Quantity | 0.68 |

| Comments | Lead Detected |

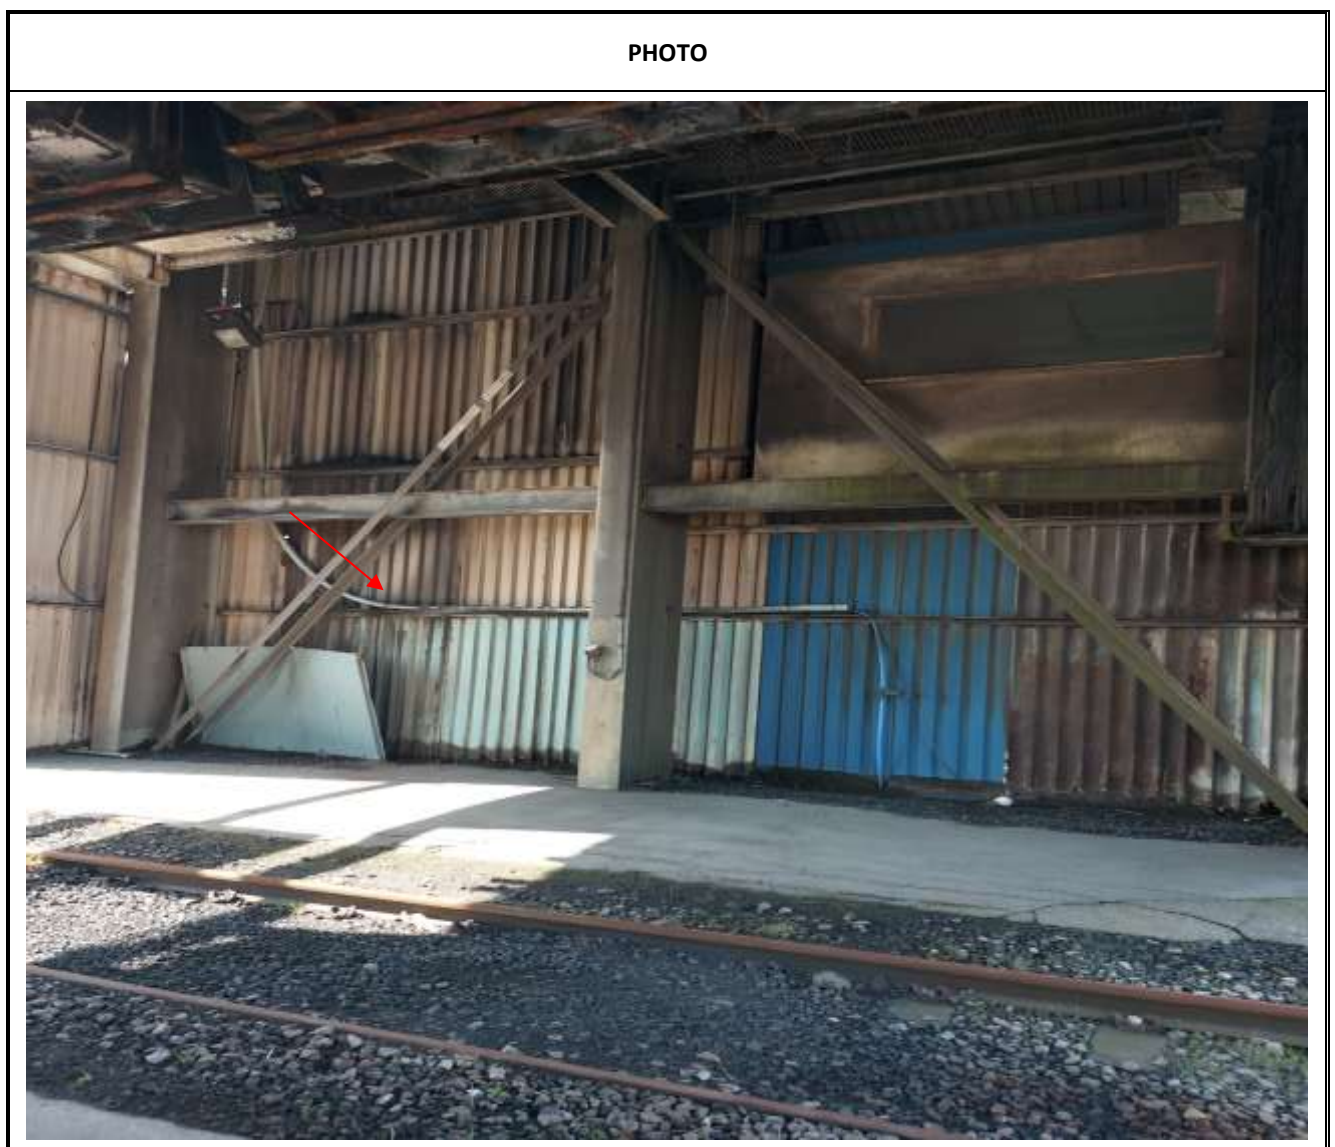
| Site | MCO HAA Areas | Sample No. | EN312290/3-LS03 |

| Location & Description of sample | LS03-HAA Building-Box Profile Sheeting Rail-Paint | | |

| Material Identification | | | | | |
|---|---|---|---|---|---|
| Lead Detected | Yes | Material Type | Paint | Quantity | 0.14 |

| Comments | <b>Lead Detected</b> |

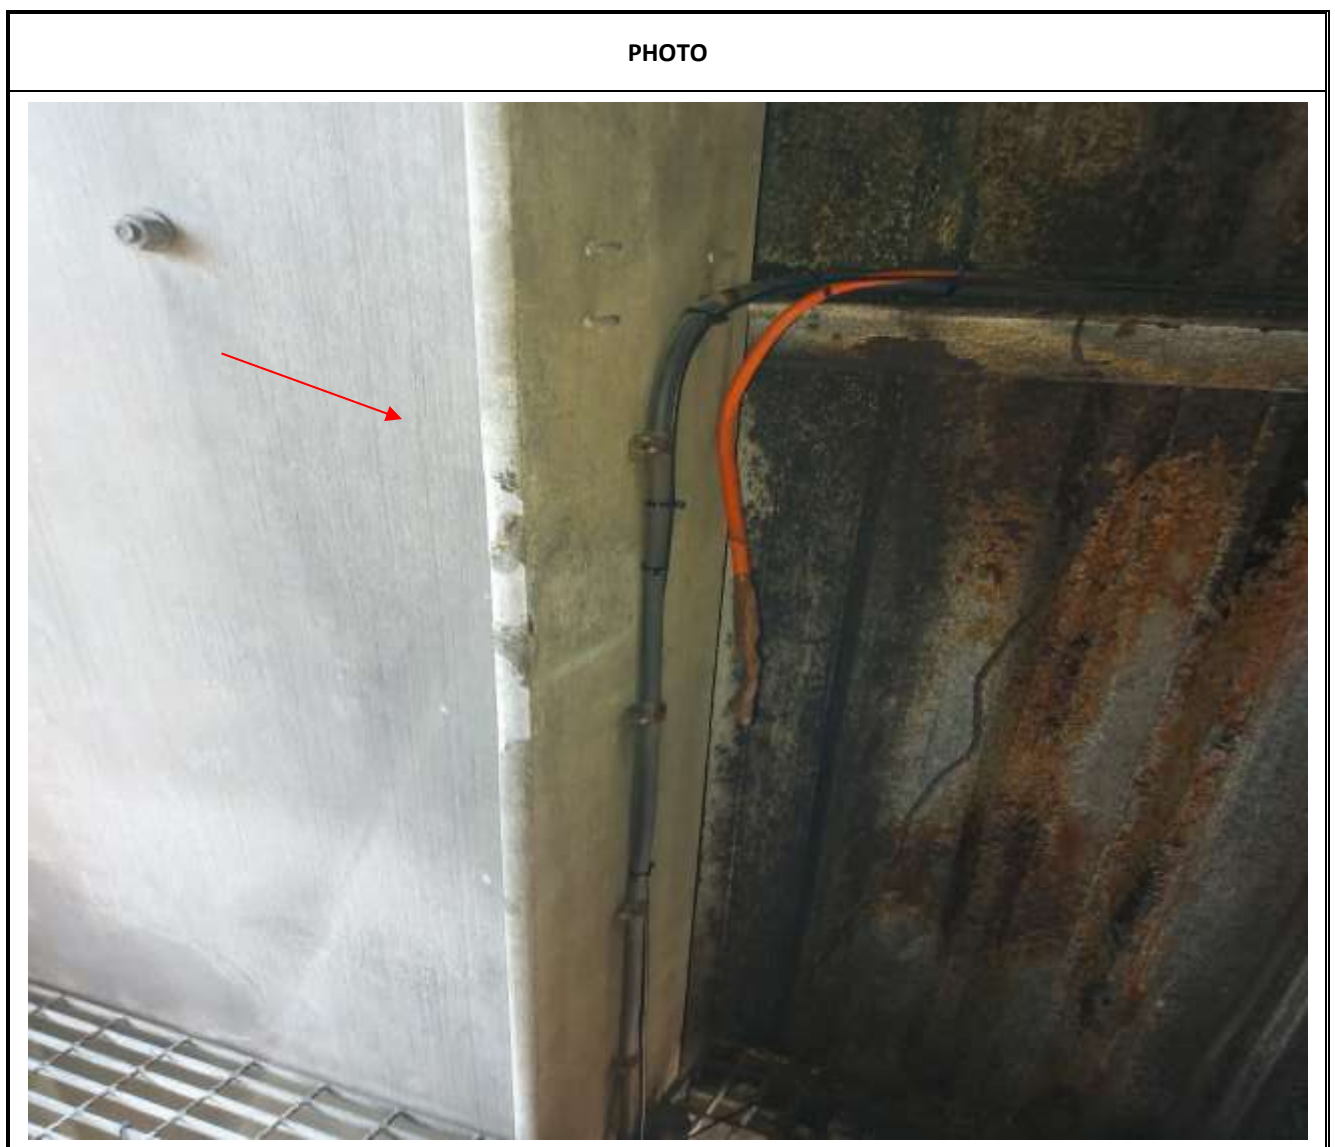
| <b>Site</b> | MCO HAA Areas | <b>Sample No.</b> | EN312290/4-LS04 |

| <b>Location &amp; Description of sample</b> | LS04-HAA Building-Structural Steel Column-1 <sup>st</sup> Floor-Paint | | |

| Material Identification | | | | | |
|---|---|---|---|---|---|
| <b>Lead Detected</b> | Yes | <b>Material Type</b> | Paint | <b>Quantity</b> | 0.71 |

| <b>Comments</b> | <b>Lead Detected</b> |

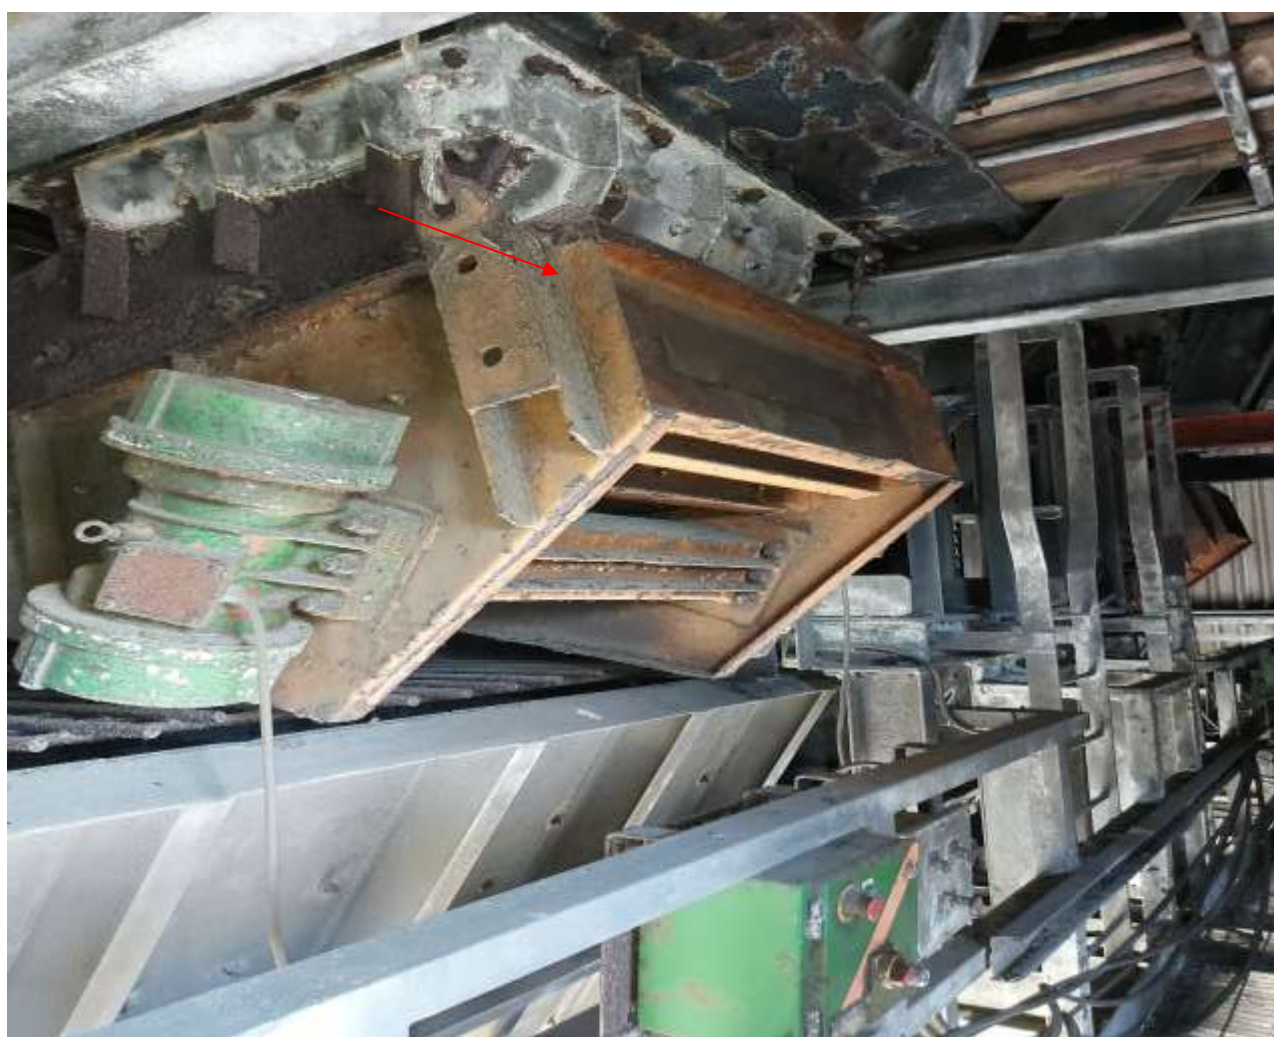
| Site | MCO HAA Areas | Sample No. | EN312290/5-LS05 |

| Location & Description of sample | LS05-HAA Building-Material Handling Chute-1 <sup>st</sup> Floor-Paint (Orange) | | |

| Material Identification | | | | | |
|---|---|---|---|---|---|
| Lead Detected | Yes | Material Type | Paint | Quantity | 3.3 |

| Comments | Lead Detected |

5.1 Only one of the ten paint samples submitted from various structures within the HAA Building at Tata Steel's Port Talbot Works was found to contain lead above the 1% (w/w) lead threshold value as quoted in The Approved Code of Practice (ACOP L132) associated with the CLAW Regulations. Sample details are given below:

- 6.3 There are several unsafe methods that should be avoided when working with paint containing a high level of lead. These include:
- power-sanding or grinding;

- dry scraping and dry sanding;
  - uncontrolled abrasive- or hydro-blasting;
  - open flame burning or high heat gun settings; and
  - paint strippers containing methylene chloride (a potential carcinogen).

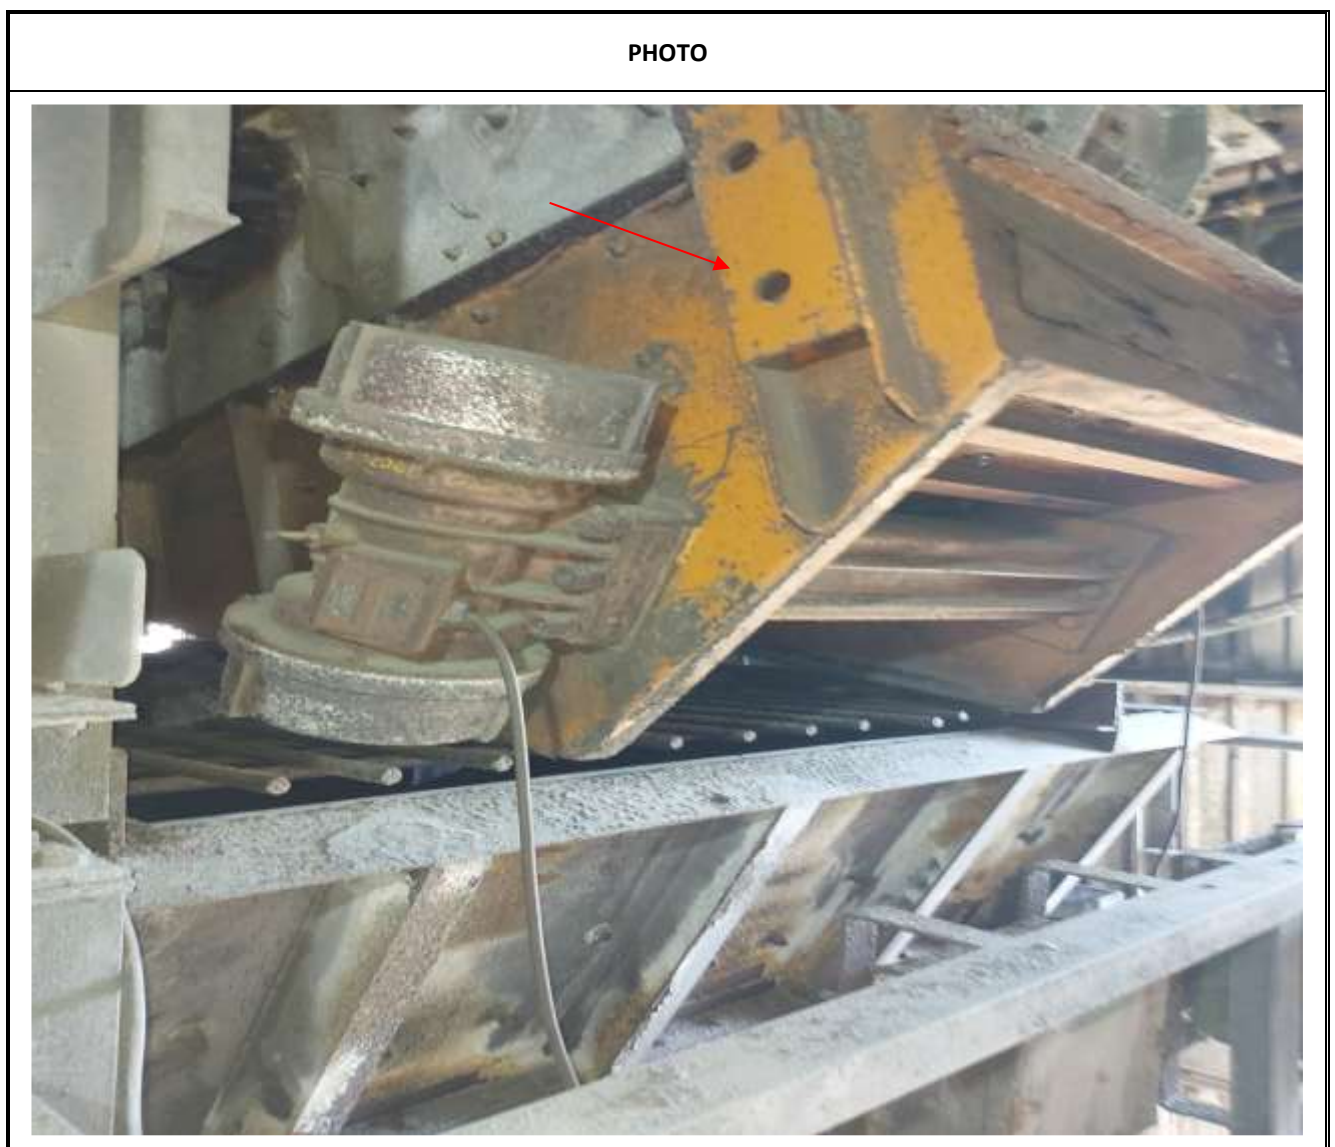
| <b>Site</b> | MCO HAA Areas | <b>Sample No.</b> | EN312290/5-VS/LS05a |

| <b>Location &amp; Description of sample</b> | VS/LS05a-HAA Building-Material Handling Chute-1 <sup>st</sup> Floor-Paint (Orange) | | |

| Material Identification | | | | | |
|---|---|---|---|---|---|
| <b>Lead Detected</b> | Yes | <b>Material Type</b> | Paint | <b>Quantity</b> | <b>3.3</b> |

| <b>Comments</b> | <b>Lead Detected Within Identical Paint</b> |

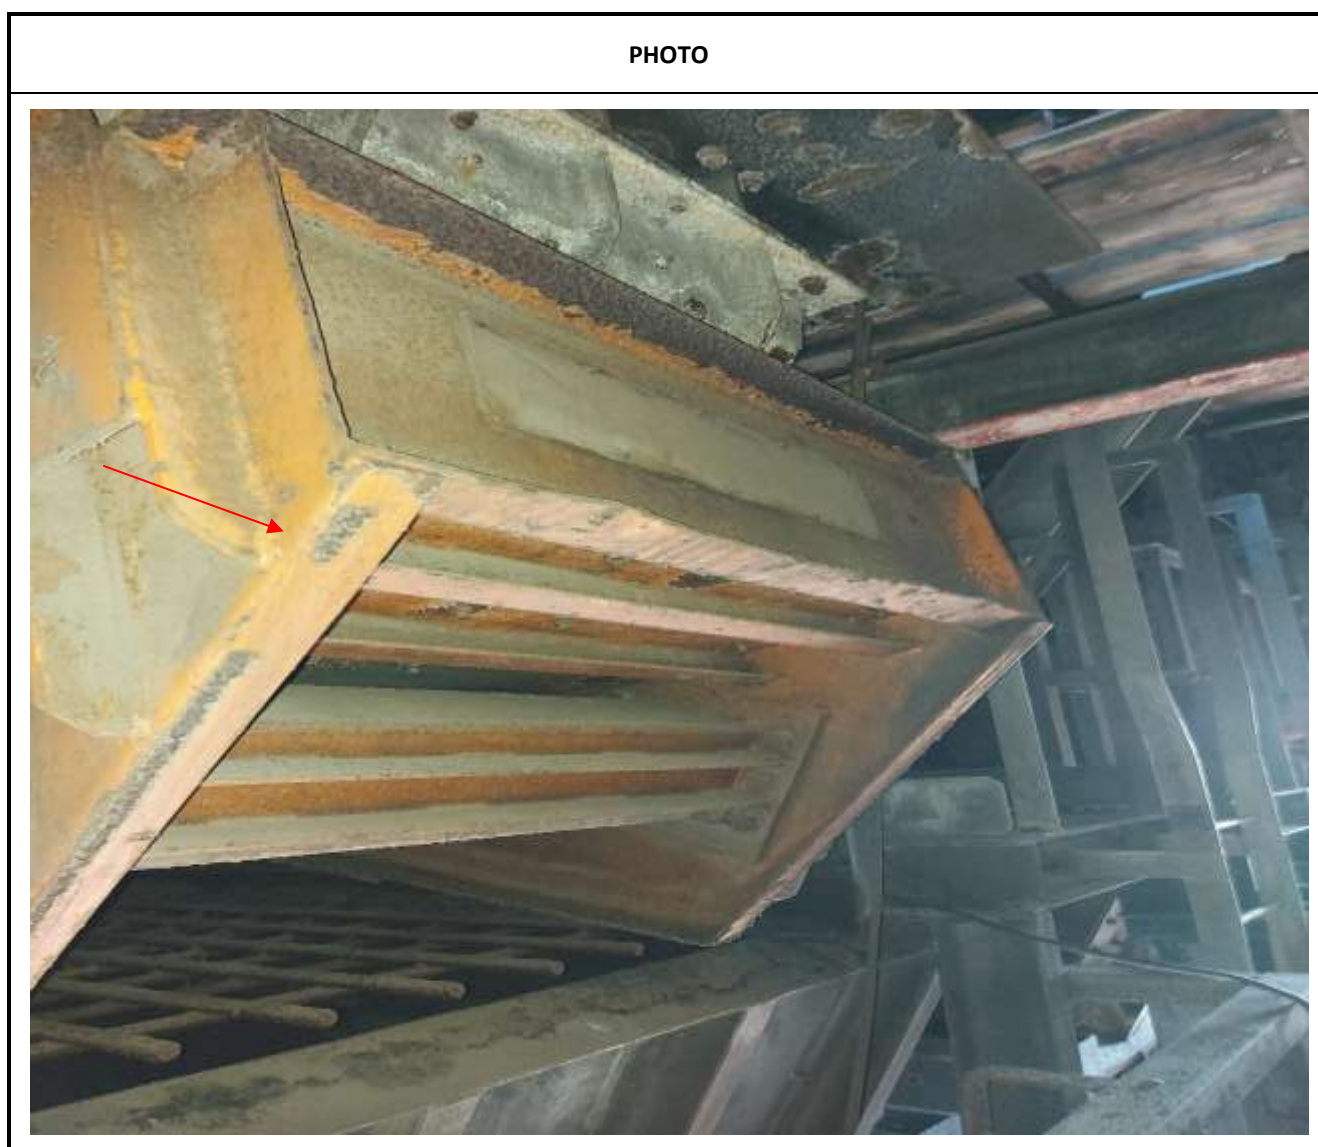
| Site | MCO HAA Areas | Sample No. | EN312290/5-VS/LS05b |

| Location & Description of sample | VS/LS05b-HAA Building-Material Handling Chute-1 <sup>st</sup> Floor-Paint (Orange) | | |

| Material Identification | | | | | |
|---|---|---|---|---|---|
| Lead Detected | Yes | Material Type | Paint | Quantity | 3.3 |

| Comments | <b>Lead Detected Within Identical Paint</b> |

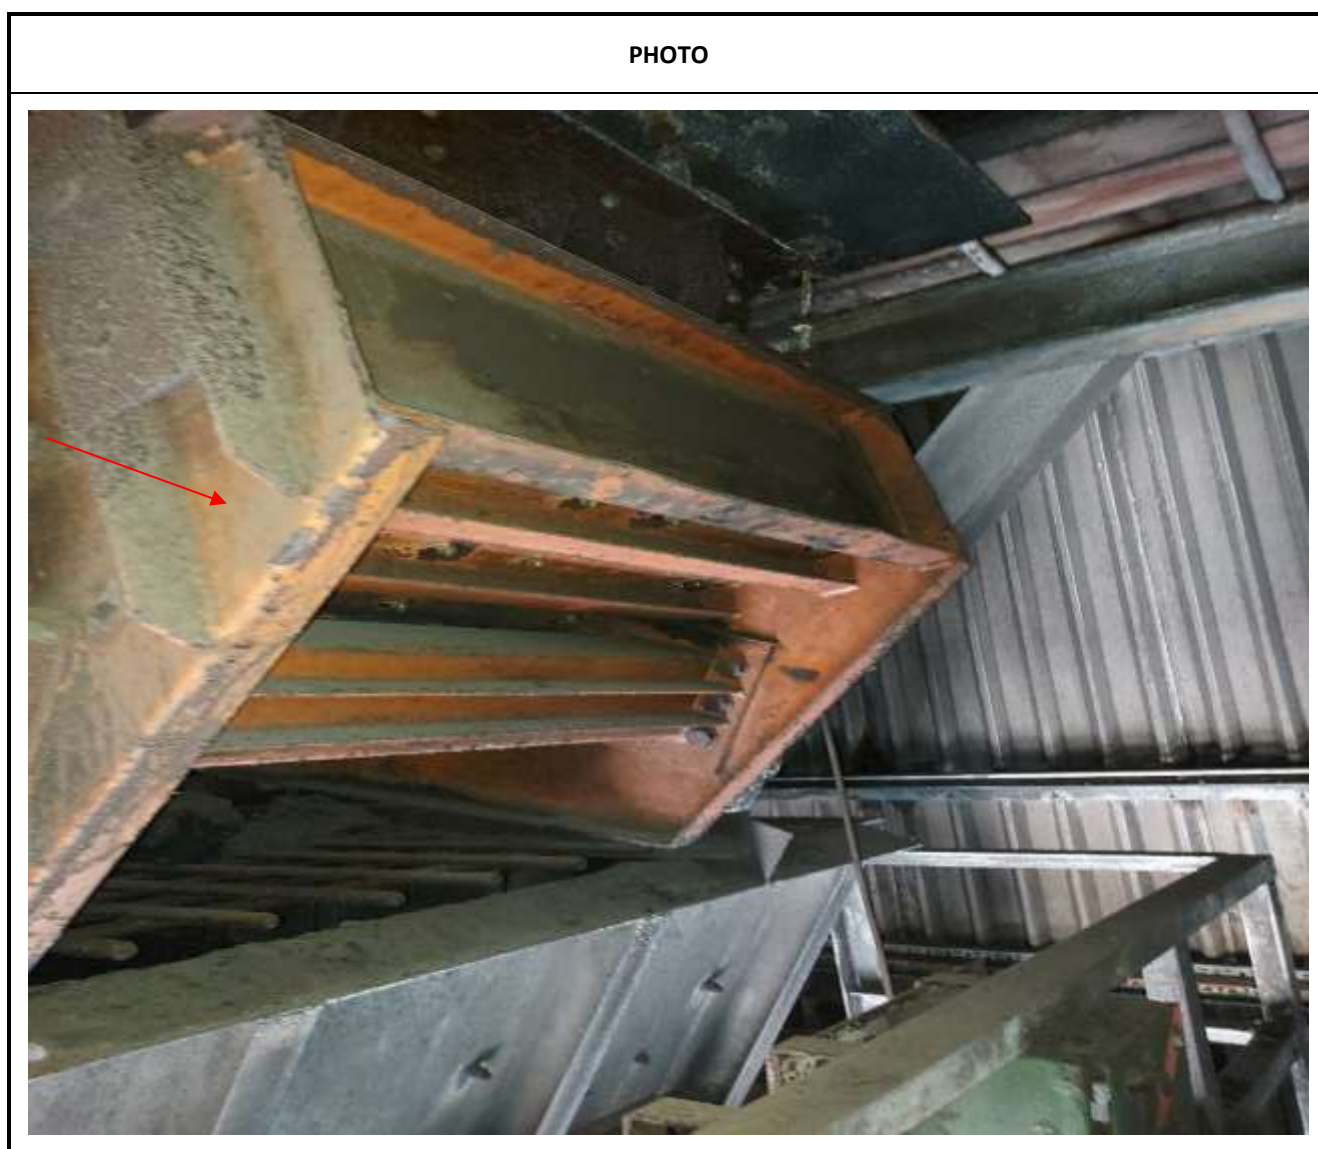
| Site | MCO HAA Areas | Sample No. | EN312290/5-VS/LS05c |

| Location & Description of sample | VS/LS05c-HAA Building-Material Handling Chute-1 <sup>st</sup> Floor-Paint (Orange) | | |

| Material Identification | | | | | |
|---|---|---|---|---|---|
| Lead Detected | Yes | Material Type | Paint | Quantity | 3.3 |

| Comments | <b>Lead Detected Within Identical Paint</b> |

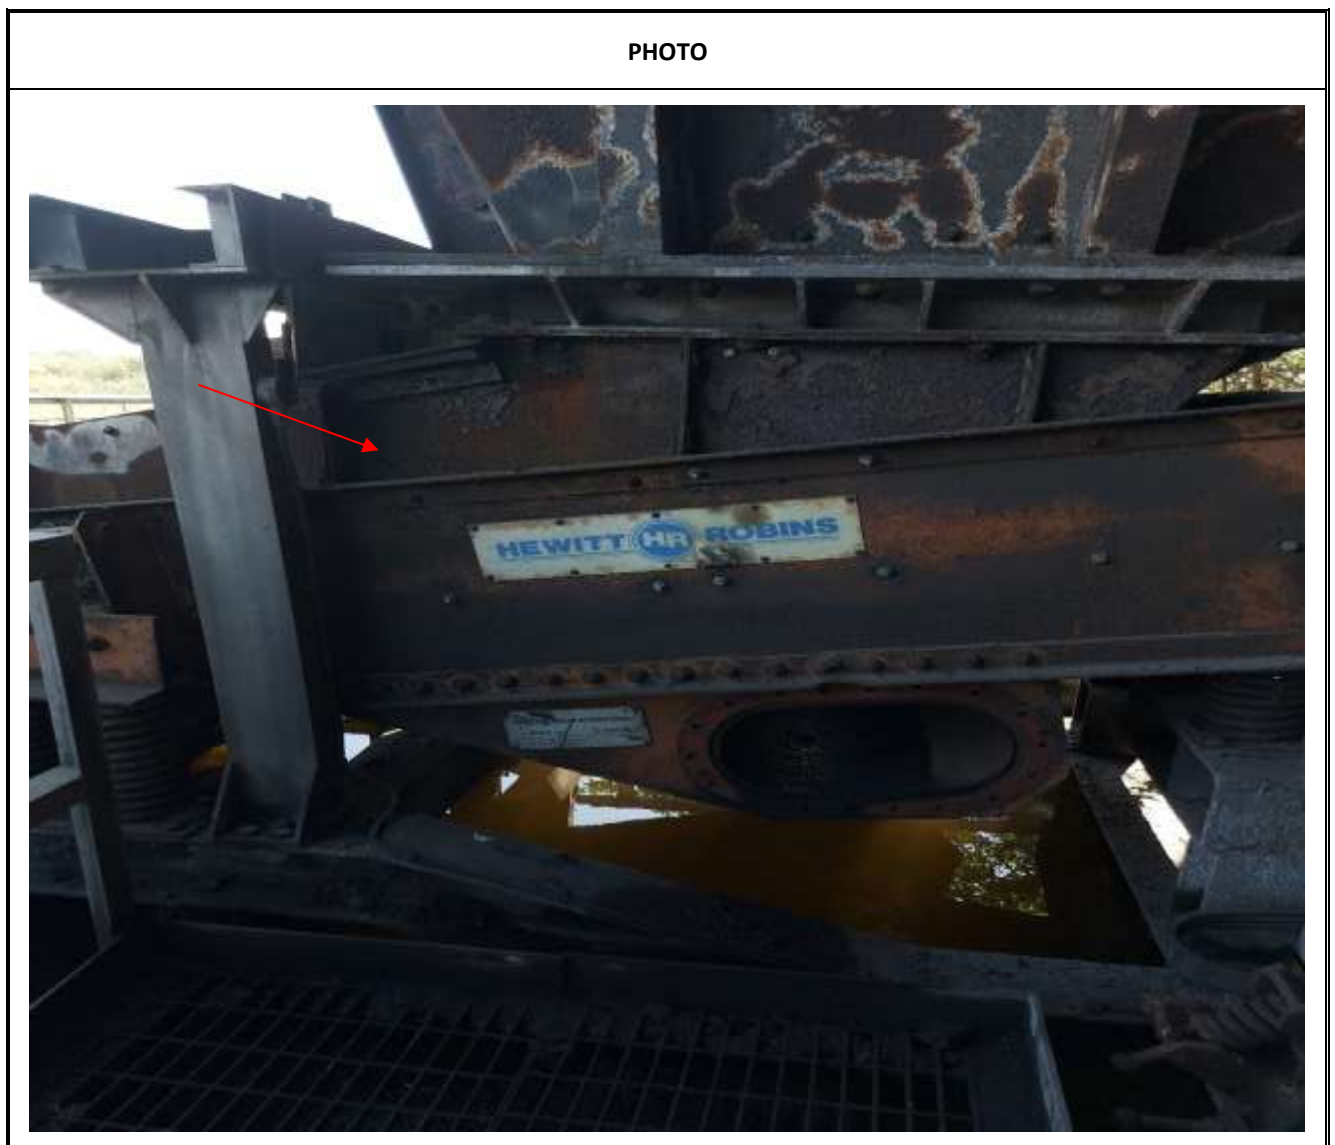
| Site | MCO HAA Areas | Sample No. | EN312290/5-VS/LS05d |

| Location & Description of sample | VS/LS05d-HAA-Redundant 1290 Conveyor Feed Hoppers-Material Handling Chute-<br>Paint (Orange) | | |

| Material Identification | | | | | |
|---|---|---|---|---|---|
| Lead Detected | Yes | Material Type | Paint | Quantity | 3.3 |

| Comments | Lead Detected Within Identical Paint |

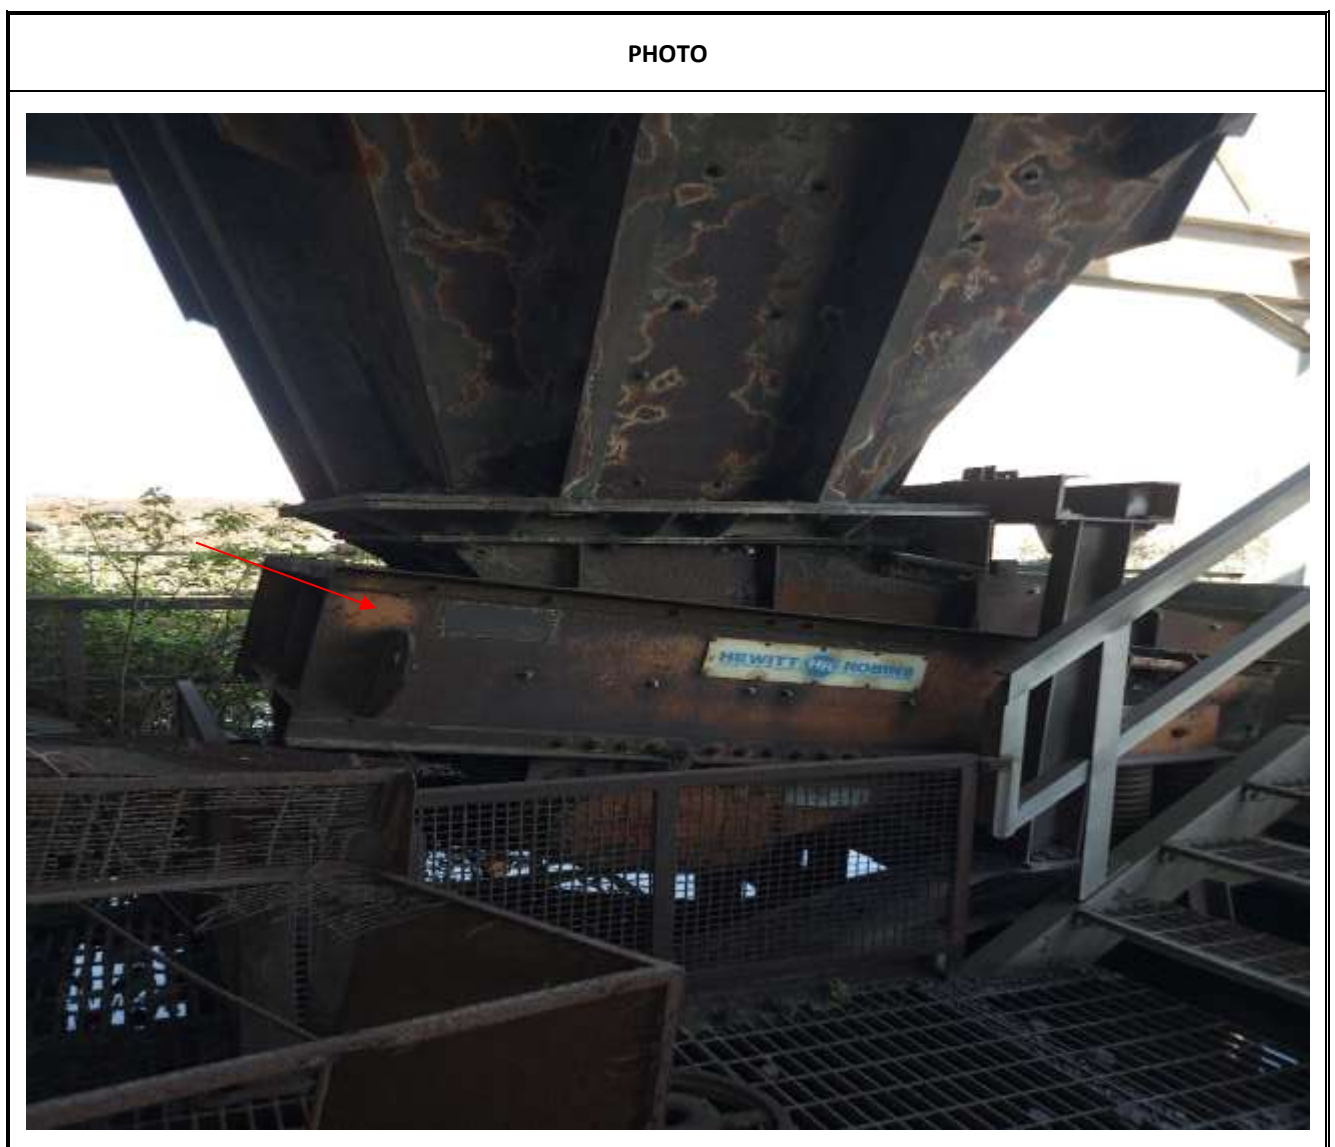
| Site | MCO HAA Areas | Sample No. | EN312290/5- VS/LS05e |

| Location & Description of sample | VS/LS05e-HAA-Redundant 1290 Conveyor Feed Hoppers-Material Handling Chute-<br>Paint (Orange) | | |

| Material Identification | | | | | |
|---|---|---|---|---|---|
| Lead Detected | Yes | Material Type | Paint | Quantity | 3.3 |

| Comments | Lead Detected Within Identical Paint |

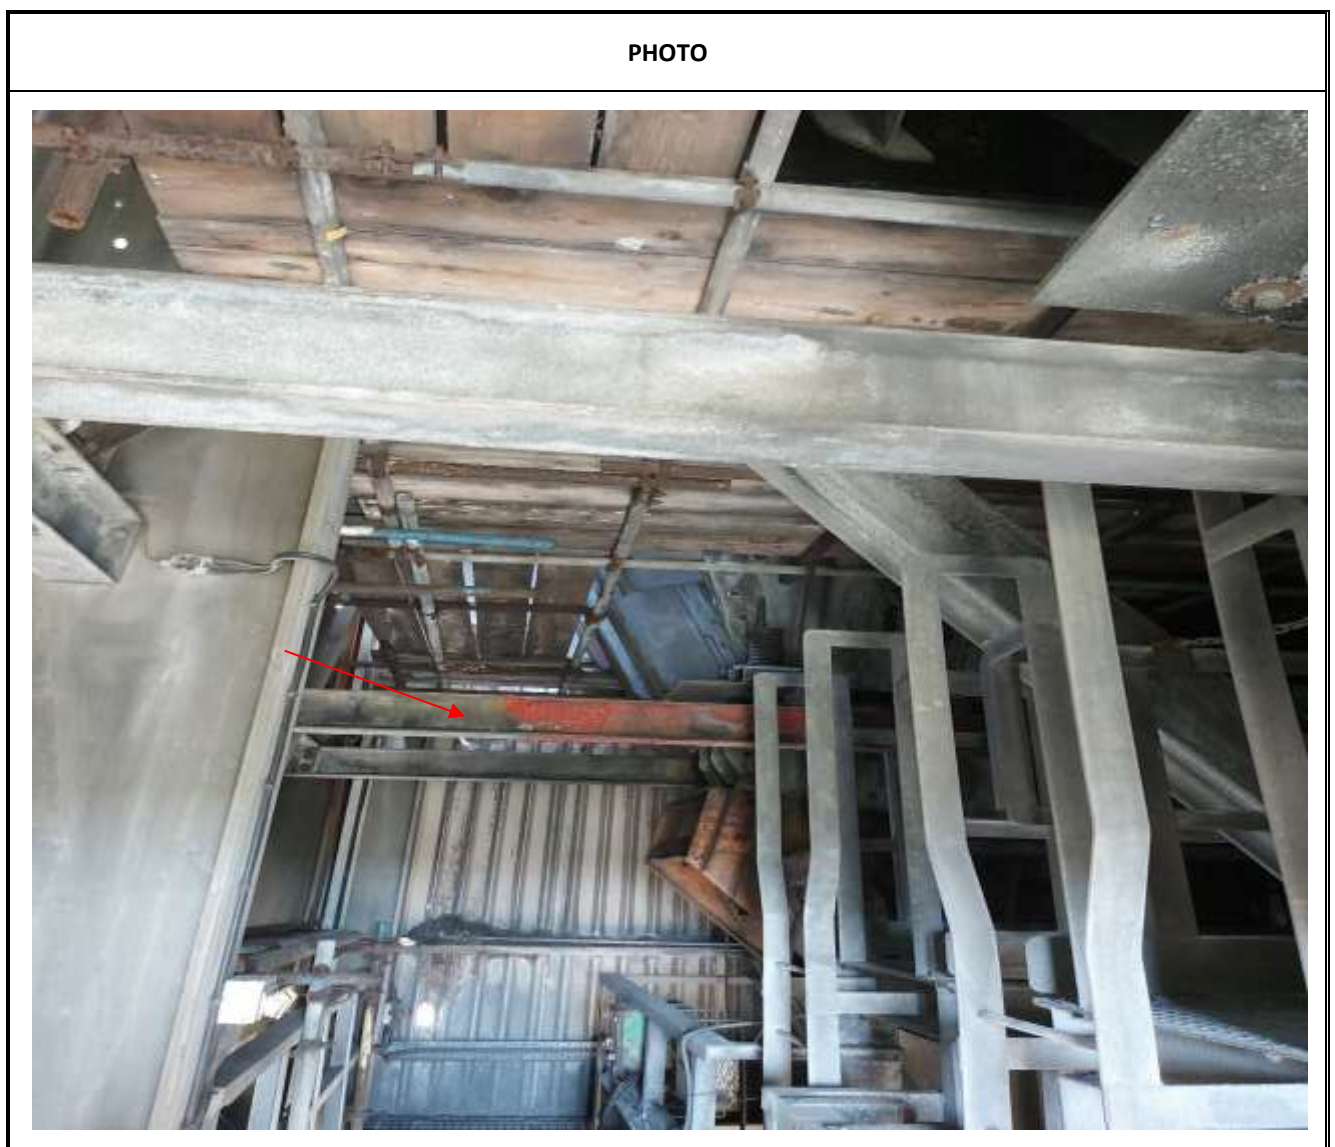
| Site | MCO HAA Areas | Sample No. | EN312290/6-LS06 |

| Location & Description of sample | LS06-HAA Building-Structural Steel Beam-1 <sup>st</sup> Floor-Paint | | |

| Material Identification | | | | | |
|---|---|---|---|---|---|
| Lead Detected | Yes | Material Type | Paint | Quantity | 0.071 |

| Comments | <b>Lead Detected</b> |

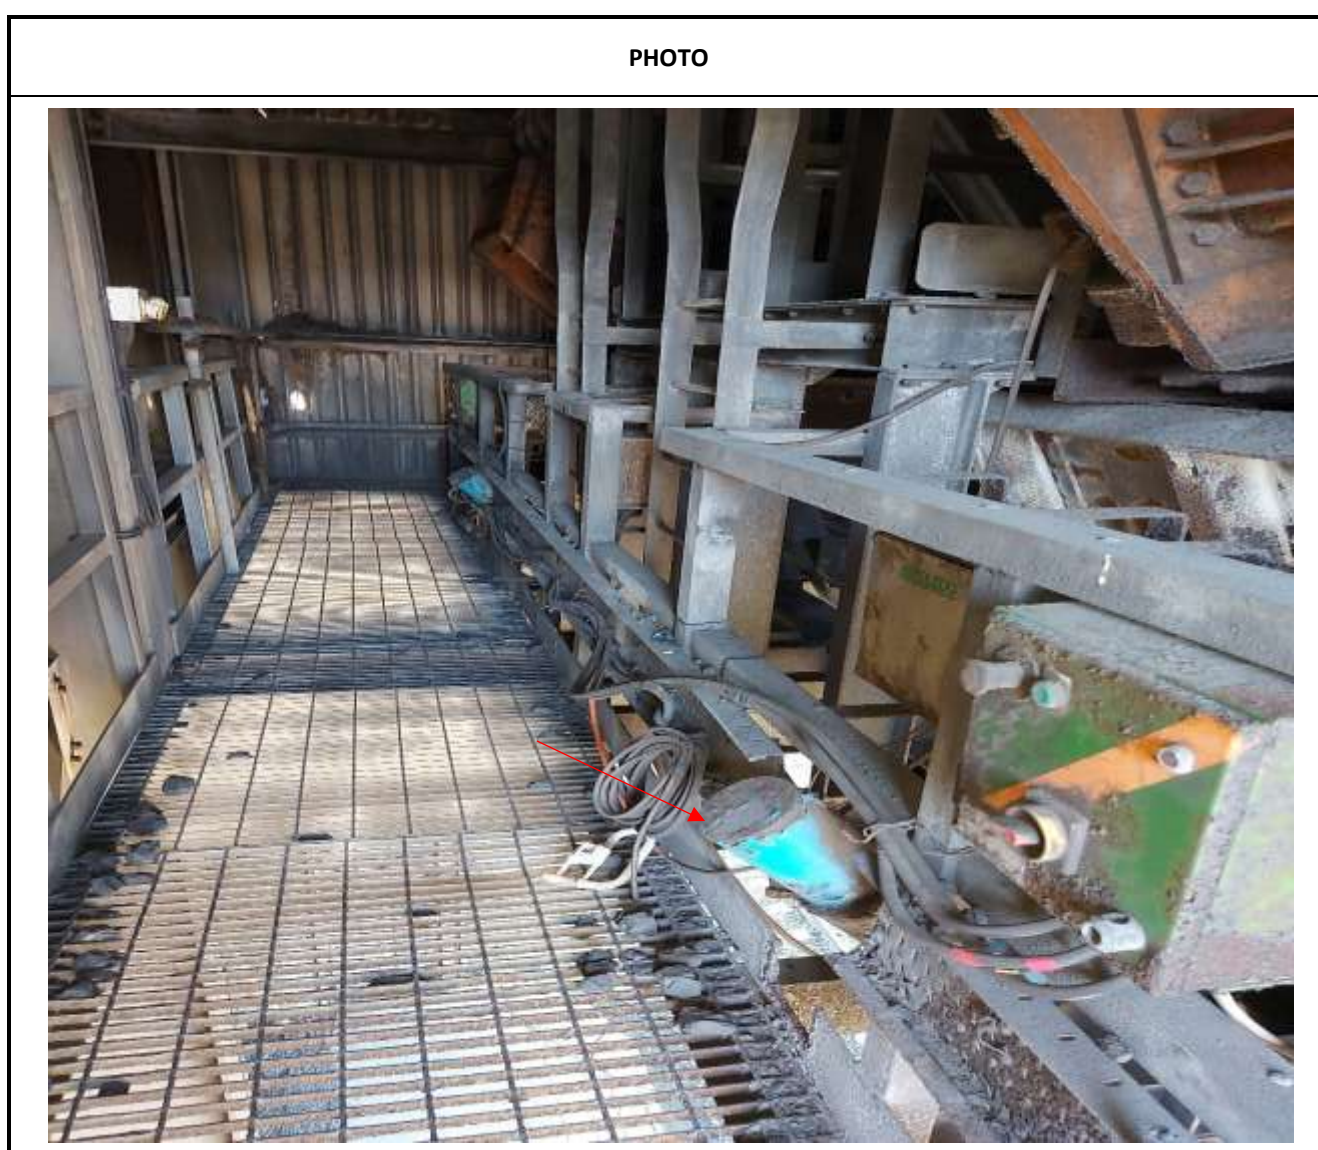
| <b>Site</b> | MCO HAA Areas | <b>Sample No.</b> | EN312290/7-LS07 |

| <b>Location &amp; Description of sample</b> | LS07-HAA Building-Material Handling Chute-Hydraulic Piston-1 <sup>st</sup> Floor-Paint (Blue) | | |

| Material Identification | | | | | |
|---|---|---|---|---|---|
| <b>Lead Detected</b> | Yes | <b>Material Type</b> | Paint | <b>Quantity</b> | 0.0062 |

| <b>Comments</b> | <b>Lead Detected</b> |

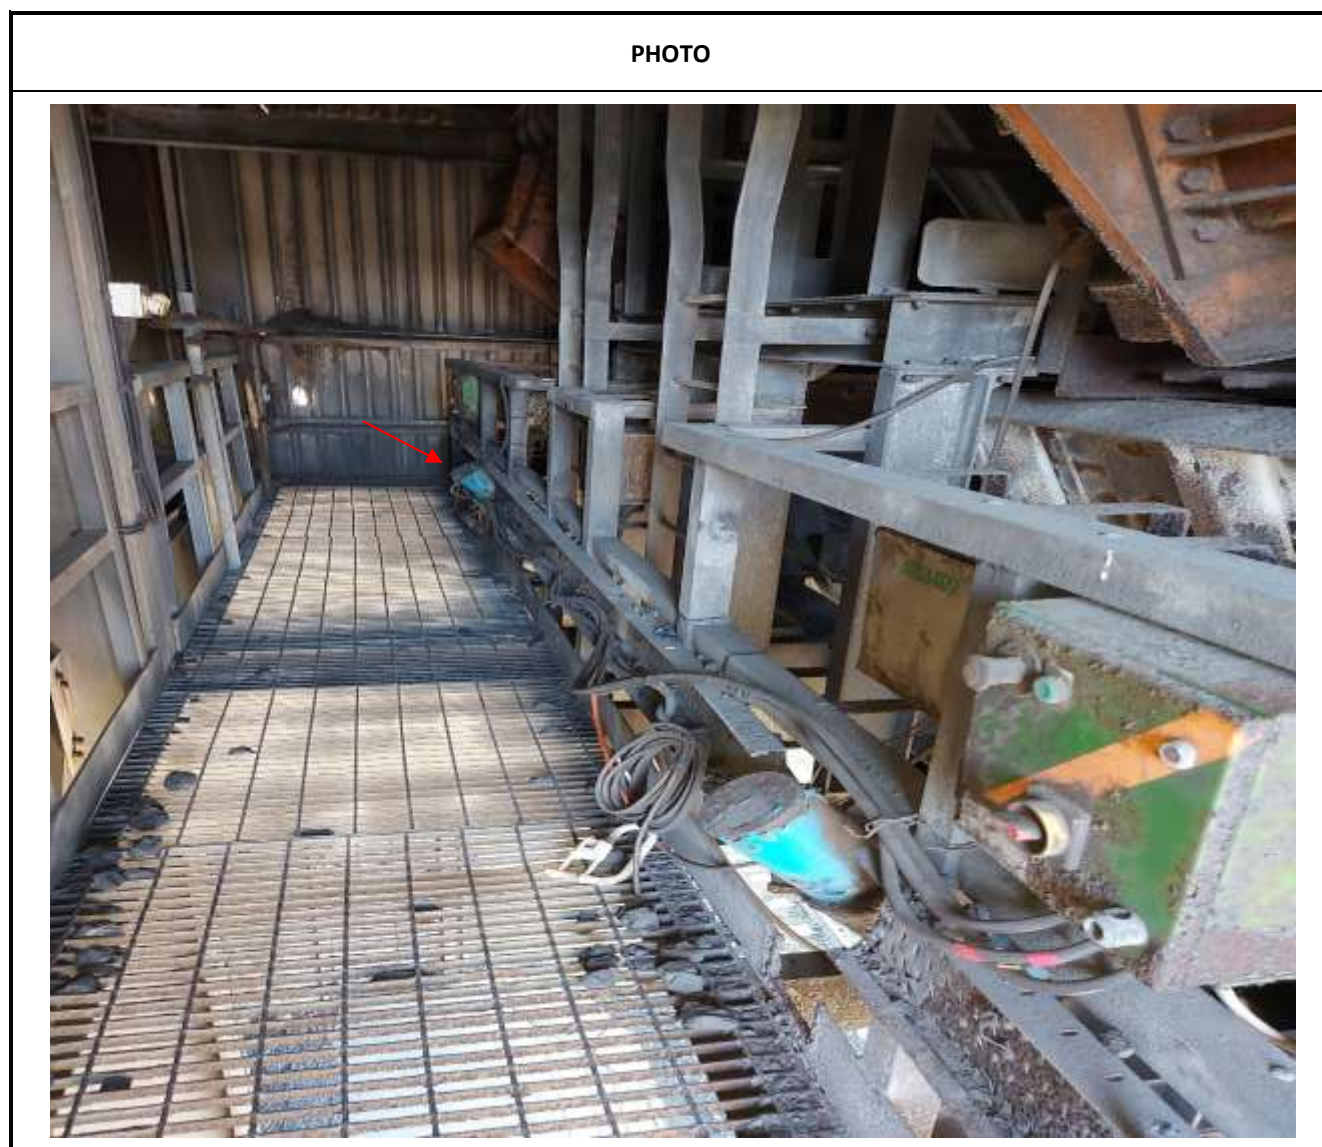
| Site | MCO HAA Areas | Sample No. | EN312290/7-VS/LS07a |

| Location & Description of sample | VS/LS07a-HAA Building-Material Handling Chute-Hydraulic Piston-1 <sup>st</sup> Floor-Paint (Blue) | | |

| Material Identification | | | | | |
|---|---|---|---|---|---|
| Lead Detected | Yes | Material Type | Paint | Quantity | 0.0062 |

| Comments | <b>Lead Detected Within Identical Paint</b> |

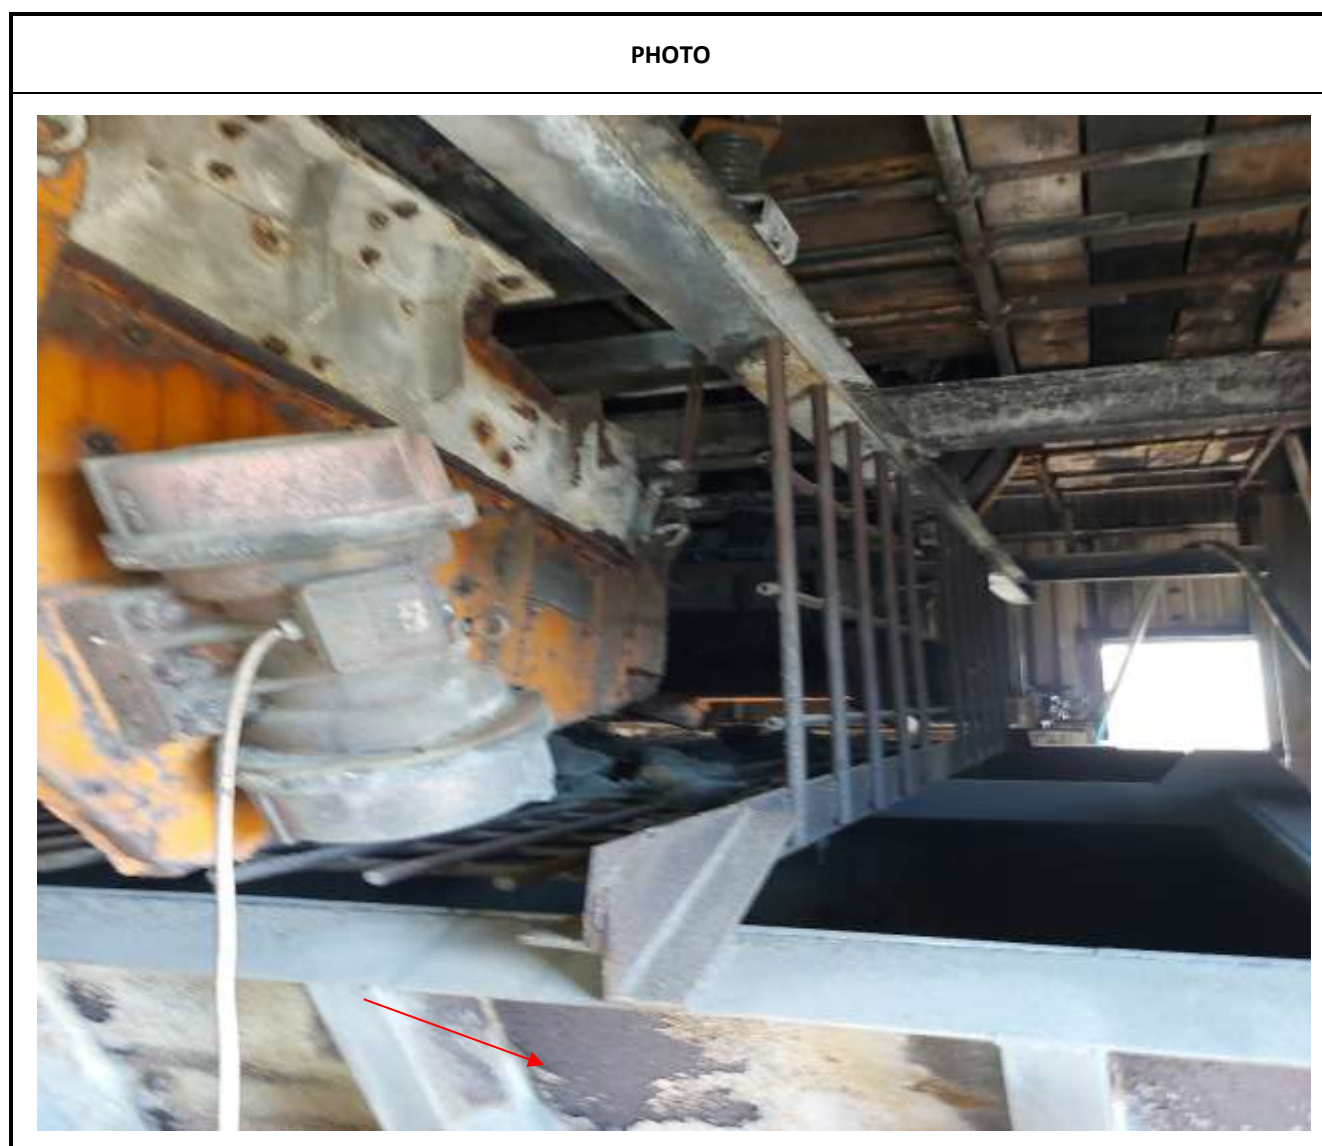
| Site | MCO HAA Areas | Sample No. | EN312290/8-LS08 |

| Location & Description of sample | LS08-HAA Building-Material Handling Chute-1 <sup>st</sup> Floor-Paint | | |

| Material Identification | | | | | |
|---|---|---|---|---|---|
| Lead Detected | Yes | Material Type | Paint | Quantity | 0.0066 |

| Comments | <b>Lead Detected</b> |
