## MONOLITHIC ENVIRONMENTAL SERVICES LTD.

### Lead Sampling-Report

Tata Steel  
Port Talbot Steel Works  
MCO HAA Areas  
SA13 2NG

| Survey No | Date of Survey | Survey Type | Prepared by | Authorised by |
|---|---|---|---|---|
| 5938 SC | 22/04/2025 | Paint Sampling | Derek Williams | Chris Avery |

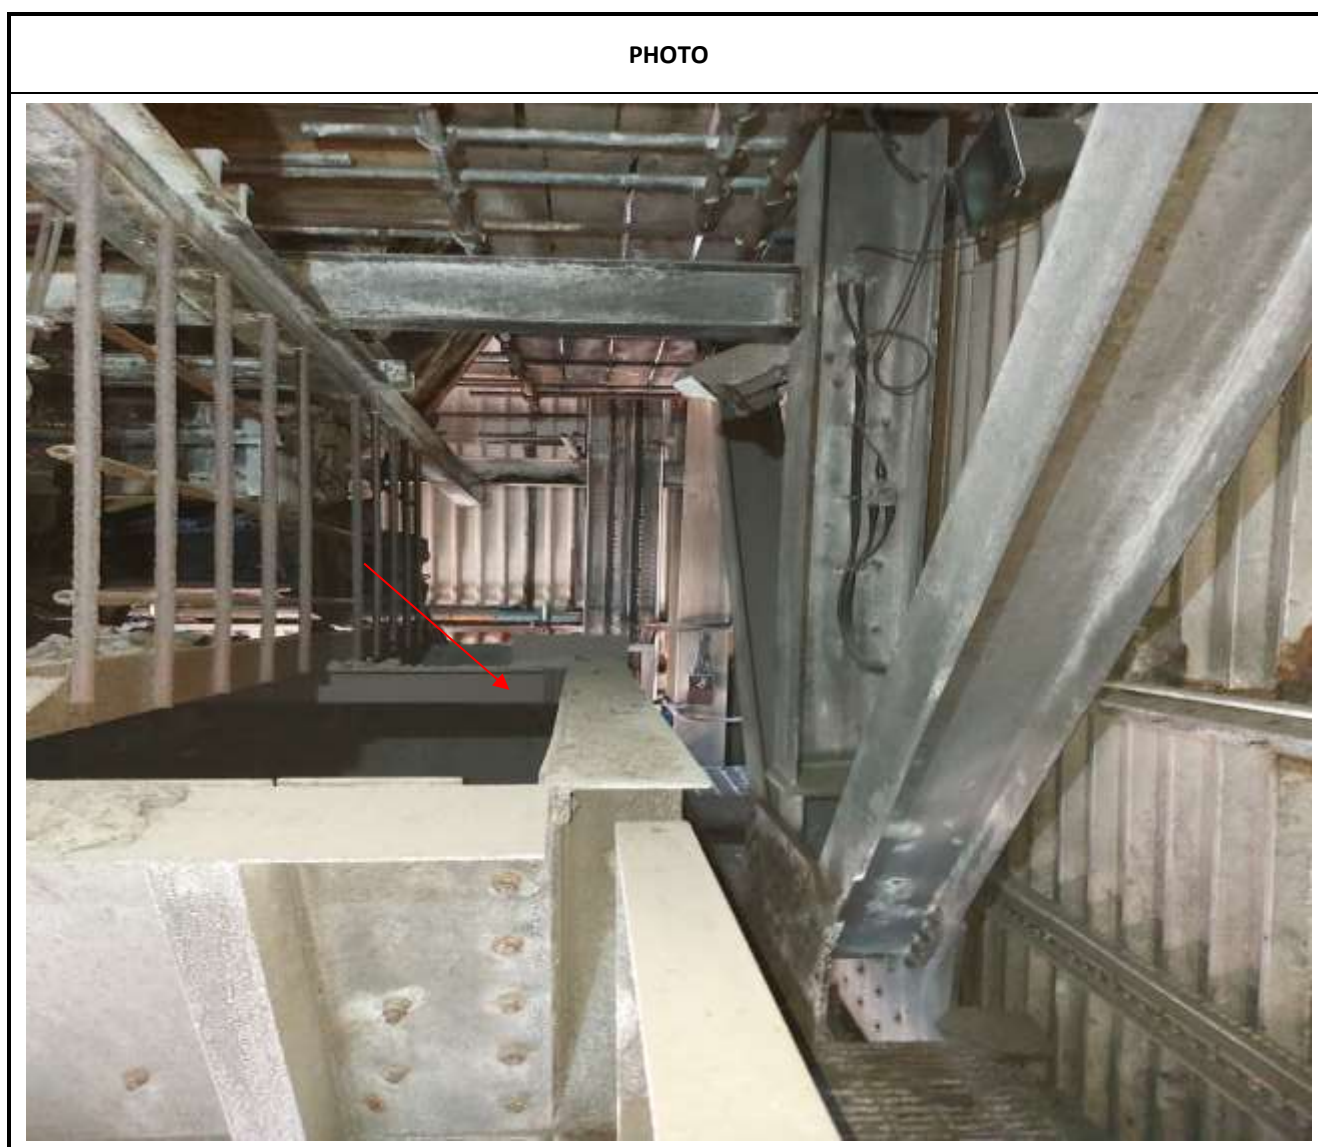
| Site | MCO HAA Areas | Sample No. | EN312290/8-VS/LS08a |

| Location & Description of sample | VL/S08a-HAA Building-Material Handling Chute-1 <sup>st</sup> Floor-Paint | | |

| Material Identification | | | | | |
|---|---|---|---|---|---|
| Lead Detected | Yes | Material Type | Paint | Quantity | 0.0066 |

| Comments | <b>Lead Detected Within Identical Paint</b> |

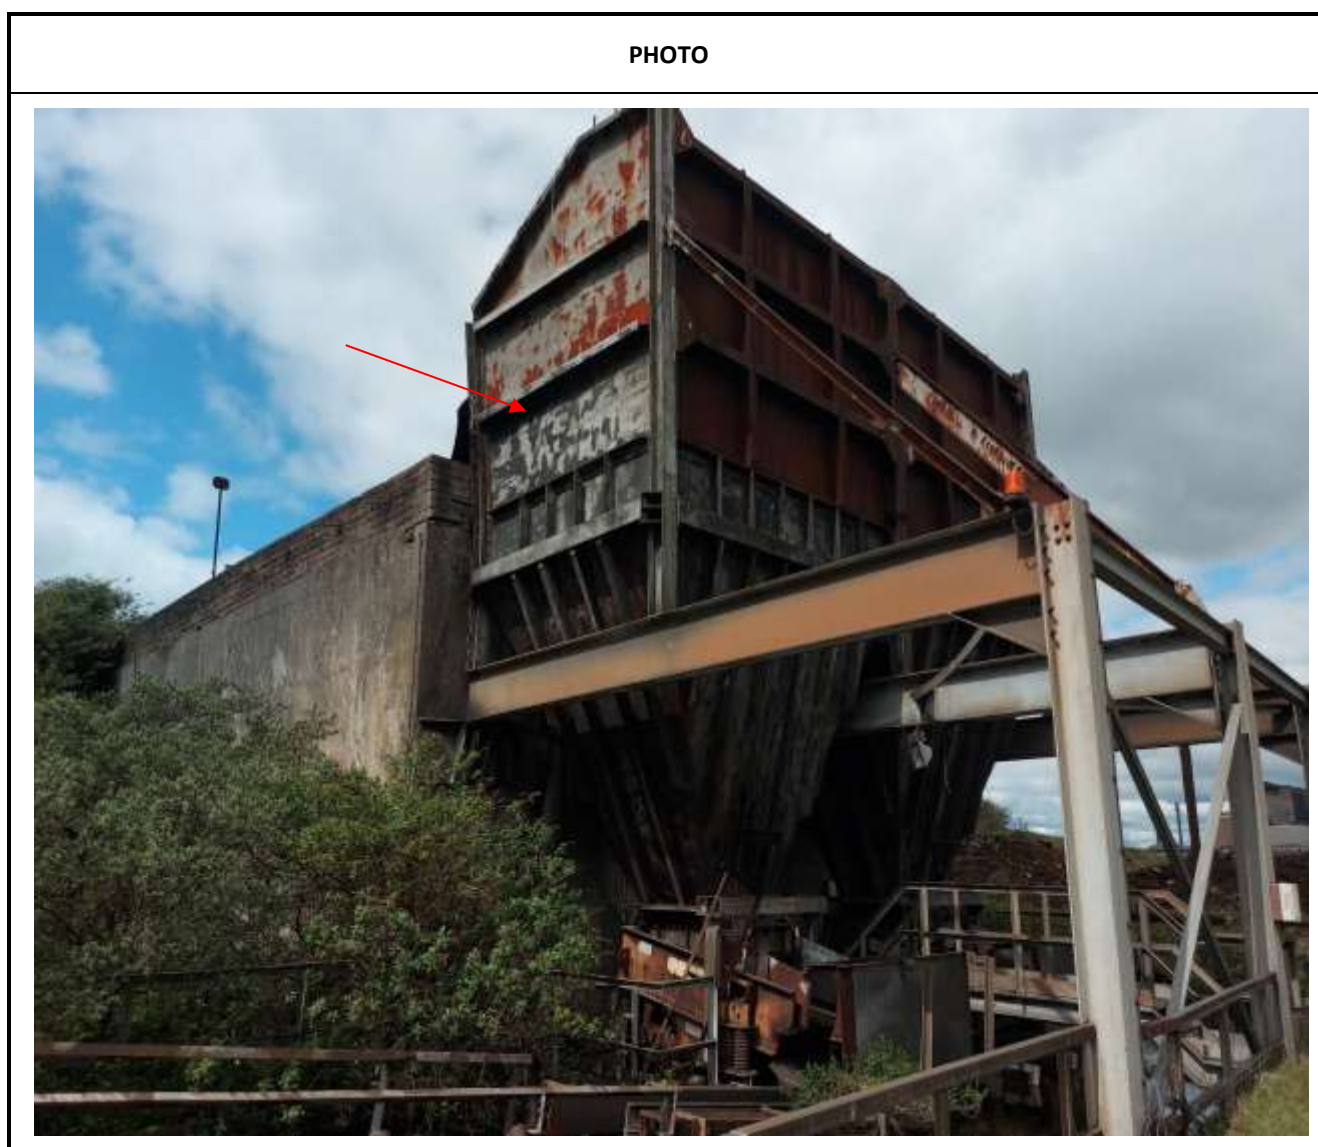
| Site | MCO HAA Areas | Sample No. | EN312290/8-VS/LS08b |

| Location & Description of sample | VS/LS08a-HAA-Redundant 1290 Conveyor Feed Hoopers-Paint | | |

| Material Identification | | | | | |
|---|---|---|---|---|---|
| Lead Detected | Yes | Material Type | Paint | Quantity | 0.0066 |

| Comments | <b>Lead Detected Within Identical Paint</b> |

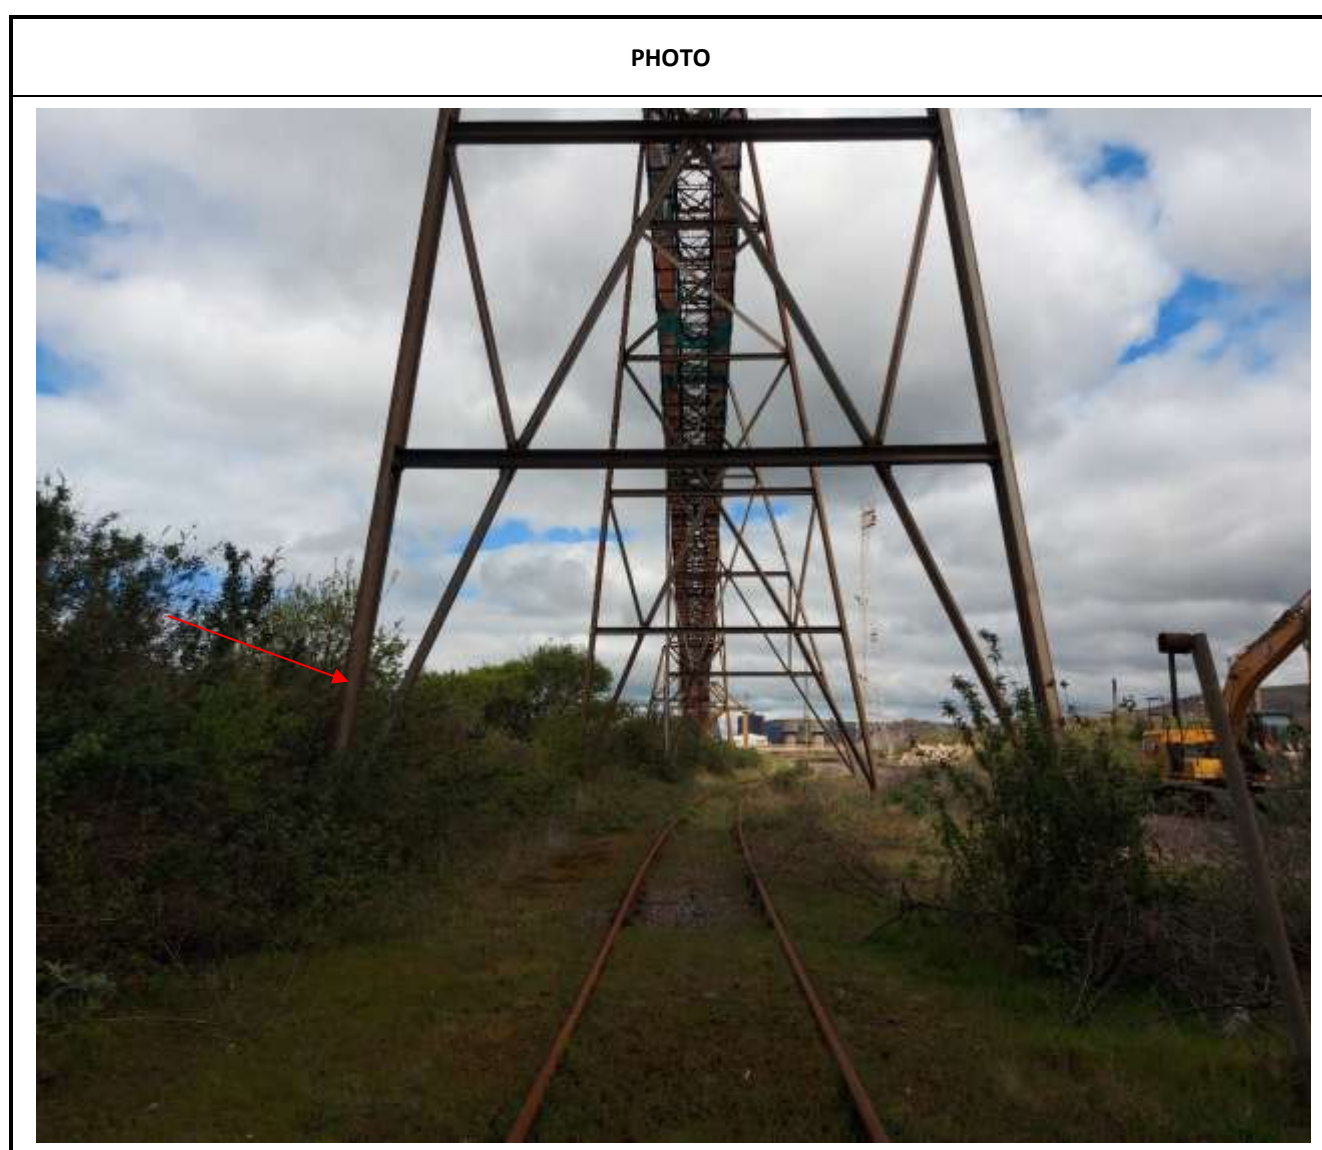
| <b>Site</b> | MCO HAA Areas | <b>Sample No.</b> | EN312290/9-LS09 |

| <b>Location &amp; Description of sample</b> | LS09-HAA Building/Feeder Hoppers-Conveyor 1290-Structural Steel Columns-Paint | | |

| Material Identification | | | | | |
|---|---|---|---|---|---|
| <b>Lead Detected</b> | Yes | <b>Material Type</b> | Paint | <b>Quantity</b> | 0.17 |

| <b>Comments</b> | <b>Lead Detected</b> |

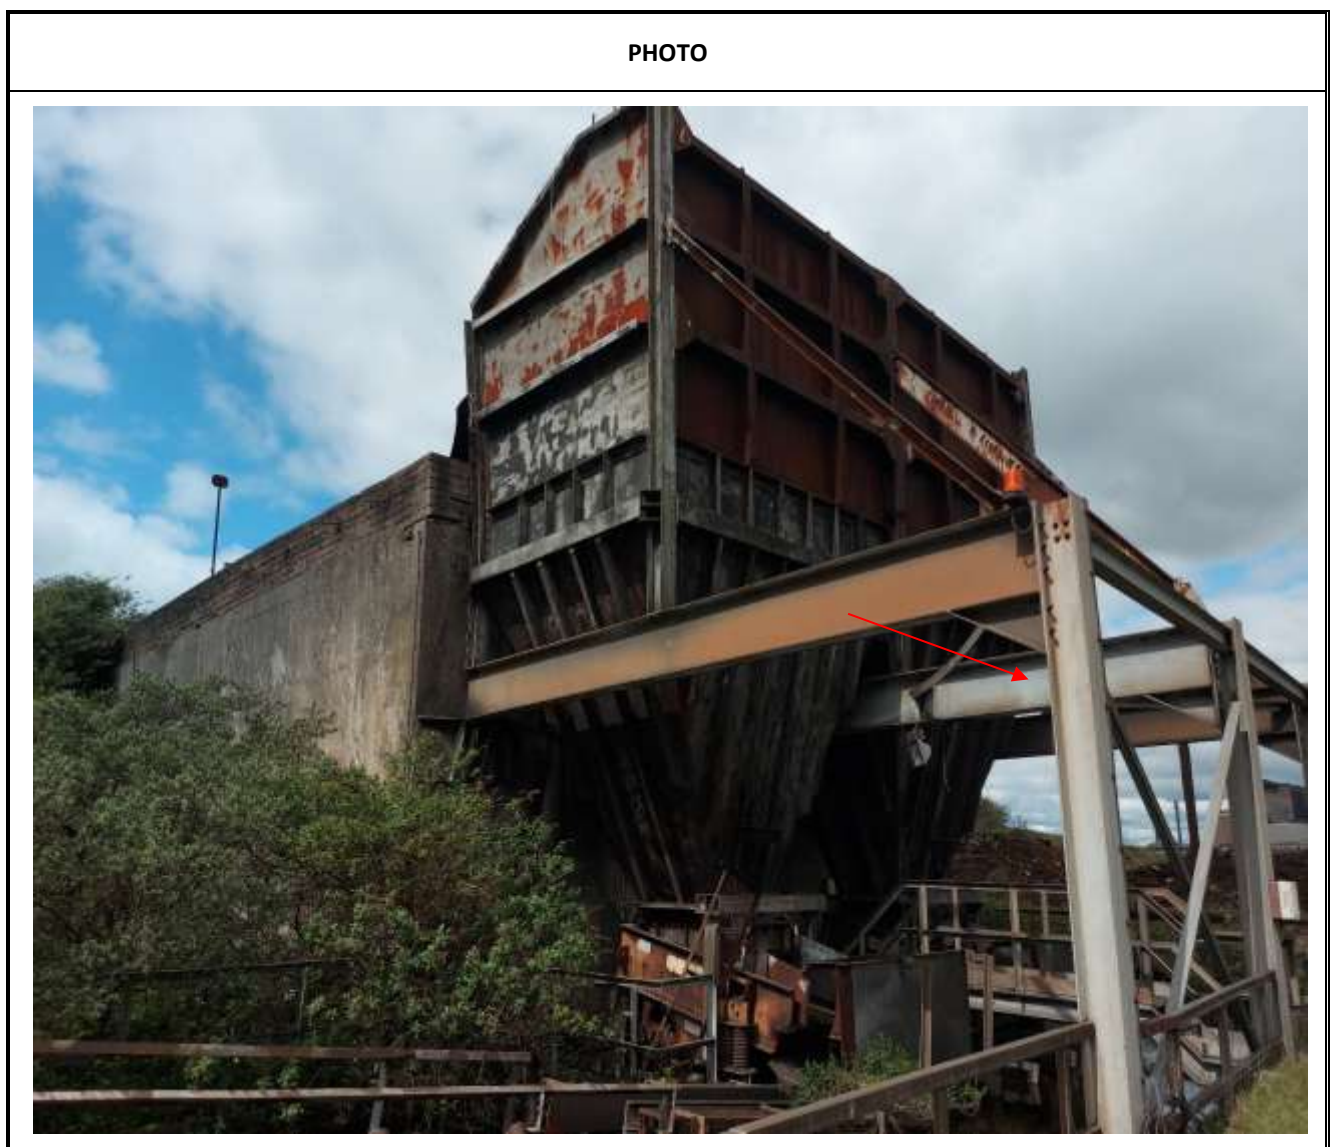
| Site | MCO HAA Areas | Sample No. | EN312290/9-VS/LS09a |

| Location & Description of sample | VS/LS09a-HAA Building/Feeder Hoppers-Structural Steel-Paint | | |

| Material Identification | | | | | |
|---|---|---|---|---|---|
| Lead Detected | Yes | Material Type | Paint | Quantity | 0.17 |

| Comments | <b>Lead Detected Within Identical Paint</b> |

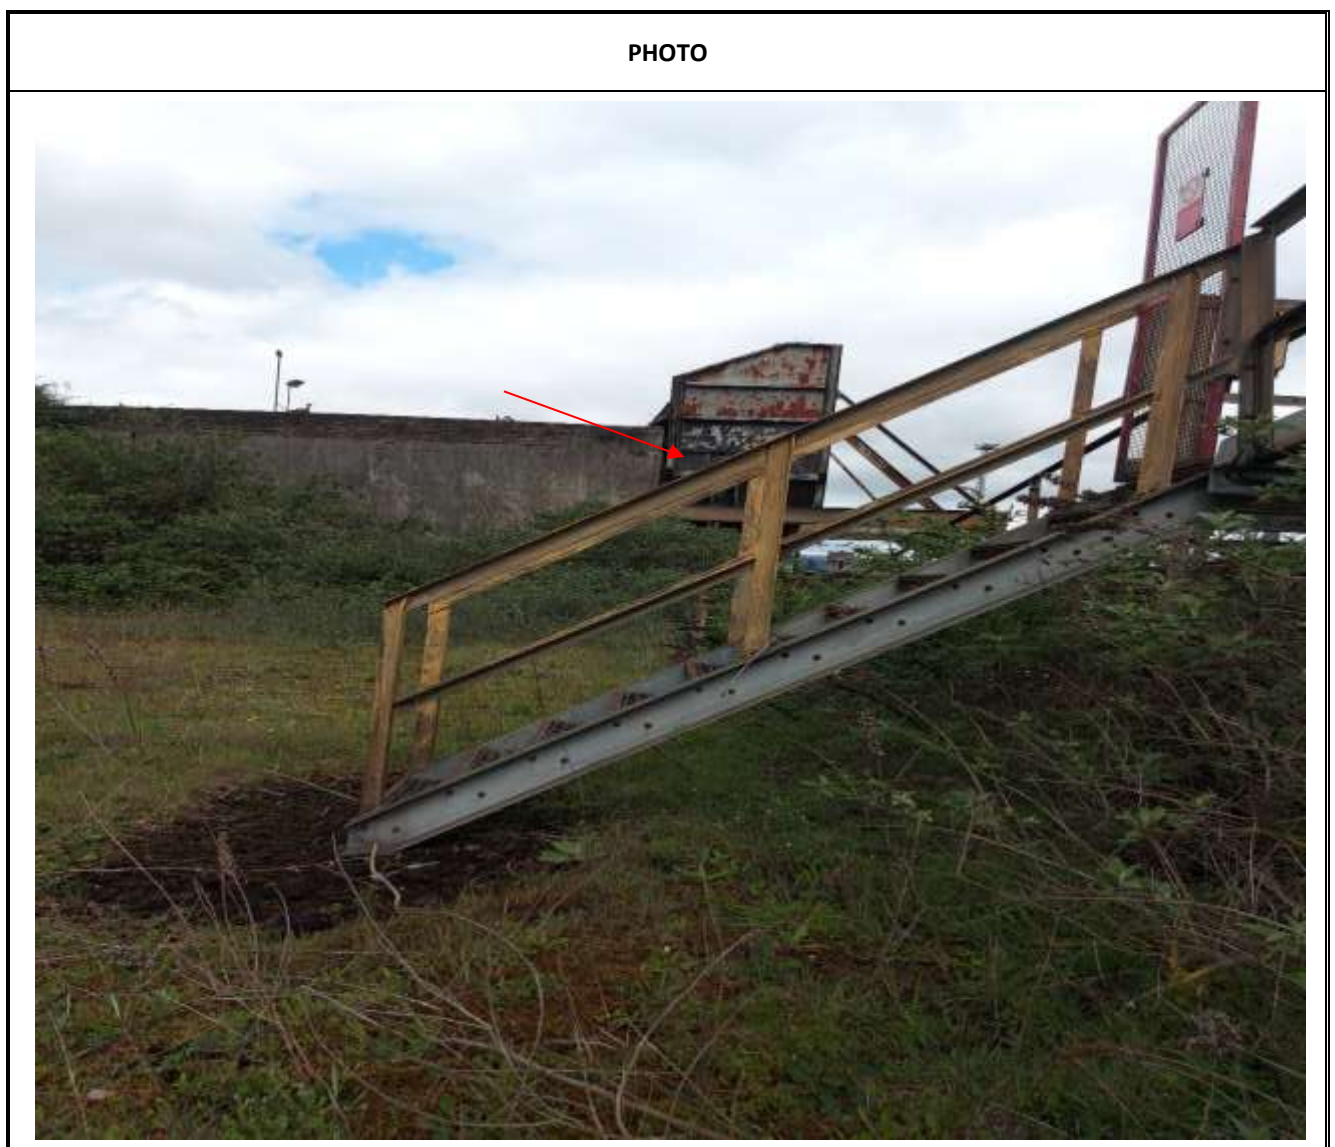
| <b>Site</b> | MCO HAA Areas | <b>Sample No.</b> | EN312290/10-LS10 |

| <b>Location &amp; Description of sample</b> | LS10-HAA Building/Feeder Hoppers-Conveyor 1290-Handrails-Paint | | |

| Material Identification | | | | | |
|---|---|---|---|---|---|
| <b>Lead Detected</b> | Yes | <b>Material Type</b> | Paint | <b>Quantity</b> | 0.17 |

| <b>Comments</b> | <b>Lead Detected</b> |

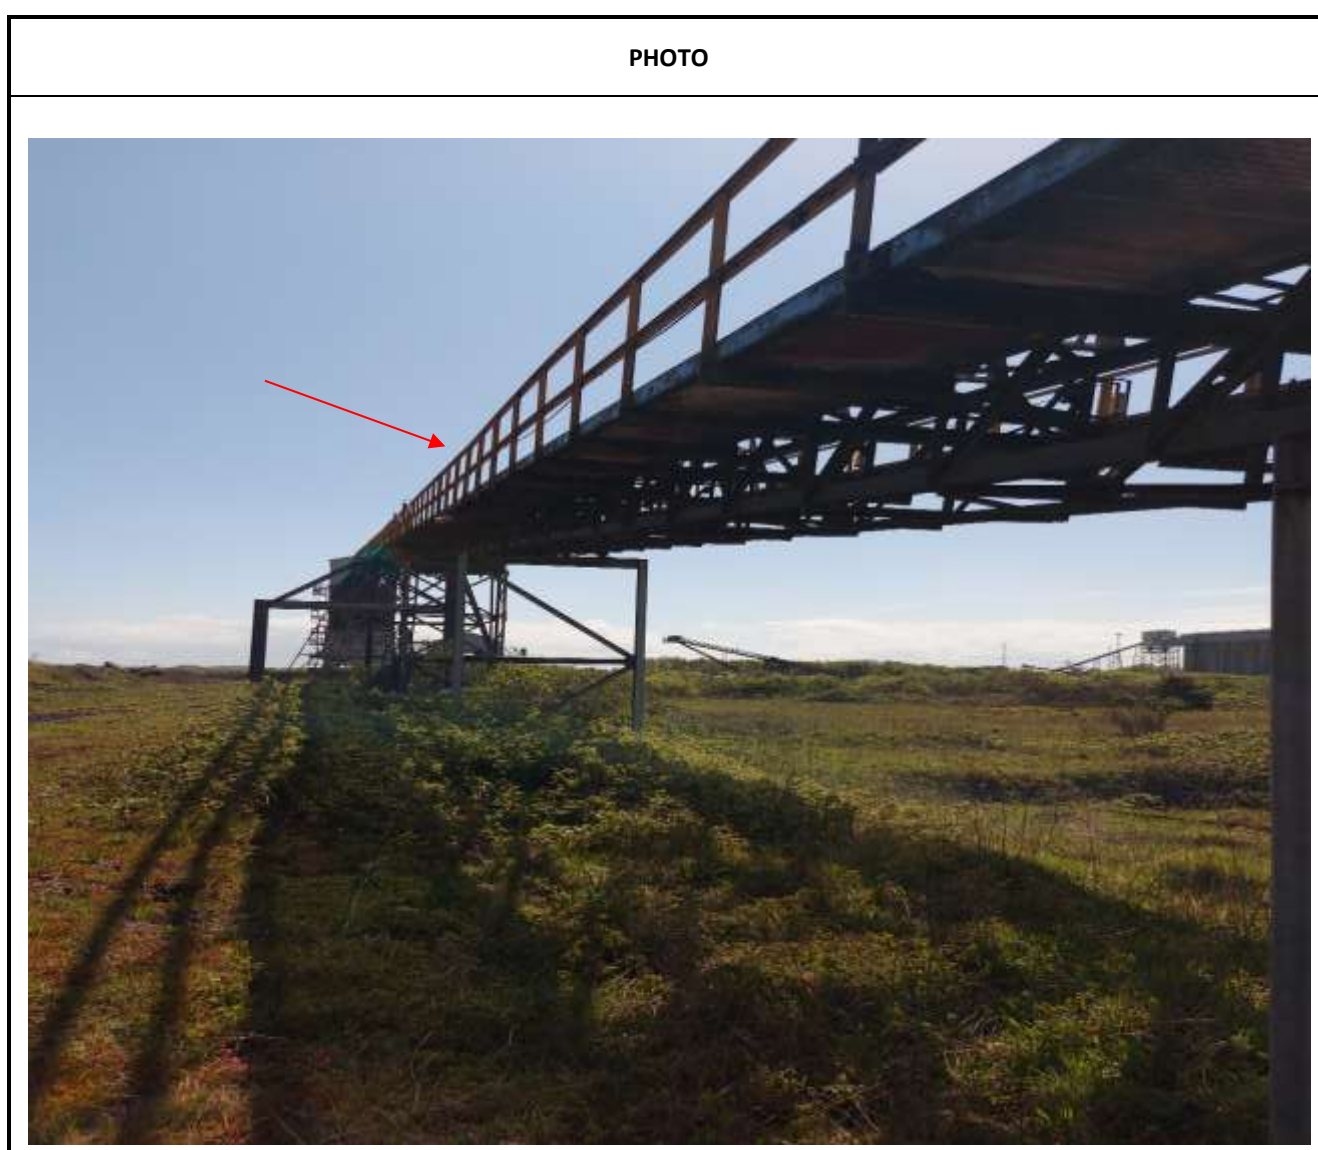
| <b>Site</b> | MCO HAA Areas | <b>Sample No.</b> | EN312290/10-VS/LS10a |

| <b>Location &amp; Description of sample</b> | VS/LS10a-HAA Building/Feeder Hoppers-Conveyor 1290-Handrails-Paint | | |

| Material Identification | | | | | |
|---|---|---|---|---|---|
| <b>Lead Detected</b> | Yes | <b>Material Type</b> | Paint | <b>Quantity</b> | 0.17 |

| <b>Comments</b> | <b>Lead Detected Within Identical Paint</b> |
