**PRELIMINARY ECOLOGICAL APPRAISAL  
BRIDGE REPLACEMENT, BANK STABILISATION AND CULVERT  
REPLACEMENT**

**20 Neath Road, Fforest Goch, Neath, SA8 3JB**

Prepared by Spectrum Ecology

Date: 20<sup>th</sup> February 2025

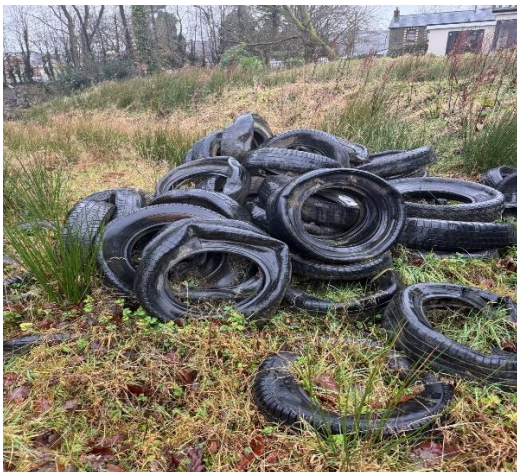
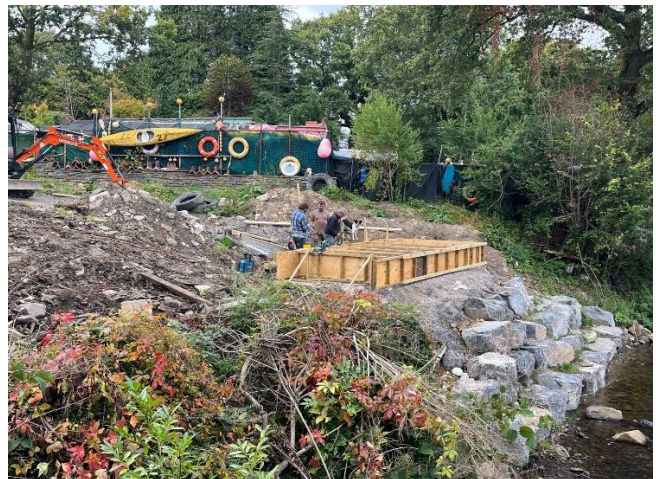
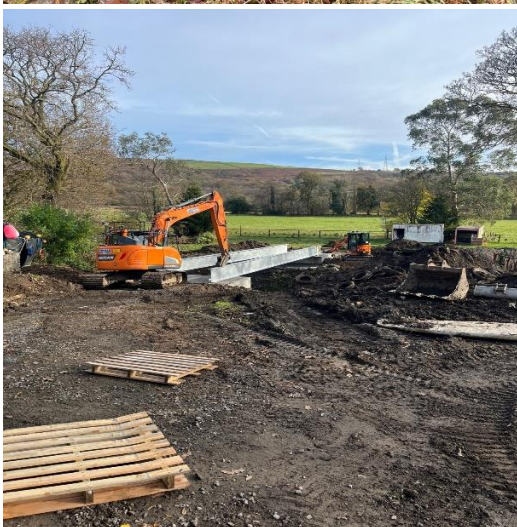
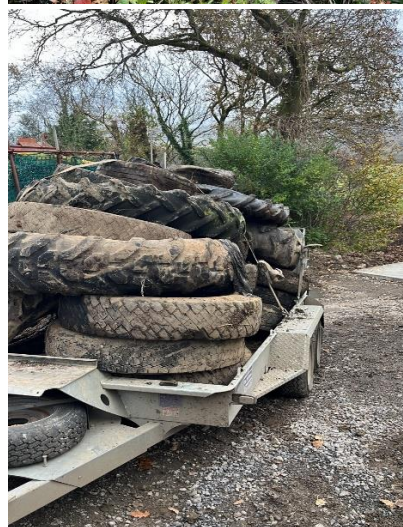
The previous bank protection structure comprised stacked and interlocking tyres. During the extraction process between the tyres general landfill material such as carpets, household waste, furniture was removed. No cavities or void systems were present at that time, as advised by the owner.

All works were undertaken from the top of bank and no in-channel plant operation occurred.

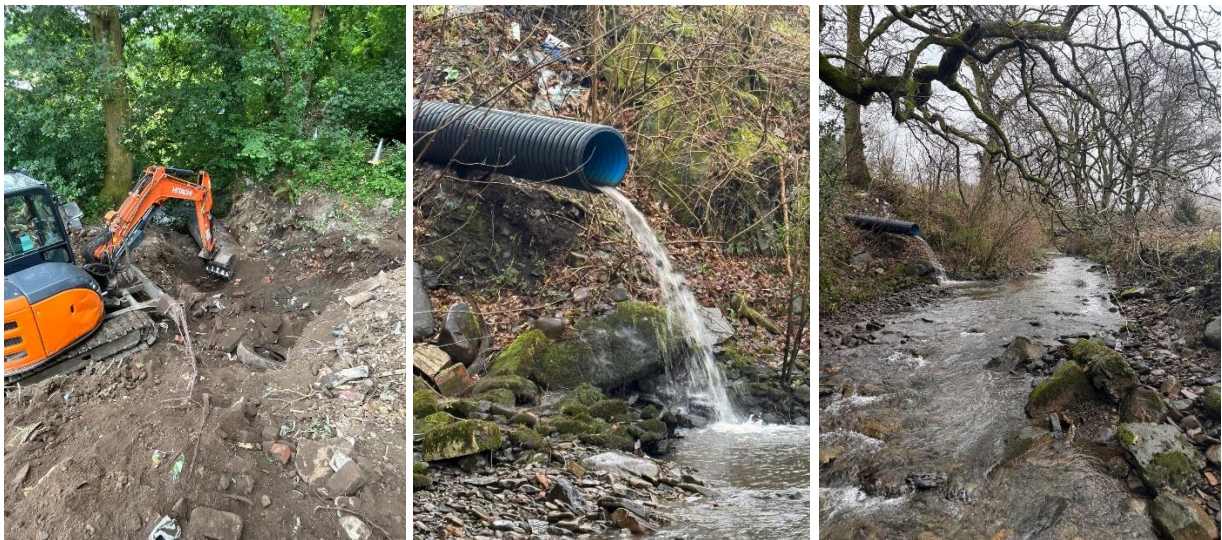
It should be noted that a 600mm diameter surface water culvert located on the client's land had collapsed, resulting in flooding of the adjacent land and garden. However this is not confirmed. The culvert was replaced with a plastic pipe like-for-like in diameter.

During the survey there had been heavy rain in the morning and there was considerable outfall from the pipe causing significant turbidity in the water course. When the line of the pipe was traced back the origin of the pipe is not confirmed but is considered to collect surface water runoff, potentially from highway drainage.

The culvert was installed from the top of bank. No channel excavation was undertaken. Backfill comprised clean 50mm limestone.

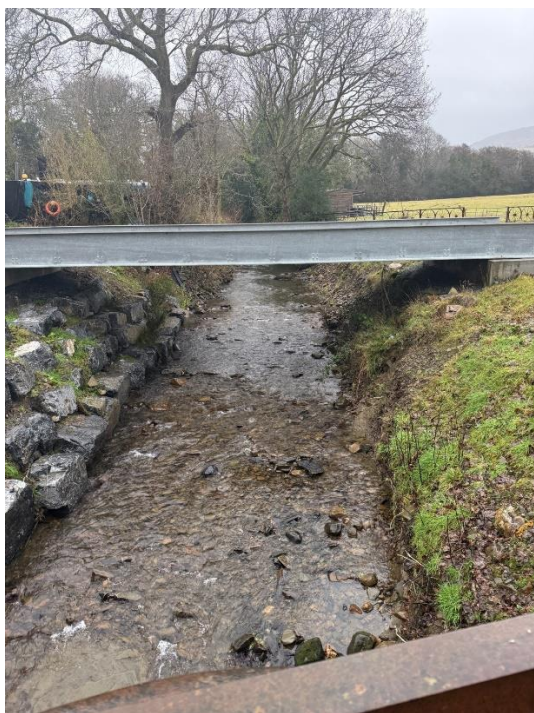
Retained riparian corridor taken on 20<sup>th</sup> January 2026
