# Oak Tree Farm Brynamman

Tree Condition Survey 10th April 2026

| Site Location: Oak Tree Farm Brynamman | Report Reference: 04.26/OTF/V1 |

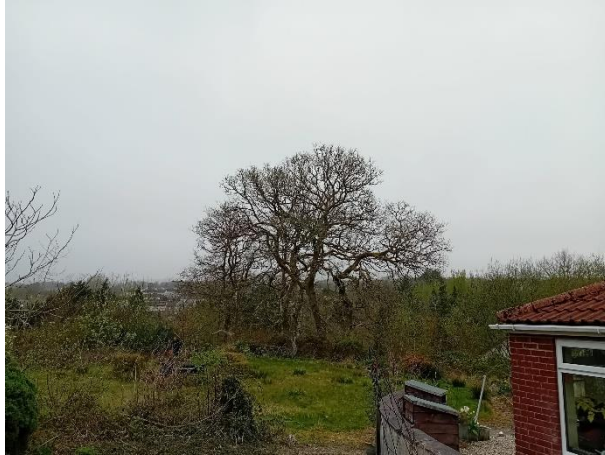
Trees viewed from Oak Tree Farm

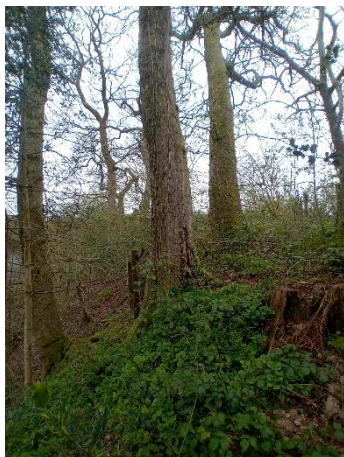
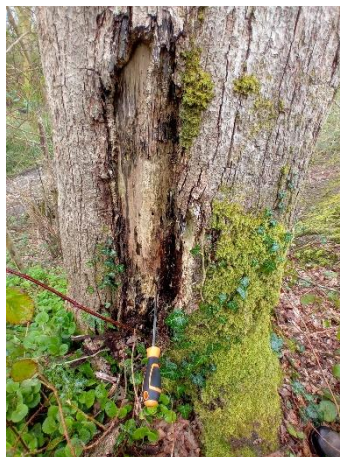
| Tree Ref | Species | H (m) | Spr (m) | Maturity | Condition | Action Recommendations | Hours | Priority | Done | Inspected |
|---|---|---|---|---|---|---|---|---|---|---|
| Comment: Large area of dead bark from ground to 0.5m - likely to be Phytophthora ramorum. | | | | | | | | | | |

| Tree Number | Species | Work Required | Priority |
|---|---|---|---|
| T440 | Oak | Fell | 6 Months |

| Tree Ref | Species | H (m) | Spr (m) | Maturity | Condition | Action Recommendations | Hours | Priority | Done | Inspected |
|---|---|---|---|---|---|---|---|---|---|---|
| T440 | Sessile Oak | 15 | 5 | SM | Poor | Fell :: Fell to ground level | | 6 Months | No | 09-Apr-26 |

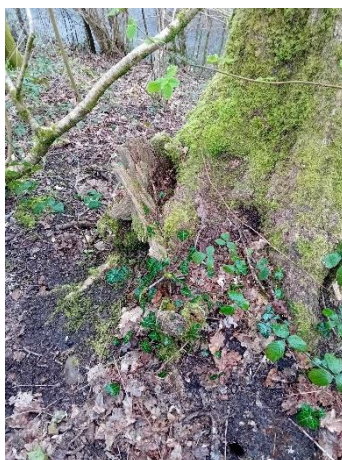
| Tree Ref | Species | H (m) | Spr (m) | Maturity | Condition | Action Recommendations | Hours | Priority | Done | Inspected |
|---|---|---|---|---|---|---|---|---|---|---|
| Comment: Damage to buttress west side and exposed roots - probably caused by removal of a secondary stem; no resonance change when percussion test performed on lowest 1.5 metres of stem indicating low likelihood of decay in this area. tree leaning to east; reduce height by 3m reduce laterals to east by 2m over road and neighbouring property. | | | | | | | | | | |

| Tree Number | Species | Work Required | Priority |
|---|---|---|---|
| T443 | Oak | Reduce height by 3m and laterals to east by 2m. | 1 Year |

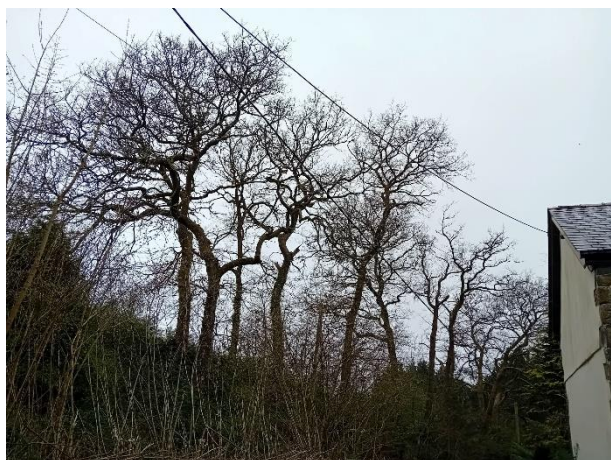
Trees viewed from public highway
