# Asbestos Demolition Survey Report

**Site Address:**  
**Ysgol Gynradd Gymraeg Tregales**  
**SA10 7ND**

**Survey Report Number:**  
J077853

Asbestos Demolition Survey – Demolition survey of Unit 1

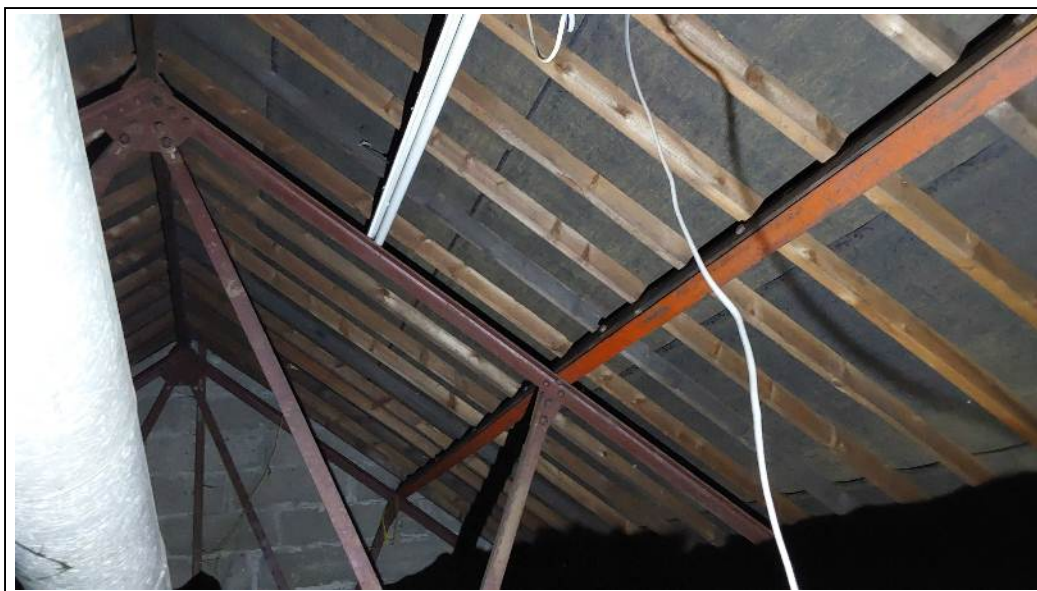
| Item Number | 0001 |

| Room/Area | Roof void/Roof |

| | | Score |
|---|---|---|
| Product Type | Bitumen | N/A |
| Extent of Damage | Good Condition | N/A |
| Asbestos Type | No asbestos detected | 0 |

| Recommendations | No Action Required |

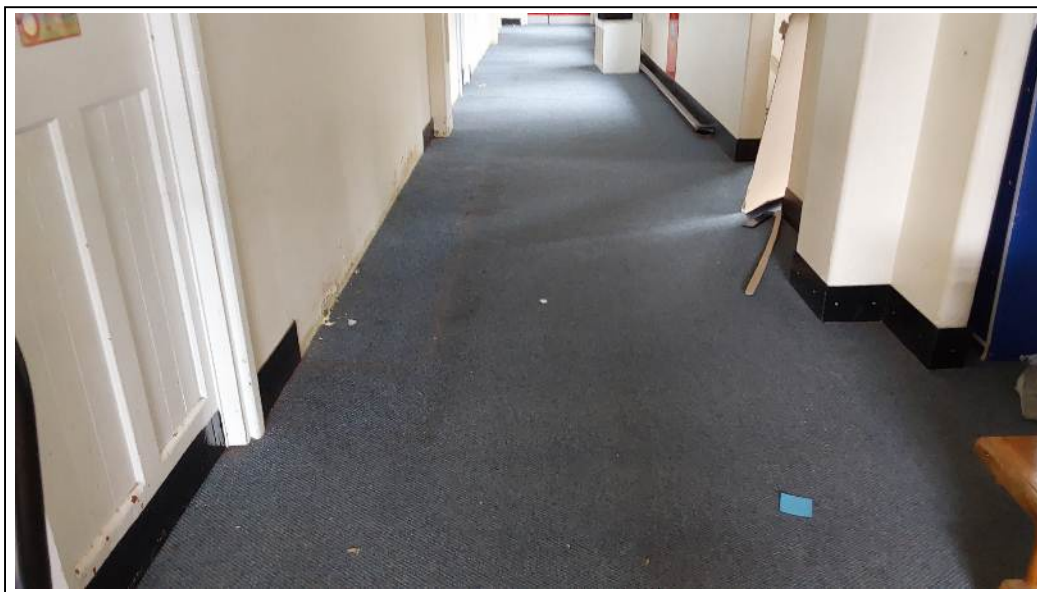
| Item Number | 0002 |

| Room/Area | GF11 Corridor/To concrete floor beneath carpet covering |

| | | Score |
|---|---|---|
| Product Type | Vinyl With Bitumen Adhesive | 1 |
| Extent of Damage | Good Condition | 0 |
| Asbestos Type | Chrysotile | 1 |

| Material Risk Score | 2 |

| Recommendations | Remove |

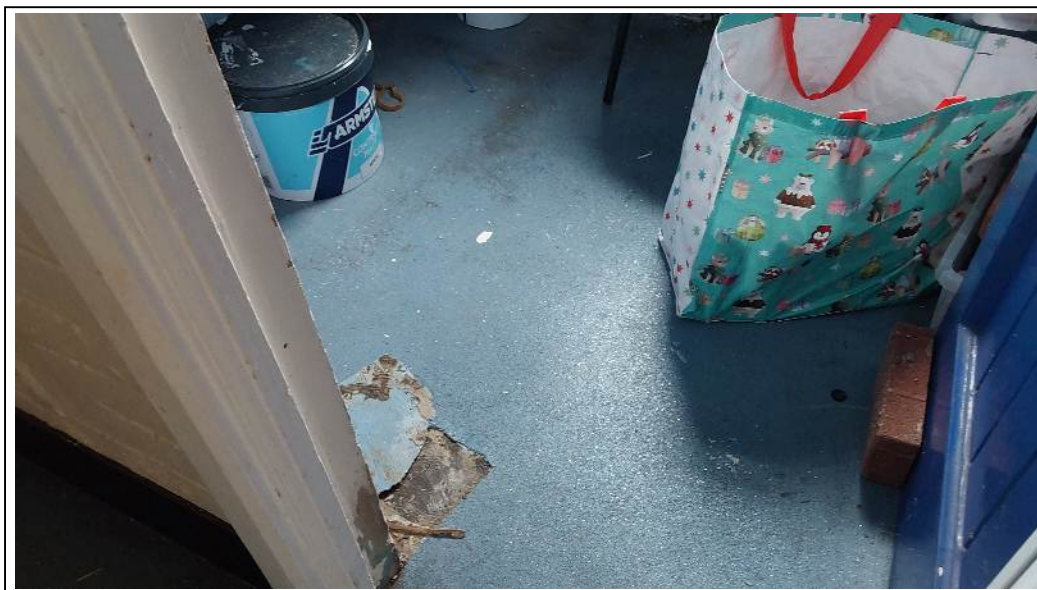
| Item Number | 0003 |

| Room/Area | GF08 Store/To concrete floor beneath modern vinyl covering |

| | | Score |
|---|---|---|
| Product Type | Bitumen | 1 |
| Extent of Damage | Good Condition | 0 |
| Asbestos Type | Chrysotile | 1 |

| Material Risk Score | 2 |

| Recommendations | Remove |

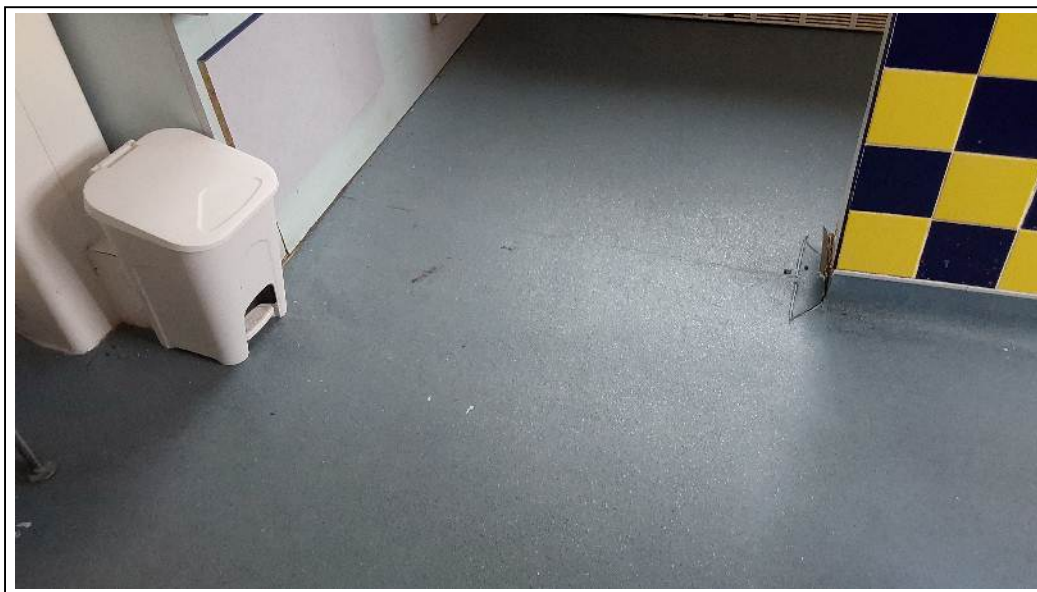
| Item Number | 0004 |

| Room/Area | GF09 & GF09a Boys toilets/To concrete floor beneath modern vinyl covering |
| Level of Identification | Strongly Presumed |

| | | Score |
|---|---|---|
| Product Type | Bitumen | 1 |
| Extent of Damage | Good Condition | 0 |
| Asbestos Type | Chrysotile | 1 |

| Material Risk Score | 2 |

| Recommendations | Remove |

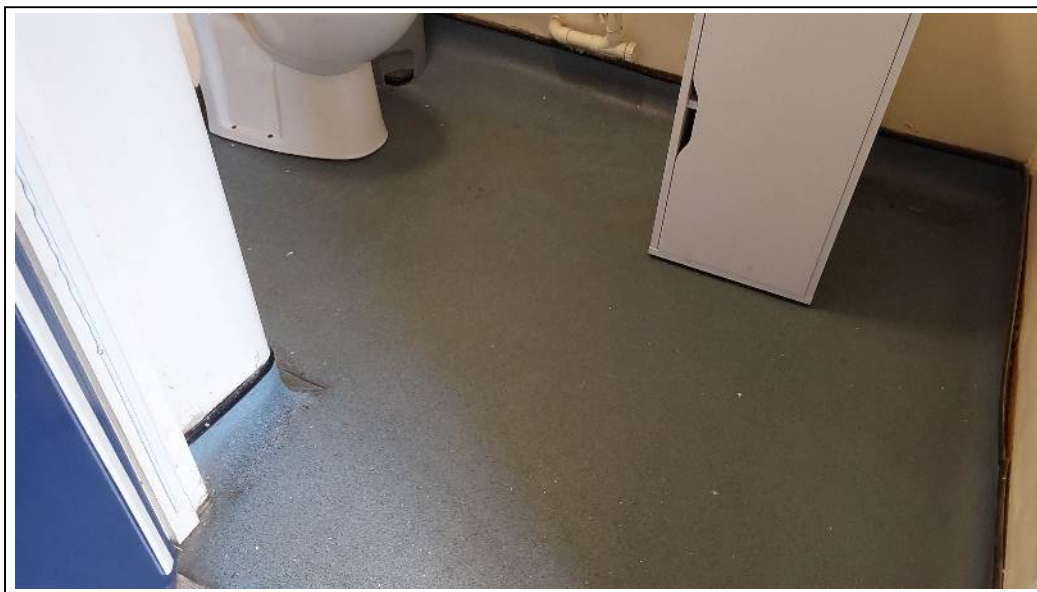
| Item Number | 0005 |

| Room/Area | GF10 Staff toilets/To concrete floor beneath modern vinyl covering |
| Level of Identification | Strongly Presumed |

| | | Score |
|---|---|---|
| Product Type | Bitumen | 1 |
| Extent of Damage | Good Condition | 0 |
| Asbestos Type | Chrysotile | 1 |

| Material Risk Score | 2 |

| Recommendations | Remove |

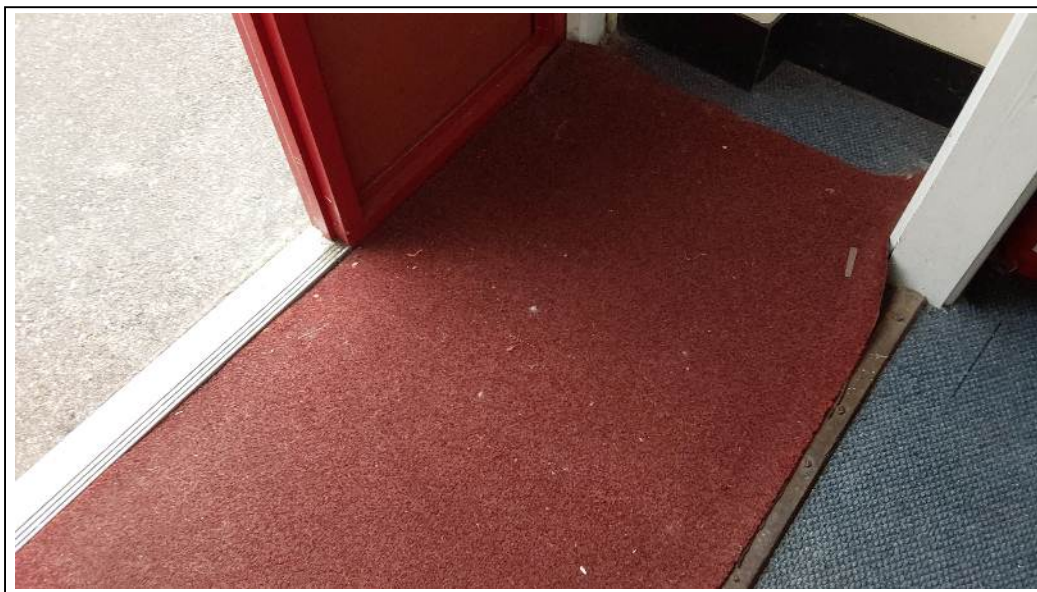
| Item Number | 0006 |

| Room/Area | GF07 Entrance Lobby/To concrete floor beneath carpet covering |
| Level of Identification | Strongly Presumed |

| | | Score |
|---|---|---|
| Product Type | Vinyl With Bitumen Adhesive | 1 |
| Extent of Damage | Good Condition | 0 |
| Asbestos Type | Chrysotile | 1 |

| Material Risk Score | 2 |

| Recommendations | Remove |

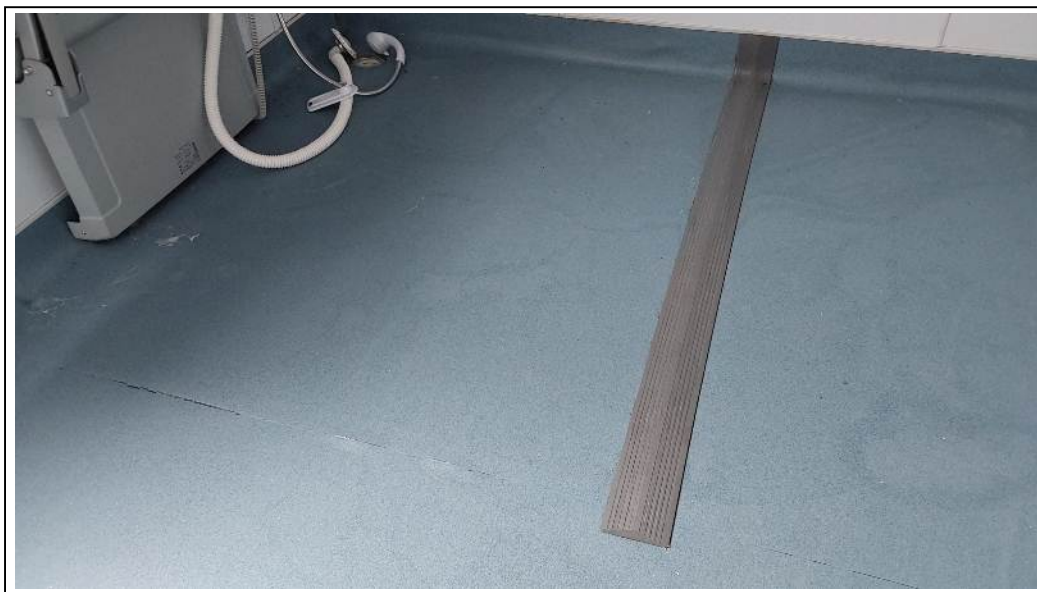
| Room/Area | GF19 Wet room/To concrete floor beneath carpet covering |
| Level of Identification | Strongly Presumed |

| | | Score |
|---|---|---|
| Product Type | Vinyl With Bitumen Adhesive | 1 |
| Extent of Damage | Good Condition | 0 |

| Recommendations | Remove |

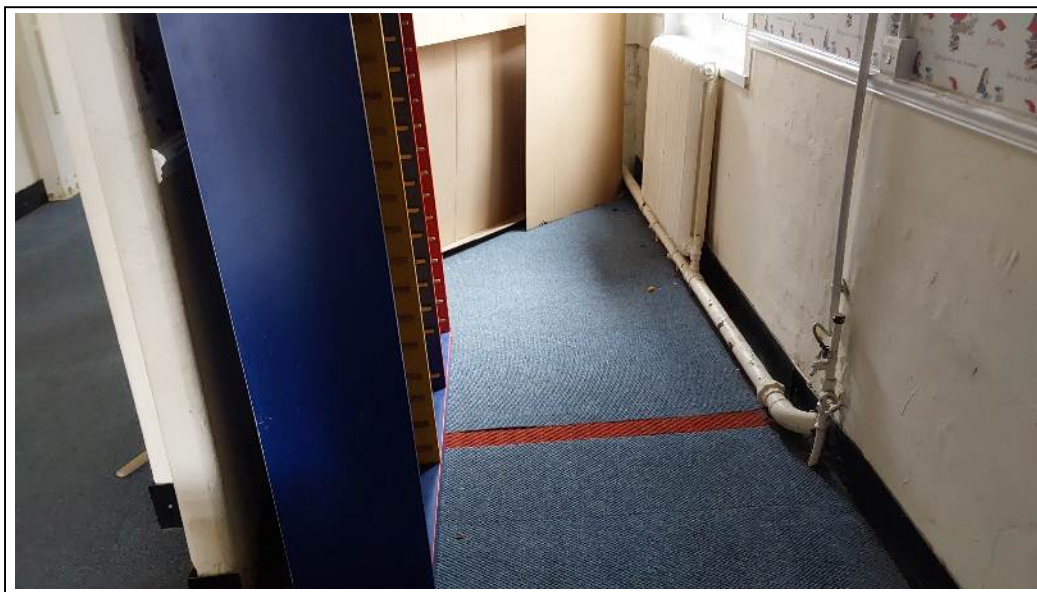
| Room/Area | GF18 Cloaks/To concrete floor beneath carpet covering |
| Level of Identification | Strongly Presumed |

| | | Score |
|---|---|---|
| Product Type | Vinyl With Bitumen Adhesive | 1 |
| Extent of Damage | Good Condition | 0 |

| Recommendations | Remove |

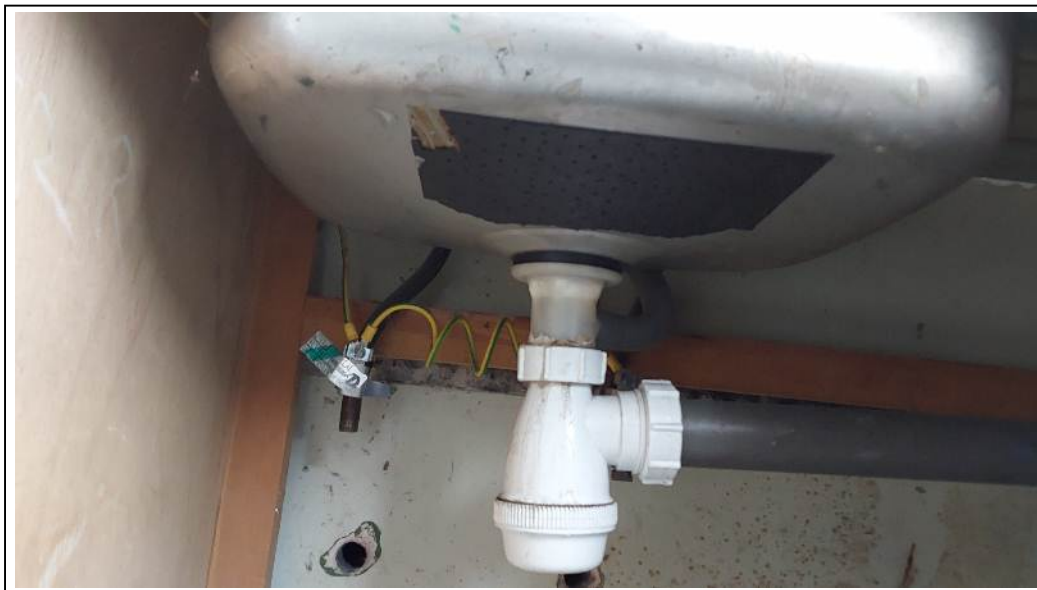
| Room/Area | GF05 Classroom/Underside of sink and drainer |
| Level of Identification | Identified |

| | | Score |
|---|---|---|
| Product Type | Bitumen | N/A |
| Extent of Damage | Good Condition | N/A |

| Recommendations | No Action Required |

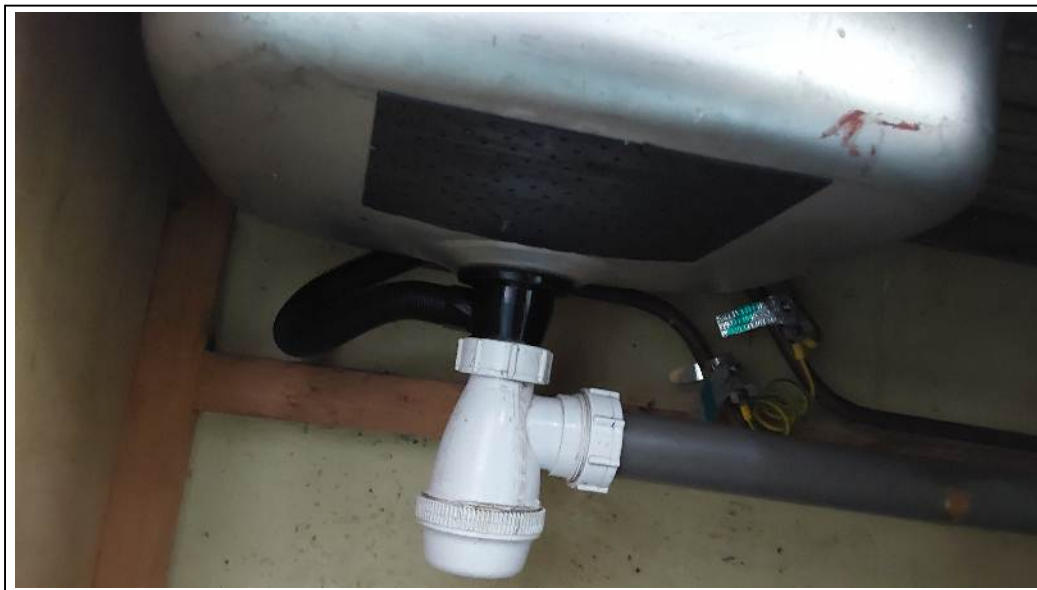
| Room/Area | GF04 Classroom/Underside of sink and drainer |
| Level of Identification | Strongly Presumed |

| | | Score |
|---|---|---|
| Product Type | Bitumen | N/A |
| Extent of Damage | Good Condition | N/A |

| Recommendations | No Action Required |

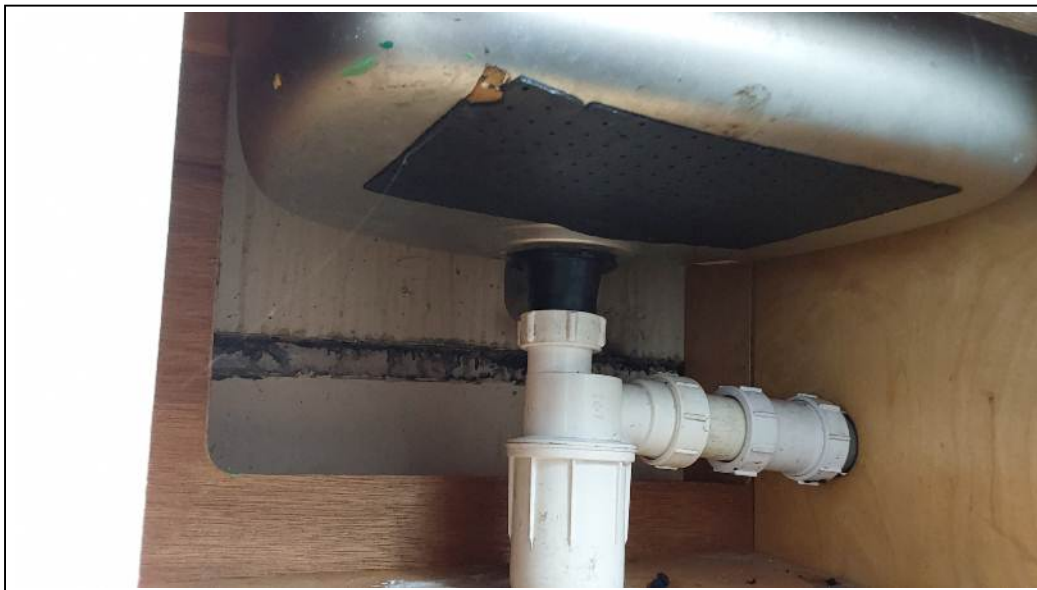
| Room/Area | GF03 Classroom/Underside of sink and drainer |
| Level of Identification | Strongly Presumed |

| | | Score |
|---|---|---|
| Product Type | Bitumen | N/A |
| Extent of Damage | Good Condition | N/A |

| Recommendations | No Action Required |

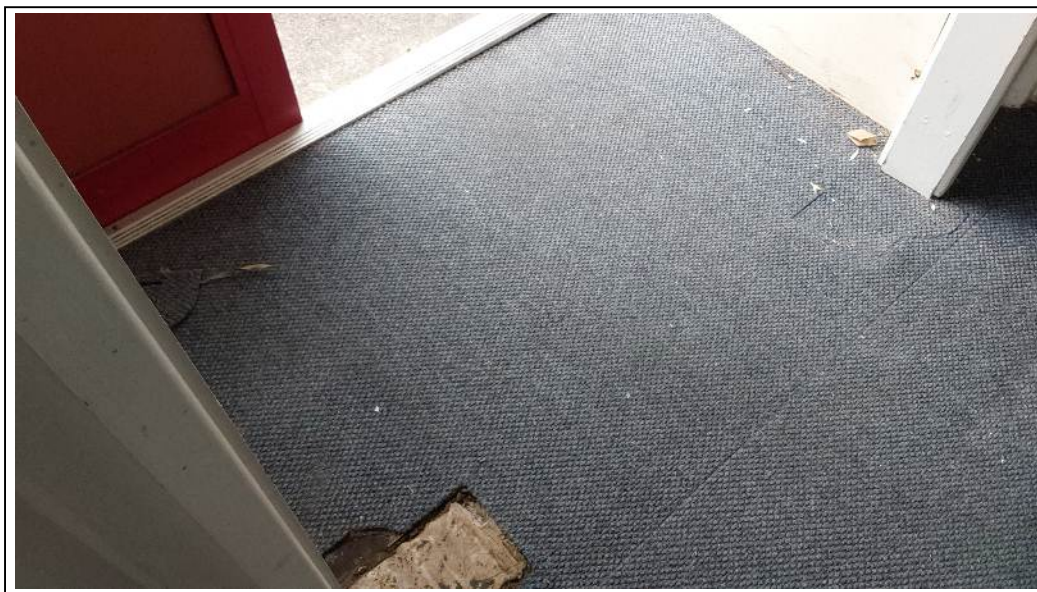
| Room/Area | GF12 Entrance Lobby/To concrete floor beneath carpet covering |
| Level of Identification | Strongly Presumed |

| | | Score |
|---|---|---|
| Product Type | Vinyl With Bitumen Adhesive | 1 |
| Extent of Damage | Good Condition | 0 |

| Recommendations | Remove |

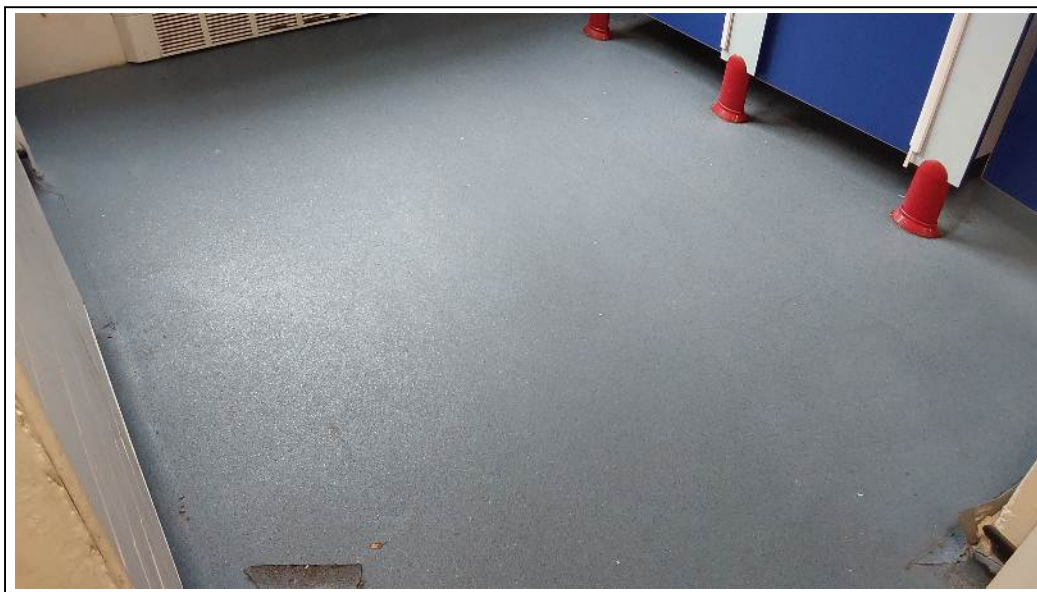
| Room/Area | GF13 Girls toilets/To concrete floor beneath modern vinyl covering |
| Level of Identification | Strongly Presumed |

| | | Score |
|---|---|---|
| Product Type | Bitumen | 1 |
| Extent of Damage | Good Condition | 0 |

| Recommendations | Remove |

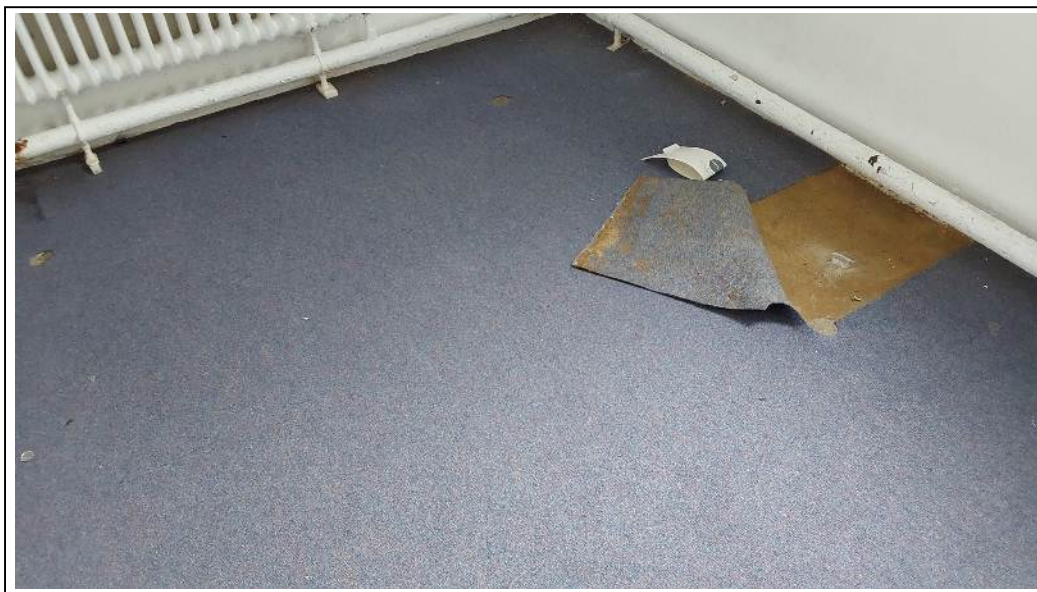
| Room/Area | GF15 Store/To concrete floor beneath carpet covering |
| Level of Identification | Identified |

| | | Score |
|---|---|---|
| Product Type | Bitumen | 1 |
| Extent of Damage | Good Condition | 0 |

| Recommendations | Remove |

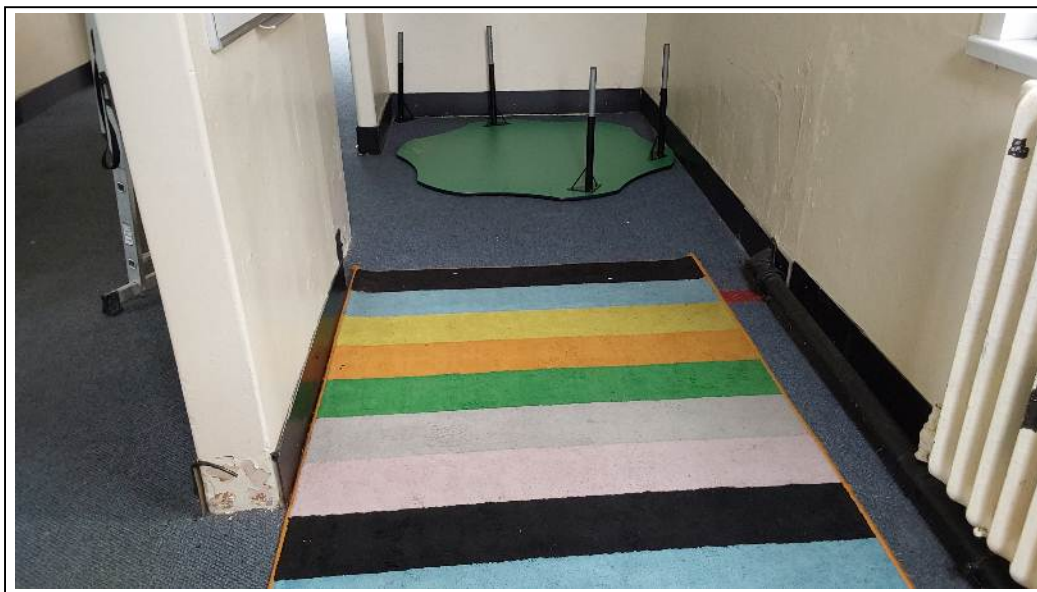
| Room/Area | GF17 Cloaks/To concrete floor beneath carpet covering |
| Level of Identification | Strongly Presumed |

| | | Score |
|---|---|---|
| Product Type | Vinyl With Bitumen Adhesive | 1 |
| Extent of Damage | Good Condition | 0 |

| Recommendations | Remove |

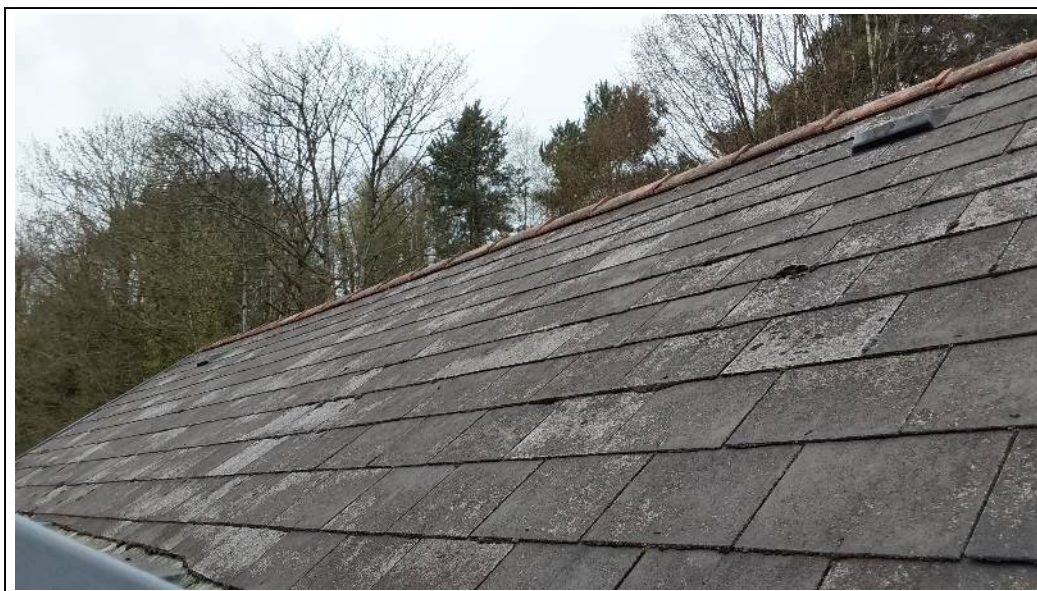
| Room/Area | Externals/Roof |
| Level of Identification | Identified |

| | | Score |
|---|---|---|
| Product Type | Cement | N/A |
| Extent of Damage | Good Condition | N/A |

| Recommendations | No Action Required |

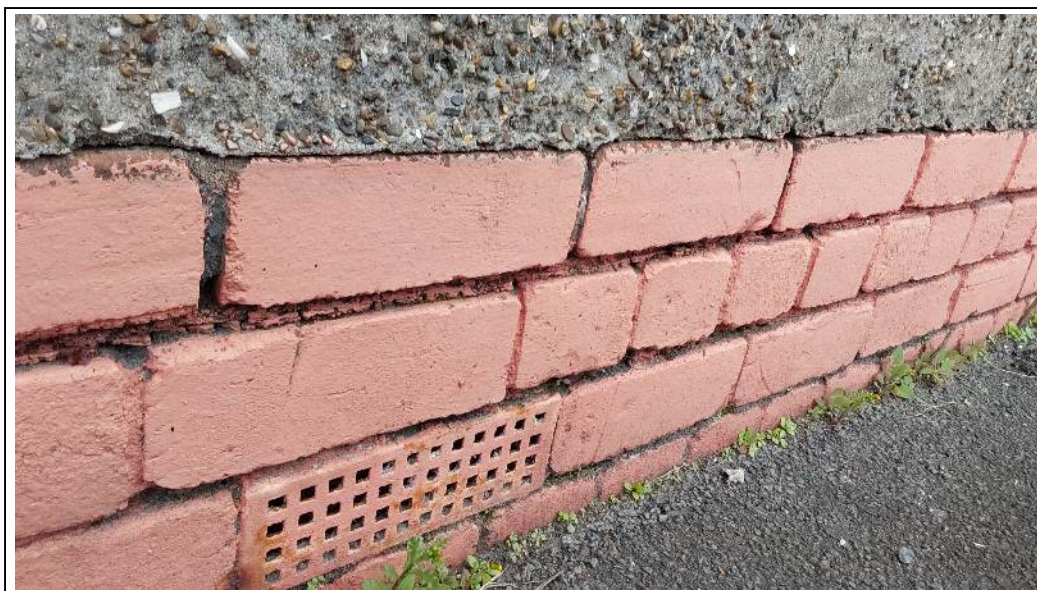
| Room/Area | Externals/Walls |
| Level of Identification | Identified |

| | | Score |
|---|---|---|
| Product Type | Bitumen | N/A |
| Extent of Damage | Good Condition | N/A |

| Recommendations | No Action Required |
