## **Structural Analysis Report**

Port Talbot And Aberavon Constitution Club  
62 – 62A Station Rd, Port Talbot

June 2025

Type of report: Structural Appraisal

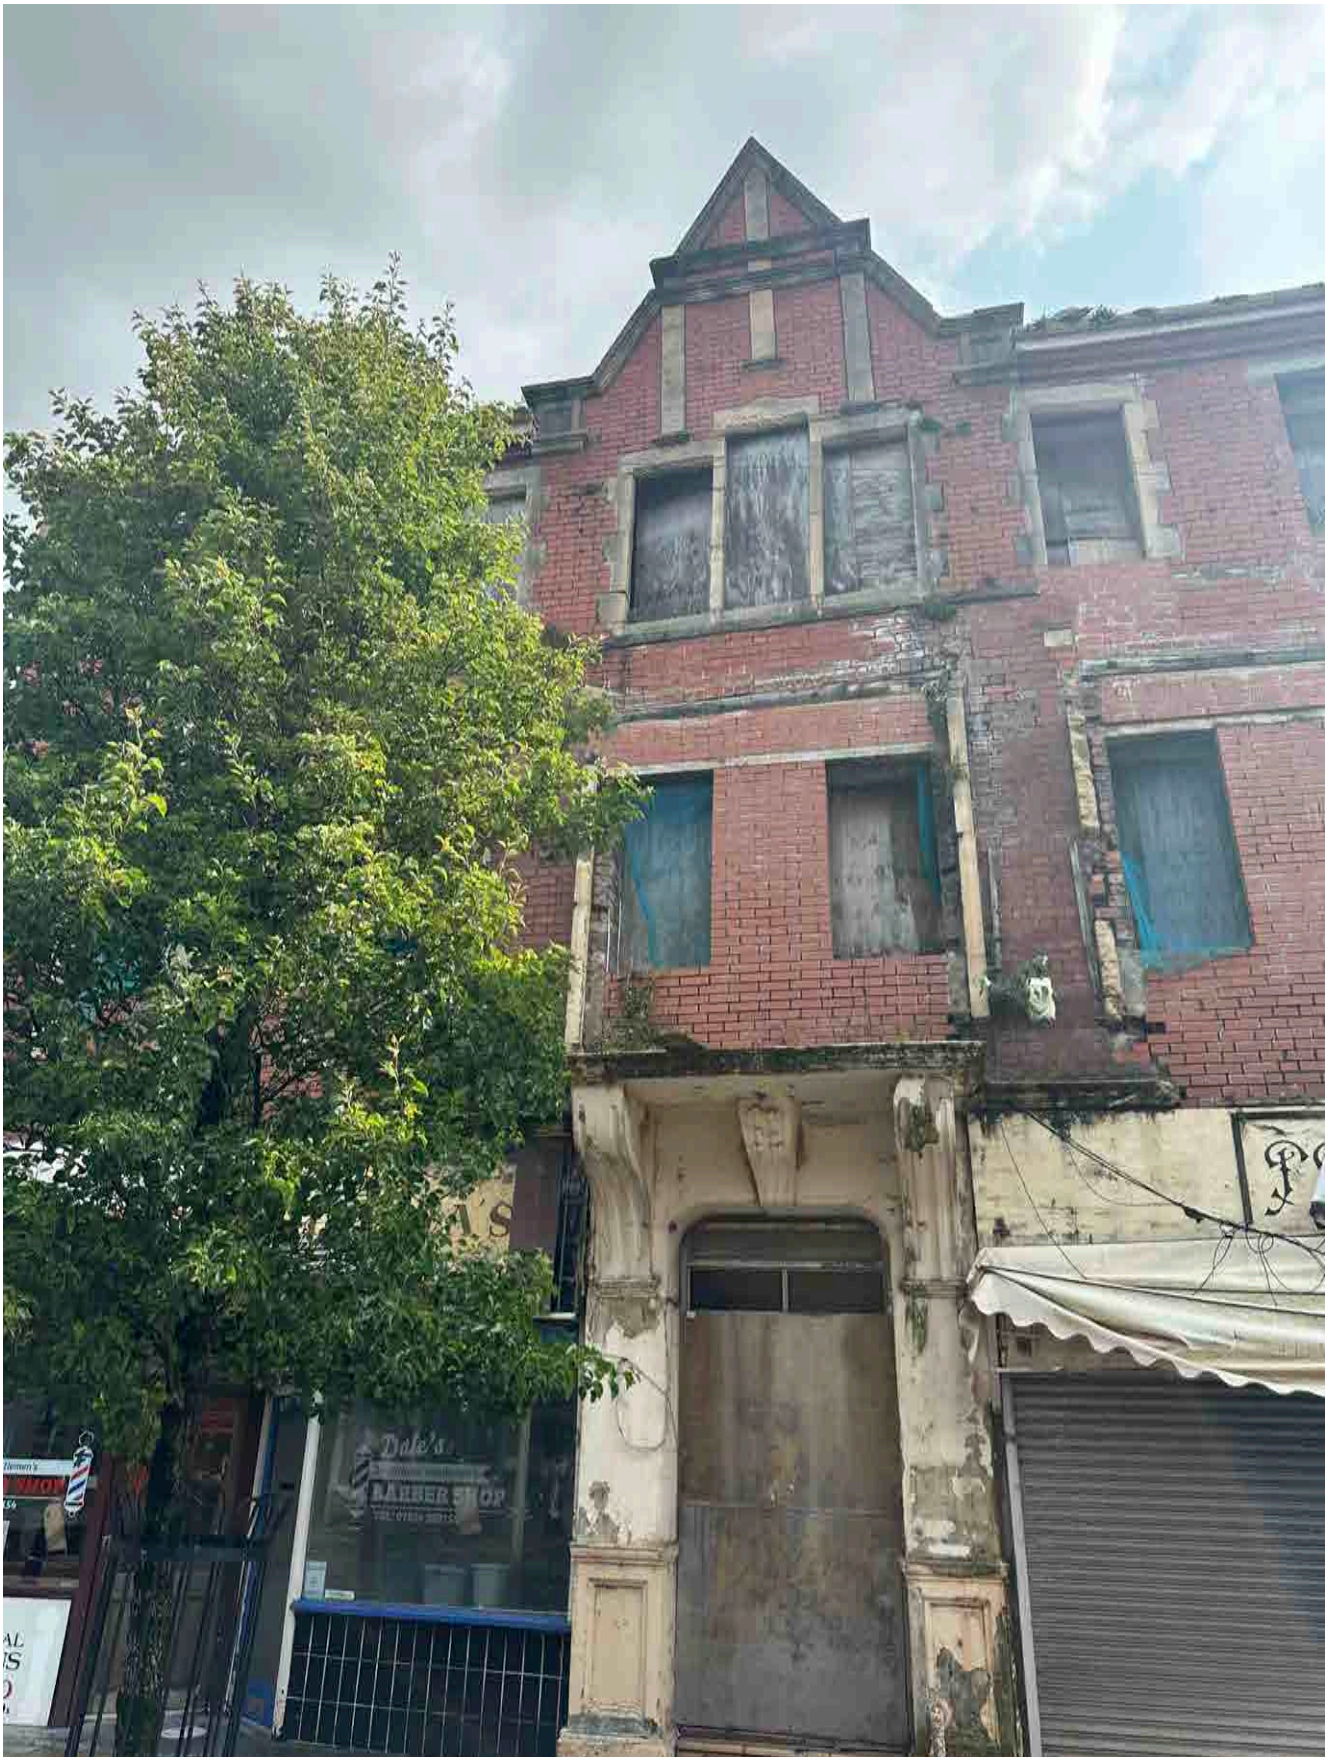
The front façade is constructed of brickwork and shows visible signs of historic alteration. It appears that bay windows were removed and the openings infilled with new brickwork. The brickwork across the front façade is visibly bowed. There is evidence that the infill works following the bay window removal have introduced instability. Specifically, Insufficient support appears to have been provided above the former window openings. The new brickwork is not adequately tied or bonded to the existing masonry. The original masonry piers between the windows appear to have been compromised during the alteration.

Front facade of the building. There are signs of bowing in the masonry panels.

The front façade should be carefully dismantled and rebuilt with proper tying into return walls or structural framing, in line with conservation best practices due to the building's historical importance.

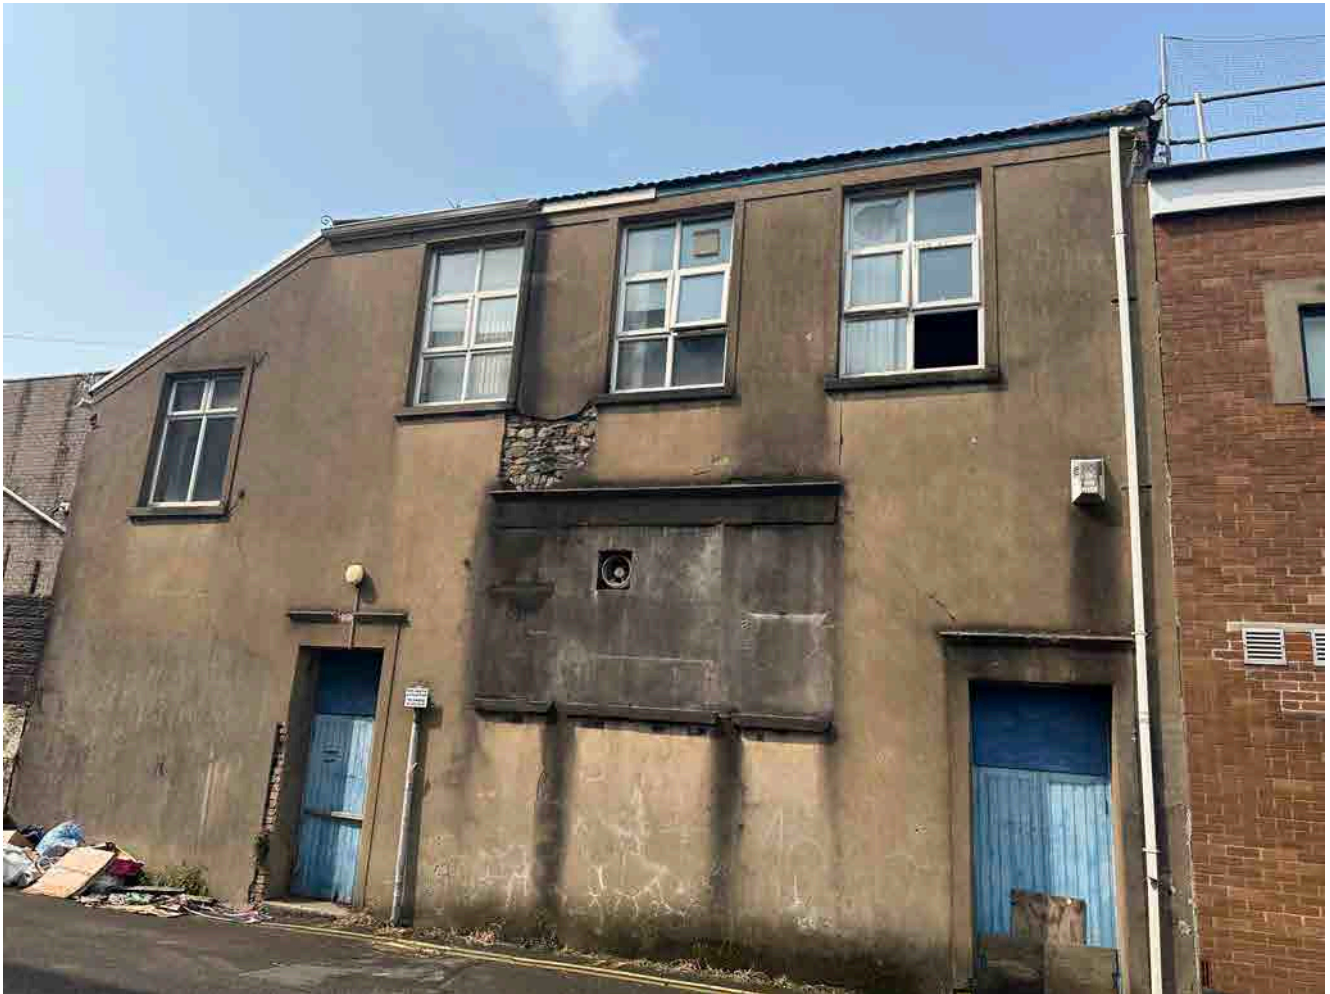
The rear elevation is constructed in stone masonry with a rendered finish. Cracking is evident in the render, and small areas have detached, though this appears to be superficial. There are no visible signs of major structural movement or instability in the masonry wall itself.

The rear of the building. Render has fallen off the wall in areas.

Localised render repairs and reapplication are advised, with allowance for suitable expansion joints and breathable materials. No further structural action is considered necessary at this stage.

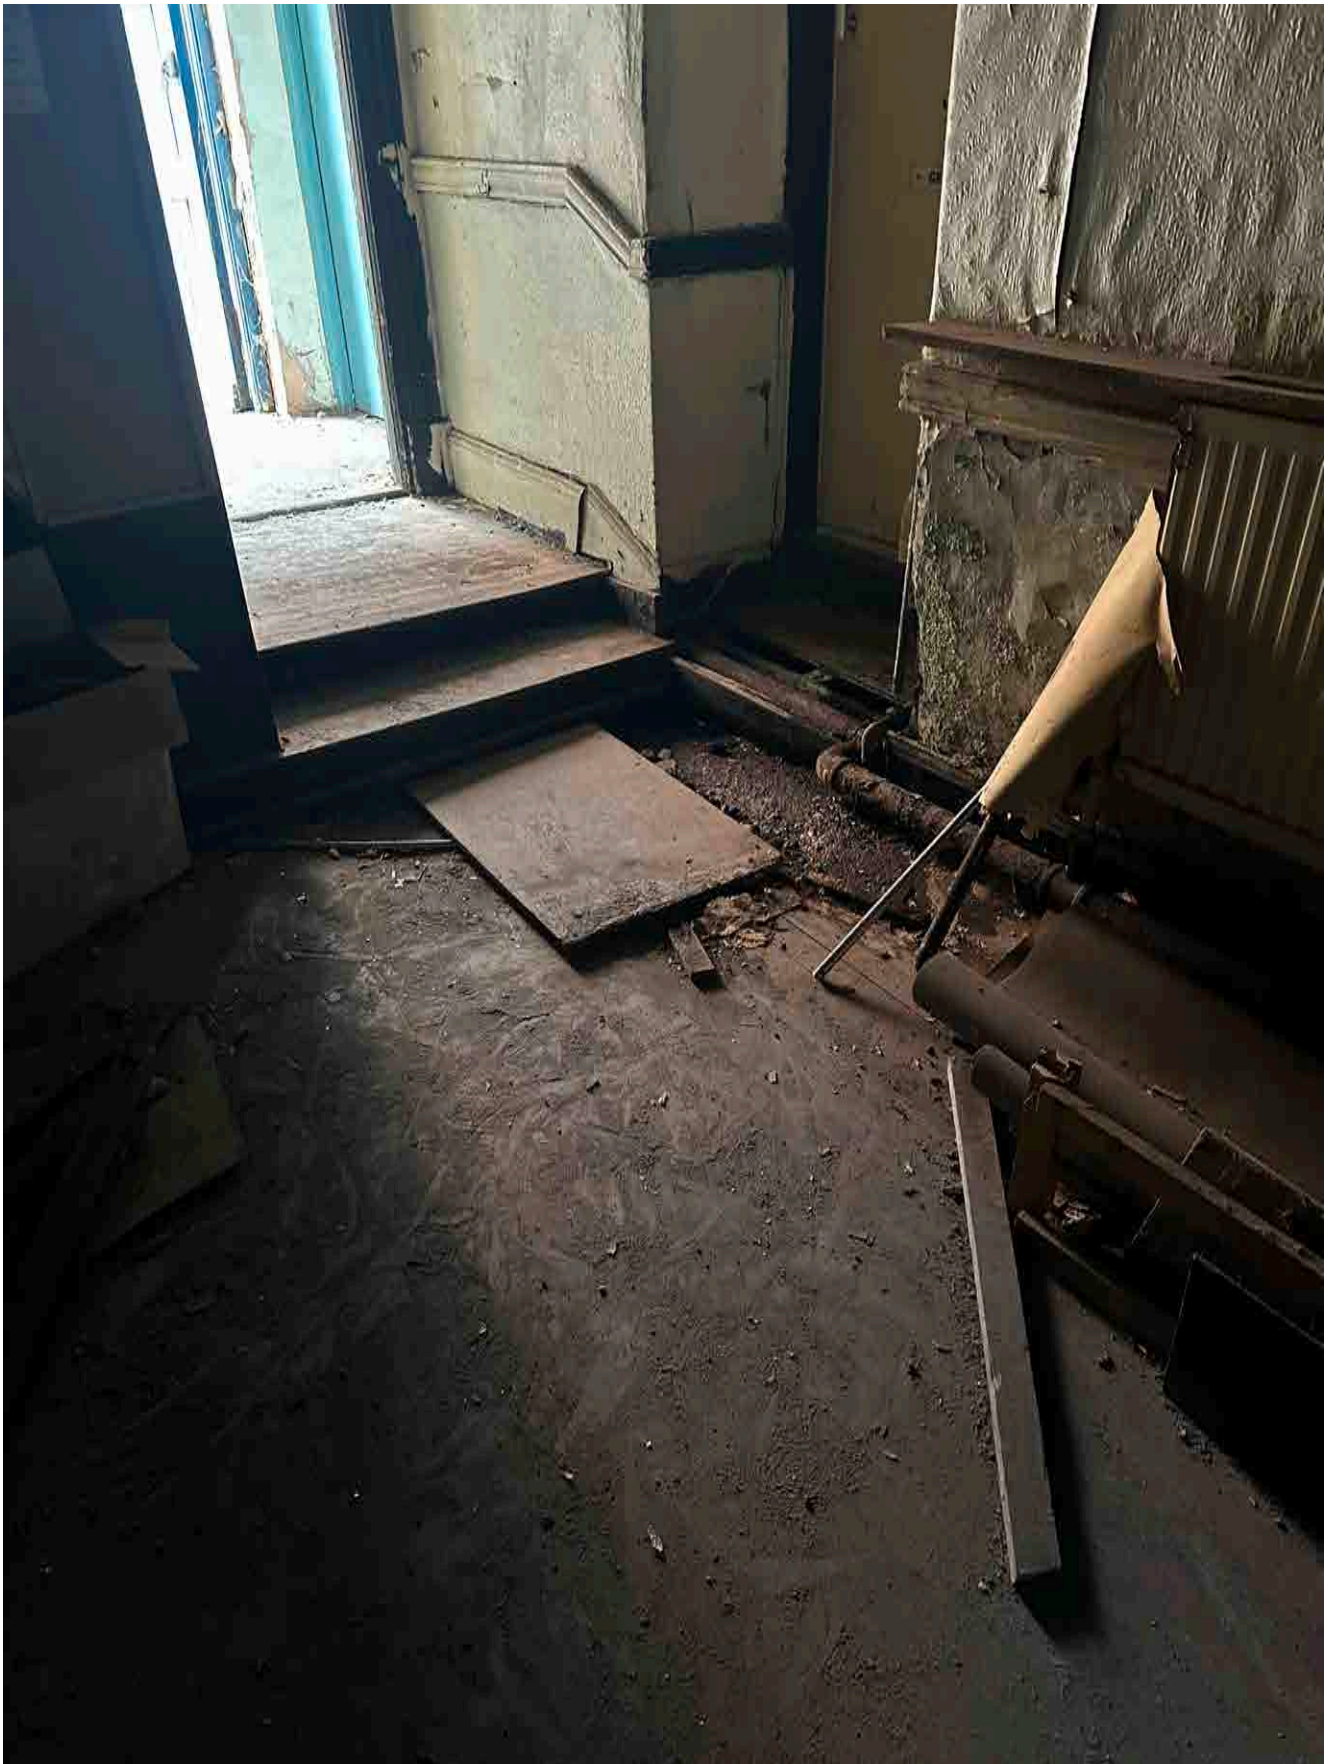
The rear section of the ground floor is constructed as a suspended timber floor. Although visually intact, the floor exhibits a noticeable degree of bounce when walked upon, indicating insufficient stiffness or deterioration in the supporting structure.

Suspended timber ground floor in the rear section of the building

Replacement of the suspended timber floor is advised to ensure it meets modern load-bearing and vibration standards, particularly for domestic use.

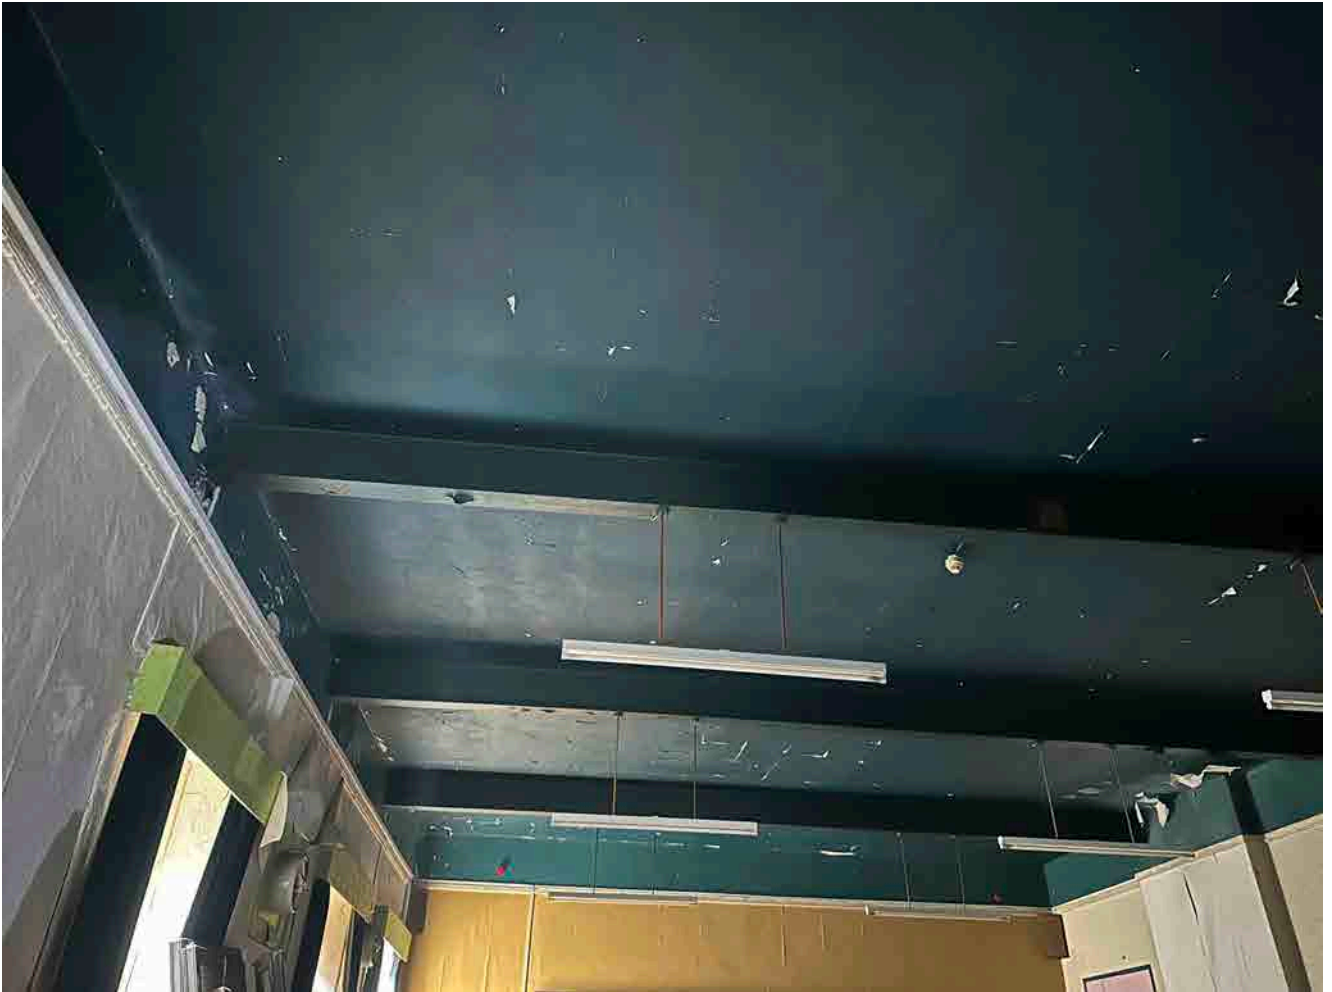
The first floor in the central and rear section of the building consists of timber joists spanning between steel beams which are supported by the stone masonry side walls. The floor appears generally sound, and there is no visible deflection or damage to the steelwork.

First floor supported by steel beams

While no immediate structural concerns were identified, we recommend a structural analysis of the existing members to verify their adequacy for the intended new loading regime under domestic conversion.

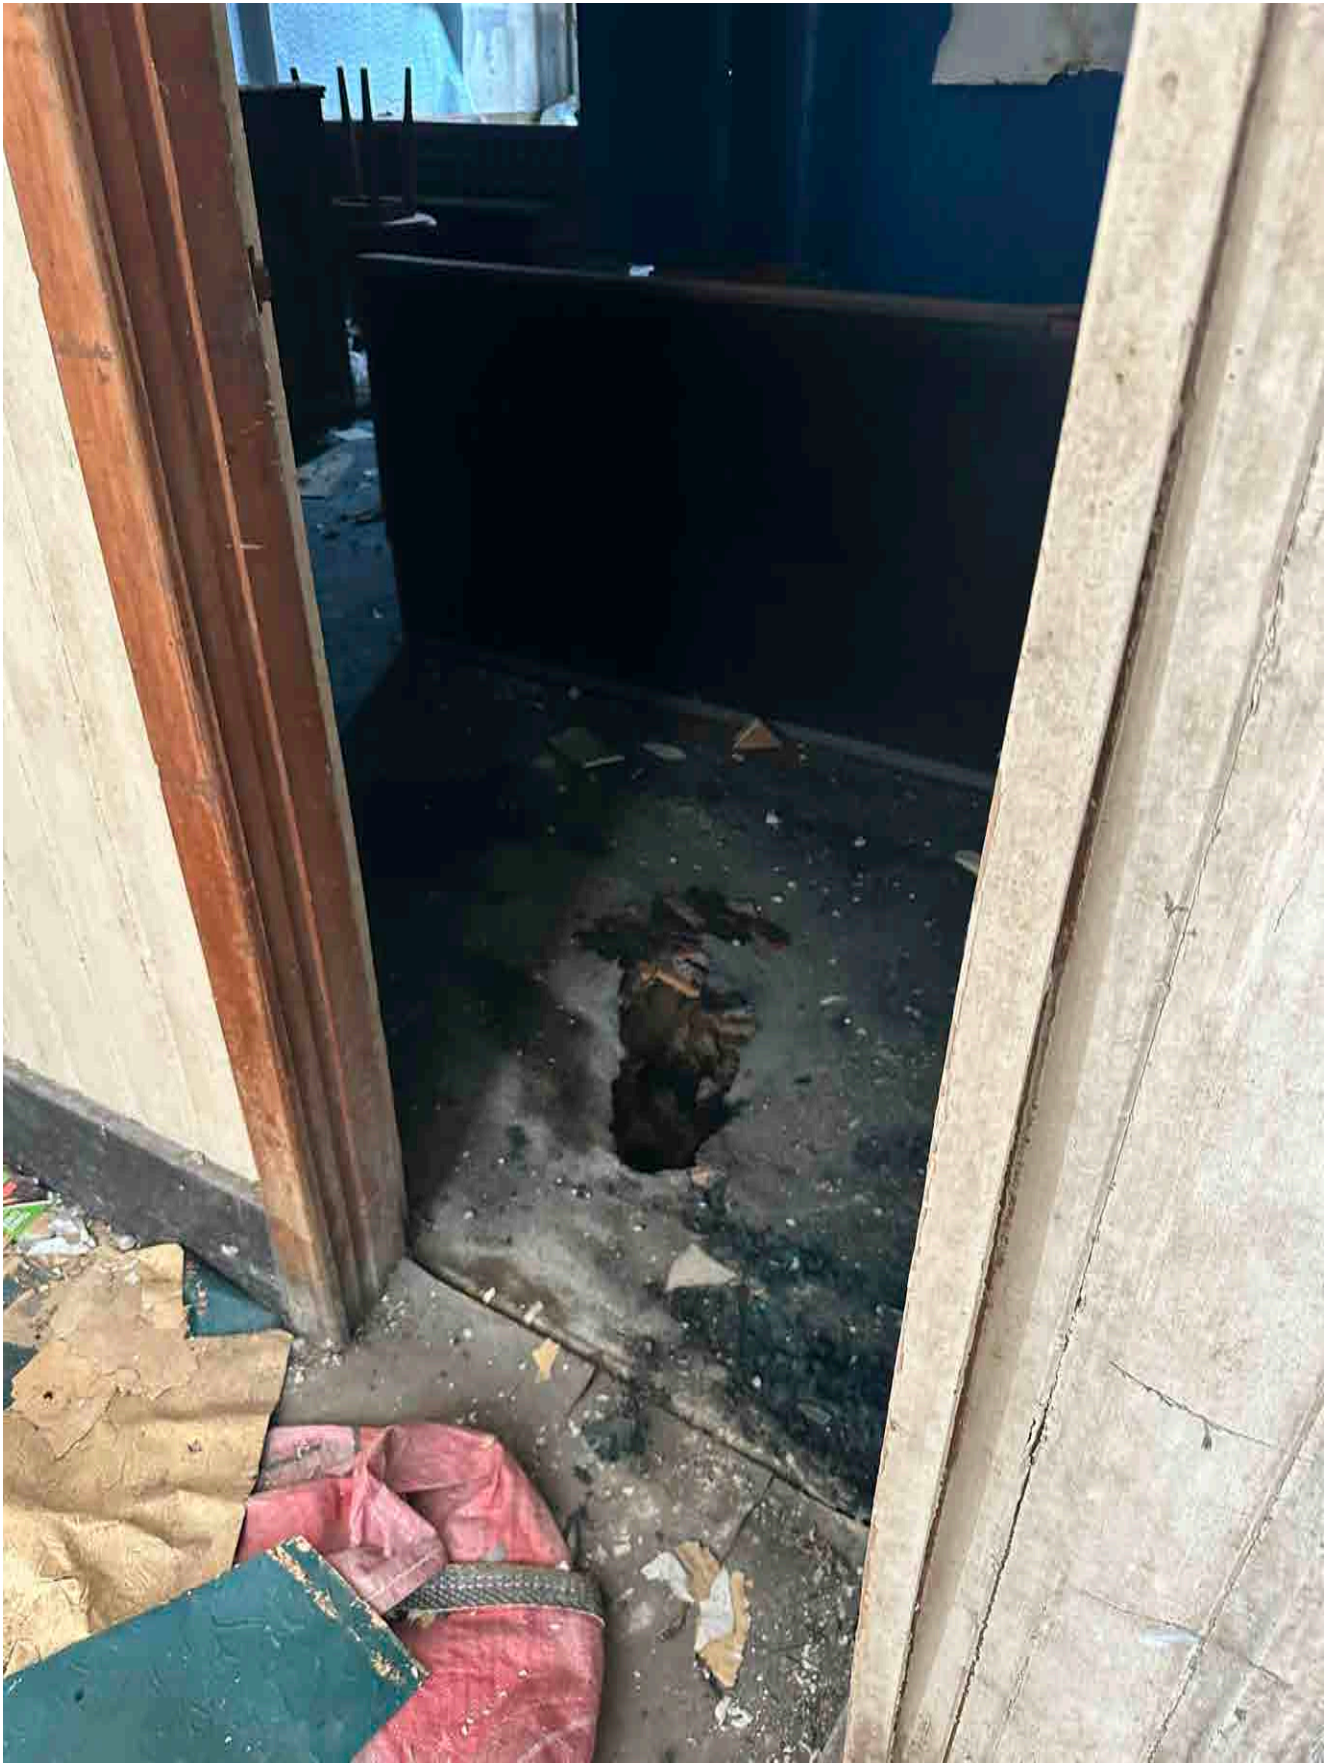
Internally, the front façade is visibly separating from the rest of the structure, and there is no evidence of suitable tying-in with return walls or internal walls. The first-floor structure and ceilings within the front section of the building show signs of significant timber decay and rot. These elements are considered structurally unsound and unsafe for use.

First floor in front section of the building. The timber is rotten and areas break underfoot

The affected floors and ceilings should be removed and reconstructed using treated structural timbers and suitable modern methods of restraint and support.

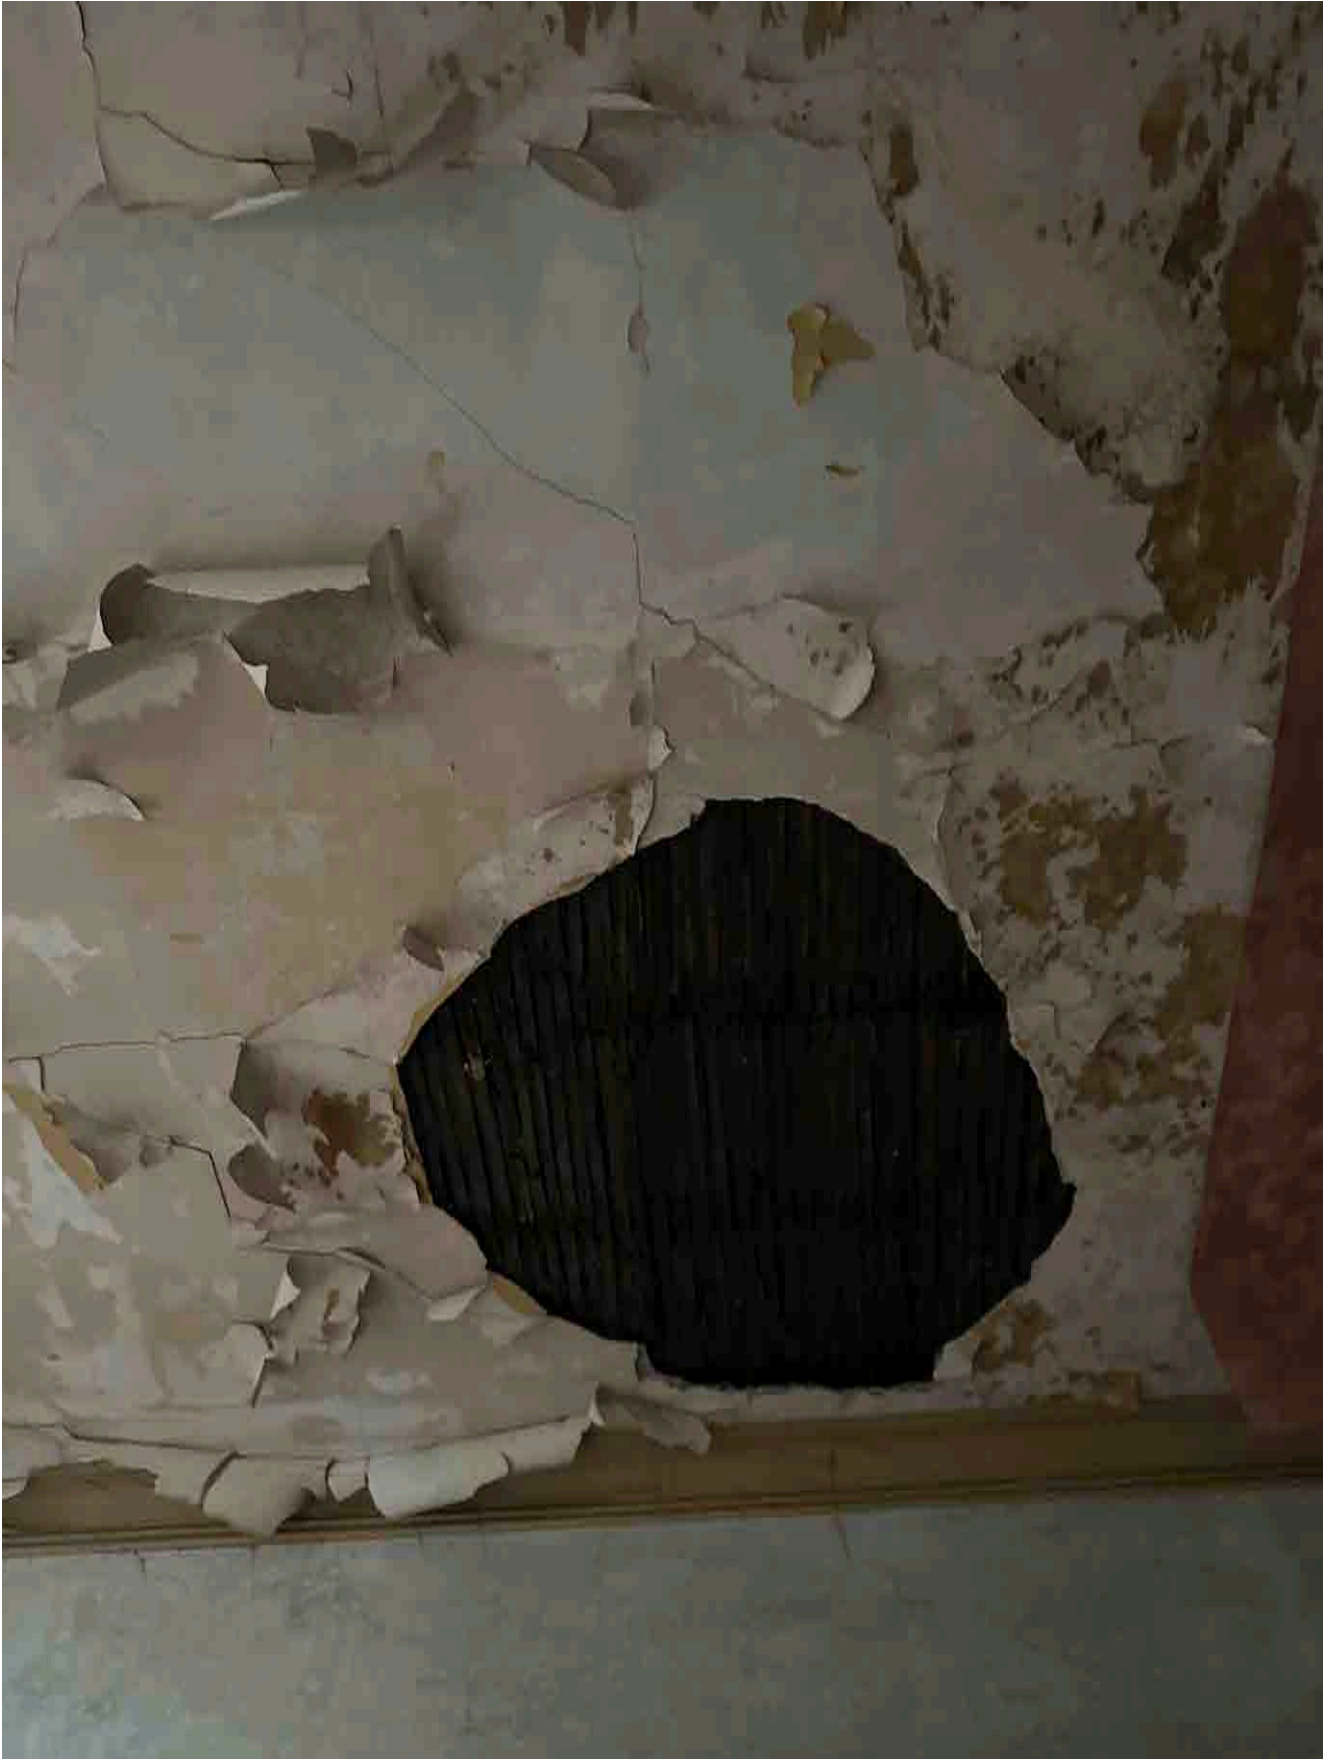
The first floor ceiling in the front section of the building is rotten and collapsed in some areas.

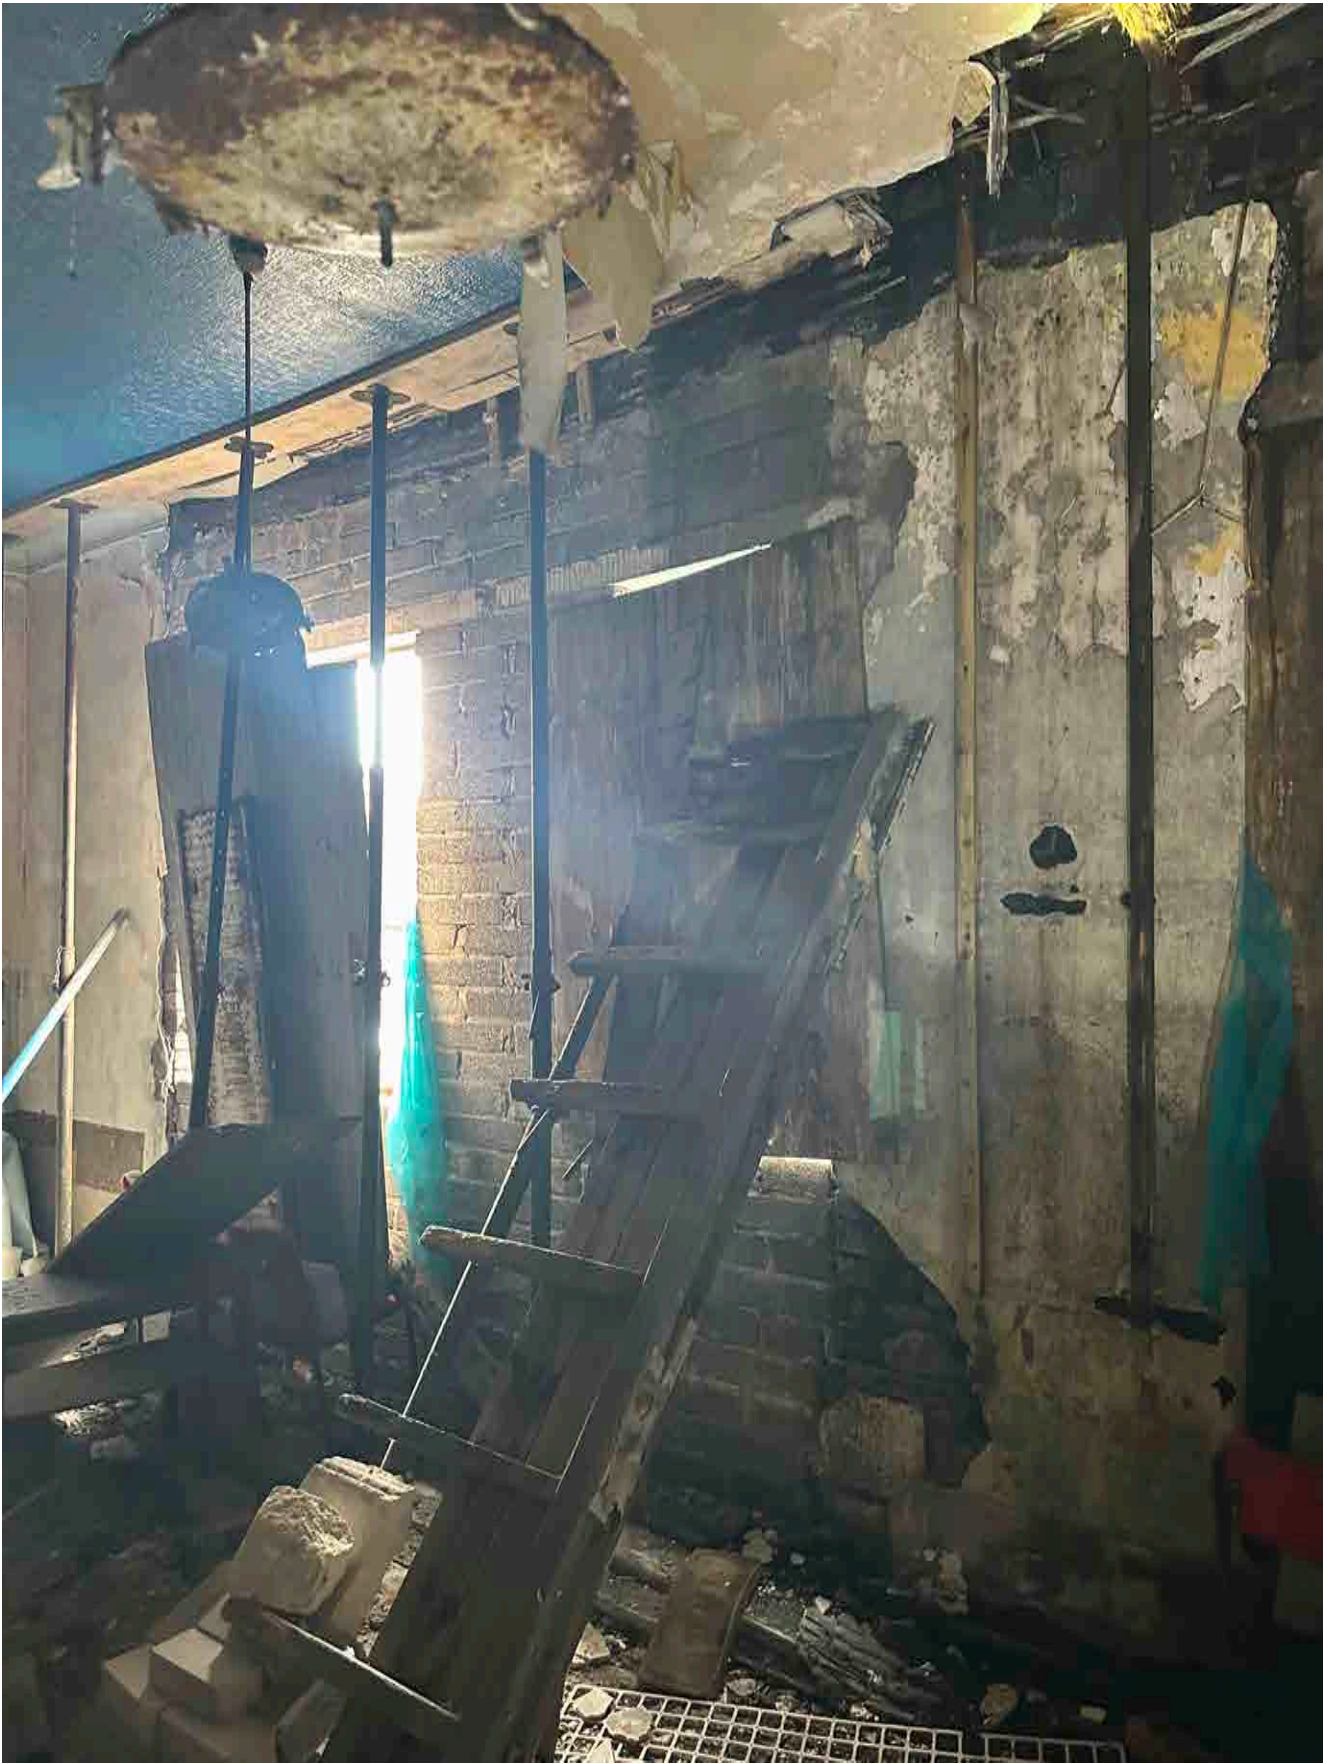
The interior face of the front facade. The floor above is propped as the timber sections have come a way from the facade in areas. The facade is leaning outwards.

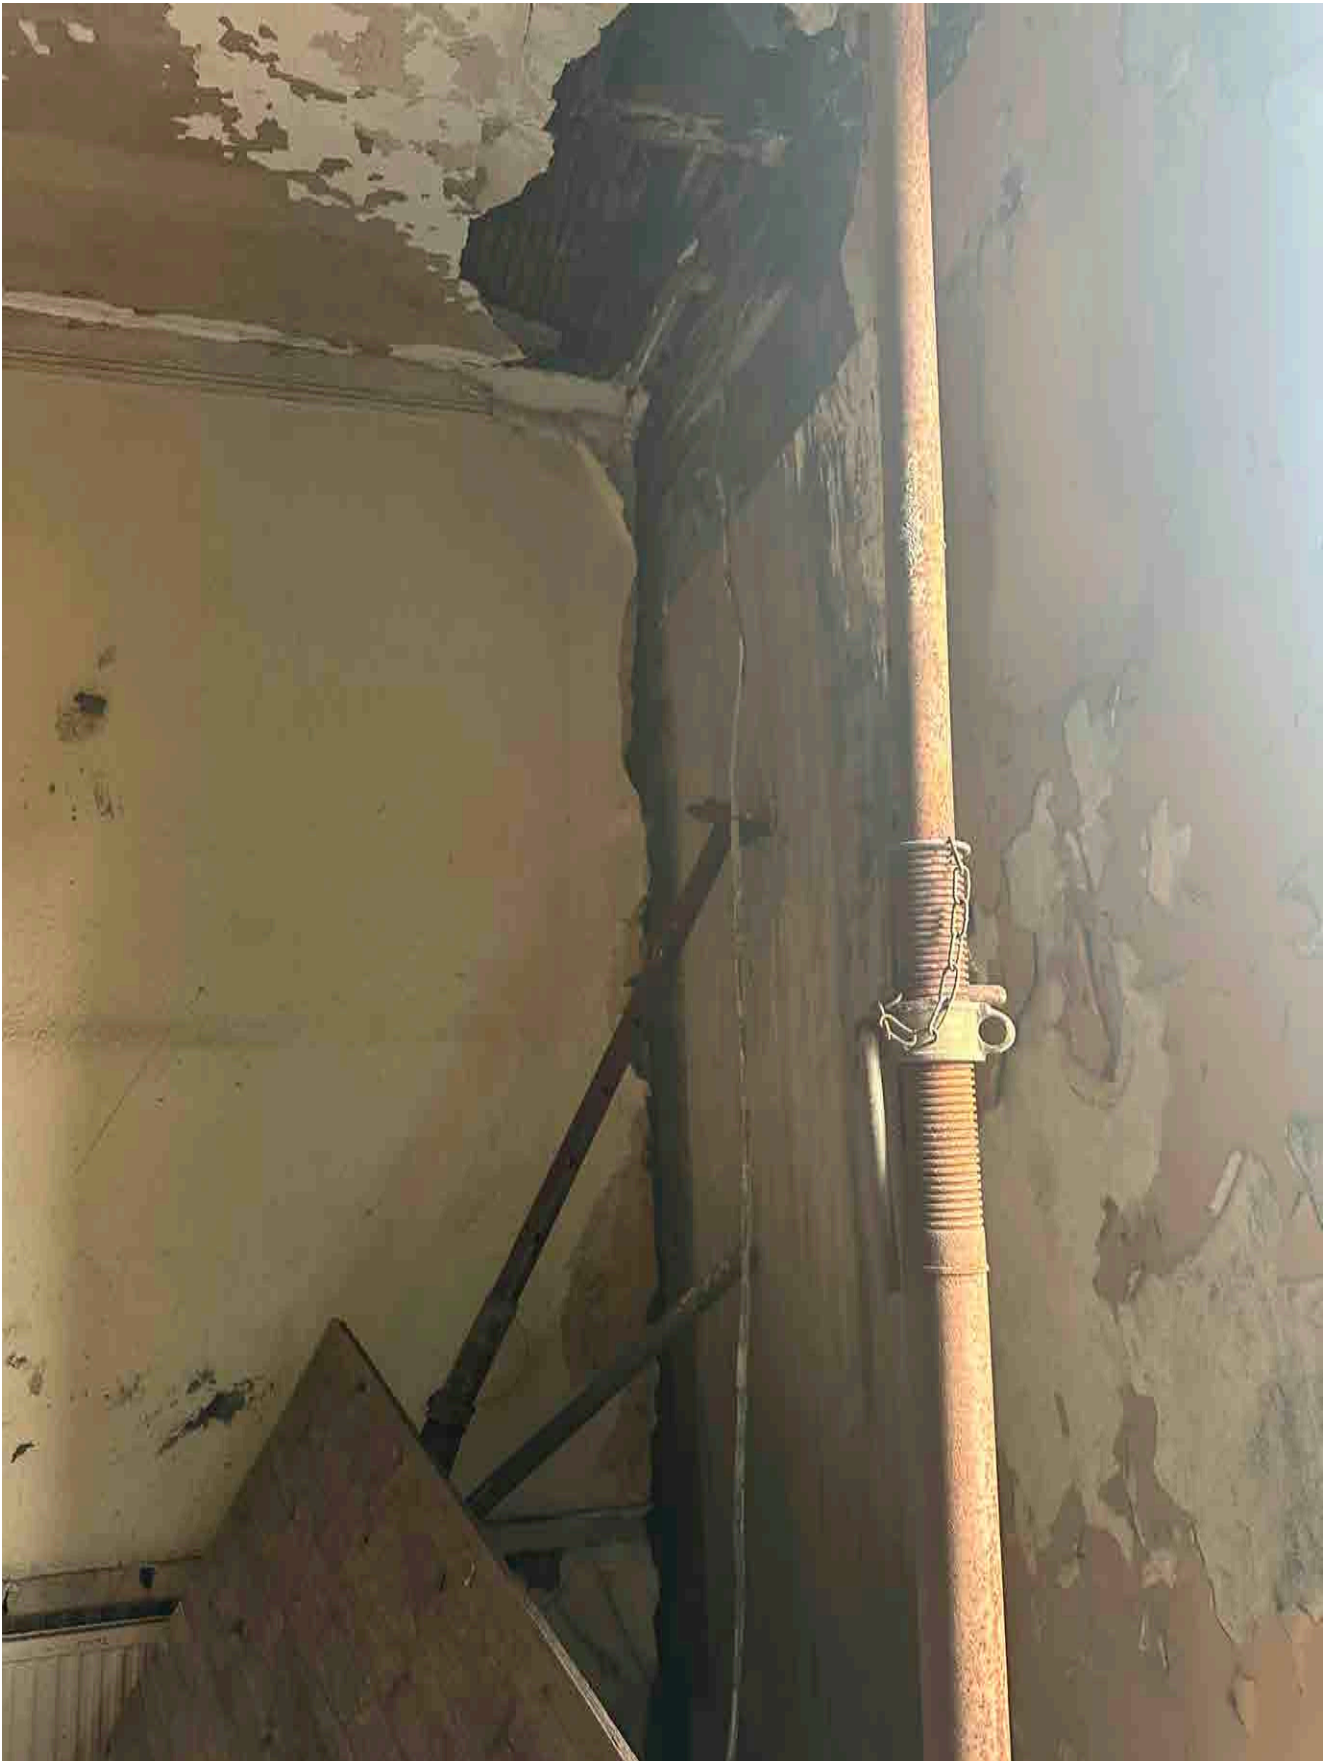
The front facade has become separated from a return wall inside the building

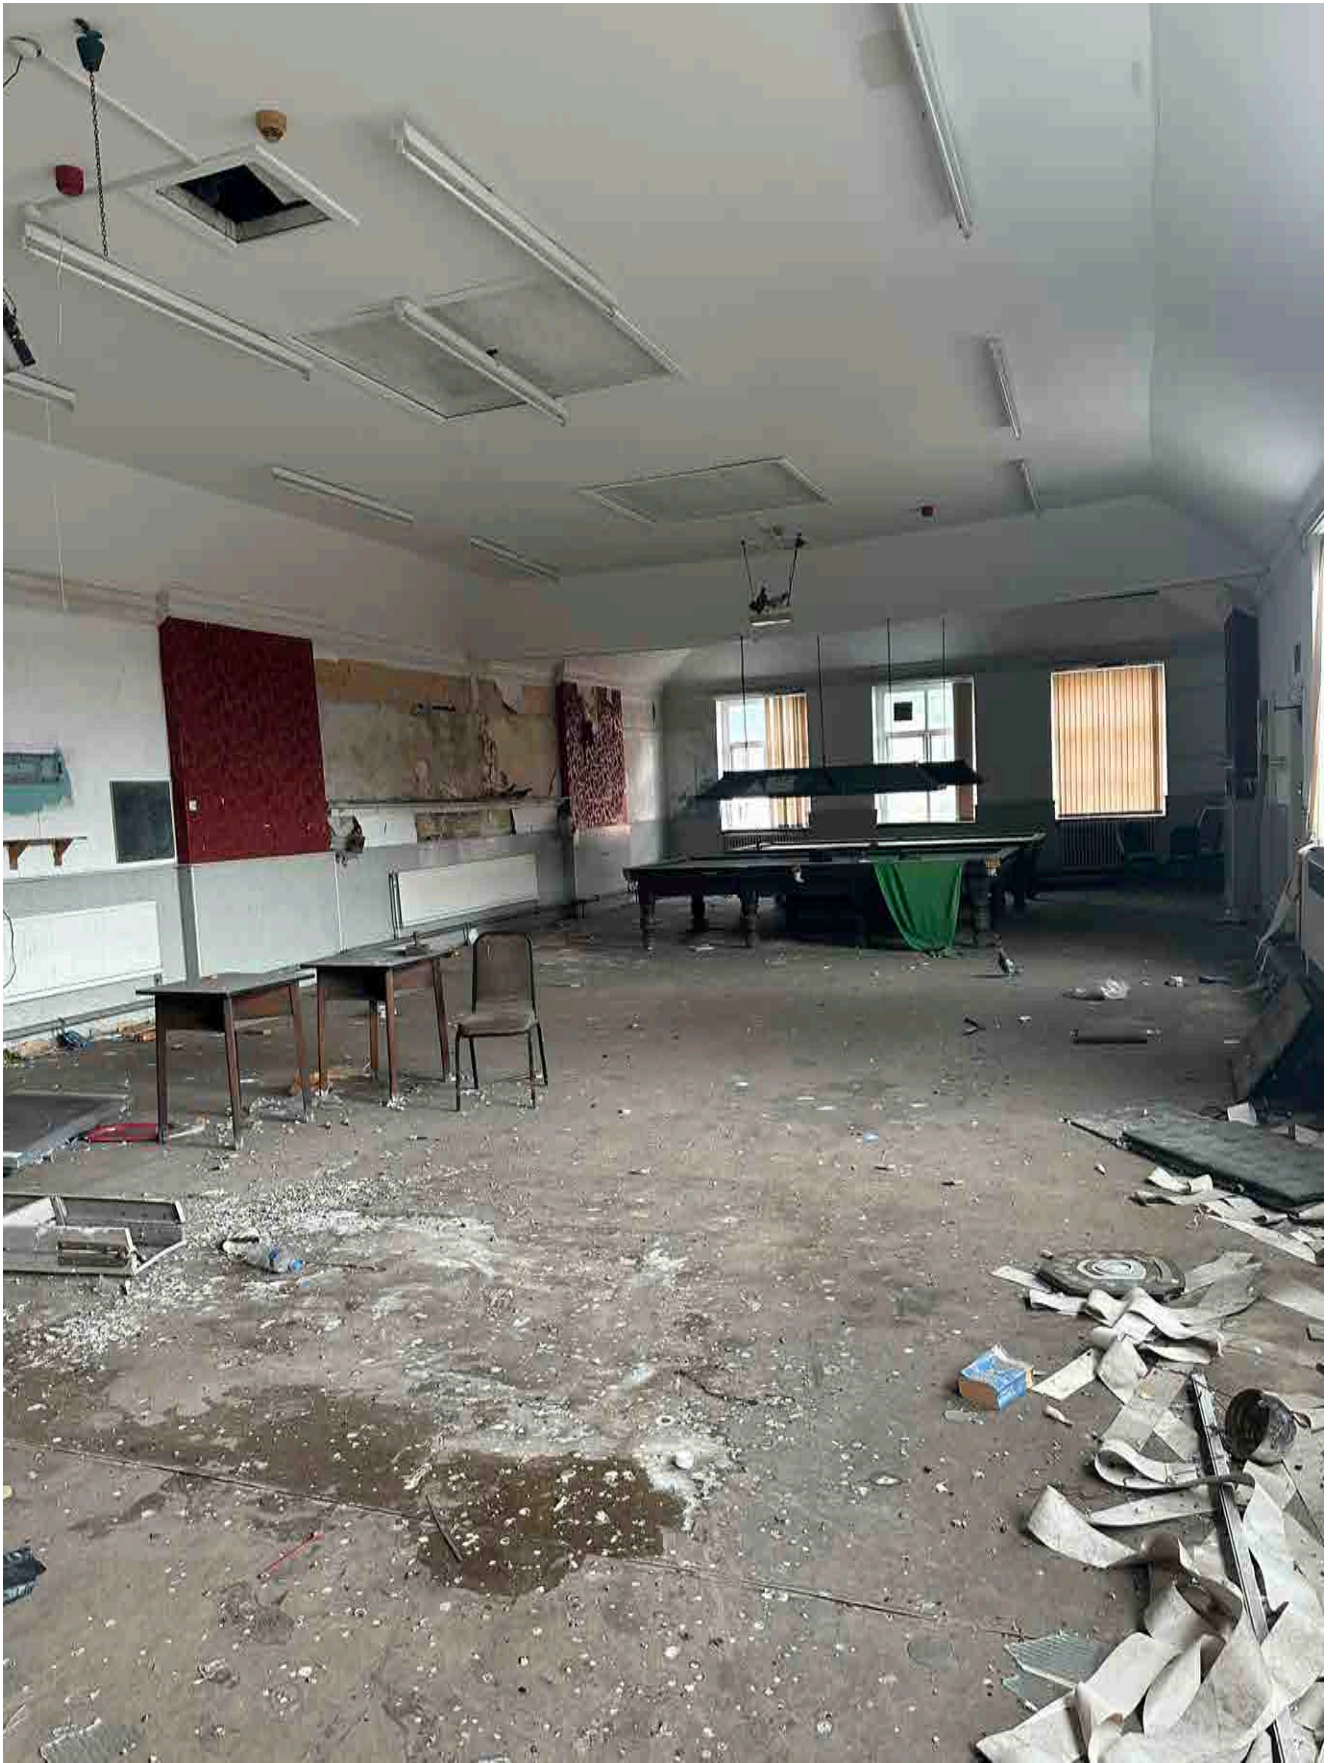
This large space appears to be in good structural condition, with substantial timber trusses supporting the roof.

The rear room on the first floor

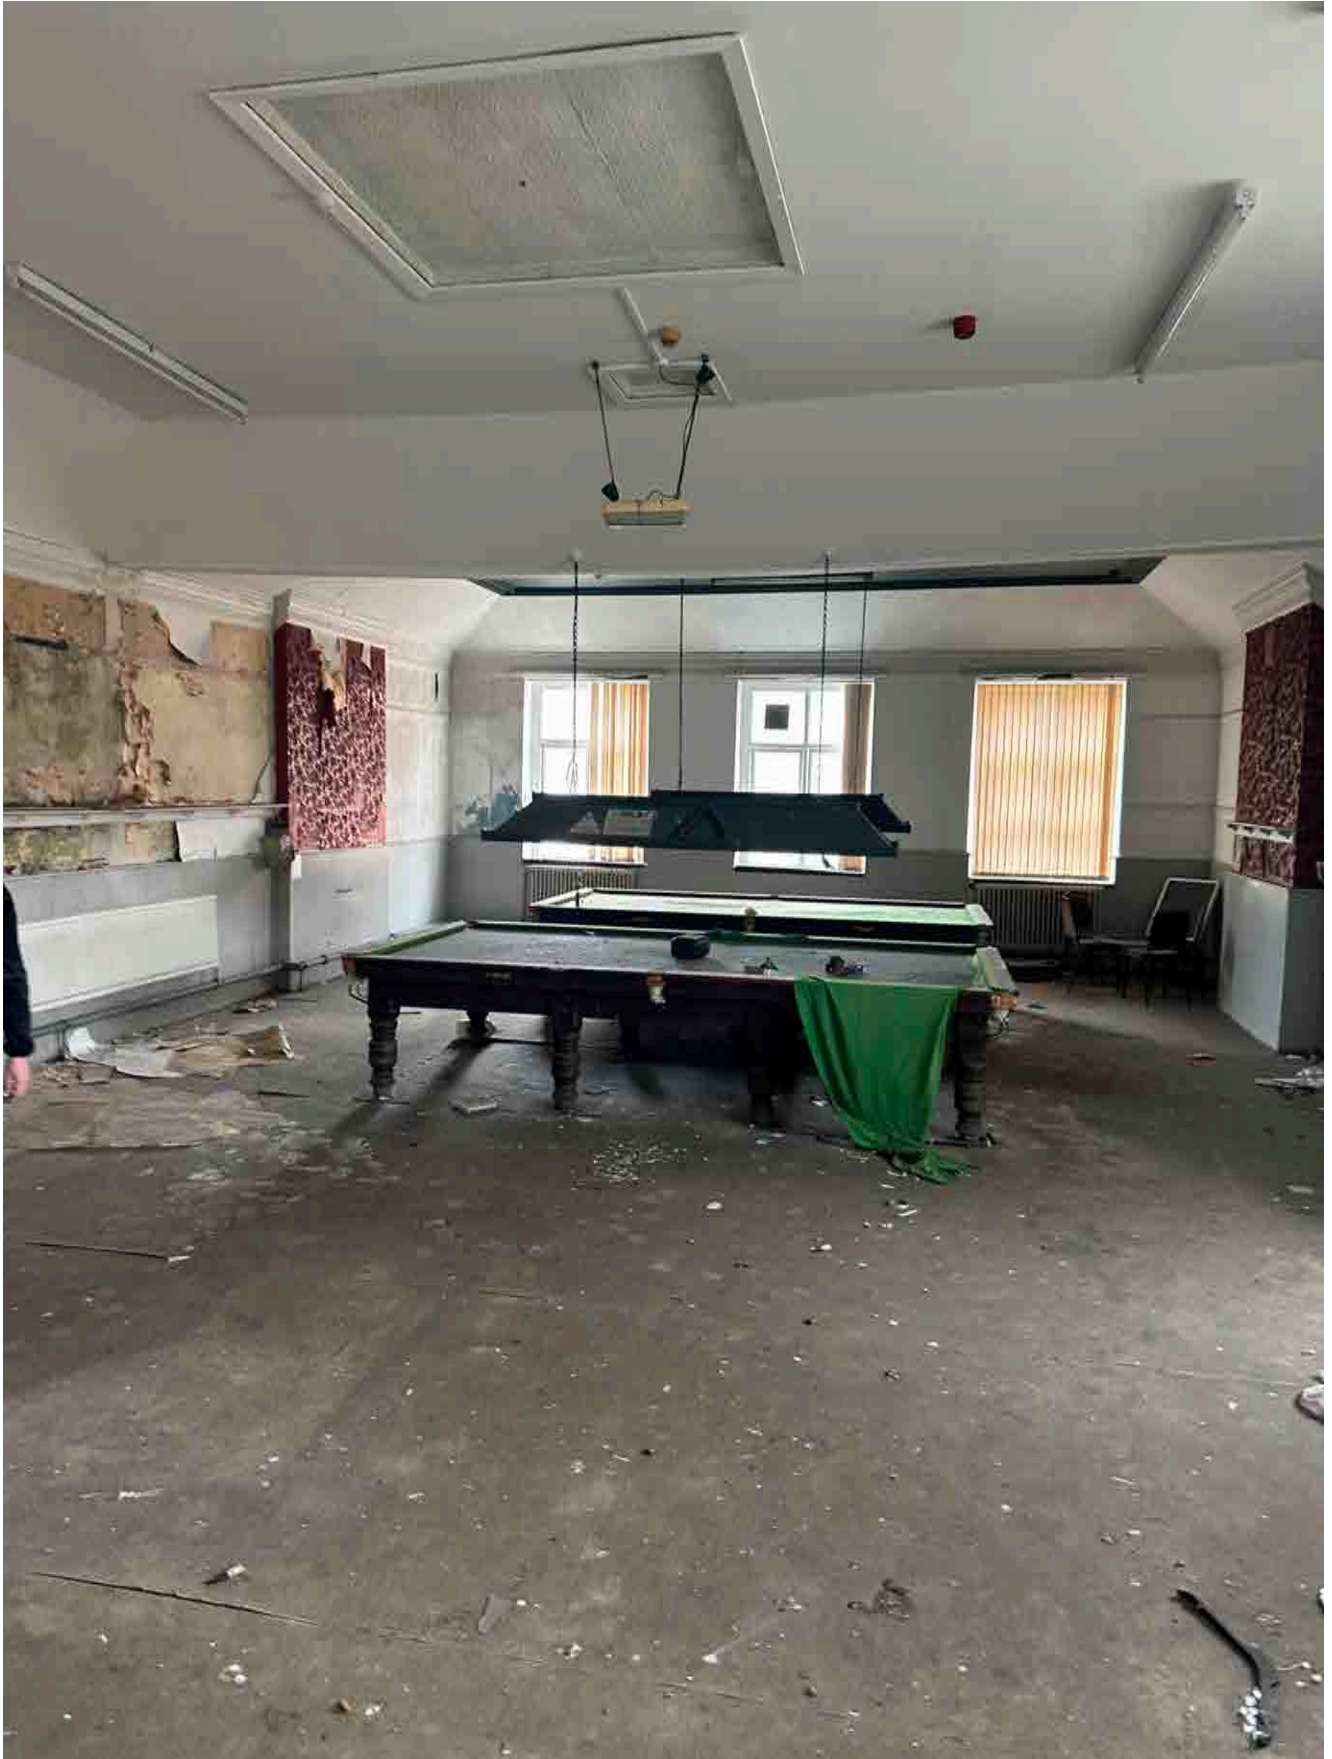
One truss located at the rear of the room exhibits noticeable bowing at mid-span.

The truss in the rear first floor room shows signs of bowing and should be strengthened

The affected truss should be structurally strengthened, subject to detailed structural analysis and conservation constraints.
