## **Structural Analysis Report**

Port Talbot And Aberavon Constitution Club  
62 – 62A Station Rd, Port Talbot

June 2025

Type of report: Structural Appraisal

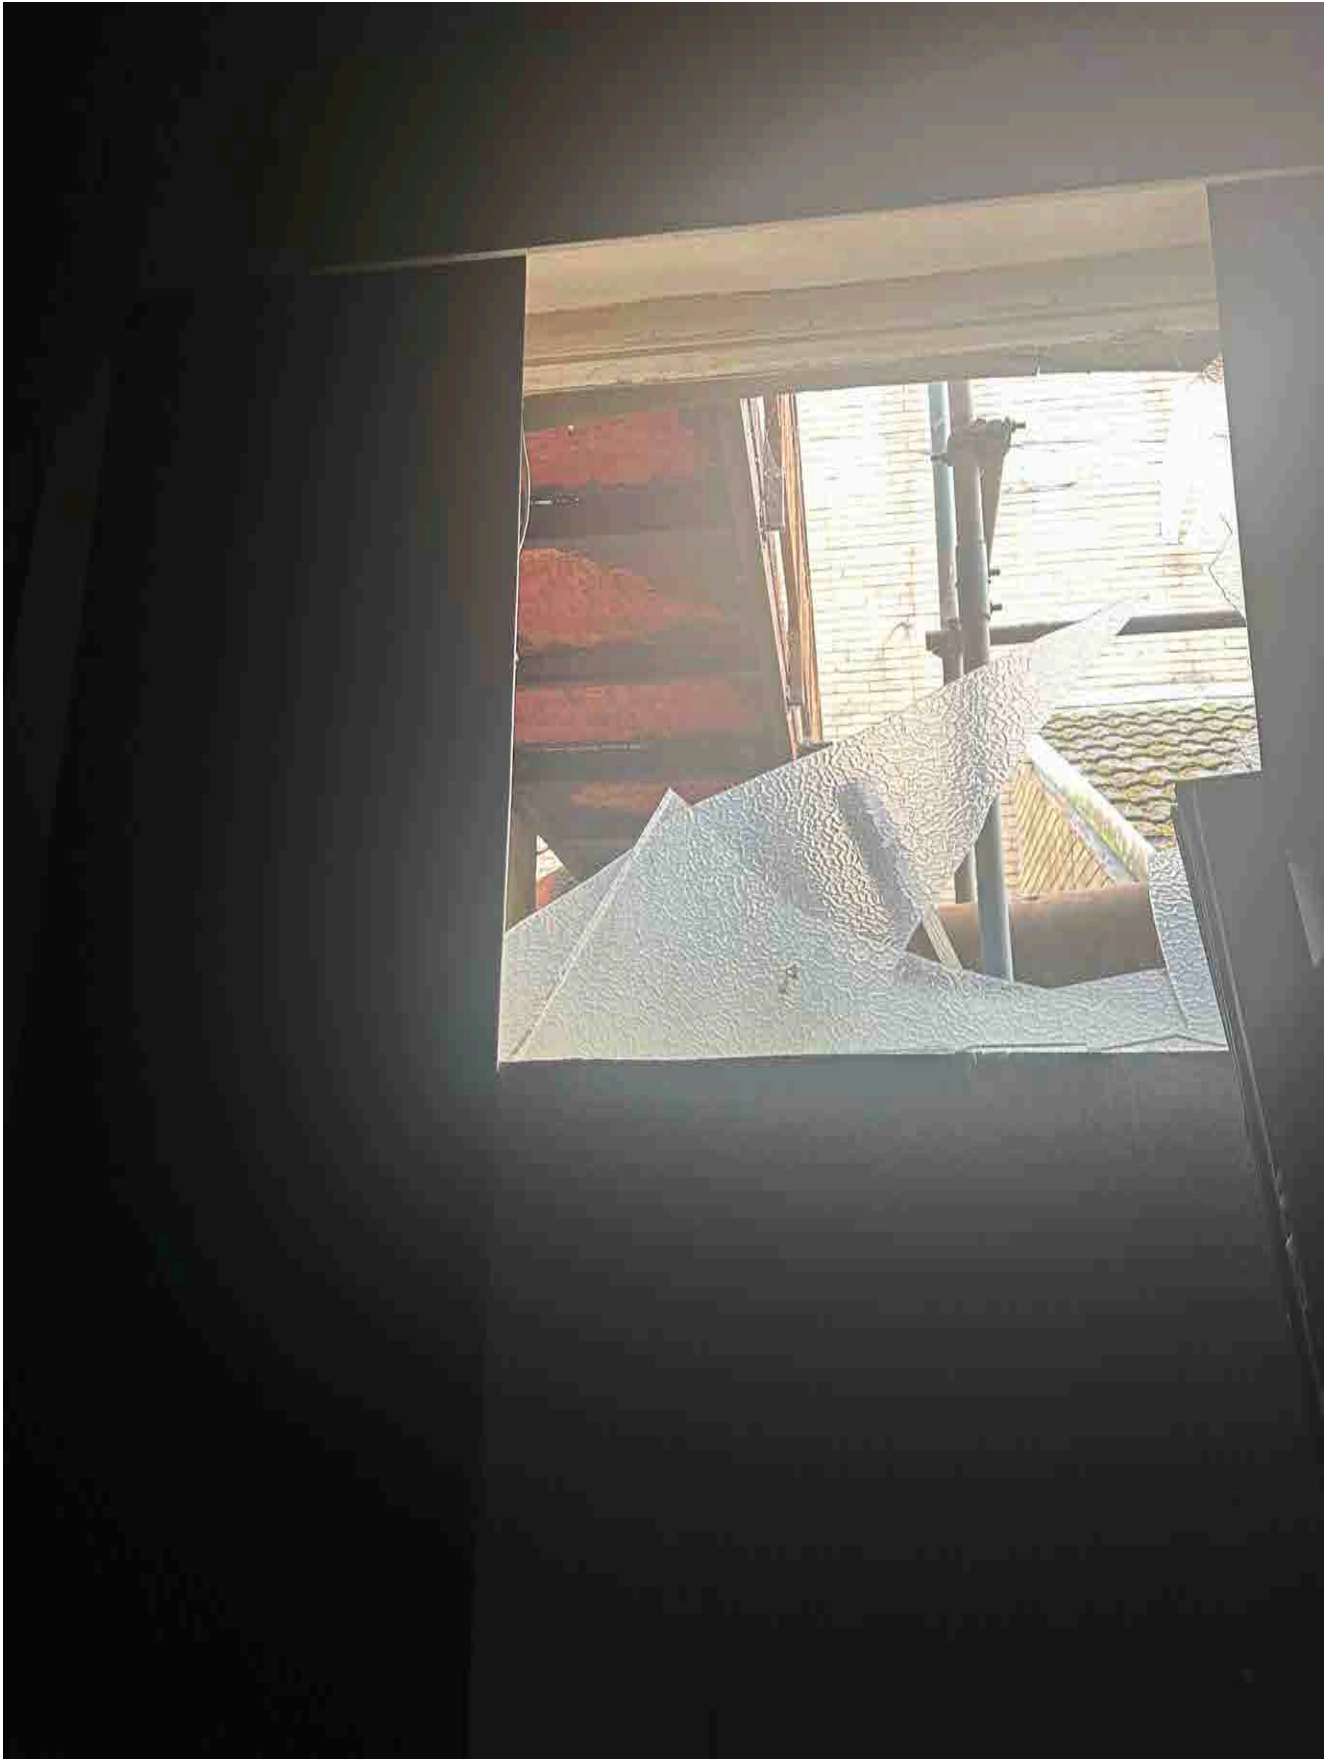
The steel fire escape structure to the rear of the building shows advanced signs of corrosion at the stringers and landings.

The fire escape at the rear shows signs of corrosion and should be replaced.

Full replacement of the fire escape is advised to ensure safety and compliance with current building regulations.
