**Caewern House, Neath, Swansea, Wales**

**Section 278 & Section 38 Highway Works**

**Road Safety Audit Combined Stage 1 & 2**

**on behalf of  
Neath Port Talbot County Borough Council**

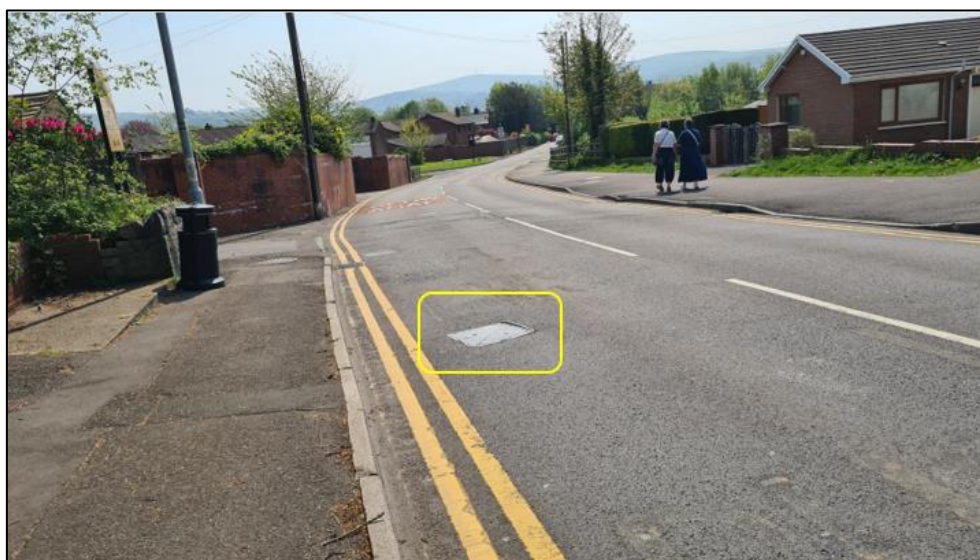
Location: Dwr Y Felin Road – service chamber cover

Summary: Risk of loss of control collisions due to reduced surface friction.

There is a metal service chamber inspection cover located within the extents of the proposed junction which has become smoothed, reducing its surface friction. The cover will be in the critical braking and turning area, particularly for users turning left into the development from the west. The location of the smoothed cover increases the risk of loss of control collisions, particularly for powered two-wheelers.

Dwr Y Felin Road looking south, showing smoothed metal service chamber cover

The service cover should be relocated out of the critical braking area. If it is not possible to relocate, it should be replaced with a cover with a non-slip surface with a similar PSV as the surrounding carriageway.
