**BS5837:2012 Tree Survey & Arboricultural  
Constraints Report**

**Visitor Arrival Centre  
Margam Country Park**

**January 2026**

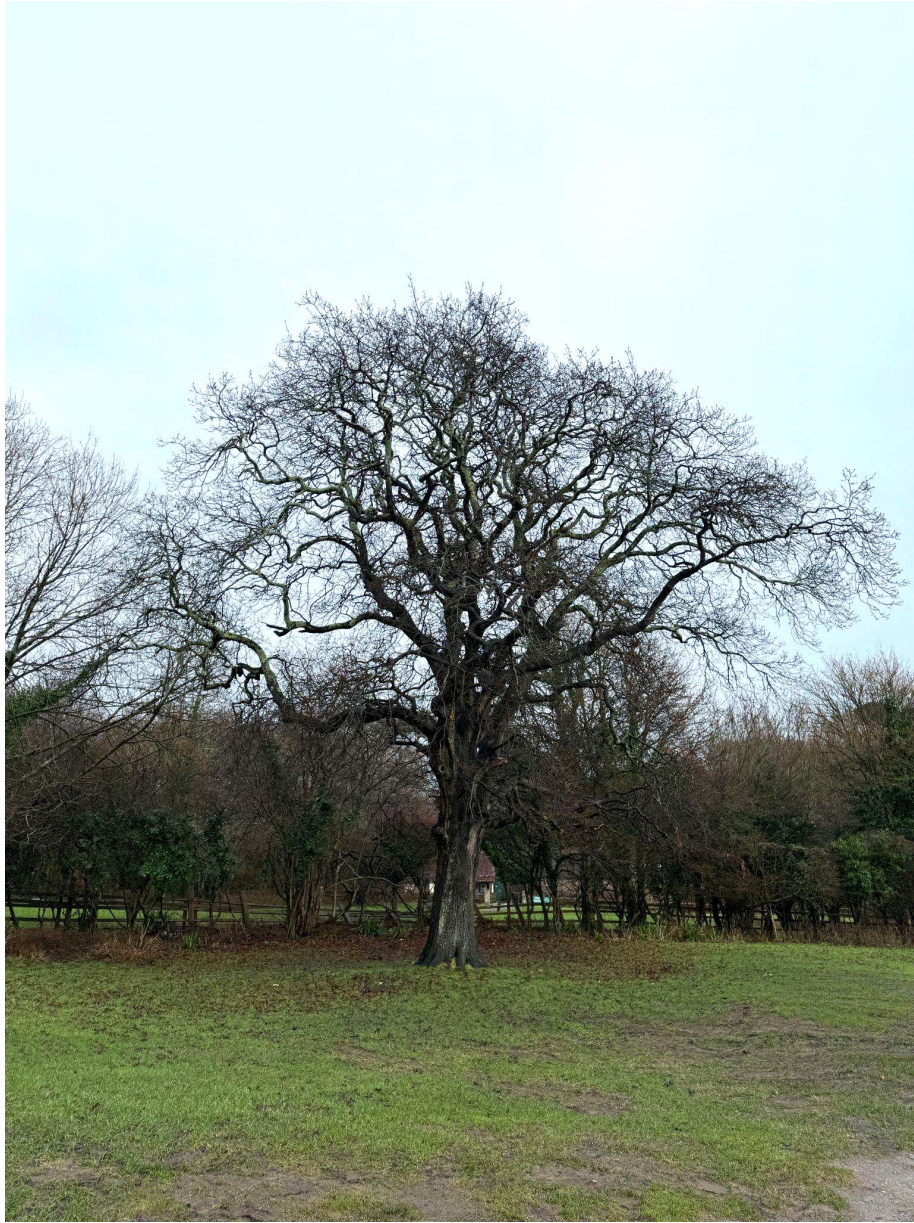
**IMAGE 1 : Tree 161**

| Tree no. | Species | Ht. (m) | Stem dia. (cms) | Age | Crown spread (m) | | | | Low branches | Cat. | Notes |
|---|---|---|---|---|---|---|---|---|---|---|---|
| 161 | Oak | 15.0 | 87 | EM | 9.0 | 9.8 | 9.1 | 7.7 | 2.0 | B1 | An open grown spreading form with numerous cavities on the main stem and scaffold branches. Deadwood in the inner crown. |

| Tree no. | Species | Mean stem dia. (cms) | RPA 1 (m2) | Minimum radial protection (m) | | Justification for RPA modification | Position of protective barrier |
|---|---|---|---|---|---|---|---|
| 161 | Oak | 87 | 346 | 10.5 | No | NA | As shown on the tree survey plan. |

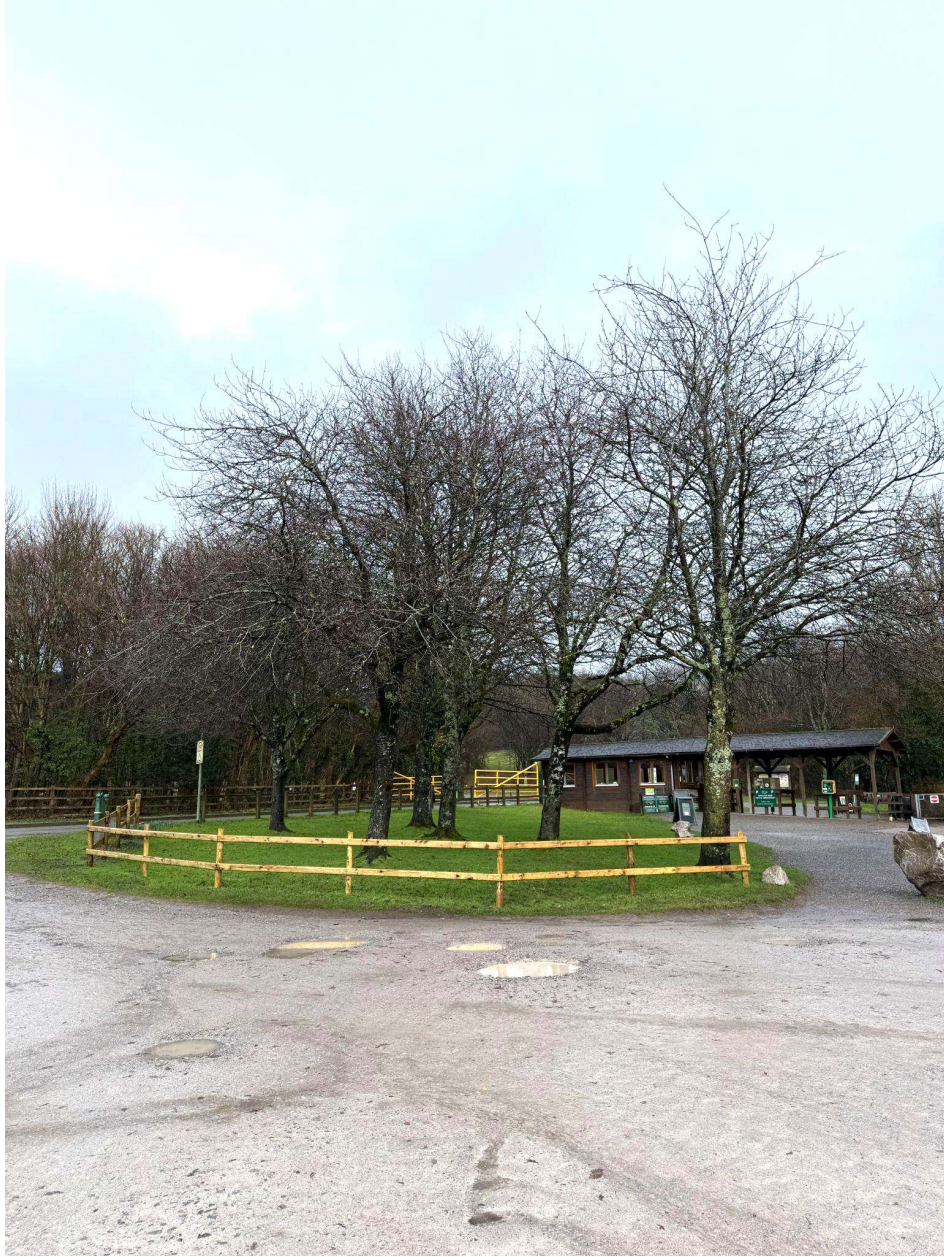
**IMAGE 2 : Trees 163 to 168**

| Tree no. | Species | Ht. (m) | Stem dia. (cms) | Age | Crown spread (m) | | | | Low branches | Cat. | Notes |
|---|---|---|---|---|---|---|---|---|---|---|---|
| 163 | Cherry | 10.0 | 41 | EM | 3.0 | 5.0 | 4.3 | 4.4 | 2.5 | B2 | This tree is bordering the B / C category with a poor form and a fork with included bark at 3 metres above ground level. There is also a girdling root at the base of the main stem. |
| 164 | Cherry | 11.0 | 37 | EM | 6.4 | 3.2 | 5.1 | 4.8 | 2.5 | B2 | A well balanced form. |
| 165 | Cherry | 10.0 | 38 | EM | 4.2 | 8.1 | 2.2 | 2.6 | 2.5 | B2 | An asymmetric form with a lean to the east. |
| 166 | Cherry | 13.0 | 41 | EM | 3.4 | 4.5 | 2.7 | 3.0 | 4.0 | B2 | Numerous girdling roots on the buttress roots. |
| 167 | Cherry | 13.0 | 49 | EM | 7.5 | 7.4 | 2.9 | 2.6 | 2.5 | B2 | Poor form. |
| 168 | Cherry | 10.0 | 41 | EM | 6.4 | 3.0 | 3.6 | 3.0 | 2.5 | B2 | A well balanced form. |

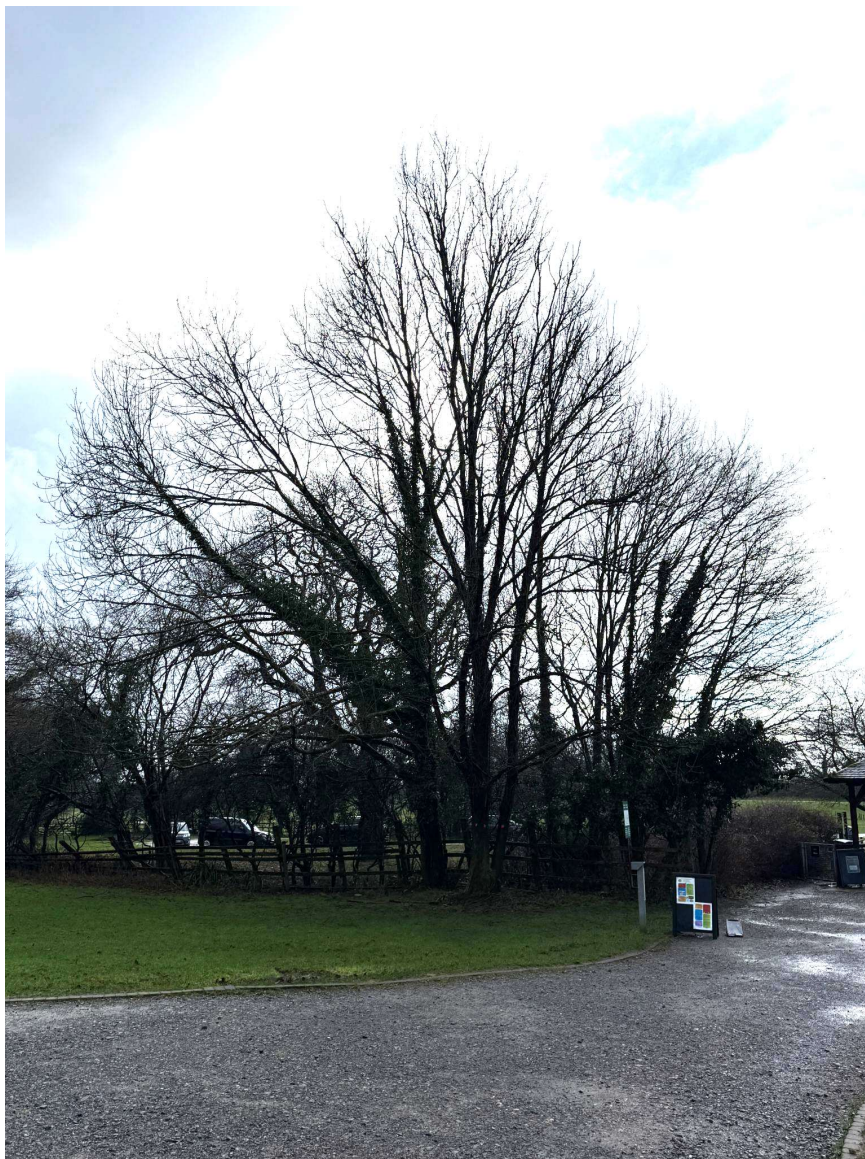
**IMAGE 3 : Trees 169 to 174**

| Tree no. | Species | Ht. (m) | Stem dia. (cms) | Age | Crown spread (m) | | | | Low branches | Cat. | Notes |
|---|---|---|---|---|---|---|---|---|---|---|---|
| 169 | Rowan | 9.0 | 17 | SM | 3.8 | 1.0 | 1.0 | 3.5 | 2.5 | C2 | An asymmetric crown due to suppression from tree 170. |

| 170 | Field Maple | 8.0 | 27 | SM | 5.6 | 3.7 | 3.4 | 6.0 | 2.0 | B2 | NC |
| 171 | Ash | 10.0 | 28 | SM | 4.2 | 0.0 | 5.2 | 6.0 | 1.6 | C2 | A poor form with an asymmetric crown. Monitor annually for Chalara Ash dieback disease. |
| 172 | Ash | 12.0 | 23 | SM | 1.9 | 1.5 | 2.6 | 3.0 | 3.5 | C2 | Monitor annually for Chalara Ash dieback disease. |
| 173 | Ash | 13.0 | 40 | EM | 6.2 | 6.1 | 1.6 | 2.9 | 2.5 | U | Infected with Chalara dieback disease. Remove tree. |
| 174 | Ash | 13.0 | 54 | EM | 1.8 | 8.8 | 8.0 | 2.8 | 1.5 | B2 | A poor form with an asymmetric crown. Deadwood in the lower crown. Monitor annually for Chalara Ash dieback disease. |

5.12 To replace tree 173 on completion of the development it would be beneficial to the site and surrounding area if three new trees are planted. Suitable species would be two Field Maple (*Acer campestre*) and one Rowan (*Sorbus aucuparia*).
