# 93 Gwyn Street

Tree Condition Survey 12th December 2025

| Site Location: 93 Gwyn Street, Alltwen | Report Reference: 12.25/GWS/V3 |

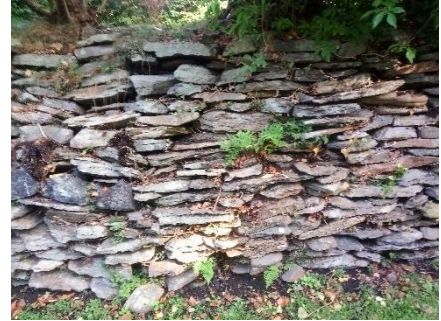
4.3 T8, beech, the wall below this tree is bowing out; this should be monitored for increased movement.

October 2022

December 2025

There does not appear to have been any significant changes in the condition of the wall.

| Tree Ref | Species | H (m) | Spr (m) | Maturity | Condition | Action Recommendations | Hours | Priority | Done | Inspected |
|---|---|---|---|---|---|---|---|---|---|---|
| Comment: Stones falling out of wall below this tree. | | | | | | | | | | |
