### **Tree condition report**

This report has been prepared for Phillip Hopkin it relates to the 2 Common Oak (*Quercus robur*) tree (T1 and T2) to the rear of the house at 60 Waun Daniel, Rhos. I was contacted to discuss pruning T2 initially. But on further investigation it became clear that T1 was a safety risk to the homeowners and neighbouring properties. As a result, I've been asked to prepare this report to support the request for the removal of both T1 and T2 to ground level. The evidence to support this report are on page 3 of this document.

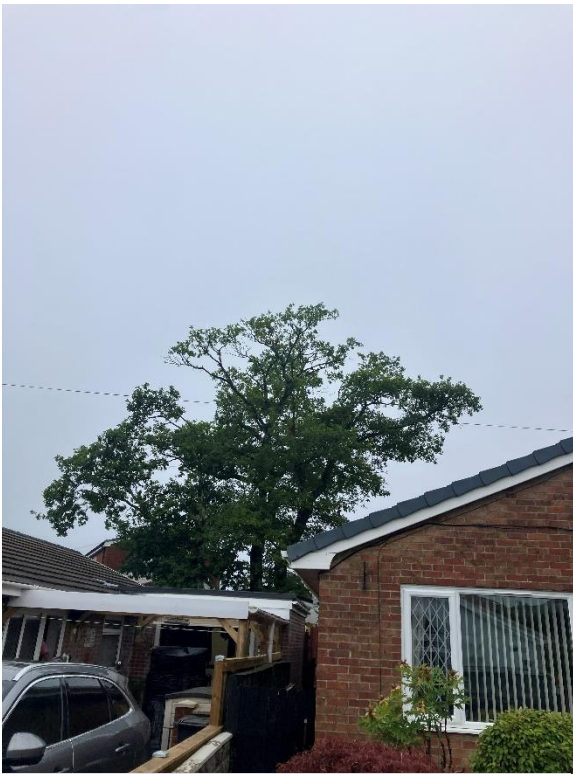
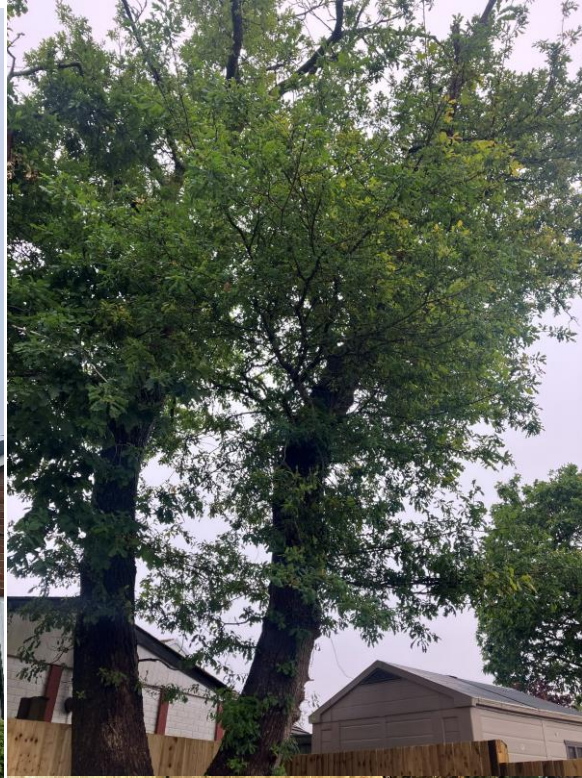
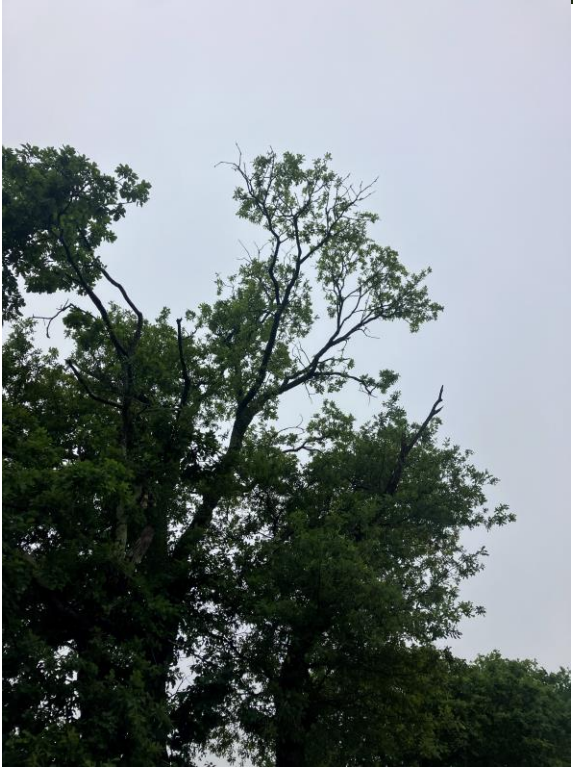
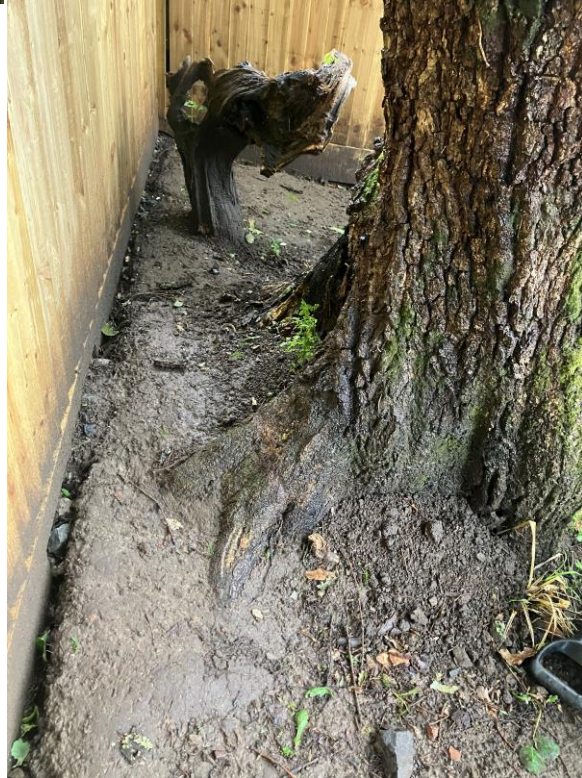
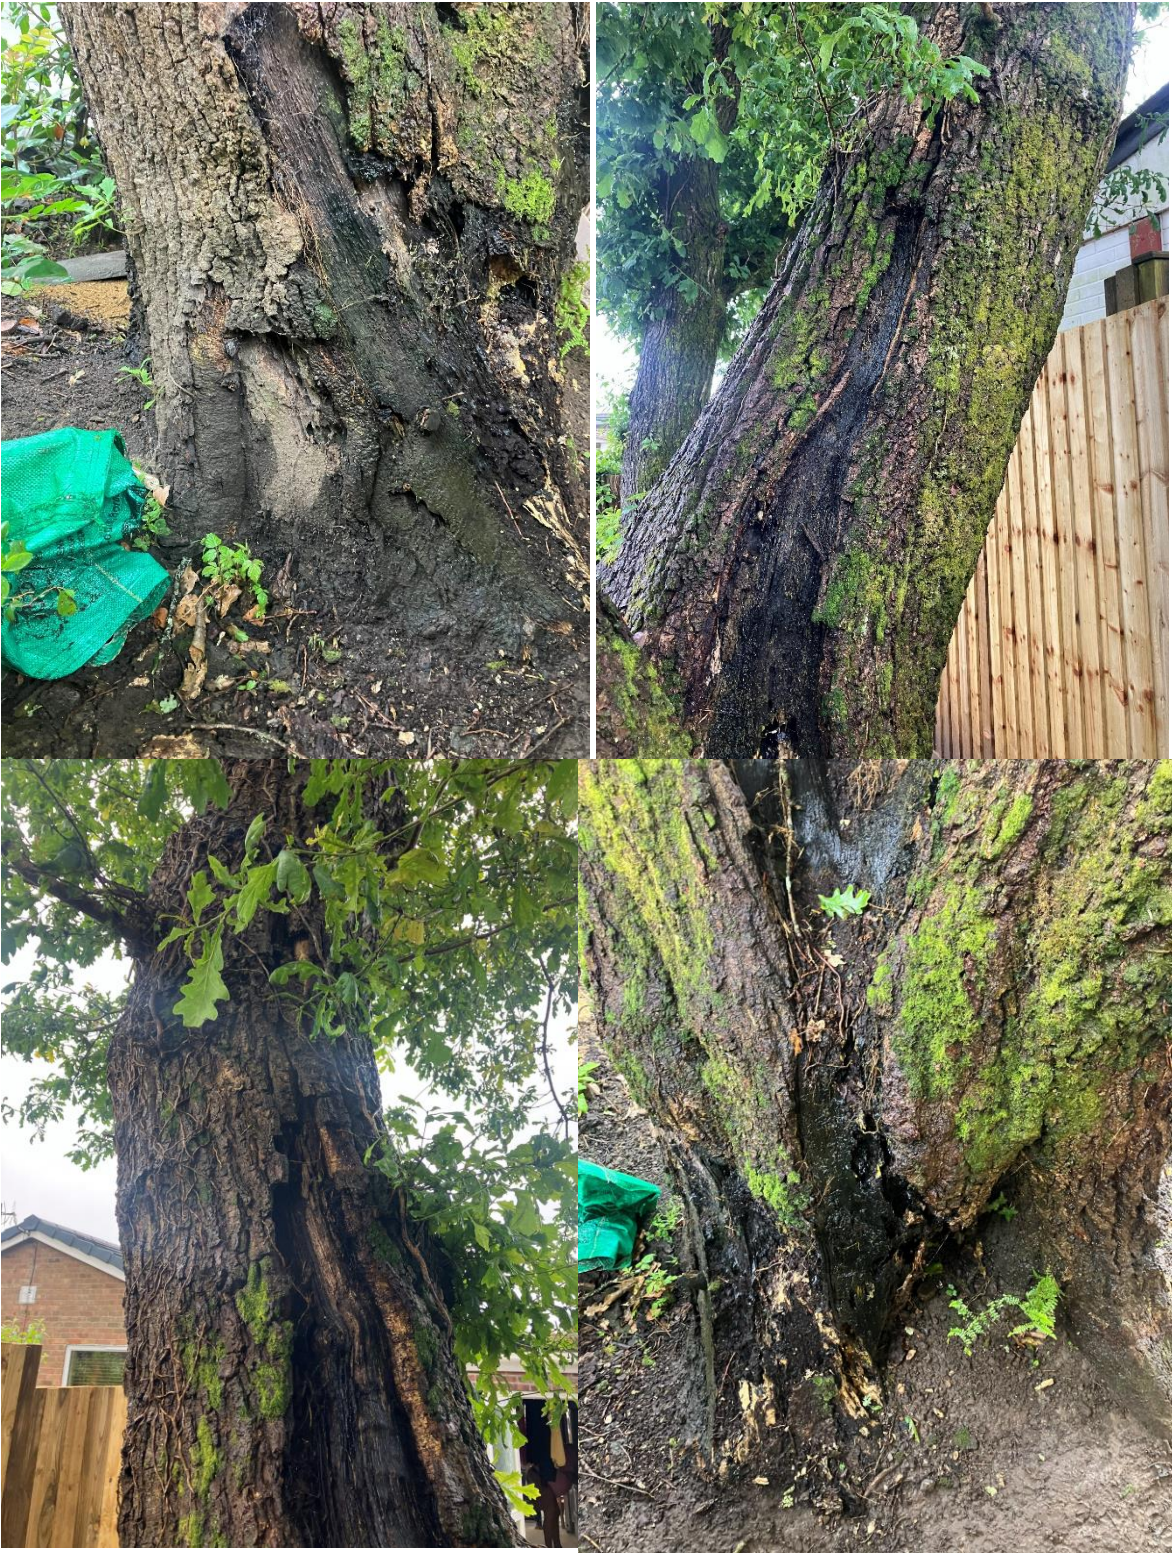
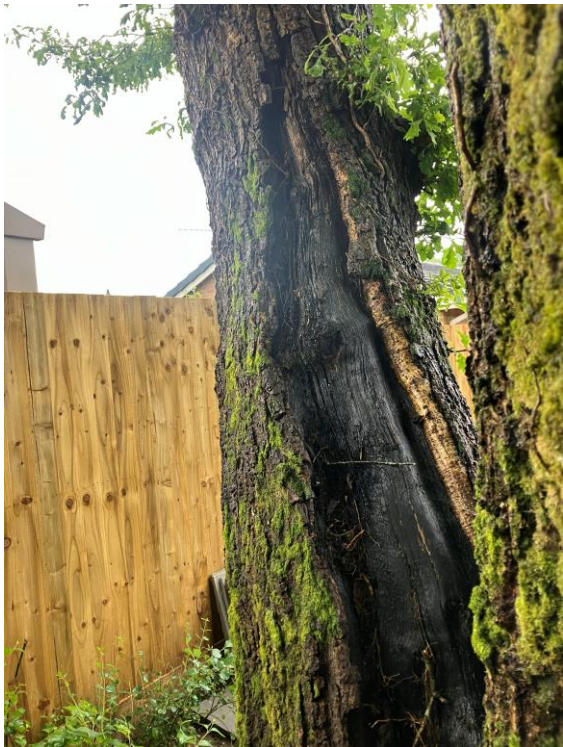
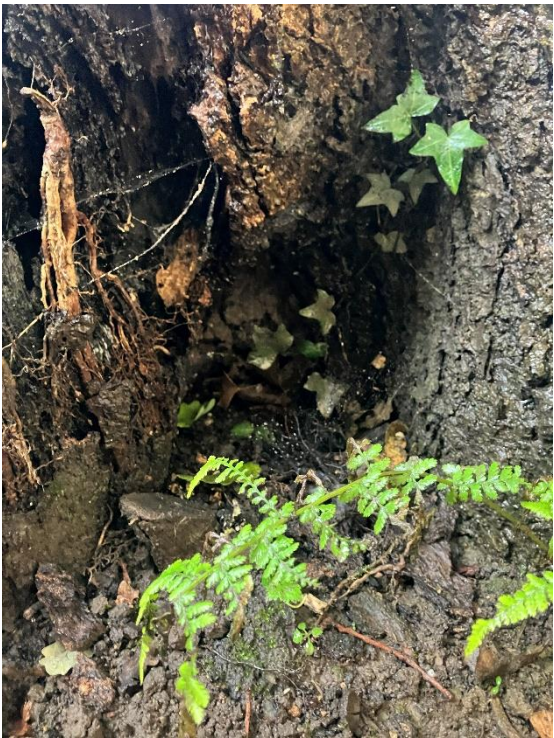
Evidence of T1

T1 is a large, mature tree that forks at approx. 18inches above ground level. The fork is broad with no areas of included bark or compression in the union. The tree is lacking obvious root space for the size of the tree. With multiple small developments/constructions in close proximity to the tree such as a garage and fence. Though the garage was built some time ago, the roots may have still been disturbed during the construction.

There is a large area of dysfunction on the tension side of both stems of T1. Even with it being a common oak, the extent of decay is still a concern especially with the colonisation of Honey fungus. The extent of this decay even without invasive techniques is of high concern. Honey fungus breaks down the structural wood and lignin within the roots and butt area of the tree. It leads to root decay and potentially windthrow. It also has a detrimental effect on the vascular system of the tree preventing the passing of nutrients, which causes canopy dieback.

There looks to be older dysfunction below the union at the base. There is Extensive decay/dysfunction at the base of the union. Resulting honey fungus has colonised the wounds and beyond. There is a lot of rhizomorphs or "bootlaces" present in and around the wounds. Wounds run up both stems, approx 3m up north stem, 2.5m up south stem. The tree has attempted to put on ribbing growth to reduce the spread of decay (wall 4 codit).

The Canopy is starting to decline with evidence of dieback and smaller dead branches appearing. There is one large dead/decaying branch on the east side of the canopy with decaying fungus likely turkey tail present. The leaf coverage is quite extensive, however the majority of this would look to be epicormic growth. The epicormic growth is present on the main stems and it extends along the limbs. The leaf colour isn't as green as it should be, nor as green as the neighbouring trees. The leaves are slightly more yellow and underdeveloped in some cases.

I would recommend that T1 is to be removed in its entirety. This is due to the number of targets beneath the canopy of the tree and in proximity to the stems should they fail due to the extensive dysfunction in the main union of the tree. The tree is obviously in decline with more deadwood in the canopy than in previous years, some of which is over 100mm in diameter. The amount of epicormic growth throughout the tree would lead me to believe that the tree is under serious stress. And the vitality of the leaves also leads me to believe the tree is under stress as they aren't as green as they should be. I believe that the Honey fungus present in the main union is certainly contributing to the decline of the tree as is the nature of the decay mechanism of this fungi.

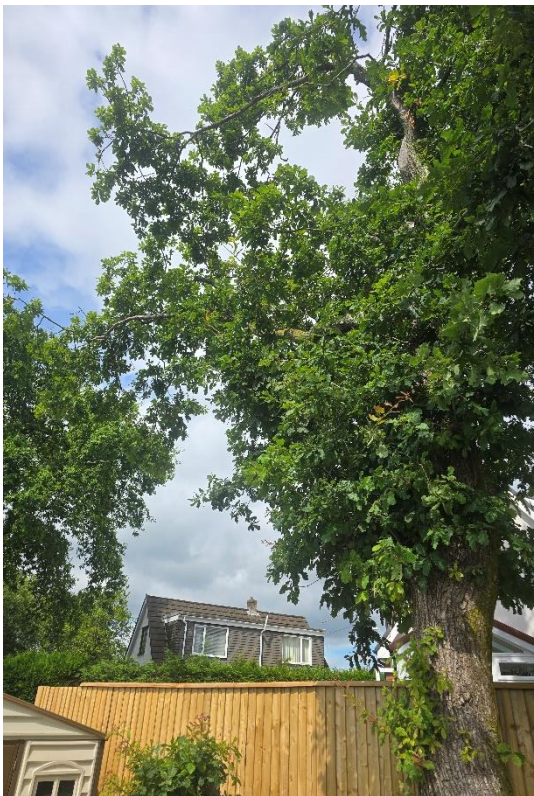
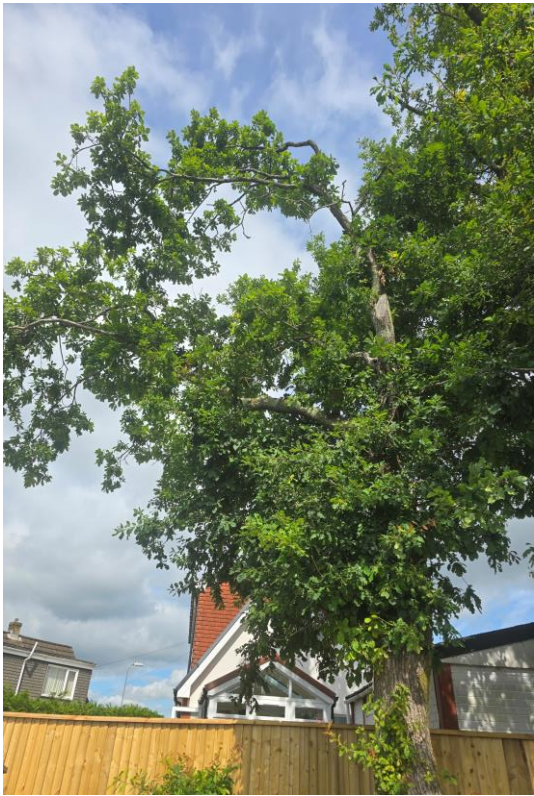
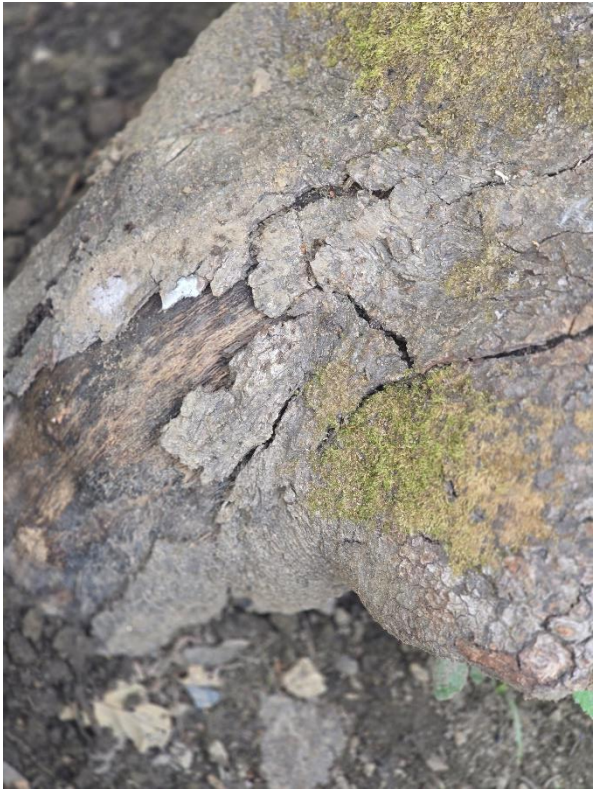
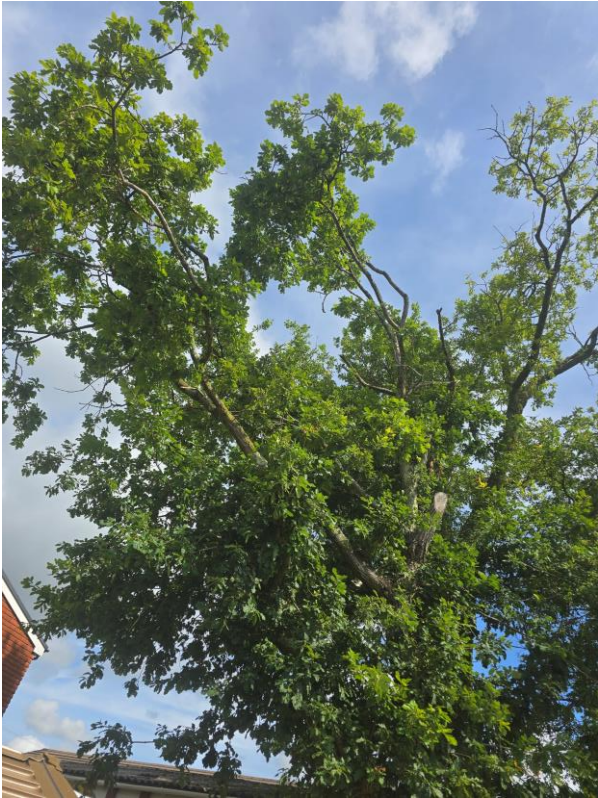
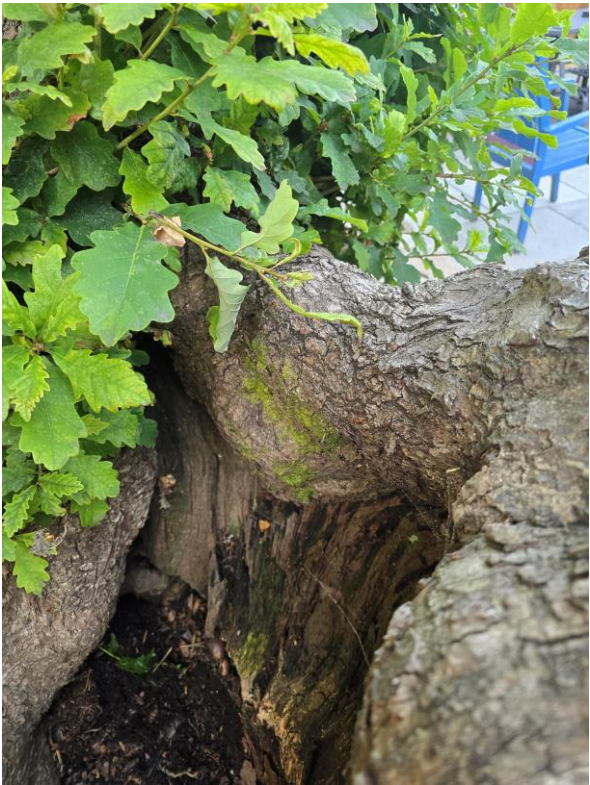
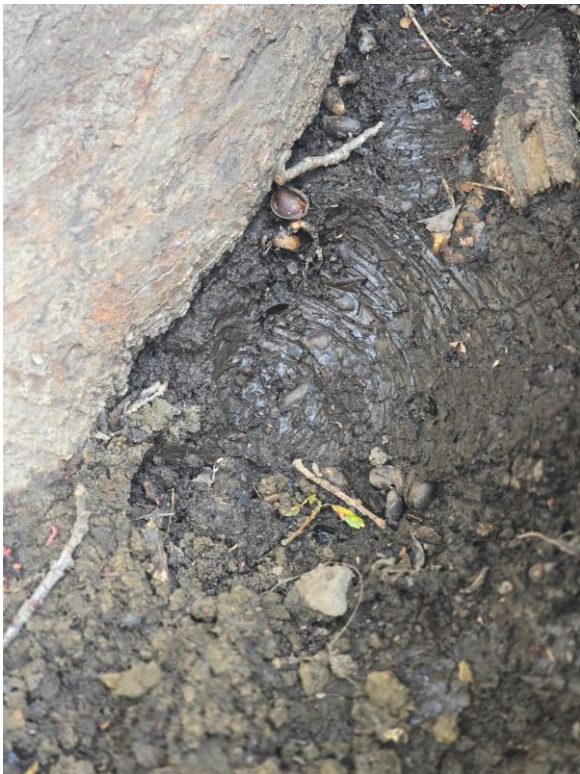
Evidence of T2

T2 is a much smaller single stem tree, which has had a lot of previous extensive pruning which has resulted in a lot of epicormic growth. It would seem the main leader has been removed at some point (not in accordance with BS3998:2010 recommendations for tree work), with a large 6inch wound in the centre of the remaining canopy. The tree is also in the shade of the larger T1.

The canopy is overextended to the South side of the tree, the unions of the limbs look stable however they are very long and tip heavy. I have concerns that these may fail if they are left too long, either through hazard beam fractures or cupboard door type failures. There are some smaller dead branches in the canopy which is likely an early sign of dieback resulting from subterranean stresses. These stresses are likely similar to the ones relating to T1.

At the base of T2 there is a cavity which is quite extensive (upwards of 50% of the overall diameter of the tree). This is also on the tension side of the tree. There are areas of bark flaking from buttress roots which will be contributing to the demise of the vascular system of the tree. Though I couldn't immediately see signs of Honey fungus, it's likely that it is present on this tree too as it is in such close proximity to T1. This colonisation is what's likely lead to the bark flaking from the buttress areas.

My initial thought was that T2 could be retained. However, after considering the removal of T1 this would compromise T2 greatly. The resulting instability and exposure to any adverse weather conditions would almost certainly lead to failure of the overextended limbs or potential windthrow due to the poor rooting conditions/area.
