## Drainage Survey Report

**Job Number : 21618**

**Project Name: Cefn Lodge Nursing Home, Cefn-Parc, Skewen, Neath SA10 6YR**

**Site Date: 19-05-2026**

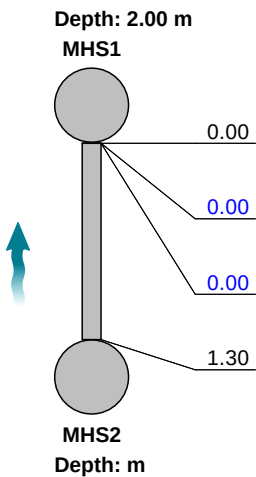
## Section Inspection - 19/05/2026 - MHS2X

| Scale: | 1:50 | Position [m] | Code | Observation | MPEG | Photo | Grade |
|---|---|---|---|---|---|---|---|
| | | 0.00 | MH | Start node, manhole, reference: SMH1 | 00:00:00 | | |
| | | 0.00 | WL | Water level, 10% of the vertical dimension | 00:00:02 | | |
| | | 0.00 | REM | General remark: A PIPE | 00:01:09 | | |
| | | 1.30 | MHF | Finish node, manhole, reference: SMH2 | 00:00:13 | | |

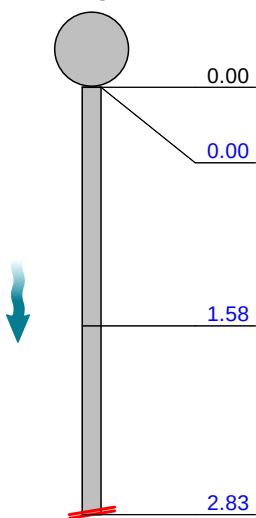
## Section Inspection - 19/05/2026 - MHS1X

| Scale: | 1:50 | Position [m] | Code | Observation | MPEG | Photo | Grade |
|---|---|---|---|---|---|---|---|
| | | 0.00 | WL | Water level, 30% of the vertical dimension | 00:00:02 | | |
| | | 1.58 | CUW | Loss of vision, camera under water | 00:00:12 | | |
| | | 2.83 | SA | Survey abandoned: UNABLE TO GET PASSED STONE IN LINE | 00:00:41 | | |

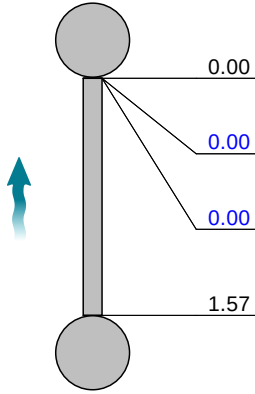
## Section Inspection - 19/05/2026 - MHS2X

<table><tr><td>0.00</td><td>MH</td><td>Start node, manhole, reference: MHS1</td><td>00:00:00</td></tr><tr><td>0.00</td><td>WL</td><td>Water level, 5% of the vertical dimension</td><td>00:00:01</td></tr><tr><td>0.00</td><td>REM</td><td>General remark: B PIPE</td><td>00:00:20</td></tr><tr><td>1.57</td><td>MHF</td><td>Finish node, manhole, reference: MHS2</td><td>00:00:15</td></tr></table>

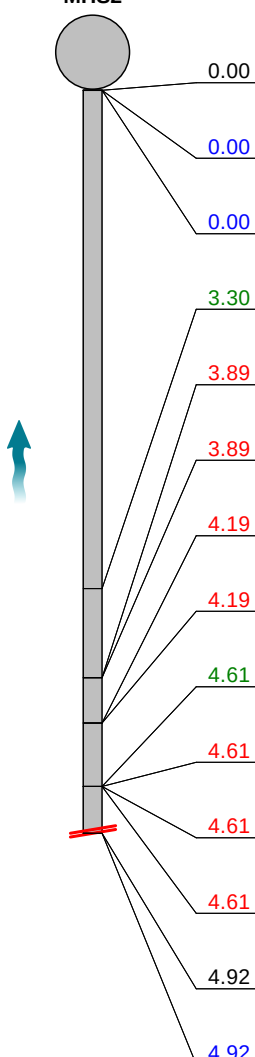
## Section Inspection - 19/05/2026 - MHS3X

<table><tr><td>0.00</td><td>MH</td><td>Start node, manhole, reference: MHS2</td><td>00:00:02</td><td></td></tr><tr><td>3.30</td><td>LR</td><td>Line deviates right</td><td>00:00:23</td><td></td></tr><tr><td>3.89</td><td>CL</td><td>Crack, longitudinal at 10 o'clock</td><td>00:00:30</td><td>2 / 2</td></tr><tr><td>3.89</td><td>CL</td><td>Crack, longitudinal at 12 o'clock</td><td>00:00:31</td><td>2 / 2</td></tr><tr><td>4.19</td><td>CL</td><td>Crack, longitudinal at 4 o'clock</td><td>00:00:37</td><td>2 / 2</td></tr><tr><td>4.19</td><td>CL</td><td>Crack, longitudinal at 6 o'clock</td><td>00:00:38</td><td>2 / 2</td></tr><tr><td>4.61</td><td>JDL</td><td>Joint displaced, large</td><td>00:00:47</td><td>1 / 4</td></tr><tr><td>4.61</td><td>FL</td><td>Fracture, longitudinal at 10 o'clock</td><td>00:00:58</td><td>3 / 2</td></tr><tr><td>4.61</td><td>FL</td><td>Fracture, longitudinal at 9 o'clock</td><td>00:00:59</td><td>3 / 2</td></tr><tr><td>4.92</td><td>SC</td><td>Pipe size changes, new size(s), 225mm high</td><td>00:01:13</td><td></td></tr><tr><td>4.92</td><td>SA</td><td>Survey abandoned: UNABLE TO GET PASSED DRIVE THROUGH</td><td>00:01:14</td><td></td></tr></table>

| STR No. Def | STR Peak | STR Mean | STR Total | STR Grade | SER No. Def | SER Peak | SER Mean | SER Total | SER Grade |
|---|---|---|---|---|---|---|---|---|---|
| 7 | 120.0 | 24.8 | 122.0 | 3.0 | 7 | 9.0 | 2.2 | 11.0 | 4.0 |
